W.W. SANDERS, JR.
F.W. KLAIBER
H.A. ELLEBY
L.W. TIMM
APRIL 1975

Interim Report
ISU-ERI-Ames-75101

**ULTIMATE LOAD BEHAVIOR OF FULL-SCALE
HIGHWAY TRUSS BRIDGES: PHASE I—
ULTIMATE LOAD TESTS OF THE HUBBY BRIDGE—
BOONE COUNTY**

Iowa State Highway Commission
HR-169

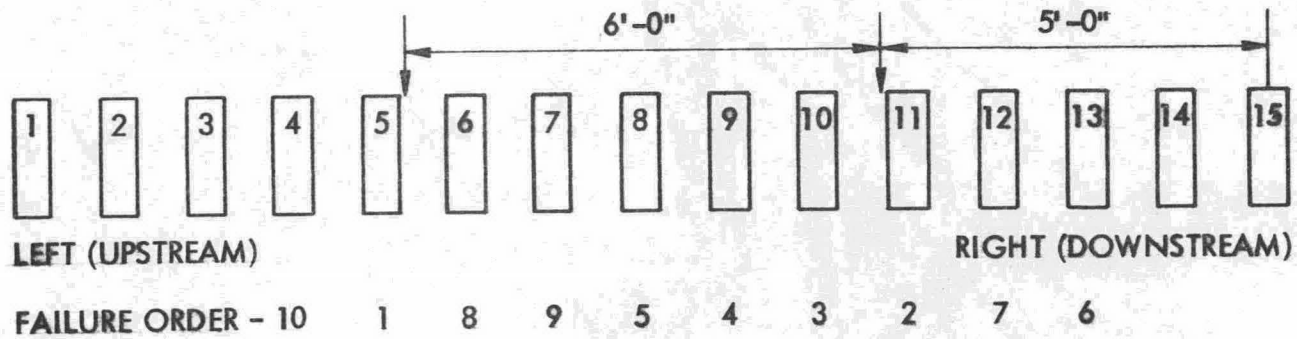
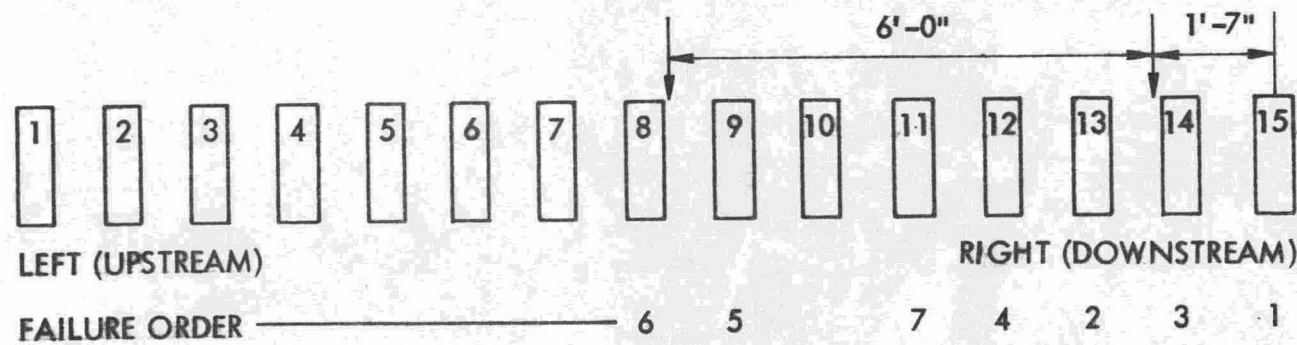
Fig. 13. Numbering system and failure order of stringers for deck tests 1 and 2.

Figure 13 shows the order in which the stringers failed for each of the two deck tests. The first two stringers to fail in deck test 1 were near the applied loads. The third through seventh stringers to fail were mainly under the influence of the loads on the right side of the panel. This behavior indicates either that more of the load was applied to the right side of the panel than to the left side of the panel or that the right side of the panel was not as strong as the left side of the panel. The last three stringers to fail were under the influence of the load on the left side of the panel.

The first four stringers to fail in deck test 2 were located near the load that was applied toward the edge of the panel. This occurred because there were fewer stringers available to take the load that was applied toward the edge of the panel. The next two stringers to fail were under the load applied near the center of the panel. The final stringer to fail was located midway between the loads. This stringer failed as a result of the unfailed stringers trying to carry the load that had been carried by the previously failed stringers.

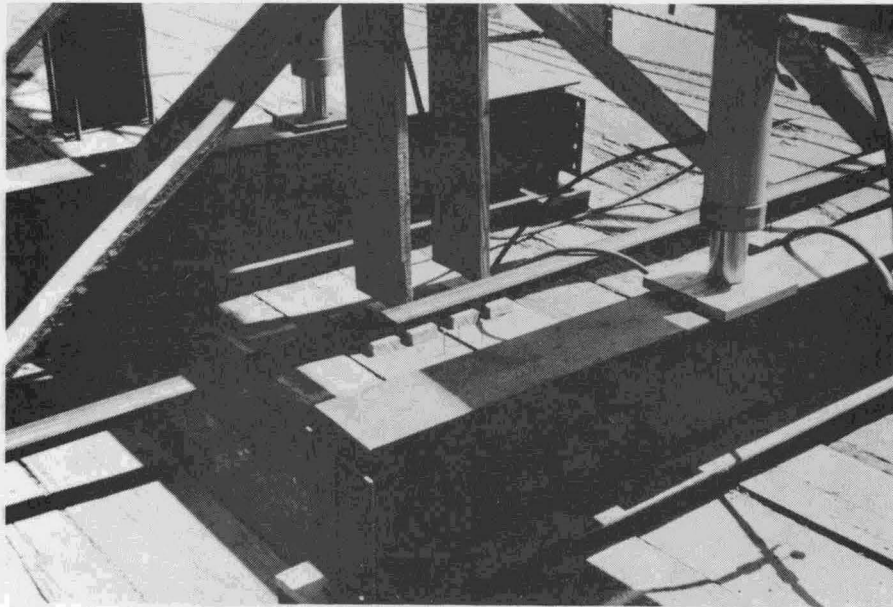
The load was first applied in increments of 10 kips, but as the loading progressed to higher levels, the load increments were reduced to 5 kips until failure was reached. Loading proceeded as planned on the first test at loads up to 65 kips, when the fifth stringer from the left broke. As the load was increased up to the maximum load of 101.5 kips, stringers split and failed. The behavior of the deck at loads above 65 kips can be seen in Fig. 17 and the failure order of the stringers in Fig. 13. At each failure there was a sudden drop in load. However, upon reloading there was usually a recovery of load and a further increase in load. After the failure of 10 stringers the test was terminated because the deck was unable to sustain any additional load. Figure 18 shows the top of the deck at a load near failure. The failed stringers are shown in Fig. 19.

Fig. 18. Photograph of deck test 1 near ultimate load.

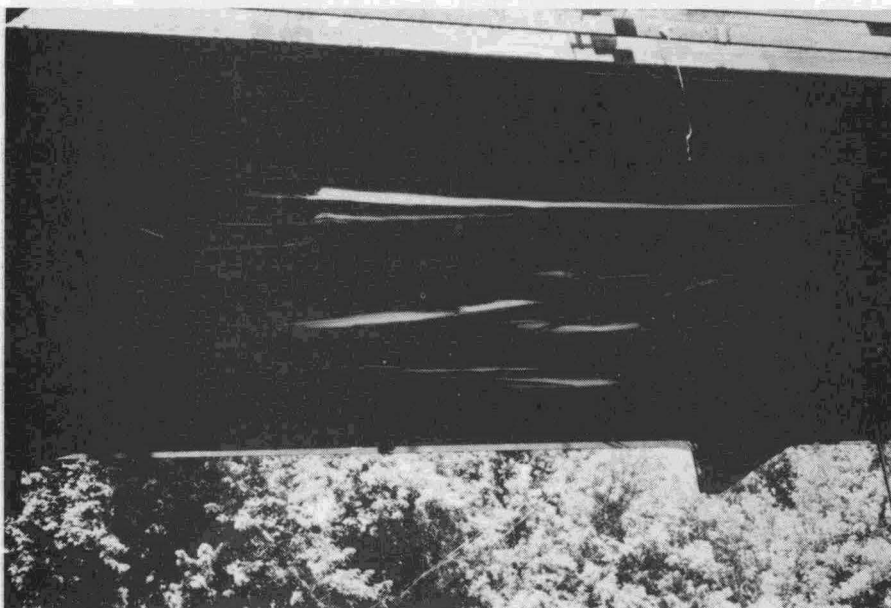
The final failure configuration of deck test 1 indicates that all of the failed stringers were interior stringers. Ten of the original 15 stringers were failed. The 5 remaining stringers appeared to be in excellent condition.

Fig. 19. Photograph of failed stringers from deck test 1.

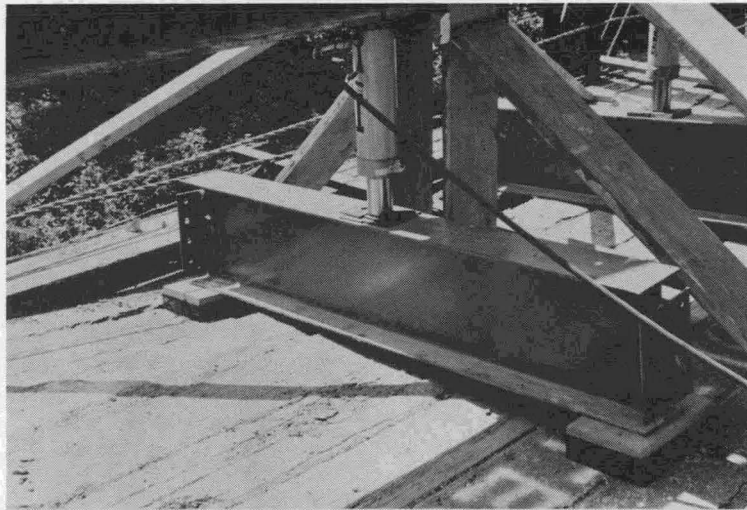
also given in Fig. 13. At each failure there was a sudden drop in load. However, upon reloading there was usually a recovery of load and a further increase in load. After the failure of seven stringers, the test was terminated due to the transverse load beam resting on the floor planking of the bridge, as shown in Fig. 21. Figure 22 shows the failed stringers near the loaded edge of the deck.

Fig. 21. Photograph of deck test 2 near ultimate load.

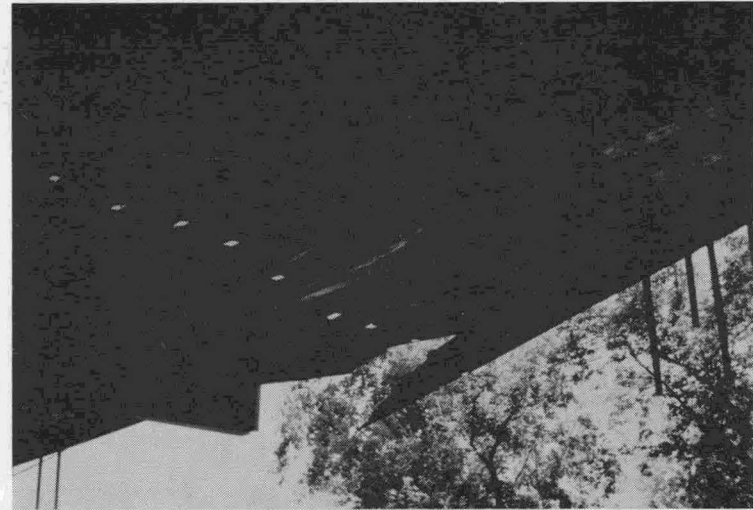
The failure of deck test 2 indicates that all of the failed stringers were on the loaded side of the panel. The failed stringers were clustered around the load points. Seven of the original 15 stringers were failed. The remaining unfailed stringers appeared to be in excellent condition.

Fig. 22. Photograph of failed stringers from deck test 2.

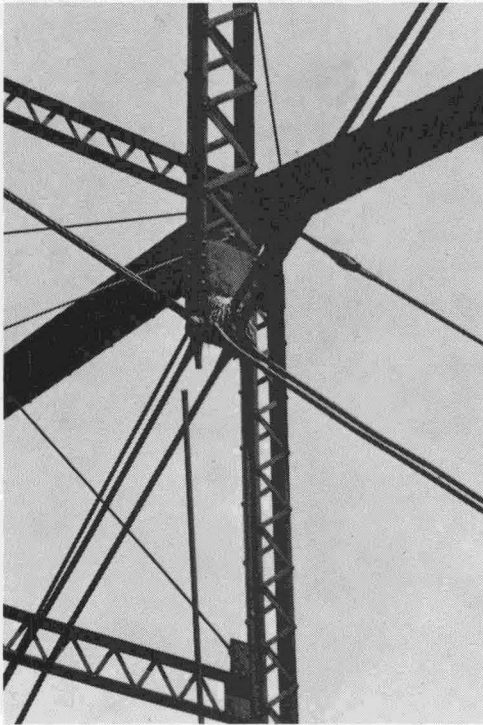
At a total load of 133 kips (106.4 kips at L_5 and 26.6 kips at L_4), one of the hangers at L_5 (upstream side) failed. The location of the failure and a close-up of the fracture are shown in Figs. 34 and 35.

The initial failure of the truss took place at a load of 133 kips. This failure was the breaking of one of the hangers which made up member L_5M_5 . The applied loading was 106 kips and 27 kips at L_5 and L_4 , respectively. Additional load was applied in an attempt to get additional members to fail. A large distortion of the lower chord of the truss near the load at L_5 occurred under this higher loading without any failure. The maximum load under this general loading was 140 kips; 112 kips at L_5 and 28 kips at L_4 . The maximum vertical deflection at L_5 at this time was 15 inches.

The capacity of the hangers at L_5 as calculated using data from coupon tests was 110 kips. This was just a few kips greater than the load that actually caused the fracture of one of these hangers. The actual stress at fracture was 47.4 kips/square inch. This indicates that the "lap," near where the fracture occurred, was about 97 percent effective. An examination of the fracture (Fig. 35) indicates also that only a very small portion of the section was not fused. The current practice is to assume the "lap" only 40 percent effective, which is much lower than the actual capacity of the member.

Fig. 34. Photograph showing location of failure of member L_5M_5 .

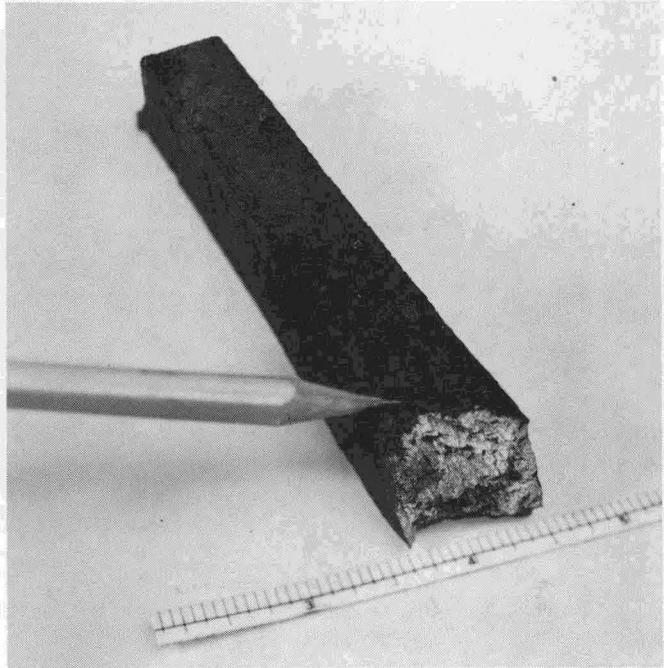
Fig. 35. Photograph of fracture.

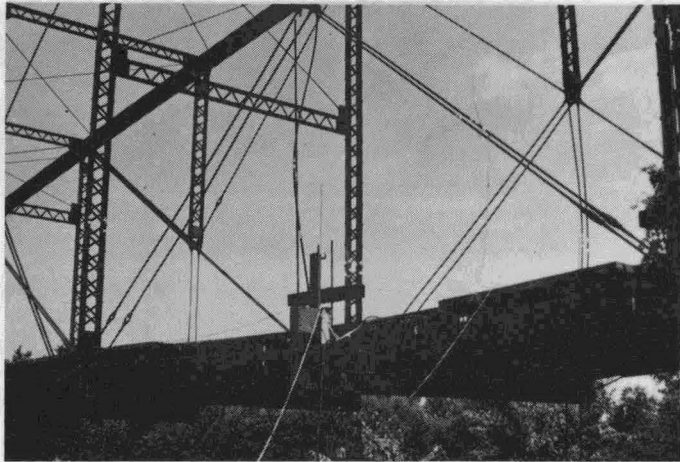
Fig. 36. Photograph of hangers buckling at L_5 .

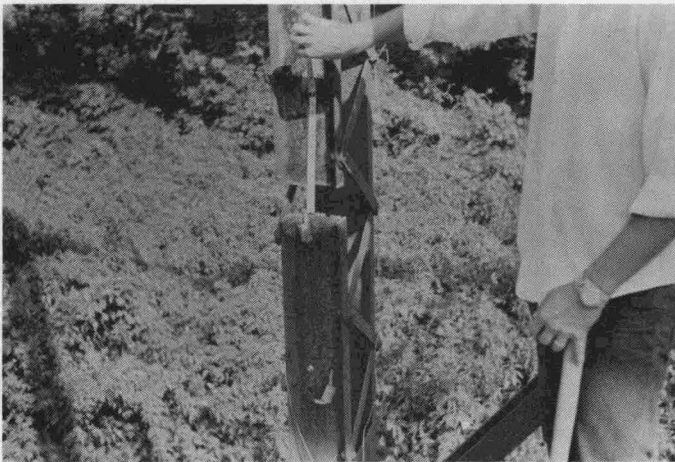
Fig. 38. Photograph of damaged member (one channel cut).

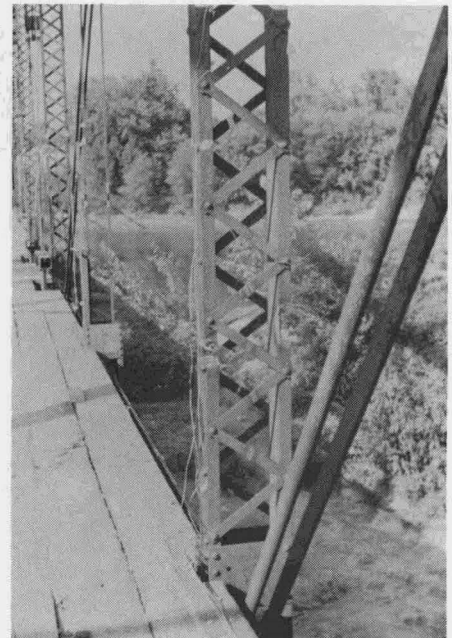
It was decided that further testing of the trusses would not provide additional meaningful information. The decision was then made to pursue the objectives of the second truss test by "damaging" one of the key members and reloading. To simulate the damage, member L_2U_2 was cut with an acetylene torch. This member was damaged because it is representative of laced channel compression members. Secondly, severely damaging an end post would result in an immediate catastrophic failure. Finally, the forces required to sufficiently damage an end post would require the use of an elaborate loading system. The cut (Fig. 38) was made 46 inches from the center line of the pin and 32 inches from the timber deck, but only one of the two channels comprising the members was cut. Initial instrumentation readings were taken and reloading at L_4 began. The load was increased to 70 kips with sets of instrumentation readings taken at periodic intervals. After the load of 70 kips was reached without any signs of additional distress, the decision was made to cut the other channel comprising member L_2U_2 to obtain a failure of the truss. The member was cut so as to leave only the web of one channel remaining intact (Fig. 39).

Fig. 39. Photograph of damaged member with only web of outside channel remaining.

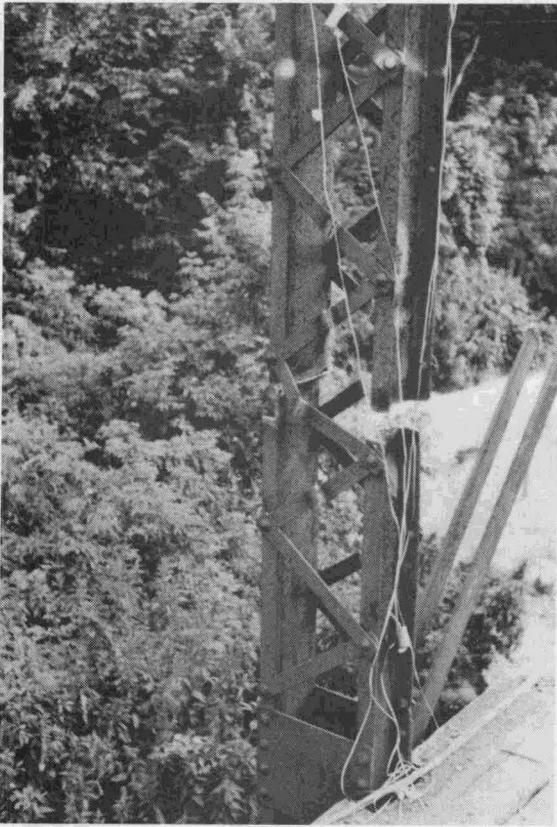
Fig. 40. Photograph of damaged member cut completely through.

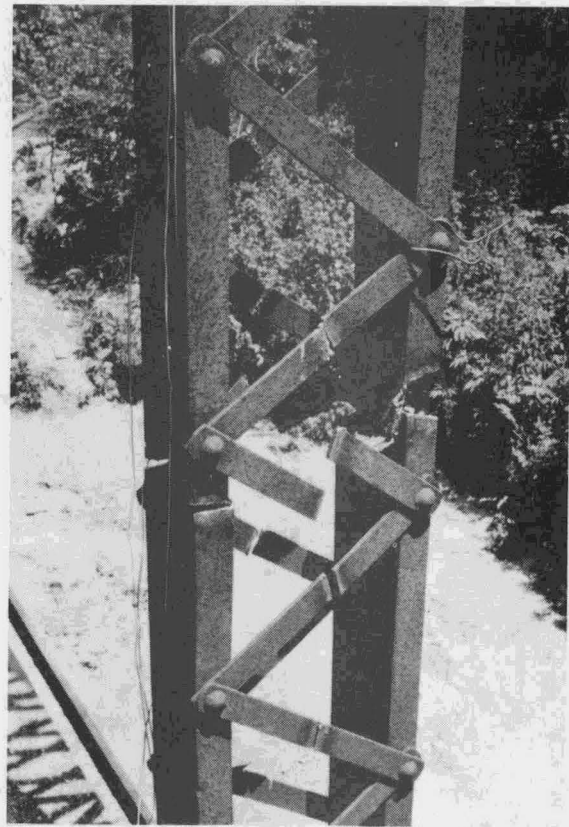
After adjustment of the loading system, all load was applied at L_4 with the maximum load being 78.5 kips. The test program then included damaging a member. After member L_2U_2 was cut completely through, a load of 39 kips produced a failure of the truss. This resulted in a vertical displacement of the member at the cut location.

Fig. 41. Photograph of damaged member after collapsing upon itself.

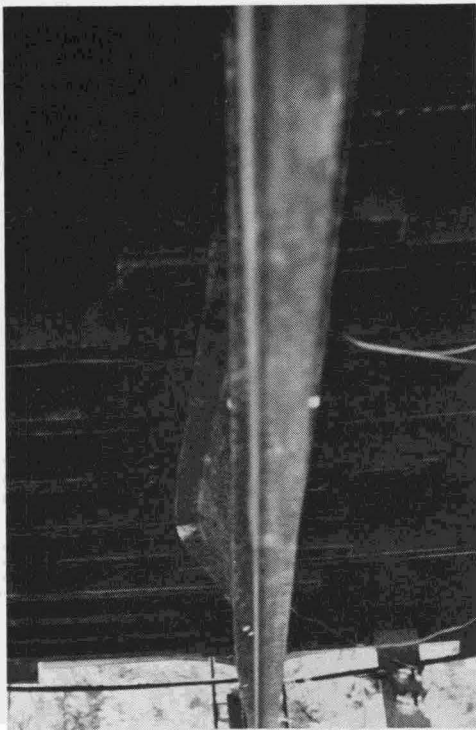
The load was first applied in increments of 10 kips, but as the loading progressed to higher levels the load increment was reduced to 5 kips until failure was reached. The test on floorbeam 5 proceeded as planned up to a load of 40 kips. At this load the floorbeam had started to buckle laterally between load points as well as to pull away from the timber stringers. As the load reached 45 kips the floorbeam continued to buckle laterally and pull away from the stringers. The load was then increased to 50 kips, at which point the lateral deflection due to buckling was approximately one inch beyond the initial crookedness of the floorbeam at its centerline. It was noted that a vertical channel which was part

Fig. 48. Photograph of buckling of compression flange of floorbeam 5.

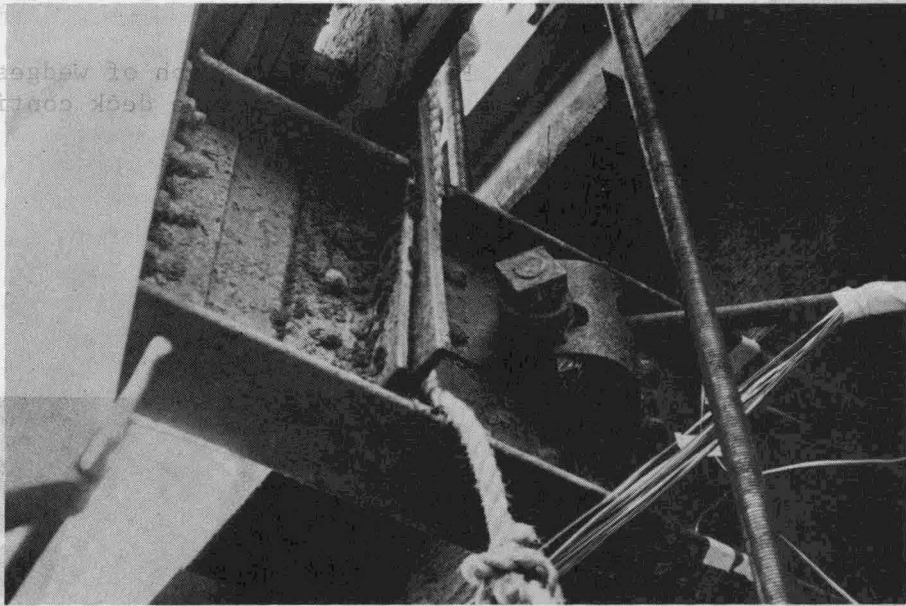
Fig. 52. Photograph showing where last four bolts broke.
