EVALUATION OF BOND RETAINAGE

**PORTLAND CEMENT
CONCRETE OVERLAYS**

**INFRARED THERMOGRAPHY
AND
GROUND PENETRATING RADAR**

**IOWA DEPARTMENT
OF TRANSPORTATION**

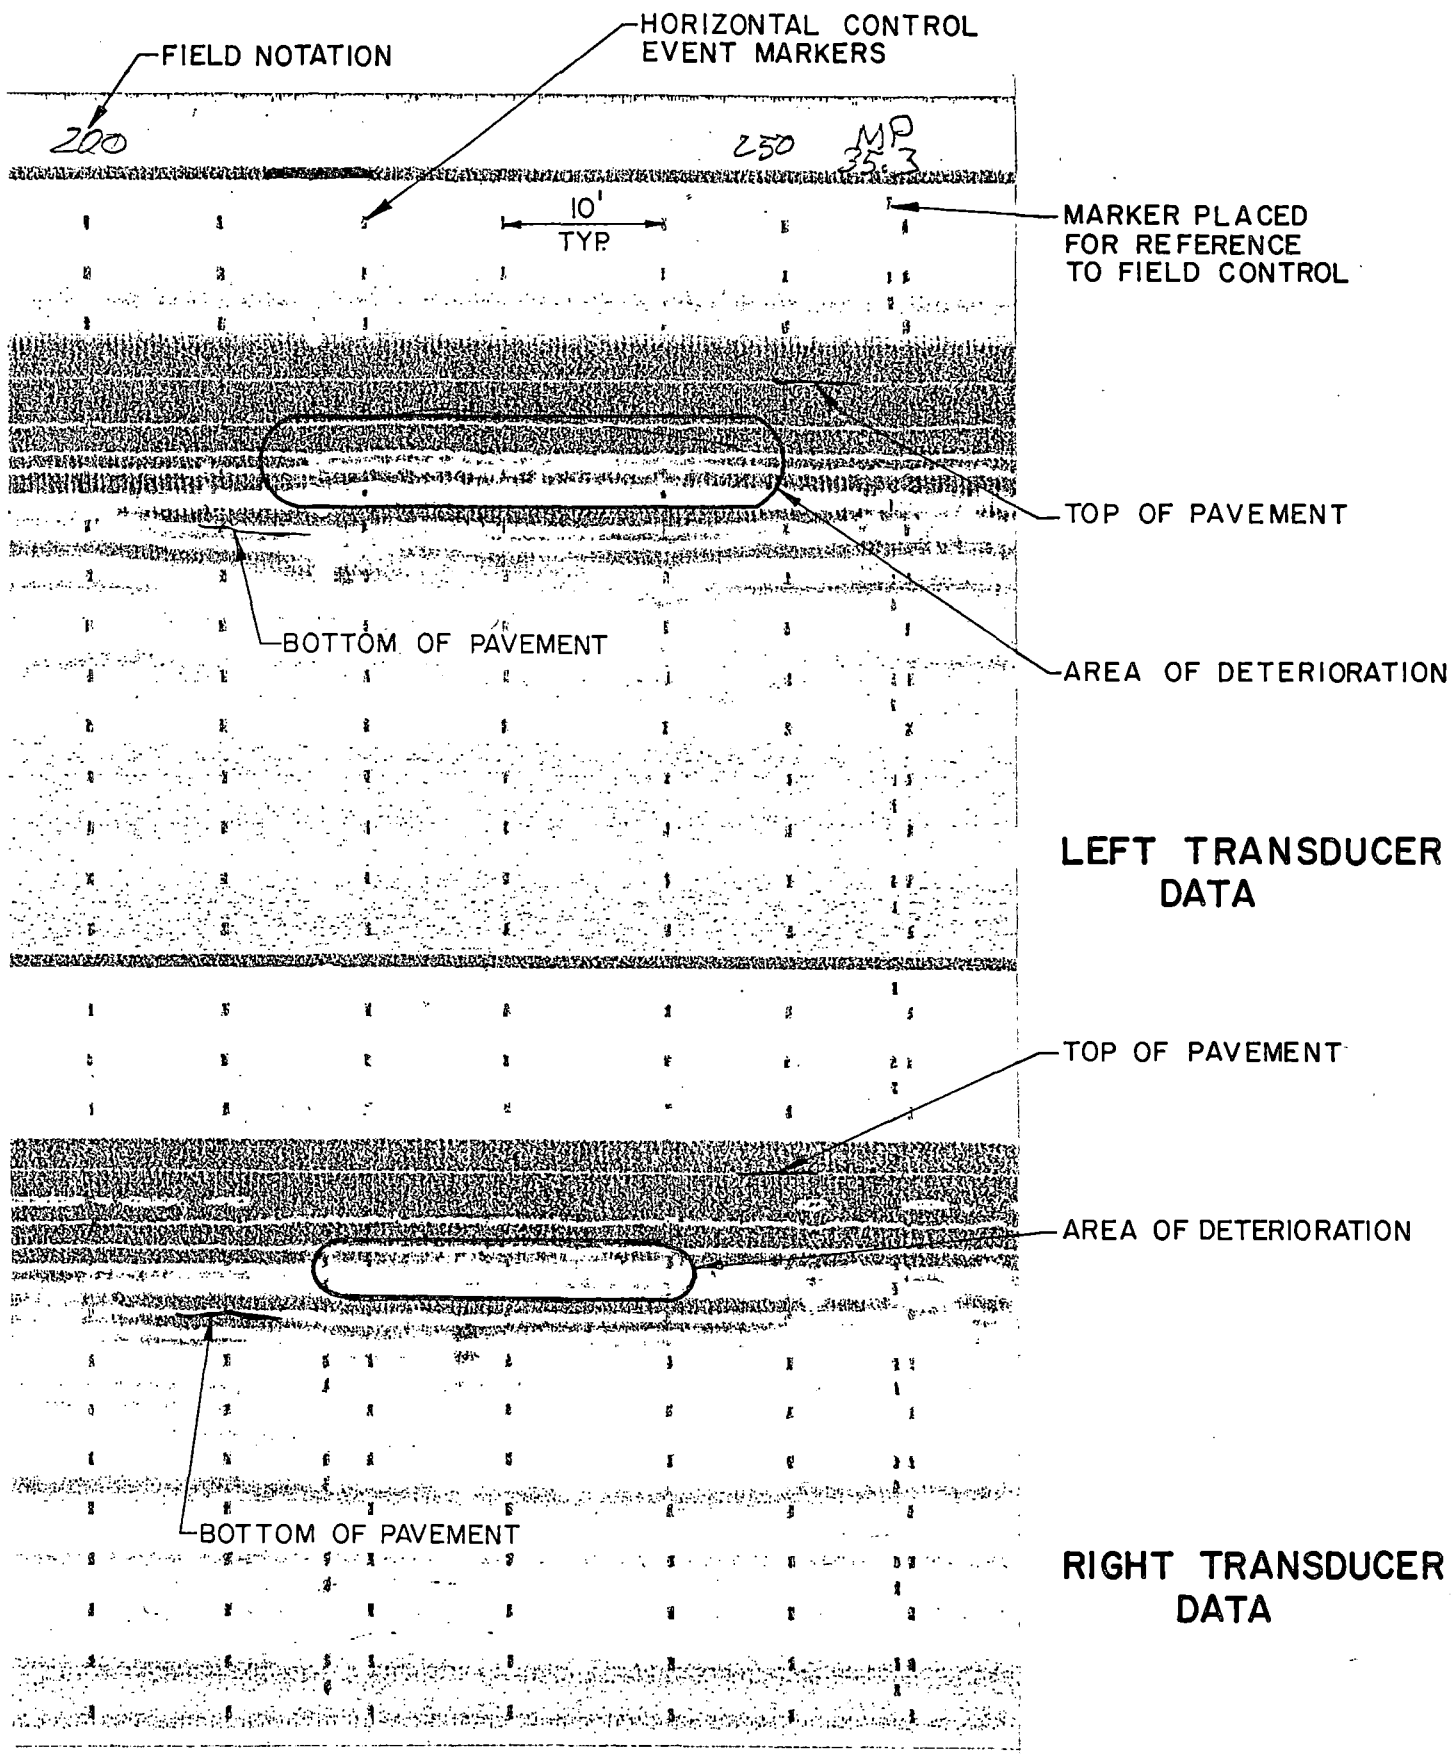
**FIGURE 3
SAMPLE OF GPR CHART SHOWING
DETERIORATION SIGNATURE
IOWA DEPT. OF TRANSPORTATION**

All three cores taken between mileposts 35.25 and 35.35 (Numbers 2, 3 and 4) and Core Number 2 between mileposts 36.00 and 36.10 on Interstate 80 were either broken during coring or broken when handled. While no debond condition was present, the cores broke easily, with light finger pressure, just below the interface between the original pavement and PCC overlay. We feel that these cores are representative of a weak concrete which is a preface to an early stage of deterioration where small fractures begin to occur. This is a condition that can be related to the degradation of the interface signature seen at various locations in these same sections (Figure 3). At two locations between mileposts 35.25 and 35.35 on Interstate 80, the degradation of the interface signature occurred in several of the data passes simultaneously.

At each site 6,336 feet of GPR data was collected and analyzed. This analysis identified 258 lineal feet of scan that showed this deteriorated condition between mileposts 35.25 and 35.35 (4.1%), and 116 lineal feet between mileposts 36.00 and 36.10 (1.8%). The location of this deterioration is shown in Appendix B. No GPR data representing any debonding that we can identify or deterioration was found at any of the other sites.

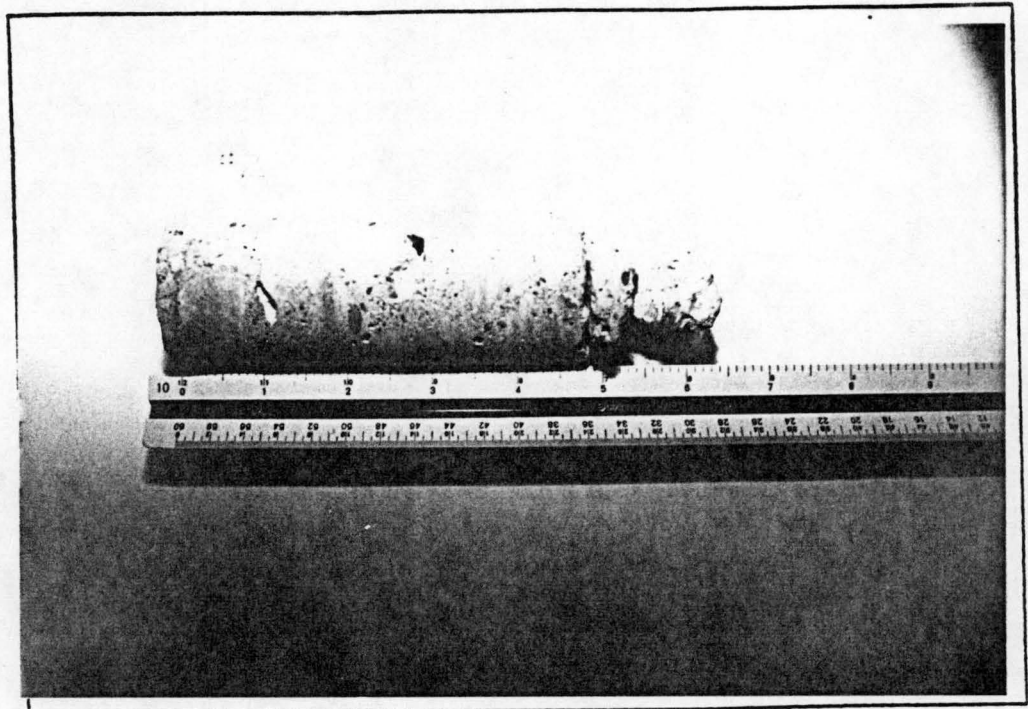
DATE: August 18, 1987
 PROJECT: Iowa D.O.T. - PCC Bond Evaluation
 CORE LOCATION: Interstate 80 - Milepost 35.25
 CORE: # 2
 DIAMETER: 2 inch
 OVERLAY THICKNESS: 4.25 inches
 CONCRETE THICKNESS: 11 inches
 FULL DEPTH Y/N: Yes
 CONDITION OF OVERLAY: Good
 DEFECTS IN CORE: Poor original pavement
 QUALITY OF CONCRETE: Poor
 REMARKS: Original Pavement broke easily

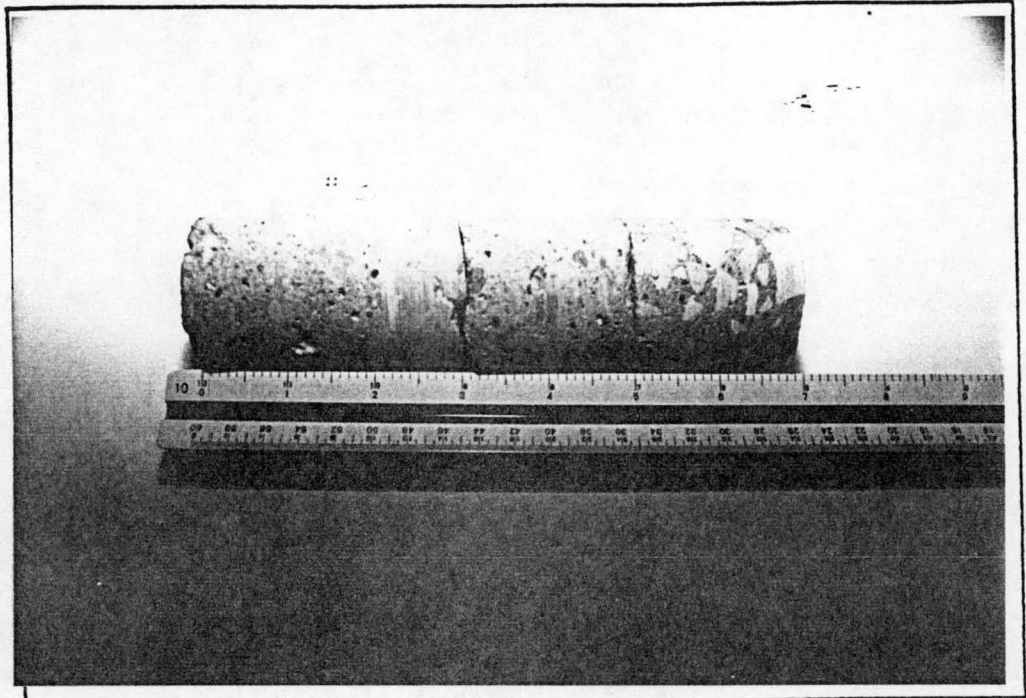
DATE: August 18, 1987
 PROJECT: Iowa D.O.T. - PCC Bond Evaluation
 CORE LOCATION: Interstate 80 - Milepost 35.25
 CORE: # 3
 DIAMETER: 2 inch
 OVERLAY THICKNESS: 4.75 inches
 CONCRETE THICKNESS: 7 inches
 FULL DEPTH Y/N: Yes
 CONDITION OF OVERLAY: Good
 DEFECTS IN CORE: Broke just beneath Bond
 QUALITY OF CONCRETE: Good
 REMARKS: _____

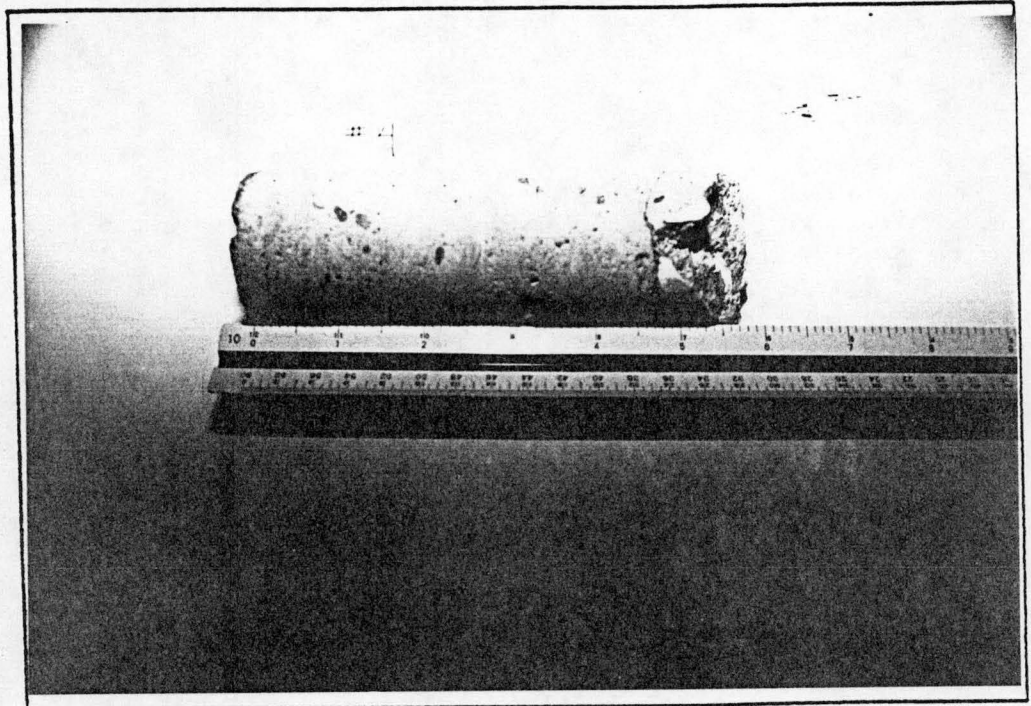
DATE: August 18, 1987
 PROJECT: Iowa D.O.T. - PCC Bond Evaluation
 CORE LOCATION: Interstate 80 - Milepost 35.25
 CORE: # 4
 DIAMETER: 2 inch
 OVERLAY THICKNESS: 4.5 inches
 CONCRETE THICKNESS: 11 inches
 FULL DEPTH Y/N: Yes
 CONDITION OF OVERLAY: Good
 DEFECTS IN CORE: Poor original pavement
 QUALITY OF CONCRETE: Poor
 REMARKS: Original pavement broke easily

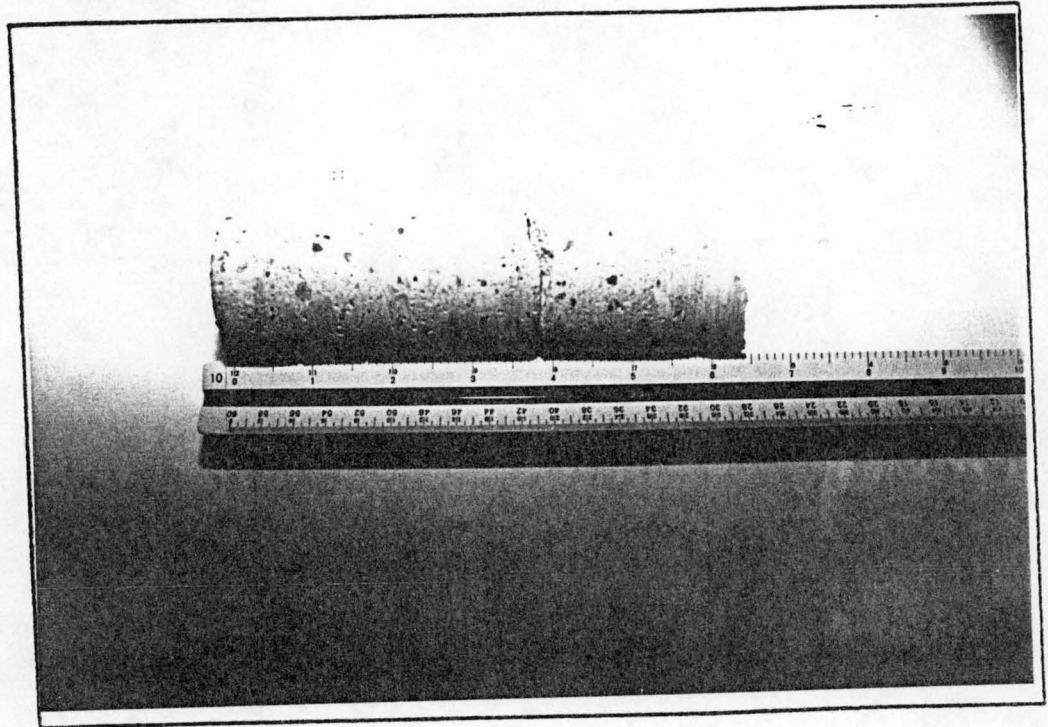
DEFECTS IN CORE: Poor original pavement

QUALITY OF CONCRETE: Poor

REMARKS: Original pavement broke easily

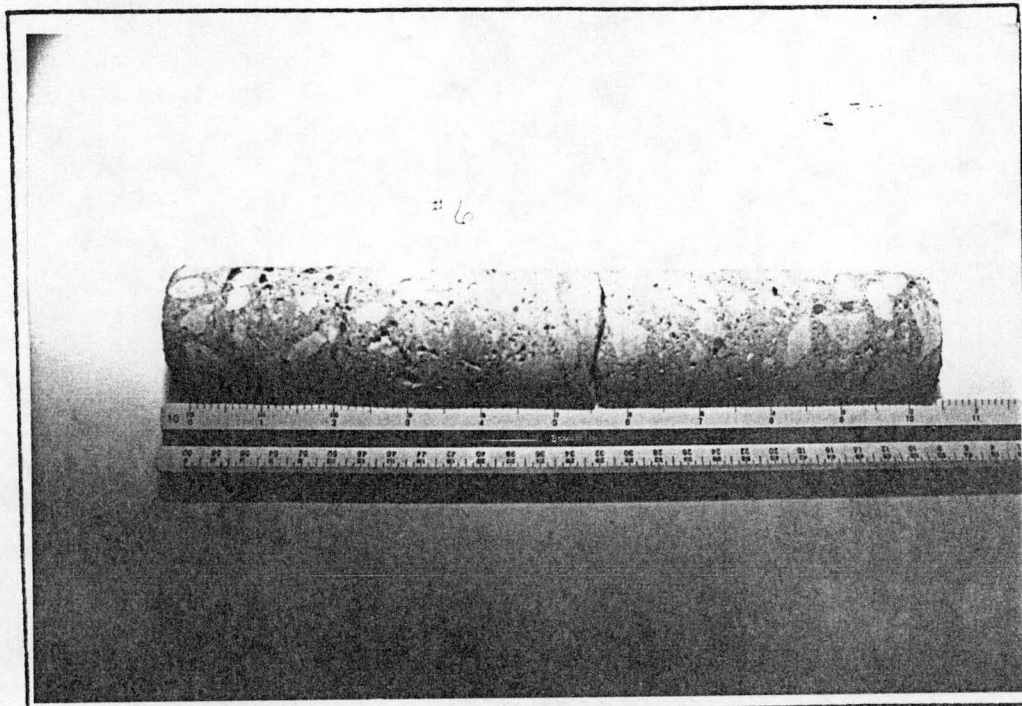
DATE: August 19, 1987
 PROJECT: Iowa D.O.T. - PCC Bond Evaluation
 CORE LOCATION: Iowa 141 - Milepost 135.9
 CORE: # 6
 DIAMETER: 2 inch
 OVERLAY THICKNESS: 10.25 inches
 CONCRETE THICKNESS: --
 FULL DEPTH Y/N: Yes
 CONDITION OF OVERLAY: Good
 DEFECTS IN CORE: None
 QUALITY OF CONCRETE: --
 REMARKS: Full Depth Repair Area

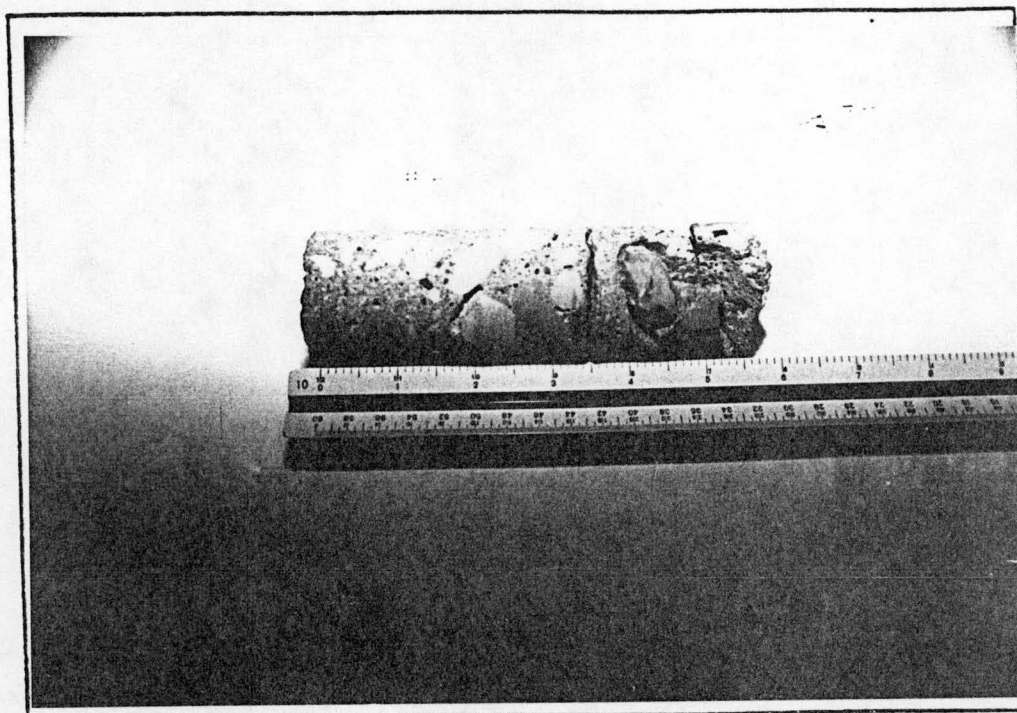
DATE: August 19, 1987
 PROJECT: Iowa D.O.T. - PCC Bond Evaluation
 CORE LOCATION: Iowa 141 - Milepost 137.0
 CORE: # 8
 DIAMETER: 2 inch
 OVERLAY THICKNESS: 3.5 inches
 CONCRETE THICKNESS: --
 FULL DEPTH Y/N: No
 CONDITION OF OVERLAY: Good
 DEFECTS IN CORE: Poor Original Pavement
 QUALITY OF CONCRETE: Poor
 REMARKS: Original Pavement Broke Easily

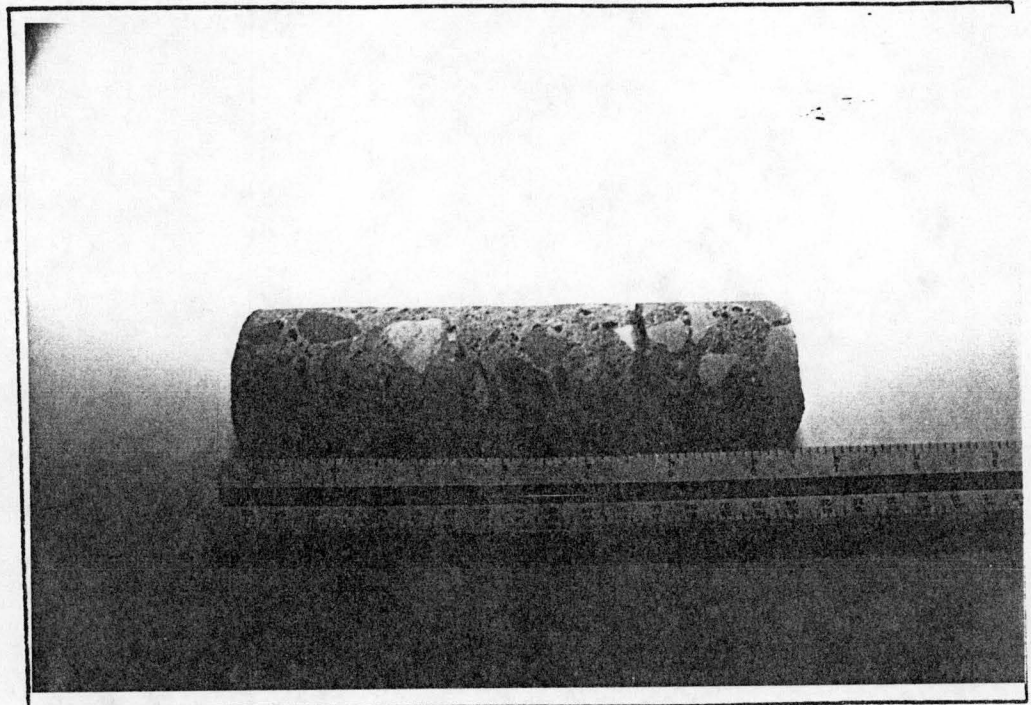
DEFECTS IN CORE: Debonded Overlay

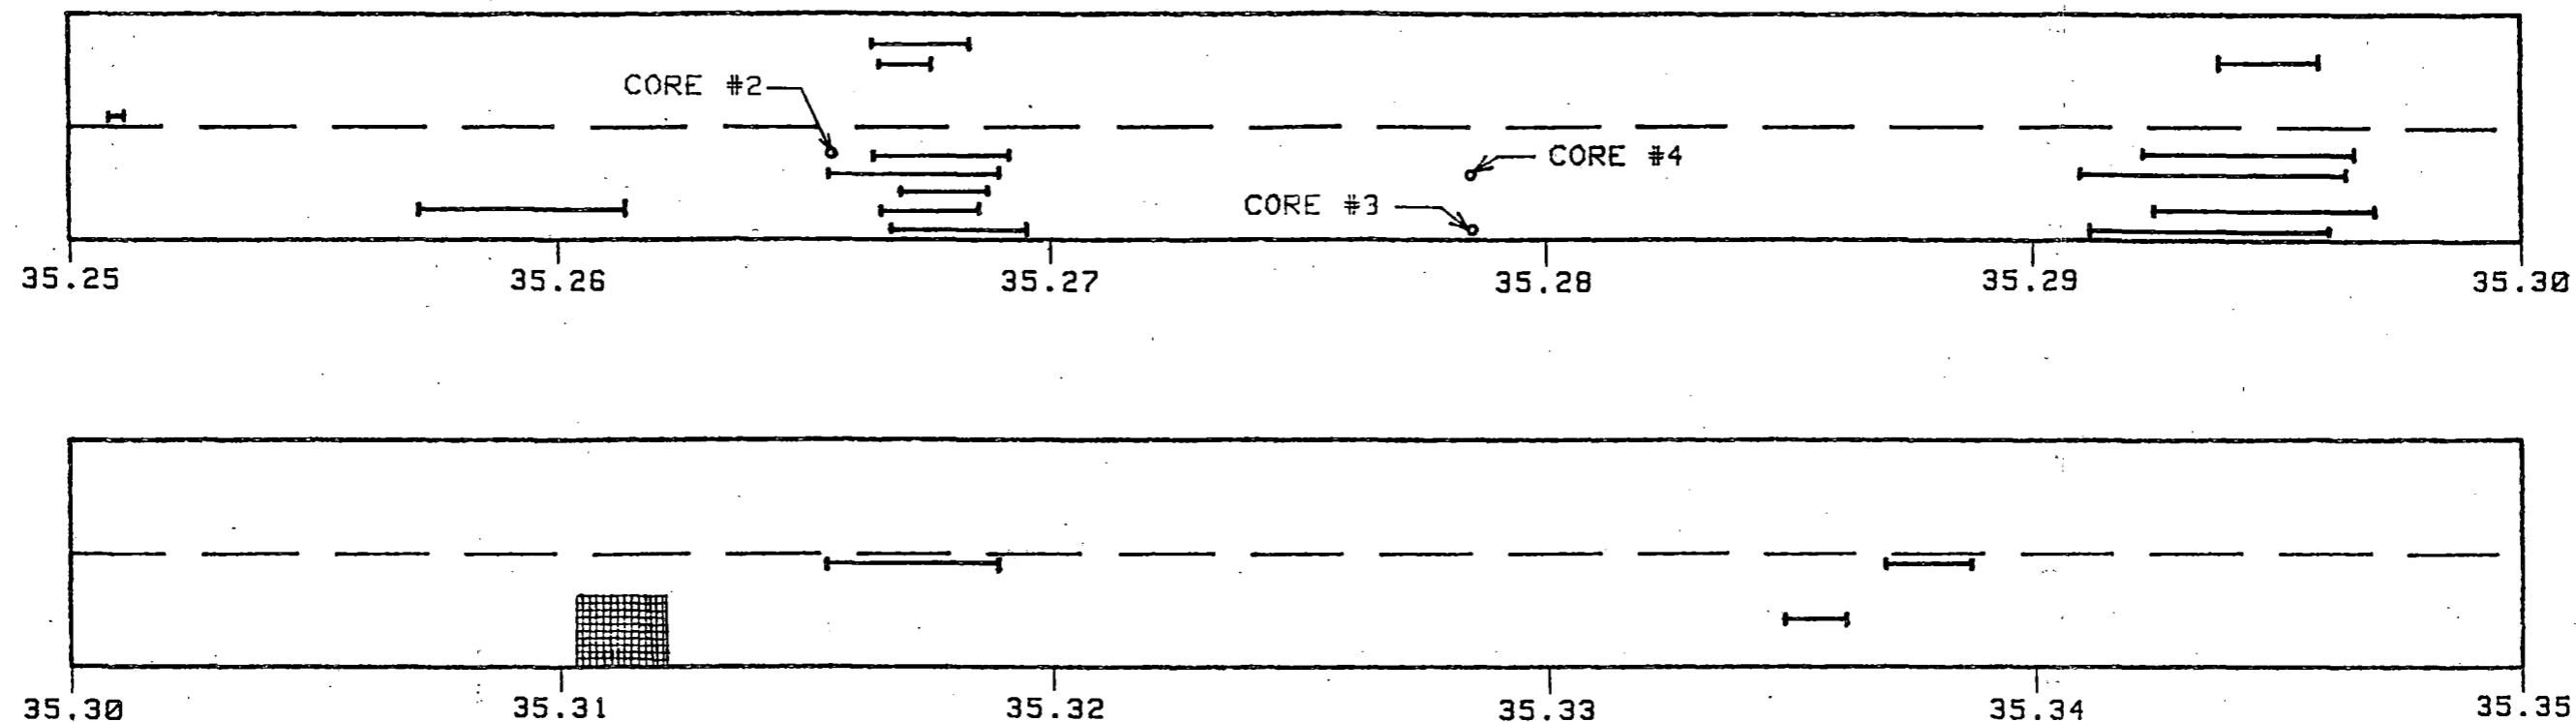
IR AND GPR EVALUATION OF BOND RETAINAGE
IN PORTLAND CEMENT CONCRETE OVERLAYS
I-80 (EASTBOUND) STA 35.25 TO STA 35.35
IOWA DEPARTMENT OF TRANSPORTATION

AREAS	EASTBOUND LANES
Total Area	12,672 (sq.ft.)
Debond (IR)	None (sq.ft.)
Concrete Patch	65 (sq.ft.)
Deterioration (GPR)	258 (lin.ft.)

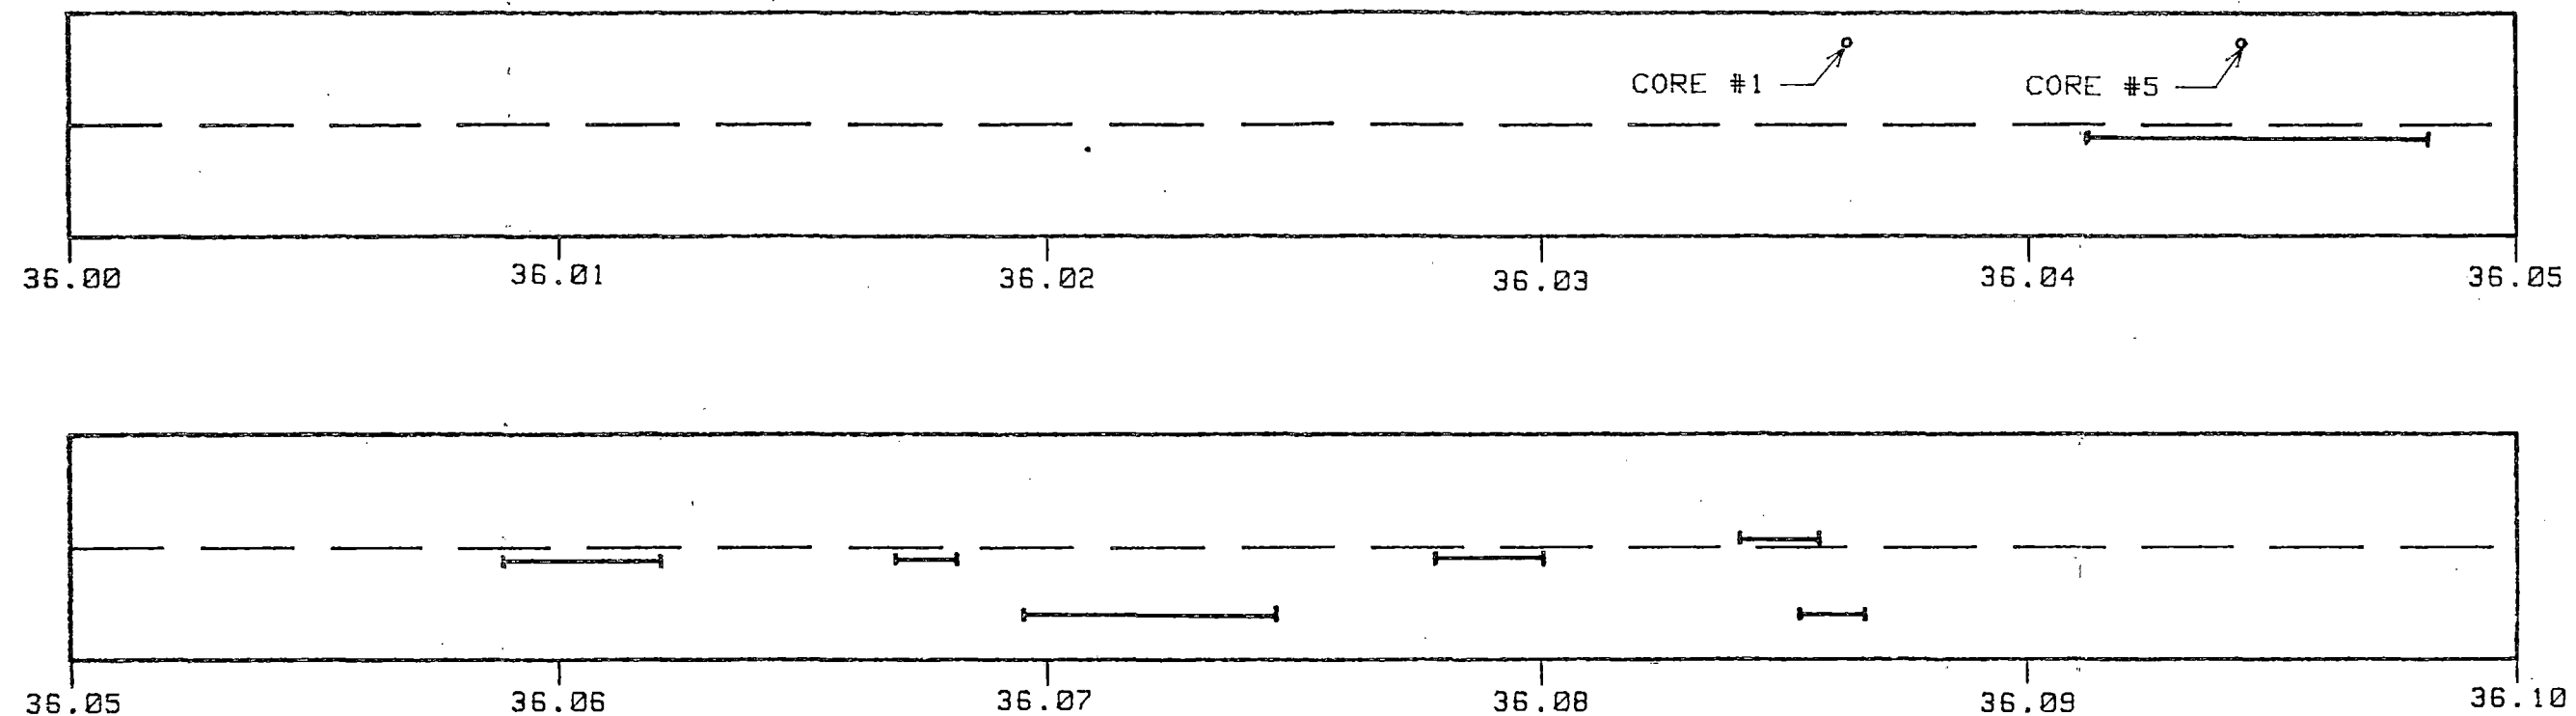
IR AND GPR EVALUATION OF BOND RETAINAGE
IN PORTLAND CEMENT CONCRETE OVERLAYS
I-80 (EASTBOUND) STA 36.00 TO STA 36.10
IOWA DEPARTMENT OF TRANSPORTATION

AREAS	EASTBOUND LANES
Total Area	12,672 (sq.ft.)
Debond (IR)	None (sq.ft.)
Concrete Patch	None (sq.ft.)
Deterioration (GPR)	116 (lin.ft.)

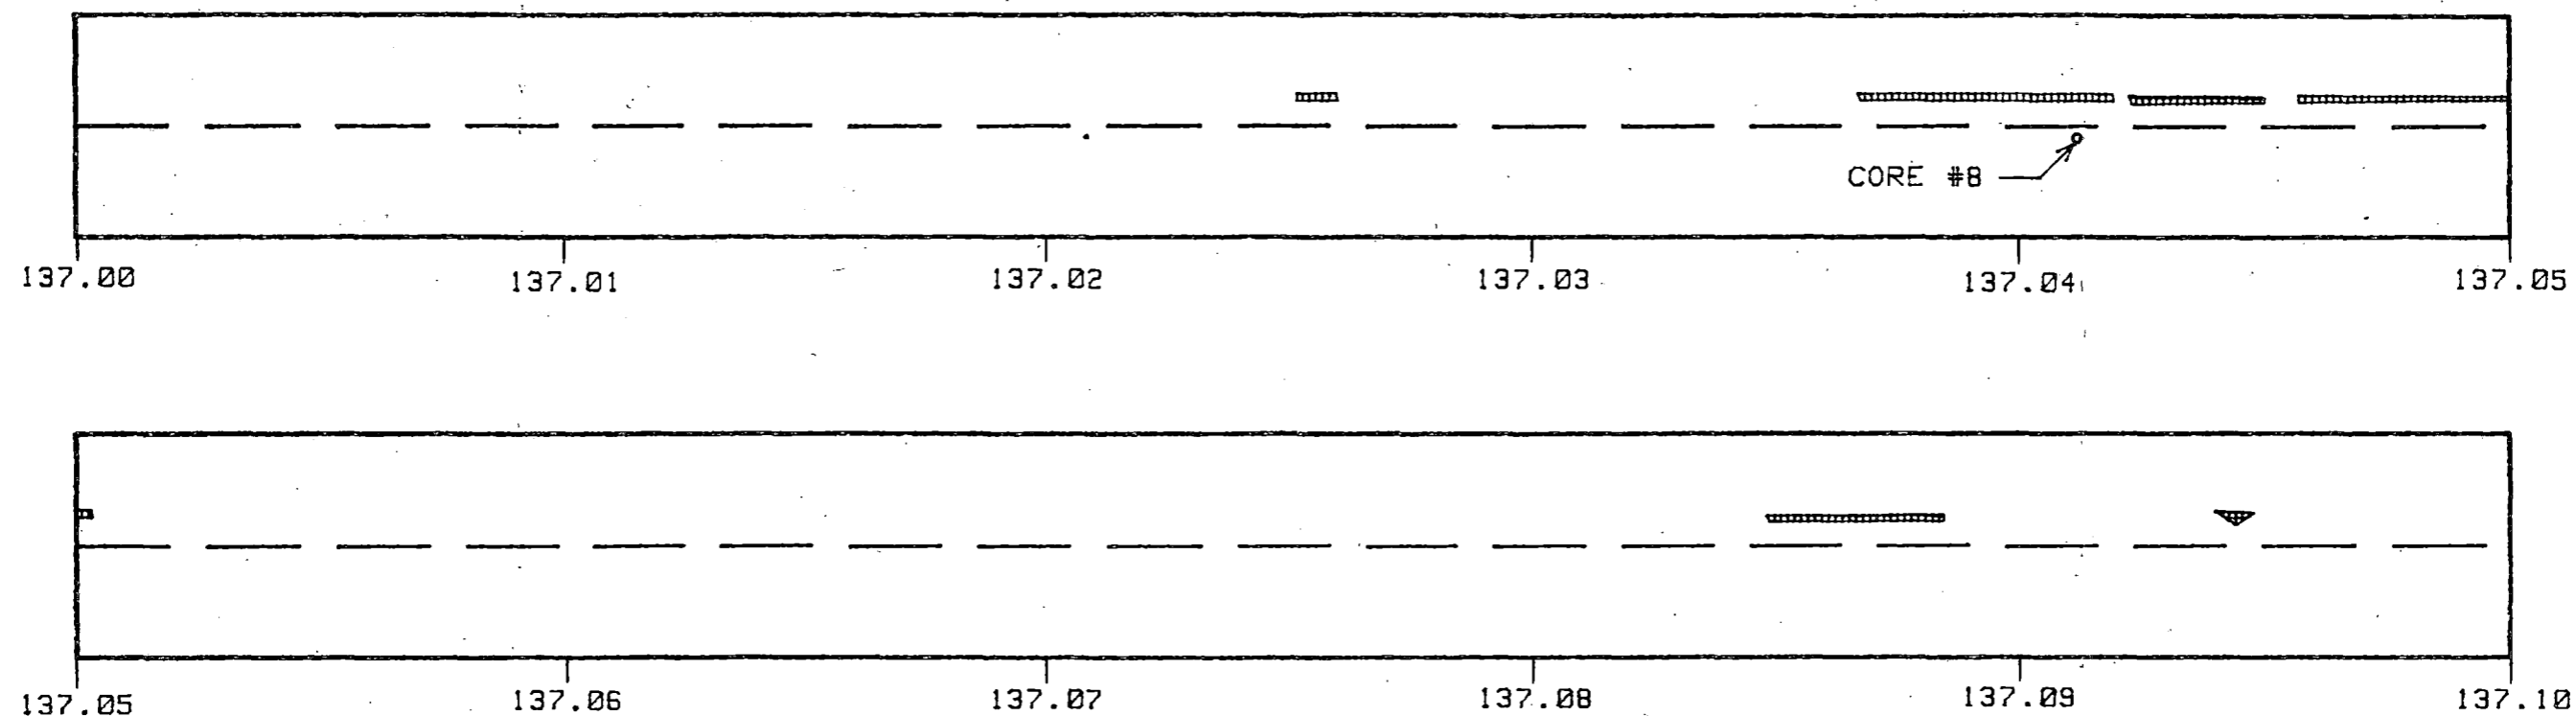
IR AND GPR EVALUATION OF BOND RETAINAGE
IN PORTLAND CEMENT CONCRETE OVERLAYS
SH141 (EB & WB) STA 137.00 TO STA 137.10
IOWA DEPARTMENT OF TRANSPORTATION

AREAS	EASTBOUND LANES	WESTBOUND LANES
Total Area	6,336 (sq.ft.)	6,336 (sq.ft.)
Debond (IR)	None (sq.ft.)	None (sq.ft.)
Concrete Patch	None (sq.ft.)	72 (sq.ft.)
Deterioration (GPR)	None (lin.ft.)	None (lin.ft.)

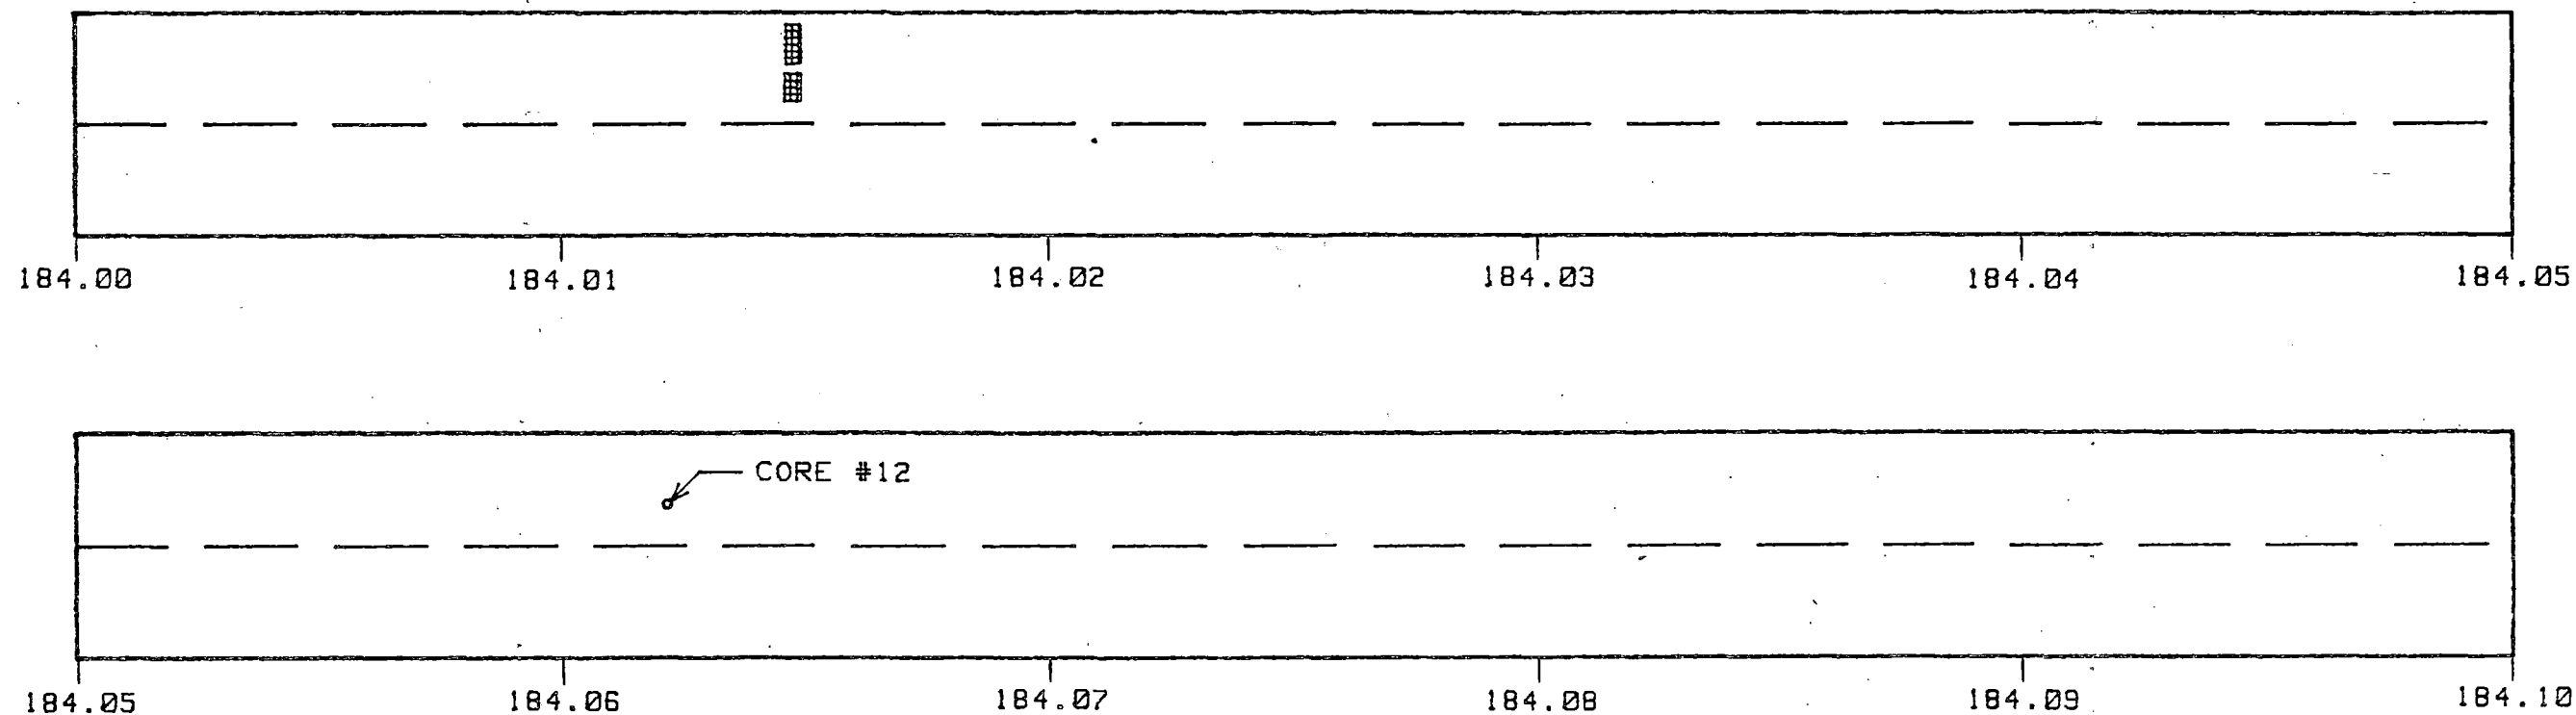
IR AND GPR EVALUATION OF BOND RETAINAGE
IN PORTLAND CEMENT CONCRETE OVERLAYS
I-80 (WESTBOUND) STA 184.00 TO STA 184.10
IOWA DEPARTMENT OF TRANSPORTATION

AREAS	WESTBOUND LANES
Total Area	12,672 (sq.ft.)
Debond (IR)	None (sq.ft.)
Concrete Patch	13 (sq.ft.)
Deterioration (GPR)	None (lin.ft.)

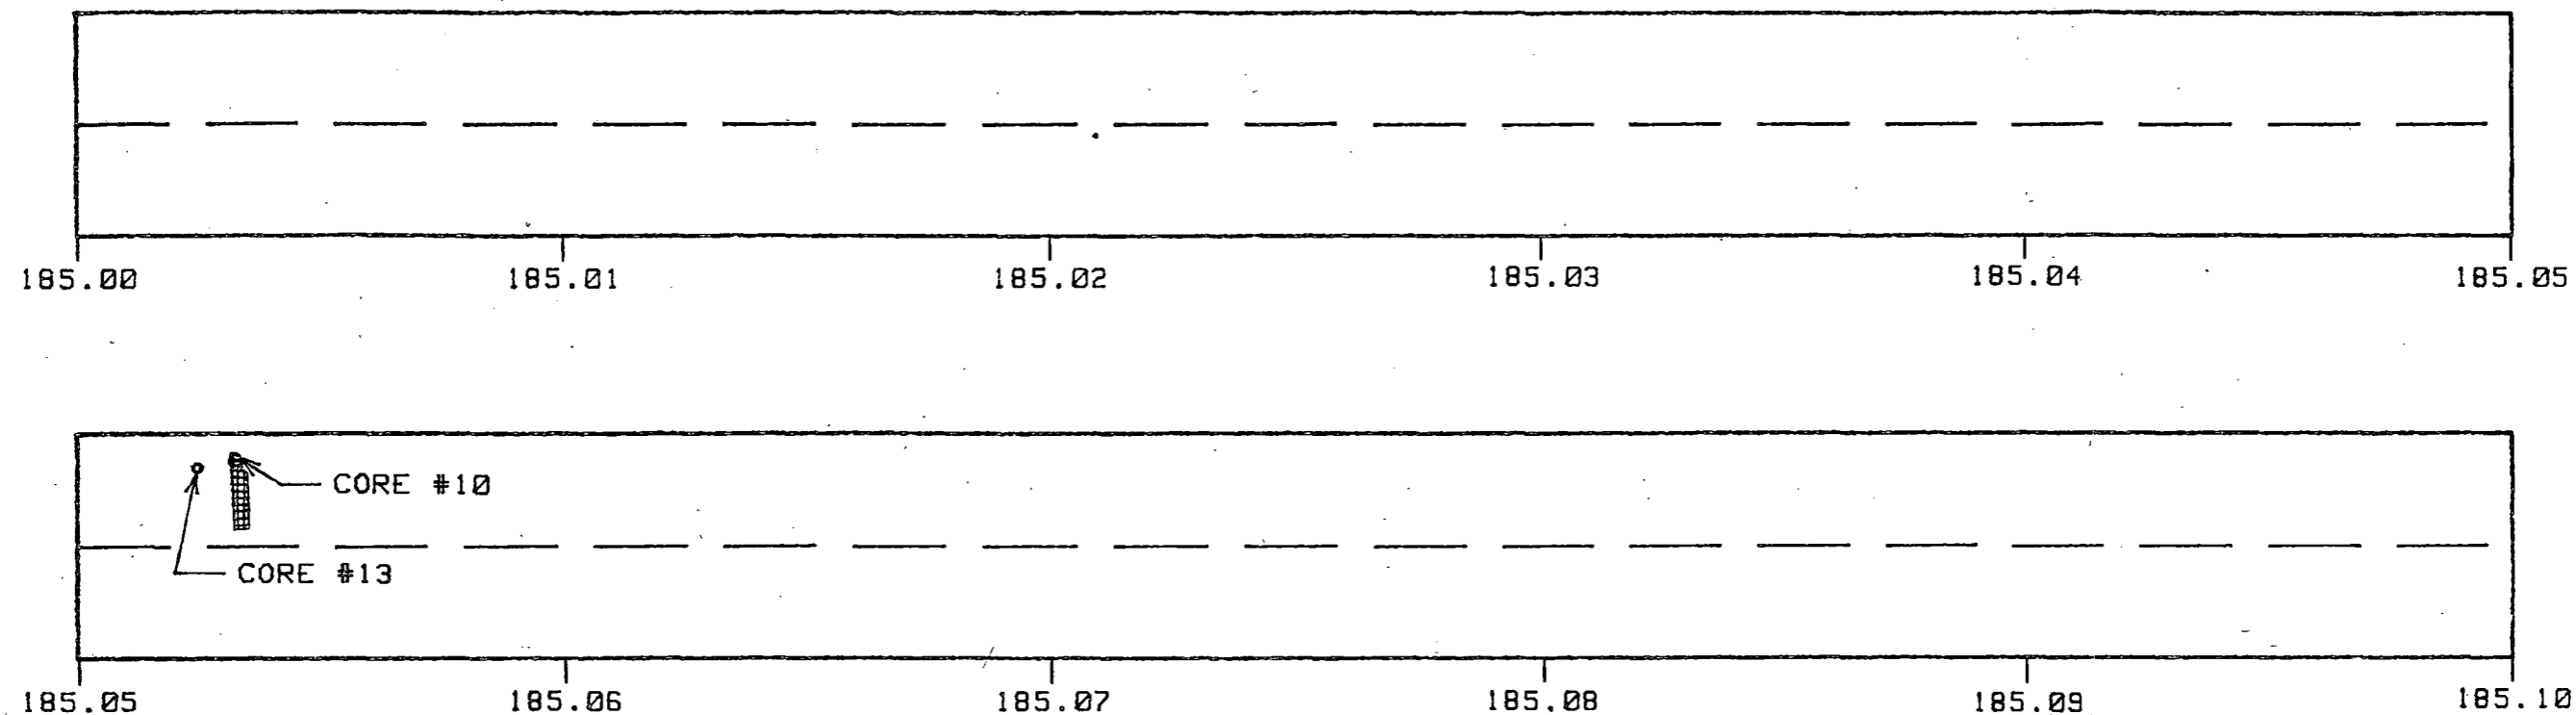
IR AND GPR EVALUATION OF BOND RETAINAGE
IN PORTLAND CEMENT CONCRETE OVERLAYS
I-80 (WESTBOUND) STA 185.00 TO STA 185.10
IOWA DEPARTMENT OF TRANSPORTATION

AREAS	WESTBOUND LANES
Total Area	12,672 (sq.ft.)
Debond (IR)	1 (sq.ft.)
Concrete Patch	11 (sq.ft.)
Deterioration (GPR)	None (lin.ft.)

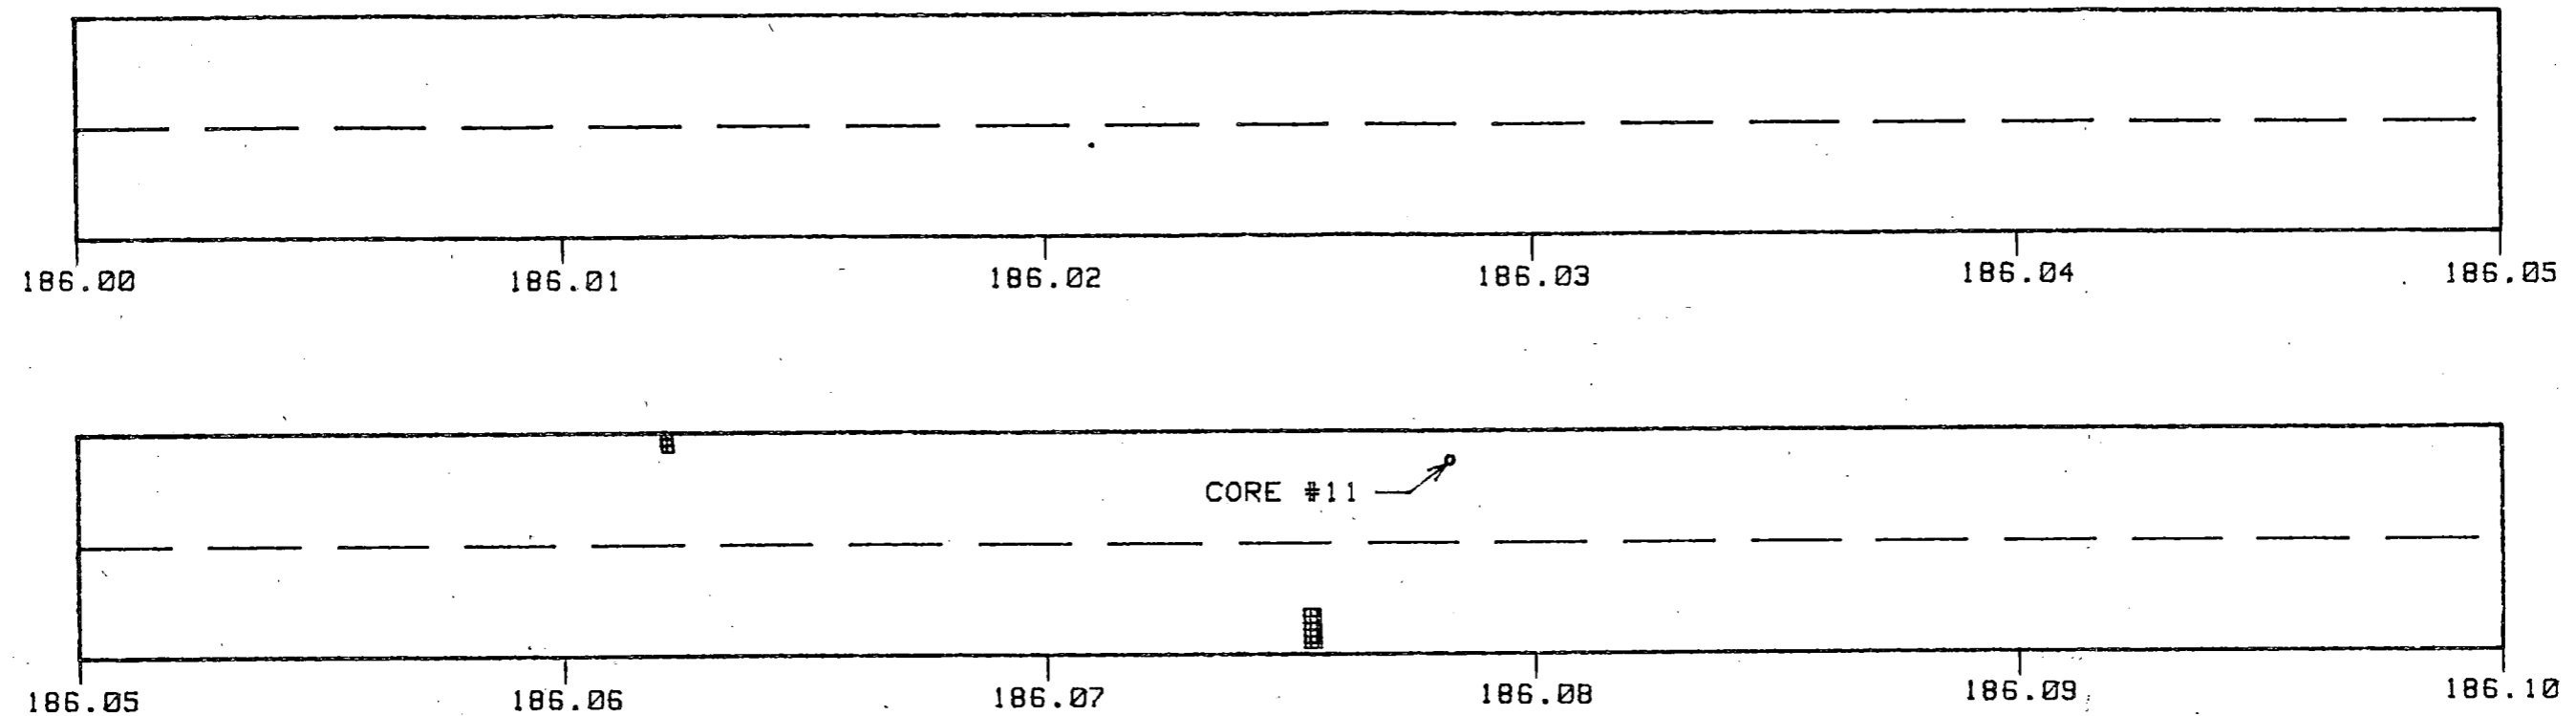
IR AND GPR EVALUATION OF BOND RETAINAGE
IN PORTLAND CEMENT CONCRETE OVERLAYS
I-80 (WESTBOUND) STA 186.00 TO STA 186.10
IOWA DEPARTMENT OF TRANSPORTATION

AREAS	WESTBOUND LANES
Total Area	12,672 (sq.ft.)
Debond (IR)	None (sq.ft.)
Concrete Patch	11 (sq.ft.)
Deterioration (GPR)	None (lin.ft.)
Inspection Date:	August, 1987
