# Concrete Overlay Performance on Iowa's Roadways

**Field Data Report  
July 2017**

National Concrete Pavement  
Technology Center

**Sponsored by**  
Iowa Highway Research Board  
(IHRB Project TR-698)  
Iowa Department of Transportation  
(InTrans Project 15-559)

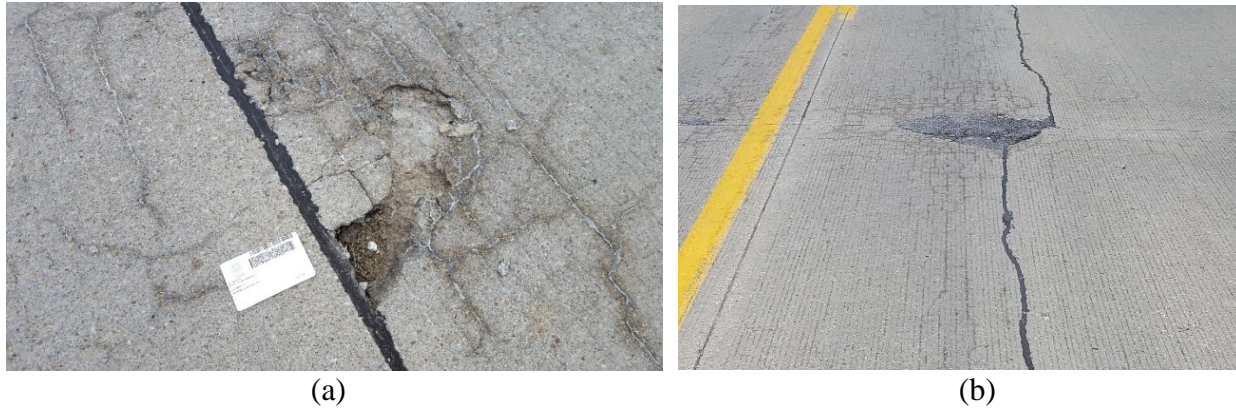
Distresses related to material deficiencies were the most common cause of performance drop based on the field reviews. The most extensive material-related distresses were observed on Pottawattamie County Highways L-34 and L-66. Areas of both overlays exhibited map- or web-shaped cracking, suggesting issues with aggregate durability (D-cracking) or reactivity (ASR). These distresses are shown in Figure 75(a). Joint deterioration was also observed on the Pottawattamie County projects, including the example shown in Figure 75(b) at the intersection of a transverse joint and longitudinal crack.

**Figure 75. Material durability-related distresses on (a) Pottawattamie County L-34 and (b) Pottawattamie County L-66 (November 2016)**

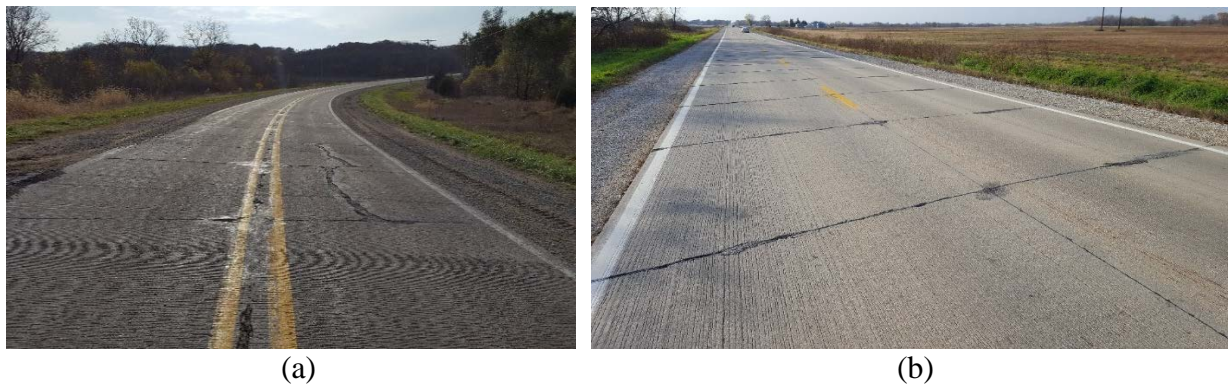
A pair of overlays in Dallas County on separate sections of County Highway F-31 west of Minburn and west of Granger also exhibited MRD in the form of joint deterioration (see Figure 76).

**Figure 76. Joint deterioration on Dallas County F-31 at sections (a) west of Minburn and (b) west of Granger (November 2016)**

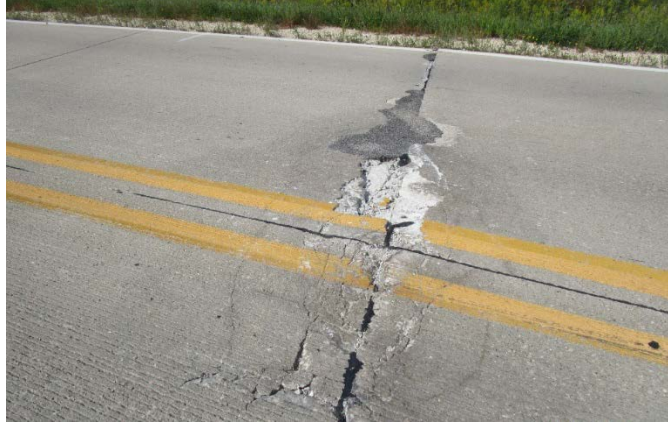
Another issue observed during field reviews was rough ride. In one area of study on North 10th Street in Linn County, the rough ride appeared to be the result of faulted dominant joints at an interval of about every three slabs. The faulting at these joints caused significant ride roughness and occasionally appeared to result in joint deterioration, as shown in Figure 77.

**Figure 77. Joint deterioration on North 10th Street in Linn County (September 2016)**

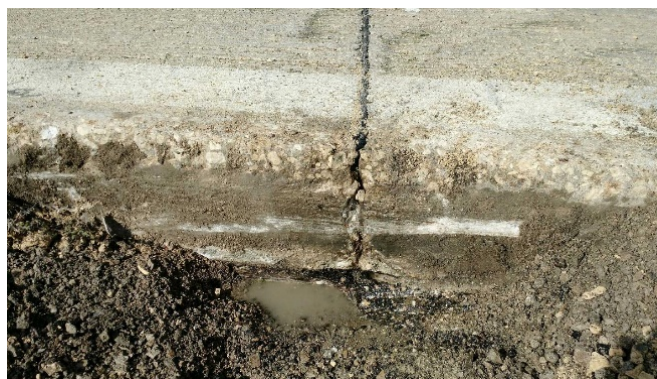
The exact cause of the faulted joints and accompanying distress on North 10th Street was unknown. There was suspicion that cracks may not have developed under every transverse joint on the overlay, perhaps leading to the dominant joint behavior at intervals of every three to four slabs. However, when county crews dug along the shoulder to observe the behavior of the transverse joints at the adjacent slabs, they found that cracks did deploy beneath those joints, as shown in Figure 78.

**Figure 78. Crack deployment in joint adjacent to blowup**

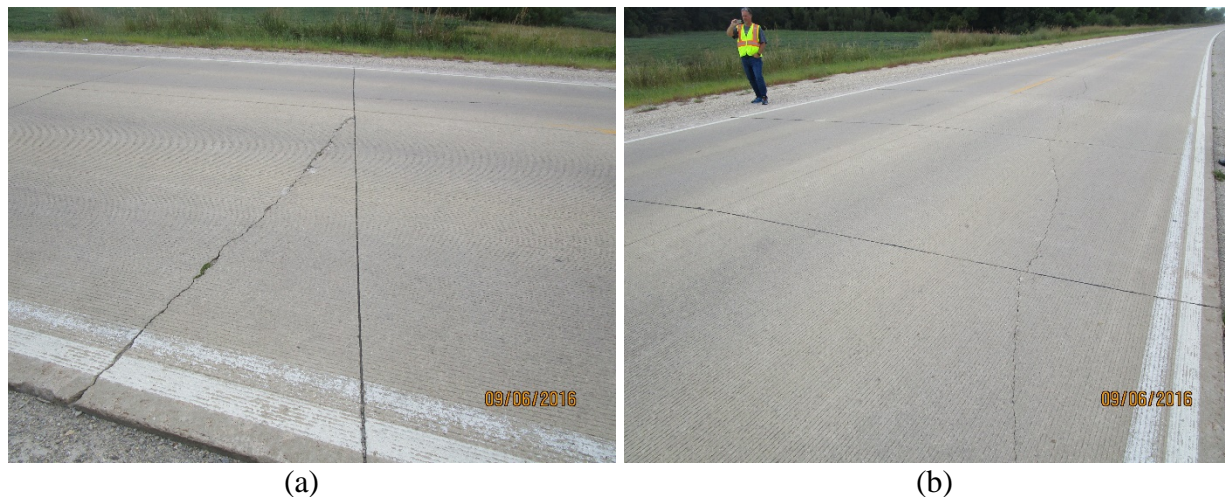
Finally, there were some projects that experienced significant amounts of cracking. Cracking issues were most significant on Blairs Ferry Road in Linn County and Dallas County Highway F-90. On Blairs Ferry Road, shown in Figure 79, the transverse and longitudinal cracking patterns appeared to result from loss of support.

**Figure 79. (a) Longitudinal and (b) corner cracking on Blairs Ferry Road (September 2016)**

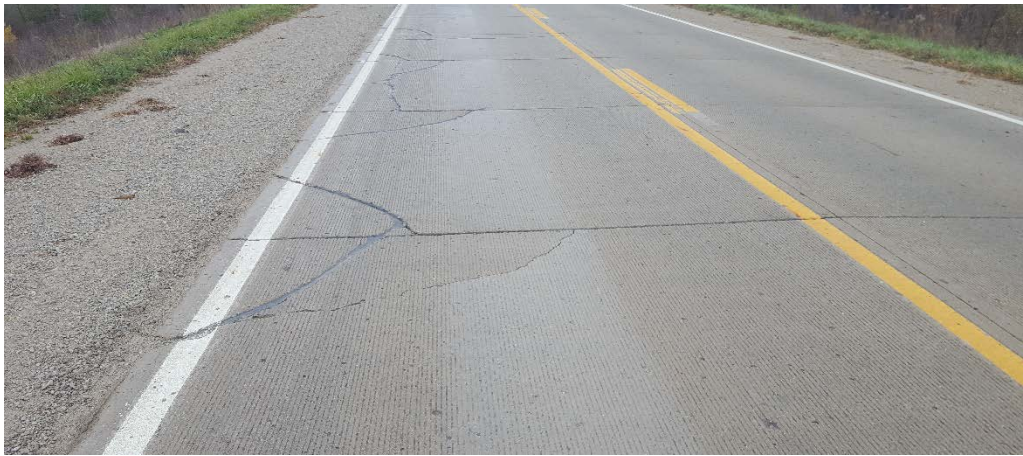
Meanwhile, cracking observed on Dallas County Highway F-90, shown in Figure 80, appeared to be caused by traffic loads.

**Figure 80. Cracking on Dallas County F-90 (November 2016)**

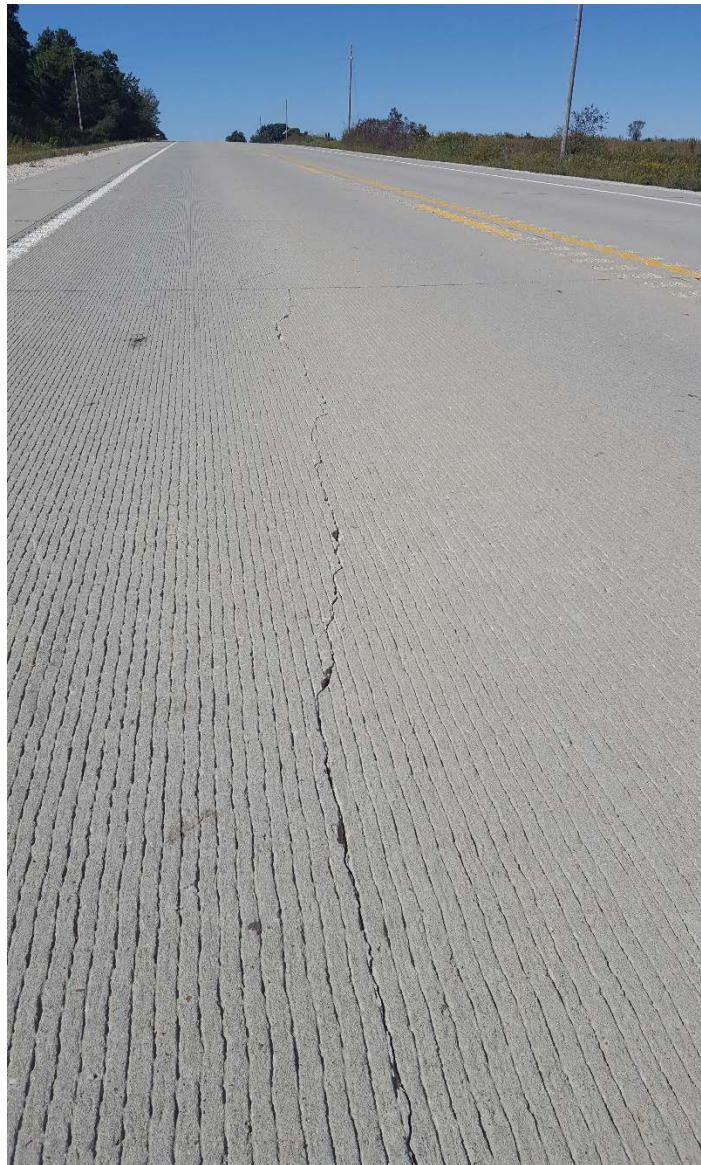
However, even at an age of three years, occasional instances of longitudinal cracking began to develop in this overlay, which can be seen in Figure A.2.

**Figure A.2. Longitudinal cracking in Buchanan County D-22, September 2016**

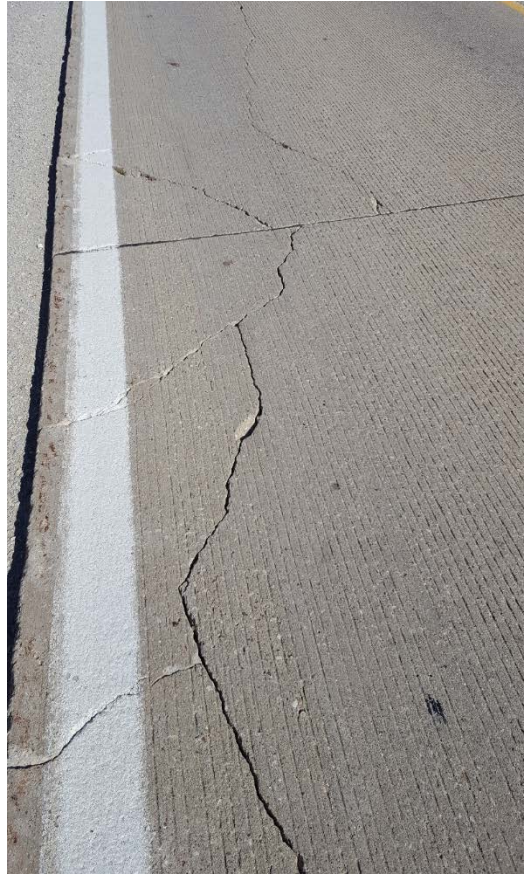
**Figure A.11. Longitudinal and corner cracking at slab edge in southbound lane of Buchanan County W-40, September 2016**

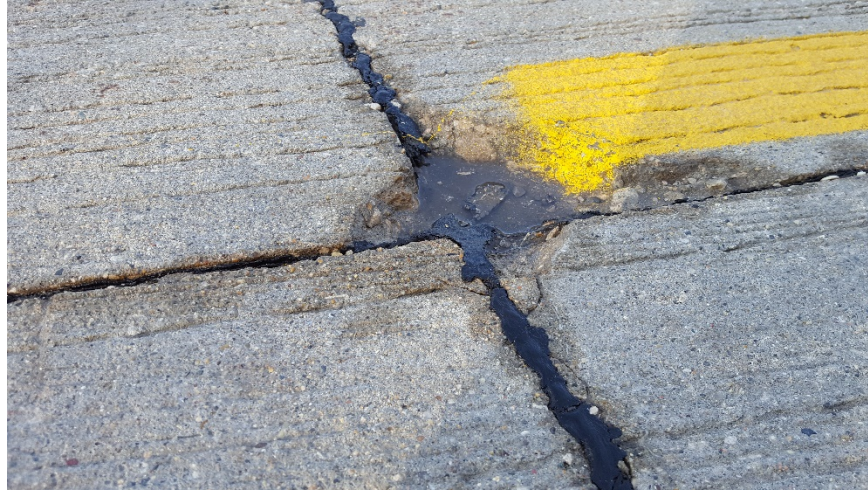
**Figure A.18. Water at spalled joint and adjacent joint shadowing on Dallas County F-31 west of Granger, November 2016**

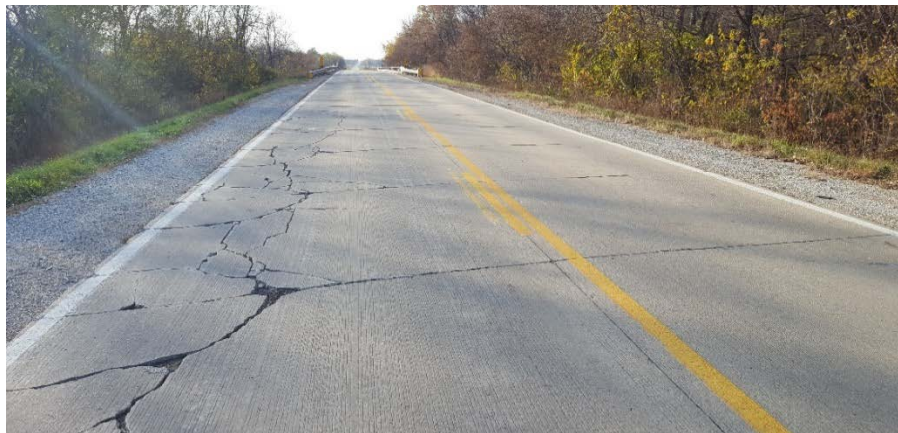
**Figure A.19. Cracking at slab edge approaching creek crossing on Dallas County F-31 west of Granger, November 2016**

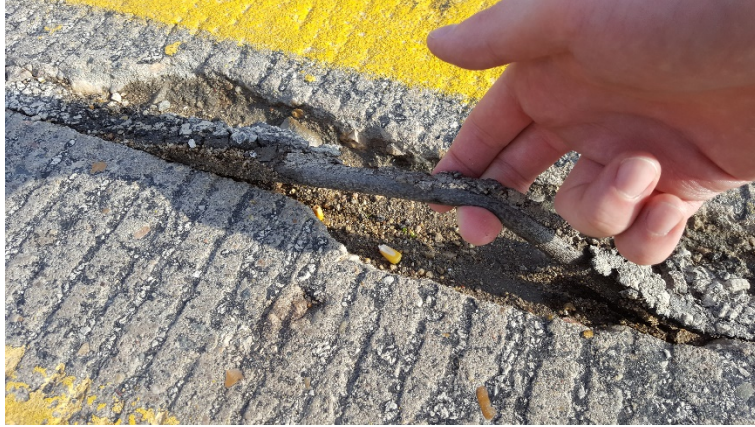
**Figure A.23. Deterioration around and underneath the backer rod on Dallas County F-31 west of Minburn, November 2016**

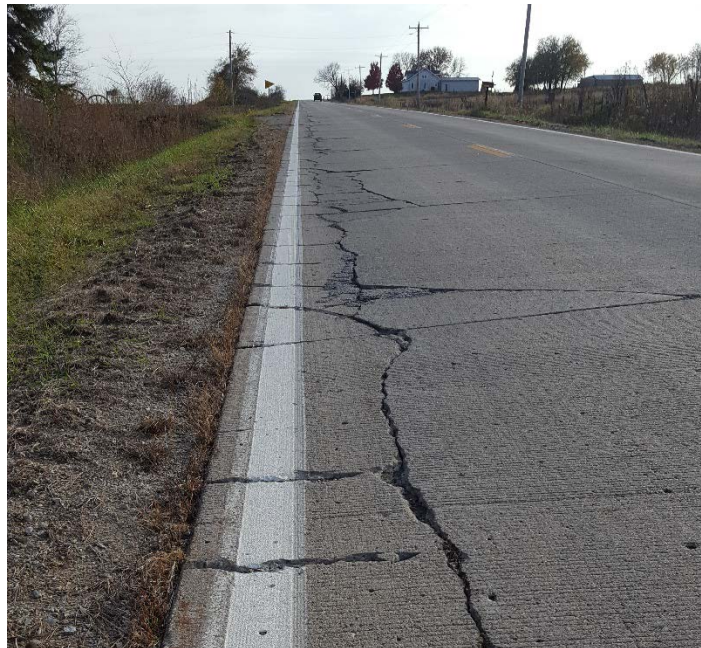
**Figure A.30. Loss of support along pavement edge on Dallas County R-22, November 2016**

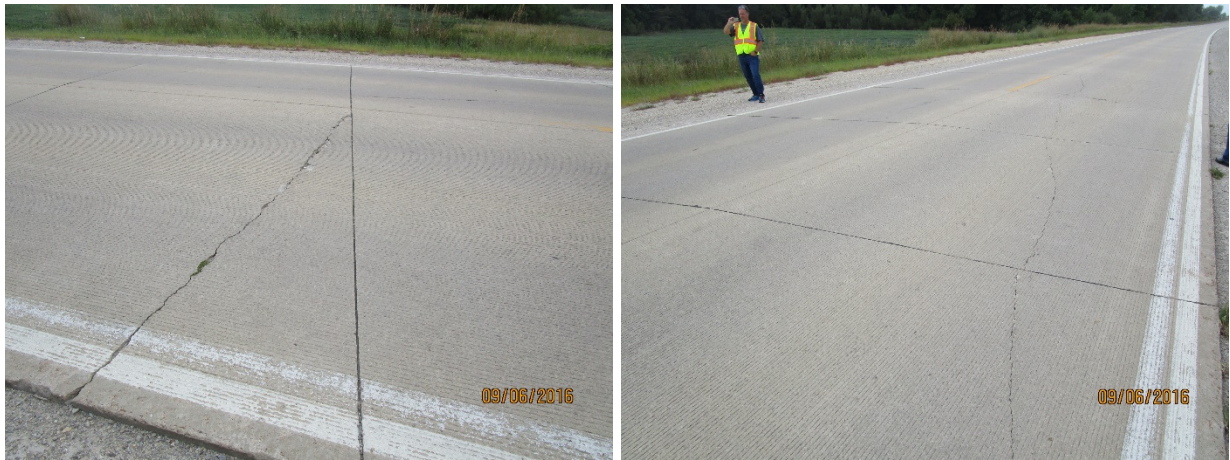
**Figure A.32. Longitudinal and corner cracking on Linn County Blairs Ferry Road, September 2016**

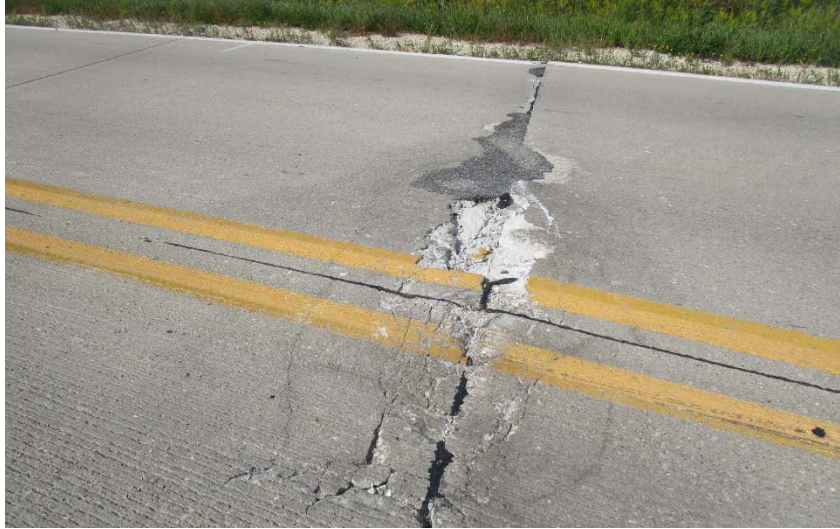
**Figure A.36. Joint deterioration on Linn County North 10th Street, September 2016**

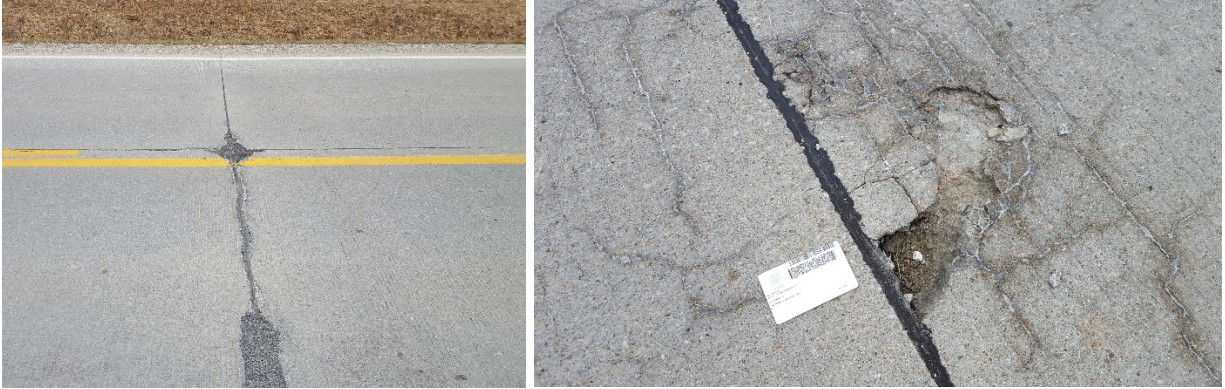
**Figure A.44. Apparent material-related distresses at joints on Pottawattamie County L-34, November 2016**

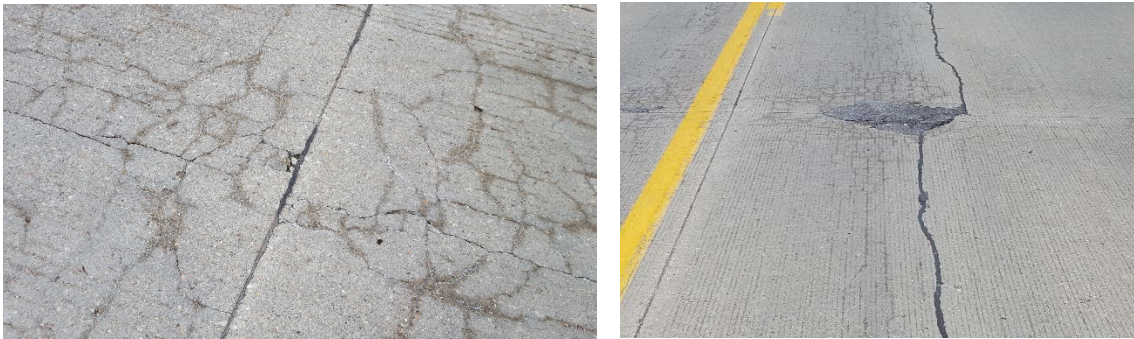
**Figure A.48. Materials-related distresses on Pottawattamie County L-66, November 2016**

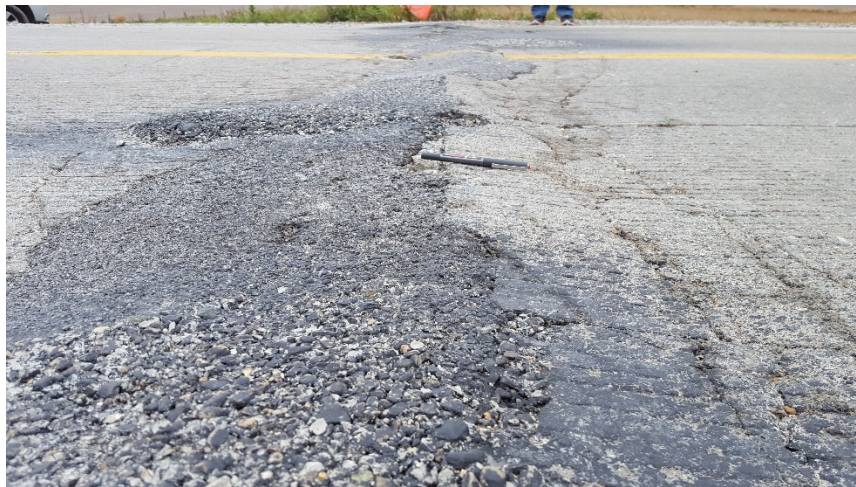
**Figure A.49. Apparent blow-up on Pottawattamie County L-66, November 2016**
