CORE ANALYSIS OF PORTLAND CEMENT CONCRETE SLIP FORMED BARRIERS

Final Report For MLR-98-4

January 2000

Highway Division

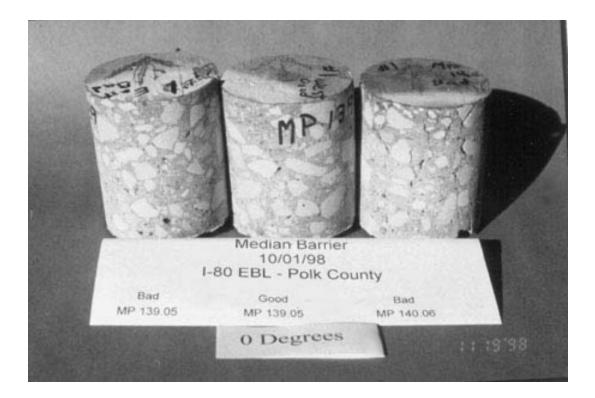
The results of coring from some areas of barriers with a bad appearing surface showed no significant "bad" problem deeper into the barrier. Examples are core photos 1A and 1C. In other cases, large voids or tears were exposed during coring which were not detectable from surface visual examinations (see core photos 2A and 2B). The concrete in core 4B was so deteriorated that it could not be prepared for laboratory analysis. The air system for most cores was found to be acceptable except for core 1A (see appendix F).

Cores 1A, 1B and 1C

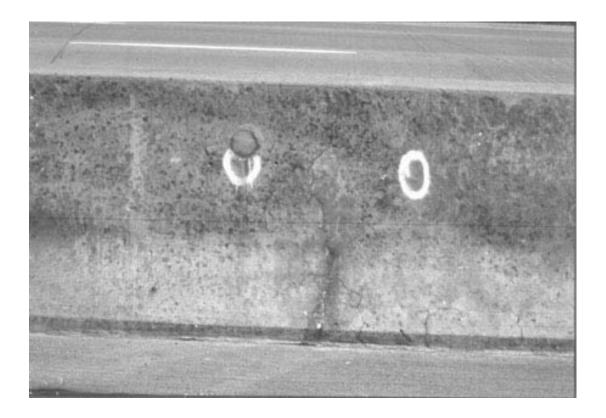
Barrier showing sites (dark 4" diameter circle) for core 1A

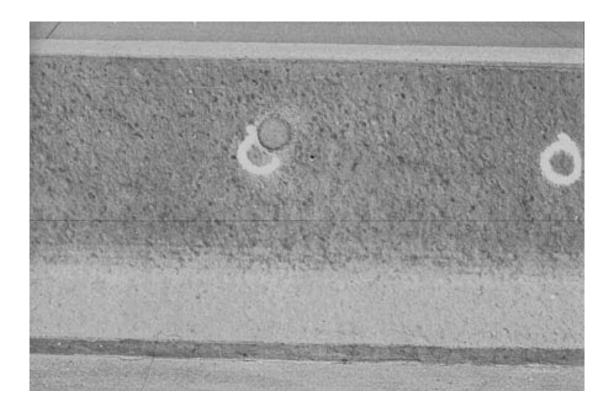
Barrier showing site (dark 4" diameter circle) for core 1B

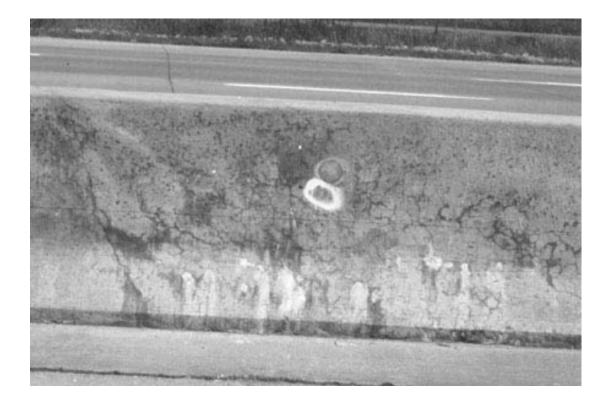
Barrier showing site (gray 4" diameter circle) for core 1C

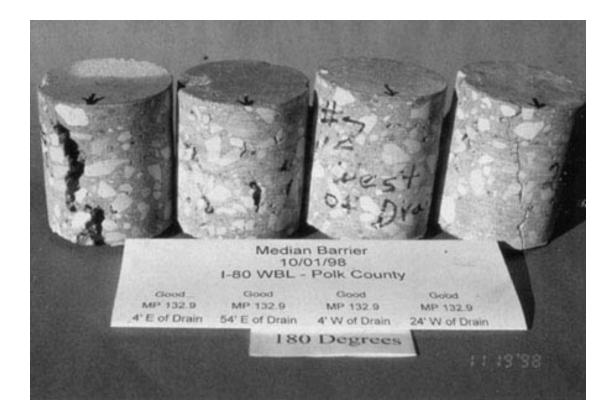
Cores 2A, 2B, 2C and 2D

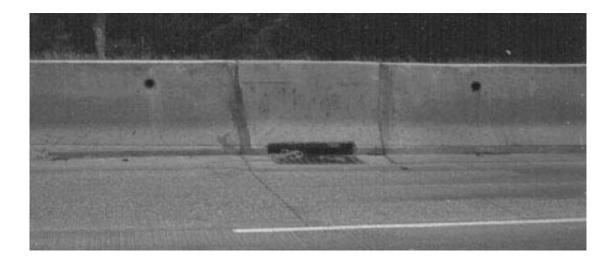
Barrier showing site (dark 4" diameter circle) for cores 2A and 2C $\,$

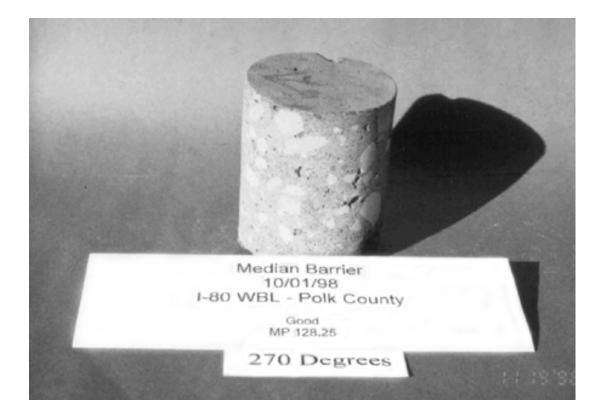
Core 3A

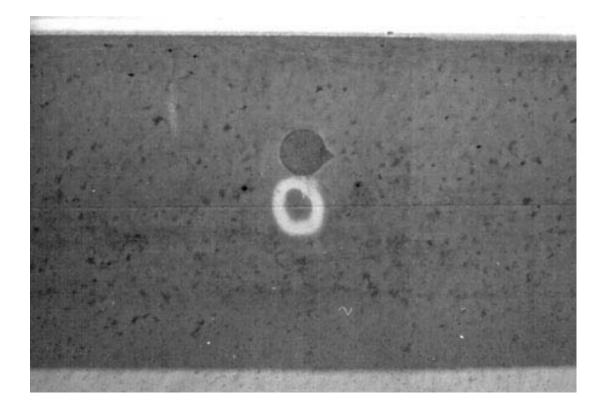
Barriers showing site (dark 4" diameter circle) for core 3A

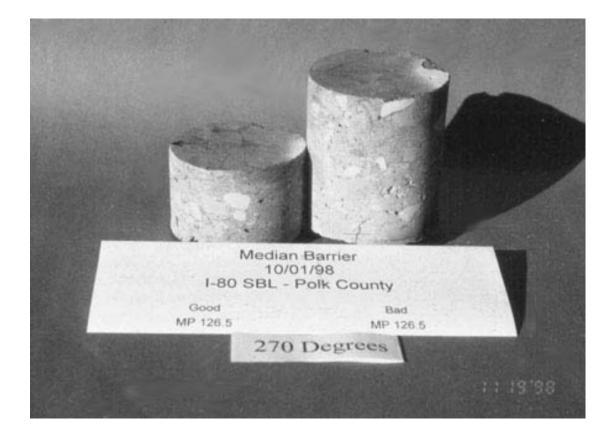
Cores 4A and 4B

NOTE: Core 4B was too deteriorated for lab analysis.

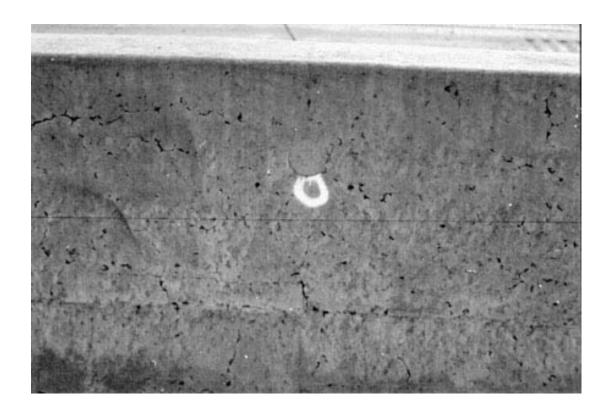
Barrier showing site (gray 4" diameter circle) for core 4A

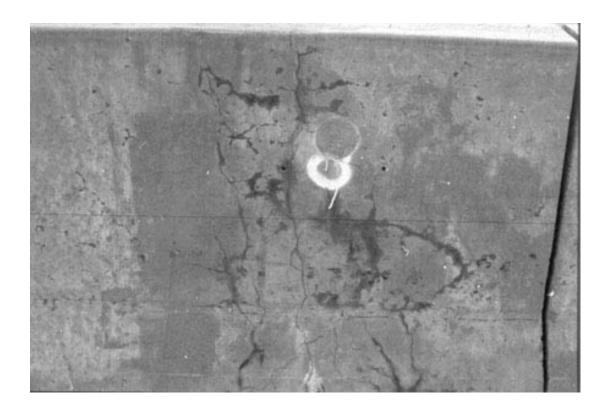
Barrier showing site (dark 4" diameter circle) for core 4B
