Performance Evaluation of Recent Improvements of Bridge Abutments and Approach Backfill

Sponsored by:
The Iowa Highway Research Board
TR-736

Final Report
November 19, 2018

Prepared by:
Mohamed K. ElBatanouny, Ph.D., S.E., P.E.
Kathleen A. Hawkins
Nathaniel S. Rende, S.E., P.E.
Paul D. Krauss, P.E.
Wiss, Janney, Elstner Associates, Inc.
Northbrook, Illinois 60062

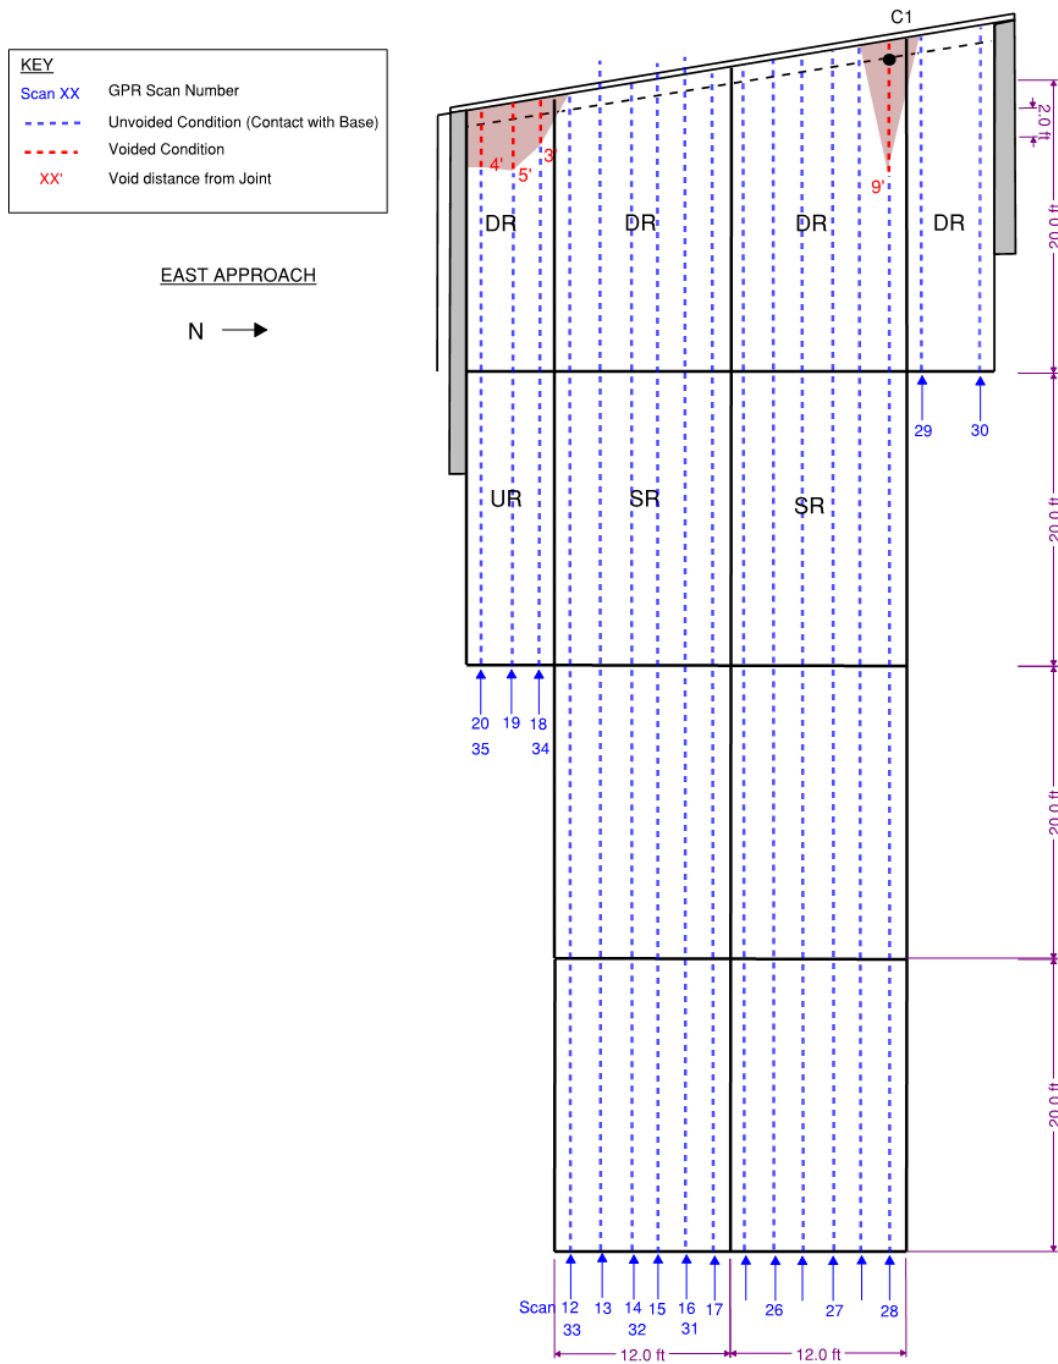
Figure 3.10. GPR results and core location at east approach of Bridge 5111.50034.

One core was collected on the east approach to verify the GPR results. The core was located close to the shoulder of the westbound lane in the east approach (Figure 3.10) and the pavement measured 14.5 inches in depth. Upon coring through the slab, the core sample dropped approximately 0.25 inches, as shown in Figure 3.12, indicating a 0.25 inch void at this location.

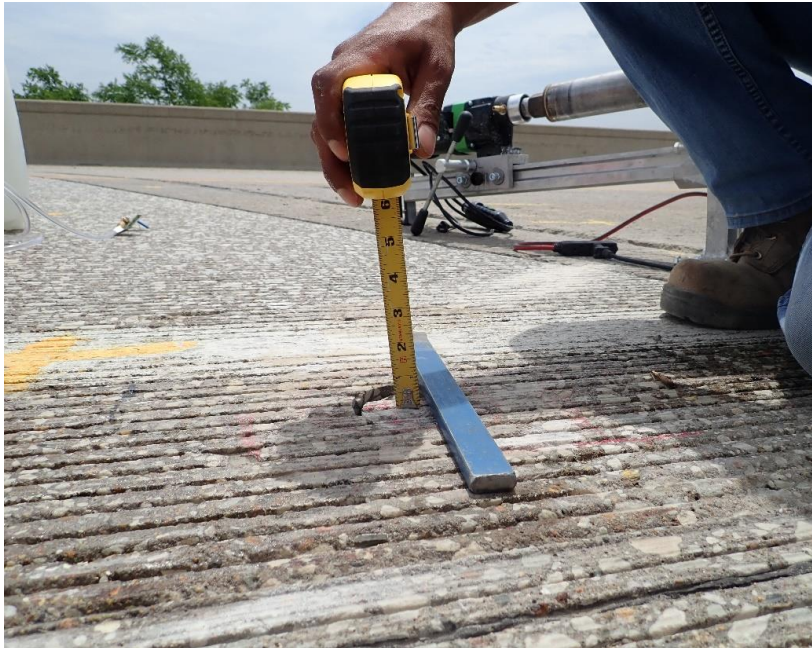
Figure 3.12. View of core drop (1/4 inch) indicating presence of minor void under the slab.

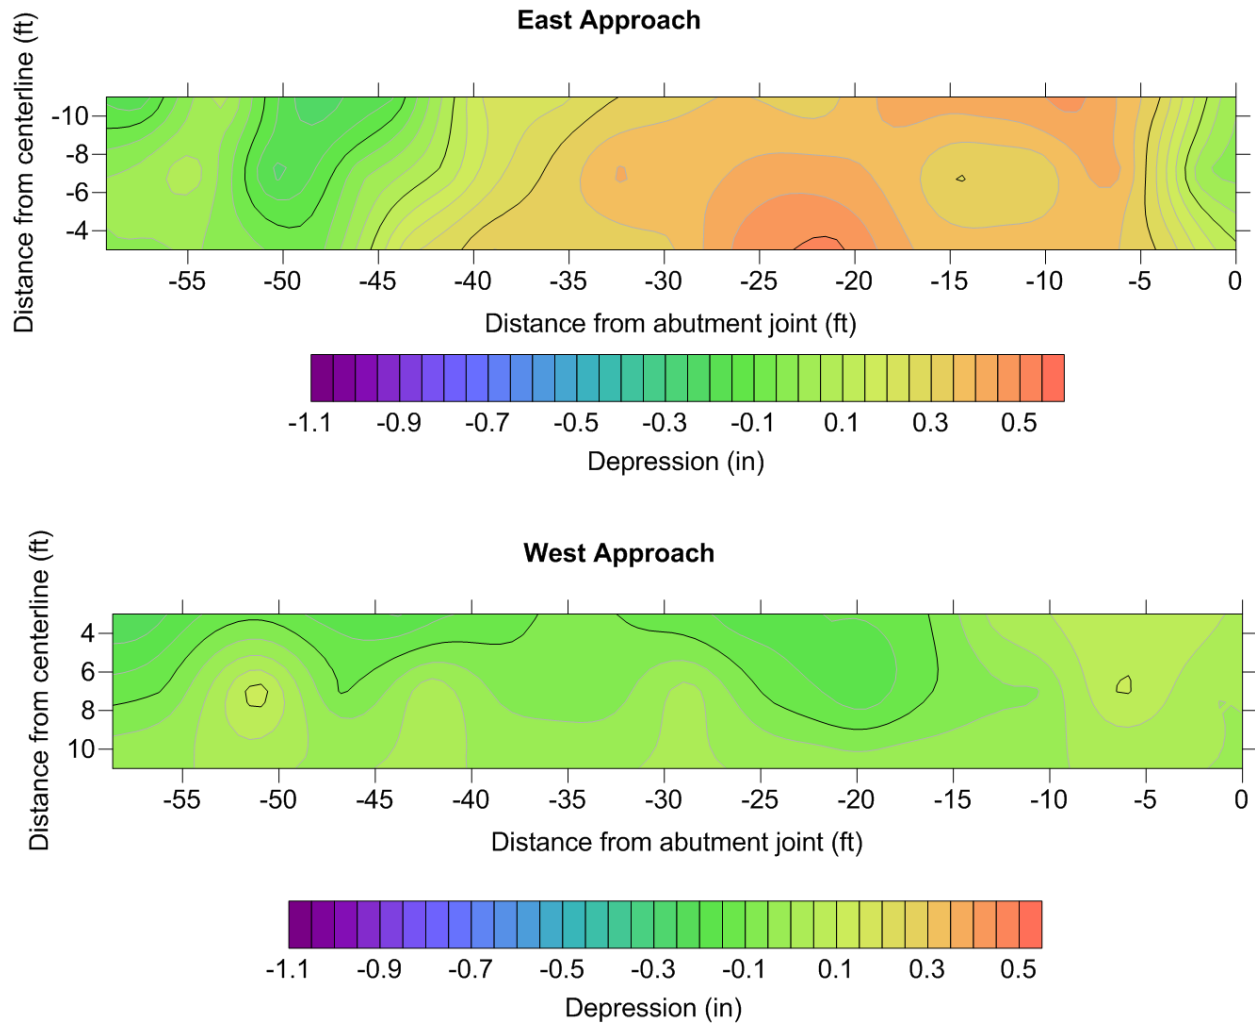
The depression maps show that negative depression (settlement) was present at the west approach while a slight positive depression was observed at the east approach. Note that this may be related to variation in the measurements. As shown in Figure 3.12, the pavement surface was grooved, which creates noise in the data and makes depressions and elevations smaller than the depth of the grooves insignificant. The survey data was used to calculate the BI value as 0.002 and 0.004 for the east and west approach, respectively. These values are small compared to values reported by White et al. (2005), which indicates that the bridge approaches are in good condition.

Figure 3.14. Contour maps of the depression (net elevation) experienced by the approaches of Bridge 5111.50034.

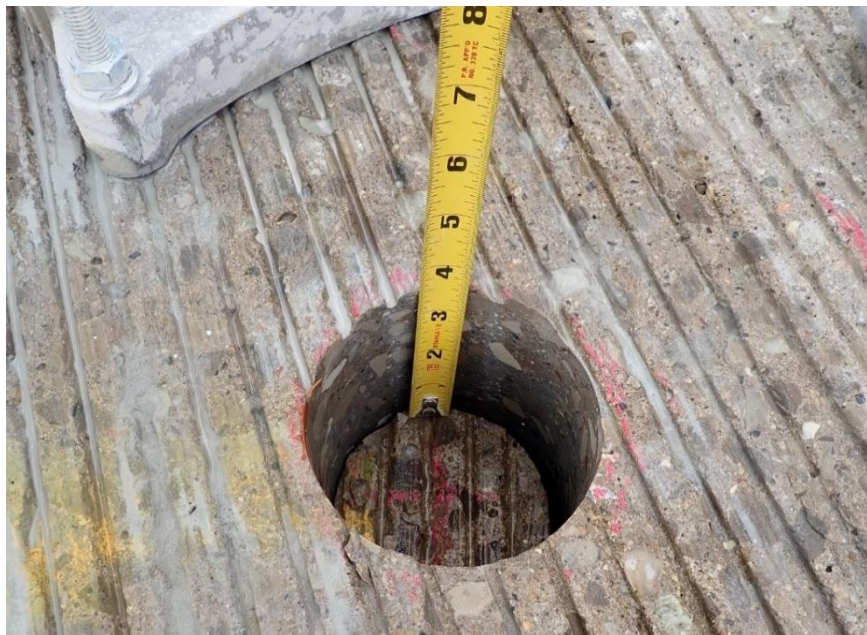
Figure 3.18. Measured drop (3.5 inches) of Core 1 of Bridge 5126.5S078.

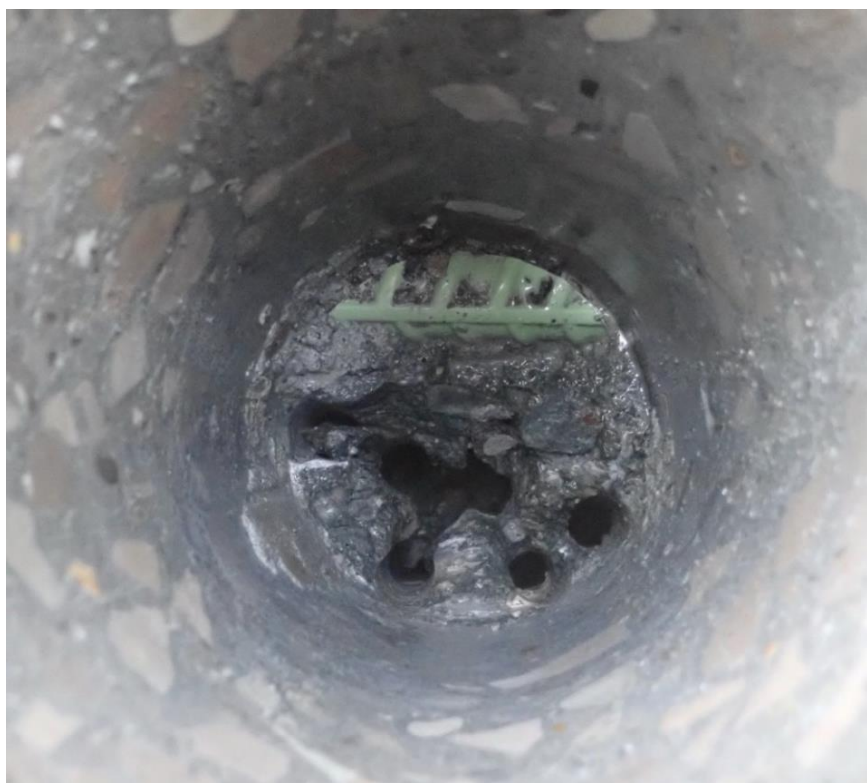
Figure 3.19. Epoxy-coated rebar and voids found under Core 2 of Bridge 5126.5S078.

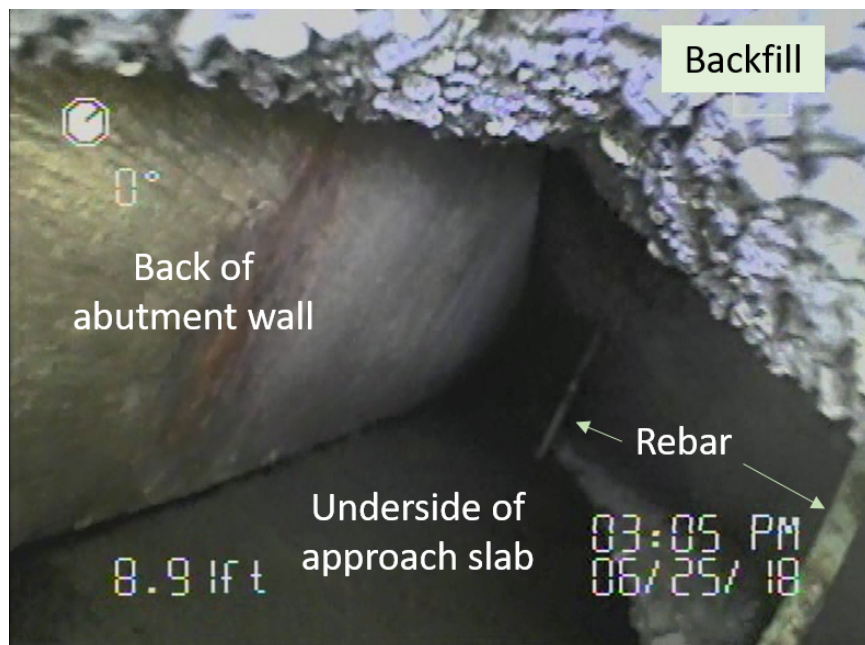
Figure 3.20. View of void beneath east approach slab of Bridge 5126.5S078 from borescope.

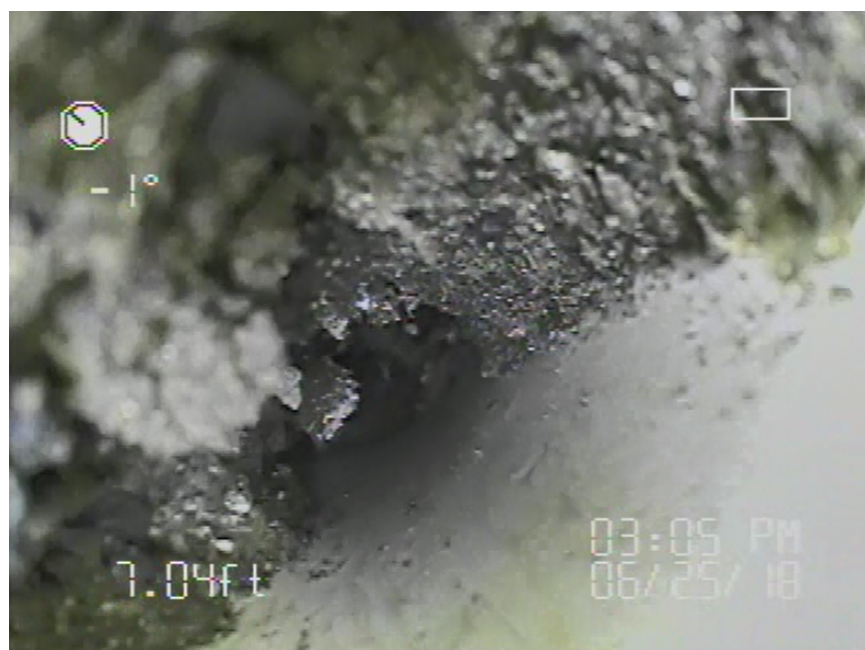
The borescope was inserted through the void underneath Core 1, the access ports at the west approach, and the northern access port at the east approach. It was not possible to inspect the southern access port because it was blocked by a wasp nest. The videos captured at the north access ports of the east and west approaches confirm the existence of voids underneath both approach slabs. For the west approach south access port the video was inconclusive as the port was filled by soil/backfill. Figure 3.20 provides an image from the video showing exposed rebar between the east approach slab and the backfill material behind the abutment wall. In addition, the access ports were mostly blocked by eroded, fine soil, as shown in Figure 3.21.

Figure 3.21. View of debris in northern access port at the east approach of Bridge 5126.5S078.

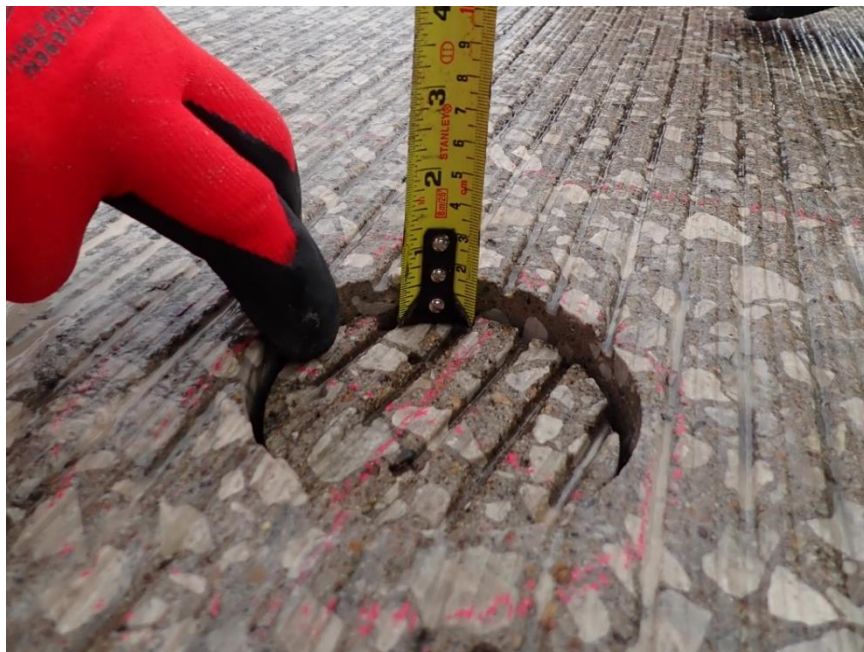
Figure 3.27. Measured drop (0.5inch) of Core 1 of Bridge 5622.5O061.

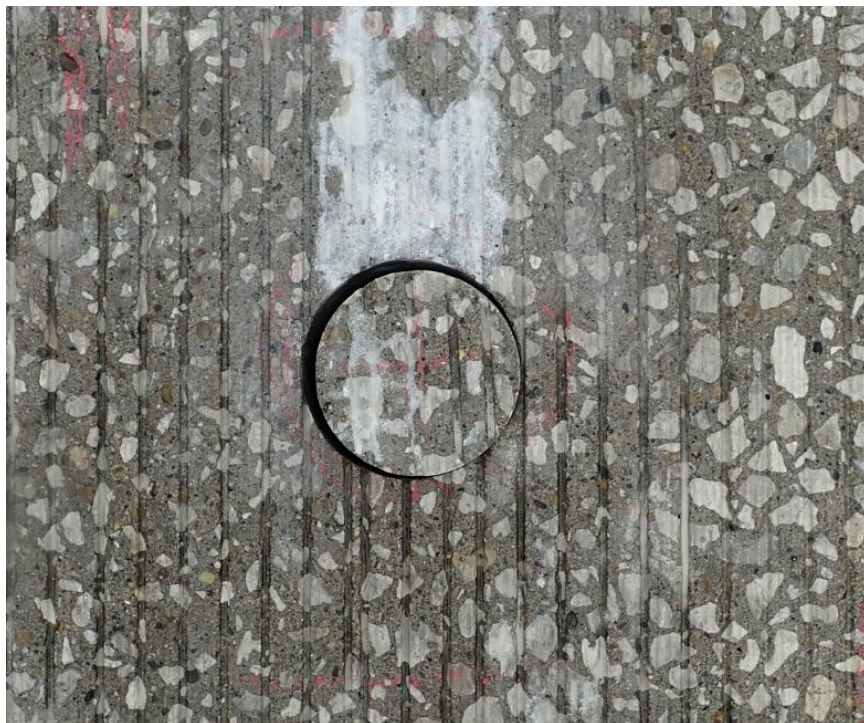
Figure 3.28. View of Core 2 of Bridge 5622.5O061 (no void).

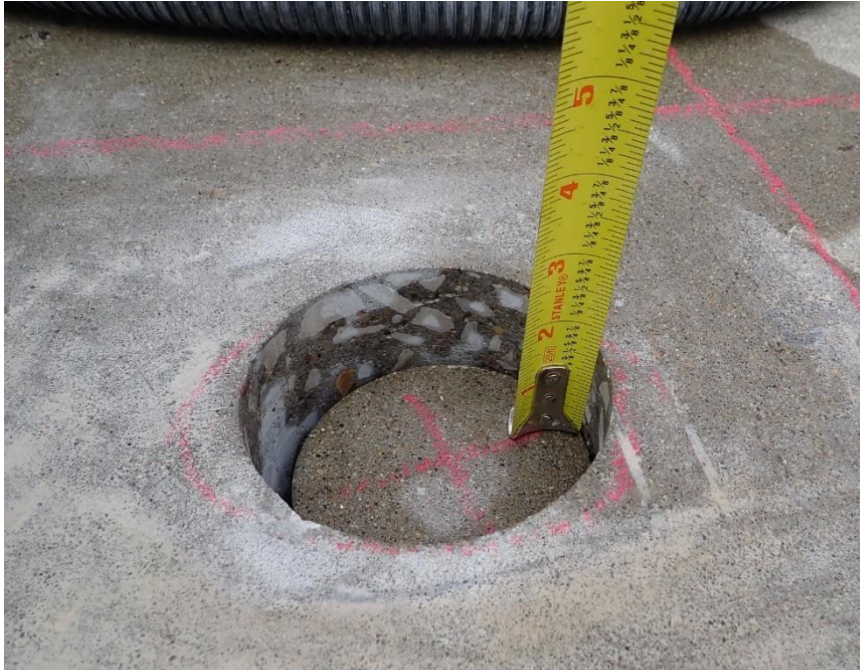
Figure 3.29. Measurement of void (1.5inch) underneath Core 3 of Bridge 5622.5O061.

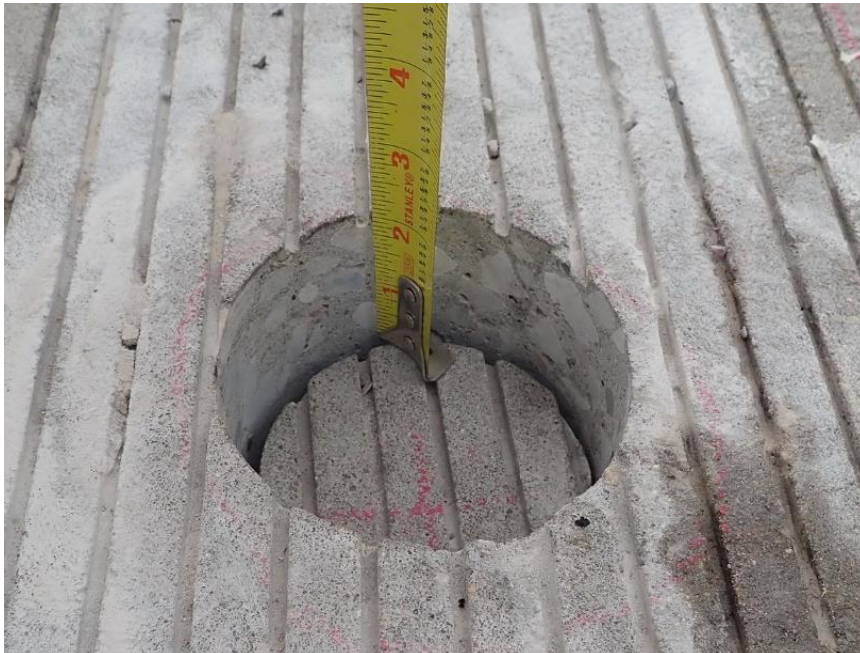
Figure 3.30. Measurement of void (2.0inch) underneath Core 4 of Bridge 5622.5O061.

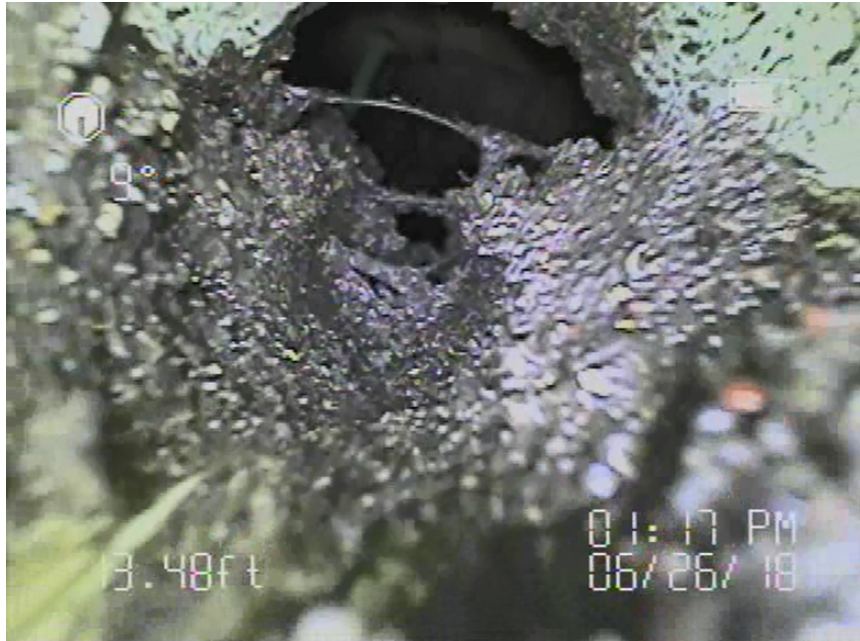
The borescope was inserted through Cores 3 and 4 and all of the access ports located in the wing walls. The back of the abutment wall was visible when the borescope was inserted through the cores, confirming the voids found by the GPR. Both of the access ports at the east approach and the north access port under the west approach were blocked with large aggregates such that the borescope could not get through. The south access port under the west approach had some metal across its entrance under the slab. The vertical rebar and bottom of the approach slab were visible, as shown in Figure 3.31.

Figure 3.31. Entrance of south access port under west approach of Bridge 5622.5O061.

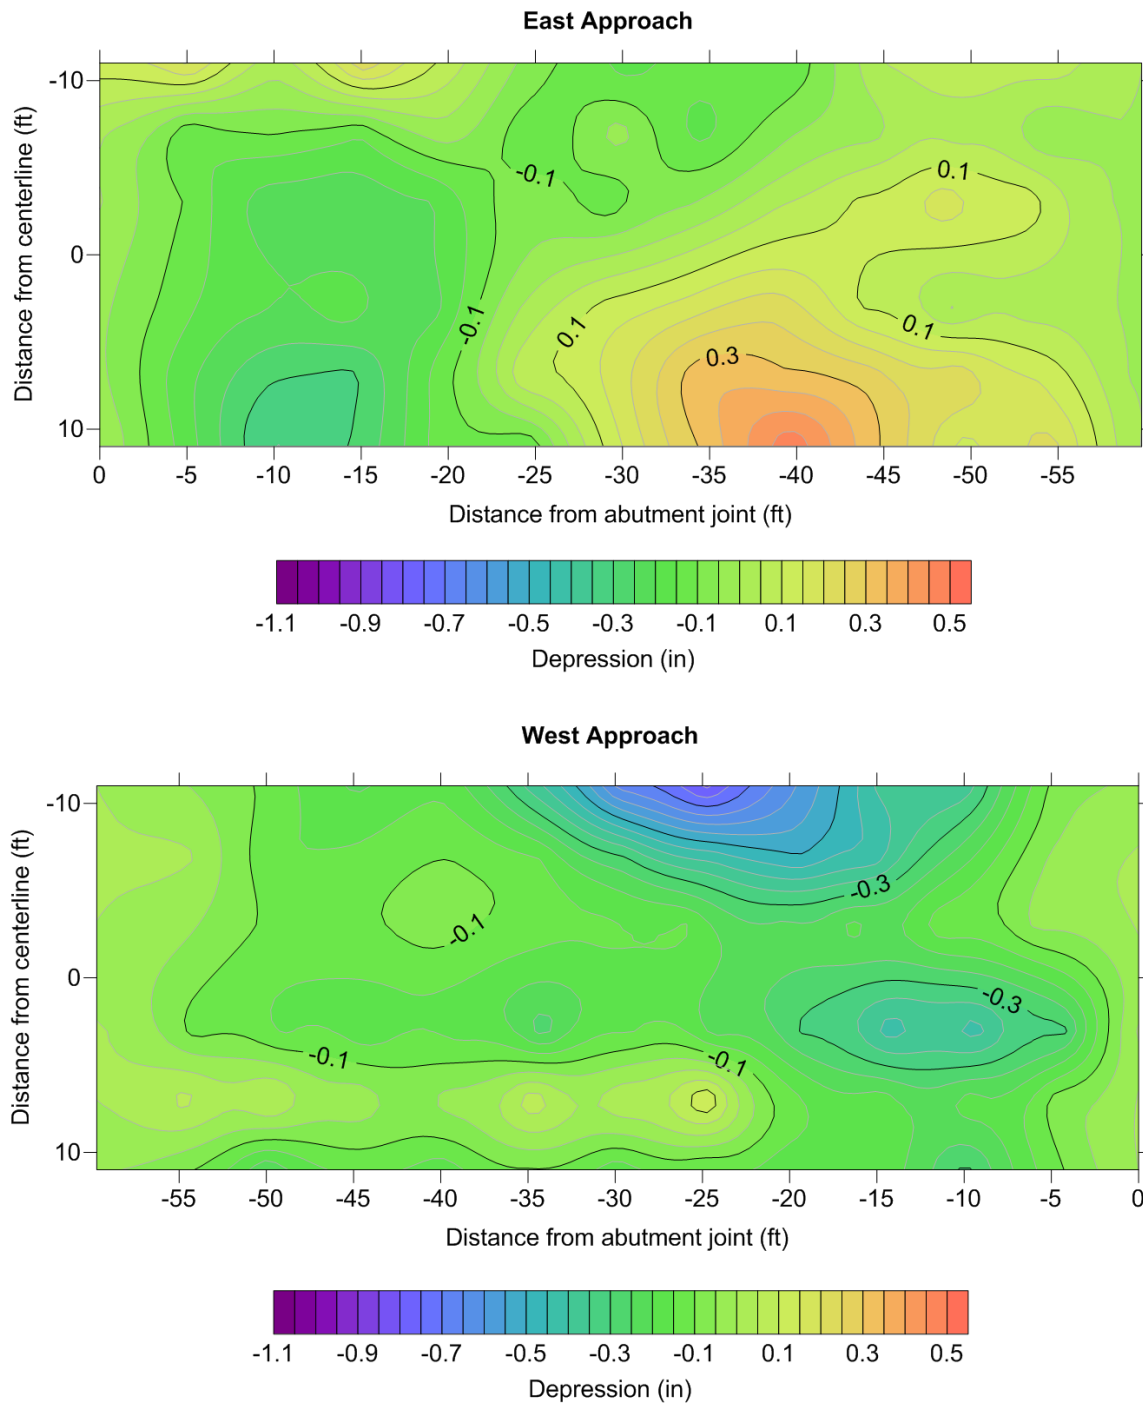
The V-shaped patterns on the elevation contour maps show the typical drainage pattern. For this bridge, the maximum amount of depression was 1.0 inches at the west approach and 0.6 inches at the east approach. The maps indicate that there are no areas with a bump at either approach. The BI value was calculated as zero and 0.014 for the east and west approaches, respectively. These values are small compared to values reported by White et al. (2005).

Figure 3.33. Contour maps of the depression experienced by the approaches to Bridge 5622.50061.

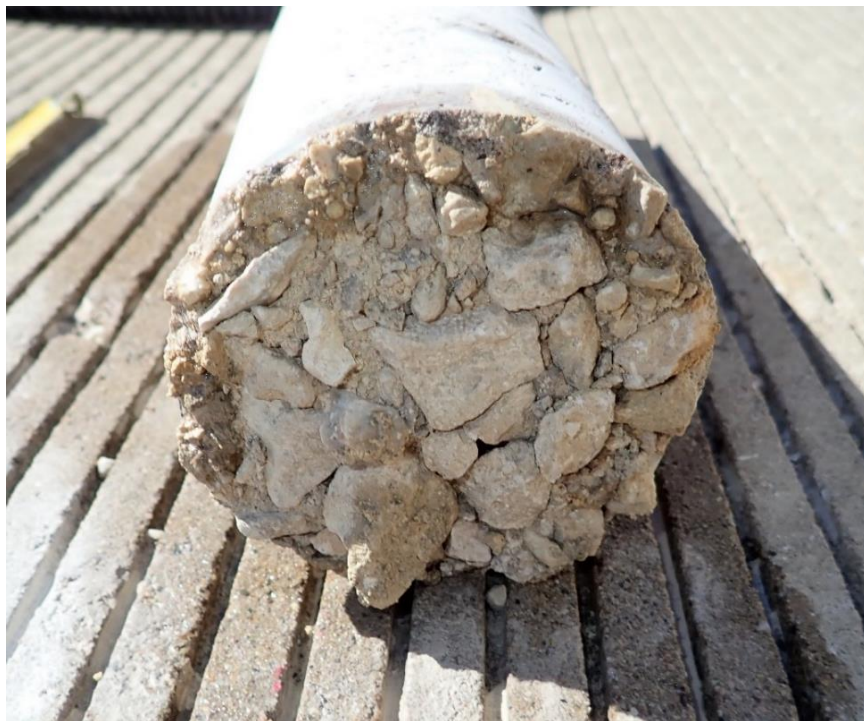
Figure 3.37. Bottom of Core 1 of Bridge 5624.20061, showing original contact with the base.

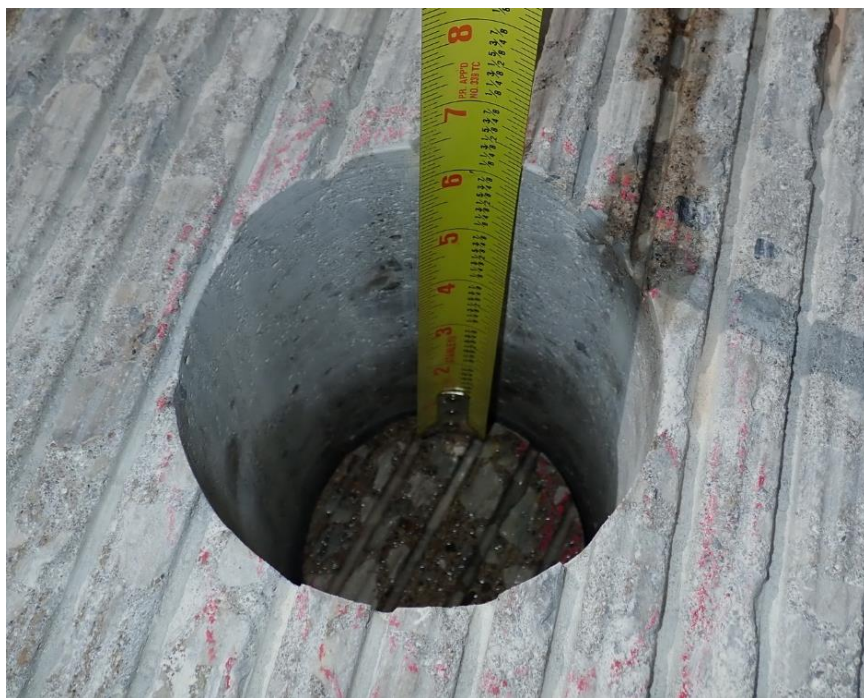
Figure 3.38. Measurement of void underneath Core 2 of Bridge 5624.20061.

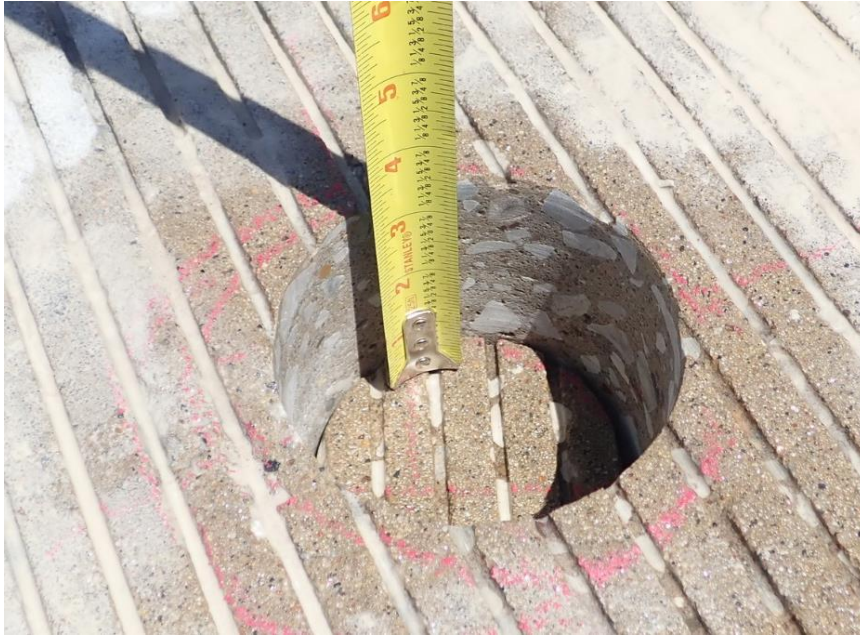
Figure 3.39. Measurement of void underneath Core 3 of Bridge 5624.2O061.

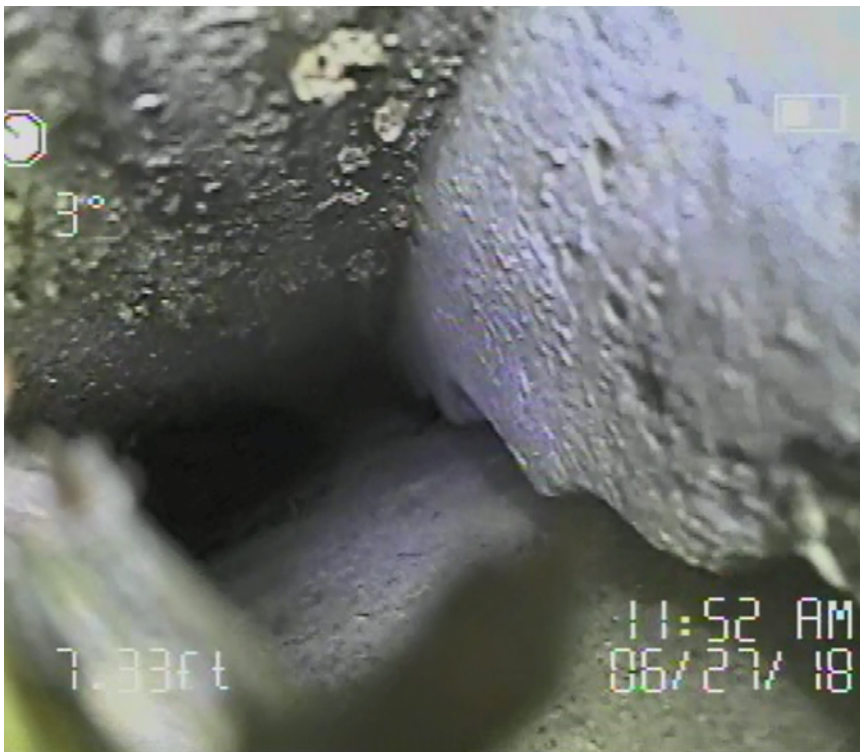
The borescope was inserted into Core 2 and each of the access ports. Both of the access ports underneath the east approach were blocked by soil/ backfill. The south access port under the west approach was partially blocked by soil/backfill such that the borescope could not get through. However, the borescope successfully reached the void under the west approach through Core 2 and the north access port. The paving notch appears to be damaged, there is a gap between the approach slab and the paving notch, and extensive erosion has occurred, as shown in Figure 3.40.

Figure 3.40. The paving notch and west approach slab of Bridge 5624.2O061, as shown by the borescope.

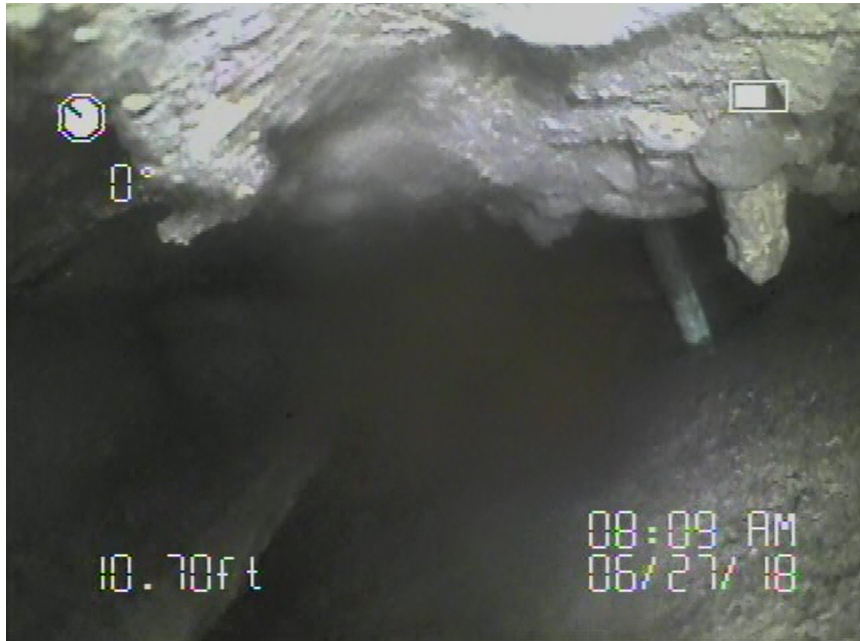
Figure 3.44. Void under north approach from Bridge 5617.7L061.

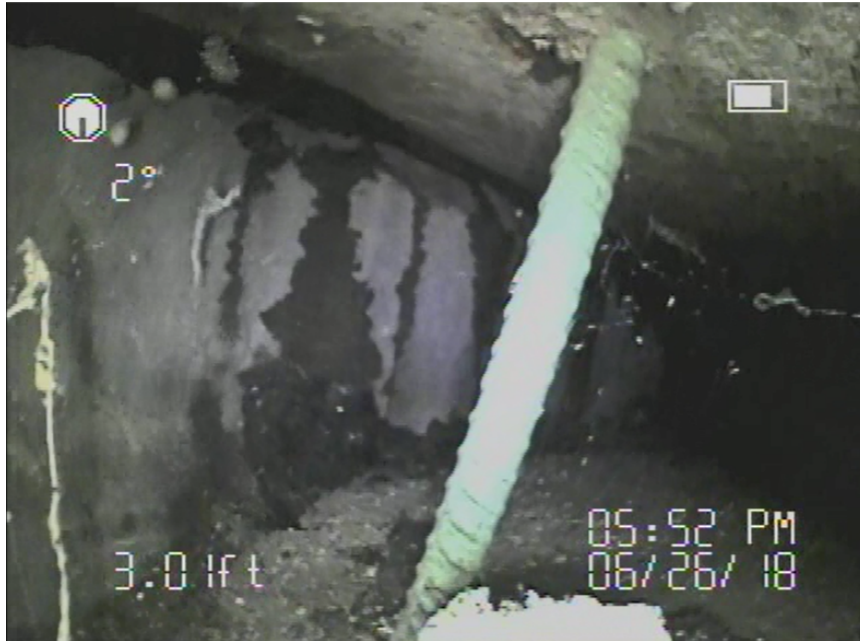
The borescope was inserted into the south access port of the east approach and both of the access ports under the west approach. The presence of a void under the west approach could not be investigated because both of the access ports were blocked with a mixture of mud, fines, and gravel. The borescope showed that there is a large void underneath the east approach slab; the epoxy-coated rebar, approach slab, and abutment backwall were all clearly visible, as shown in Figure 3.45.

Figure 3.45. Void under east approach from Bridge 5657.4O002.

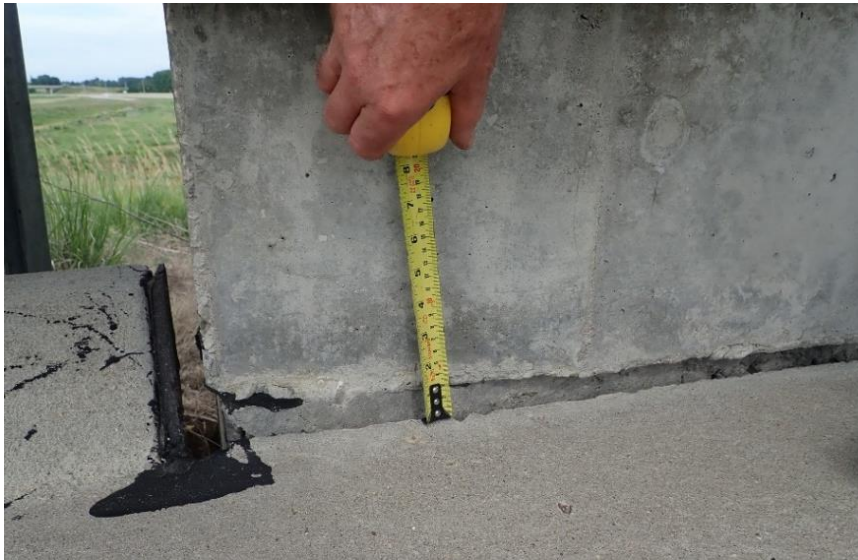
Figure 3.46. Gap between north barrier and shoulder at west approach of Bridge 5627.1O061.

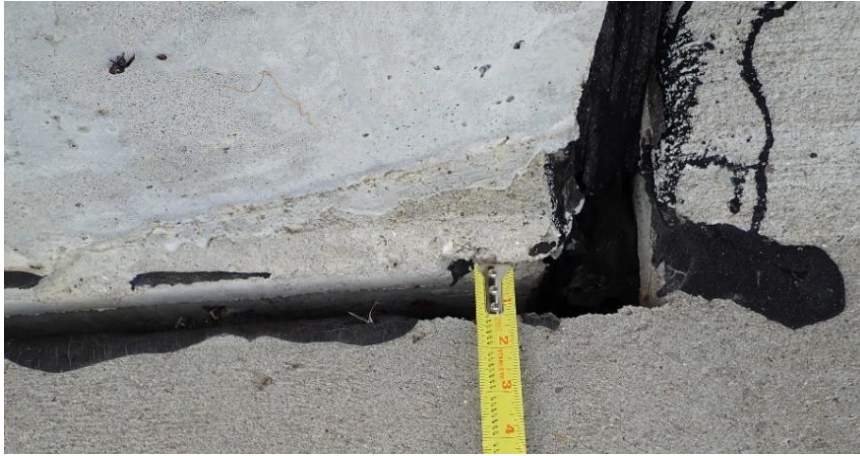
Figure 3.47. Gap between south barrier and shoulder of west approach of Bridge 5627.1O061.

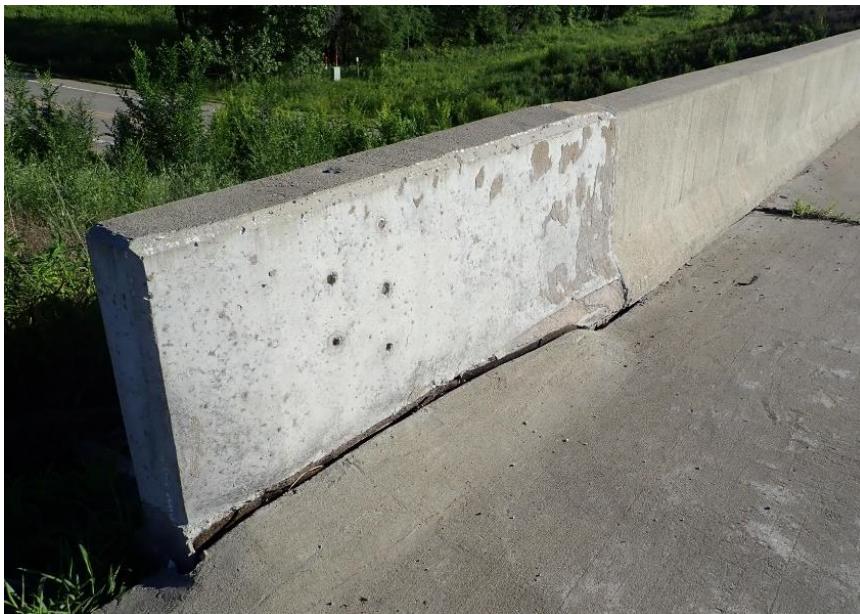
Figure 3.48. Gap between west barrier and shoulder at south approach of Bridge 5617.7L061, note effort to construct a curb along this joint.

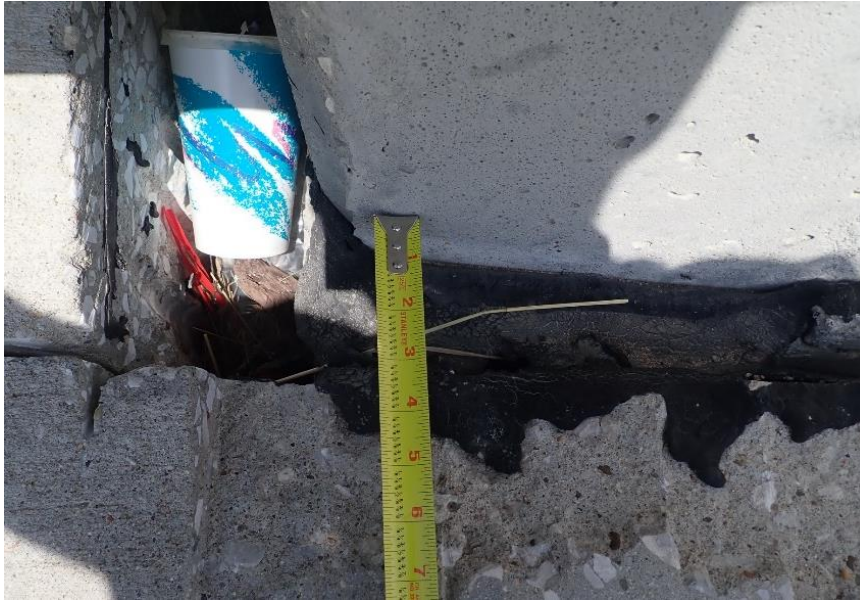
Figure 3.49. Debris in gap between shoulder and north barrier at west approach of Bridge 5622.50061.
