IDENTIFICATION OF THE BEST PRACTICES FOR DESIGN, CONSTRUCTION, AND REPAIR OF BRIDGE APPROACHES

Iowa DOT Project TR-481
CTRE Project 02-118

Final Report

January 2005

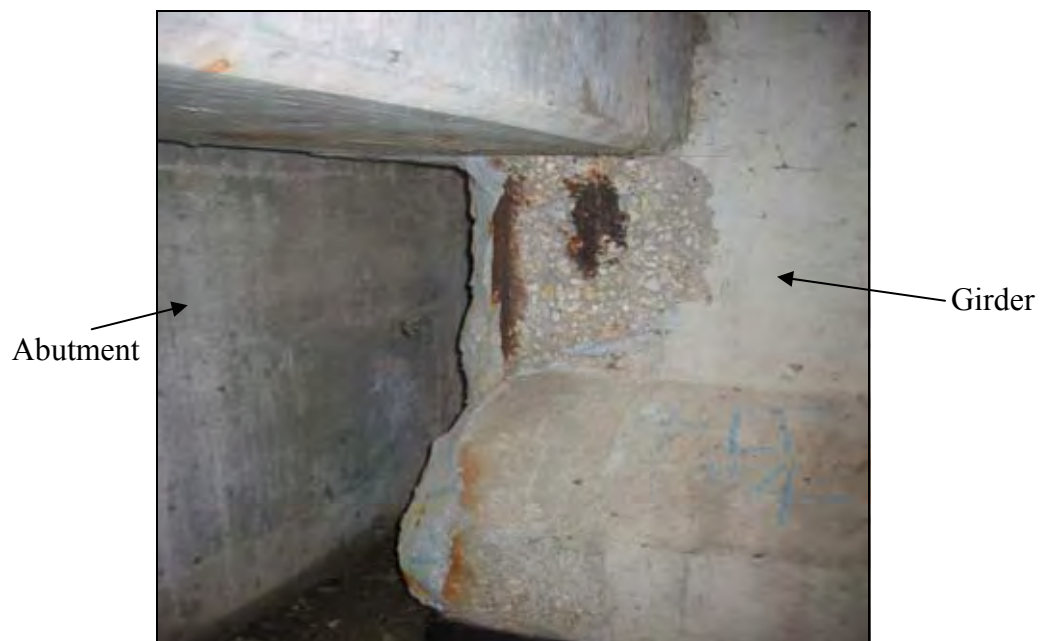
Figure 18. Deterioration of concrete with visible steel of the girders (South end NBL)

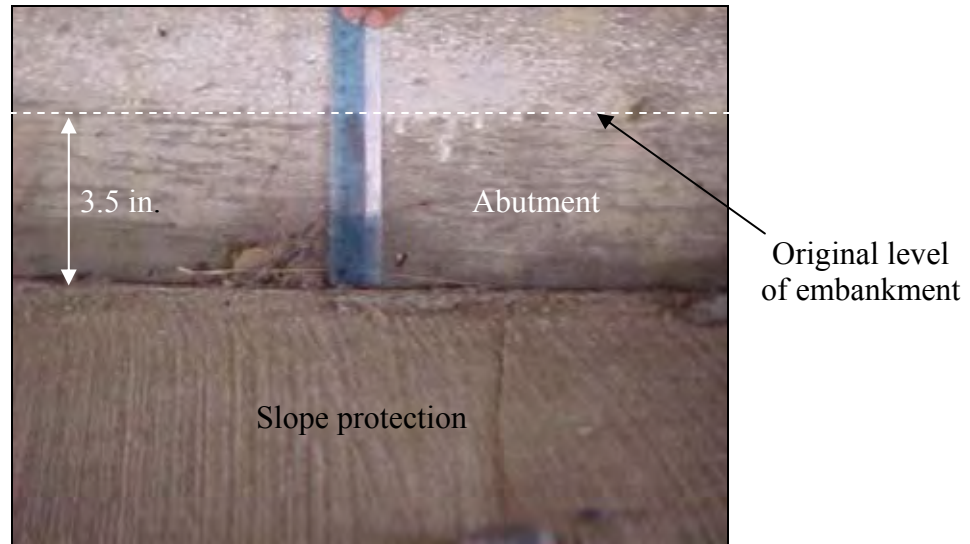
Figure 28. Settlement of embankment under the bridge

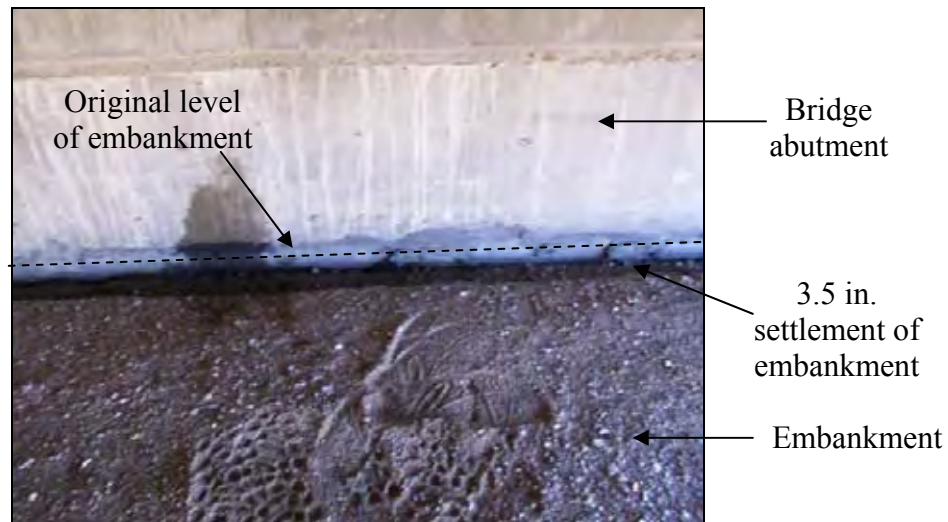
Figure 52. Settlement of the embankment under the bridge and a gap between the abutment and the embankment (East end WBL)

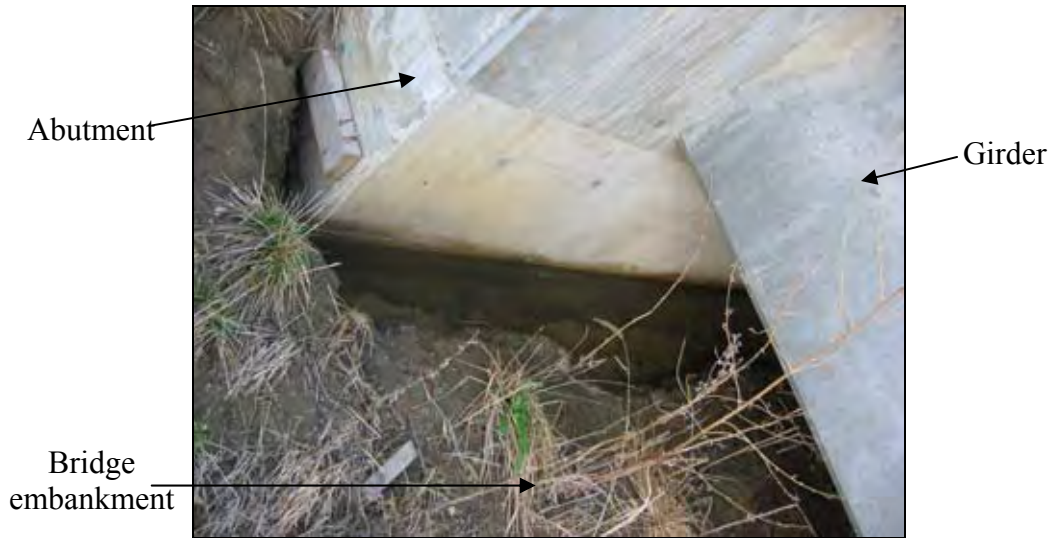
This bridge has integral abutments and prestressed concrete girders. A two-inch void was observed under the bridge approach slab. In addition, erosion of the embankments under the bridge was observed. Figure 65 shows water ponding between the embankment and the abutment.

Figure 65. Ponding water at the abutment under the bridge

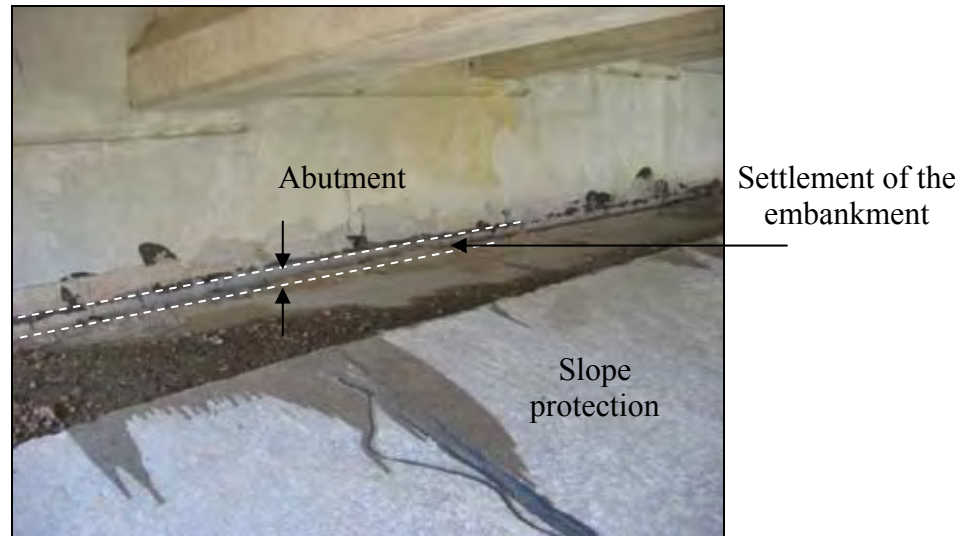
Figure 78. Settlement of the embankment under the bridge and a gap between the embankment and the abutment

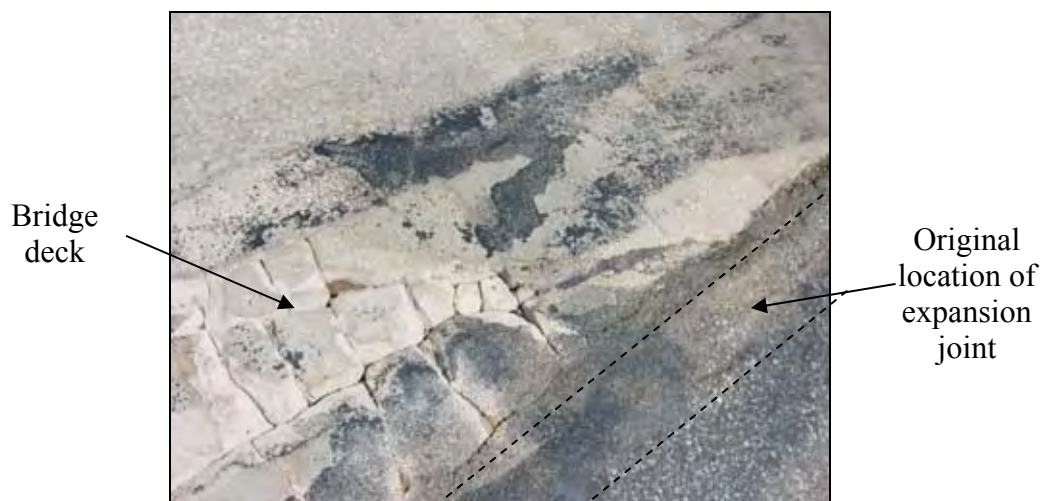
Figure 79. Breakage of bridge deck concrete

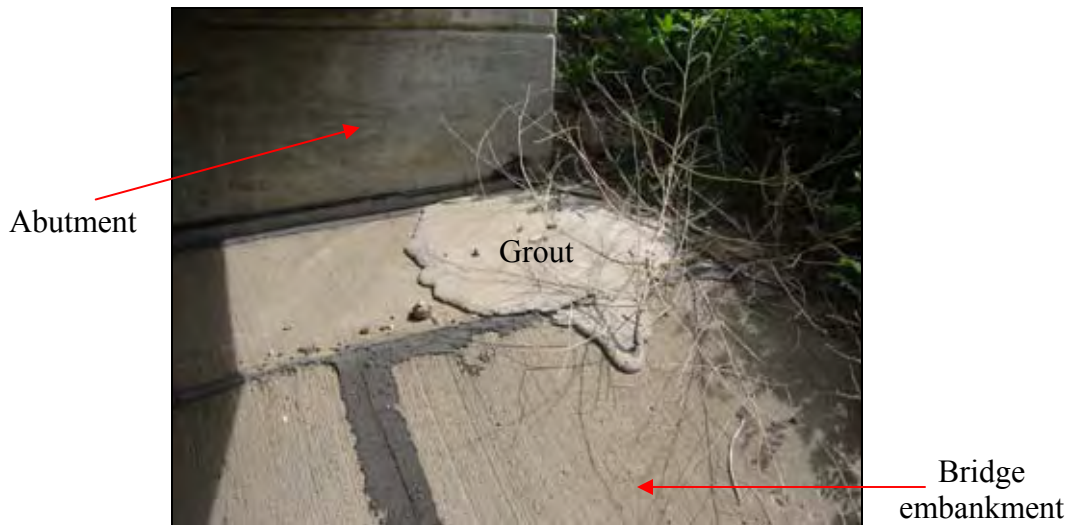
Figure 90. Grout observed on the concrete slope protection overlay indicating that void extended under the abutment

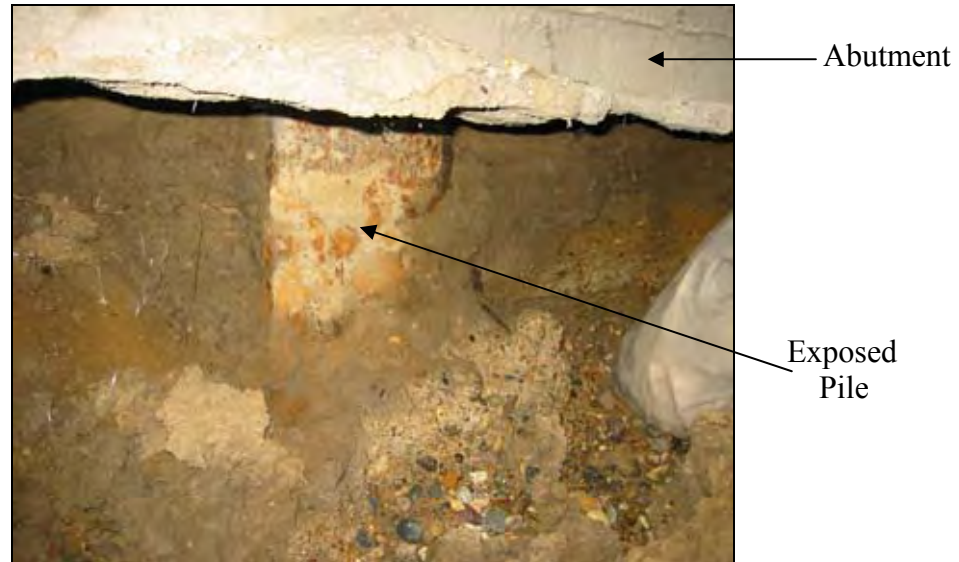
This is a three-span steel bridge with non-integral abutments. Differential settlement of about 4 inches was observed between the approach slab and wingwall. In addition, damage to the expansion joints was noted. Furthermore, soil erosion under the abutment was observed, which led to the exposure of H-piles supporting the abutment (Figure 105). No slope protection was used for the embankment under the bridge. In addition, it was observed that the approach slab panels were shaking under the impact of traffic loads, indicating a void under the approach slab.

Figure 105. Exposed H-pile caused by soil erosion under the abutment

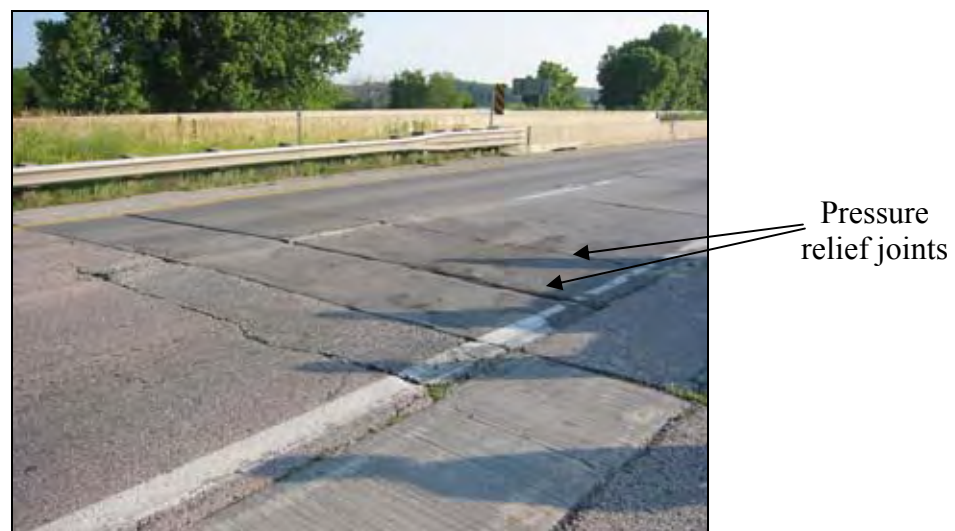
This is a three-span steel bridge with non-integral abutments. One of the observed problems at this site was cutting of the asphalt covered approach slab at 4 foot intervals to provide pressure relief joints, which caused longitudinal cracks to develop, as shown in Figure 106. Pressure relief joints were cut to allow for bridge expansion. The width of the pressure relief joint is approximately 4 inches. The bridge embankment has a concrete slope protection. Surface drains on the bridge deck allow water to fall on the embankment under the bridge, causing erosion and saturation of the embankment soil which may lead to embankment settlement. As a maintenance practice, a drainage pipe was installed to direct water collected on the bridge deck away from the embankment. Grout was pumped under the concrete slope protection to control soil erosion (Figure 107). The end drain was observed to be blocked with soil (Figure 108).

Figure 106. Pressure relief joint made by cutting the approach slab

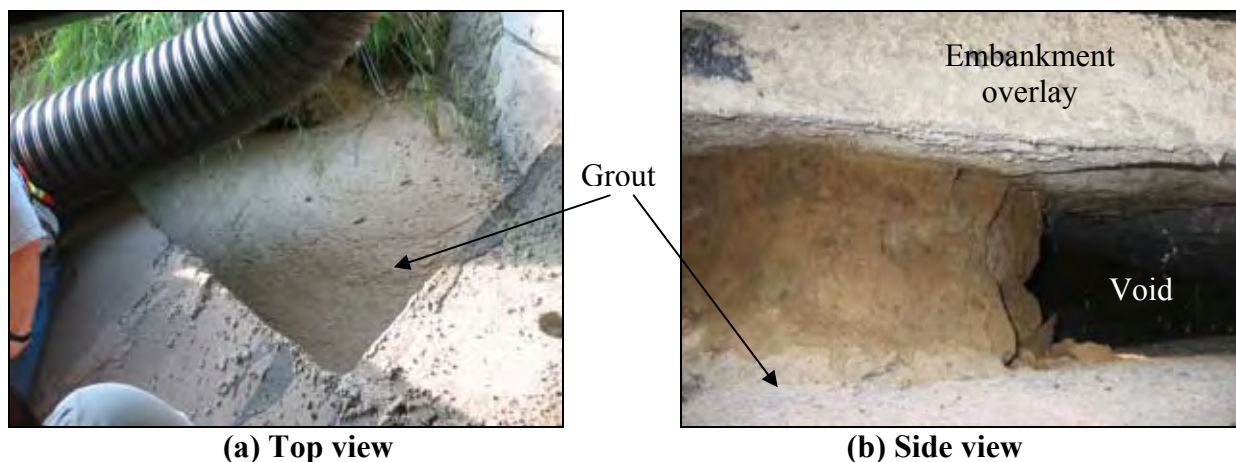
Figure 107. Grout pumped under the slope protection cover to fill the void caused by erosion

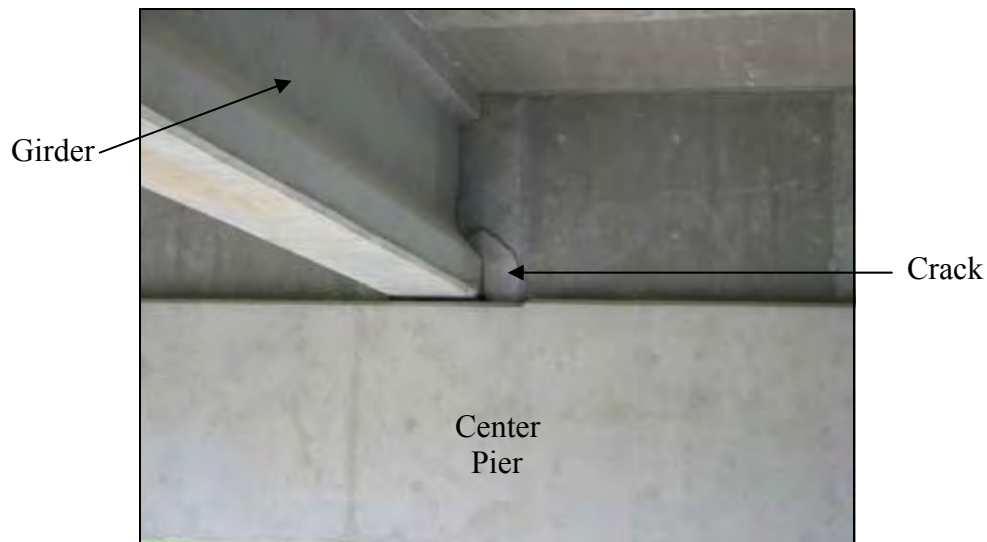
Figure 117. Cracked girder at the center pier

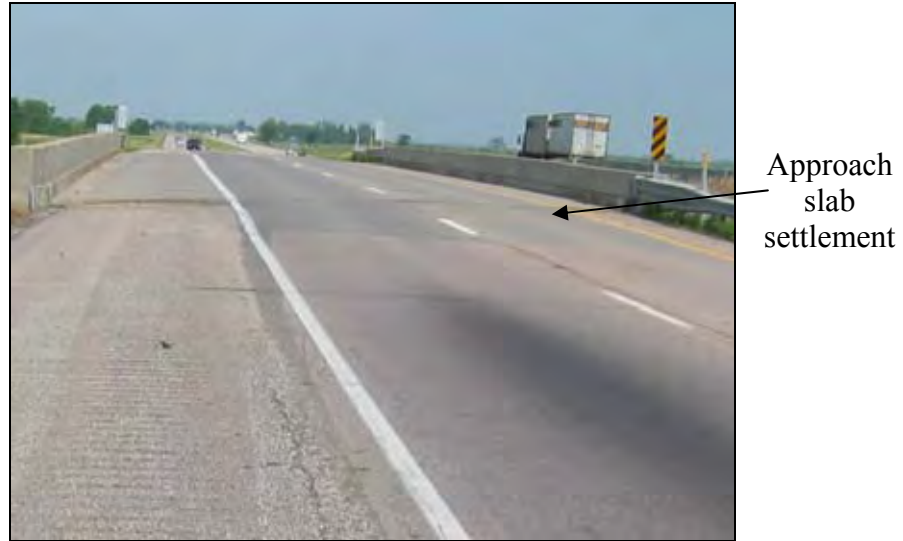
This is a three-span concrete bridge with non-integral abutments. Figure 127 shows settlement of the approach slab. Concrete spalling and cracking at the expansion joints were observed (Figure 128). Faulting of the bridge approach panels was also noted (Figure 129). The voids developed around the abutments were grouted. The embankments under the bridge had no slope protection and soil erosion was observed.

Figure 127. Settlement of bridge approach

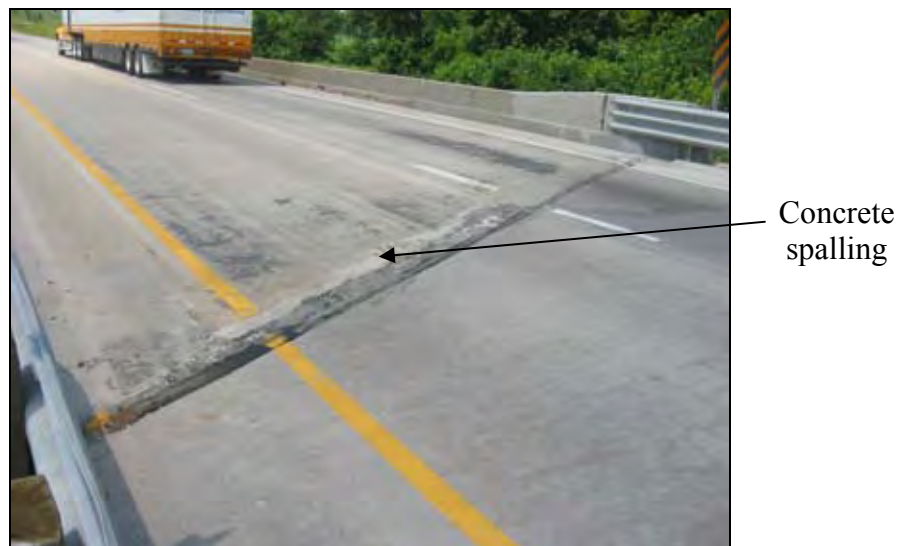
Figure 128. Concrete spalling at the expansion joint

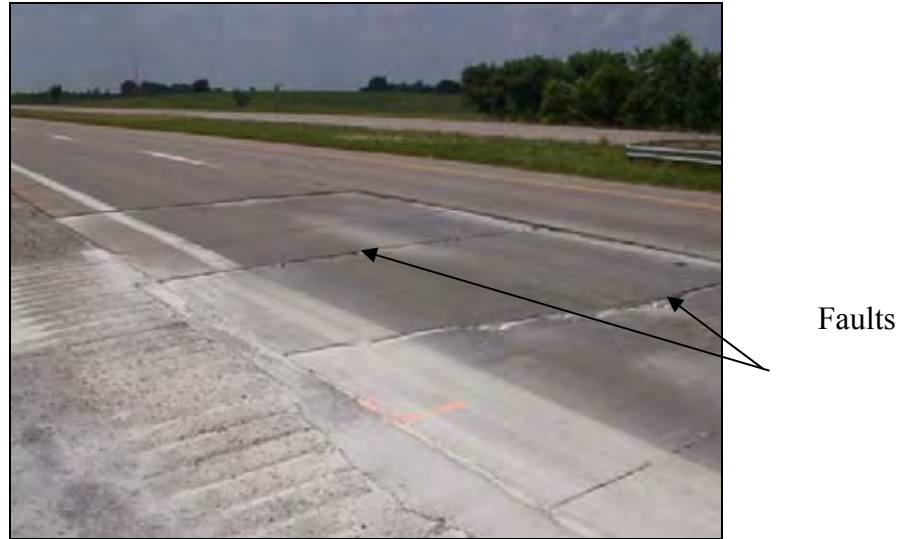
Figure 135. Faulting of bridge approach concrete panels (West end of EBL)

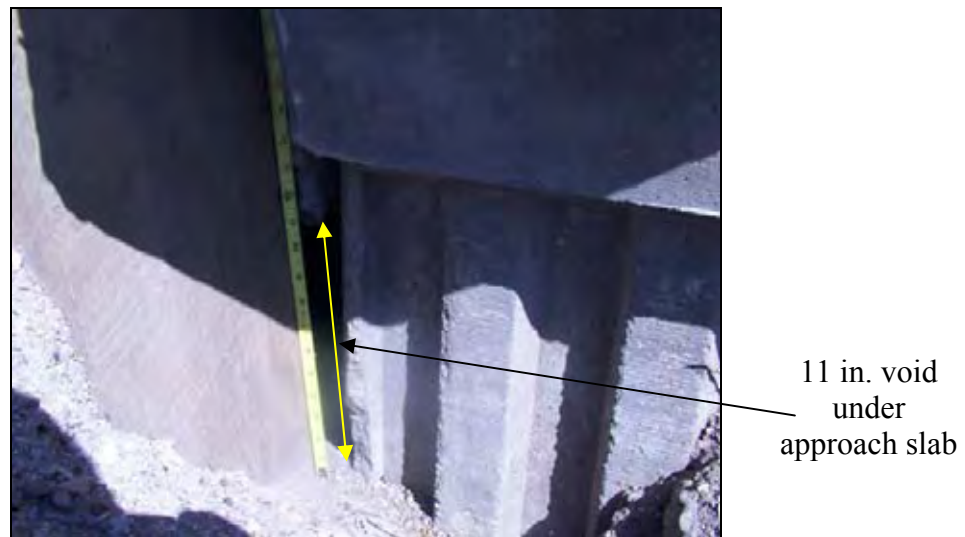
Figure 140. Void developed under the approach slab

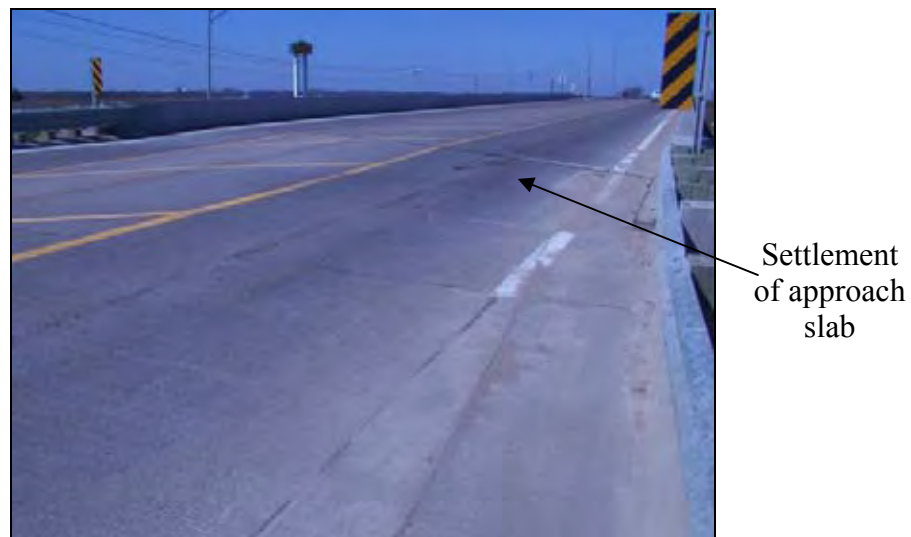
At the east end, differential settlement of about 1 inch between the approach slab and the bridge deck was measured (Figure 141). The expansion joint width was 5 inches. The sealer used to keep the joint filler in place deteriorated shortly after construction, and the forks used to hold the joint material in place were not found. As a result, the joint filler was missing leaving a large gap (Figure 142) allowing water to erode the backfill material under the approach slab. The void developed under the approach slab was about 4 inches deep (Figure 143). Another indication of poor water management was the observed erosion at the sides of the abutment (See Figure 144). Furthermore, concrete spalling was observed at the expansion joint.

Figure 141. Differential settlement at the bridge approach (East end)

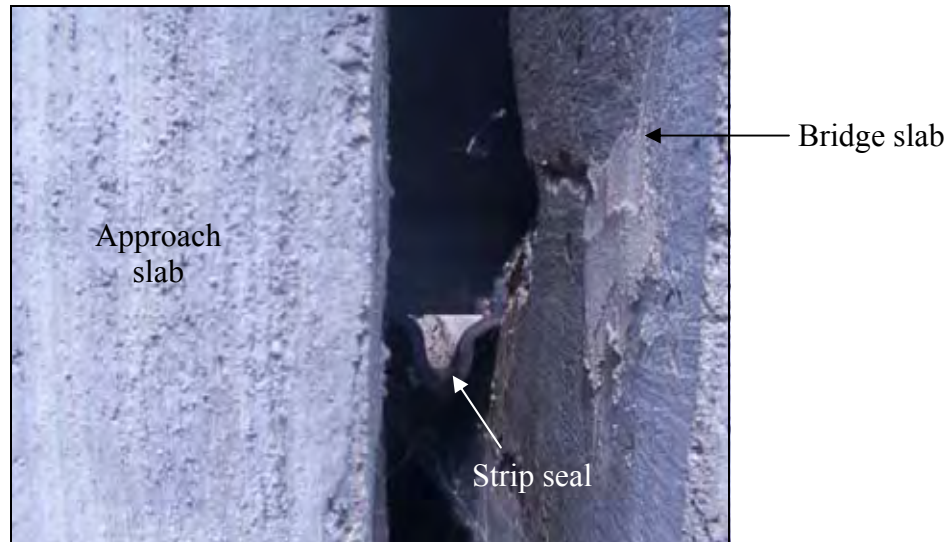
Figure 148. Side view of the strip seal which was cut short (South end of SBL)

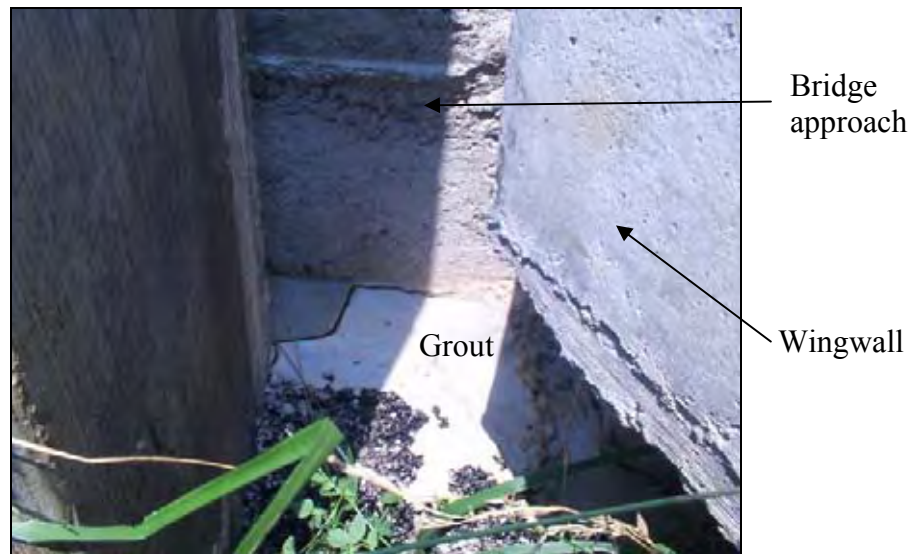
Figure 152. Grouting under the approach slab (South end of NBL)

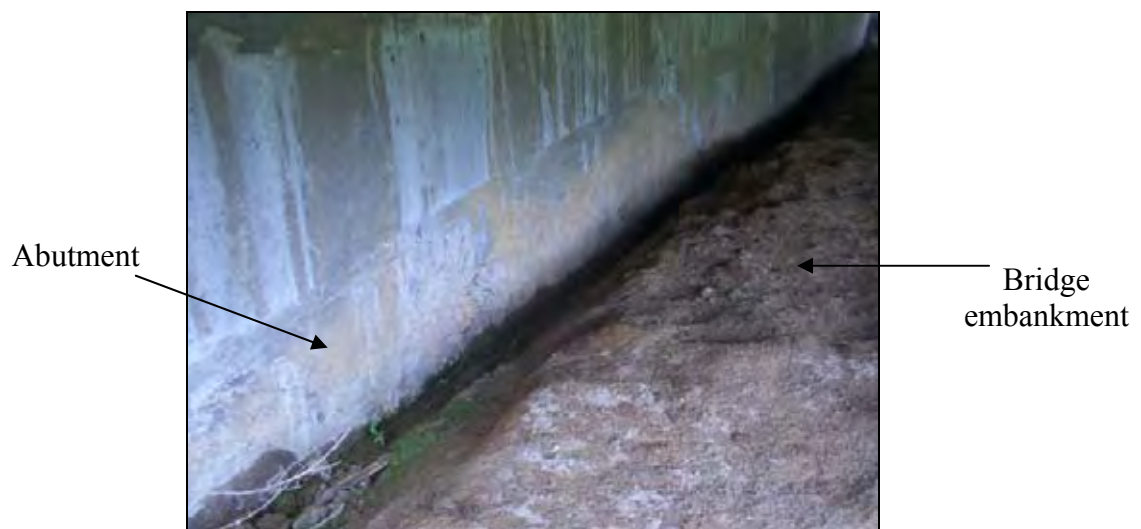
Figure 155. Erosion of the embankment soil (West end of WBL)

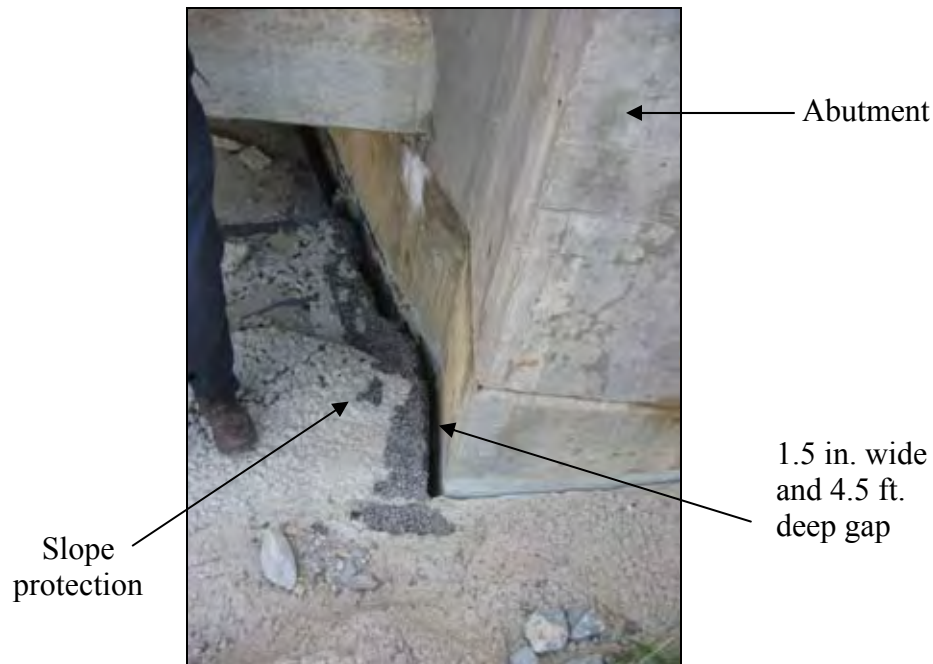
Figure 170. Gap between abutment and embankment

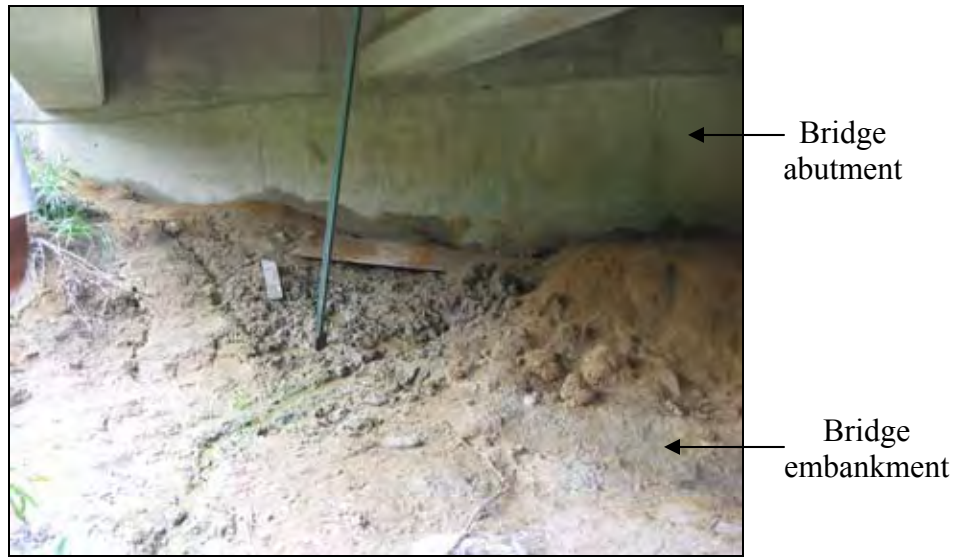
Figure 172. Soil erosion of the embankment under the bridge

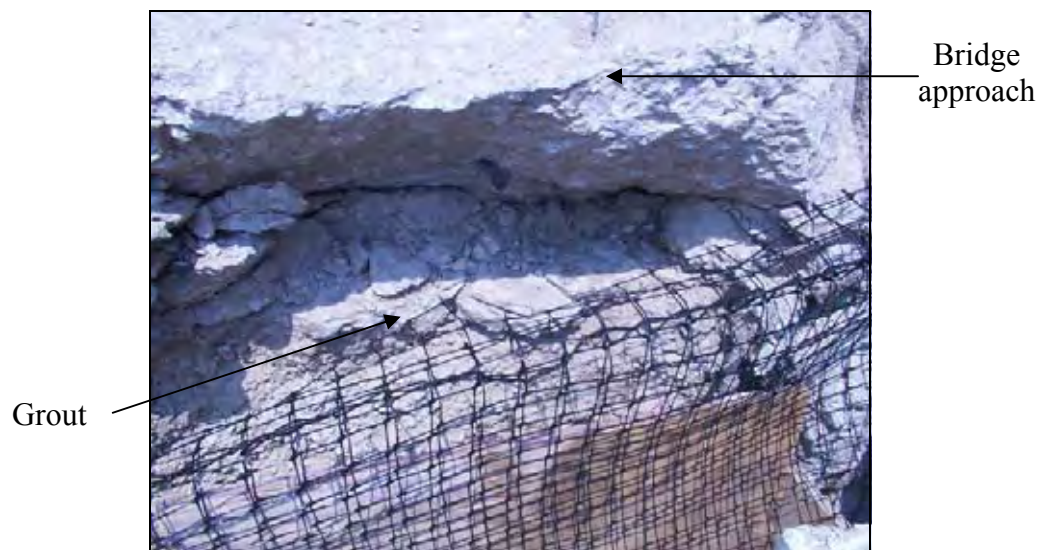
This bridge has three spans with steel girders and non-integral abutments. The bridge approach was grouted to fill a void (see Figure 236). During the field inspection, replacement of both approach slabs and the paving notch of the northbound lanes were in progress. The approach slabs were replaced due to excessive settlement and cracking, which is believed to be a result of severe erosion and subsequent void development. At the south end of the bridge, new granular backfill was placed and compacted in 8-inch-loose lifts using a vibratory base plate. The width of the newly constructed paving notch was 12 inches, with an expansion joint width of 2.5 inches (Figure 237). The bridge did not have subdrains and none were installed. The bridge embankment soil is mostly silty clay with no slope protection. At the north end of the bridge, reconstruction of the abutment was still in progress (Figure 238).

Figure 236. Grout pumped under existing approach (South end of SBL)

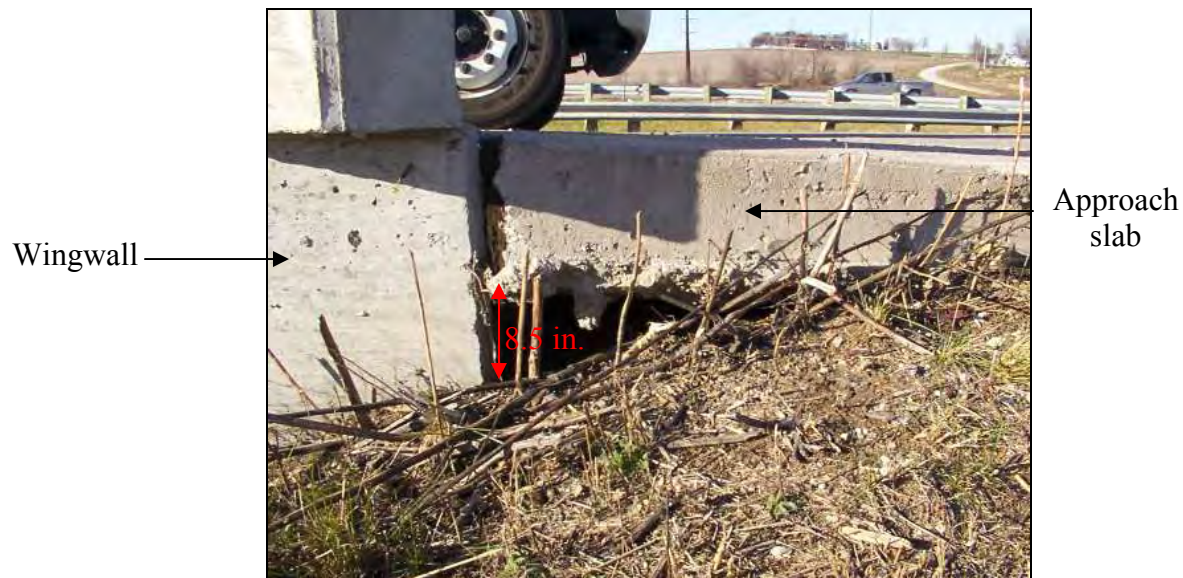
Figure 239. Void under approach slab (North end of SBL)

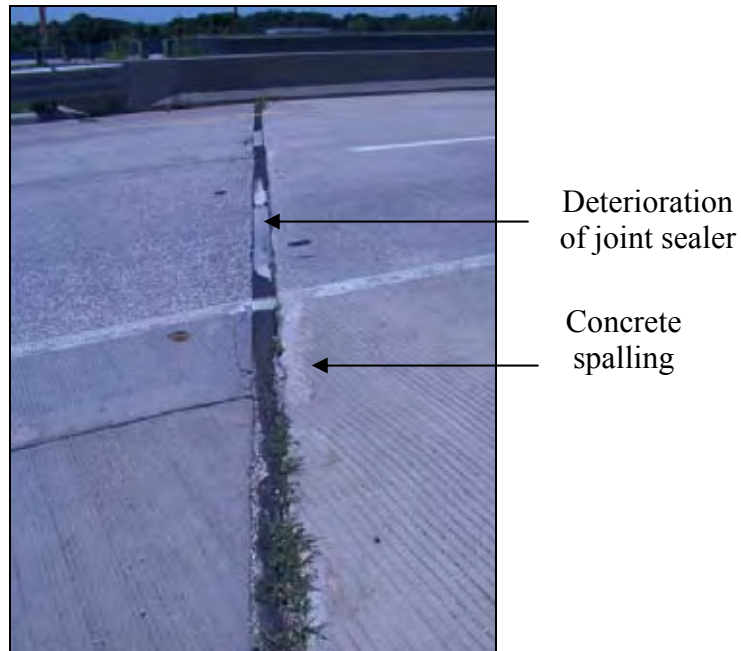
Figure 266. Deteriorated flexible foam used as joint filler (South end of NBL)

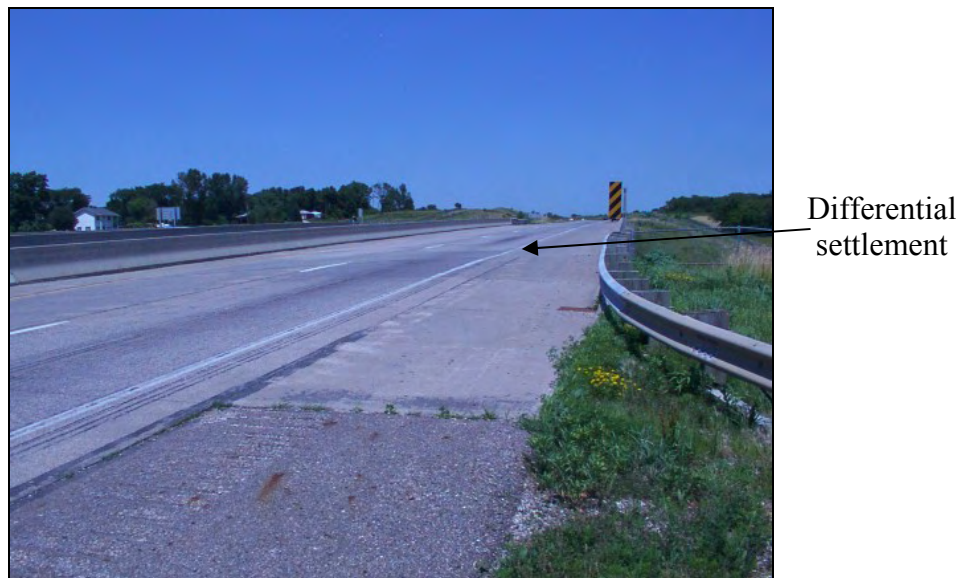
Figure 281. Differential settlement of the approach slab (North end of SBL)

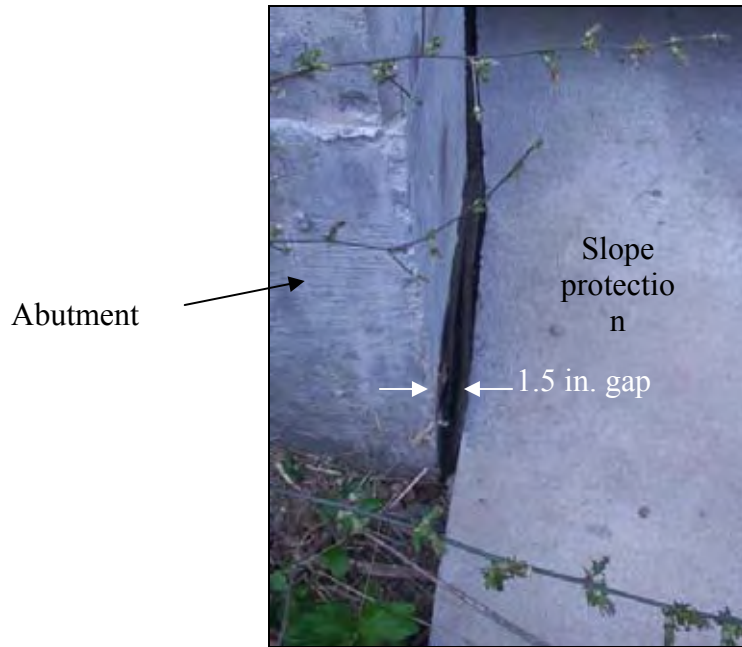
Figure 289. A 1.5 inch gap between abutment face and slope protection (South end of NBL)

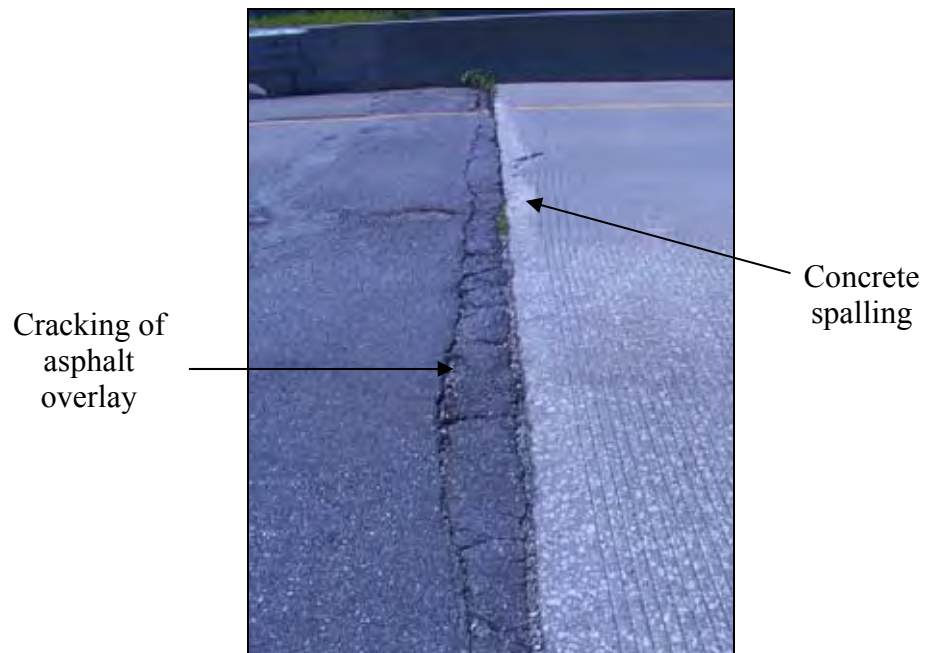
Figure 299. Concrete spalling and cracking of asphalt overlay at the expansion joint (South end of NBL)

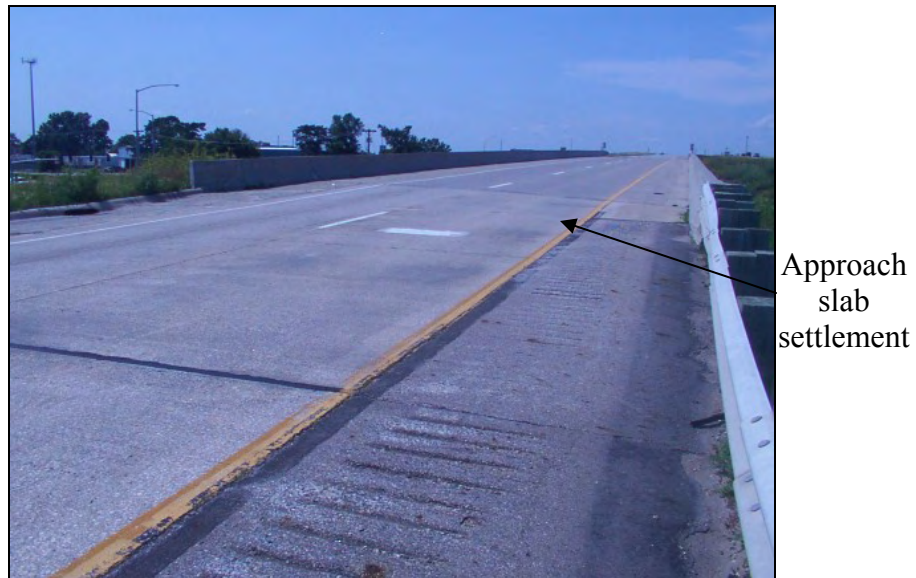
Figure 320. Bridge approach settlement (South end of SBL)

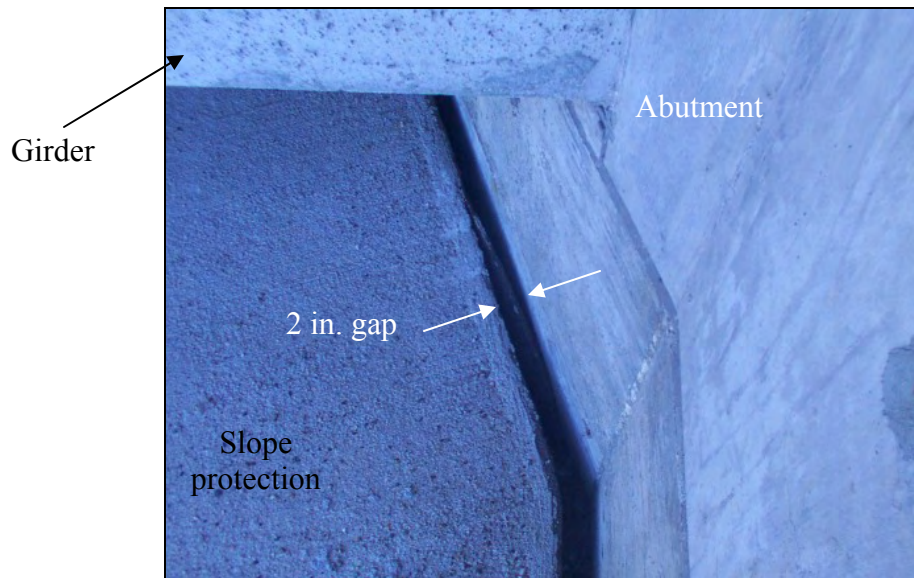
Figure 325. Lateral movement of the abutment away from the bridge embankment caused by expansion of the bridge structure (North end of NBL)

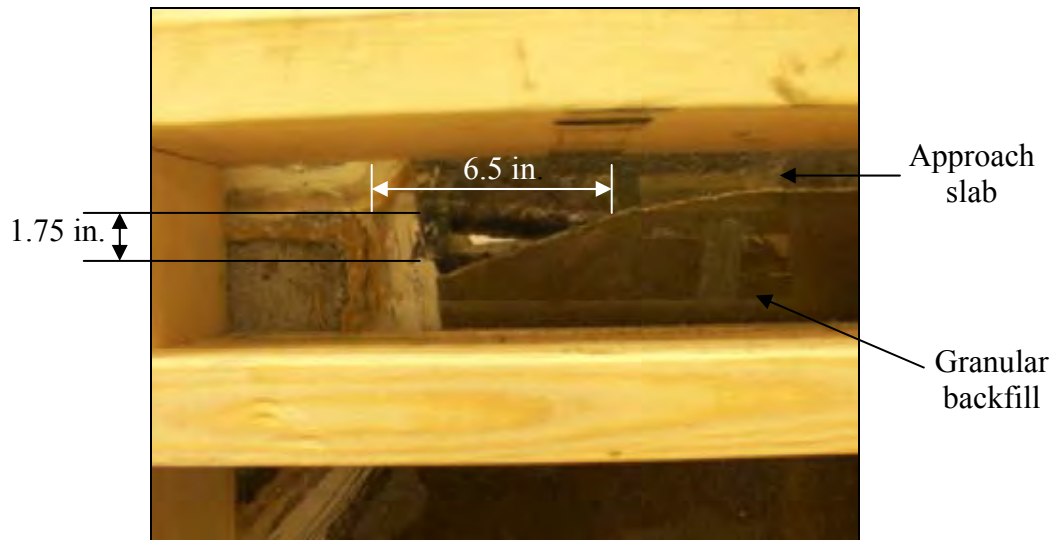
Figure 377. A void that is 1.75 in. deep and 6.5 in. long developed under the approach slab

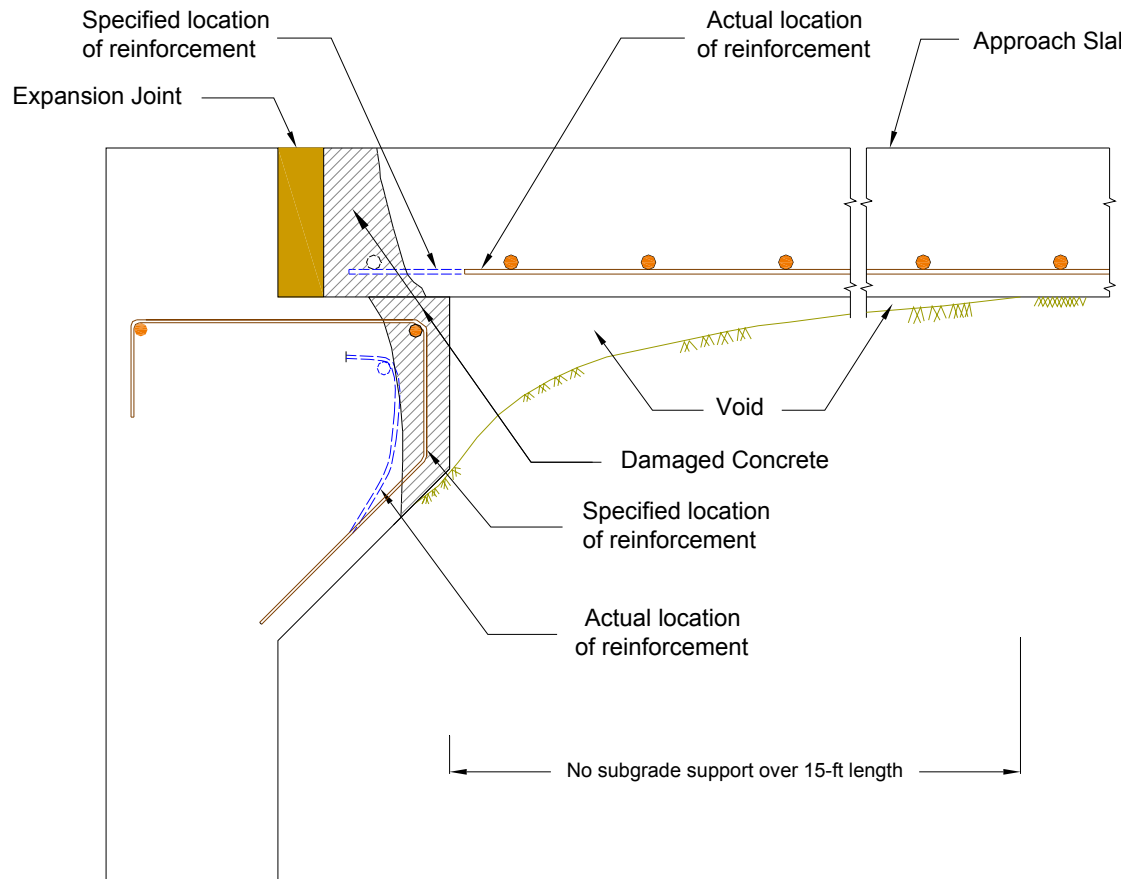
Figure 413. Inaccurate placement of reinforcing steel in the paving notch and the approach slab (Brakke 2003)
