SHENANDOAH

TRAFFIC SAFETY STUDY

SHENANDOAH, IOWA

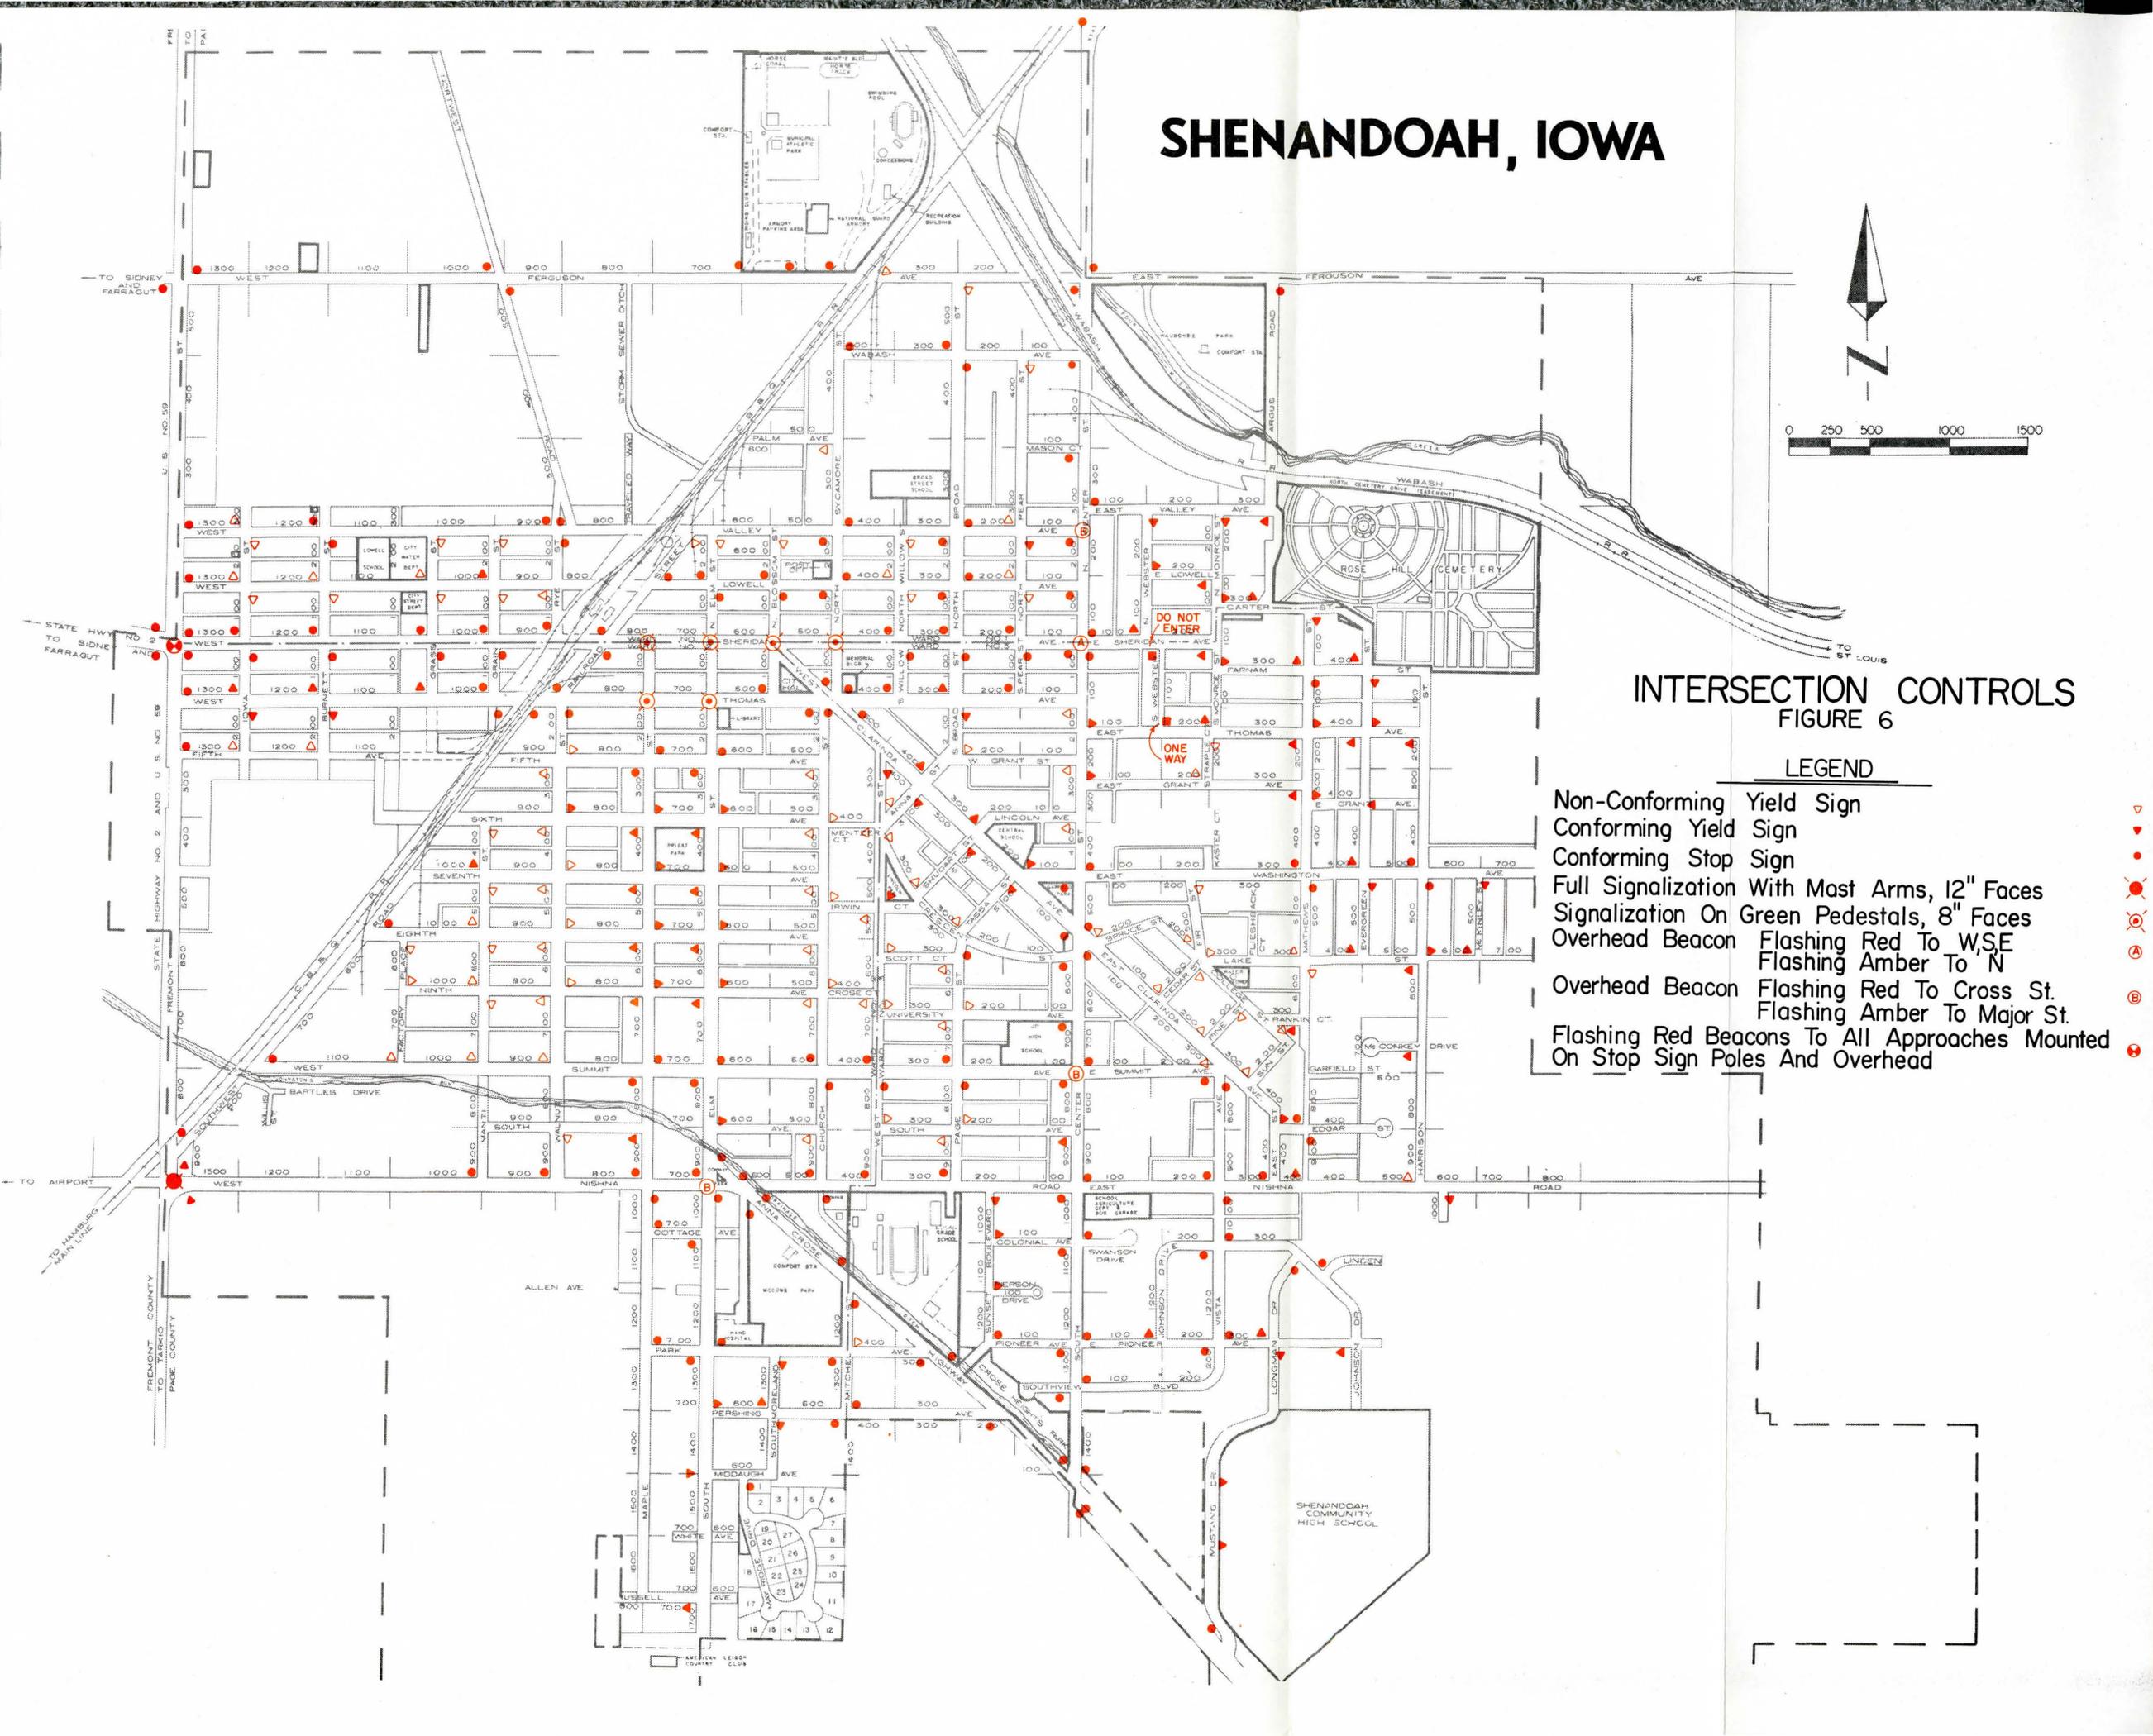
Stop signs are utilized at about 40% of the intersections and in most cases properly. Three have deteriorated reflectorization which reduces the visibility of the sign. A few others are the smaller 24-inch size and in some instances may require upgrading to the 30-inch size.

At five locations stop signs are used in conjunction with yield signs creating a potentially hazardous or at least confusing situation. At two locations, one of the approaches is not required to stop while the remaining approaches are required to stop. This too contributes to confusion and ultimately to an occasional traffic accident.

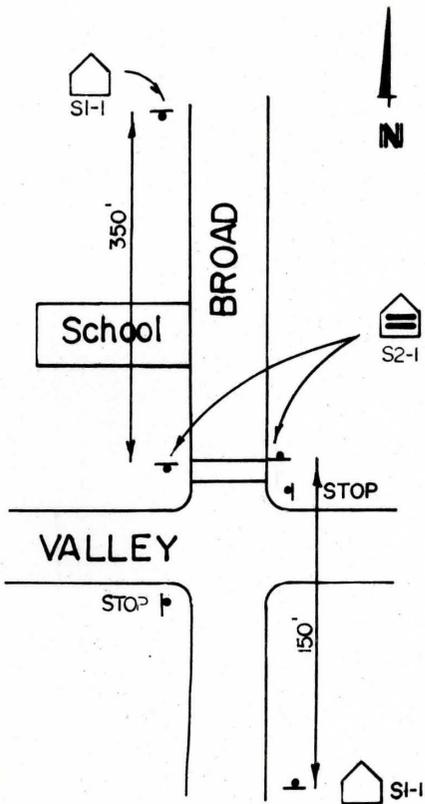
SCHOOL CROSSING AT
VALLEY & BROAD
FIGURE 11

The portable stop sign used at this crossing is non-conforming (Section 2B-5). It is recommended that the use of this device be discontinued.

During several field trips it was noted that the beacon was not flashing, but that solid red or amber indications were being displayed. Such a situation is confusing and hazardous. When the flashing unit is not working properly, it is recommended that the unit be turned off. Continued malfunction should warrant replacement of the flasher mechanism.

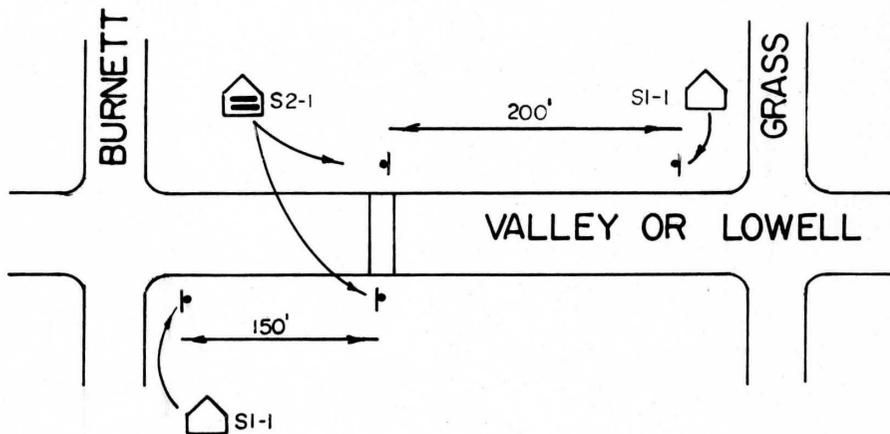
SCHOOL CROSSINGS ON
VALLEY & LOWELL
FIGURE 12

Lowell School. Three school crossings are located near Lowell School. Two are located near the school, one on Valley and one on Lowell Avenue. Presently, they are marked with diamond-shaped "School Crossing" signs. These should be removed and replaced with the newer signs as in FIGURE 12.

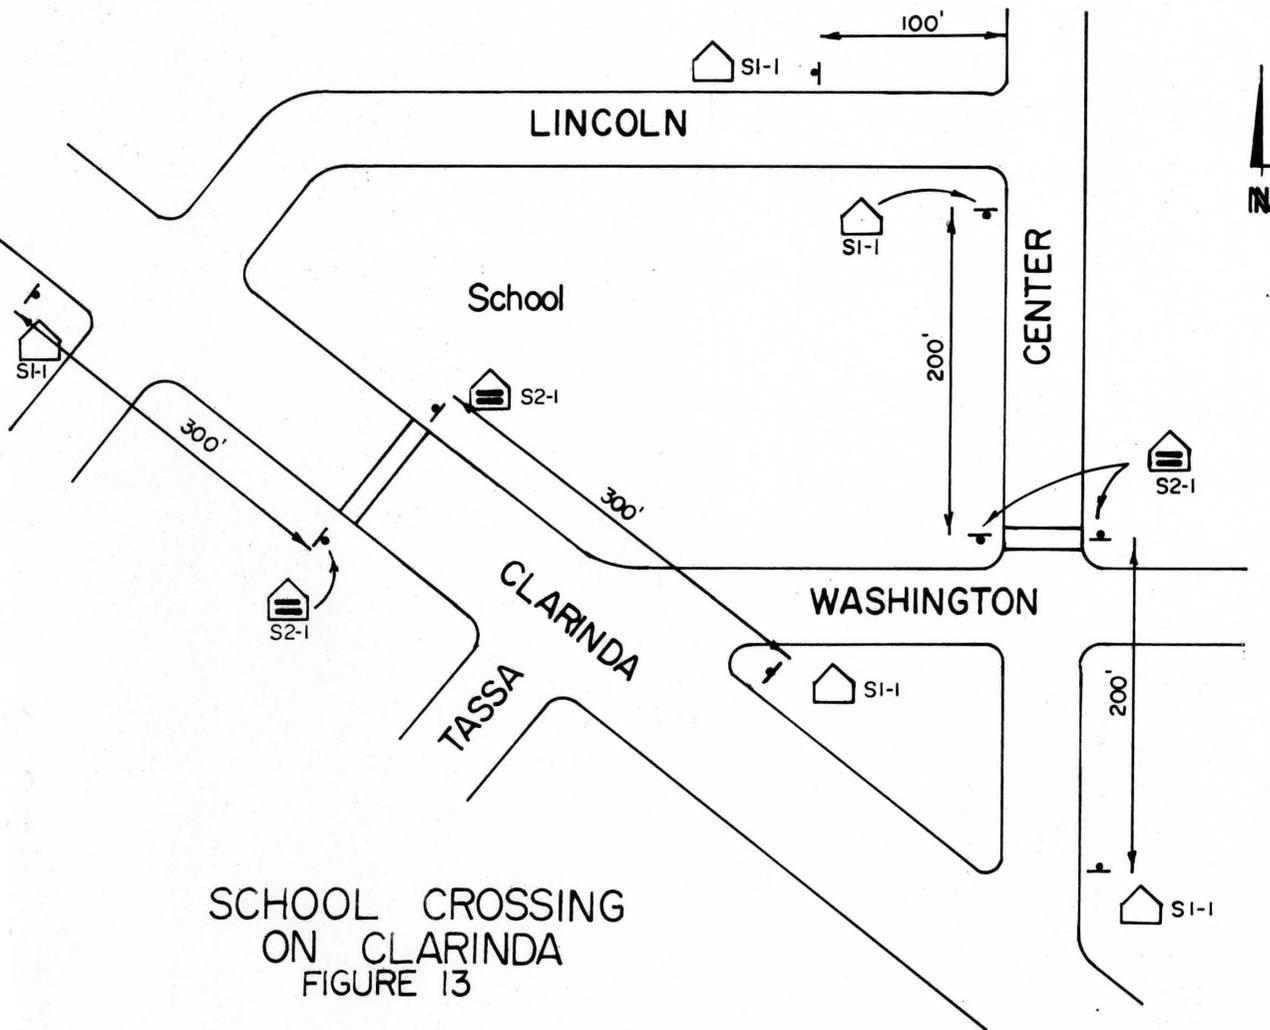
SCHOOL CROSSING
ON CLARINDA
FIGURE 13

Central School. Two crossings are located adjacent to Central School. The mid-block crossing on Clarinda in front of the school is marked by a "Slow - School" sign on each approach, and by a portable stop sign unit set in the street during hours of usage by children coming from or going to school. These signs and portable stop sign unit should be removed, and the crossing controlled as shown in FIGURE 13.

The crossing on Center Street is marked from the north by a "Slow - School" sign and is unsigned from the south. A treatment similar to that on Clarinda Avenue is recommended and is also shown in FIGURE 13.

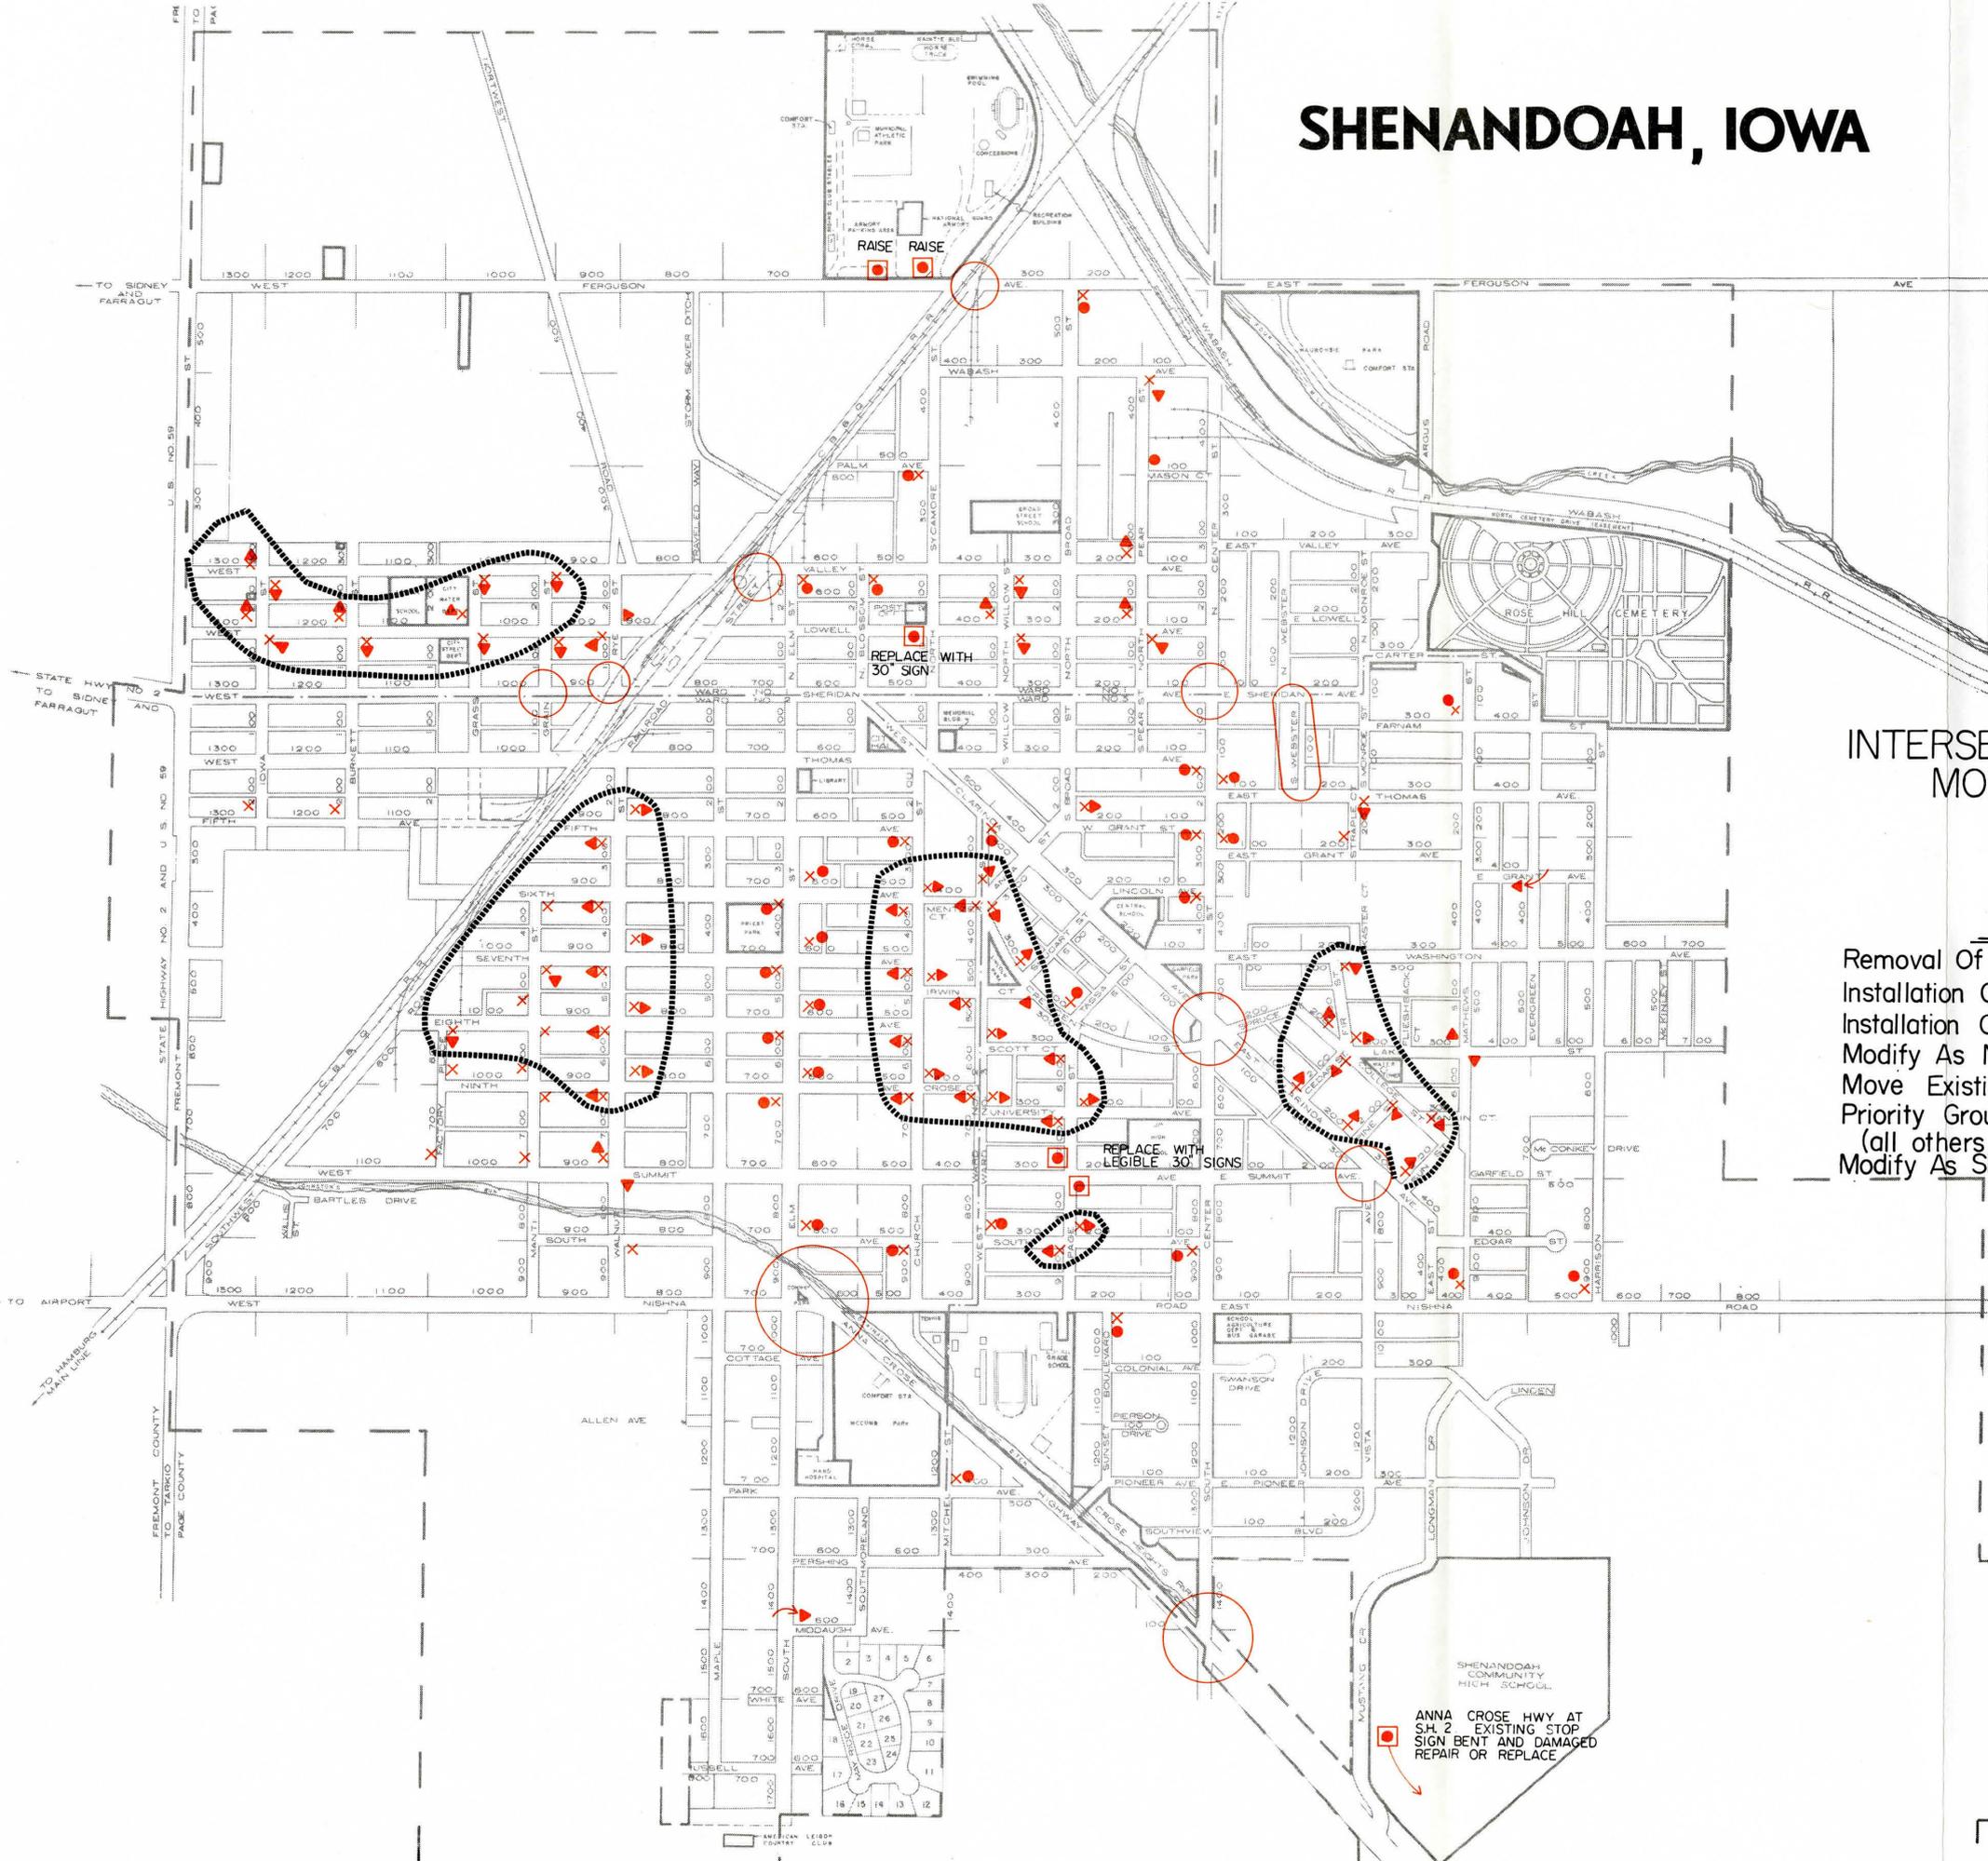
ANNA CROSE HWY AT S.H. 2 EXISTING STOP SIGN BENT AND DAMAGED REPAIR OR REPLACE

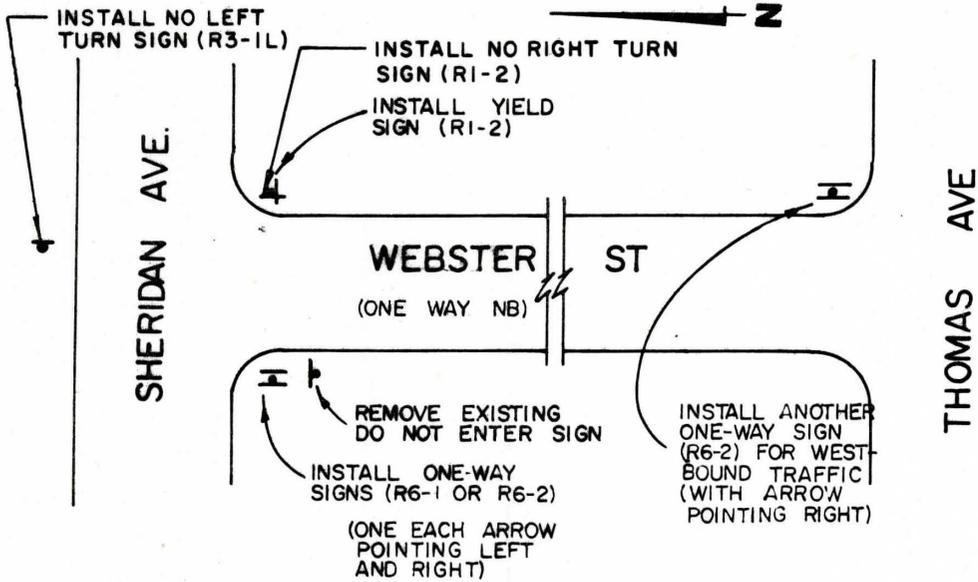
IMPROVEMENTS ON WEBSTER ST.
FIGURE 24

narrow, and is properly signed as one-way northbound. However, the recommendation is made that the signing be modified as shown in FIGURE 24 for improved clarity and conformance with standards.

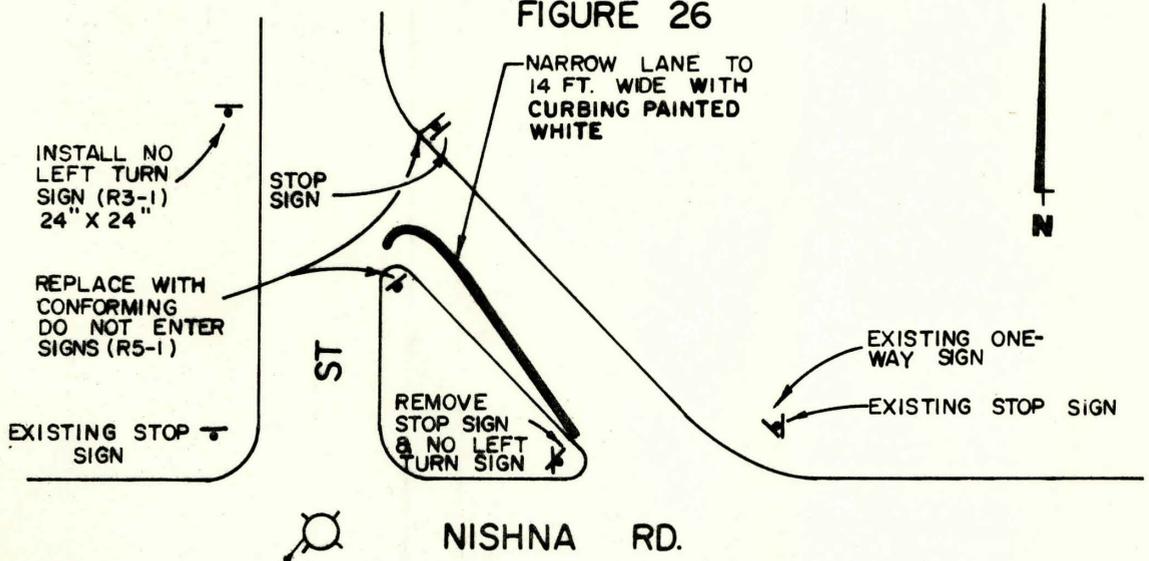
IMPROVEMENTS AT NISHNA, ELM, & ANNA CROSE HWY
FIGURE 27

Nishna Road, Elm Street, and Anna Crose Highway. This intersection has diminished in importance and in traffic since S. H. 2 was rerouted to the south. Over time, however, as Shenandoah develops to the southeast, traffic can be expected to increase. At the present time, only an updating of signing and

slight physical modification are required. As shown in FIGURE 27, it is recommended that signing changes be made as indicated, and that the one-way turning lane be narrowed and delineated. The flashing beacon can be retained, but should be painted yellow with flat black visors the next time painting is needed. Existing right-of-way designations have not been changed, as the accident history is minimal and traffic demands are adequately served.

One other modification which should be considered is the moving of the hospital drive entrance further east on Anna Crose Highway, or the provision of a different access point off of Elm Street, so as to reduce the intersection conflicts. Also, the curve signs with 25 mph speed plates located in advance of the intersection on Nishna Rd. and Anna Crose Hwy. should be removed.

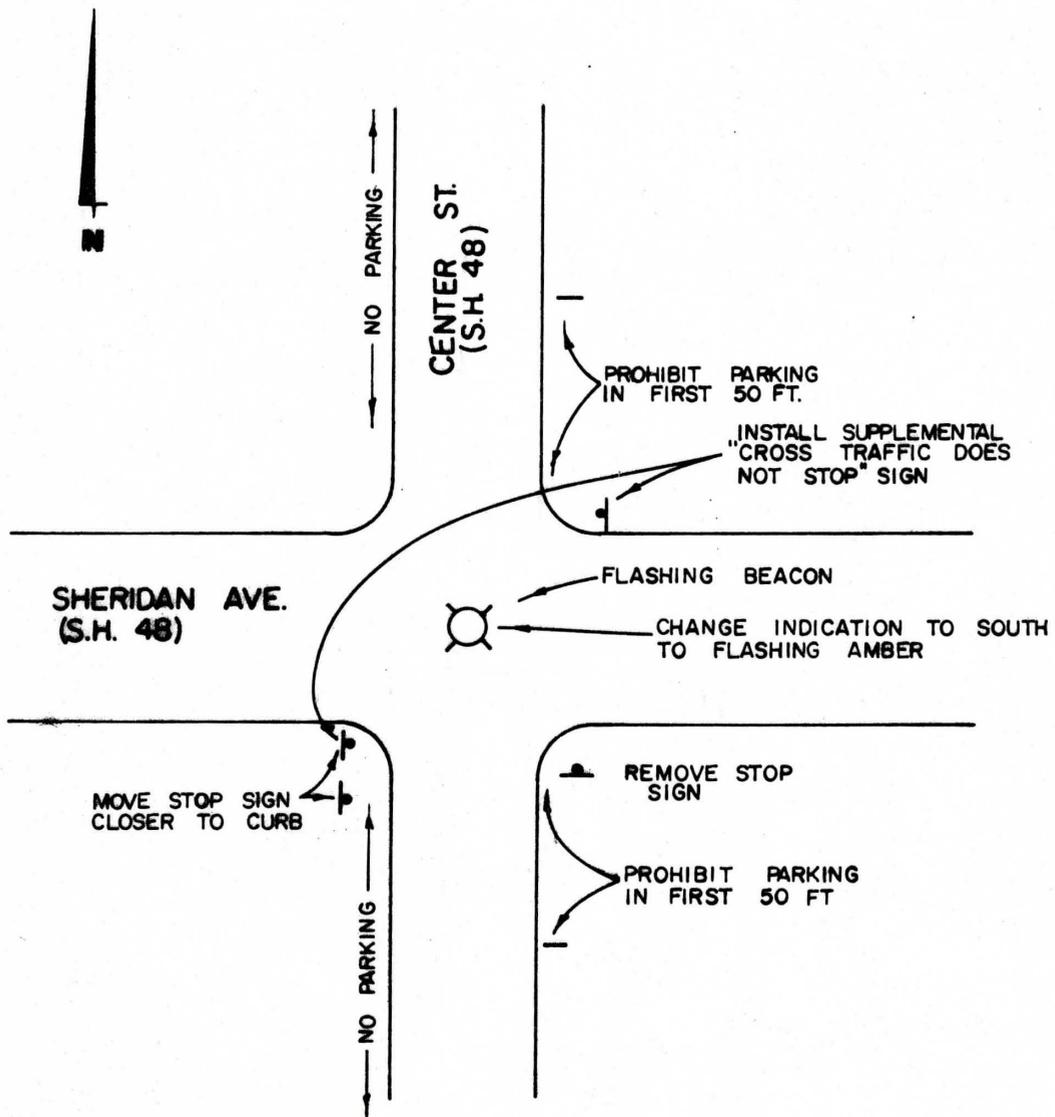
IMPROVEMENTS AT
SHERIDAN & CENTER
FIGURE 29

As Center Street carries a greater amount of traffic, 60% of which is through in nature, and the 25 mph speed limit on both streets, it is recommended that the intersection be operated as a two-way stop with Center Street as the through street. This includes the signing and parking changes as shown in FIGURE 29.

The flashing beacon indication to the south requires change to amber, and parking on the east side of Center Street to the north and south of Center Street is prohibited to allow adequate sight distance on the east leg. The stop sign on the west leg needs to be located closer to the curb for improved visibility.

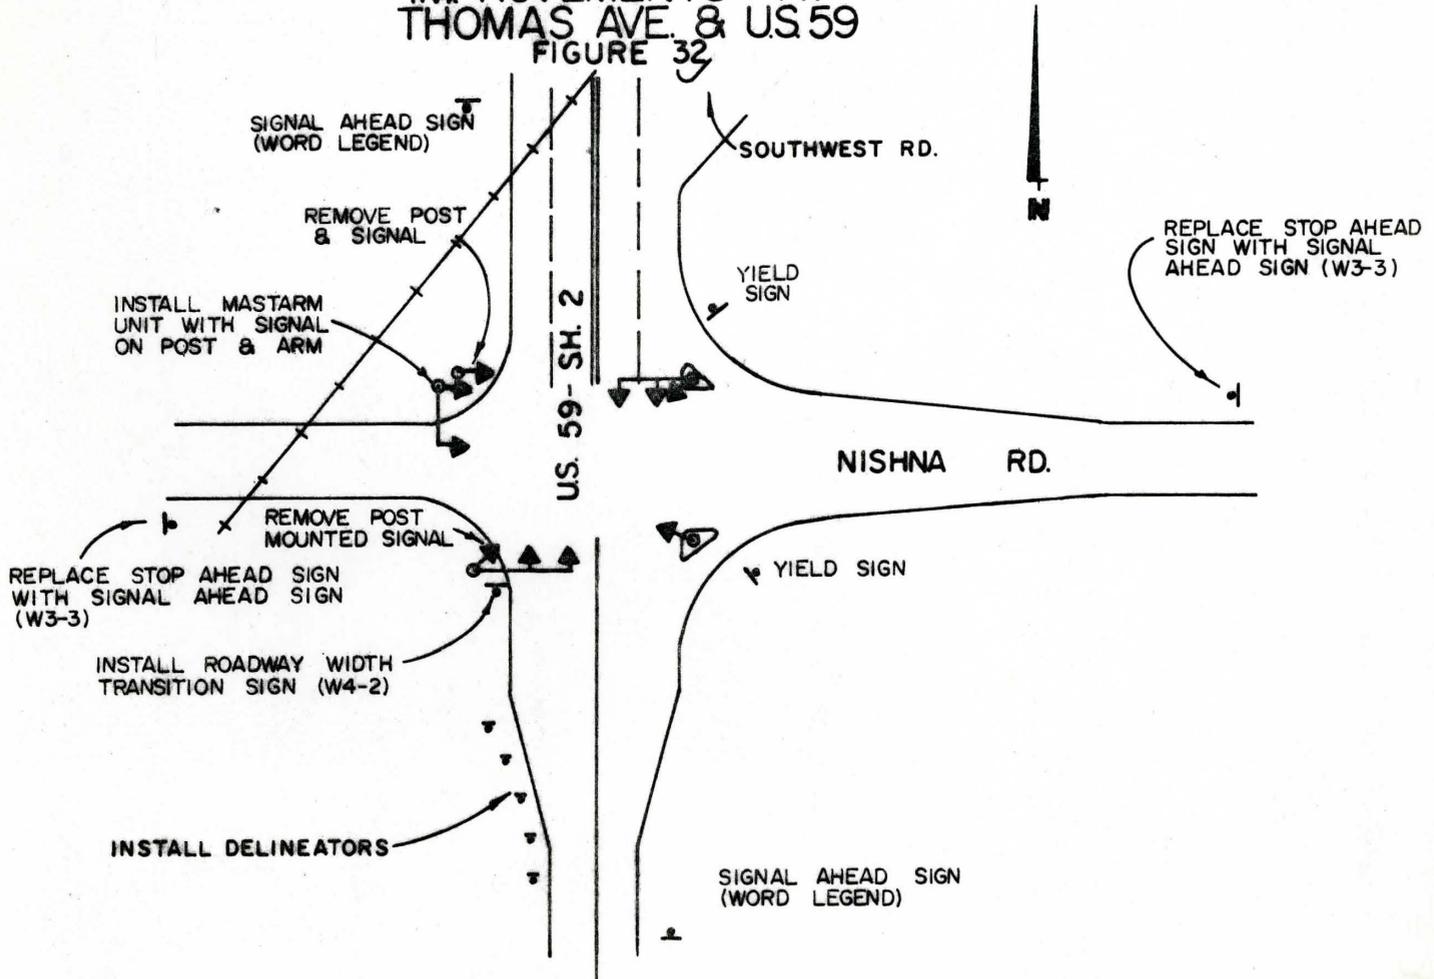
IMPROVEMENTS AT
NISHNA RD. & US 59 - SH. 2
FIGURE 33

To provide proper visibility of the far side signal faces to the east approach, it is recommended that the far side post and signal be replaced by a mast arm and pole with signals on the arm and post. The location of the base may require relocation. (See FIGURE 33).

The Stop Ahead signs on Nishna Road are recommended to be replaced by the proper Signal Ahead signs. The verbal Signal Ahead signs on U.S. 59 are acceptable, but optimally would be replaced by the newer graphic Signal Ahead sign. Also a Pavement Width Transition sign (W4-2) is to be installed on the immediate south side of the intersection to warn of the narrowing of the roadway.

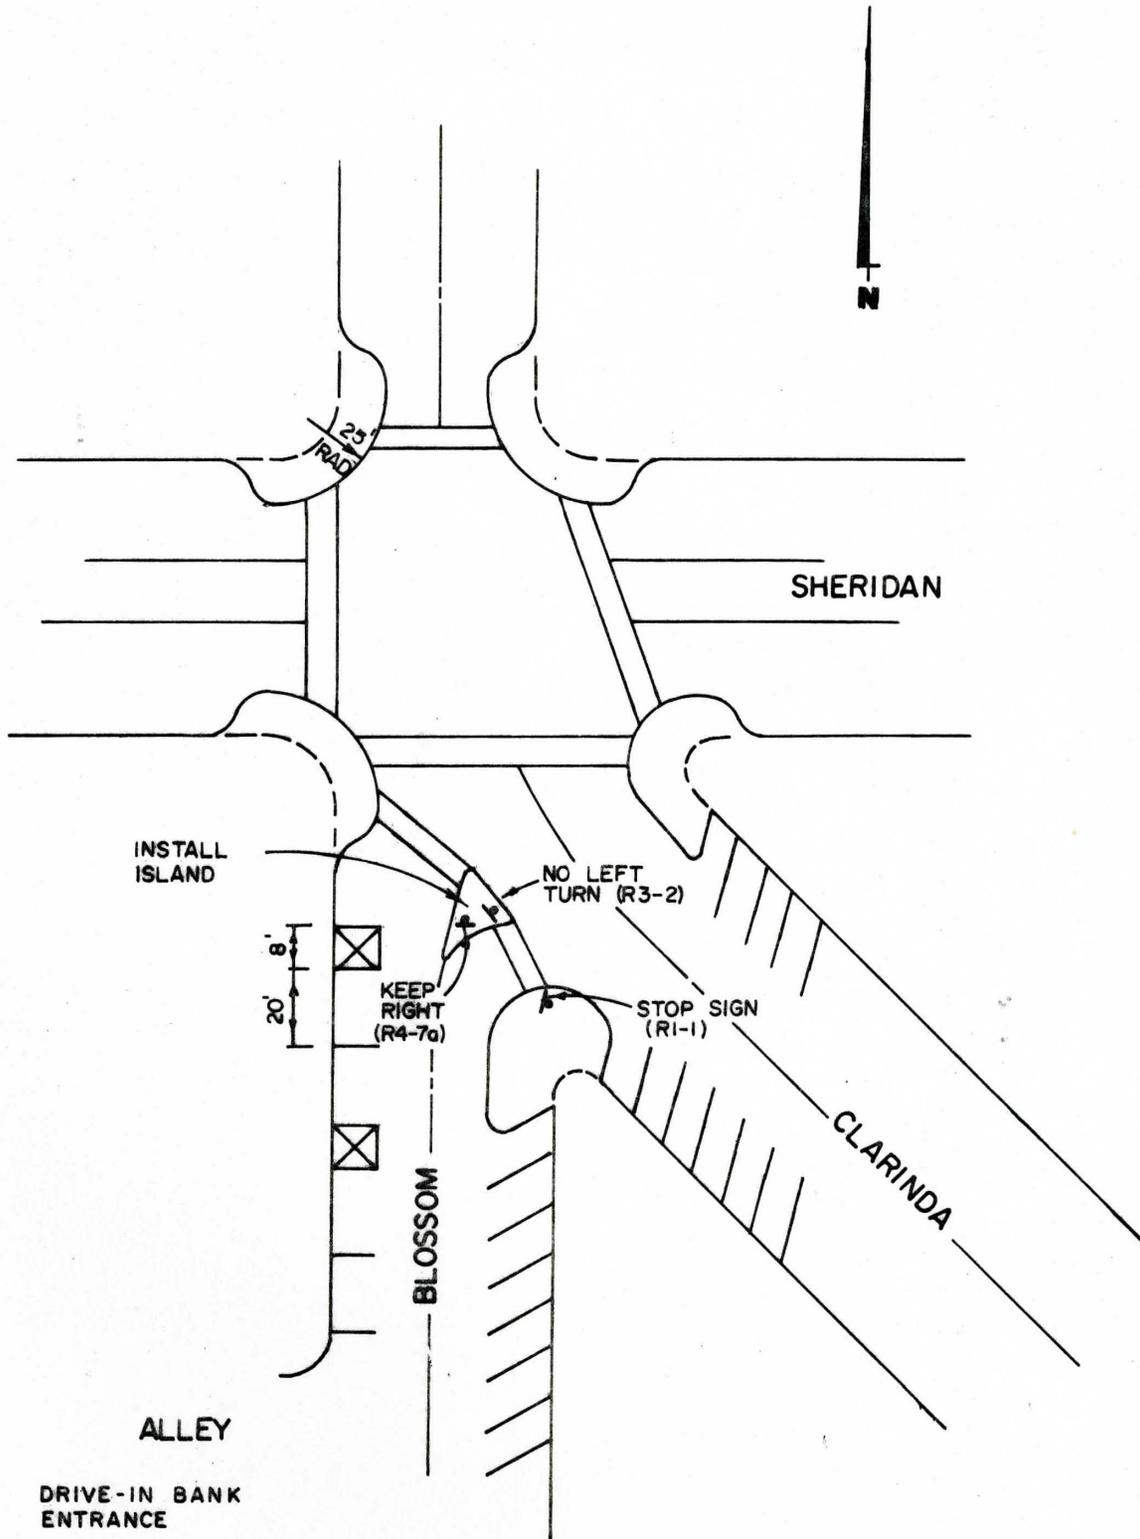
IMPROVEMENTS AT
 SHERIDAN, CLARINDA & BLOSSOM
 FIGURE 37

Special consideration is required at the intersection of Sheridan and Clarinda Avenues, and Blossom Street. The signal controls here give both Blossom and Clarinda a green indication simultaneously, a hazardous feature. As Blossom Avenue carries only about 300 vehicles per day into the intersection from the south, a treatment as shown in FIGURE 37 is recommended. Any northbound traffic would be required to turn southeast onto Clarinda Avenue.

Besides Sheridan Avenue, angle parking is also found on Clarinda Avenue and Thomas Avenue. The eventual removal of angle parking on these streets is also recommended, and would comply also with The Comprehensive Plan. As evidenced by the accident collision diagram for Thomas Avenue at Elm Street, the inherent accident potential of angle parking is beginning to show itself.

For the short term, replacement of the angle parking on these streets should not occur, as the loss of these additional spaces without adequate replacement is not practical or logical.
