# Laboratory and Field Evaluation of a Composite Glued-Laminated Girder to Deck Connection

**Final Report  
February 2019**

**NATIONAL  
CENTER  
FOR WOOD  
TRANSPORTATION  
STRUCTURES**

**Sponsored by**  
Iowa Highway Research Board  
(IHRB Project TR-680)  
Iowa Department of Transportation  
(InTrans Project 14-511)

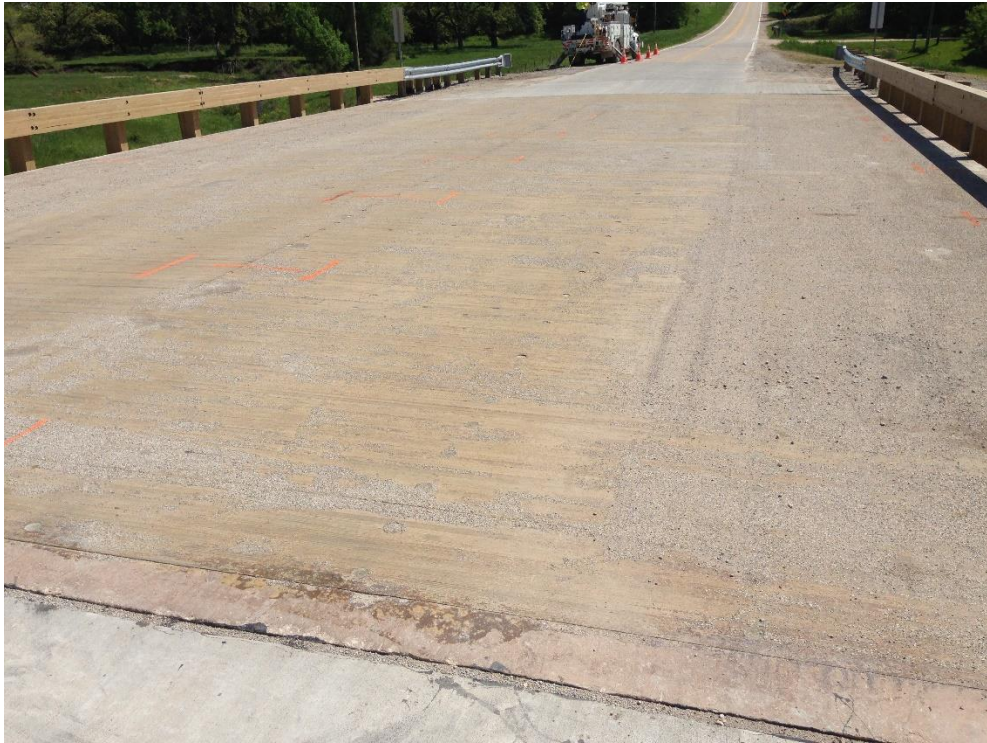
Visual inspection of the epoxy wearing surface applied to the bridge deck was completed during the live load test conducted in 2015. Initial findings by the research team were that the epoxy wearing surface was performing quite well in terms of a moisture barrier; however, much of the aggregate applied to the epoxy had been worn off by traffic, primarily in the wheel lines of the traffic lanes (see Figure 48).

**Figure 48. Epoxy wearing surface May 2015**

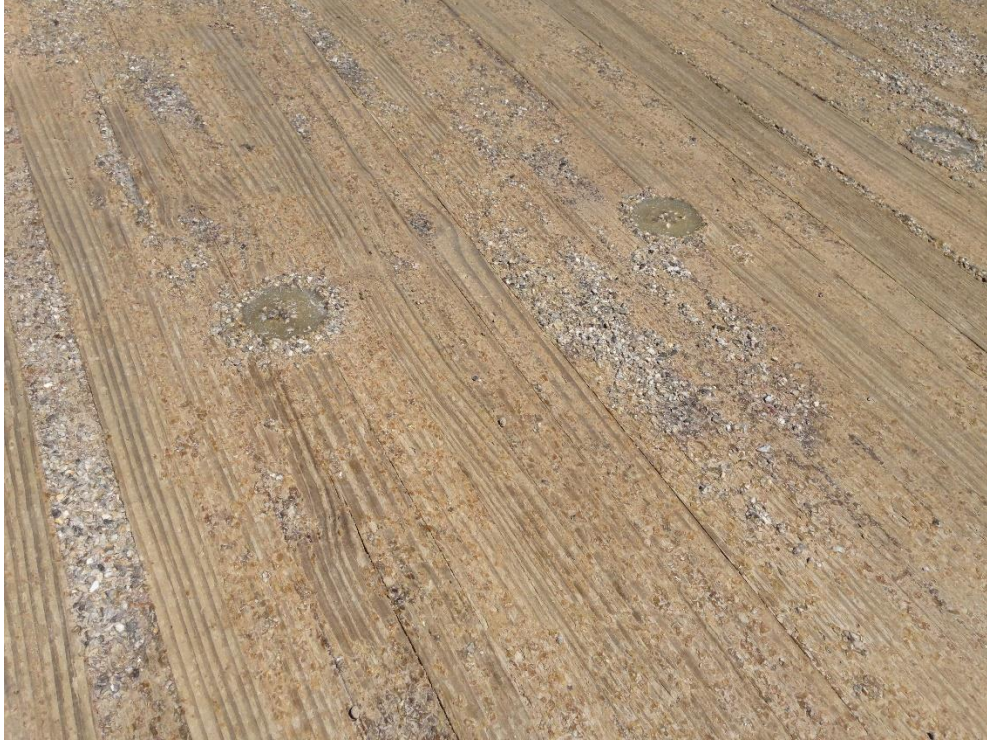
That said, the wearing surface does appear to provide an impermeable water tight barrier to the deck surface and inspection suggested that the epoxy filled all the predrilled bolt holes (see Figure 49) in the deck and, more importantly, the transverse joints between adjacent deck panels.

**Figure 49. Epoxy filling predrilled lag screw holes**
