Lake Delhi Dam Reconstruction Design Alternatives Report

**Lake Delhi Combined Recreational
Facility and Water Quality District**
Delhi, Iowa

Final
December 21, 2011

Stanley Consultants INC.

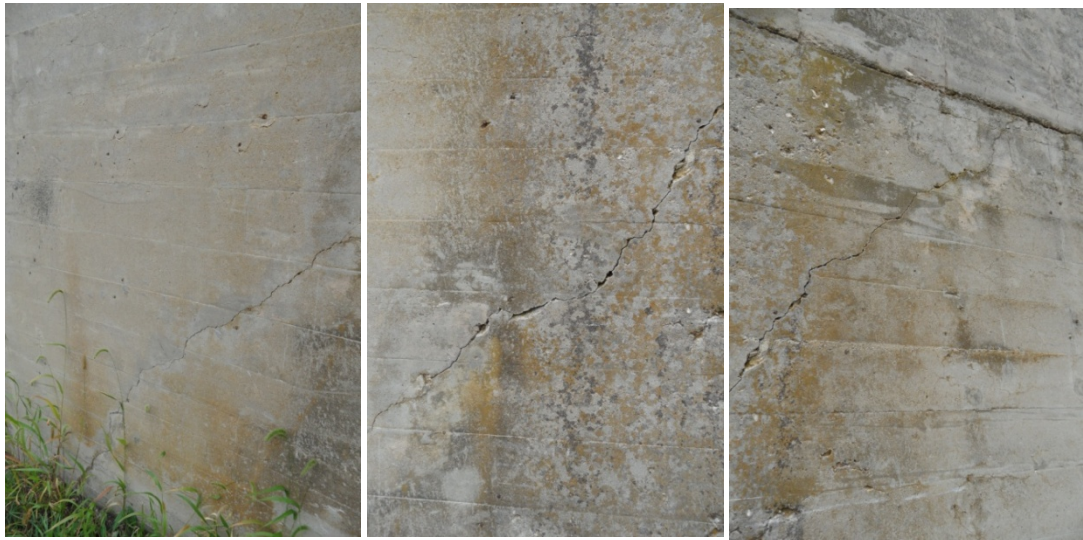
1.9 – Efflorescence around cracks in downstream retaining wall

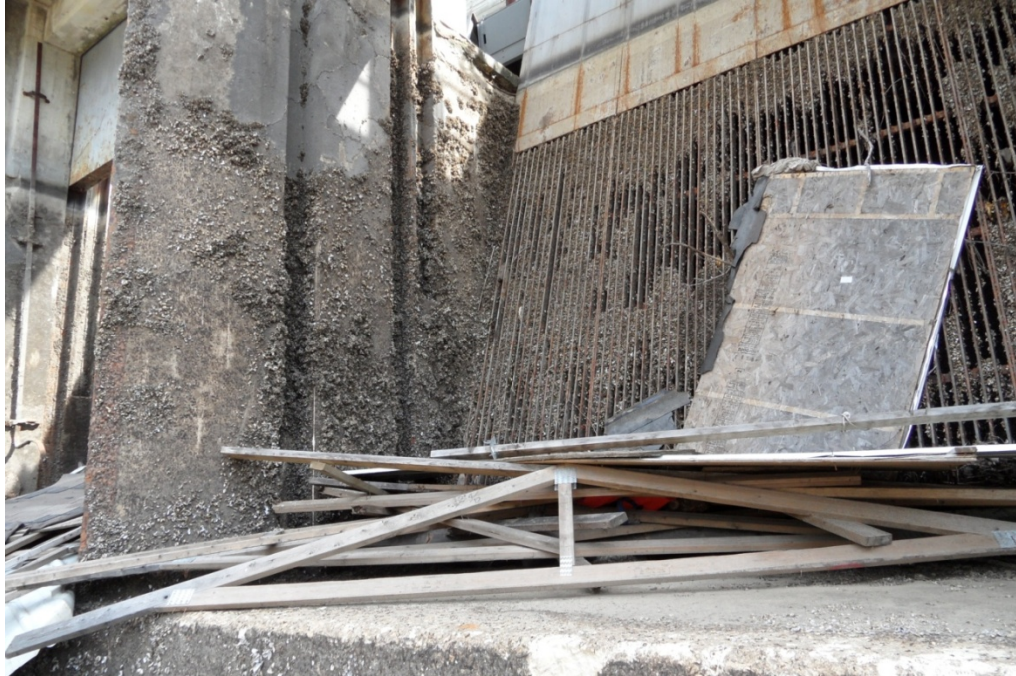
2.3 – Upstream side of Powerhouse – Note apparent spalling and past repairs above original waterline

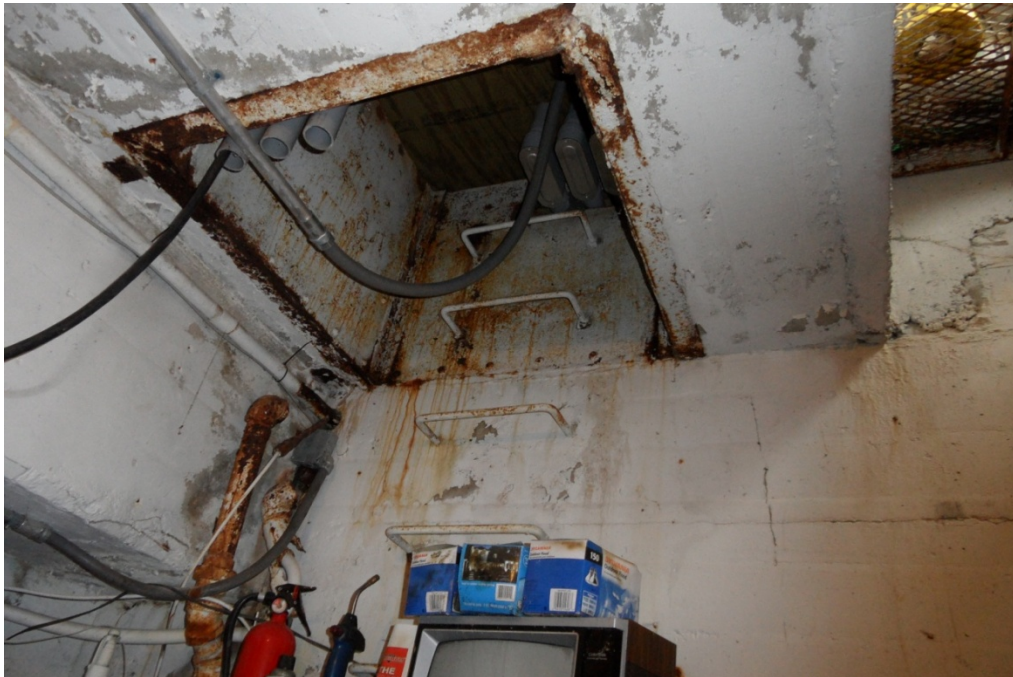
2.8 – Deterioration in downstream wall of Powerhouse

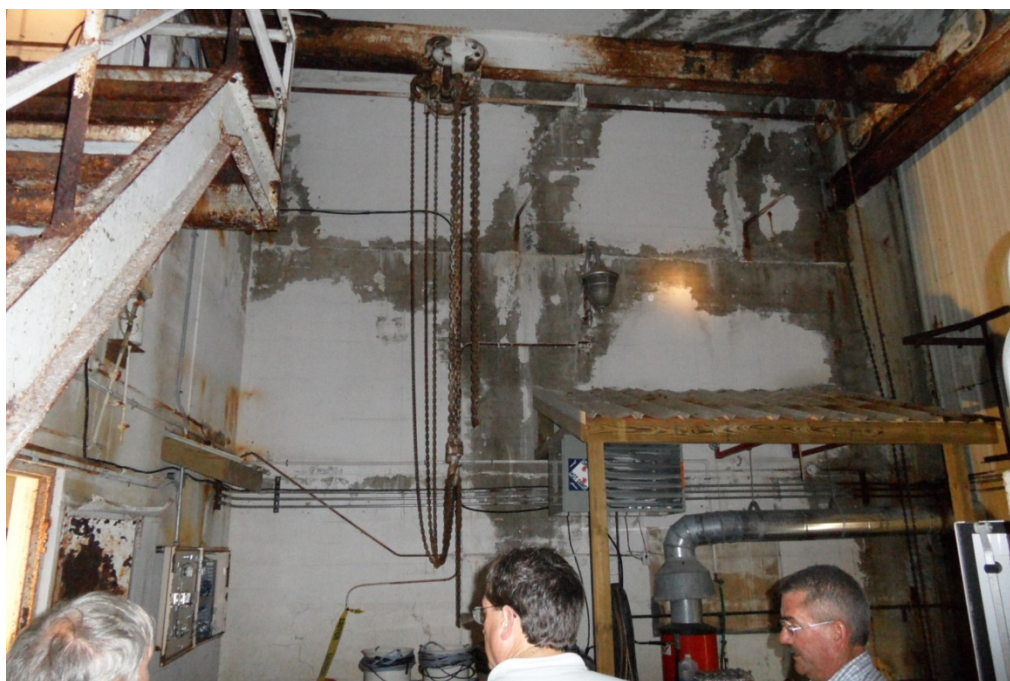
2.14 – Random cracking and efflorescence on upstream wall of Turbine Room

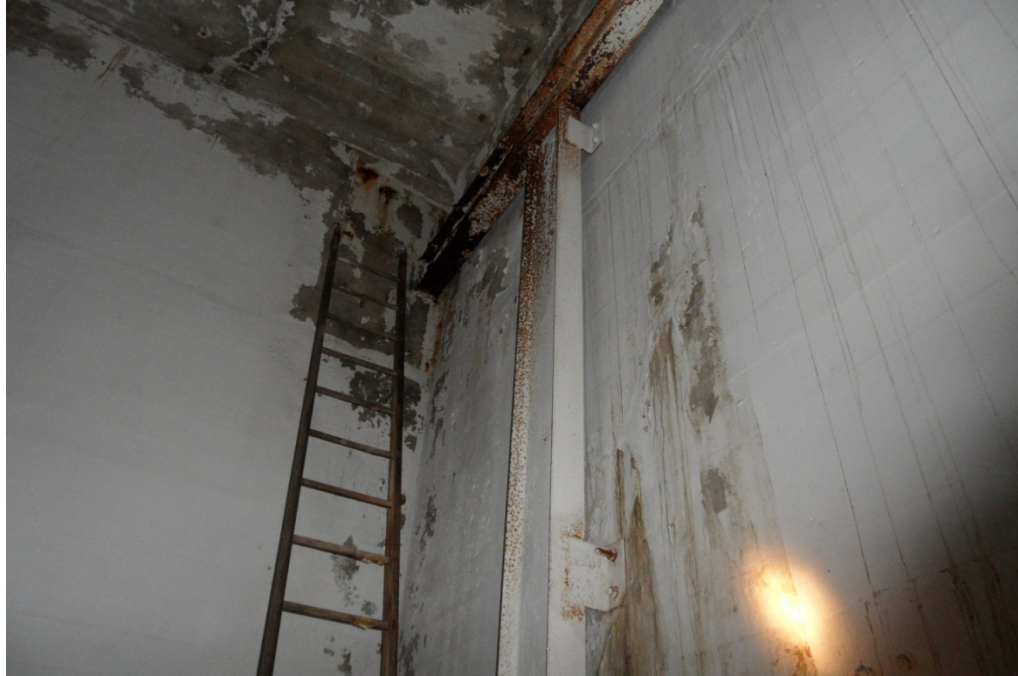
2.15 – Cracking in north wall of Turbine Room

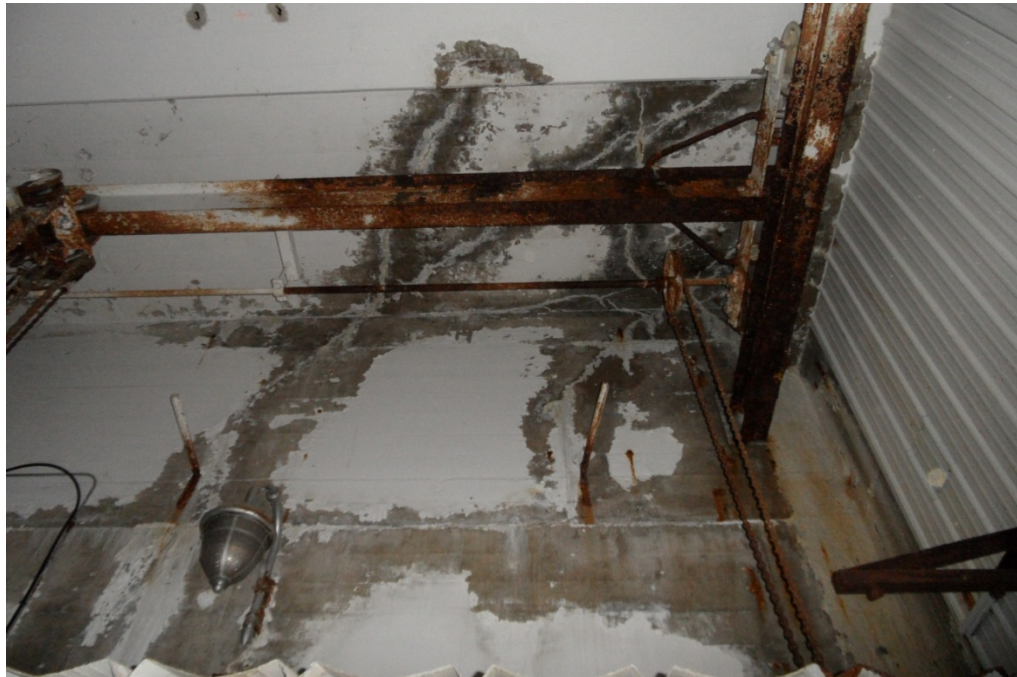
2.16 – Cracking near top of south wall of Turbine Room

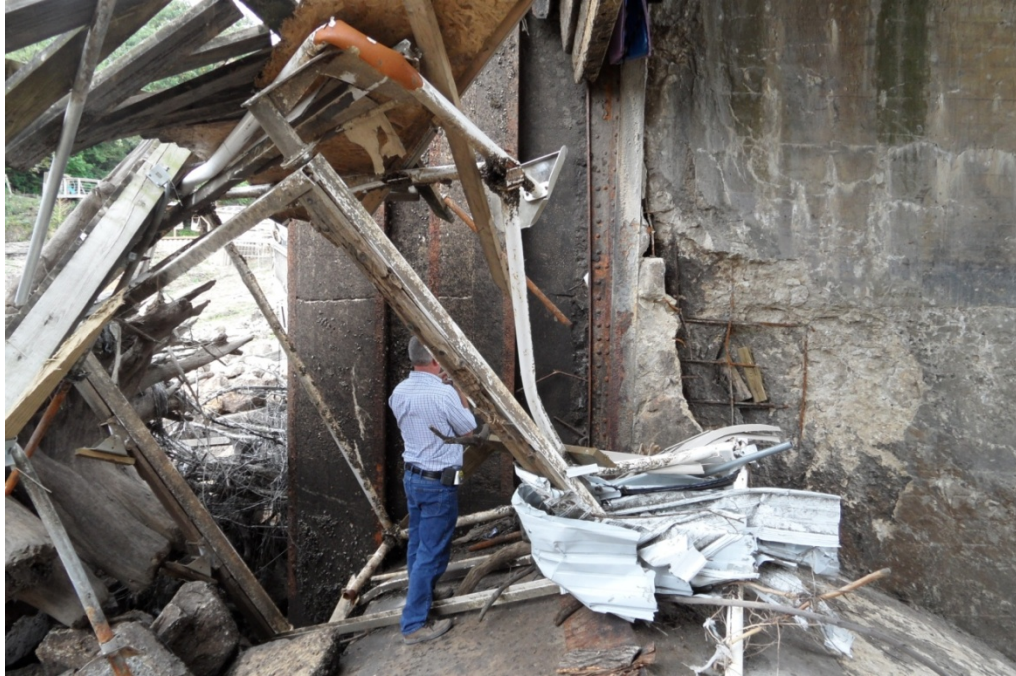
3.7 – Hollow sounding concrete when tapped with hammer at Gates 1 and 2

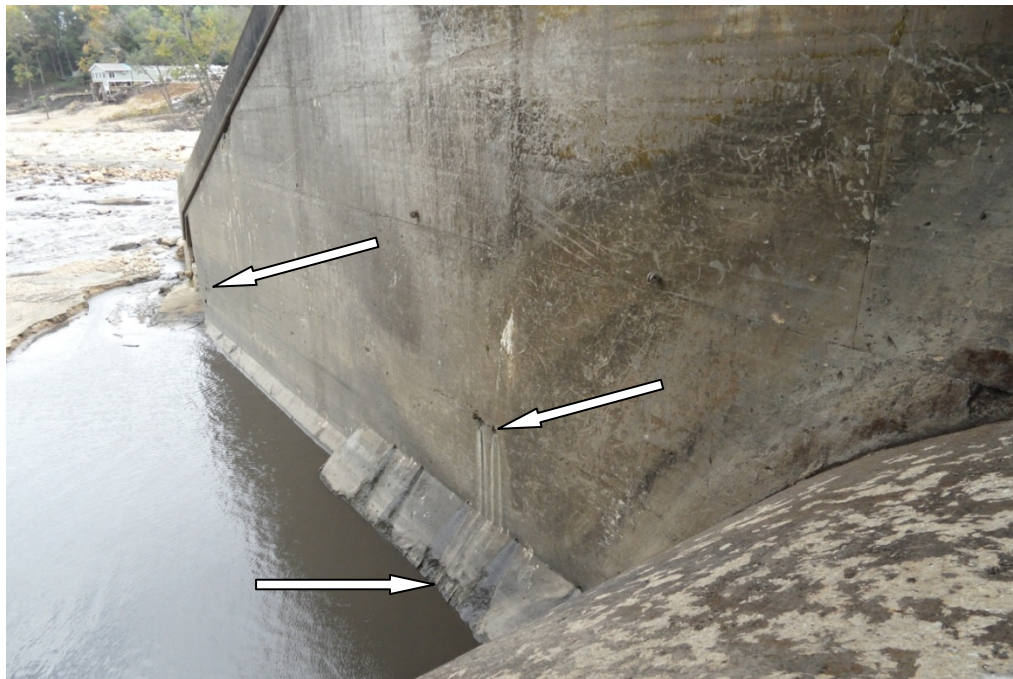
3.10 – Typical condition of embedded steel guide slots and seal plates

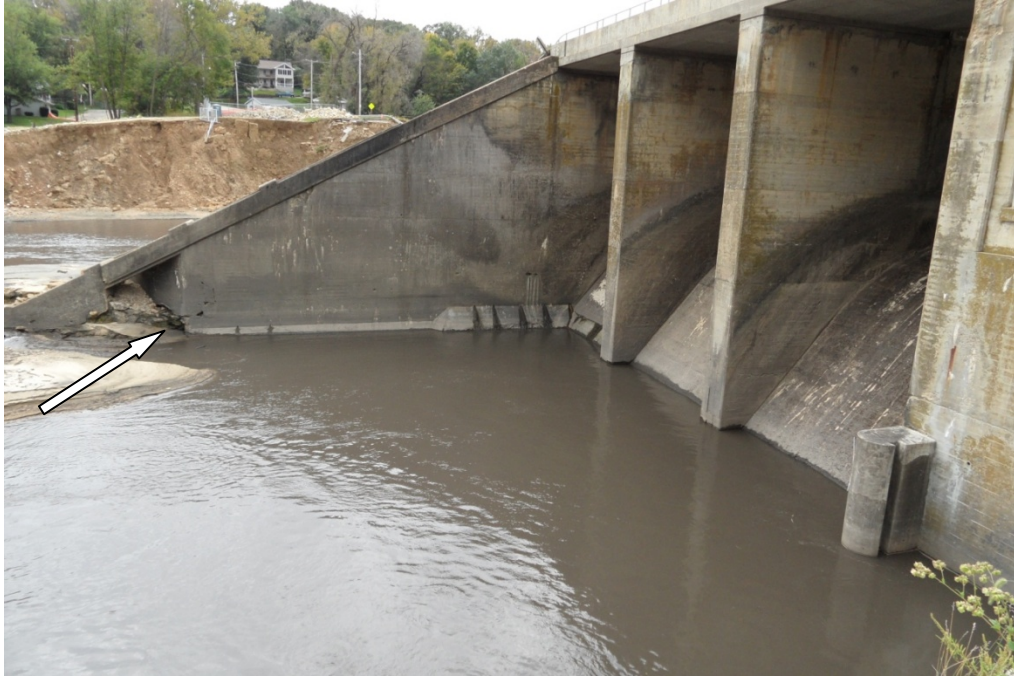
3.11 – Exposed reinforcing and holes in abutment wall downstream of spillway

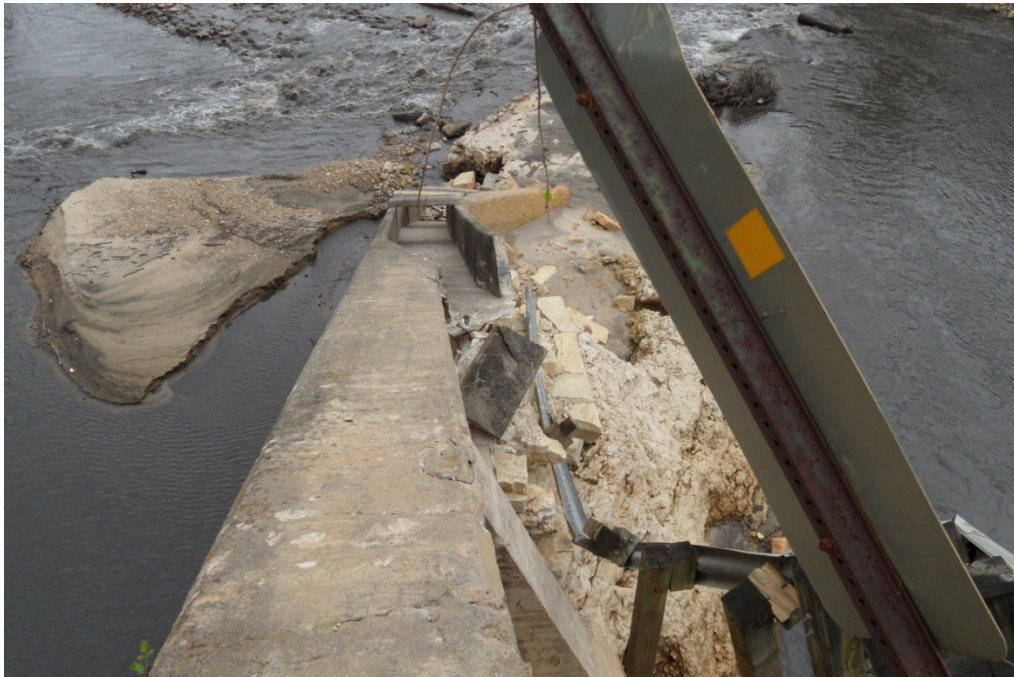
3.12 – Erosion of bedrock foundation under downstream end of abutment

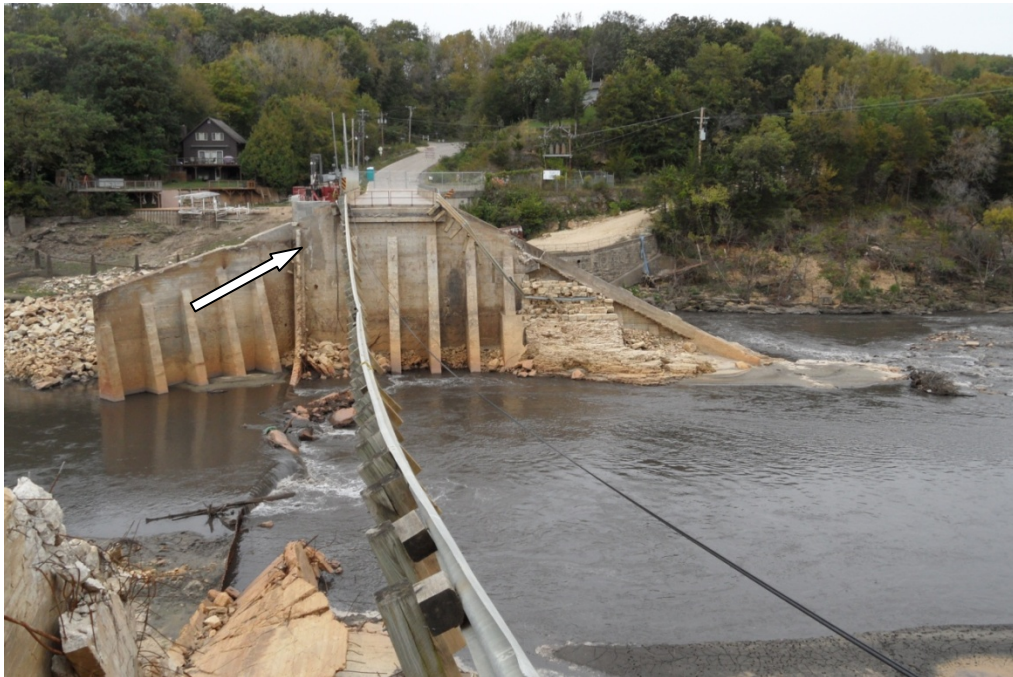
3.14 – Damage to top of upstream abutment wall

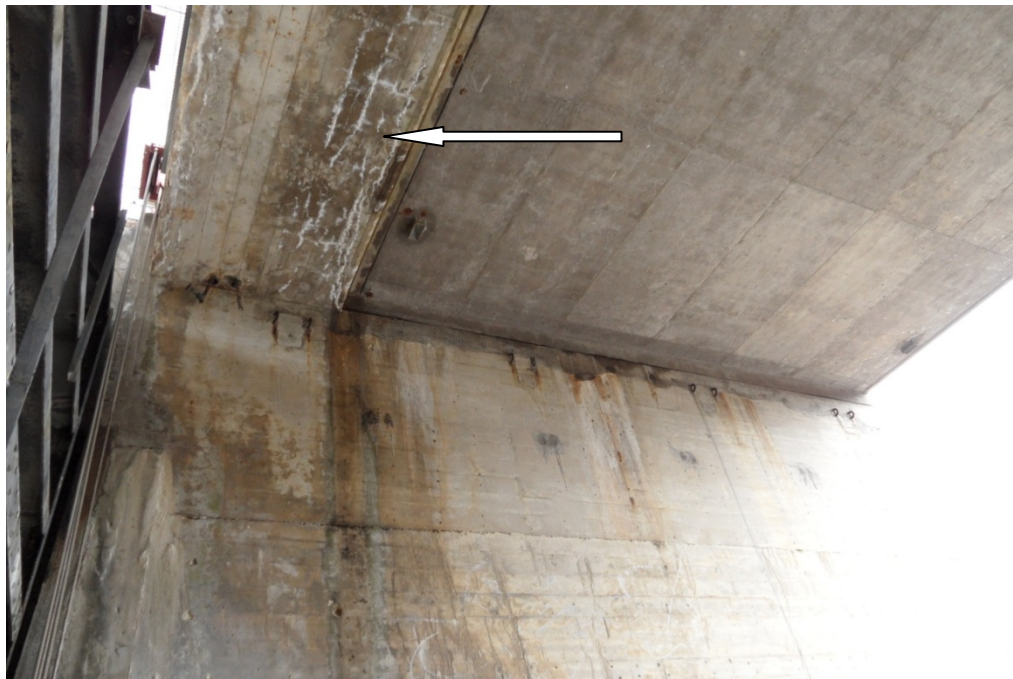
3.22 – Cracking in beams on upstream side of operator's deck

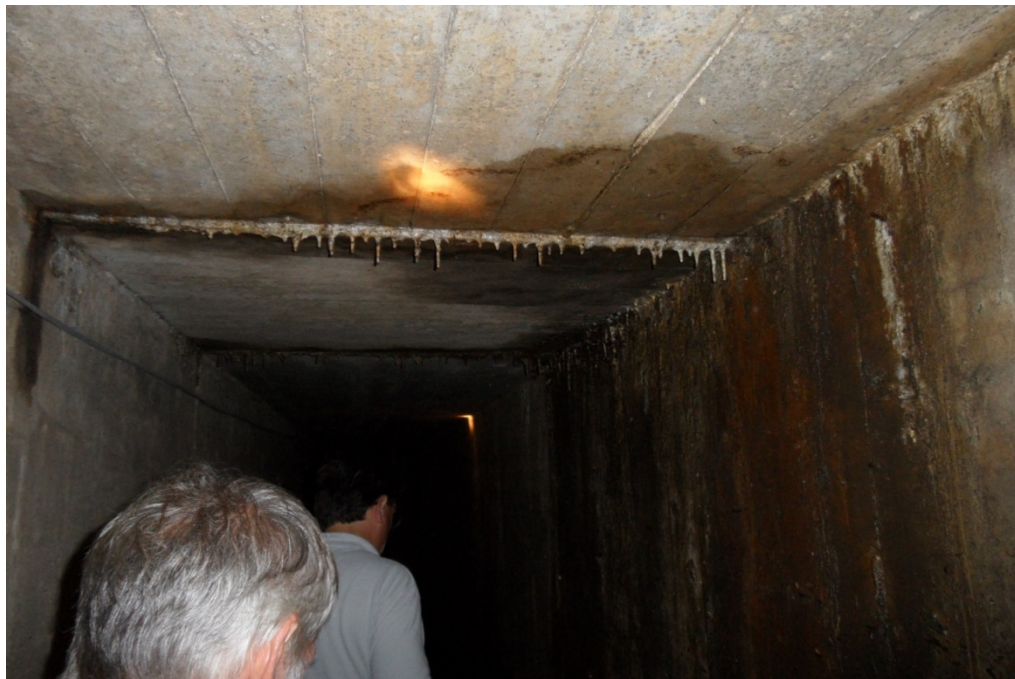
4.1 – North end of inspection tunnel (looking south)

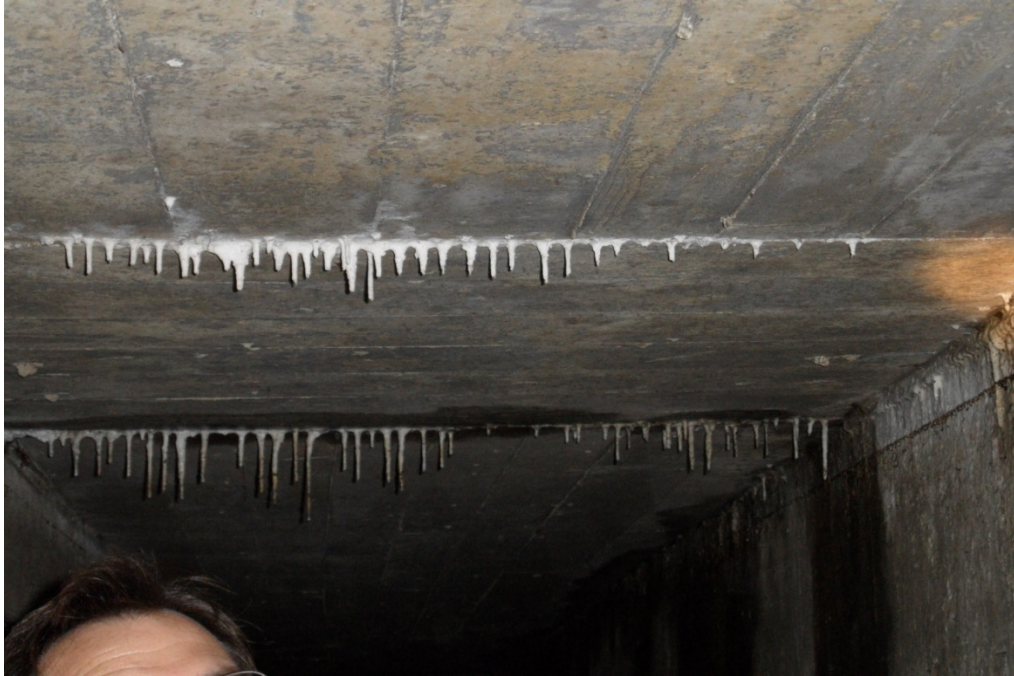
4.2 – Moisture and lime deposits on tunnel walls

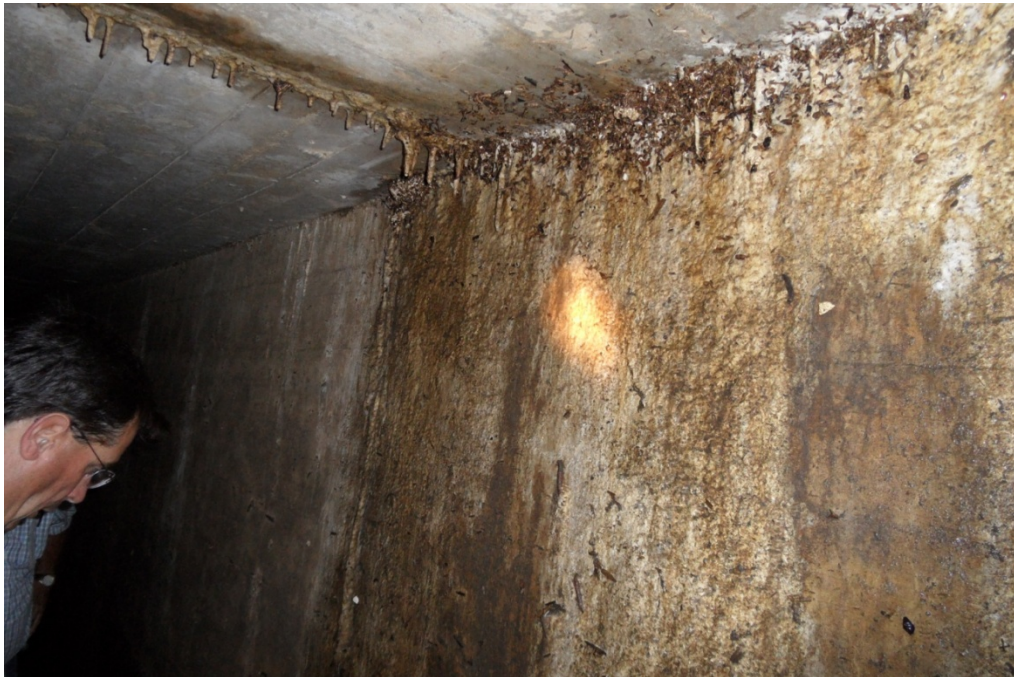
4.3 – Moisture and lime deposits on tunnel walls

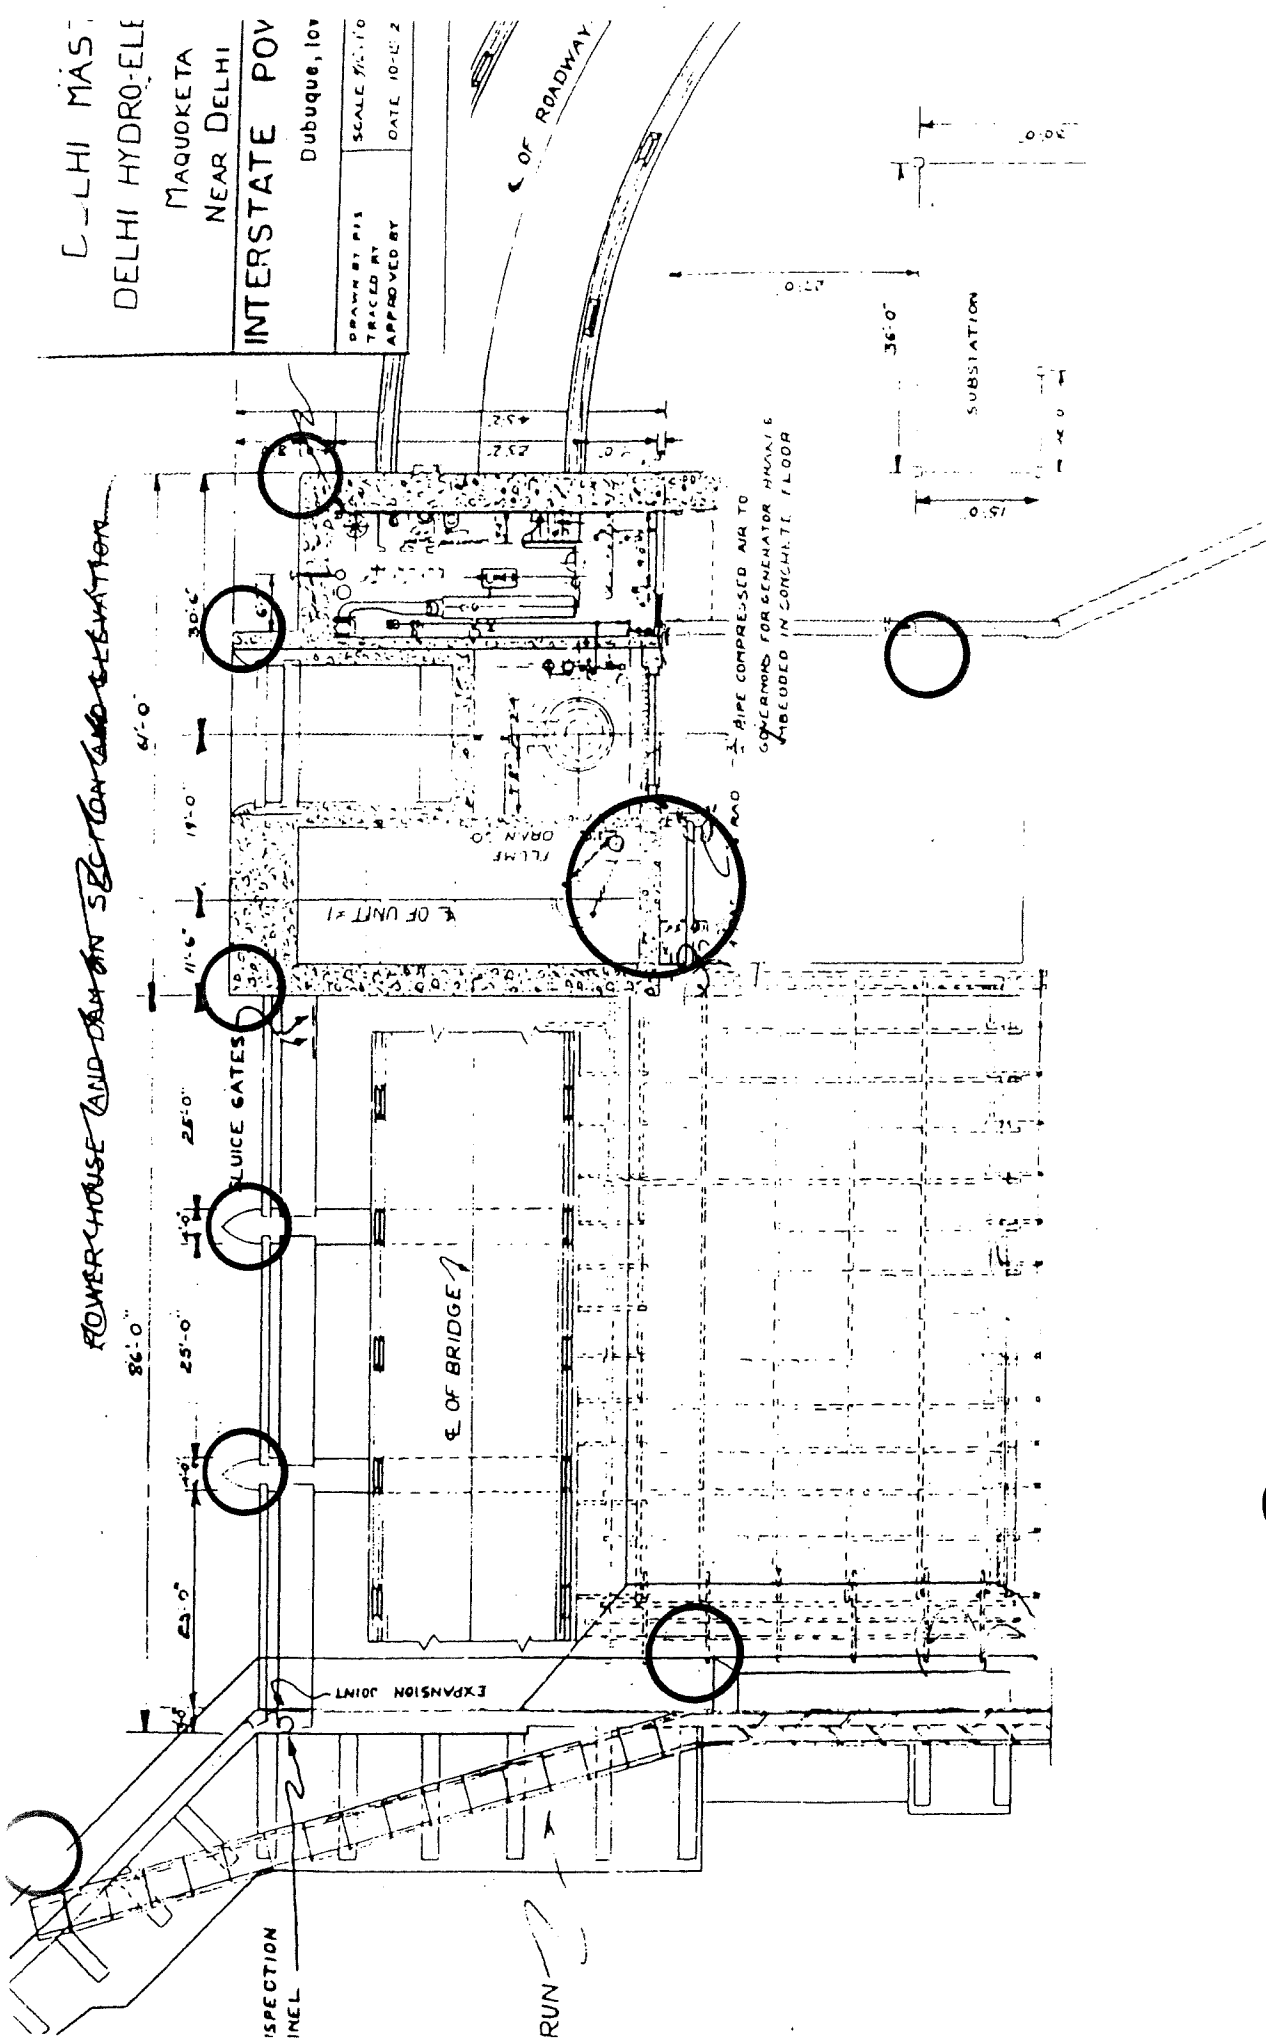
Attachment 'C'

○ Areas of PC concrete damage
