Assessment, Repair, and Replacement of Bridges Subjected to Fire

**Final Report
August 2022**

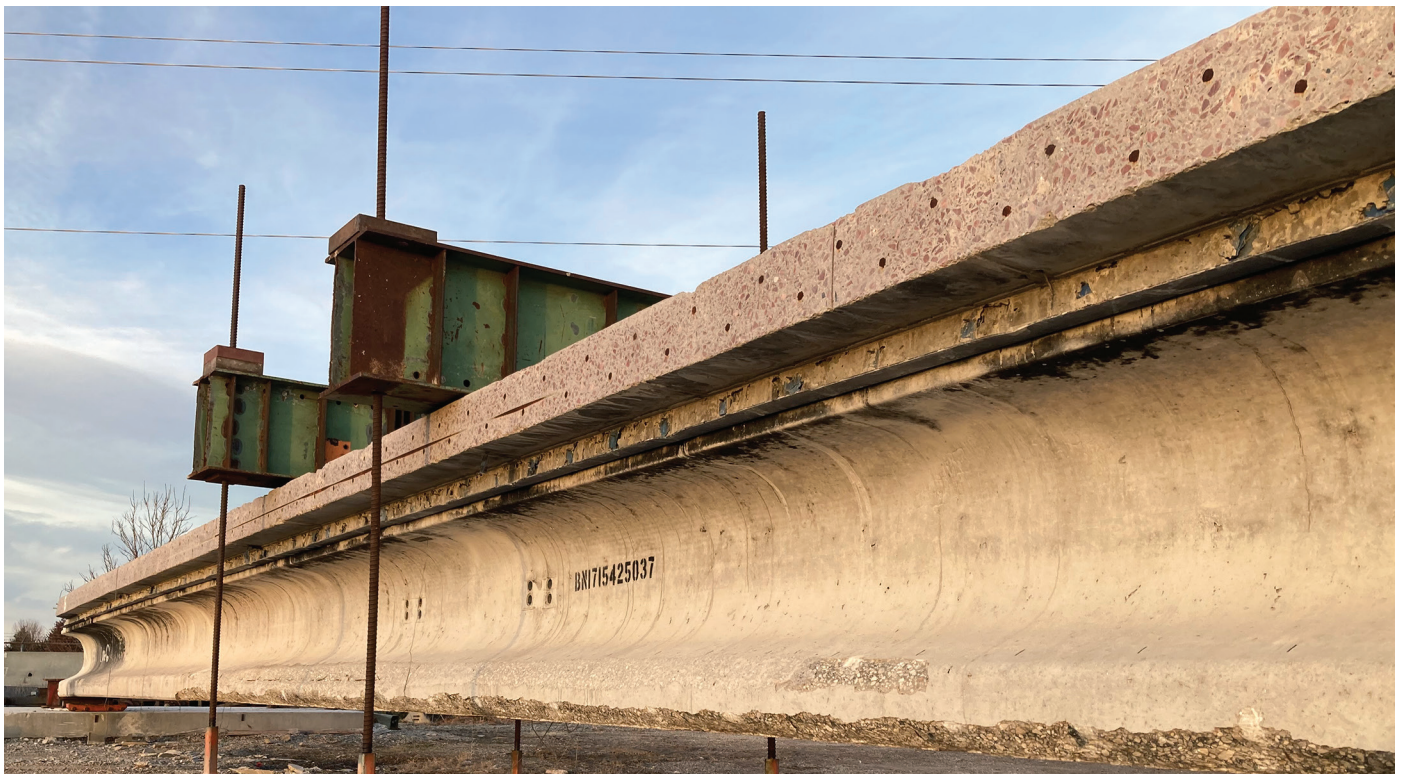
IOWA STATE UNIVERSITY
Institute for Transportation

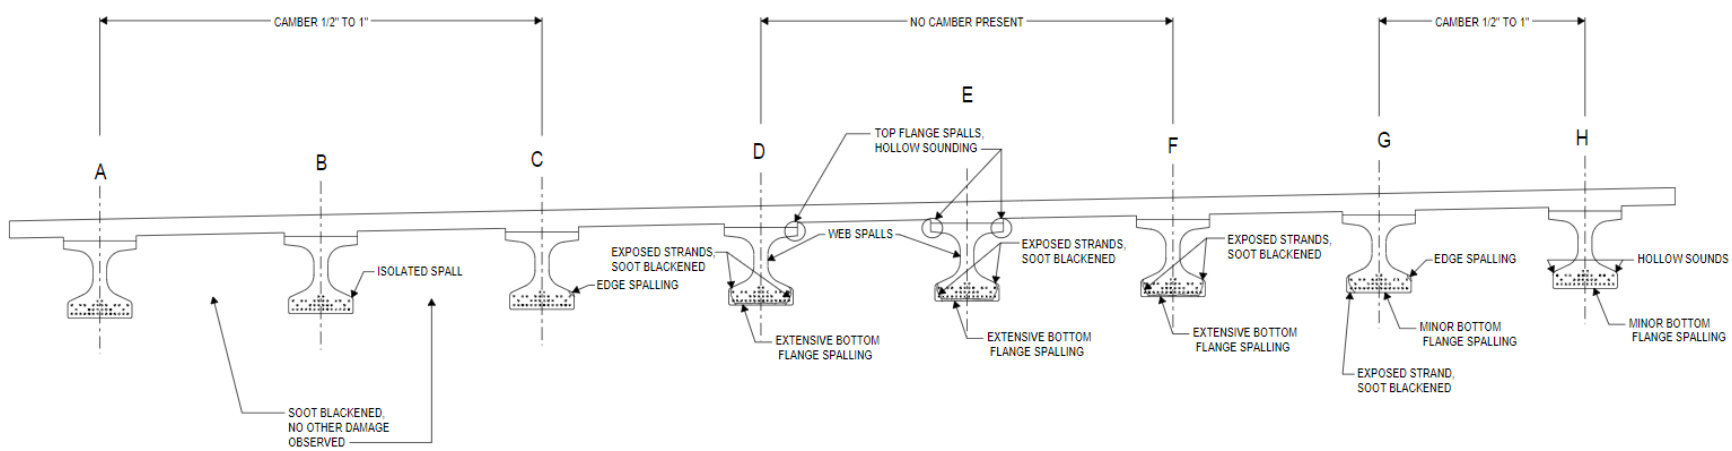
Figure 6 provides a drawing that notes the specific types and locations of damage.

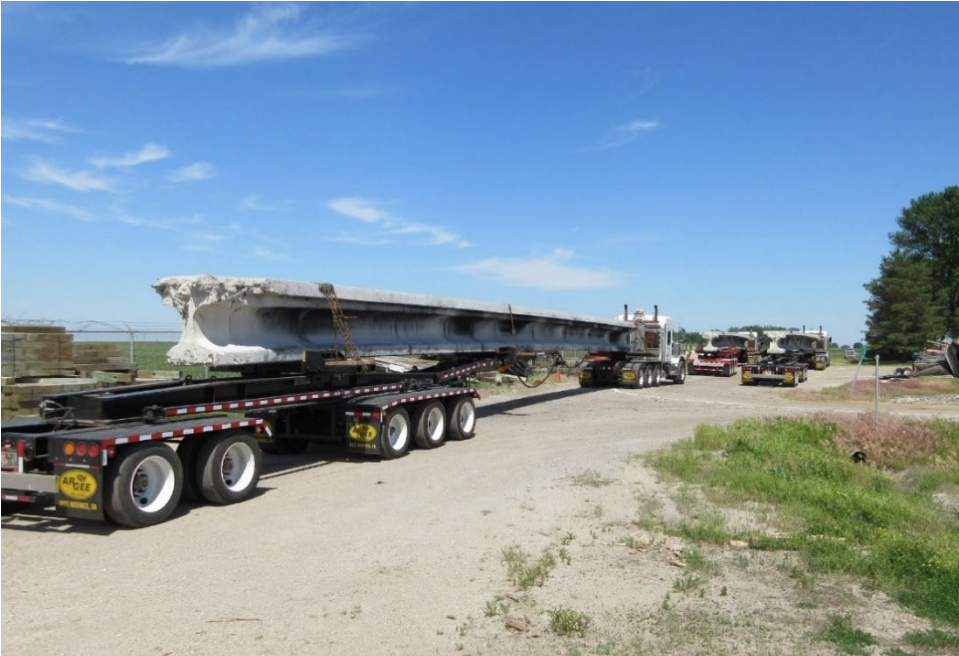
Figure 7. Girder transport from bridge site to Iowa DOT maintenance yard

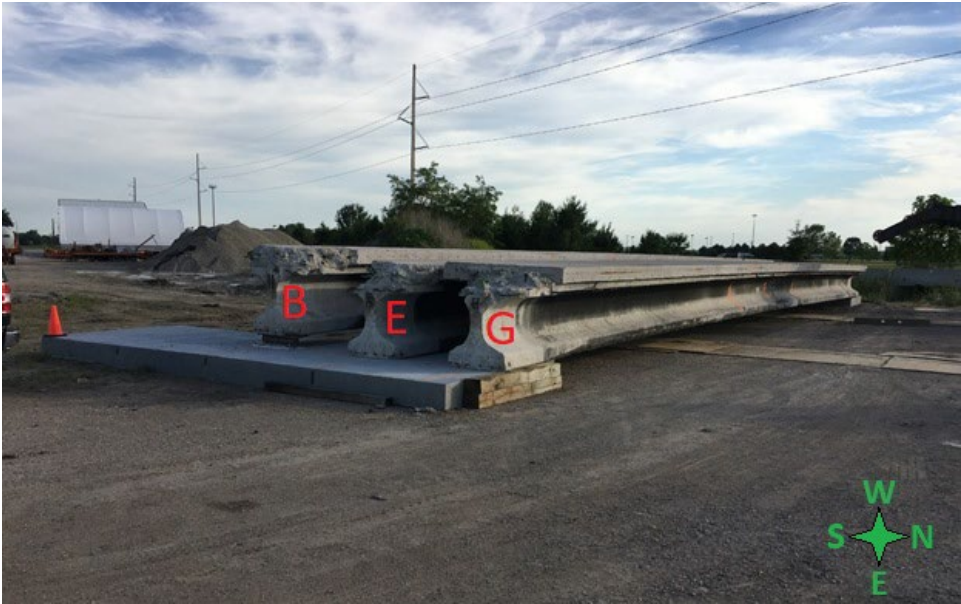
Figure 8. Girders B, E, and G at Iowa DOT maintenance yard

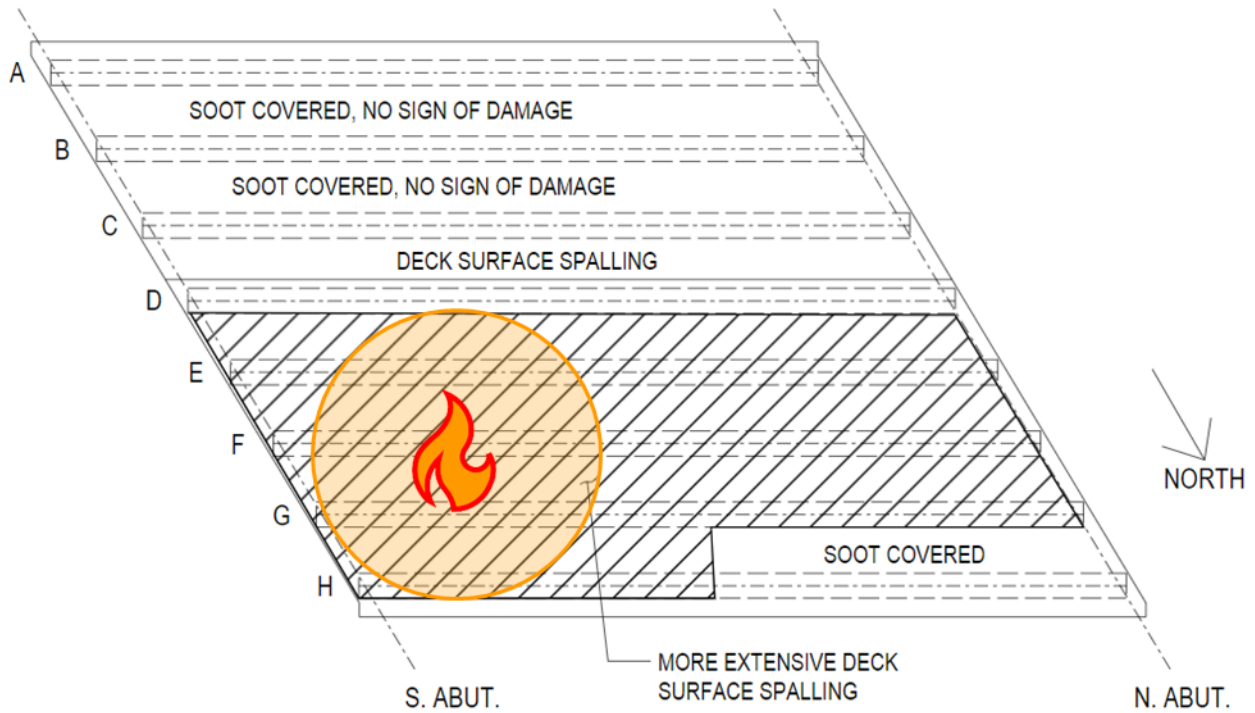
Adapted from HDR 2019

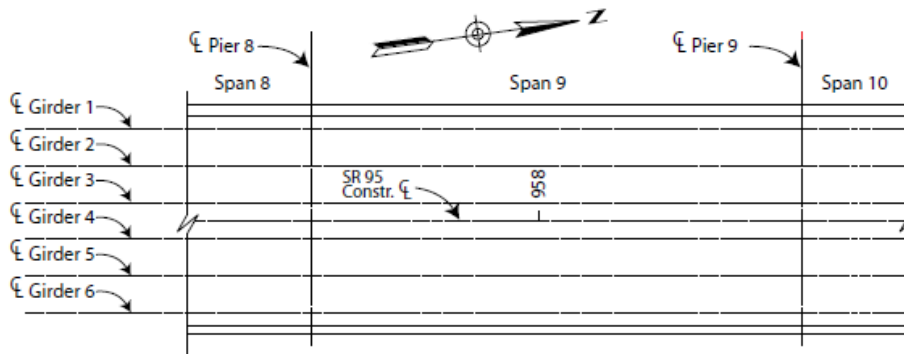
Davis et al. 2008, National Council of Structural Engineers Associations (NCSEA)

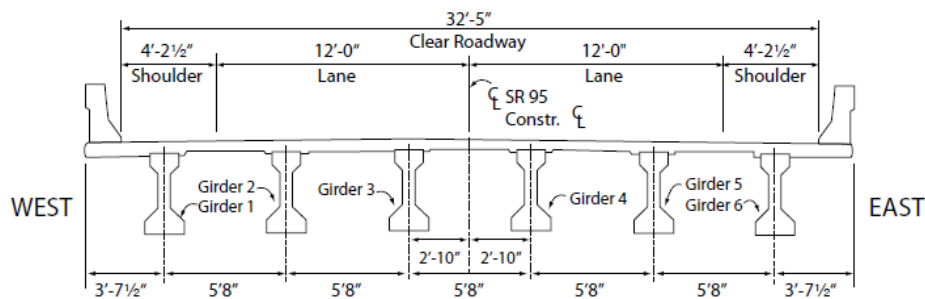
Davis et al. 2008, National Council of Structural Engineers Associations (NCSEA)

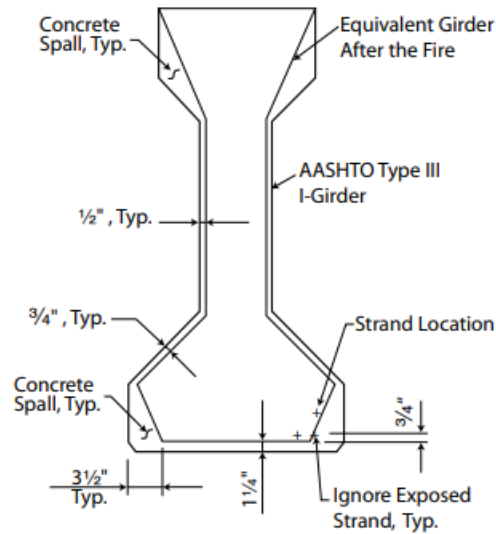
Davis et al. 2008, National Council of Structural Engineers Associations (NCSEA)

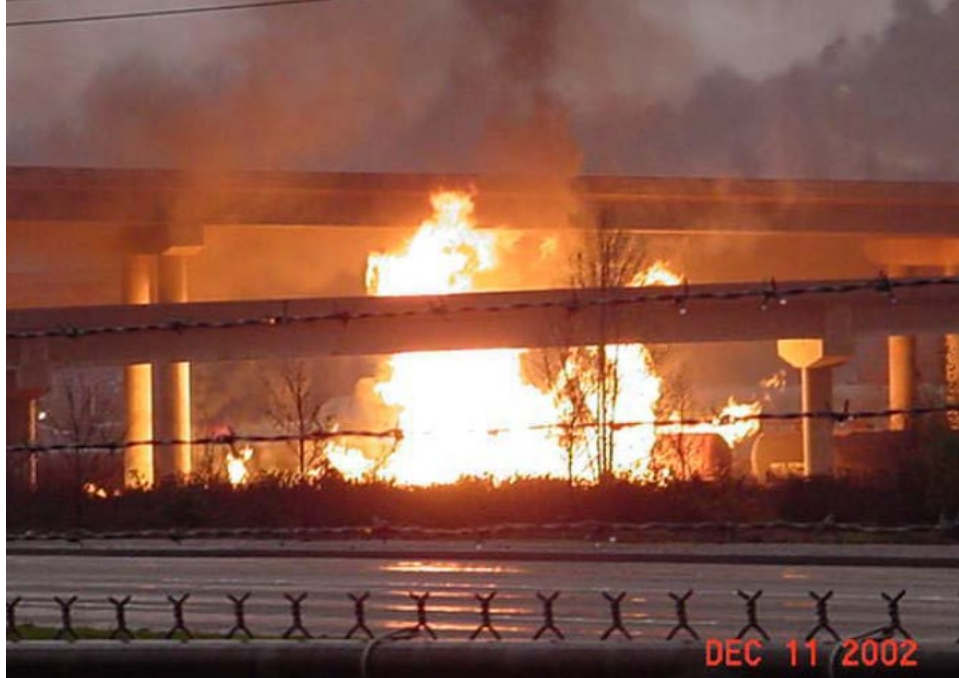
Stoddard 2004, Washington State DOT

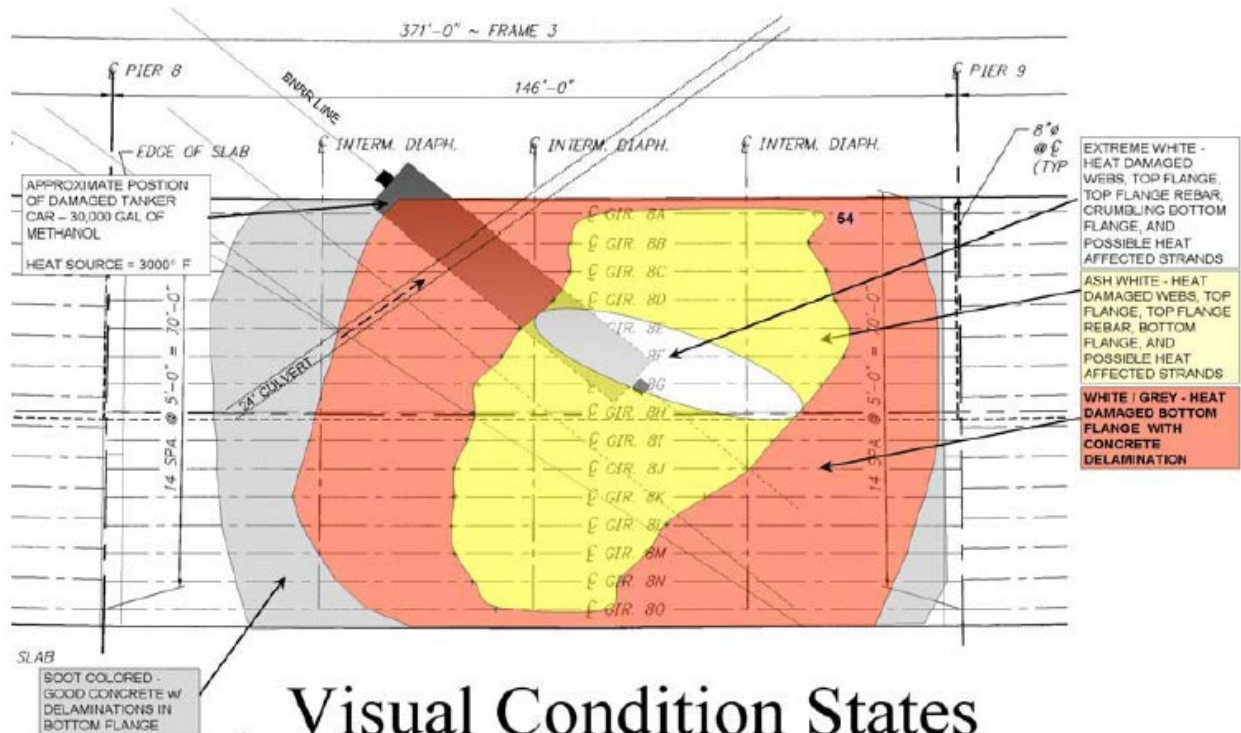
Visual Condition States

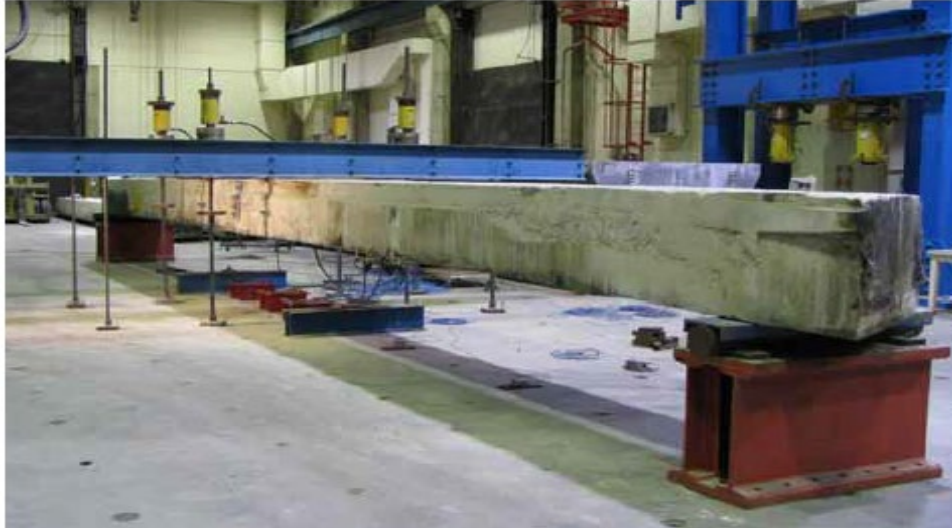
A flexure test was conducted on the damaged girders to fully determine the structural capacity remaining in the beams. A two-point load test was set up to keep a constant moment in the midspan of the beam. Both ends of the beam were supported by roller supports and loads were applied to each beam through a 12 in. wide steel plate spanning the width of the beam (Graybeal 2007). Four load cells measured the load applied to the beam at the two load points. Eleven strain gauges were placed on each beam to measure the strains throughout the tests and seven string potentiometers were used to measure the vertical deflections. Figure 18 and Figure 19 show the setup and cross-section of the beam tests.

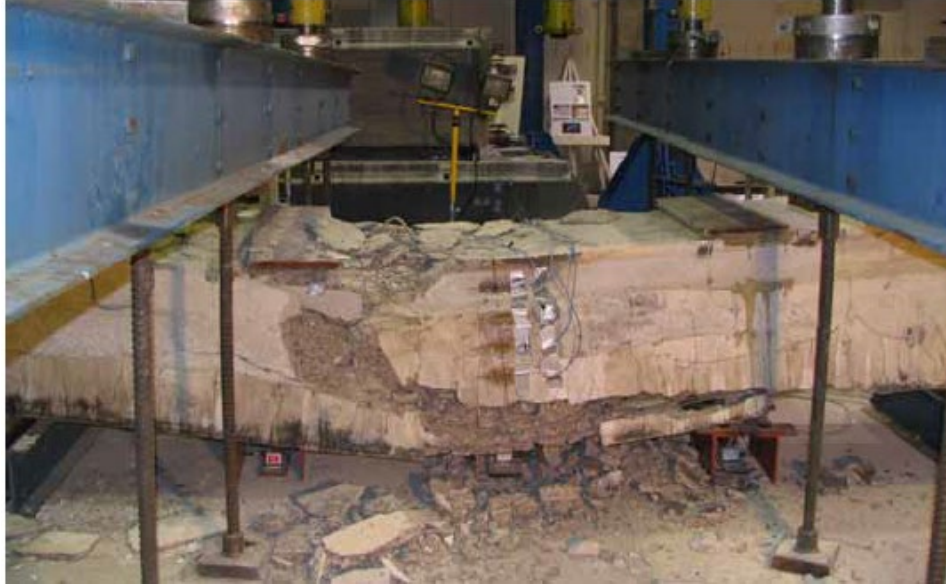
Graybeal (2007) reported the use of an incremental increase in the applied load during each test. The midspan deflection was paused at different intervals to record the flexural stiffness of each beam. About 80% of the peak load was released each time the testing was paused and reloaded by 10kN increments back to the peak load (Graybeal 2007). The loading was also paused at the different intervals to map any cracks formed during the load test. Figure 20 shows an example of one beam loaded until failure.

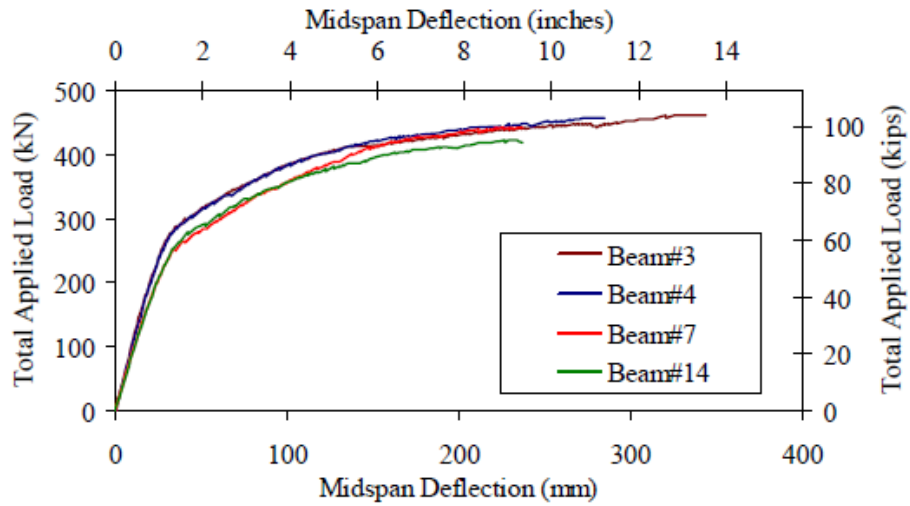
Graybeal (2007) concluded that all four beams (Beam #3, #4, #7, and #14) exhibited similar behavior when it came to flexural capacity, elasticity, and midspan deflection at flexural failure (see Figure 21).

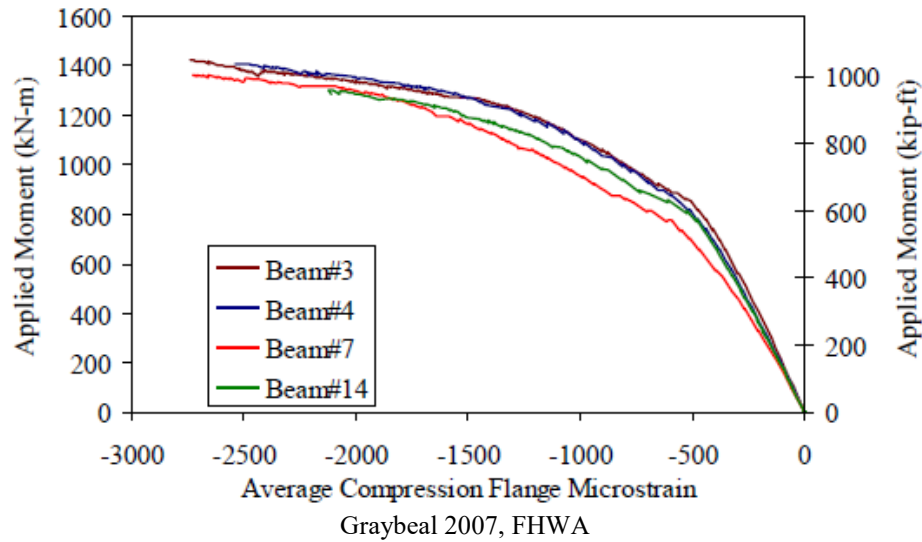
Figure 22. Applied moment vs. average compression flange microstrain for US 7 beams

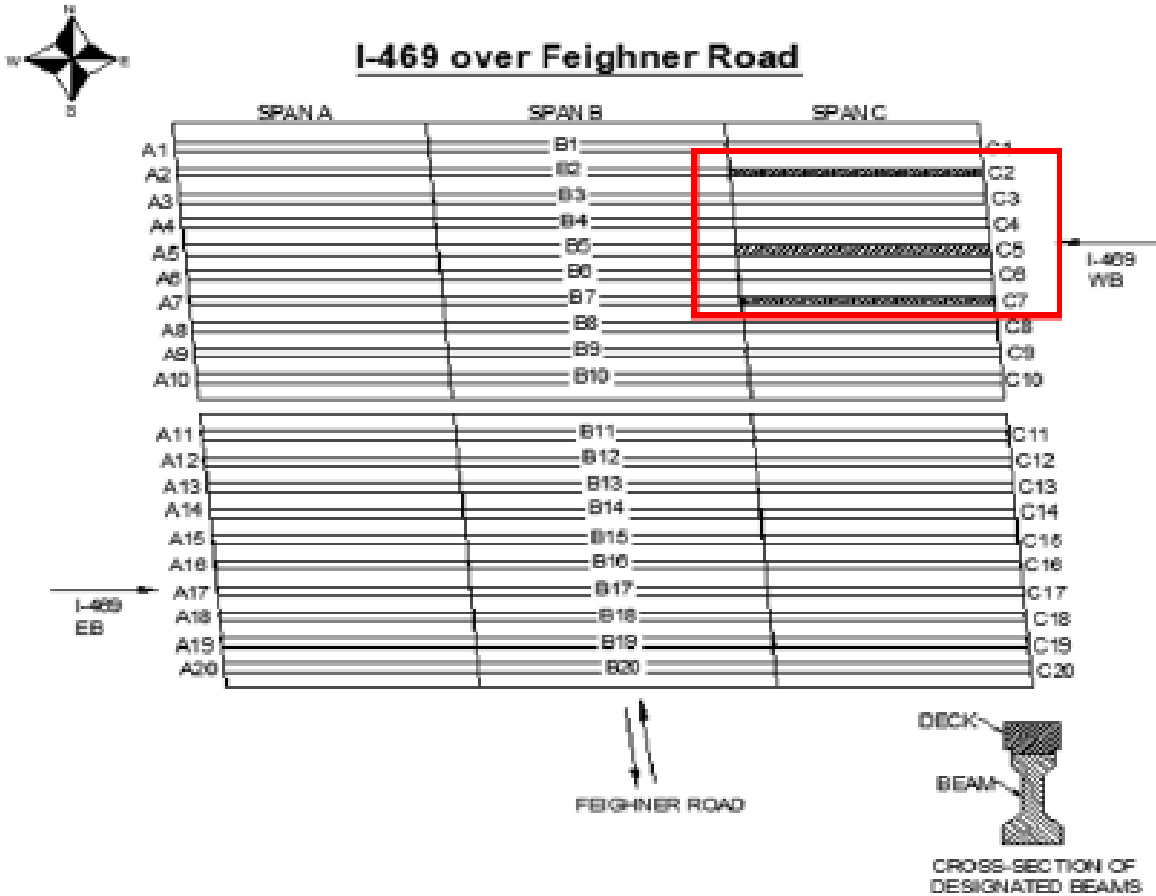
Varma et al. 2021, Joint Transportation Research Program, Purdue University

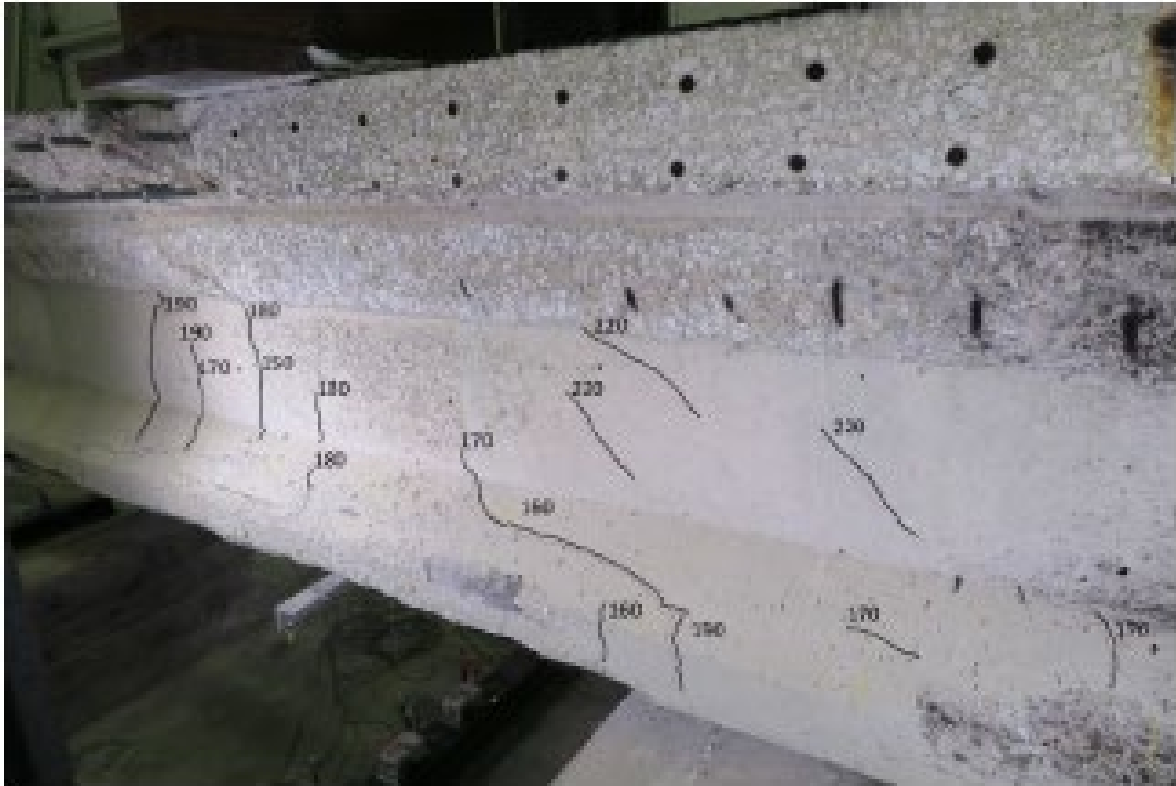
Varma et al. 2021, Joint Transportation Research Program, Purdue University

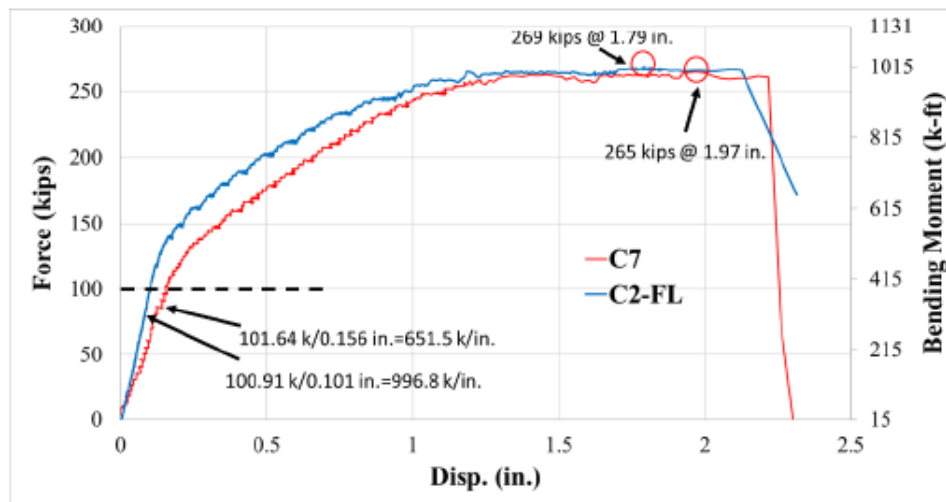
Varma et al. 2021, Joint Transportation Research Program, Purdue University

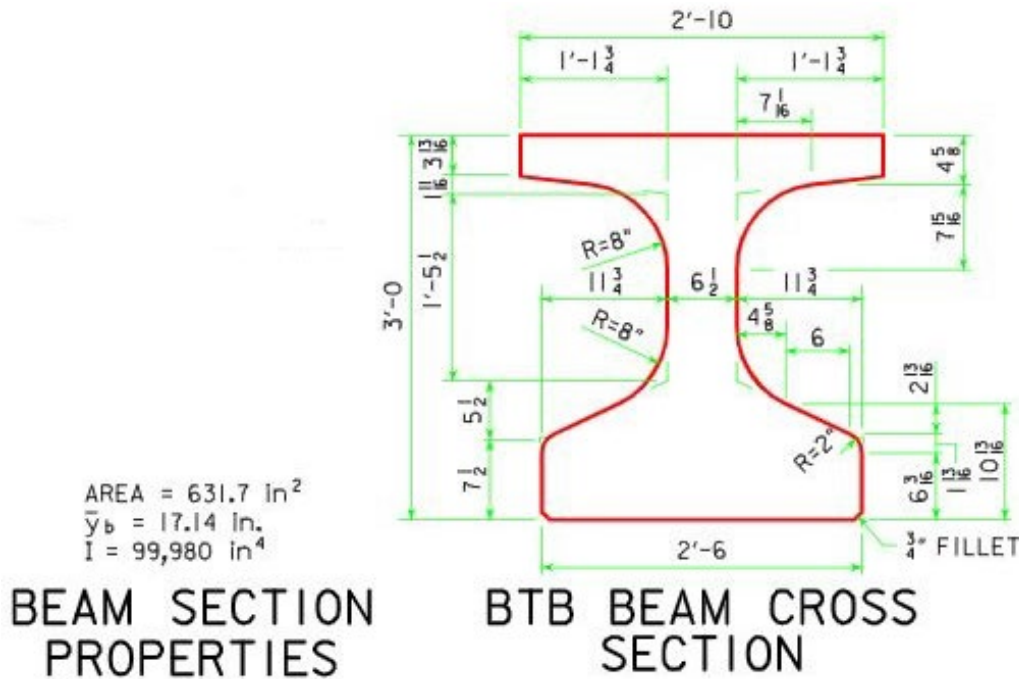
Figure 29. Girder cross-section detail

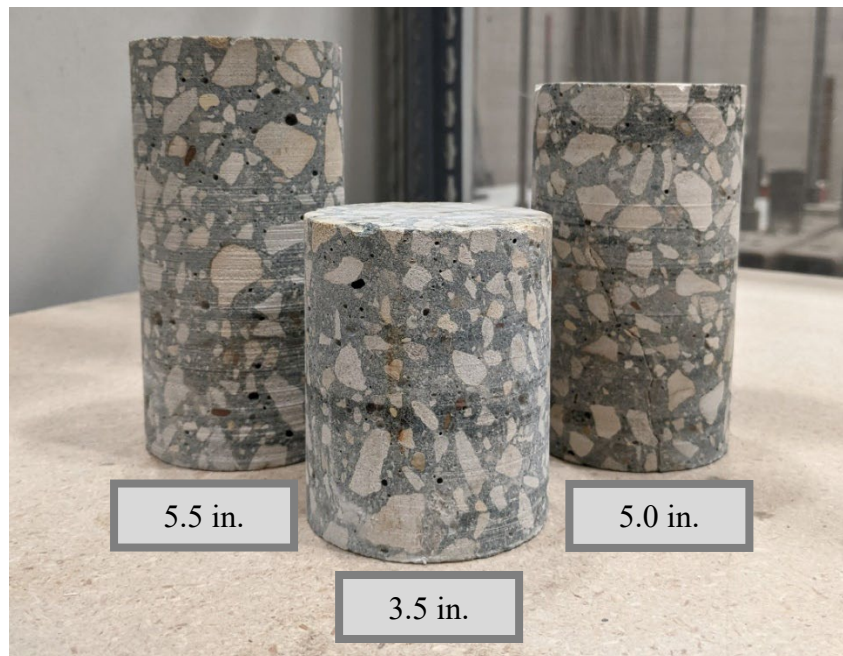
Figure 33. Concrete cylinder core samples for compression tests

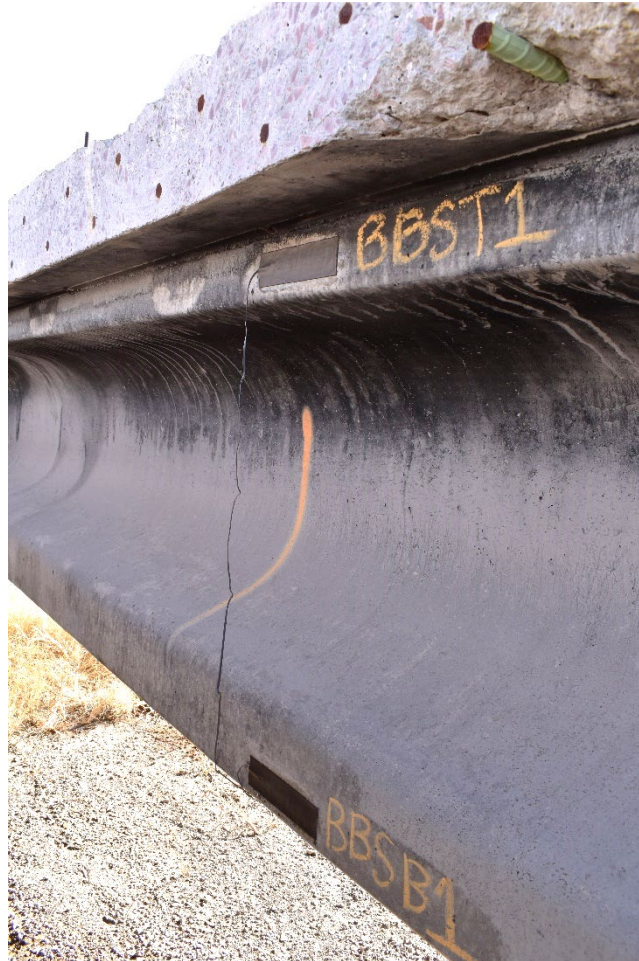
Figure 35. Girder B – Strain gauges at Section B bottom on south side

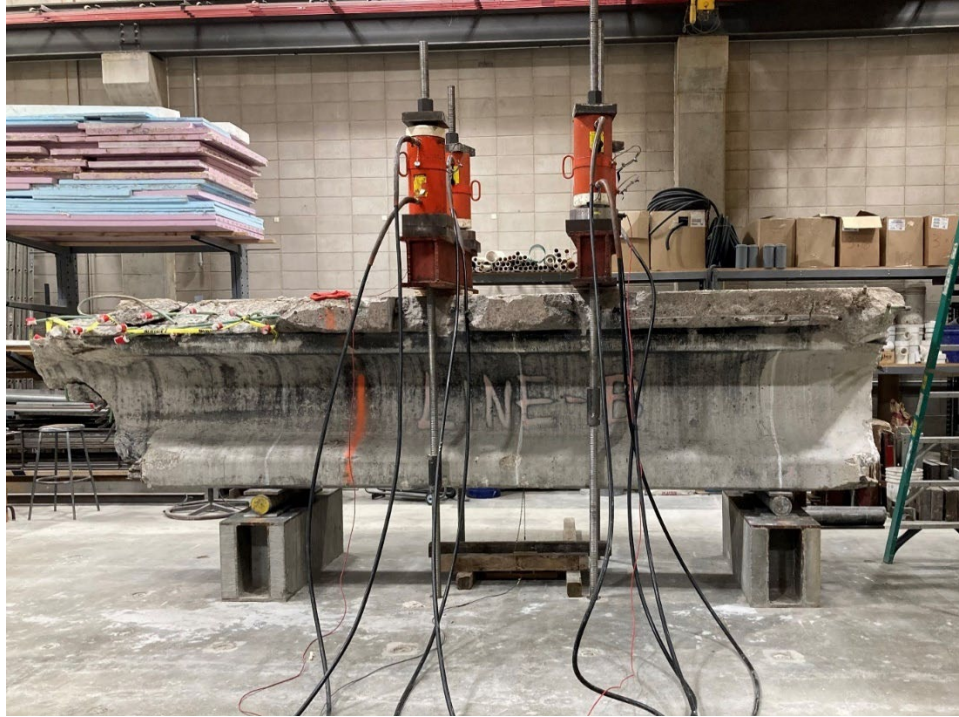
Figure 42. Girder end shear test configuration

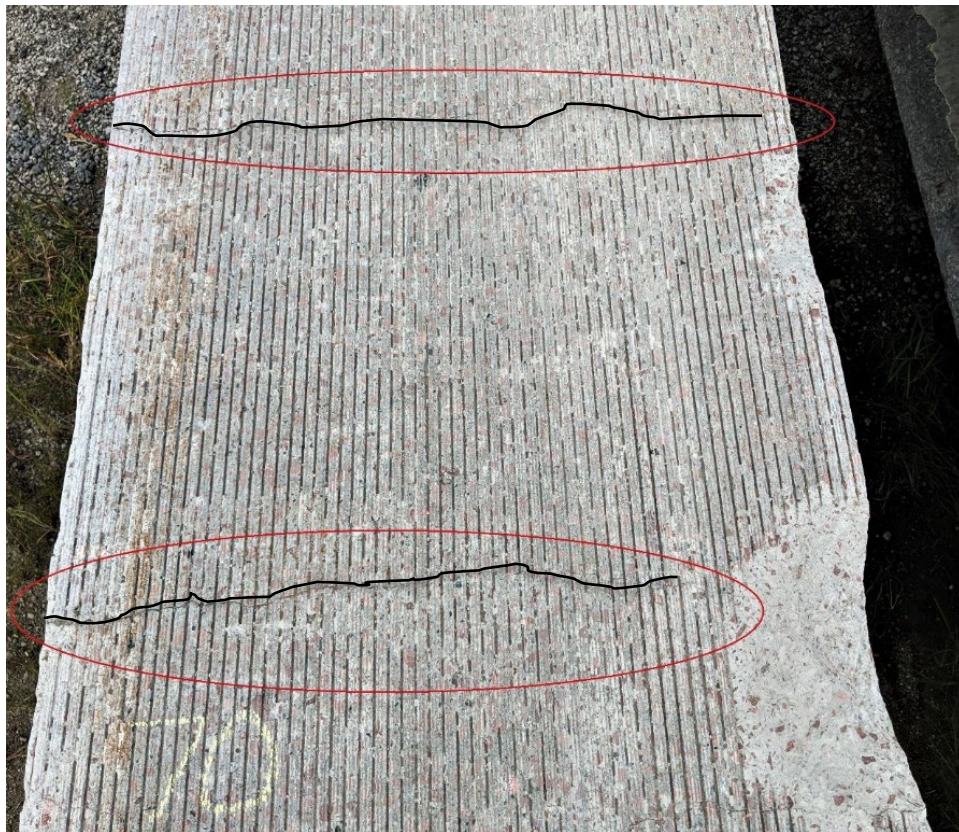
Figure 43. Typical deck surface cracking observed on Girder B

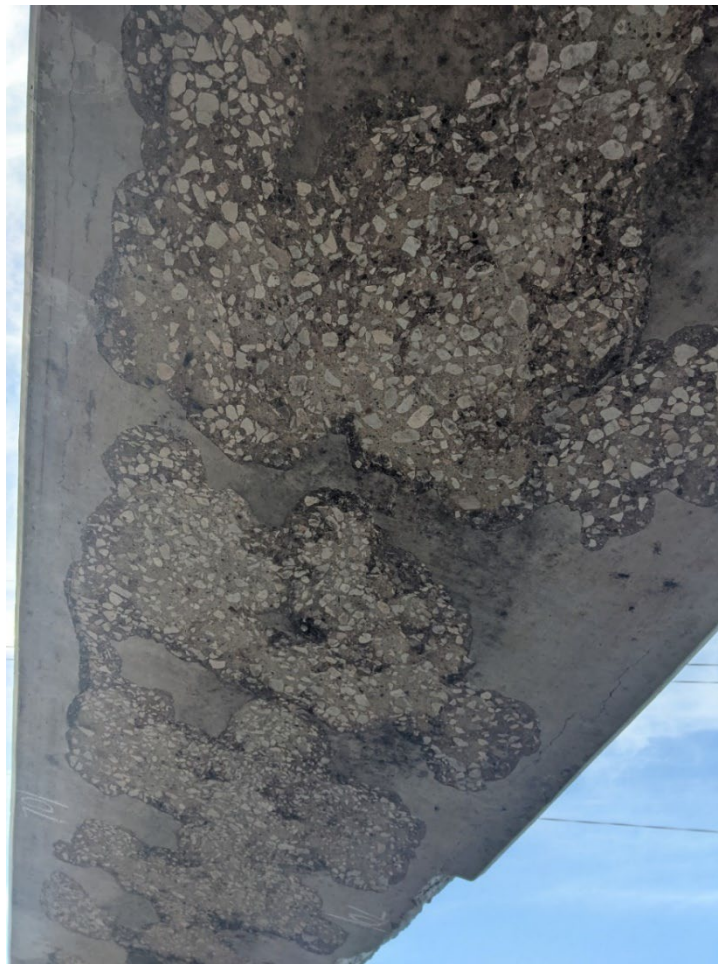
Figure 49. Spalling of concrete on bottom side of Girder G

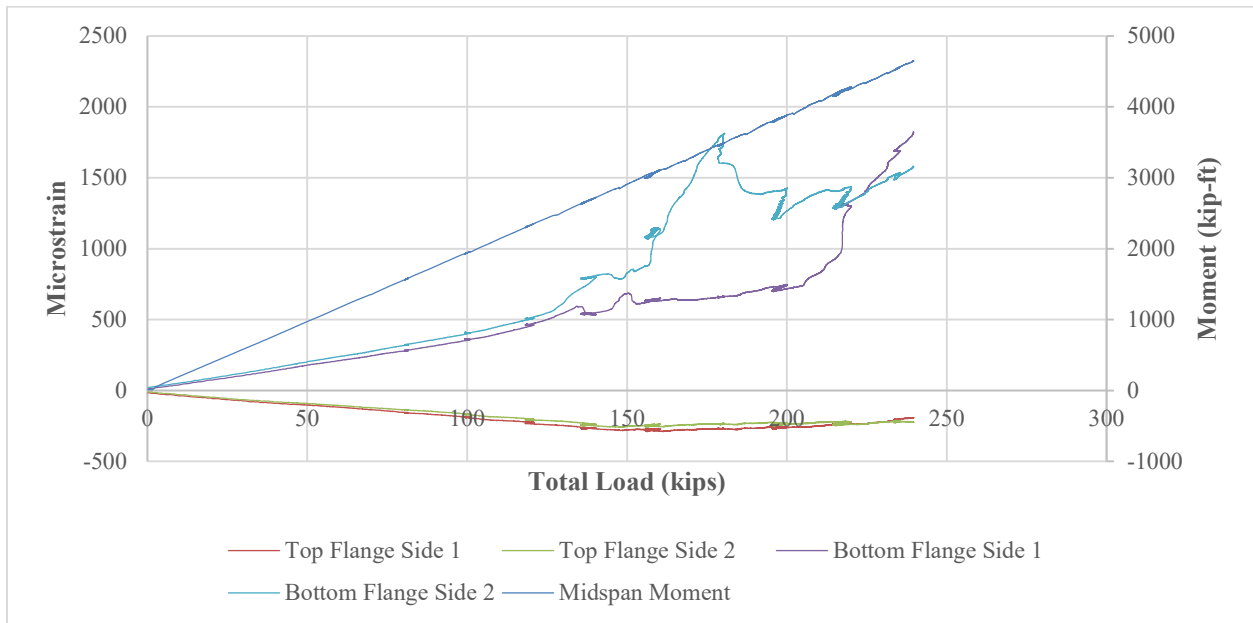
Figure 53. Midspan strain data for Girder B bending load test

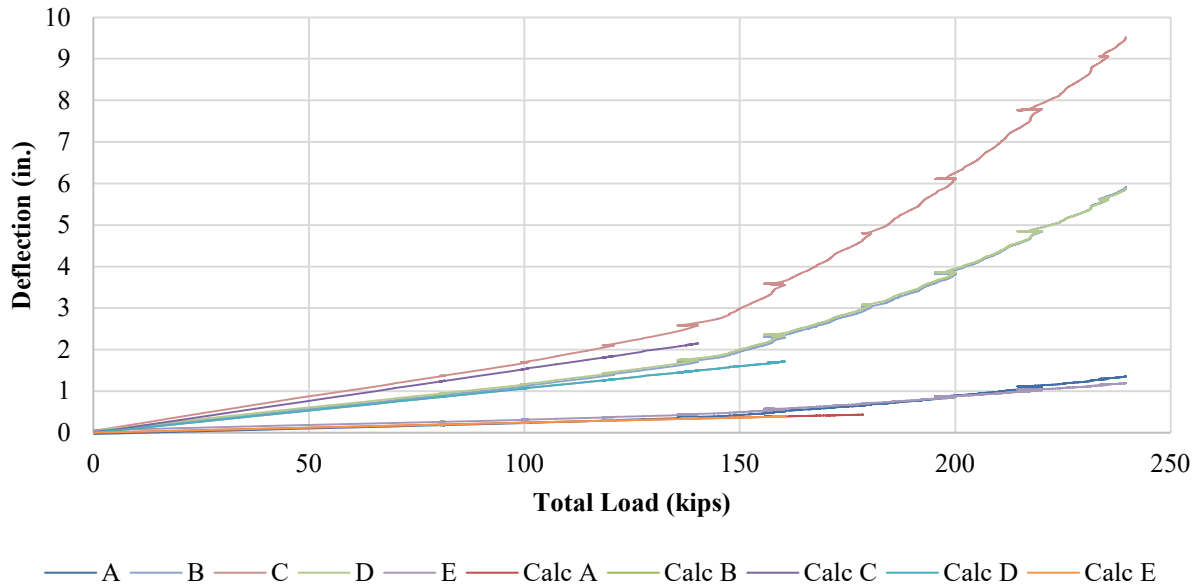
Figure 54. Actual vs. predicted deflection of Girder B

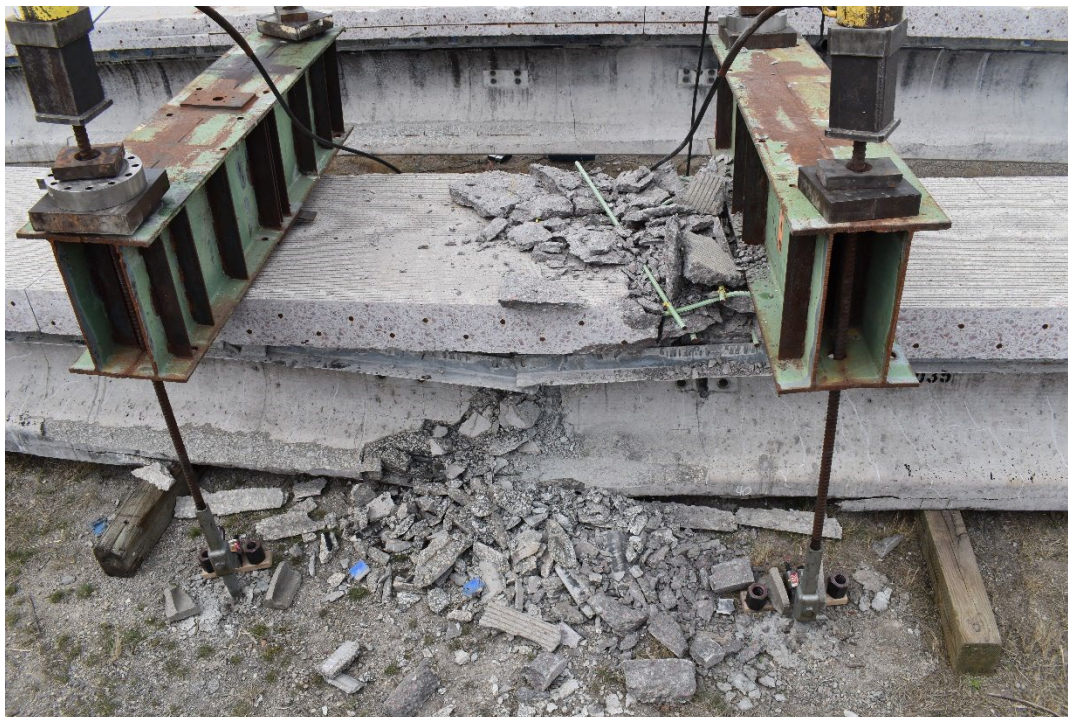
Figure 59. Girder E after failure at midspan

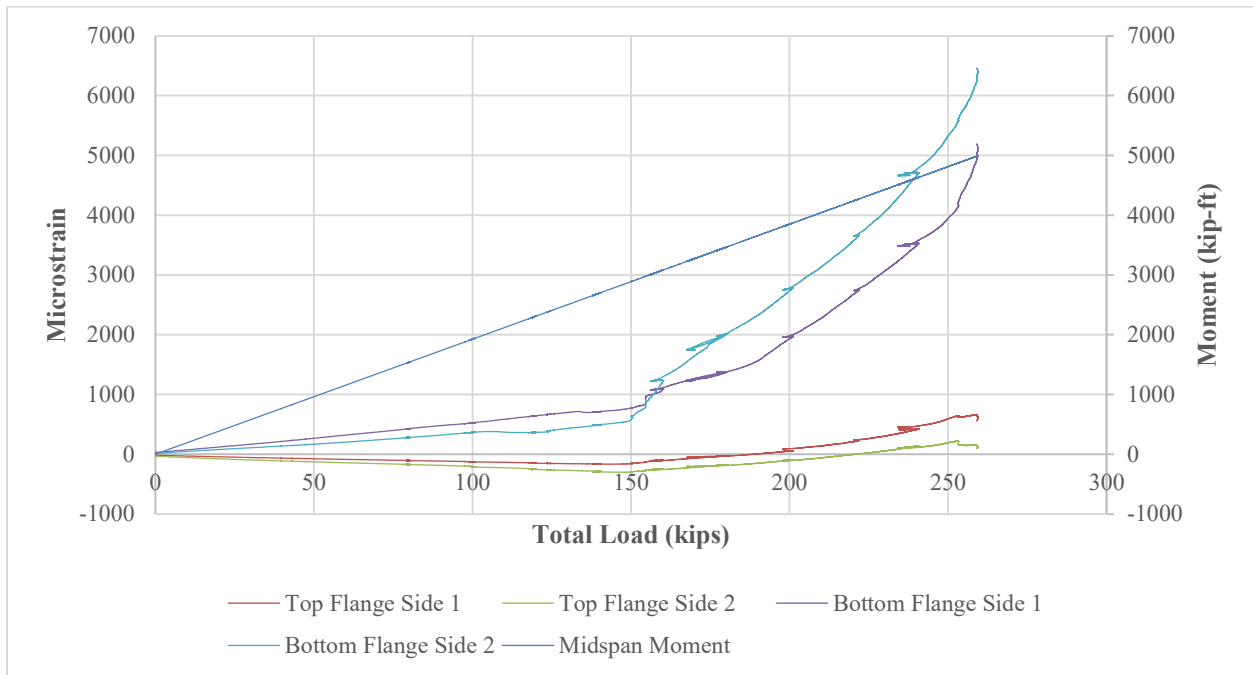
Figure 60. Midspan strain data for Girder E bending load test

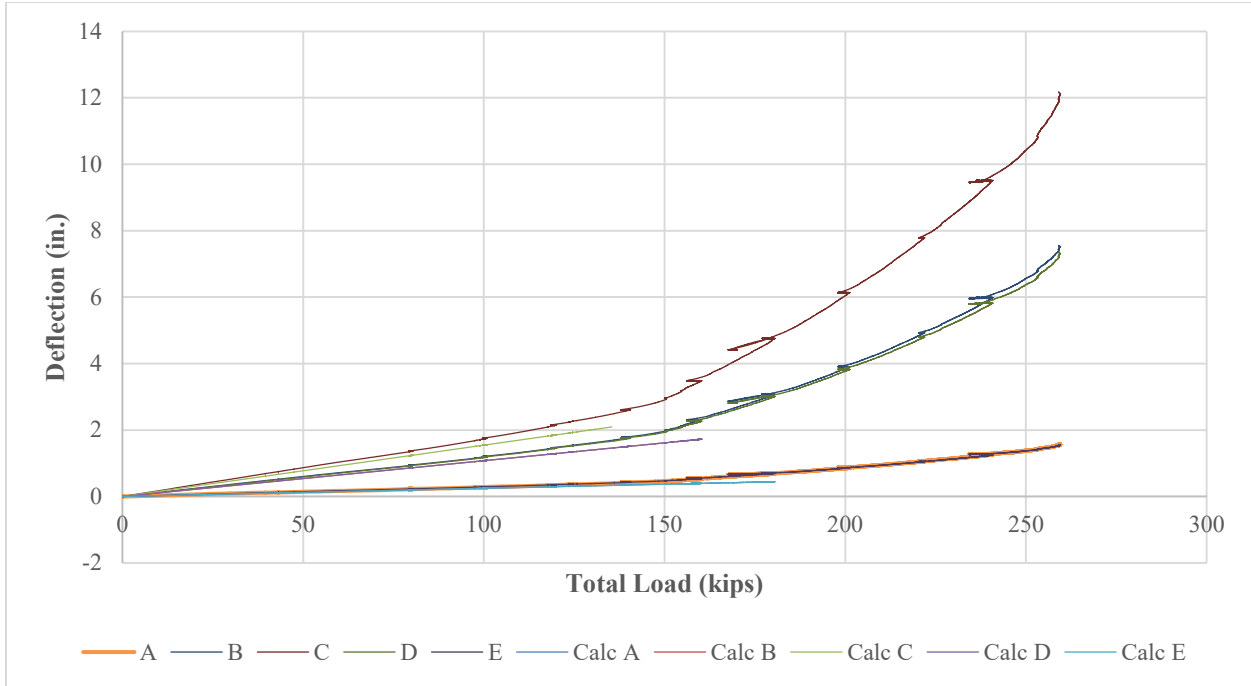
Figure 61. Actual vs. predicted deflection of Girder E

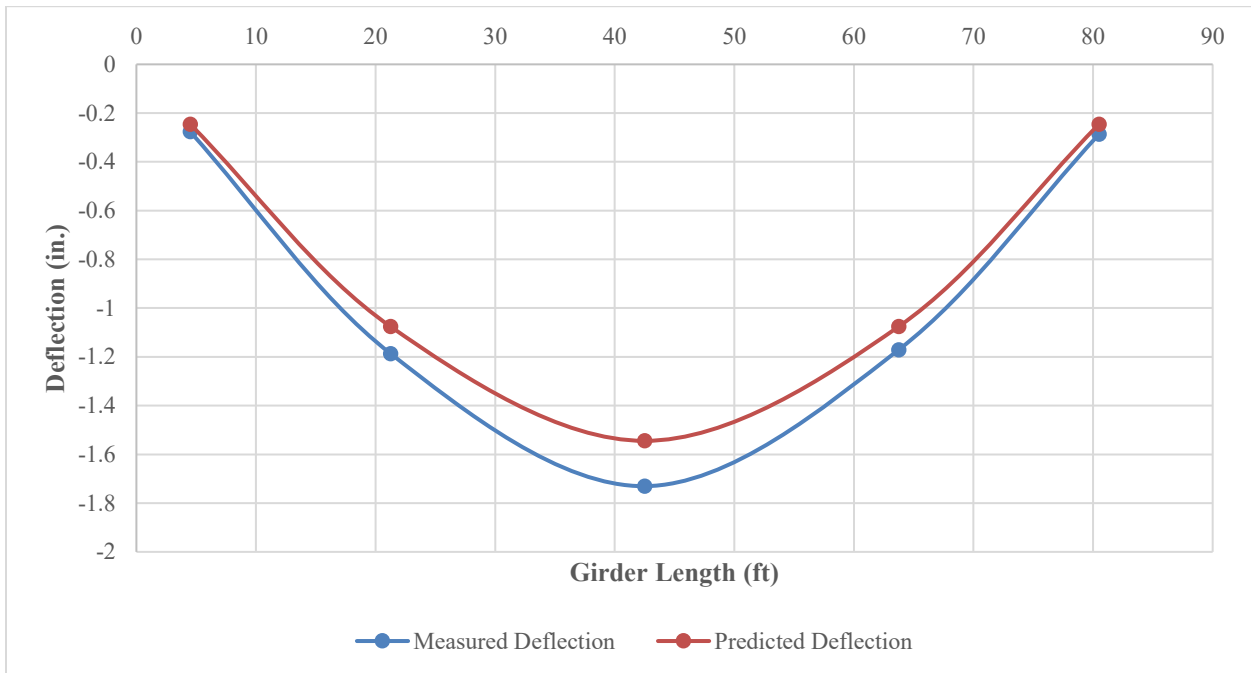
Figure 62. Girder E measured vs. predicted deflection at total load = 100 kip, M = 1,925 kip-ft

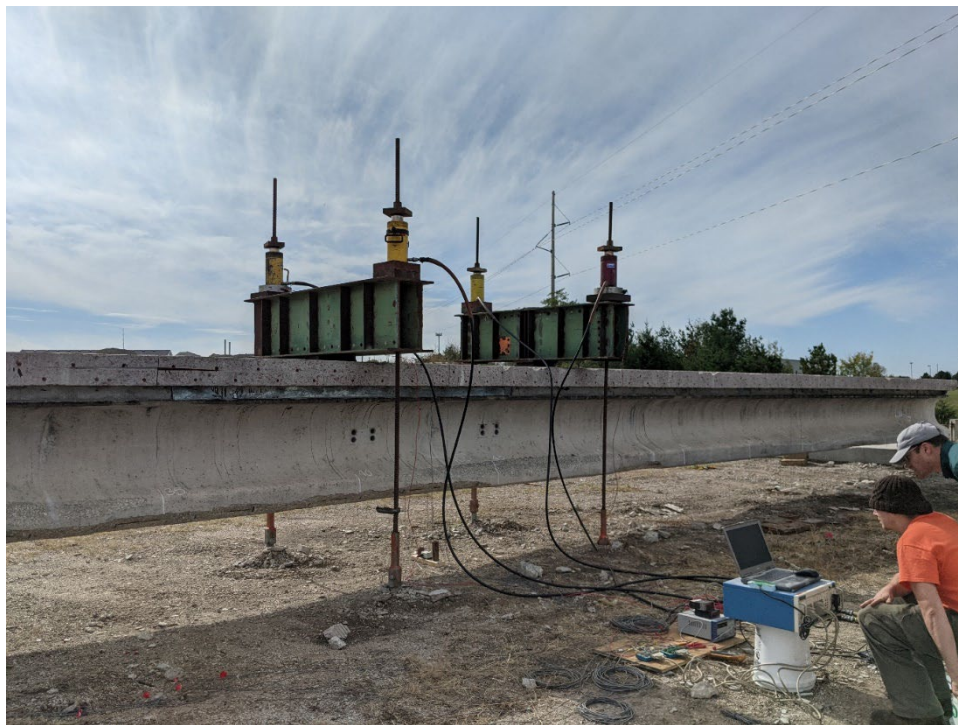
Figure 63. Girder G bending load test

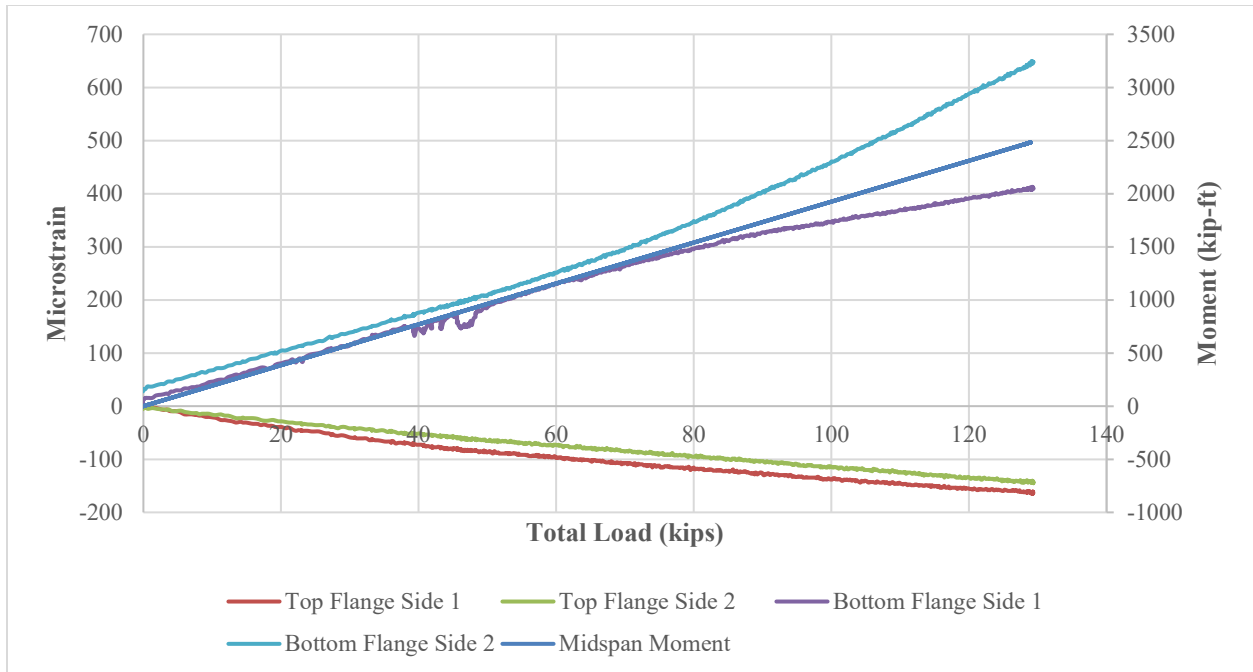
Figure 64. Measured vs. predicted deflection of Girder G

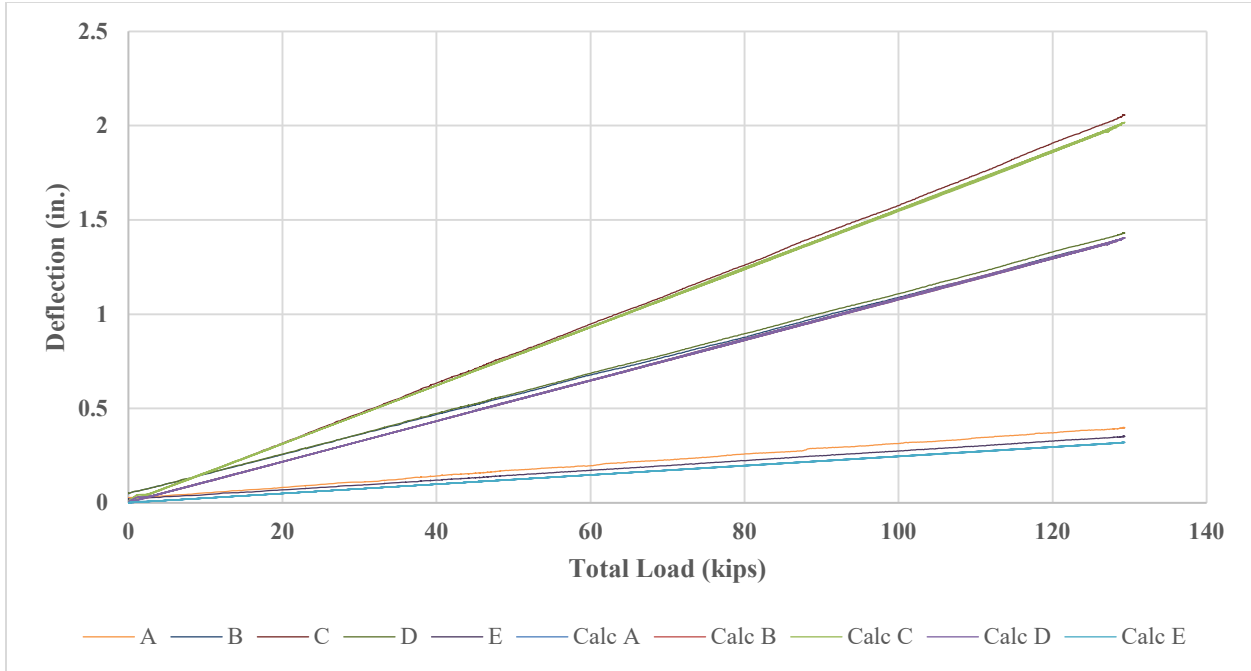
Figure 65. Measured vs. predicted deflection of Girder G at each point
