Assessment, Repair, and Replacement of Bridges Subjected to Fire

**Final Report
August 2022**

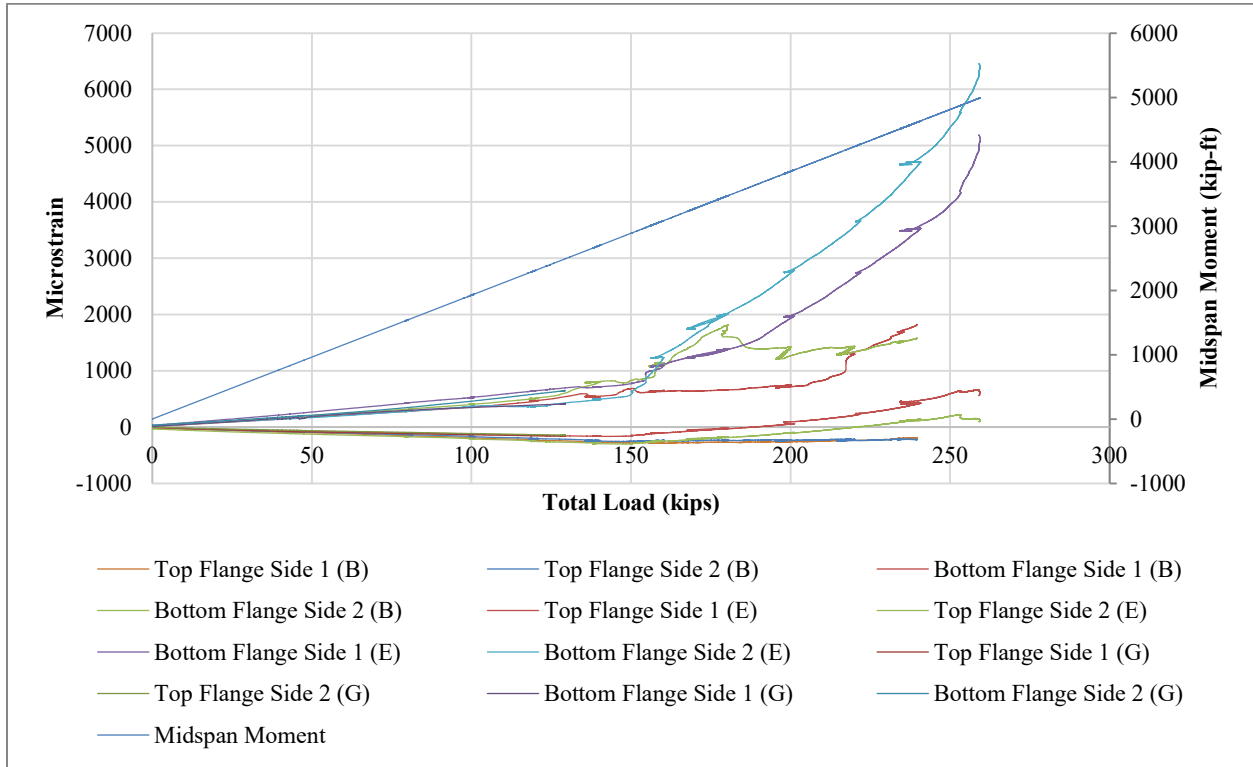
Figure 67. Combined strain results for Girders B, E, and G

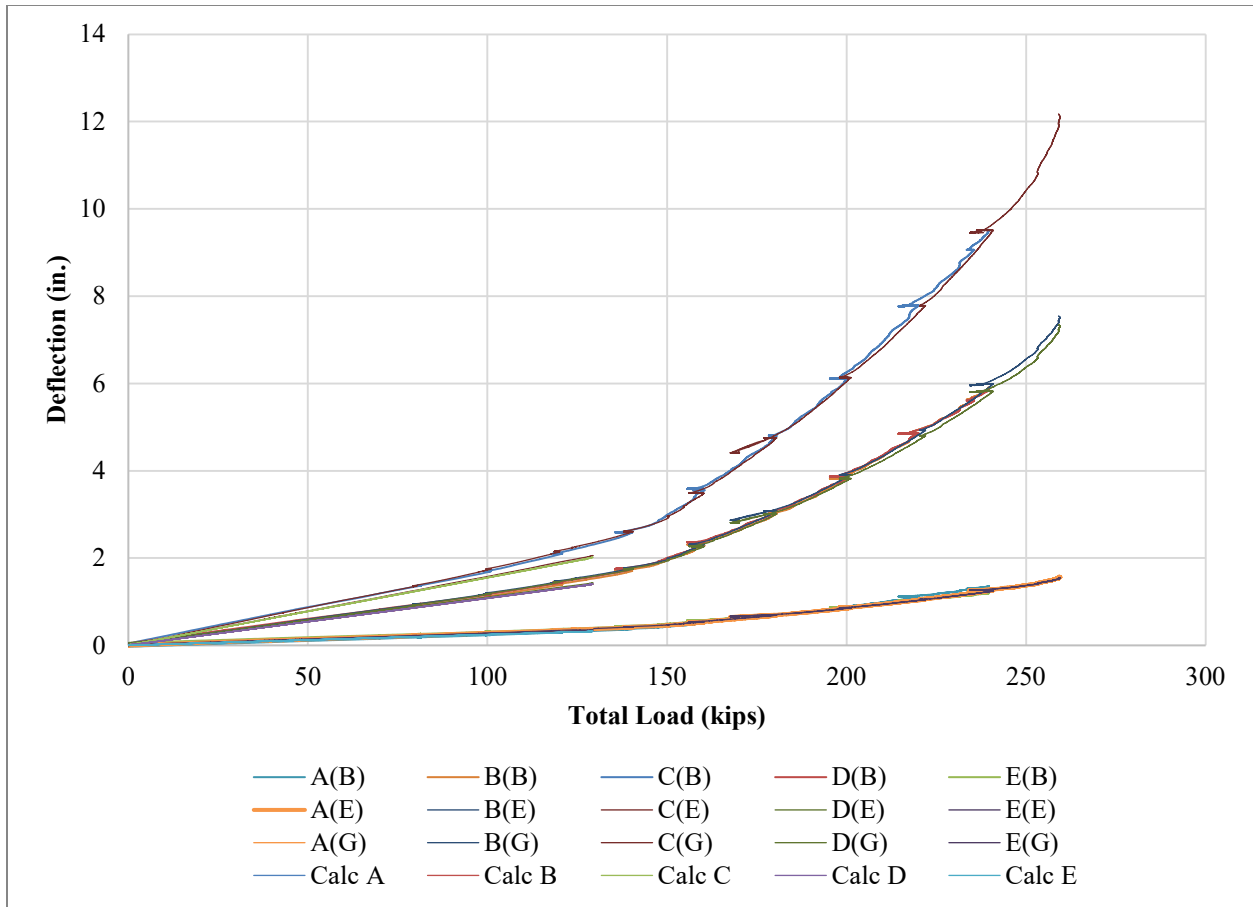
Figure 68. Combined deflection results for Girders B, E, and G

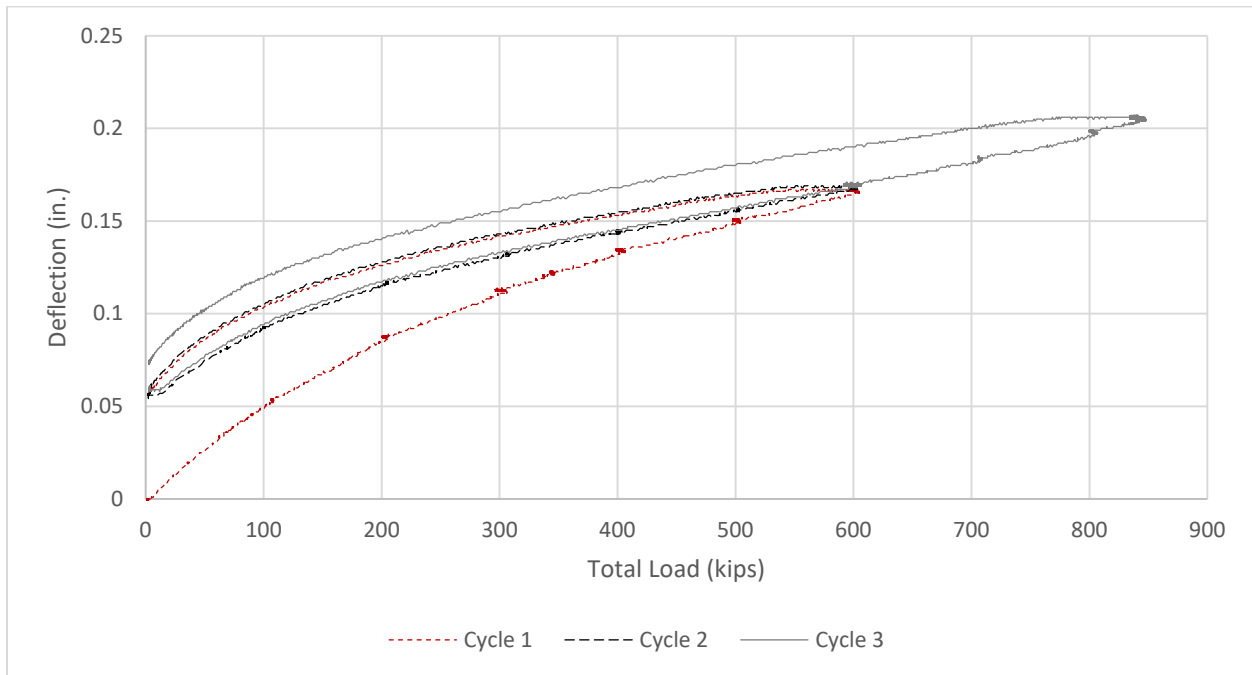
Figure 69. Deflection vs. total load for girder end shear test

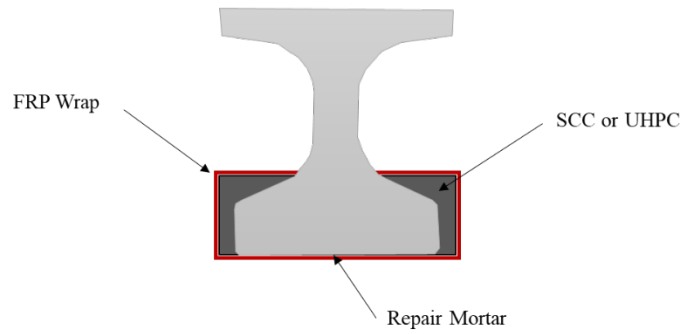
Figure 72. Repair methods for fire-damaged girder

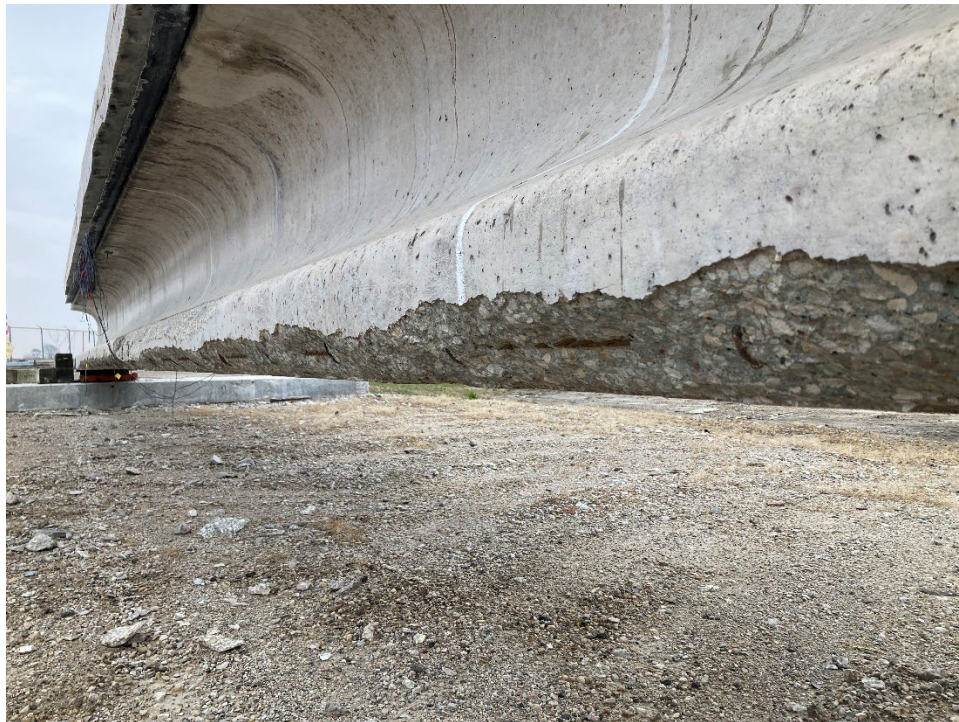
Figure 73. Removal of loose bottom flange concrete

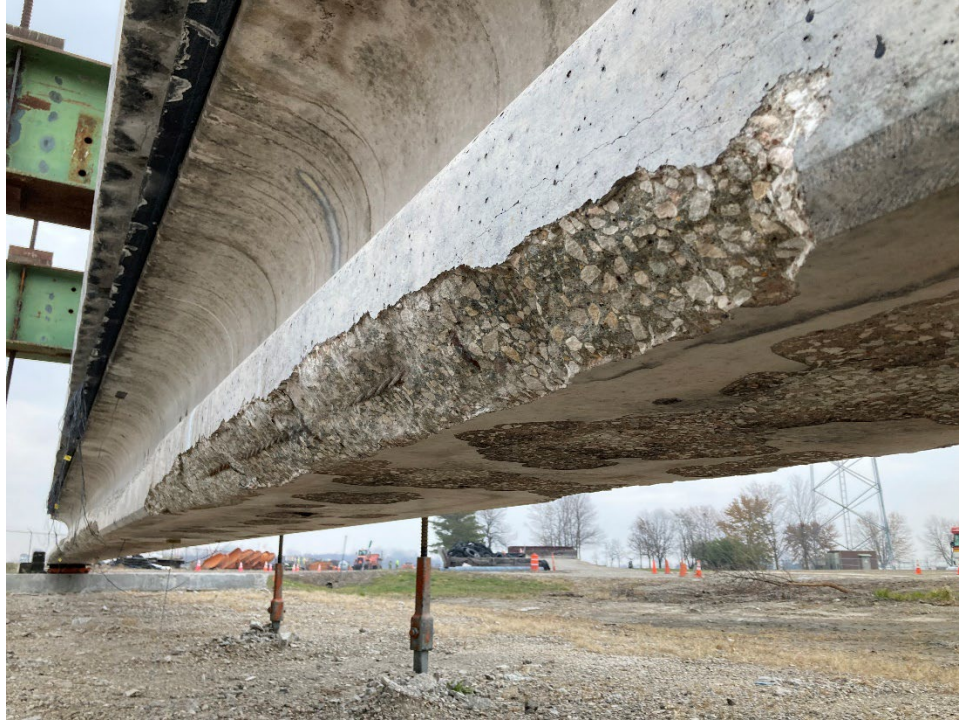
Figure 74. Bottom flange after loose concrete removal

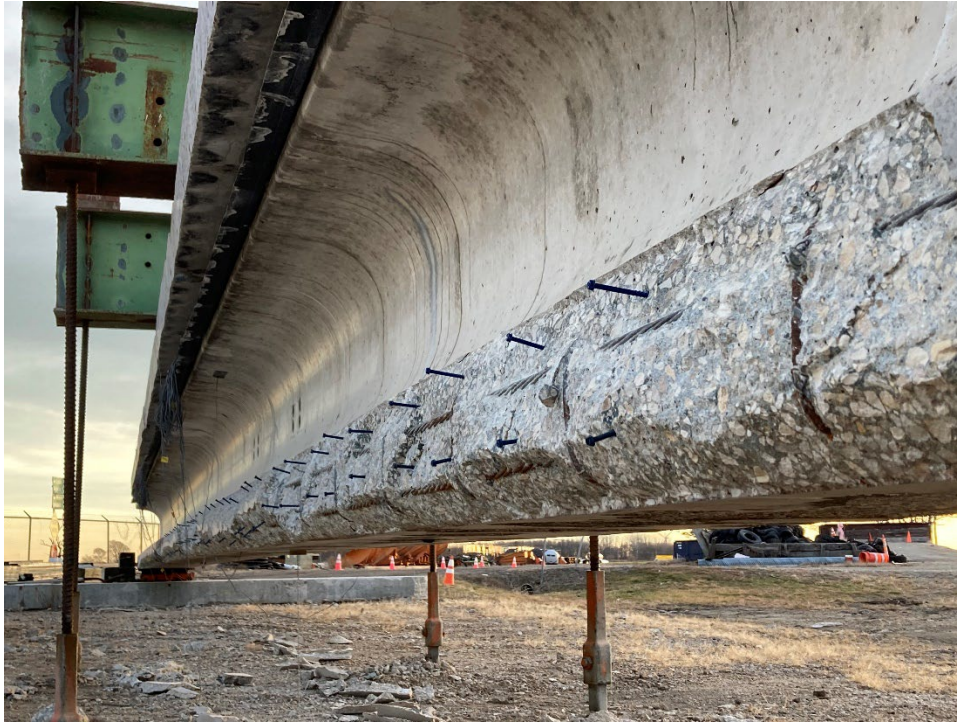
Figure 75. Concrete anchors into bottom flange

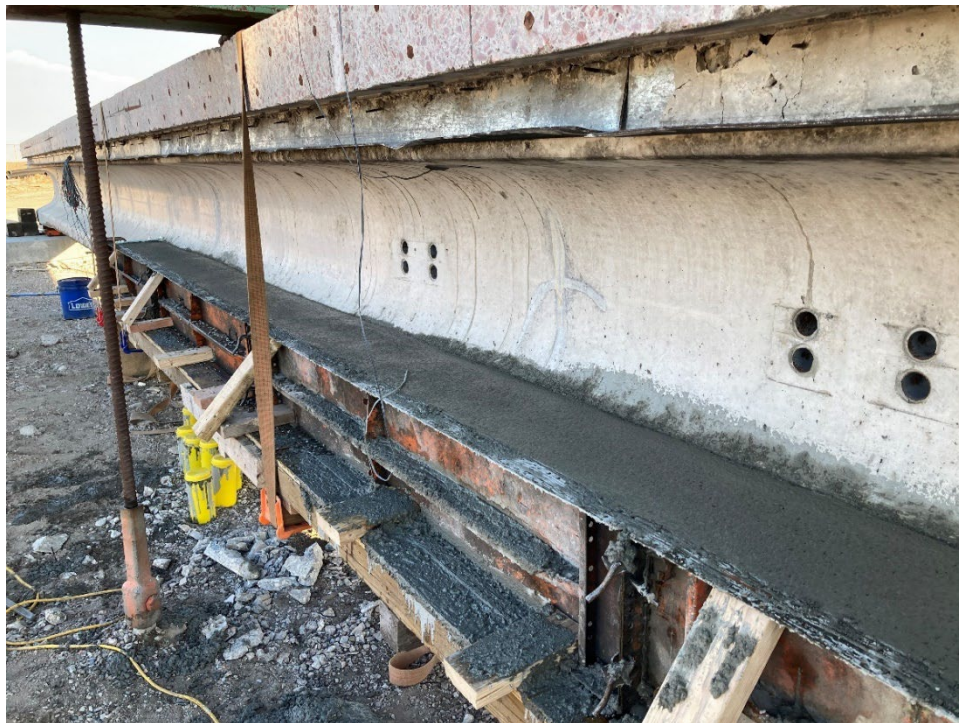
Figure 78. Placement of the SCC mix around the bottom flange

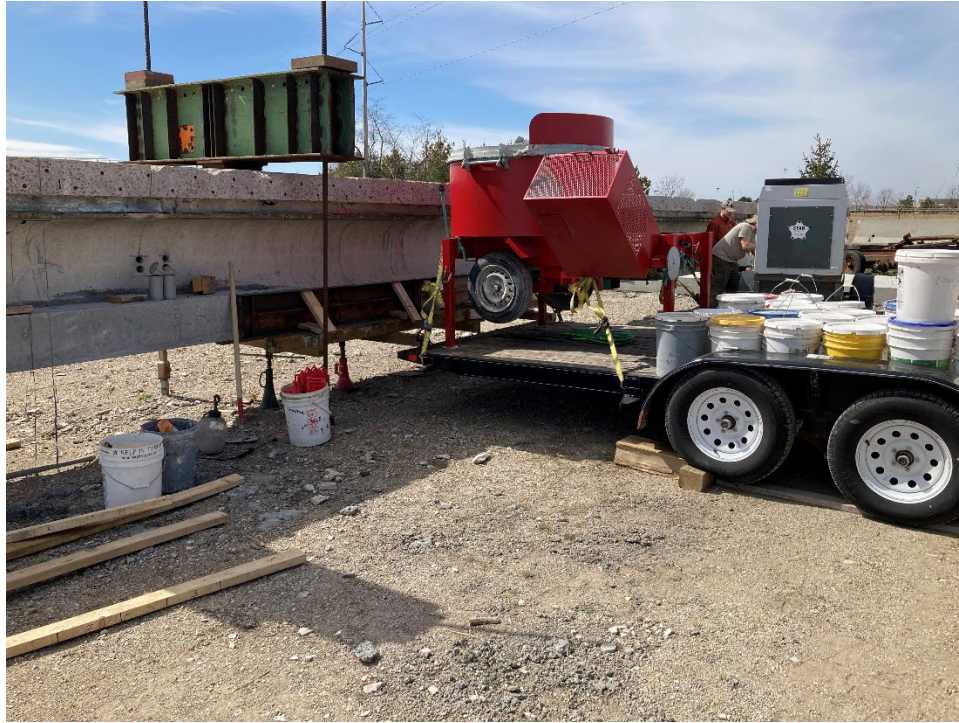
Figure 79. UHPC materials and mixer

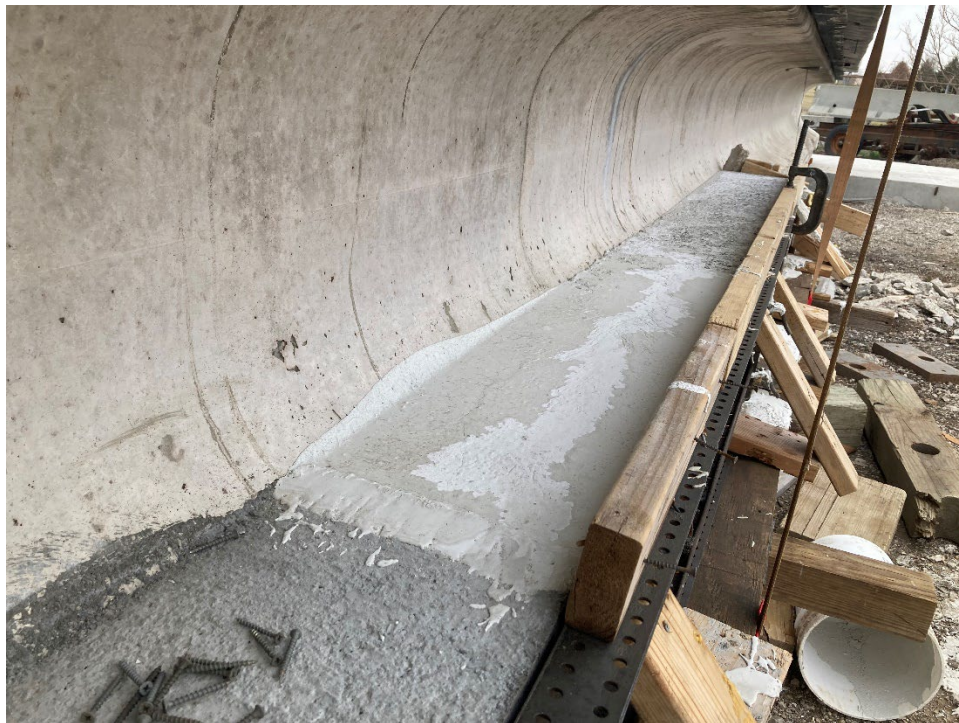
Figure 80. Placement of the UHPC section of repair

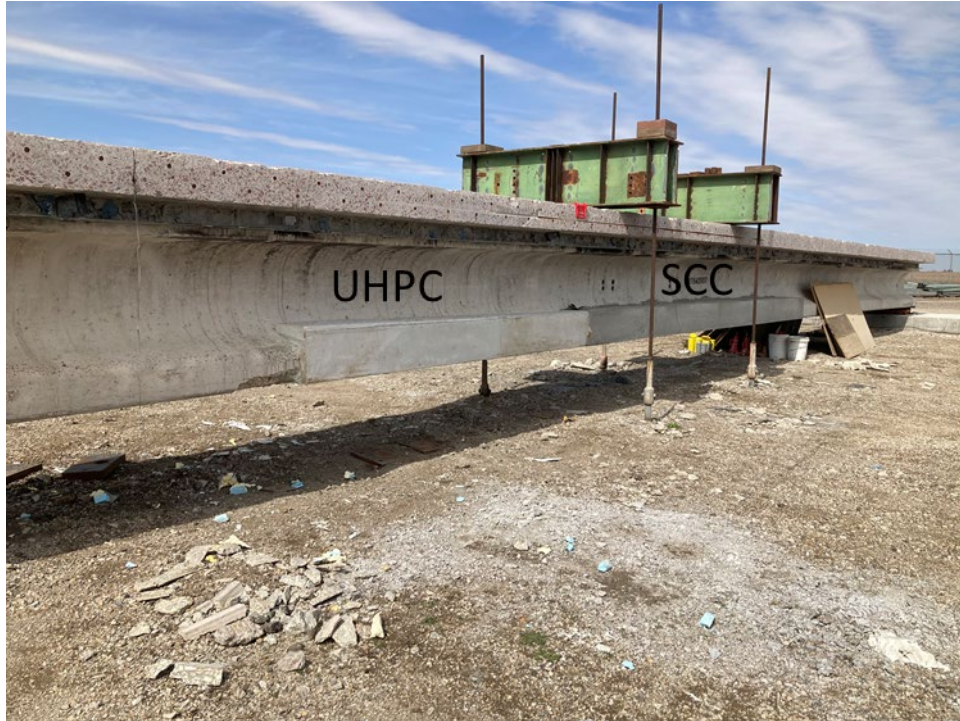
Figure 81. UHPC and SCC repair sections fully cast

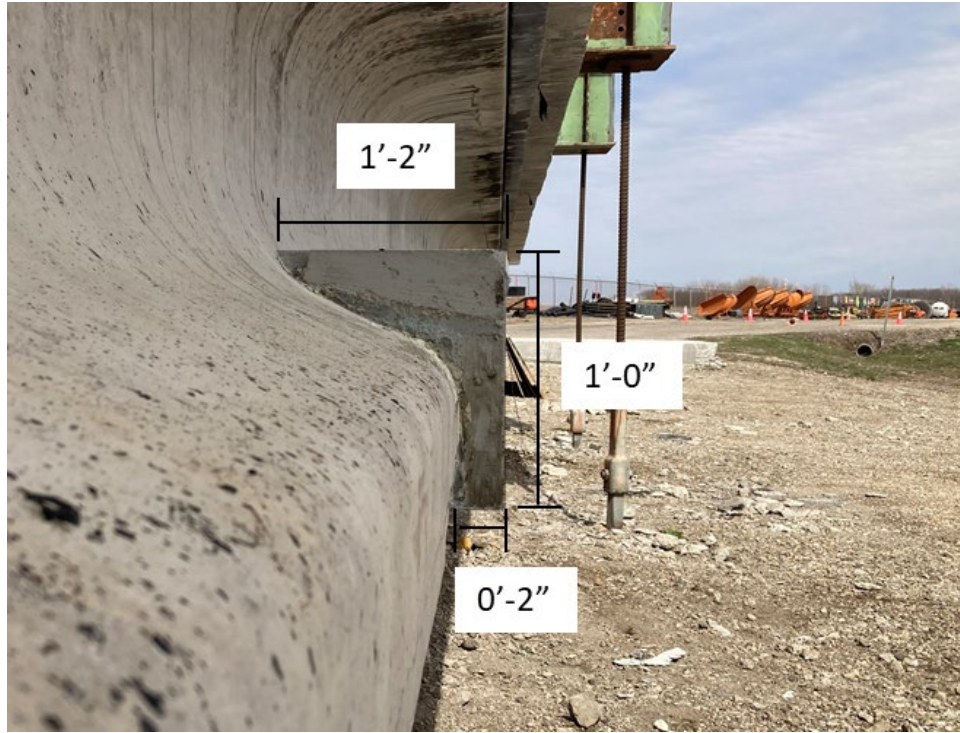
Figure 82. Dimensions of SCC and UHPC bottom flange repair

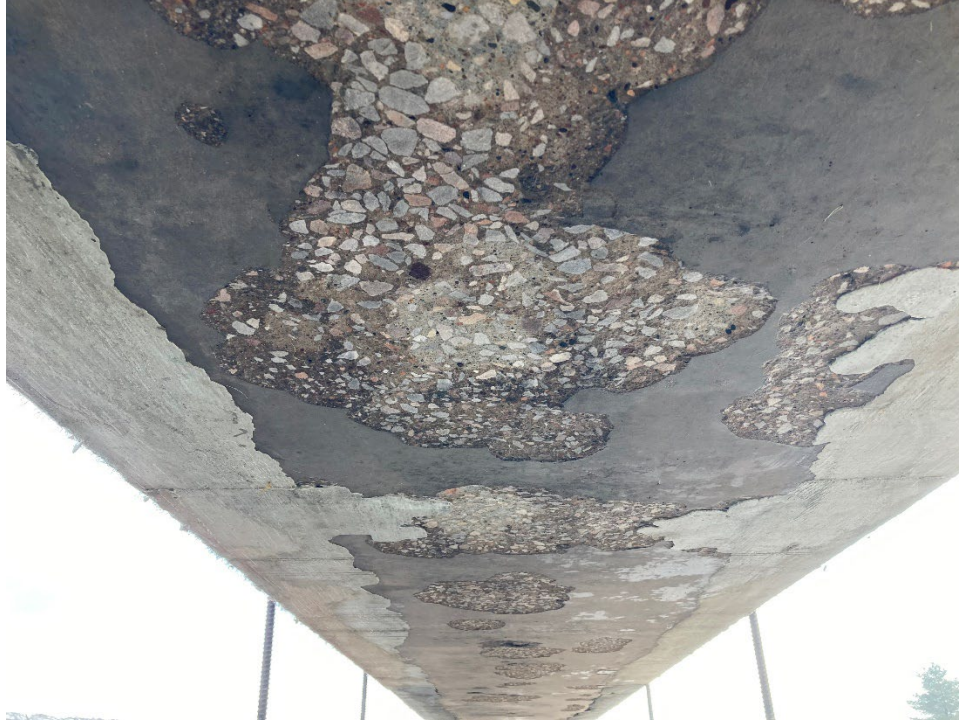
Figure 83. Bottom of girder spalls prior to repair

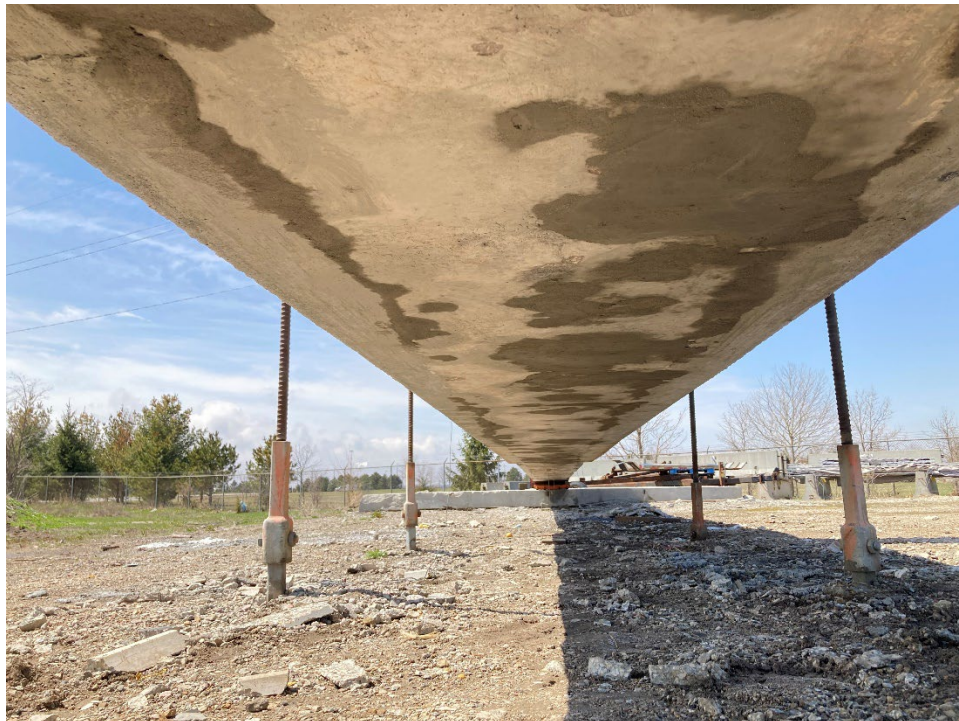
Figure 84. Bottom of girder spalls after repair mortar application

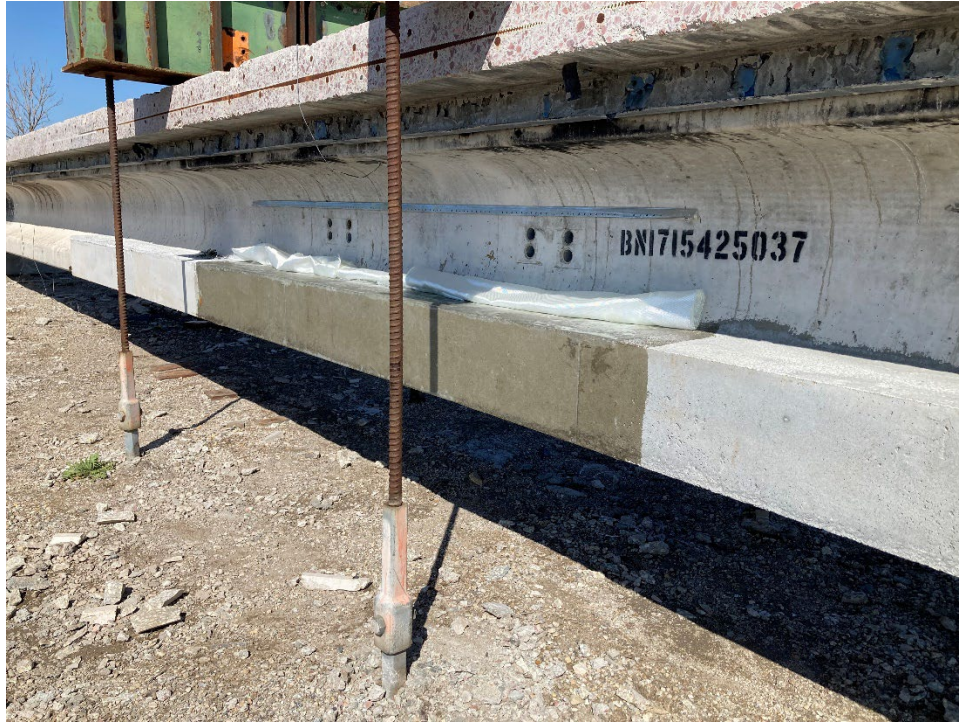
Figure 86. FRP wrap application on bottom flange repair

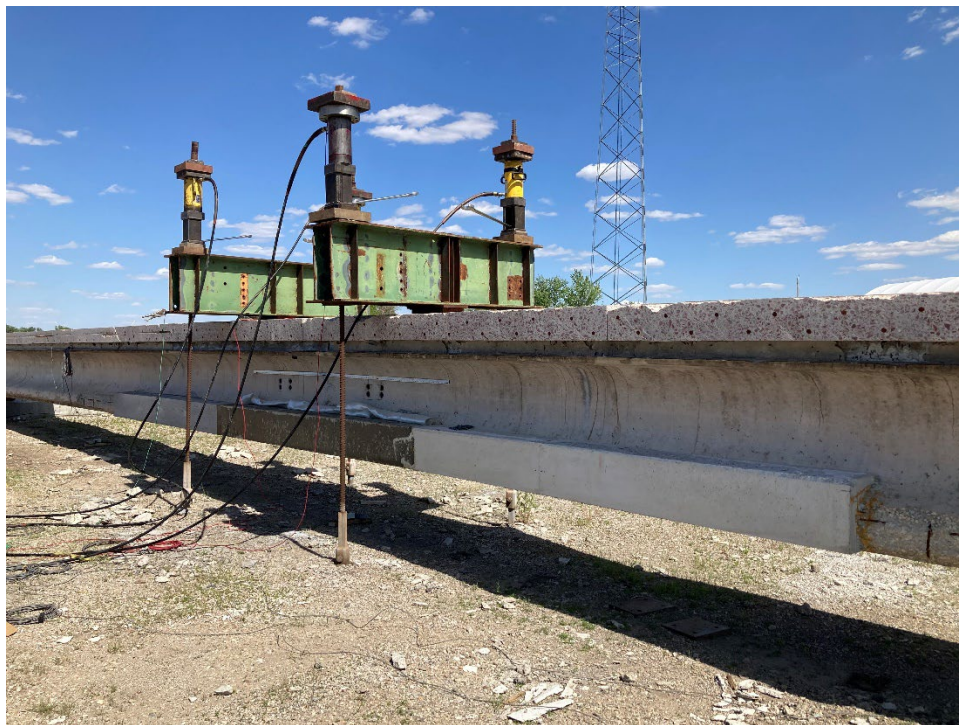
Figure 88. Load test of repaired girder

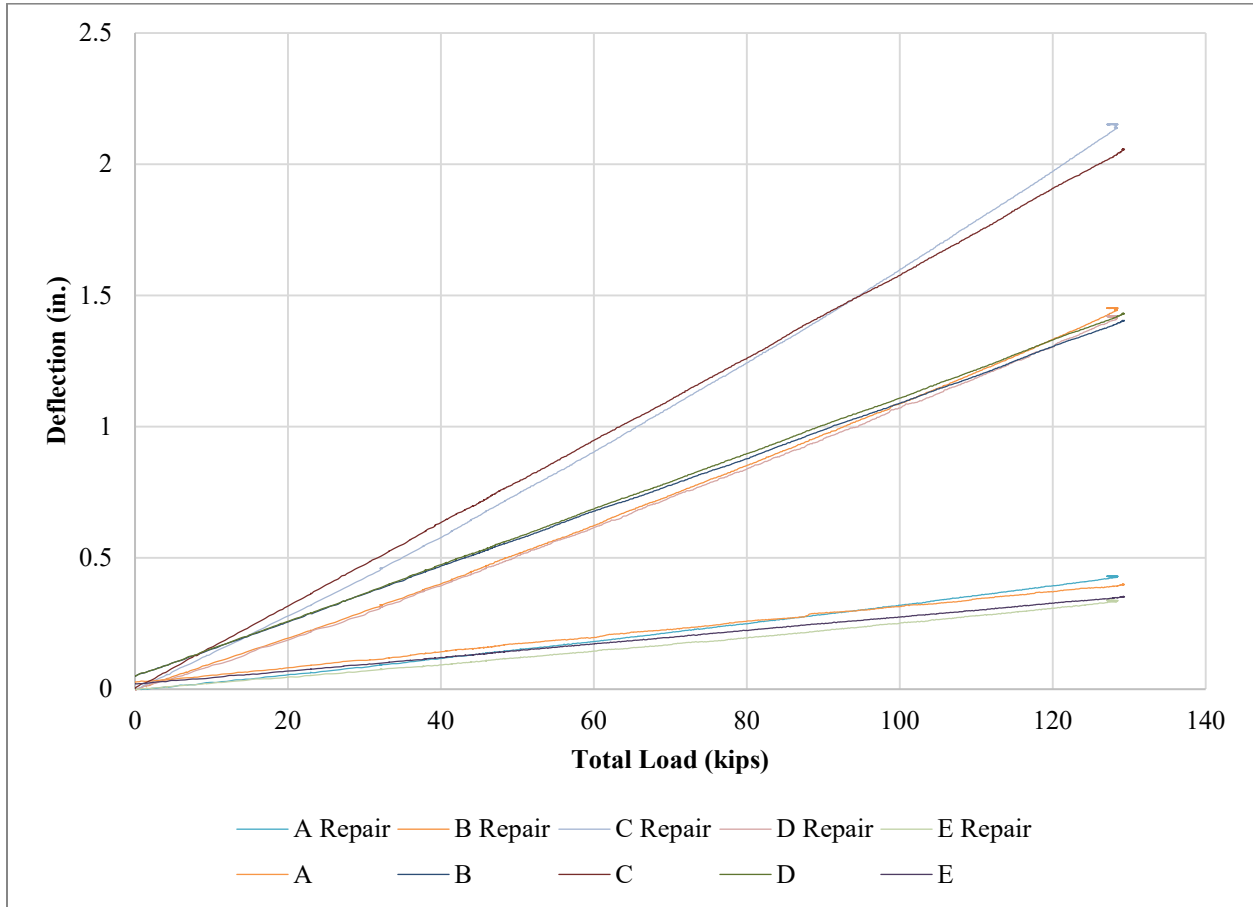
Figure 89. Comparison of repaired vs. pre-repaired Girder G deflection results

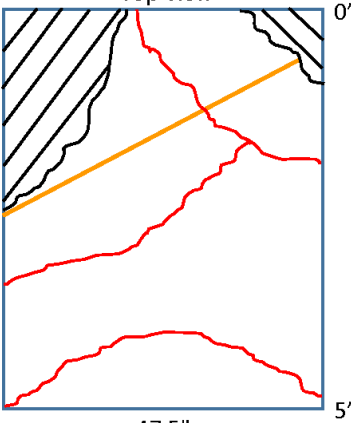
<p>0'</p><p>5'</p><p>47.5"</p></div> <div style="display: flex; justify-content: space-around;"><div style="text-align: center;">

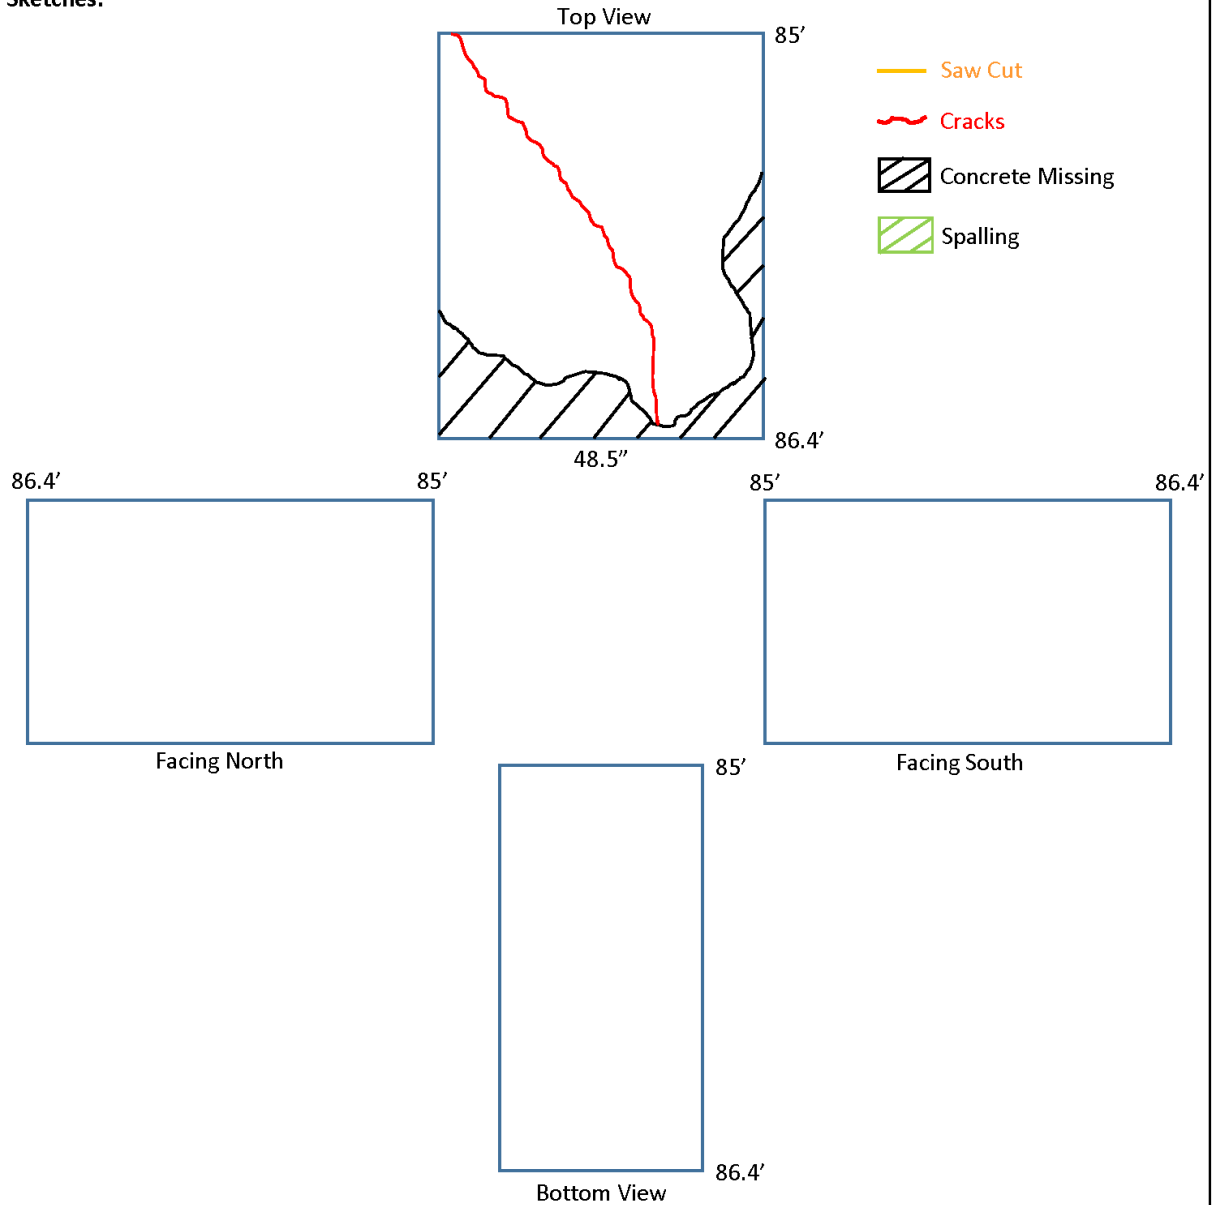
Girder E Condition Sheets

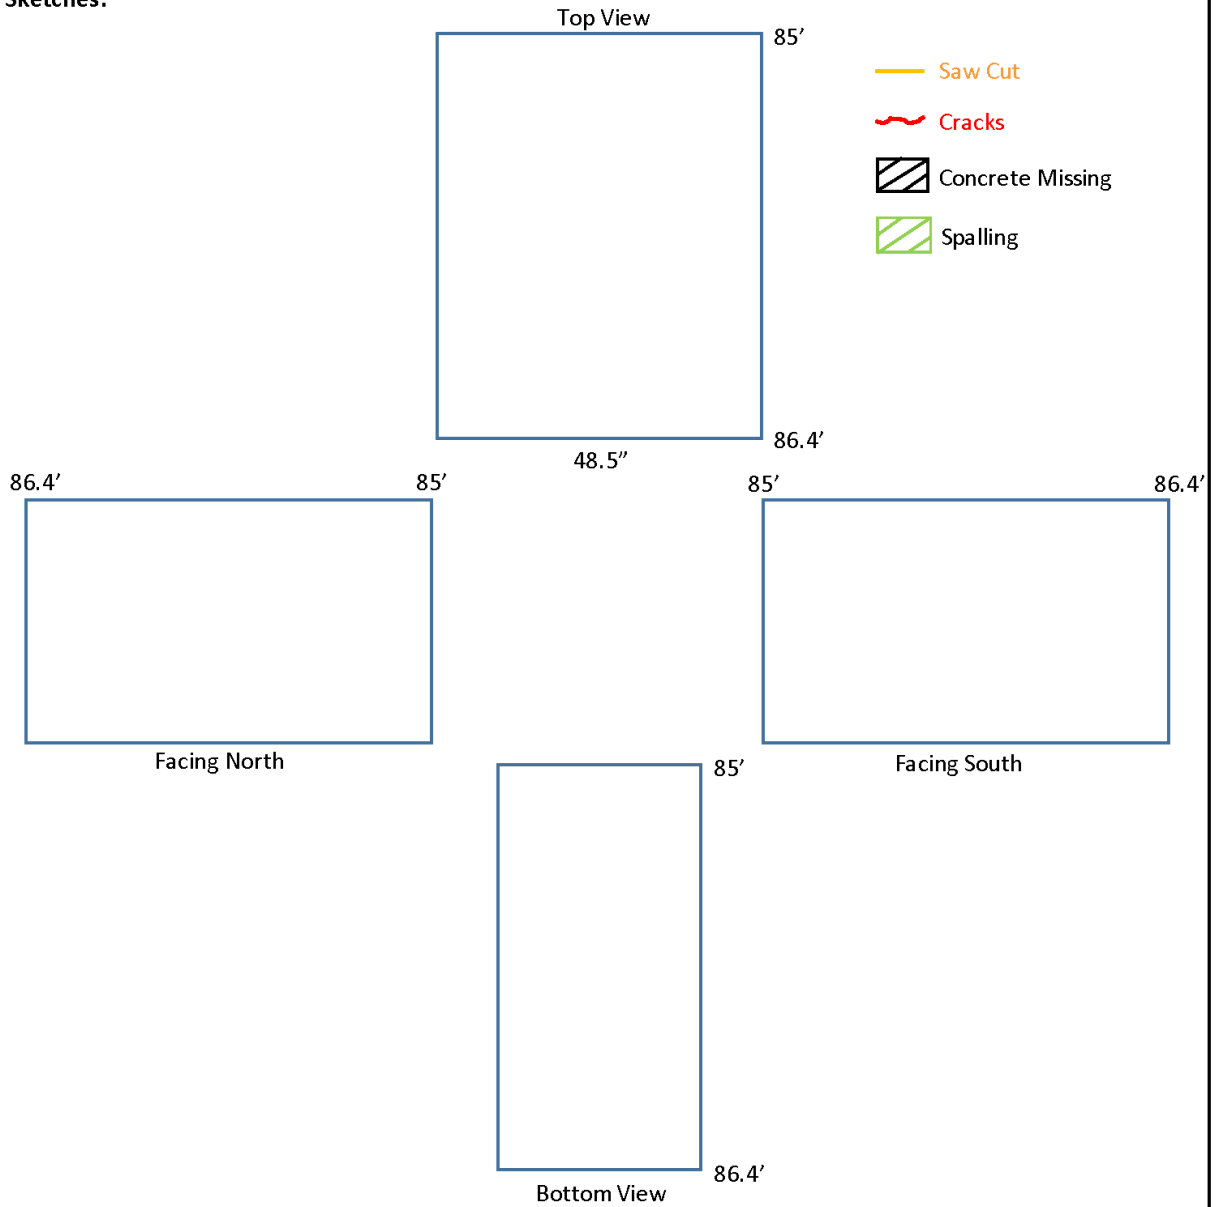
Girder G Condition Sheets
