# Assessment, Repair, and Replacement of Bridges Subjected to Fire

tech transfer summary

Assessment, Repair and Replacement of Bridges Exposed to Fire Damage

Iowa Department of Transportation  
(InTrans Project 20-734)  
Federal Highway Administration

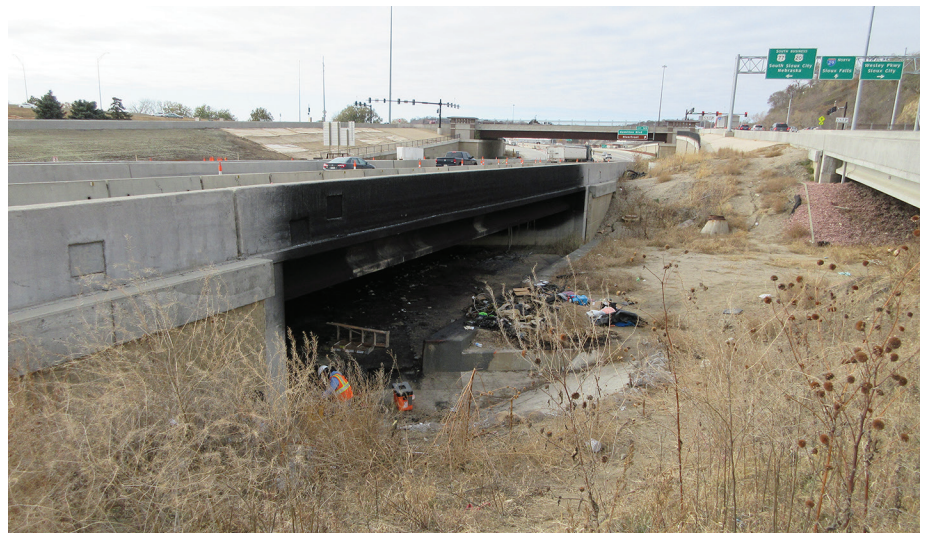
*I-29 Bridge fire north side of bridge looking toward west abutment*

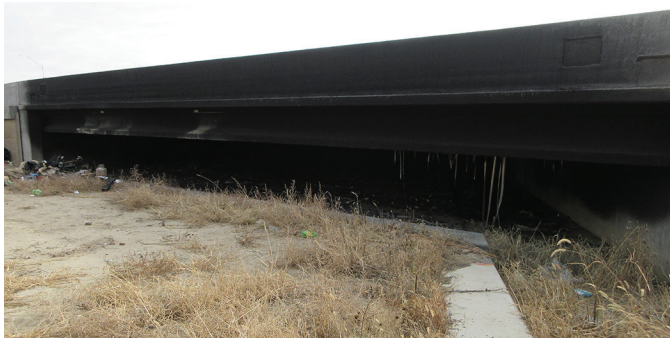
*I-29 burned bridge girders over homeless encampment in Sioux City, Iowa*

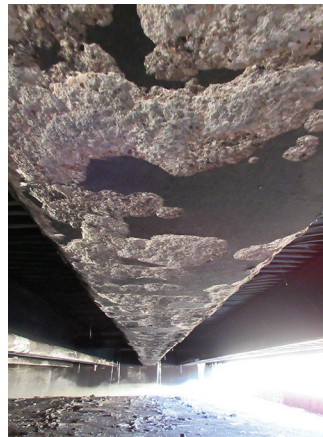
The stay-in-place polycarbonate deck forms caught on fire, which aided the spread of the fire along the deck. Spalling was extensive on the concrete prestressed girders where the fire was concentrated, resulting in the exposure of steel reinforcement strands and stirrups. Per the initial condition assessment (HDR 2019), a loss of camber was observed in three girders.

*Spalling on concrete girder*

The girders had varying levels of damage that coincided with the epicenter of the fire. At a minimum, each of the girders was soot-covered and experienced some spalling of the concrete. At worst, large concrete spalls that reached the depth of reinforcement, primarily from the bottom flange of the girder, were observed.

The primary repairs completed were necessary along the bottom flange of the girder where spalling of concrete was most significant and reinforcement had become exposed. Each repair method performed sufficiently well to protect the remaining structure during the load test and limited time of evaluation.

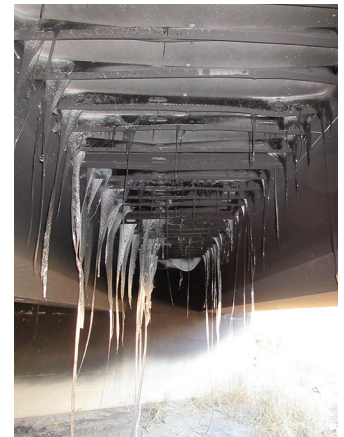
*Melted polycarbonate stay-in-place forms*

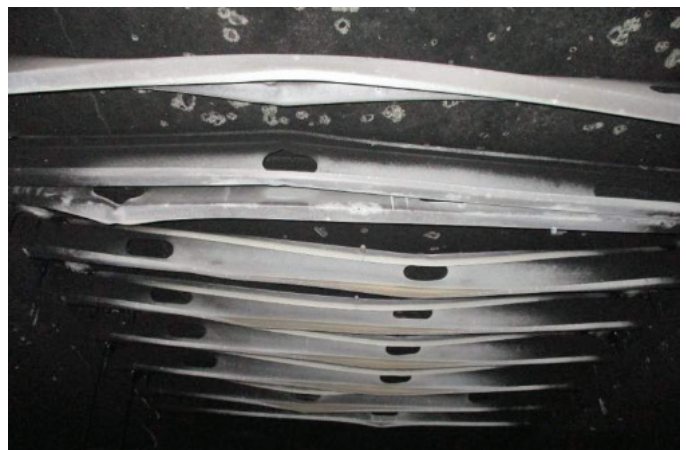
*Melted polycarbonate formwork between two girders*
