EVALUATION OF BOND RETAINAGE

PORTLAND CEMENT CONCRETE OVERLAYS

INFRARED THERMOGRAPHY AND GROUND PENETRATING RADAR

IOWA DEPARTMENT OF TRANSPORTATION

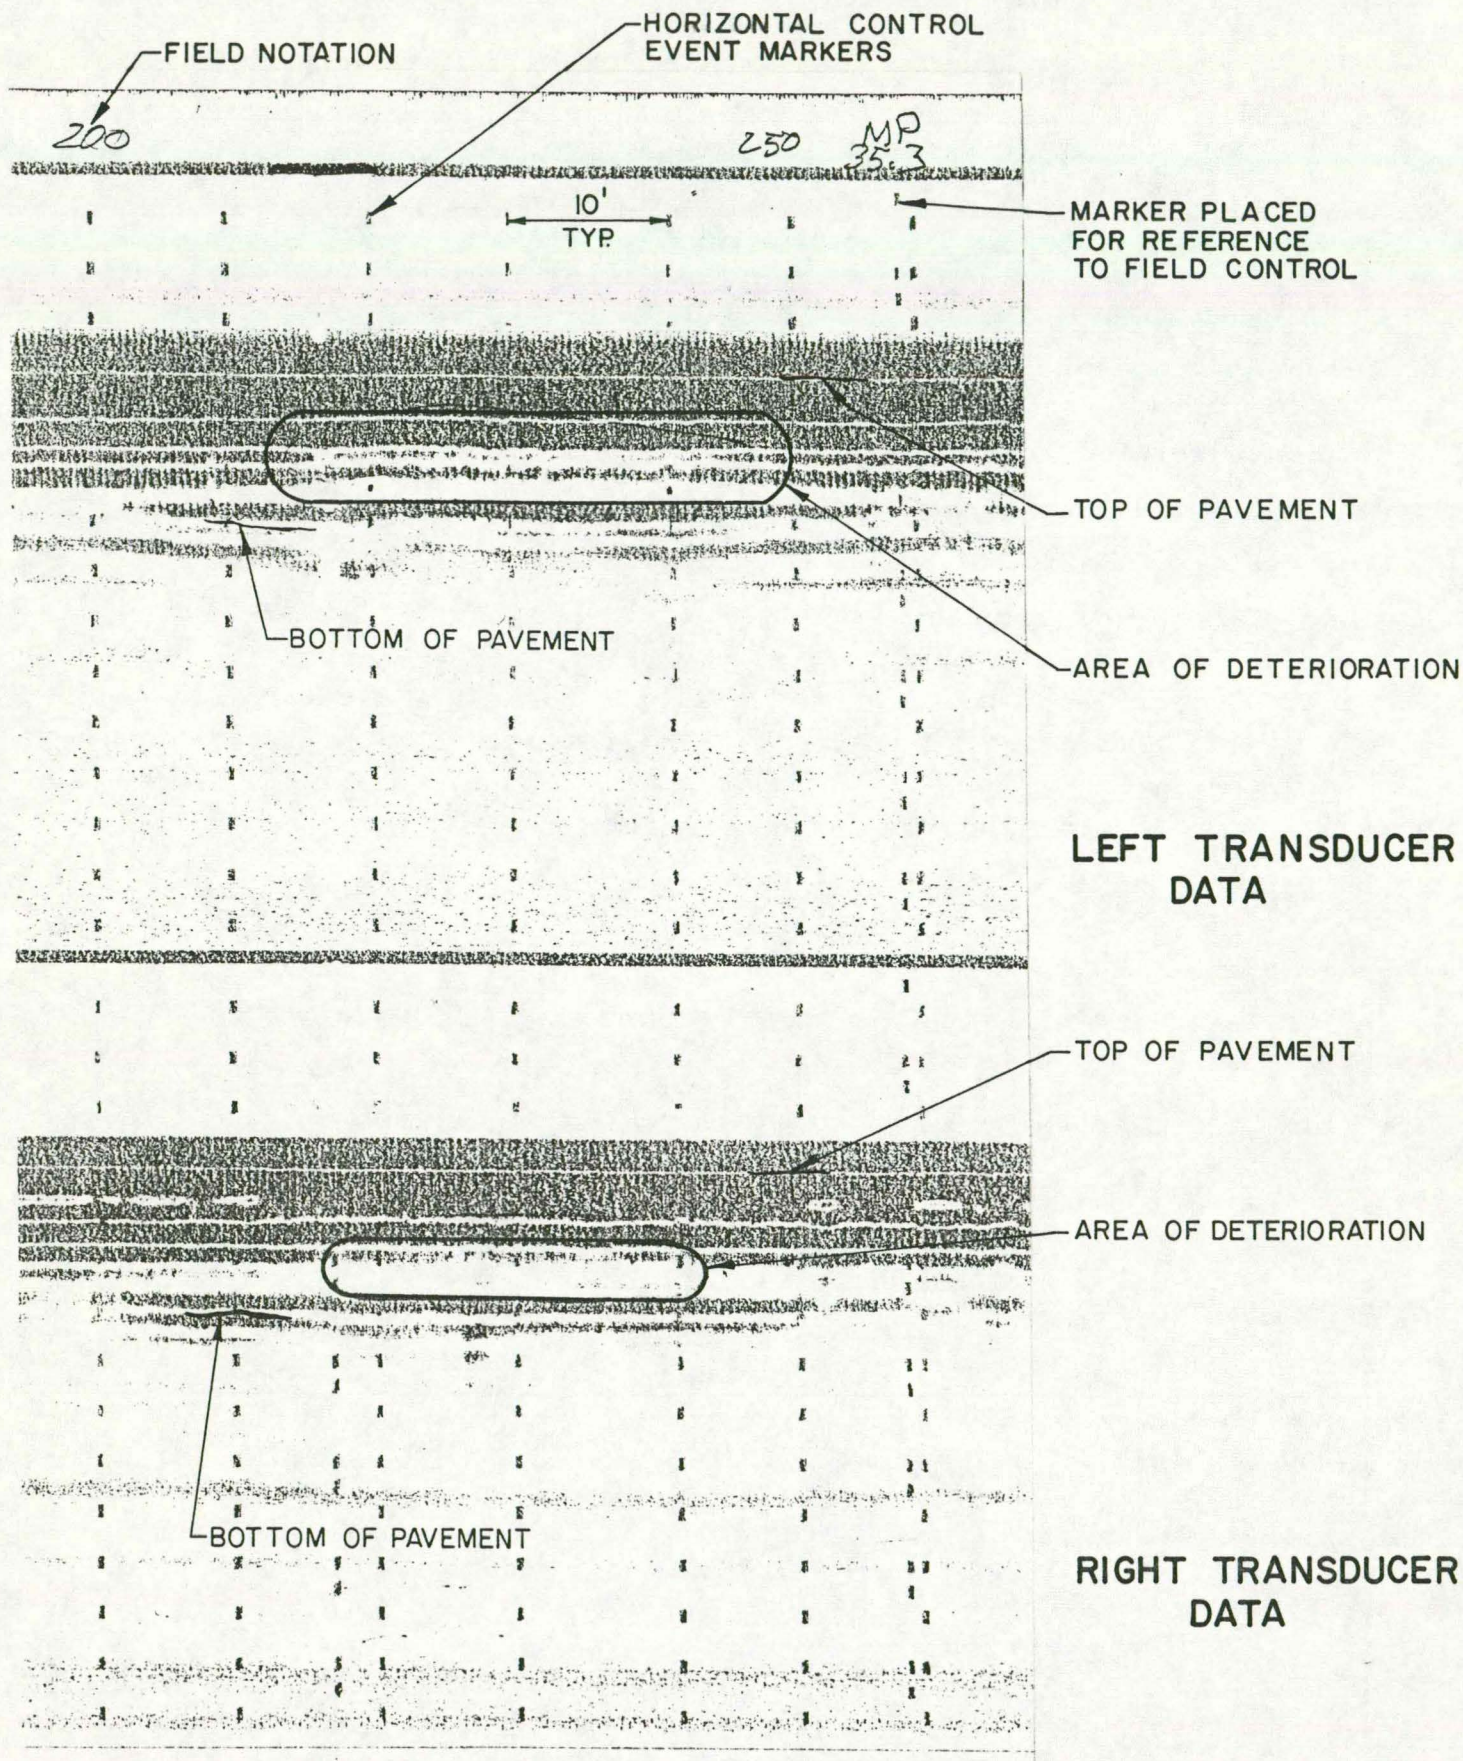
All three cores taken between mileposts 35.25 and 35.35 (Numbers 2, 3 and 4) and Core Number 2 between mileposts 36.00 and 36.10 on Interstate 80 were either broken during coring or broken when handled. While no debond condition was present, the cores broke easily, with light finger pressure, just below the interface between the original pavement and PCC overlay. We feel that these cores are representative of a weak concrete which is a preface to an early stage of deterioration where small fractures begin to occur. This is a condition that can be related to the degradation of the interface signature seen at various locations in these same sections (Figure 3). At two locations between mileposts 35.25 and 35.35 on Interstate 80, the degradation of the interface signature occurred in several of the data passes simultaneously.

At each site 6,336 feet of GPR data was collected and analyzed. This analysis identified 258 lineal feet of scan that showed this deteriorated condition between mileposts 35.25 and 35.35 (4.1%), and 116 lineal feet between mileposts 36.00 and 36.10 (1.8%). The location of this deterioration is shown in Appendix B. No GPR data representing any debonding that we can identify or deterioration was found at any of the other sites.

FIGURE 3
SAMPLE OF GPR CHART SHOWING
DETERIORATION SIGNATURE
IOWA DEPT. OF TRANSPORTATION

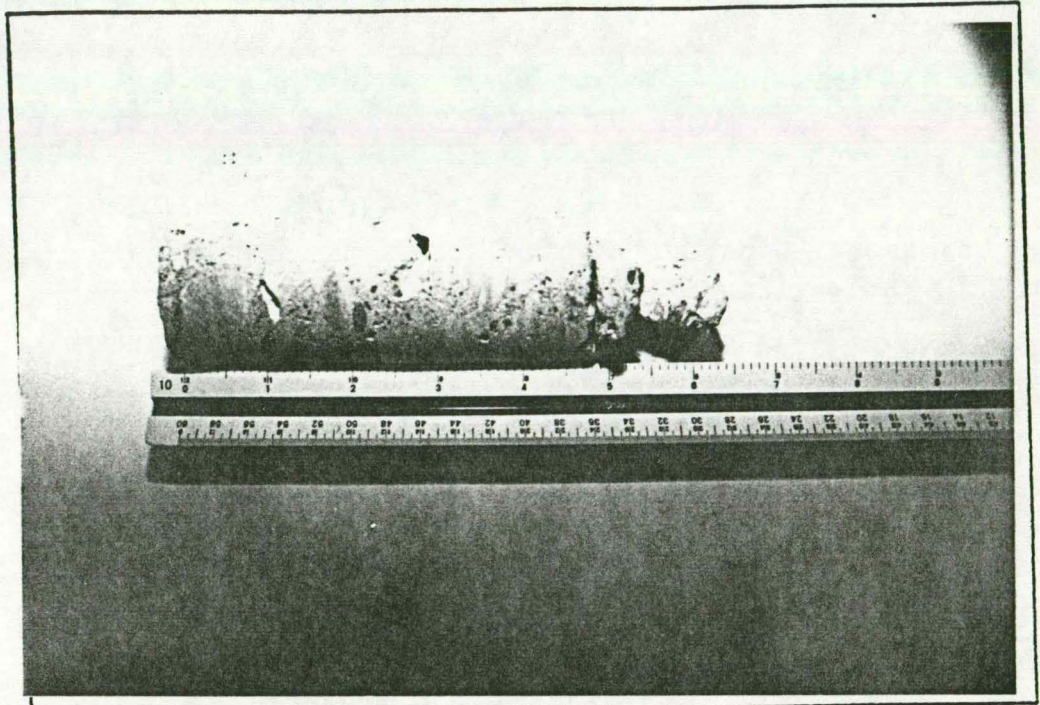
DATE: August 18, 1987
 PROJECT: Iowa D.O.T. - PCC Bond Evaluation
 CORE LOCATION: Interstate 80 - Milepost 35.25
 CORE: # 2
 DIAMETER: 2 inch
 OVERLAY THICKNESS: 4.25 inches
 CONCRETE THICKNESS: 11 inches
 FULL DEPTH Y/N: Yes
 CONDITION OF OVERLAY: Good
 DEFECTS IN CORE: Poor original pavement
 QUALITY OF CONCRETE: Poor
 REMARKS: Original Pavement broke easily

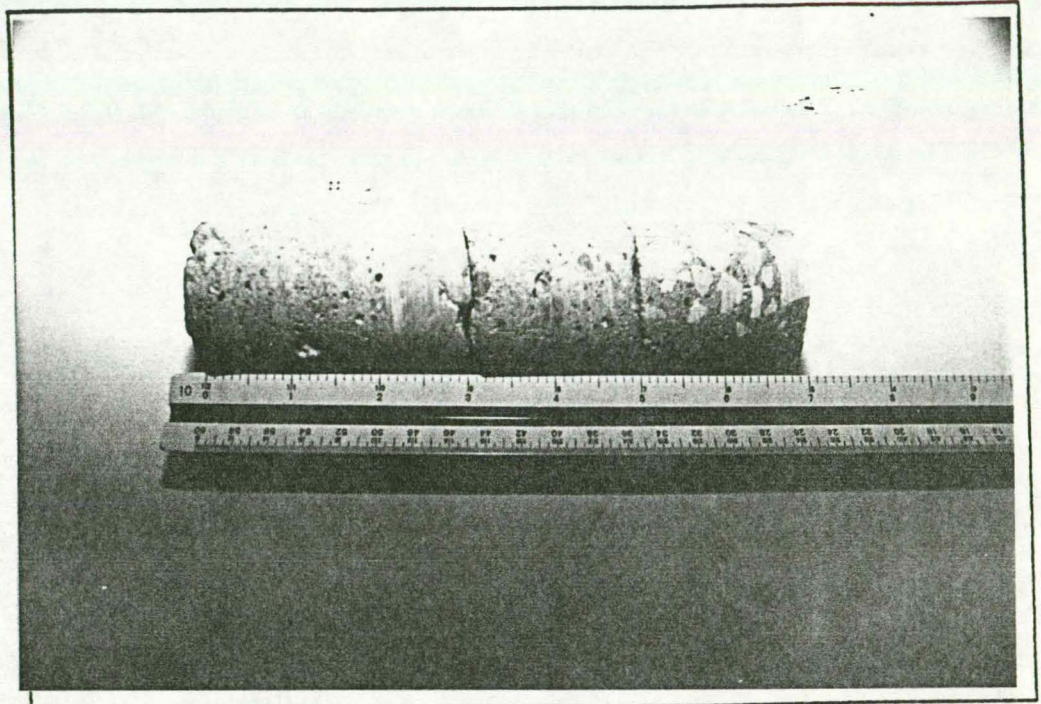
DEFECTS IN CORE: Broke just beneath Bond

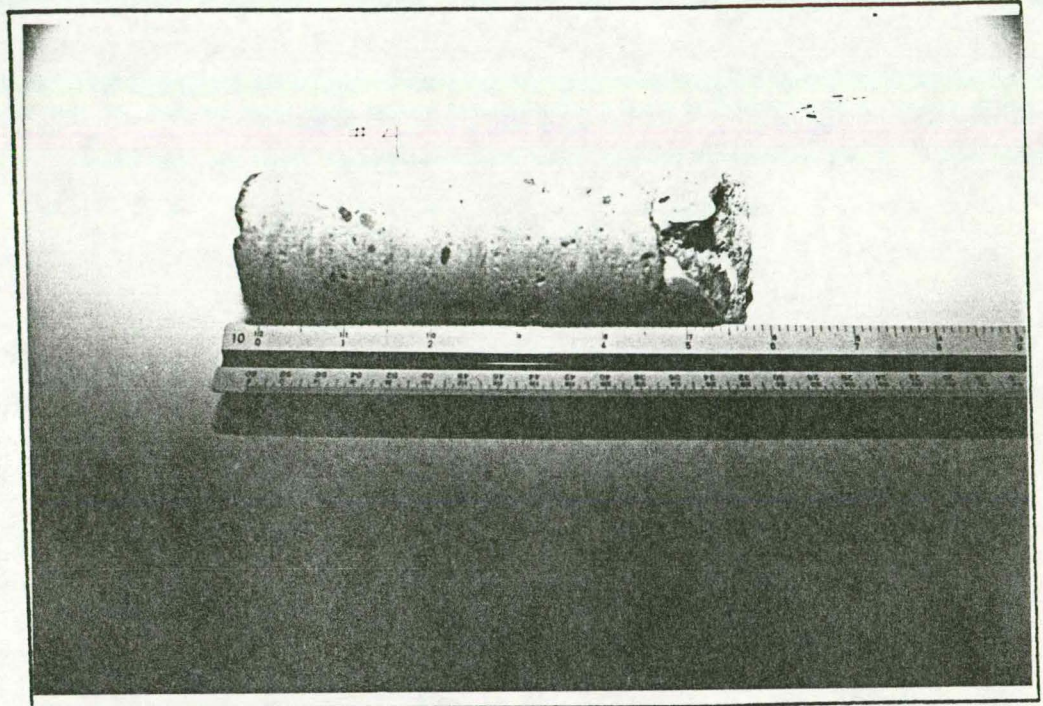
DATE: August 18, 1987
 PROJECT: Iowa D.O.T. - PCC Bond Evaluation
 CORE LOCATION: Interstate 80 - Milepost 35.25
 CORE: # 4
 DIAMETER: 2 inch
 OVERLAY THICKNESS: 4.5 inches
 CONCRETE THICKNESS: 11 inches
 FULL DEPTH Y/N: Yes
 CONDITION OF OVERLAY: Good
 DEFECTS IN CORE: Poor original pavement
 QUALITY OF CONCRETE: Poor
 REMARKS: Original pavement broke easily

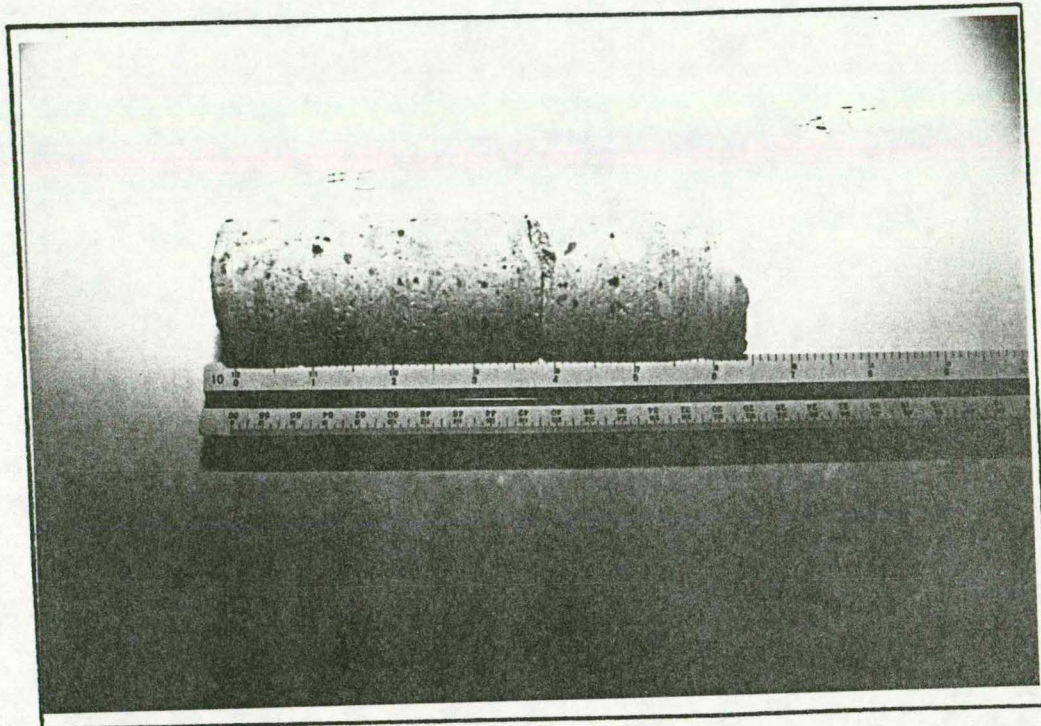
DEFECTS IN CORE: Poor original pavement

QUALITY OF CONCRETE: Poor

REMARKS: Original pavement broke easily

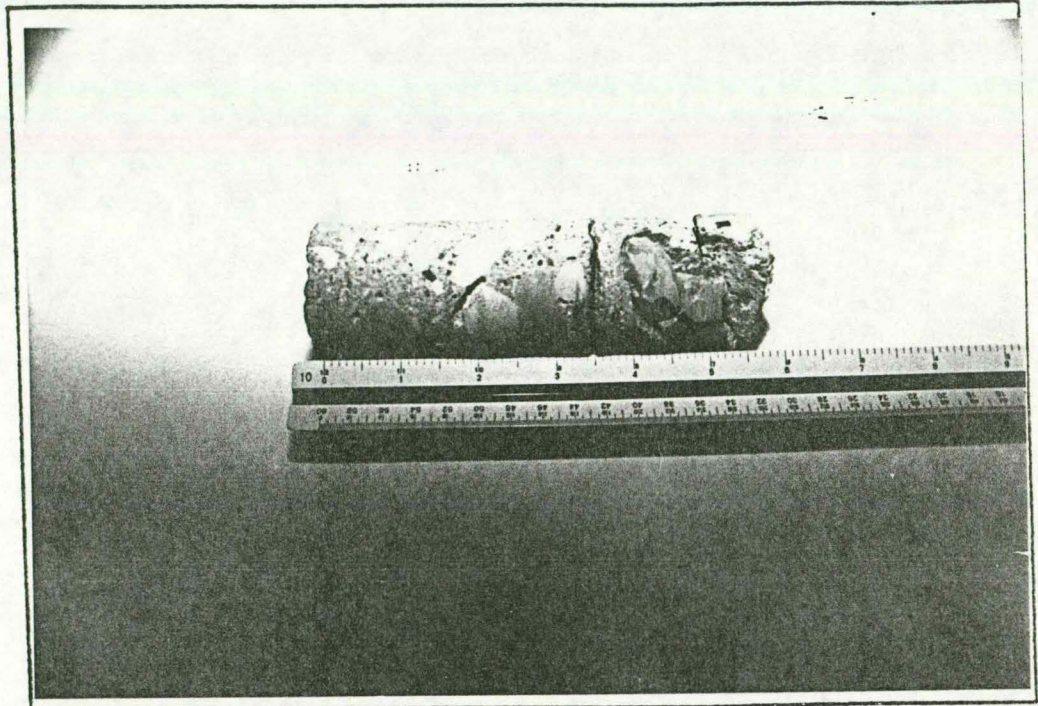
DEFECTS IN CORE: Poor Original Pavement

QUALITY OF CONCRETE: Poor

REMARKS: Original Pavement Broke Easily

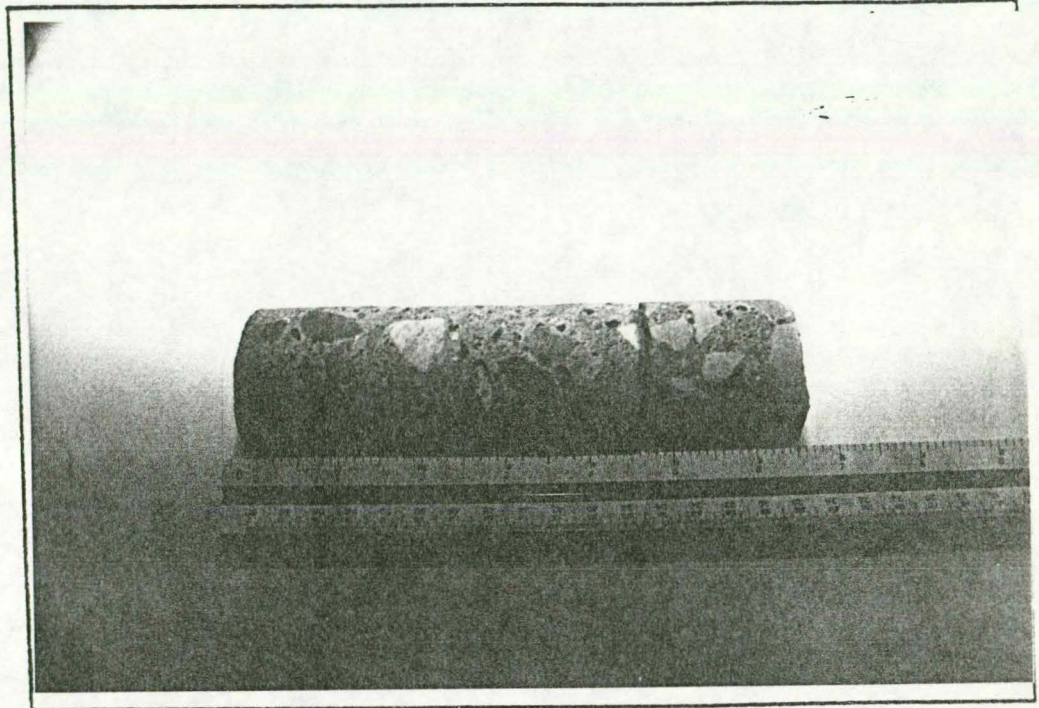
DATE: August 20, 1987
 PROJECT: Iowa D.O.T. - PCC Bond Evaluation
 CORE LOCATION: Interstate 80 - Milepost 185.1
 CORE: # 10
 DIAMETER: 2 inch
 OVERLAY THICKNESS: 4.5 inches
 CONCRETE THICKNESS: --
 FULL DEPTH Y/N: No
 CONDITION OF OVERLAY: Good
 DEFECTS IN CORE: Debonded Overlay
 QUALITY OF CONCRETE: Good
 REMARKS: _____

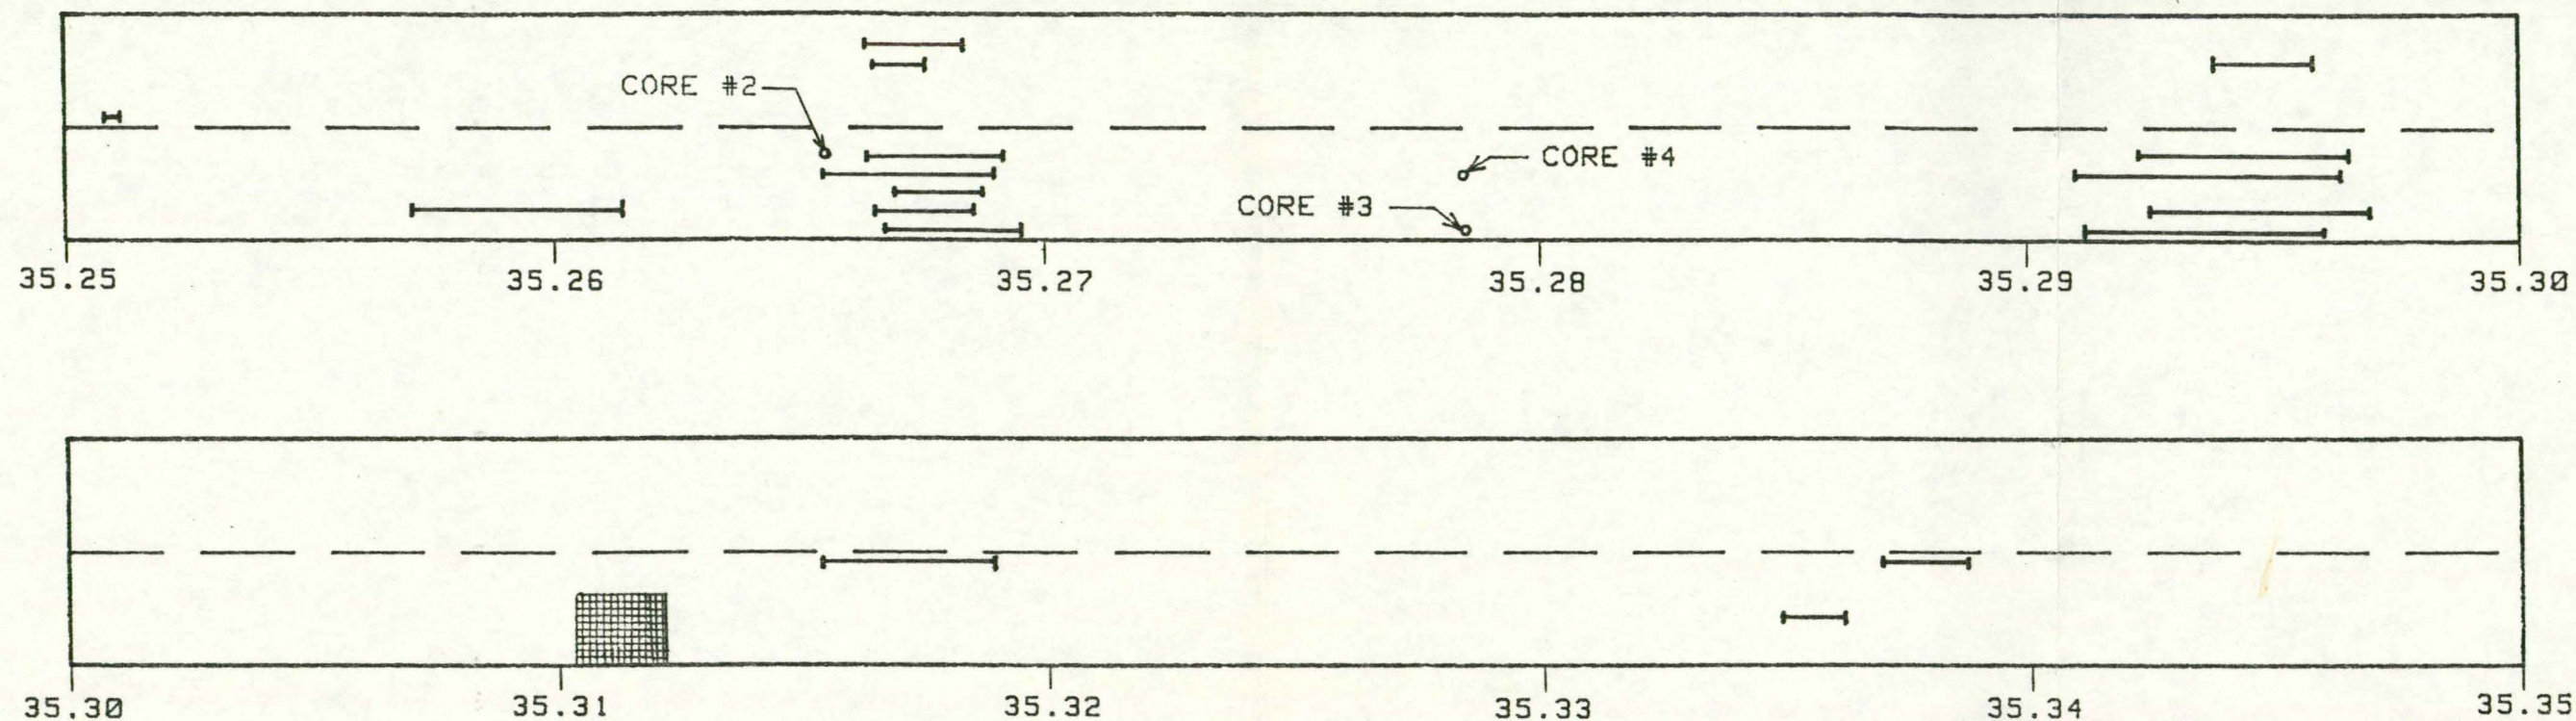
IR AND GPR EVALUATION OF BOND RETAINAGE
IN PORTLAND CEMENT CONCRETE OVERLAYS
I-80 (EASTBOUND) STA 35.25 TO STA 35.35
IOWA DEPARTMENT OF TRANSPORTATION

AREAS	EASTBOUND LANES
Total Area	12,672 (sq.ft.)
Debond (IR)	None (sq.ft.)
Concrete Patch	65 (sq.ft.)
Deterioration (GPR)	258 (lin.ft.)
Inspection Date:	August, 1987

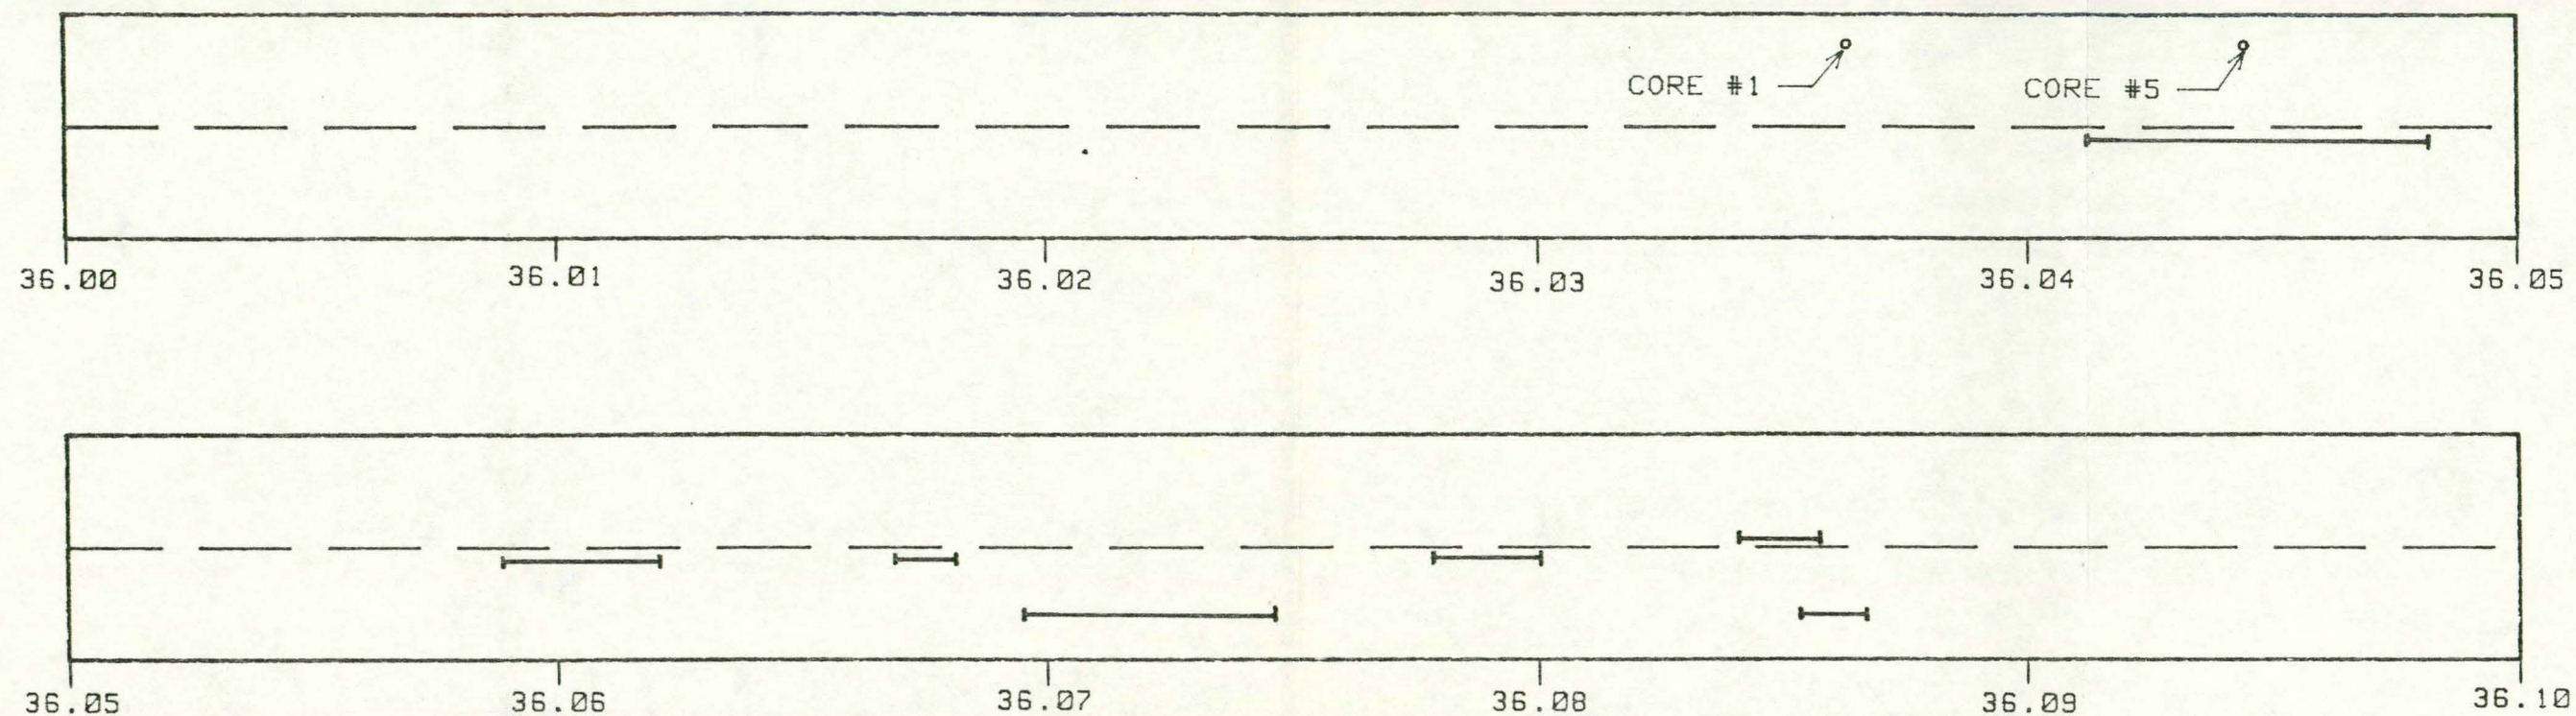
IR AND GPR EVALUATION OF BOND RETAINAGE
IN PORTLAND CEMENT CONCRETE OVERLAYS
I-80 (EASTBOUND) STA 36.00 TO STA 36.10
IOWA DEPARTMENT OF TRANSPORTATION

AREAS	EASTBOUND LANES
Total Area	12,672 (sq.ft.)
Debond (IR)	None (sq.ft.)
Concrete Patch	None (sq.ft.)
Deterioration (GPR)	116 (lin.ft.)
Inspection Date:	August, 1987

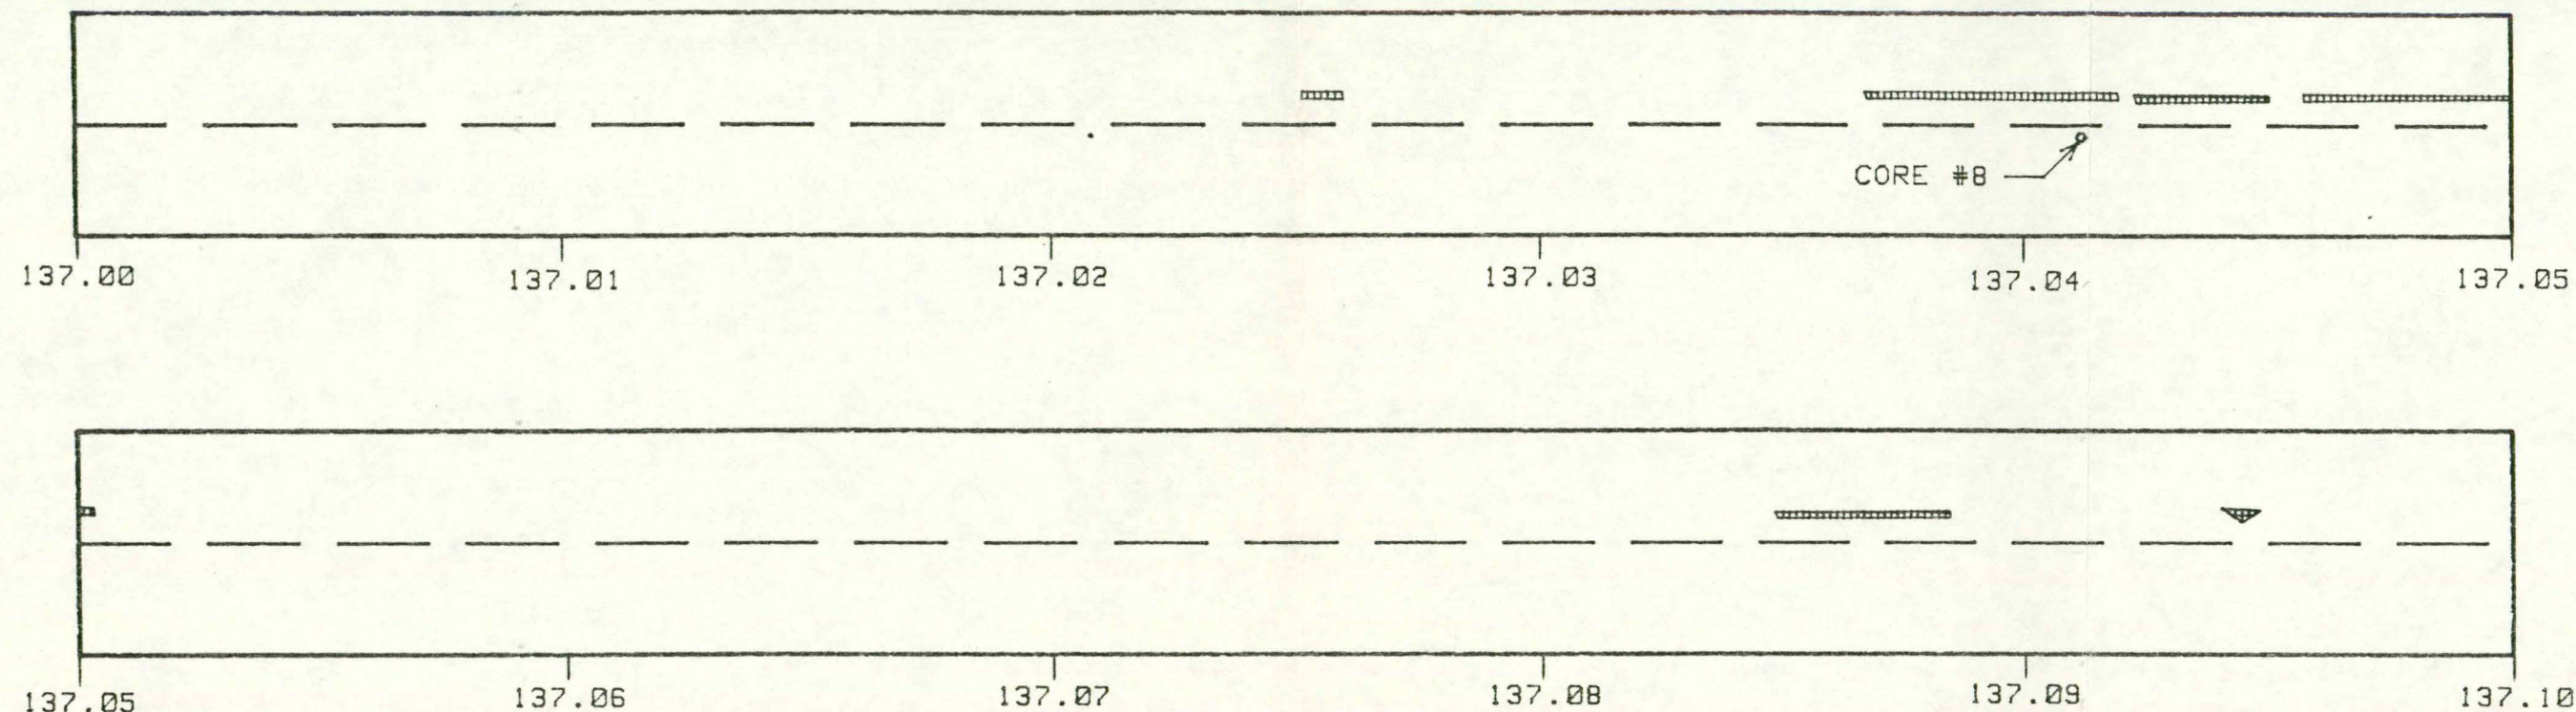
IR AND GPR EVALUATION OF BOND RETAINAGE
IN PORTLAND CEMENT CONCRETE OVERLAYS
SH141 (EB & WB) STA 137.00 TO STA 137.10
IOWA DEPARTMENT OF TRANSPORTATION

AREAS	EASTBOUND LANES	WESTBOUND LANES
Total Area	6,336 (sq.ft.)	6,336 (sq.ft.)
Debond (IR)	None (sq.ft.)	None (sq.ft.)
Concrete Patch	None (sq.ft.)	72 (sq.ft.)
Deterioration (GPR)	None (lin.ft.)	None (lin.ft.)

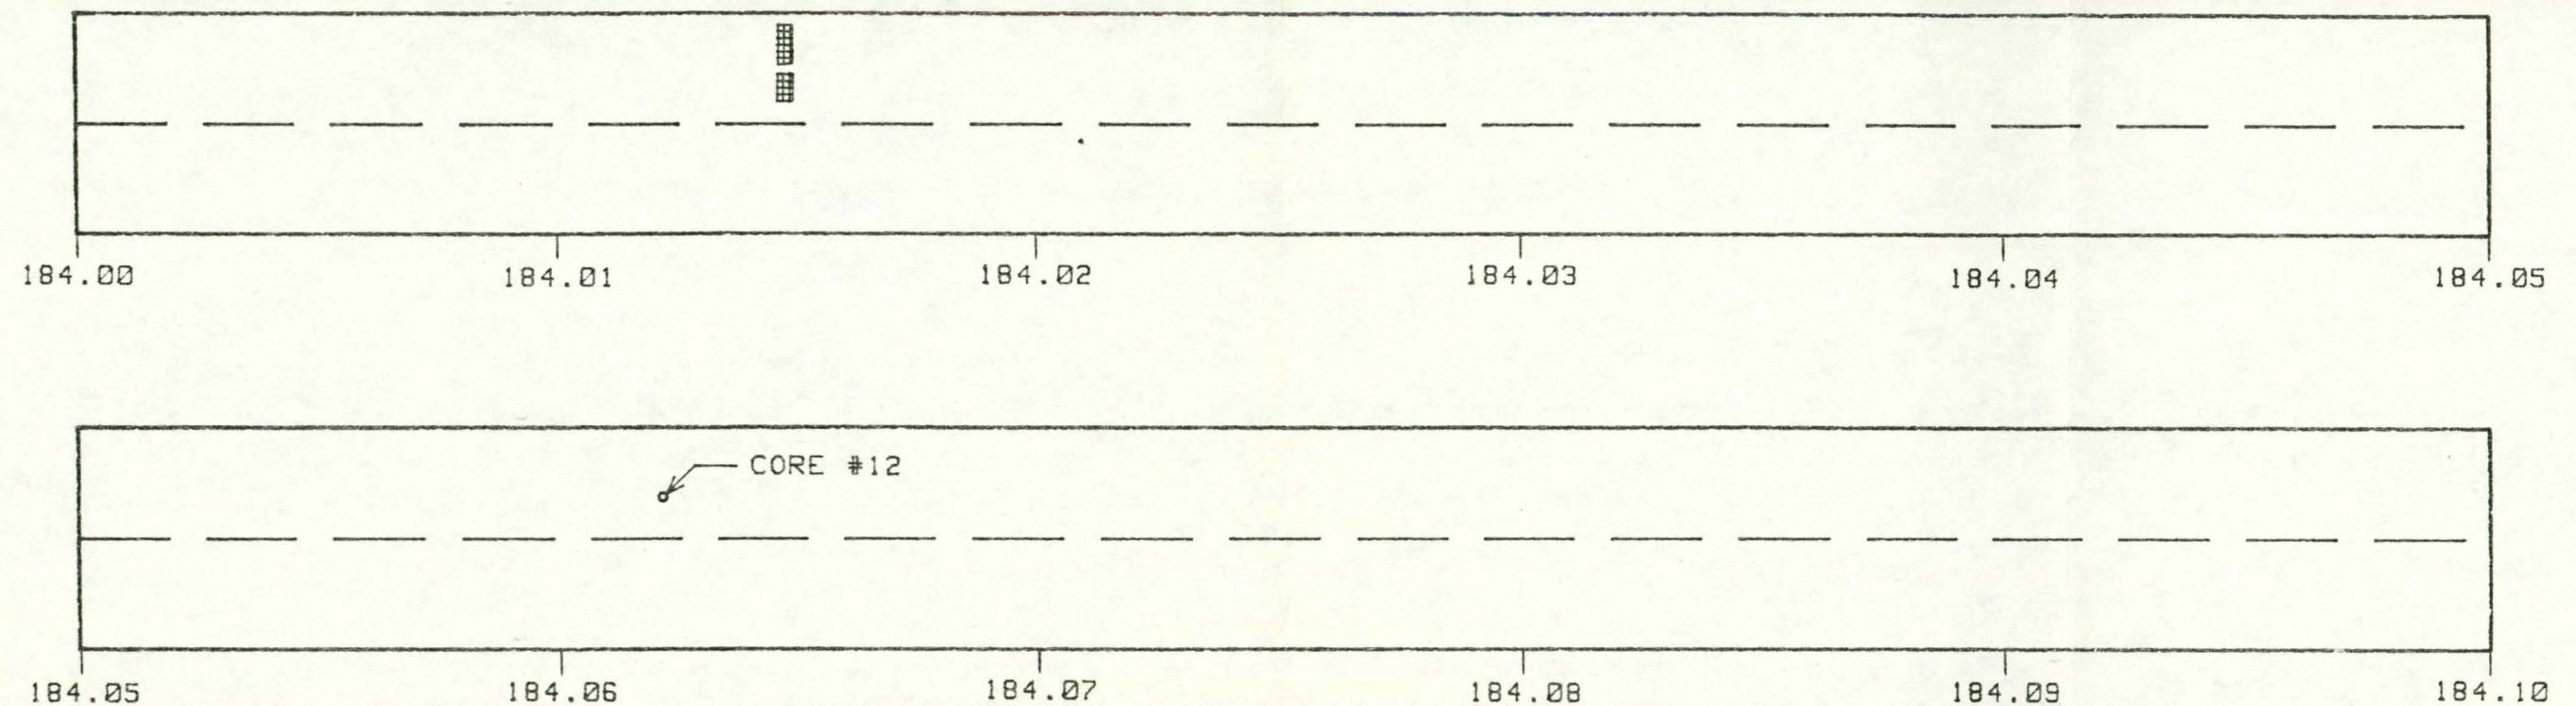
IR AND GPR EVALUATION OF BOND RETAINAGE
IN PORTLAND CEMENT CONCRETE OVERLAYS
I-80 (WESTBOUND) STA 184.00 TO STA 184.10
IOWA DEPARTMENT OF TRANSPORTATION

AREAS	WESTBOUND LANES
Total Area	12,672 (sq.ft.)
Debond (IR)	None (sq.ft.)
Concrete Patch	13 (sq.ft.)
Deterioration (GPR)	None (lin.ft.)
Inspection Date:	August, 1987

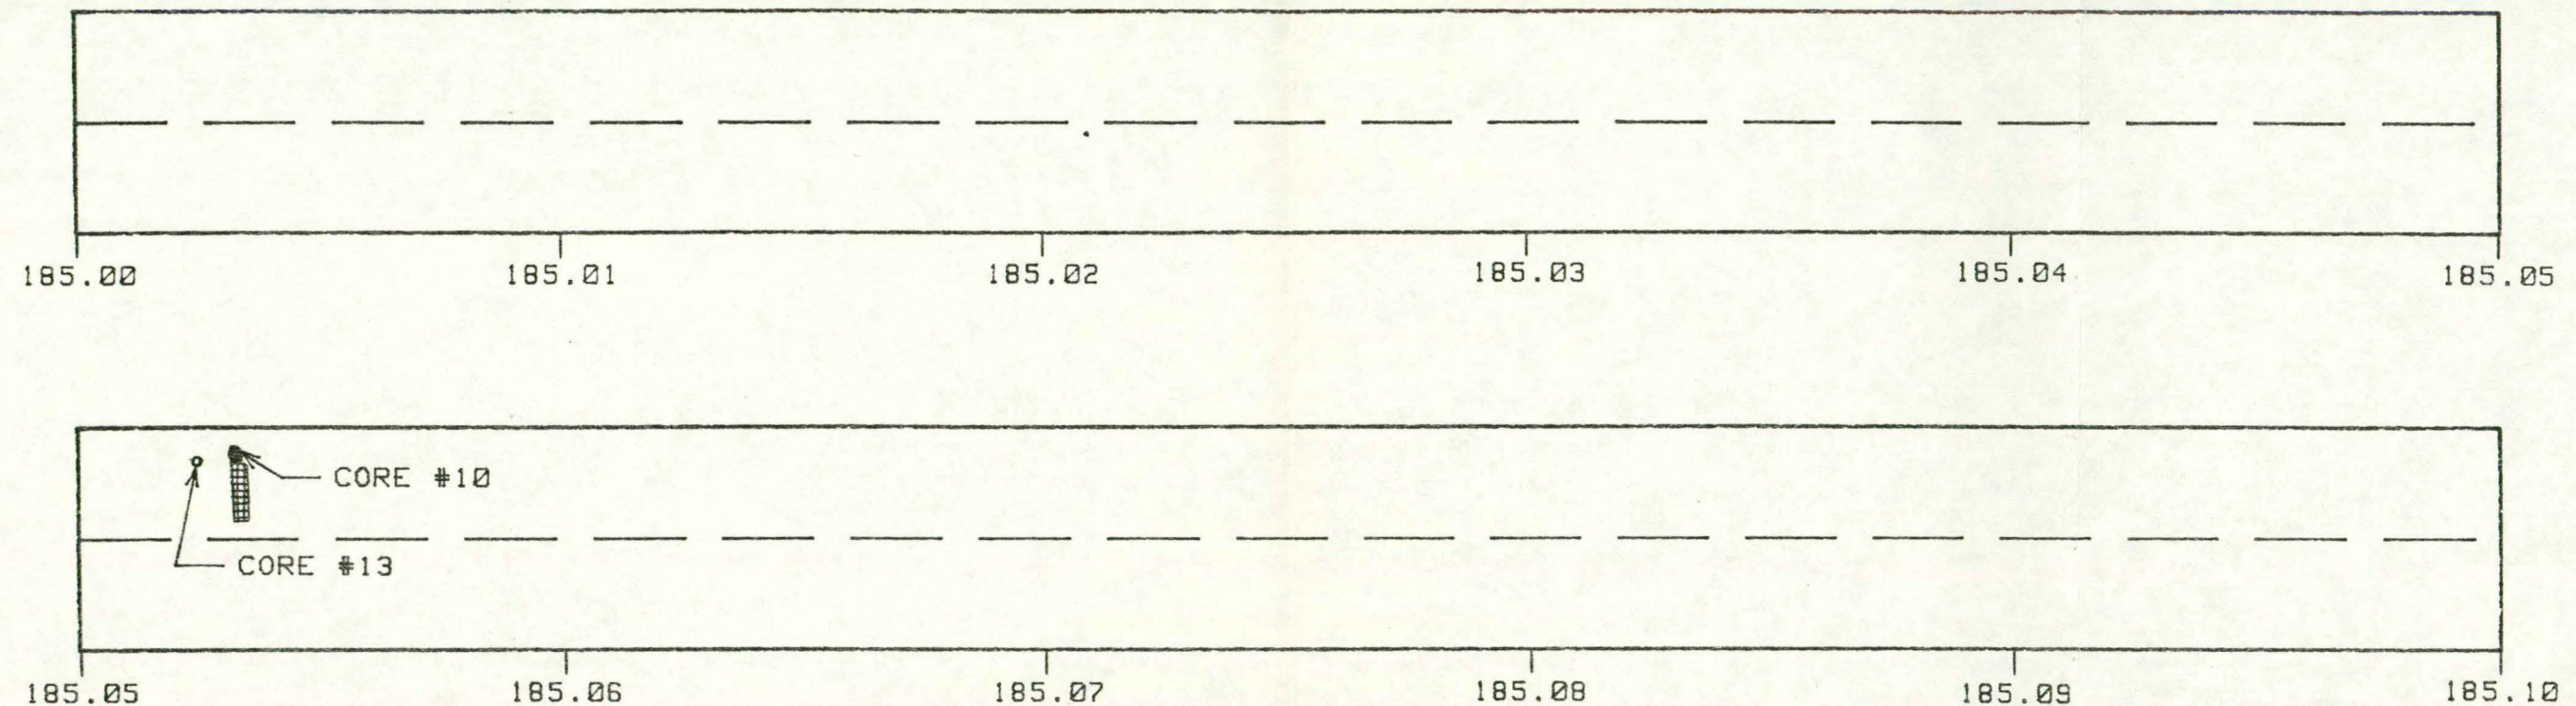
IR AND GPR EVALUATION OF BOND RETAINAGE
IN PORTLAND CEMENT CONCRETE OVERLAYS
I-80 (WESTBOUND) STA 185.00 TO STA 185.10
IOWA DEPARTMENT OF TRANSPORTATION

AREAS	WESTBOUND LANES
Total Area	12,672 (sq.ft.)
Debond (IR)	1 (sq.ft.)
Concrete Patch	11 (sq.ft.)
Deterioration (GPR)	None (lin.ft.)

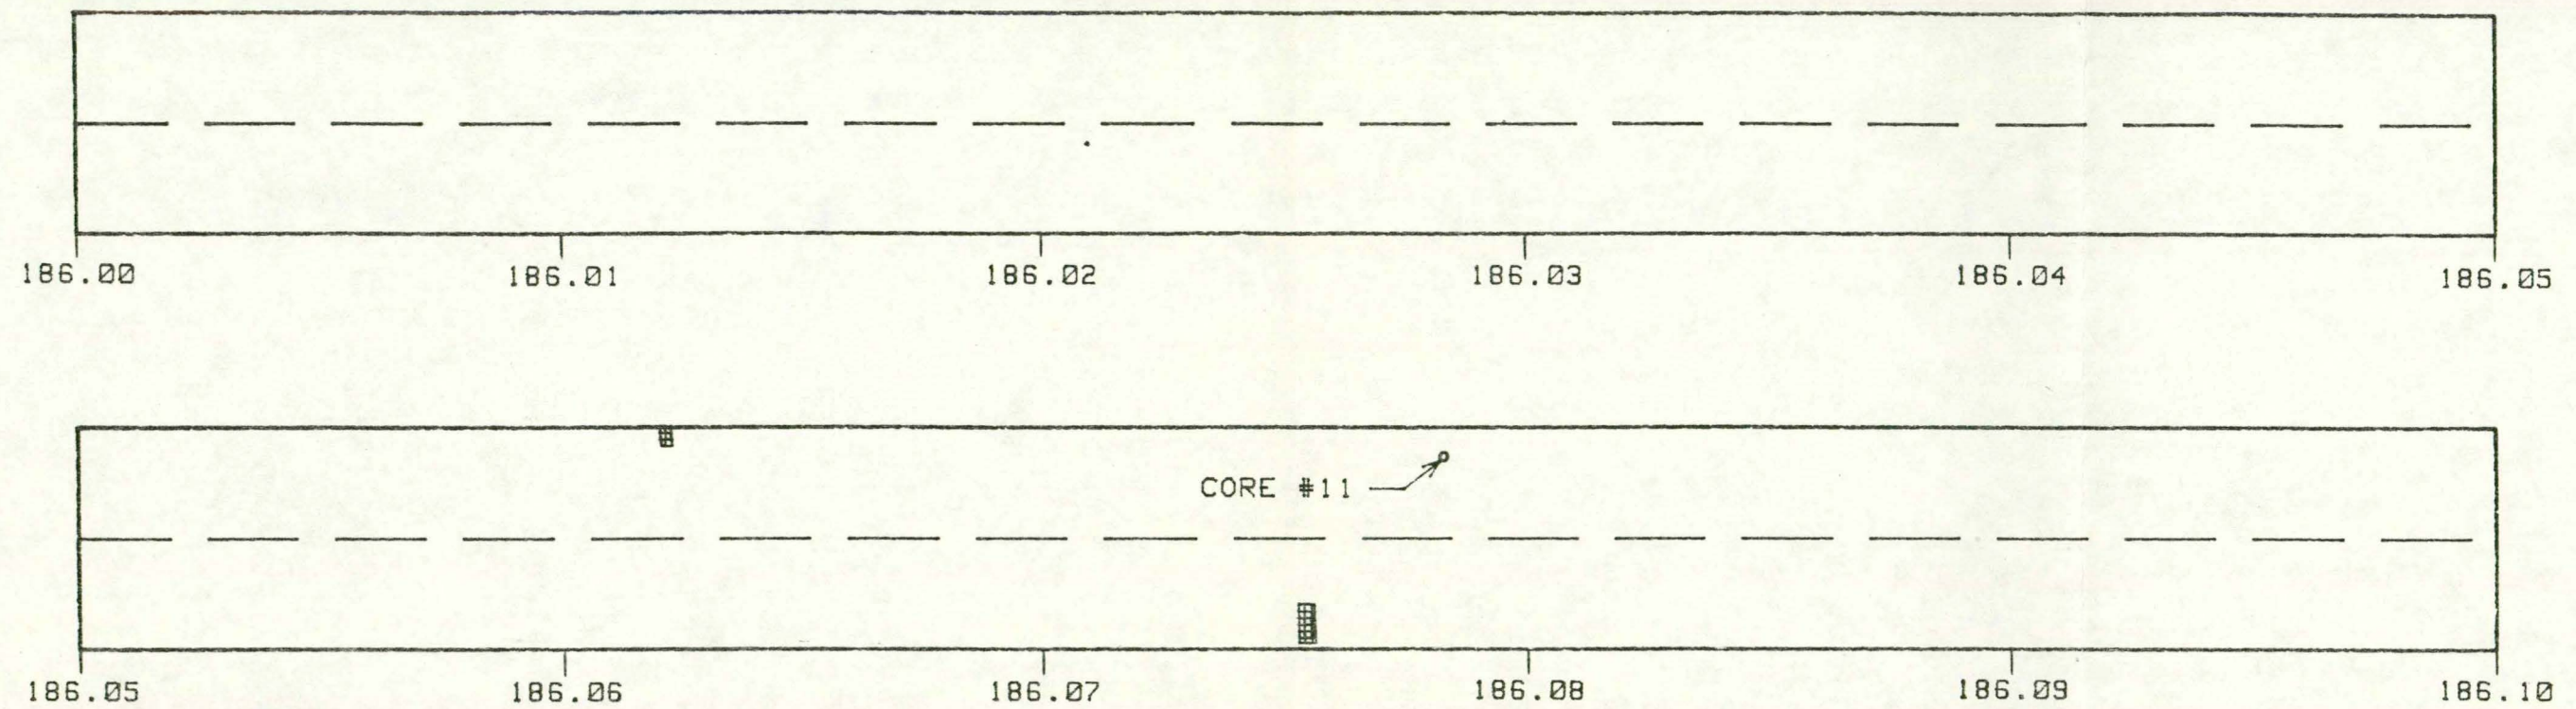
IR AND GPR EVALUATION OF BOND RETAINAGE
IN PORTLAND CEMENT CONCRETE OVERLAYS
I-80 (WESTBOUND) STA 186.00 TO STA 186.10
IOWA DEPARTMENT OF TRANSPORTATION

AREAS	WESTBOUND LANES
Total Area	12,672 (sq.ft.)
Debond (IR)	None (sq.ft.)
Concrete Patch	11 (sq.ft.)
Deterioration (GPR)	None (lin.ft.)
Inspection Date:	August, 1987
