PROTECTION OF STRUCTURAL CONCRETE SUBSTRUCTURES

IOWA HIGHWAY RESEARCH BOARD

PROJECT HR-220

CONSTRUCTION REPORT

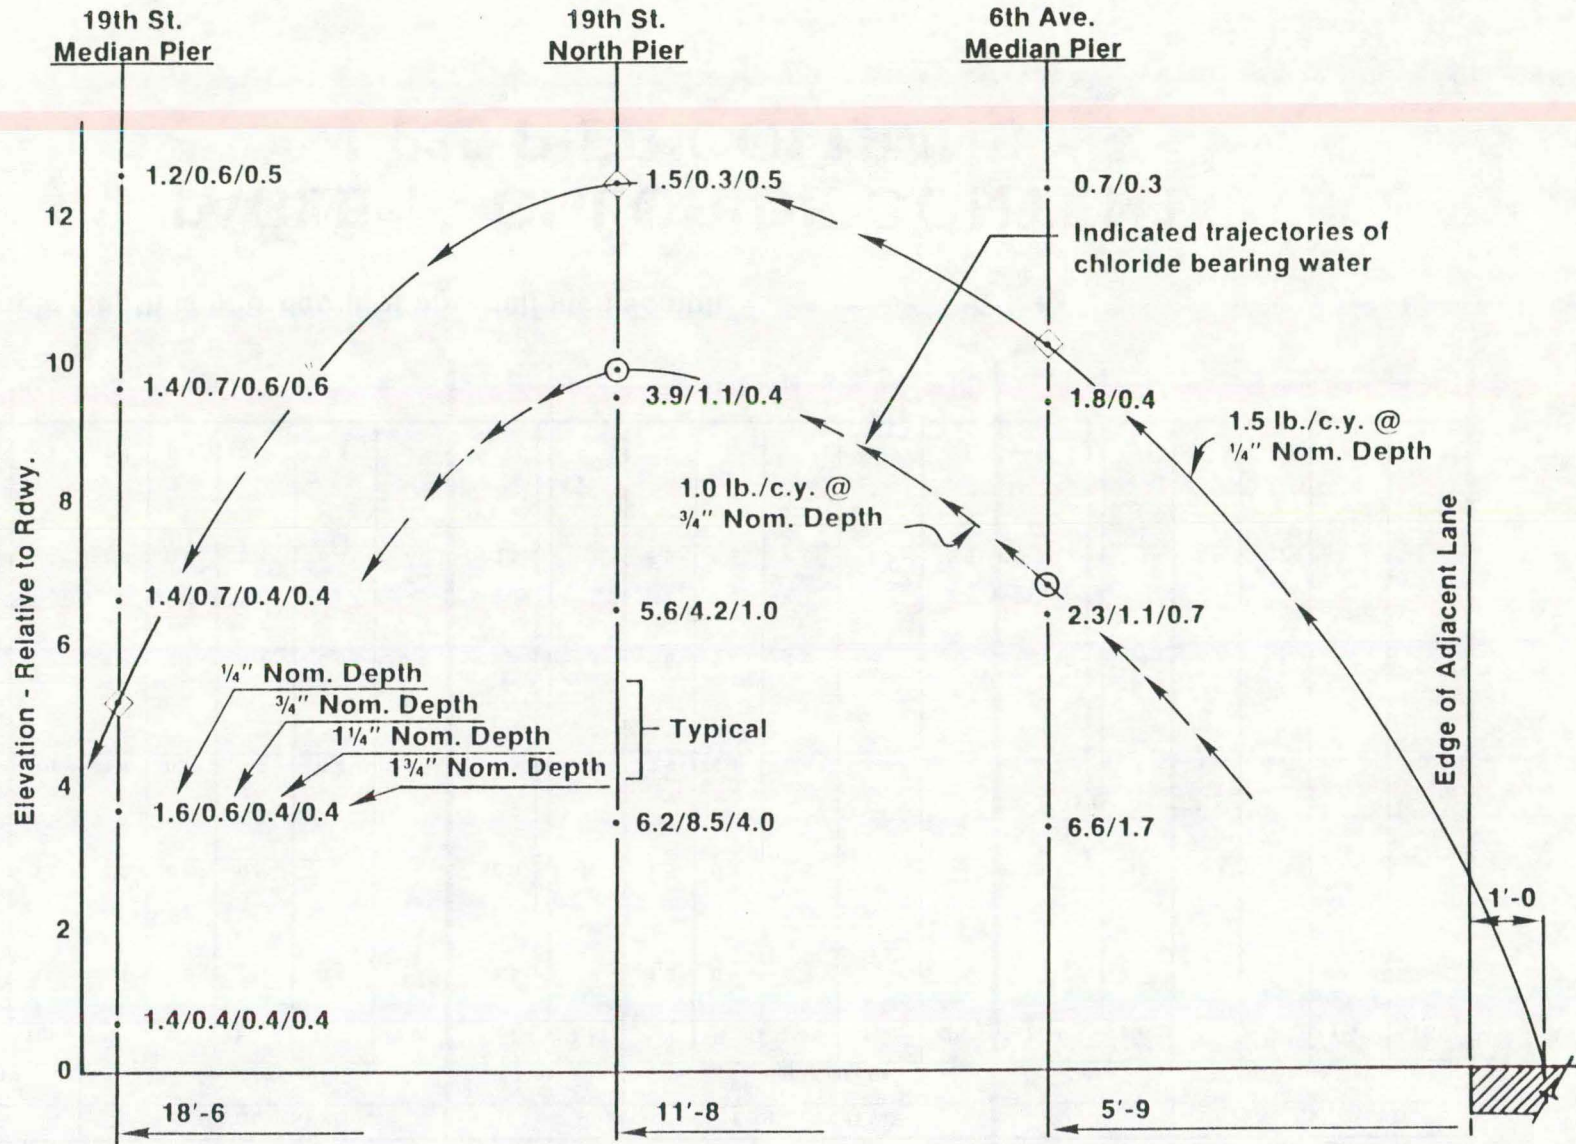
**FIGURE 1 - CHLORIDE CONTENTS  
I-235 PIER COLUMNS**

From the tests of core samples taken in the I-235 corridor, there is an indication that chloride intrusion, adequate to provide an electrolyte, is not likely beyond a zone which extends to a height of approximately twelve feet above the traffic lane and horizontally to a lateral distance of approximately twenty two feet from the edge of the traffic lane. There has been insufficient testing to date to support this as a firm conclusion (Table 1 and Figure 1, Appendix A).
