EVALUATION OF BOND RETAINAGE
IN
PORTLAND CEMENT
CONCRETE OVERLAYS
USING
— INFRARED THERMOGRAPHY
AND
GROUND PENETRATING RADAR

BRICE PETRIDES-DONOHUE
ENGINEERS & ARCHITECTS

PROJECT NO. 50389
COPYRIGHT, DONOHUE 1989

June 28, 1989

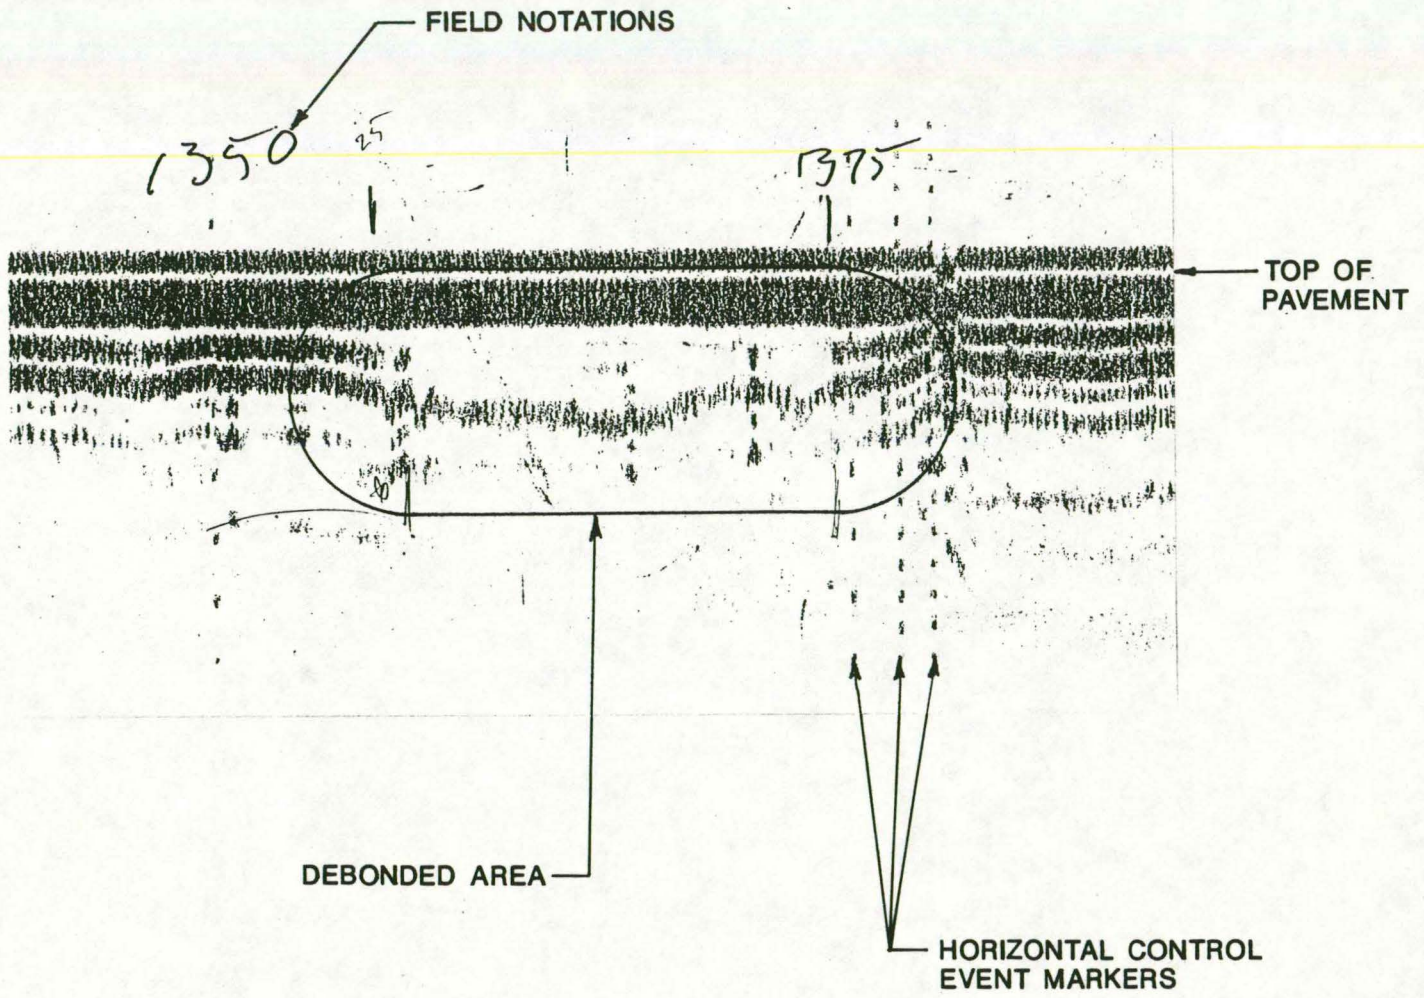
Previous work by Donohue and others (Chung, Carter, et al, 1984) indicated that at areas where debonds are present, a distinctive signature will appear on the GPR data. This distinctive signature is the result of interference with propagation of the GPR signal through the pavement caused by the very small air gap present at the debonded interface. Figure 3 is an example of a gray scale chart showing the signature obtained from a debonded portland cement overlay on a previous Donohue project.

**FIGURE 3
SAMPLE OF GPR CHART SHOWING
DEBONDED CONDITION
(FROM PREVIOUS DONOHUE PROJECT)**

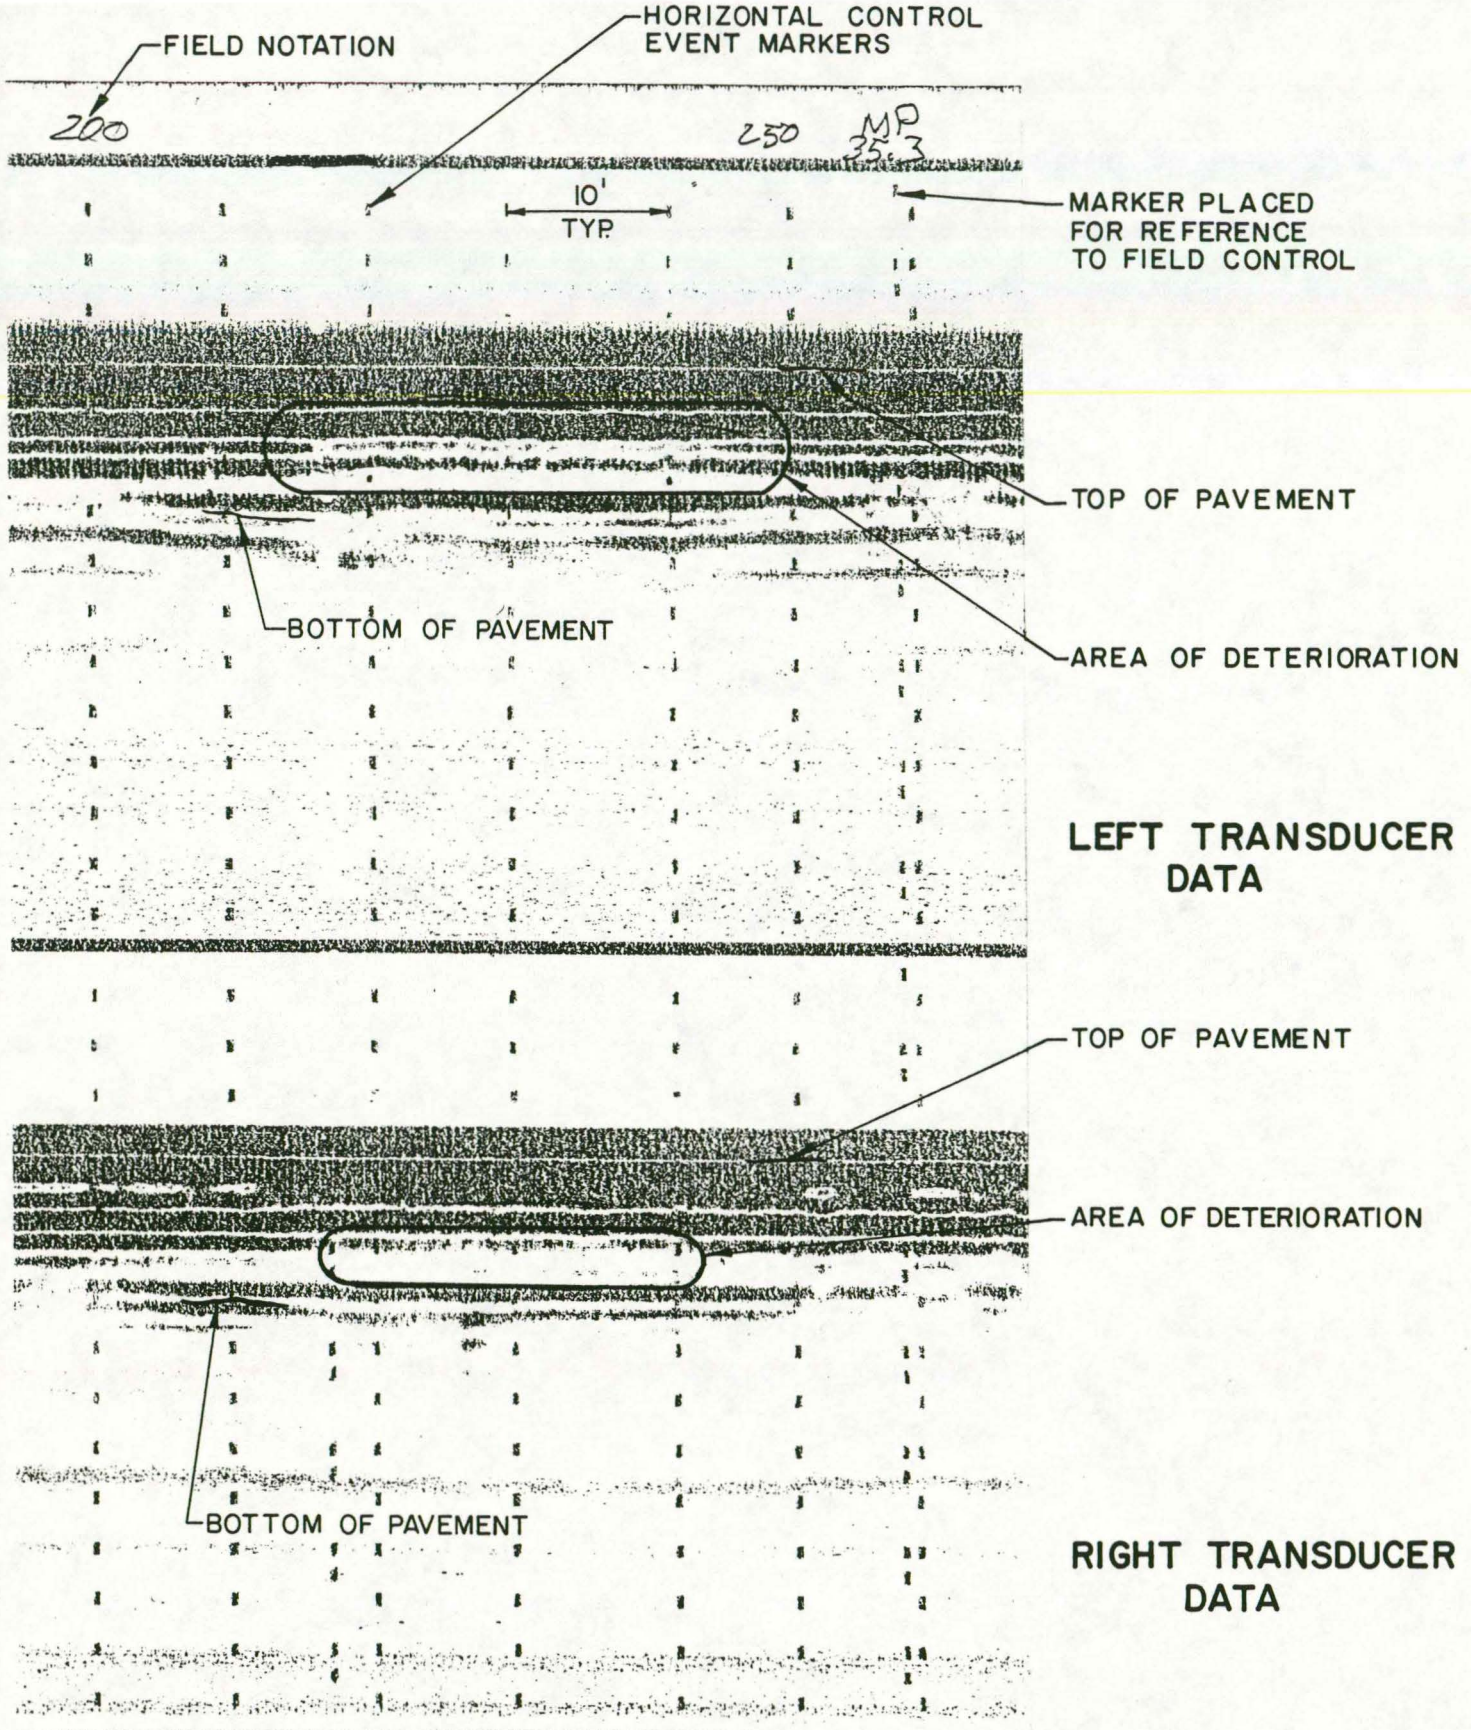
**FIGURE 5
 SAMPLE OF GPR CHART SHOWING
 DETERIORATION SIGNATURE
 IOWA DEPT. OF TRANSPORTATION**

In both 1987 and 1988, 6,336 feet of GPR data was collected at each site and analyzed. The analysis of the 1987 data identified 258 lineal feet (4.1%) of scan that showed this deteriorated condition between mileposts 35.25 and 35.35. The analysis of the 1988 data identified an additional 46 lineal feet of this deteriorated condition, for a total of 304 lineal feet (4.8%). Also, the total square footage of patched area increased from 65 square feet to 468 square feet for this test section. For the test section between mileposts 36.00 and 36.10, the 116 lineal feet (1.8%) of this deteriorated condition which was identified in 1987, decreased slightly to 112 lineal feet (1.8%) in 1988. This decrease however, is directly related to an area of patching which did not exist at the time of the 1987 data collection. While no patching was observed in 1987, a total of 120 square feet was observed in 1988. Also, in the test section between mileposts 37.00 and 37.10, 96 lineal feet (1.5%) of this deteriorated condition was identified in 1988, while none was identified in 1987. A summary of these quantities can be found in Table 1, page 2-10. The location of this deterioration is shown in Appendix B. No GPR data representing any debonding that we can identify or deterioration was found at any of the other test sites.

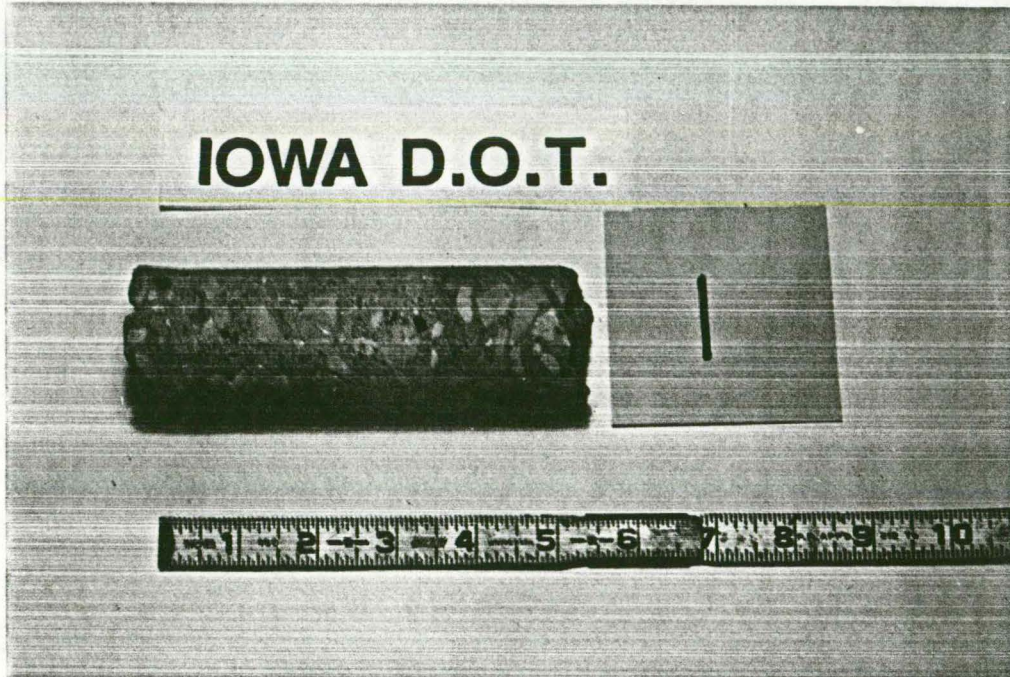
CONDITION OF OVERLAY: Good

DEFECTS IN CORE: Poor original pavement

QUALITY OF CONCRETE: Poor

REMARKS: Original pavement broke easily

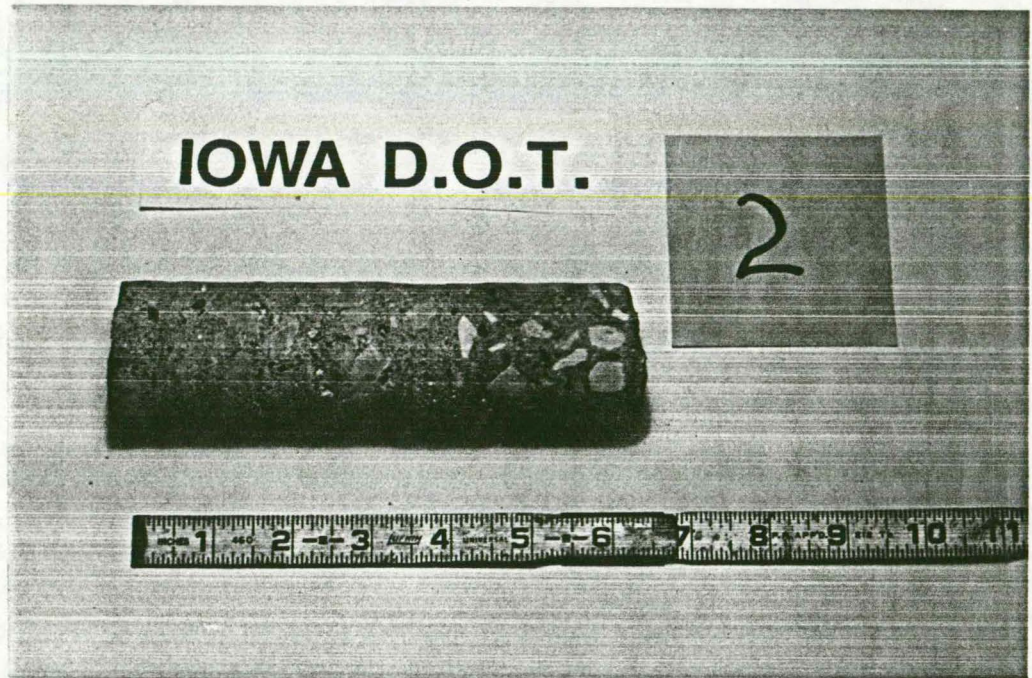
CONDITION OF OVERLAY: Good

DEFECTS IN CORE: Poor original pavement

QUALITY OF CONCRETE: Poor

REMARKS: Original pavement broke easily

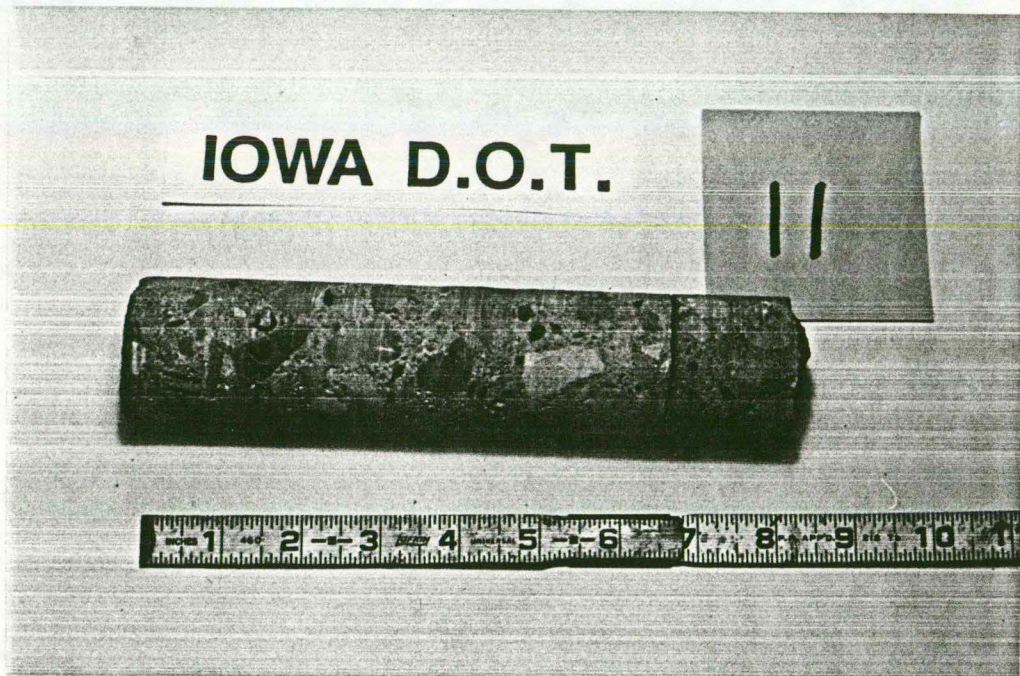
DATE: August 11, 1988
 PROJECT: Iowa DOT - PCC Bond Evaluation
 CORE LOCATION: I-80 (WB Driving) - Milepost 186.00
 CORE: ~~#~~ 11
 DIAMETER: 2 inch
 OVERLAY THICKNESS: 6.5 inches
 CONCRETE THICKNESS: 8.25 inches
 FULL DEPTH Y/N: No
 CONDITION OF OVERLAY: Good
 DEFECTS IN CORE: None
 QUALITY OF CONCRETE: Good
 REMARKS: Core broke at bond when extracted from core hole

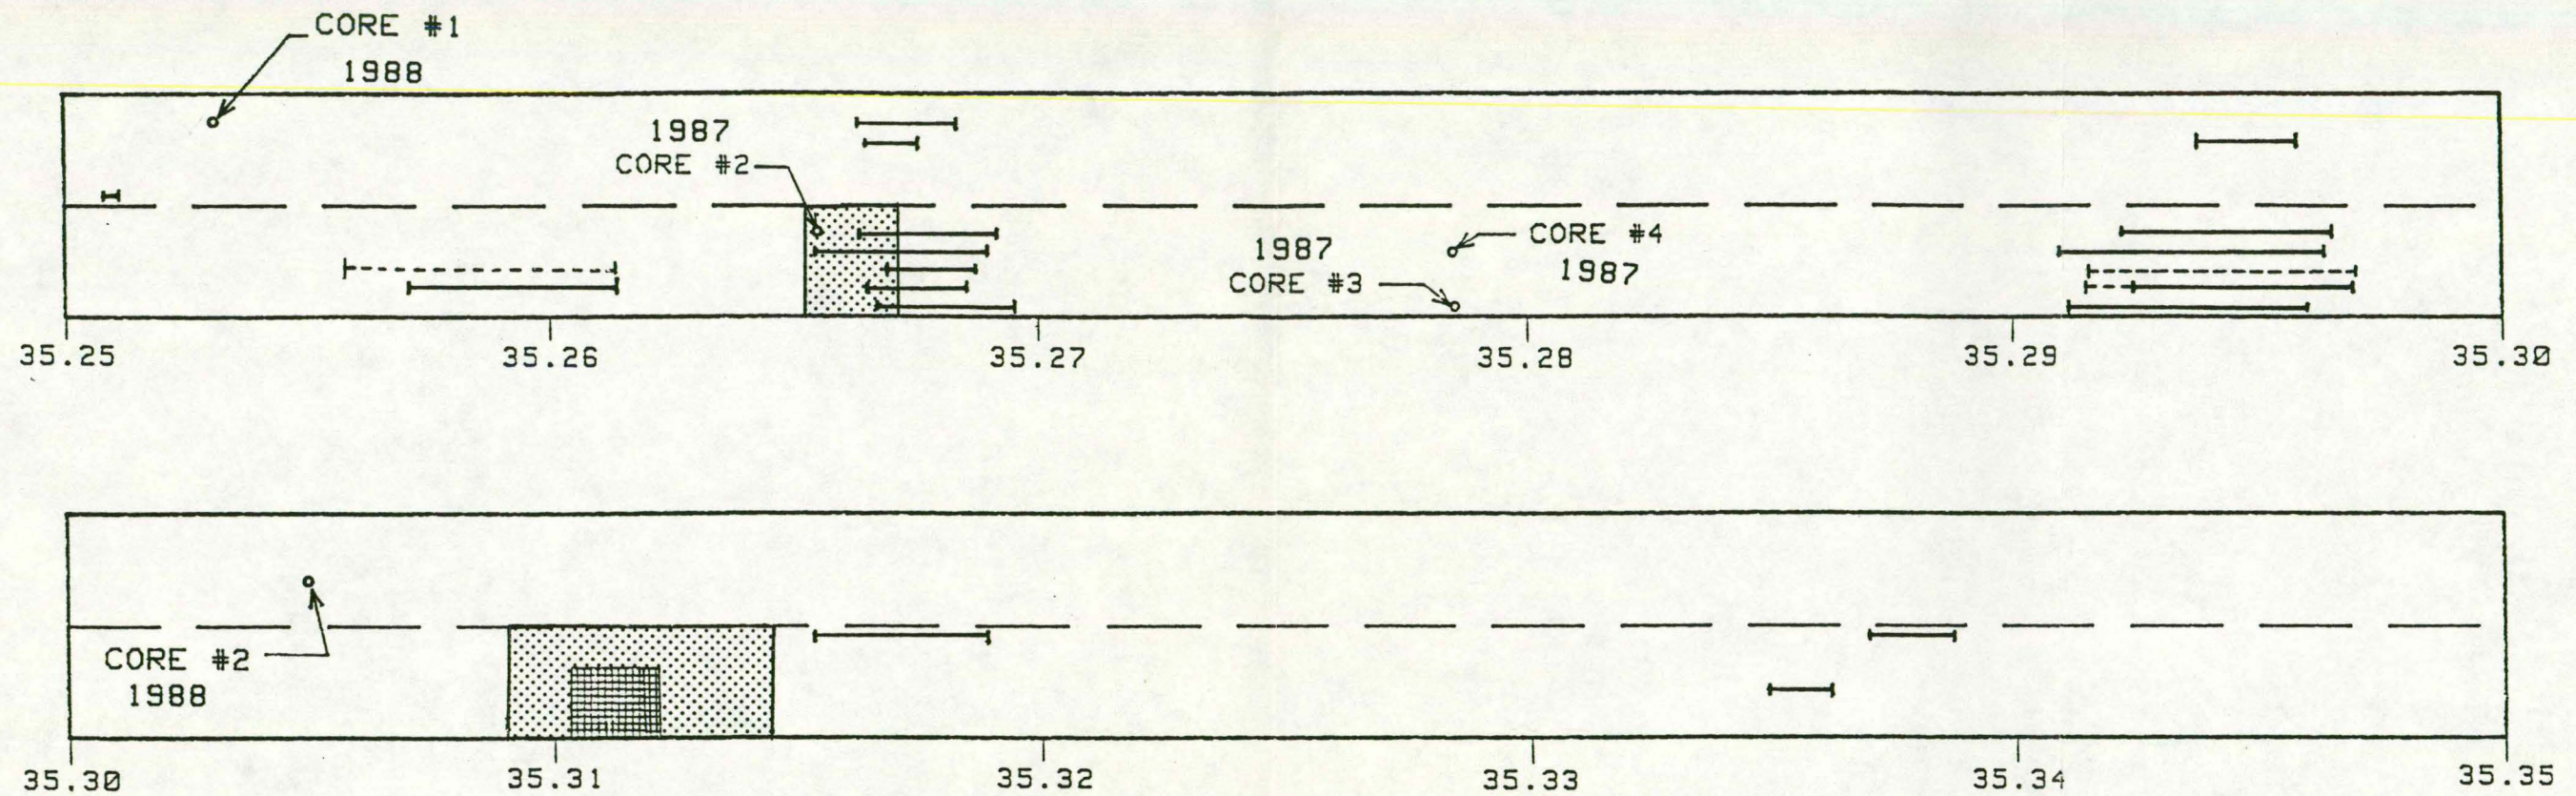
<p>Donohue Engineers & Architects</p>	IR AND GPR EVALUATION OF BOND RETAINAGE IN PORTLAND CEMENT CONCRETE OVERLAYS
	I-80 (EASTBOUND) STA 35.25 TO STA 35.35 IOWA DEPARTMENT OF TRANSPORTATION

AREAS	EASTBOUND LANES
Total Area	12,672 (sq.ft.)
Debond (IR)	None (sq.ft.)
Concrete Patch	468 (sq.ft.)
Deterioration (GPR)	304 (lin.ft.)

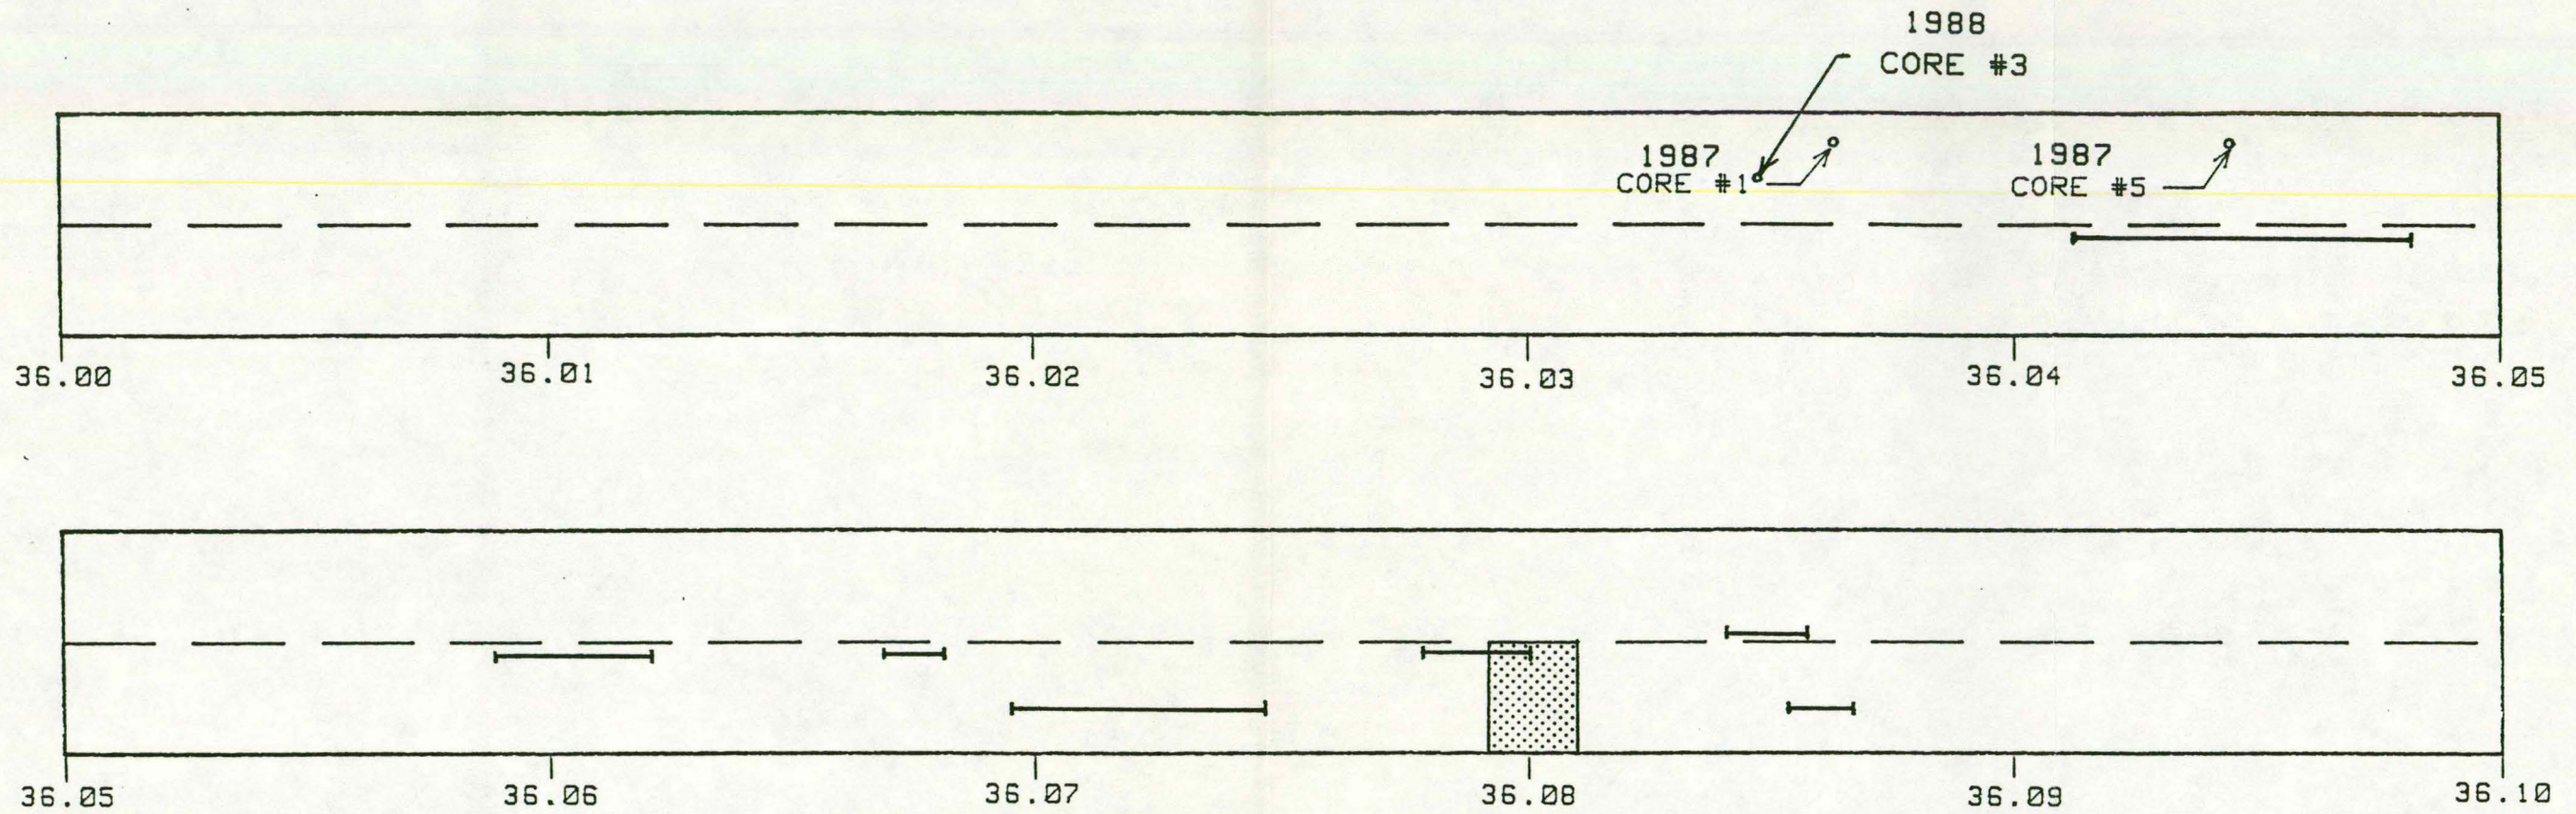
IR AND GPR EVALUATION OF BOND RETAINAGE
IN PORTLAND CEMENT CONCRETE OVERLAYS
I-80 (EASTBOUND) STA 36.00 TO STA 36.10
IOWA DEPARTMENT OF TRANSPORTATION

AREAS	EASTBOUND LANES
Total Area	12,672 (sq.ft.)
Debond (IR)	None (sq.ft.)
Concrete Patch	120 (sq.ft.)
Deterioration (GPR)	112 (lin.ft.)
Inspection Date:	August, 1987 August, 1988

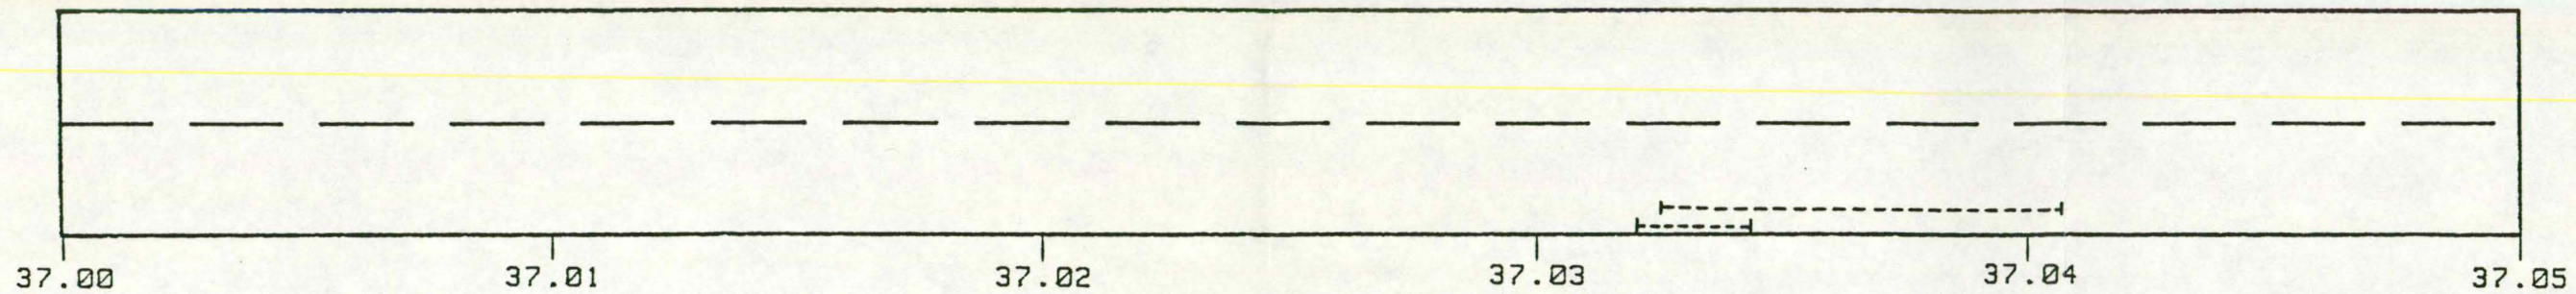
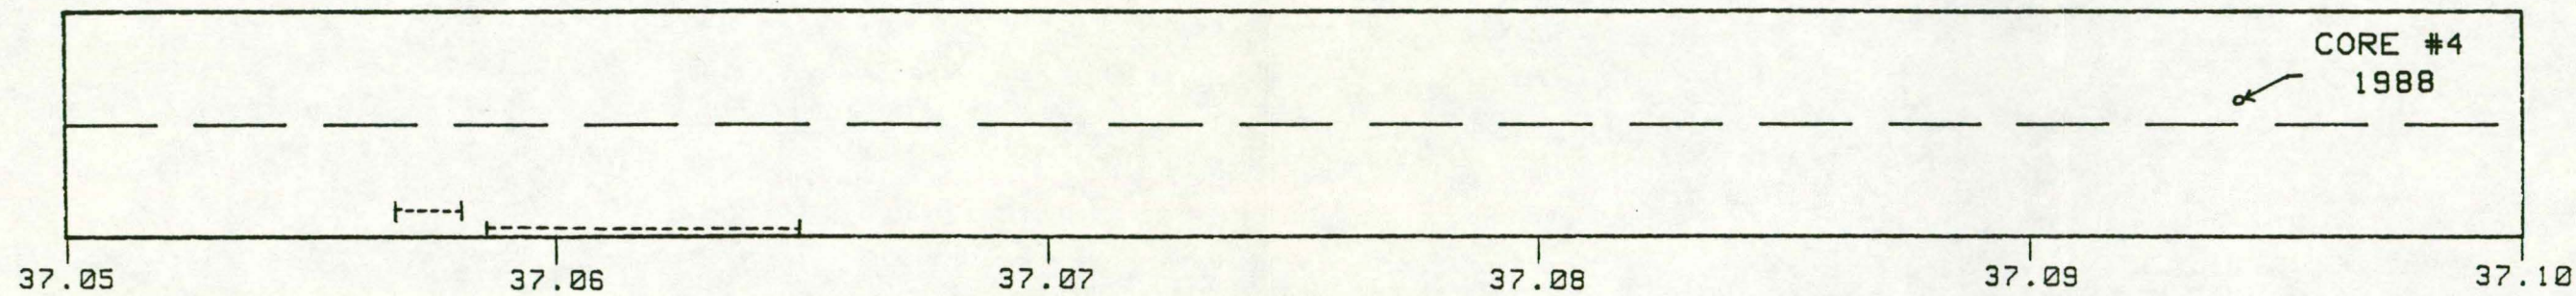
IR AND GPR EVALUATION OF BOND RETAINAGE
IN PORTLAND CEMENT CONCRETE OVERLAYS
I-80 (EASTBOUND) STA 37.00 TO STA 37.10
IOWA DEPARTMENT OF TRANSPORTATION

AREAS	EASTBOUND LANES
Total Area	12,672 (sq.ft.)
Debond (IR)	None (sq.ft.)
Concrete Patch	None (sq.ft.)
Deterioration (GPR)	95 (lin.ft.)

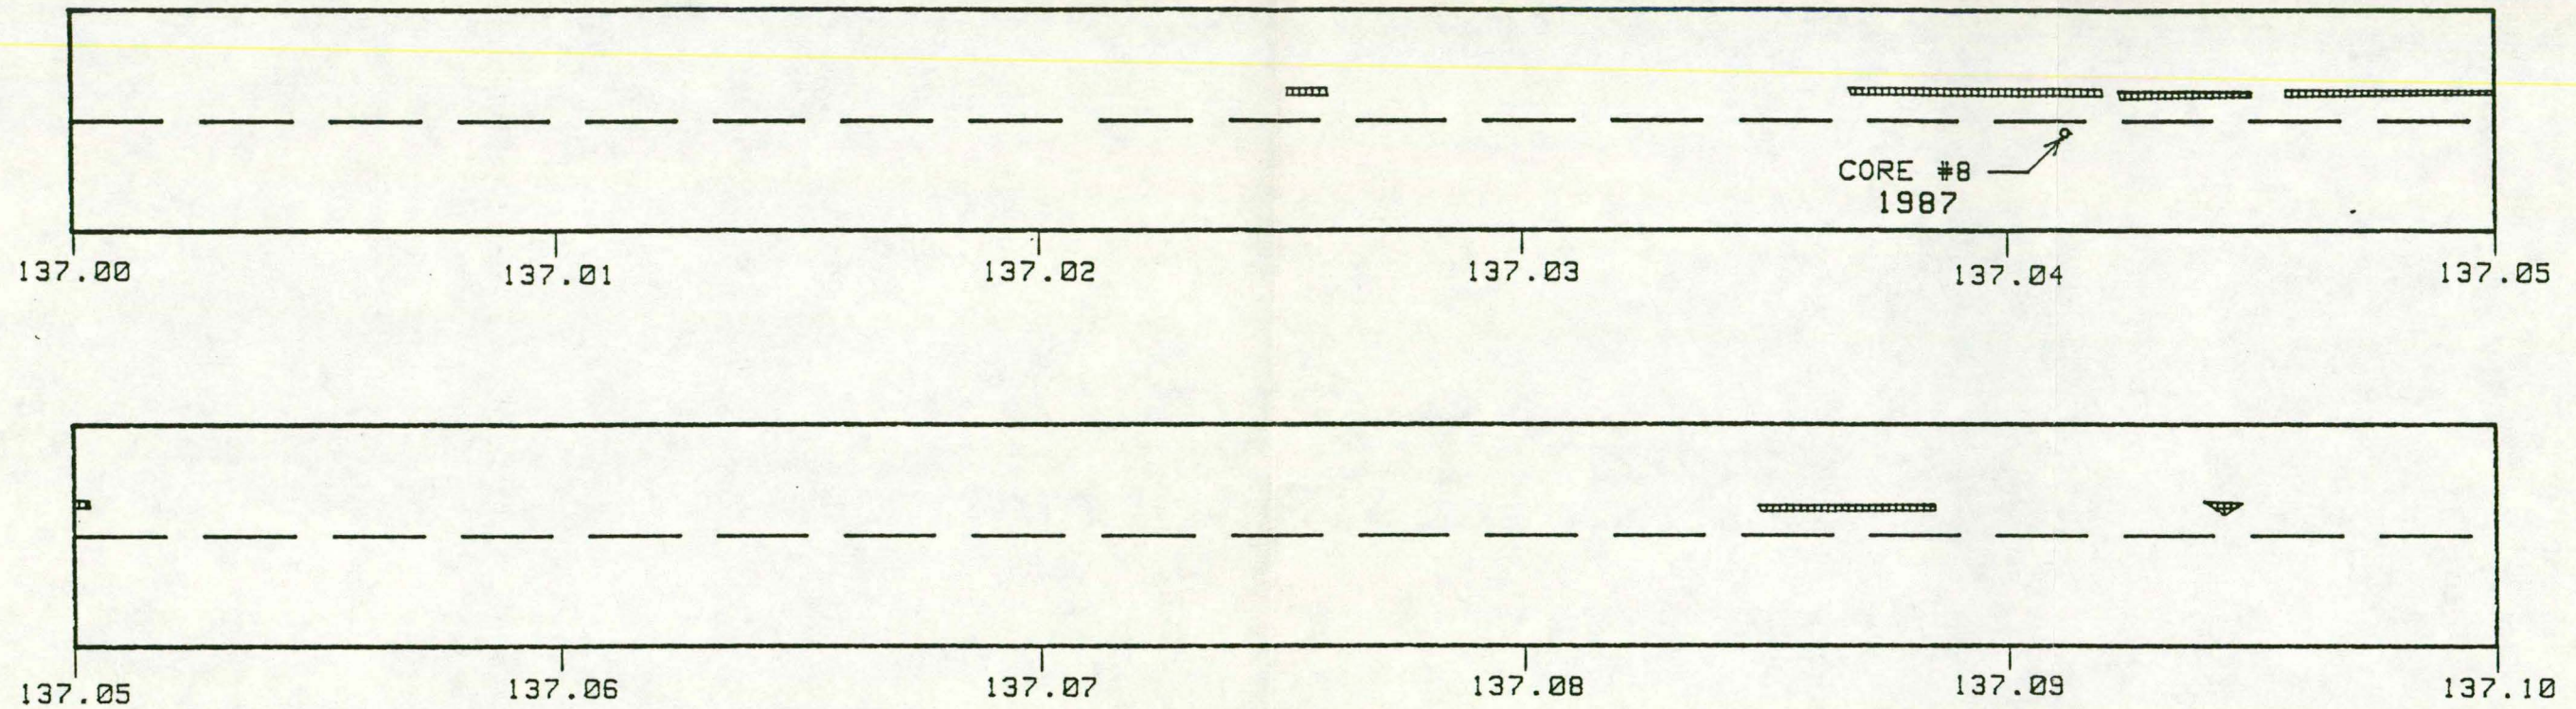
IR AND GPR EVALUATION OF BOND RETAINAGE
IN PORTLAND CEMENT CONCRETE OVERLAYS
SH141 (EB & WB) STA 137.00 TO STA 137.10
IOWA DEPARTMENT OF TRANSPORTATION

AREAS	EASTBOUND LANES	WESTBOUND LANES
Total Area	6,336 (sq.ft.)	6,336 (sq.ft.)
Debond (IR)	None (sq.ft.)	None (sq.ft.)
Concrete Patch	None (sq.ft.)	72 (sq.ft.)
Deterioration (GPR)	None (lin.ft.)	None (lin.ft.)

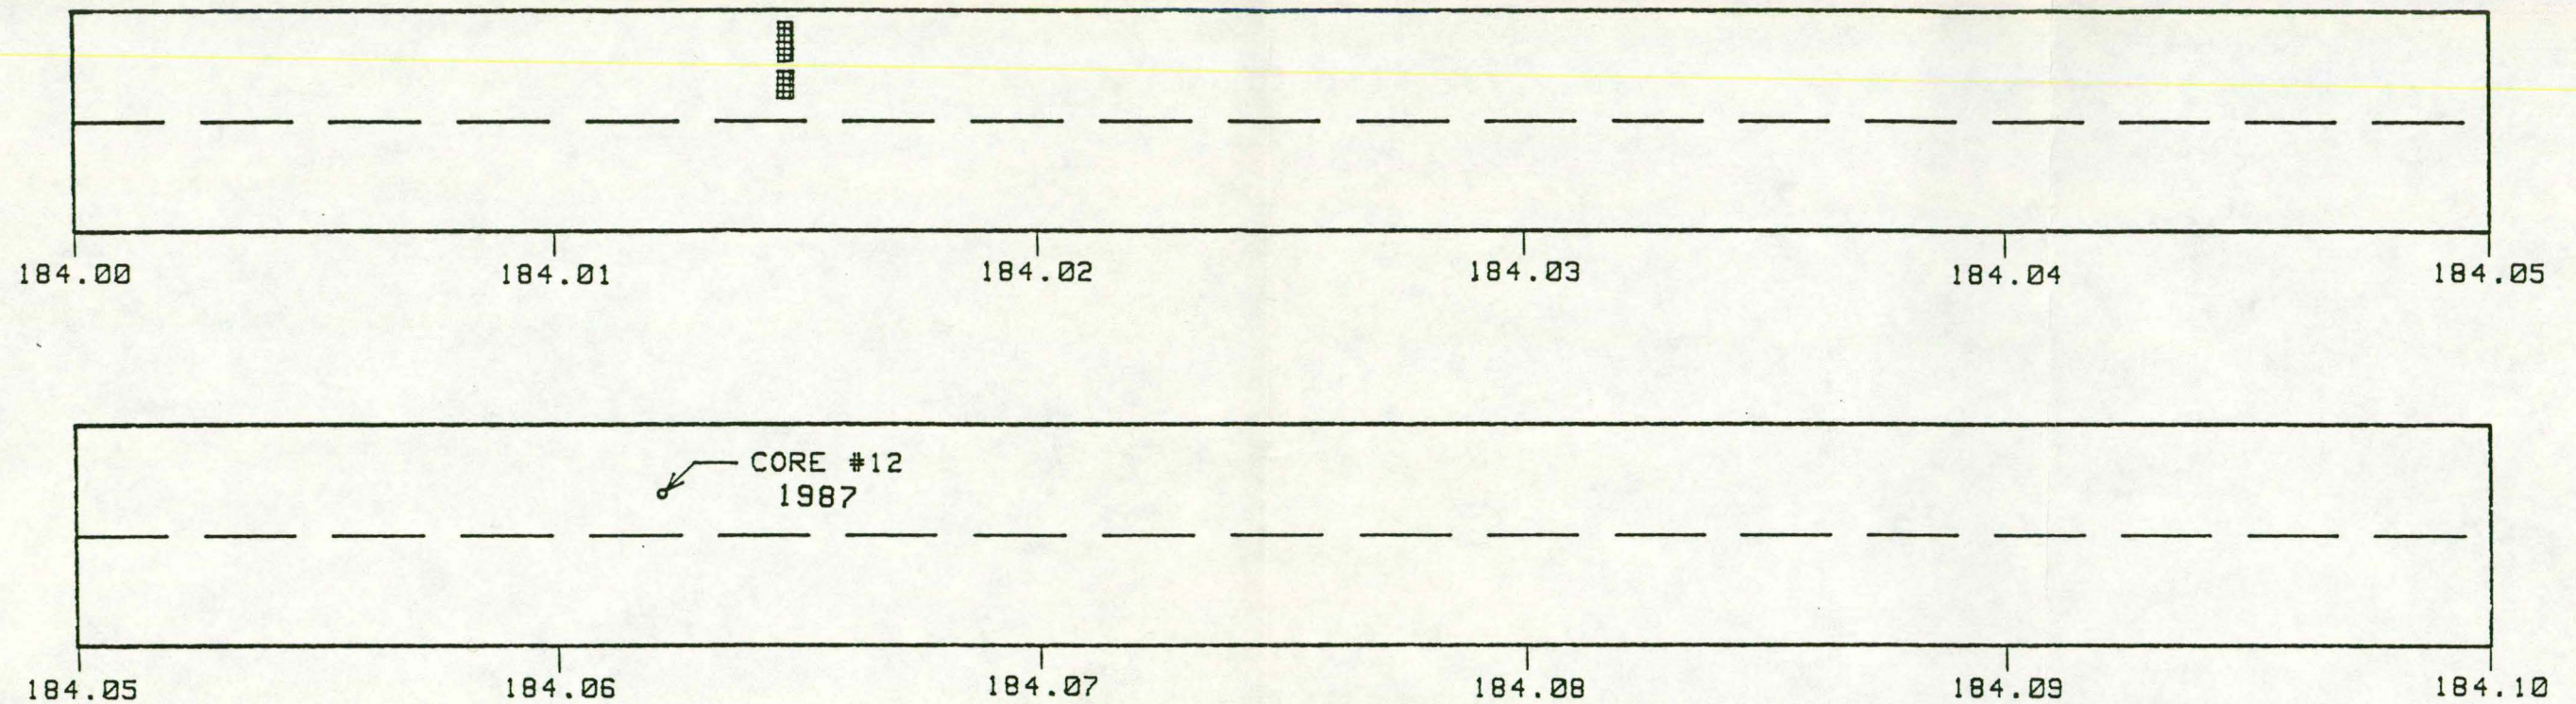
IR AND GPR EVALUATION OF BOND RETAINAGE
IN PORTLAND CEMENT CONCRETE OVERLAYS
I-80 (WESTBOUND) STA 184.00 TO STA 184.10
IOWA DEPARTMENT OF TRANSPORTATION

AREAS	WESTBOUND LANES
Total Area	12,672 (sq.ft.)
Debond (IR)	None (sq.ft.)
Concrete Patch	13 (sq.ft.)
Deterioration (GPR)	None (lin.ft.)
Inspection Date:	August, 1987 August, 1988

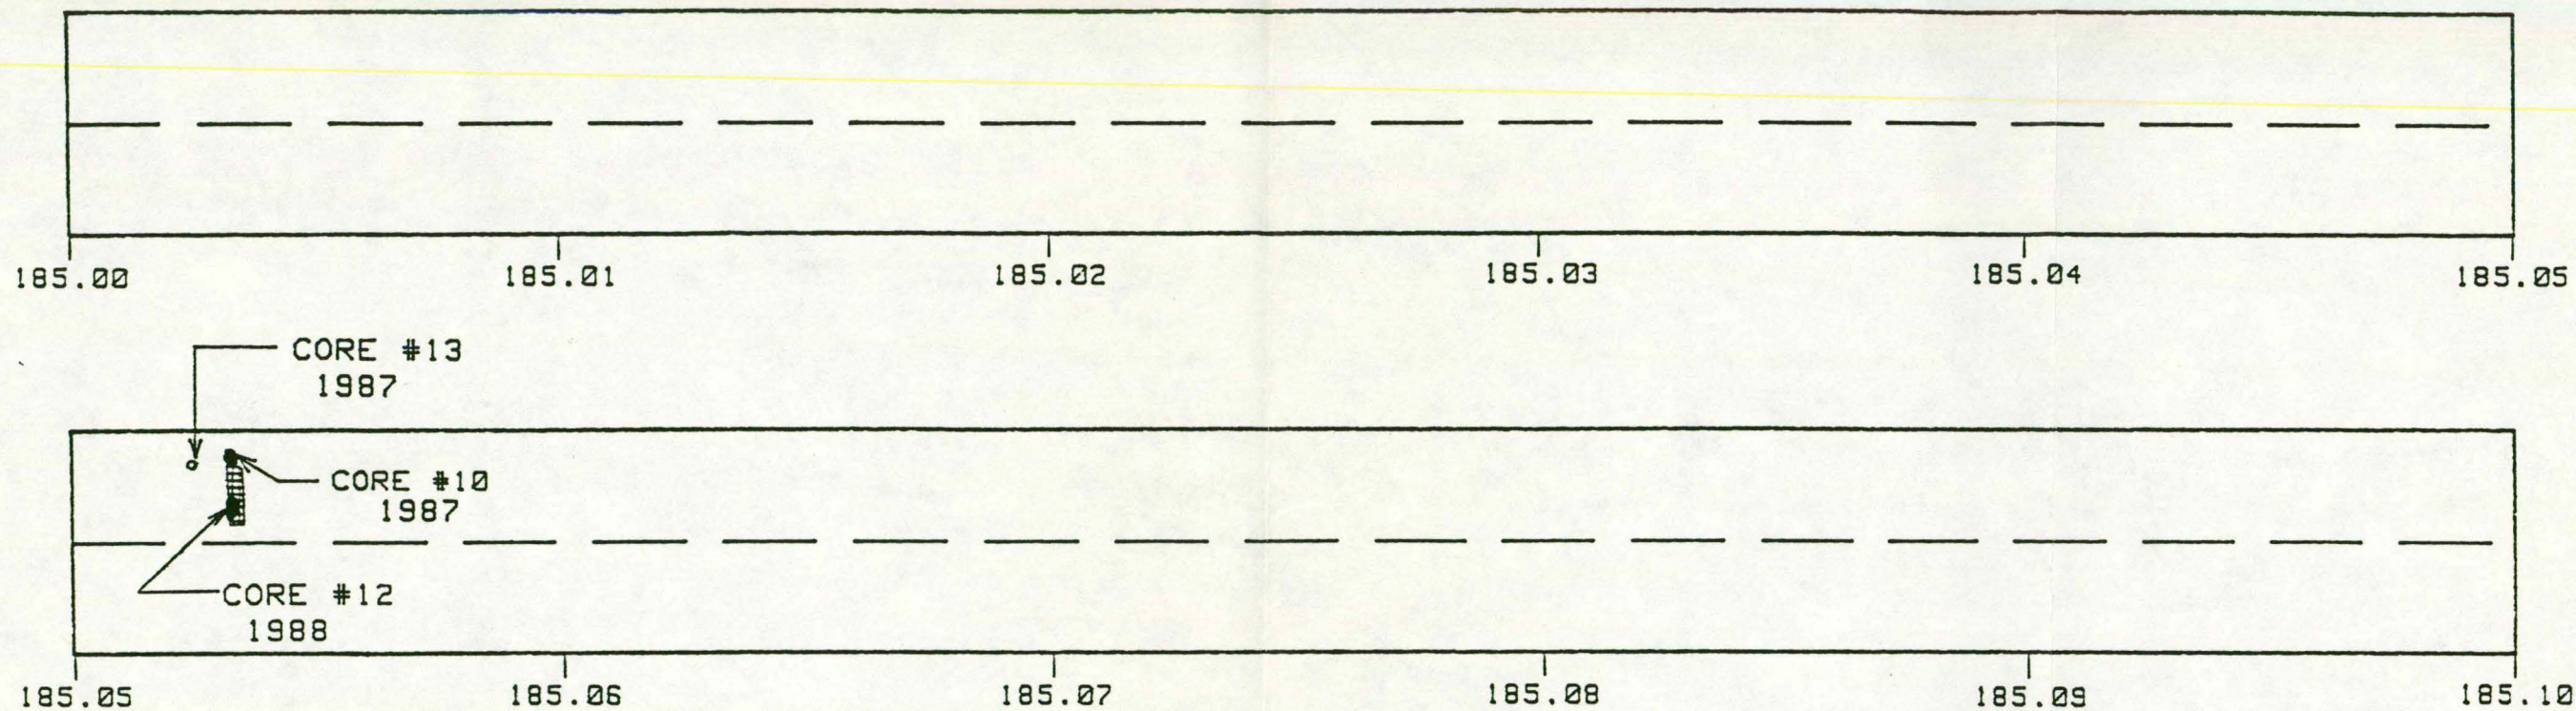
IR AND GPR EVALUATION OF BOND RETAINAGE
 IN PORTLAND CEMENT CONCRETE OVERLAYS
 I-80 (WESTBOUND) STA 185.00 TO STA 185.10
 IOWA DEPARTMENT OF TRANSPORTATION

AREAS	WESTBOUND LANES
Total Area	12,672 (sq.ft.)
Debond (IR)	2 (sq.ft.)
Concrete Patch	11 (sq.ft.)
Deterioration (GPR)	None (lin.ft.)

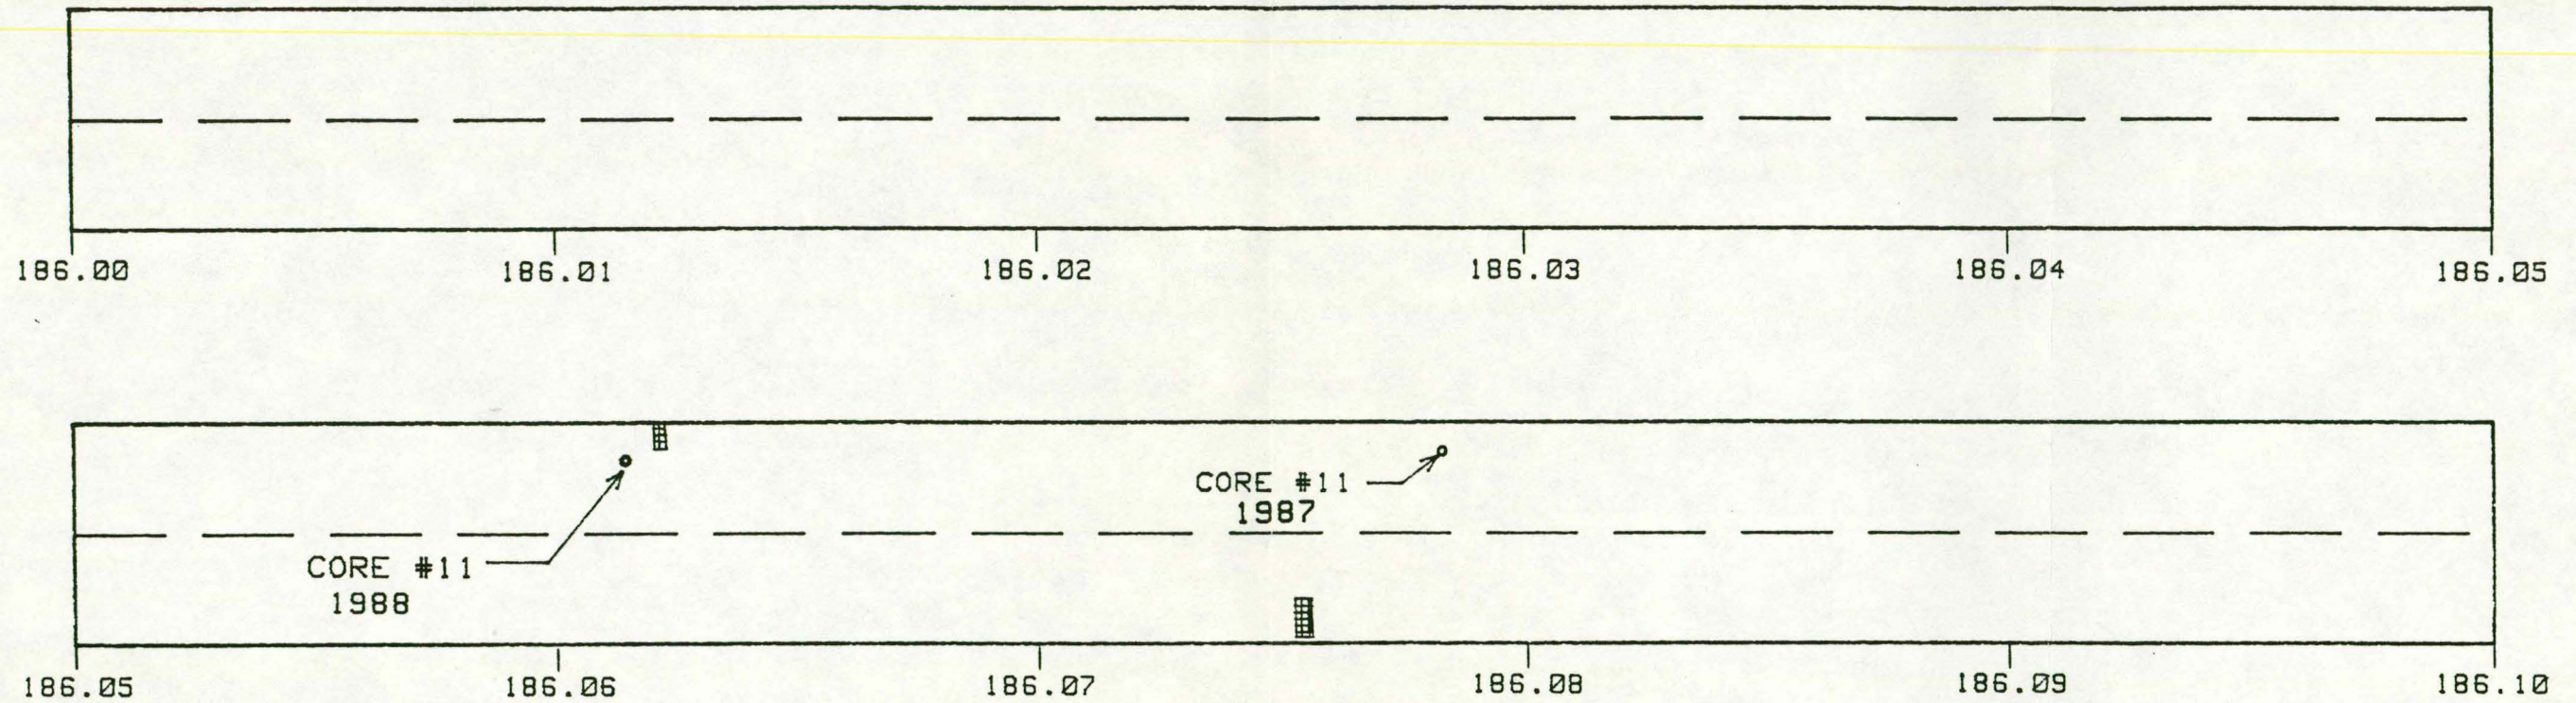
IR AND GPR EVALUATION OF BOND RETAINAGE
IN PORTLAND CEMENT CONCRETE OVERLAYS
I-80 (WESTBOUND) STA 186.00 TO STA 186.10
IOWA DEPARTMENT OF TRANSPORTATION

AREAS	WESTBOUND LANES
Total Area	12,672 (sq.ft.)
Debond (IR)	None (sq.ft.)
Concrete Patch	11 (sq.ft.)
Deterioration (GPR)	None (lin.ft.)
Inspection Date:	August, 1987 August, 1988
