PRE-CONSTRUCTION PROBLEMS OF SLOPE STABILITY

IOWA STATE HIGHWAY COMMISSION

DESIGN DEPARTMENT-SOILS DIVISION

JANUARY 1962

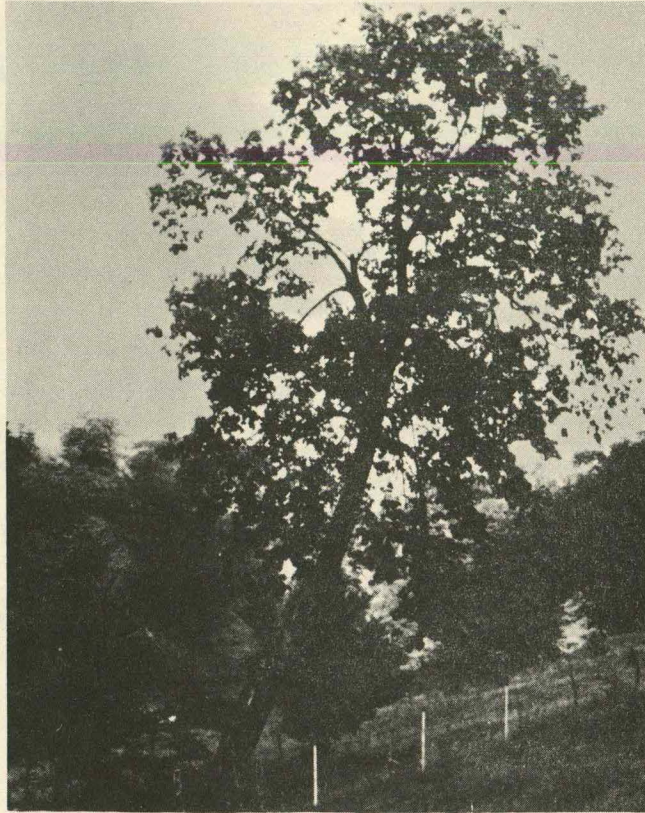
Plate 2

A tree on a sideslope near Boone, Iowa. A typical indication of movement which may be readily recognized in the field.

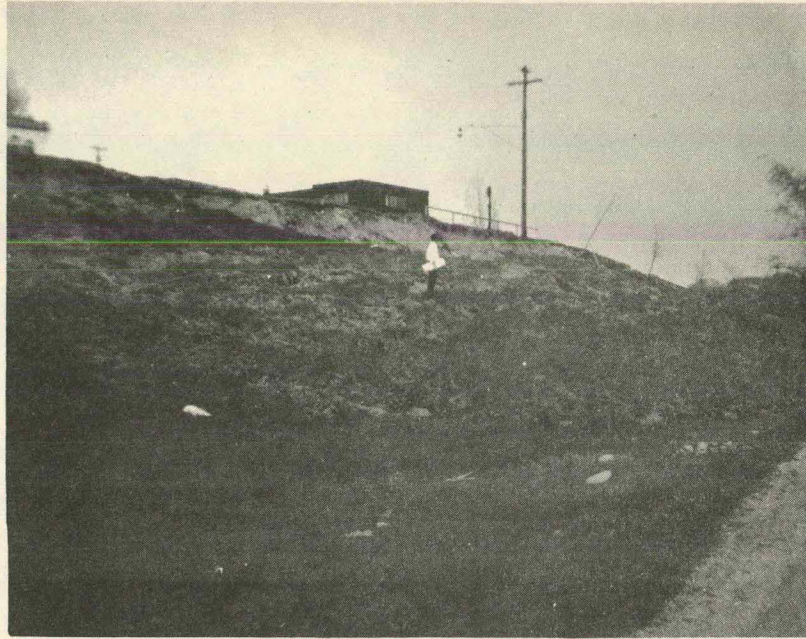
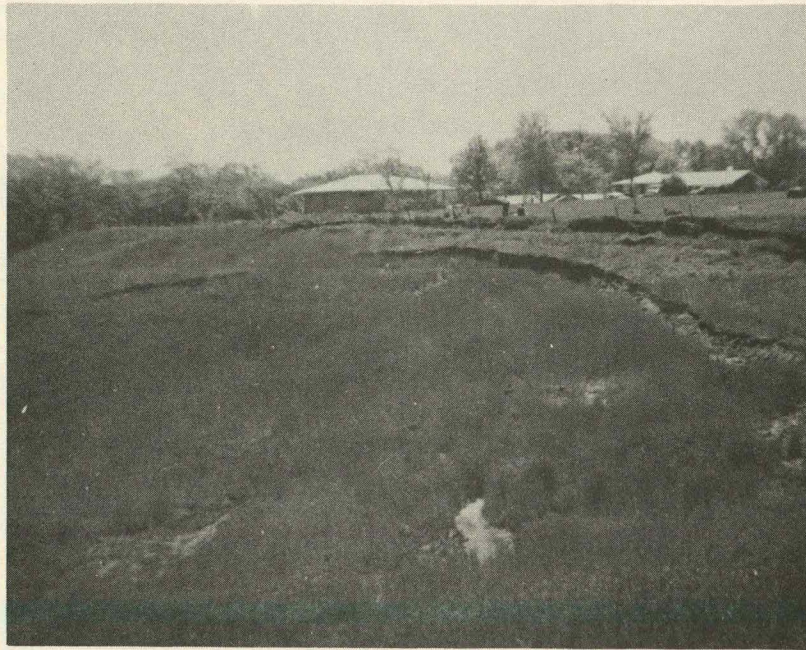
Failure of slopes as a result of effluent water from nearby dwellings. Top - U.S. 20 in Dubuque, Iowa. Bottom - Highway borrow area near Des Moines, Iowa.

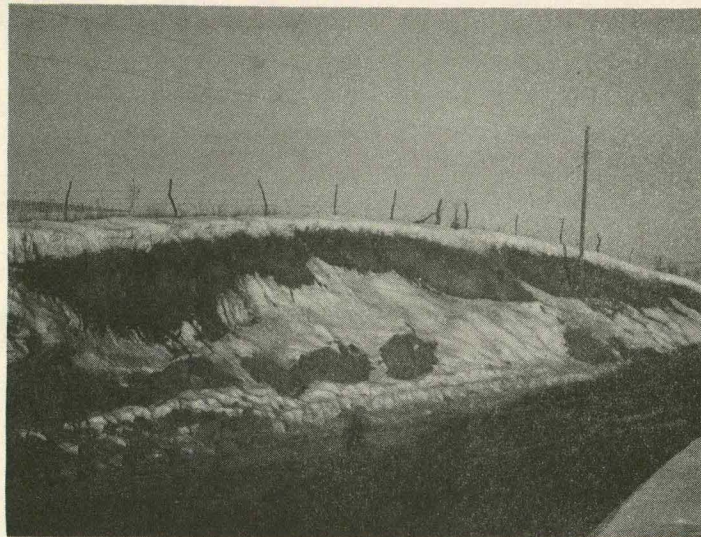
Plate 4

Typical earthflow in highway backslope resulting from impervious clay layer holding up natural water table. U.S. 34 near Tenville, Iowa.

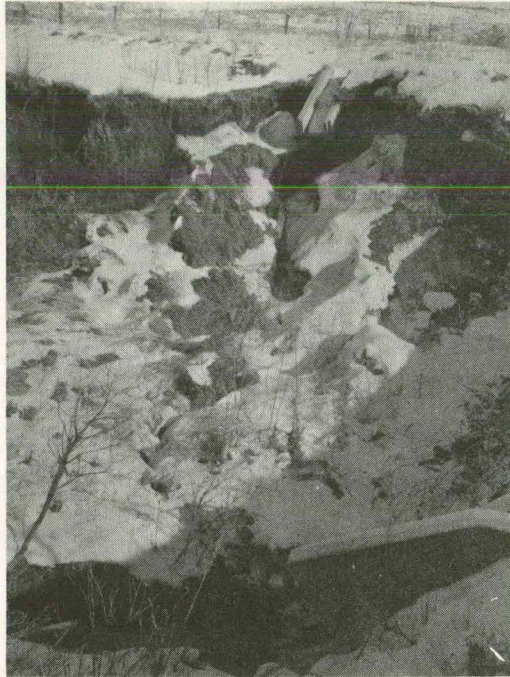
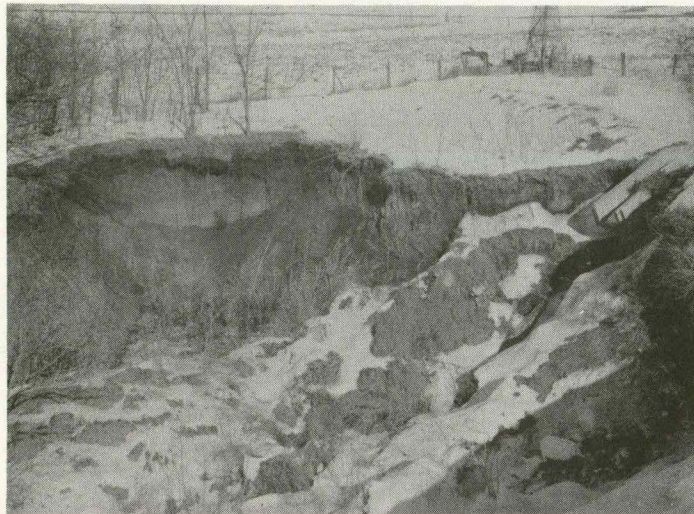
Failure in highway foreslope and bordering natural slope resulting from water table being held up by impervious clay layer. Iowa State Highway 333 west of Hamburg, Iowa.

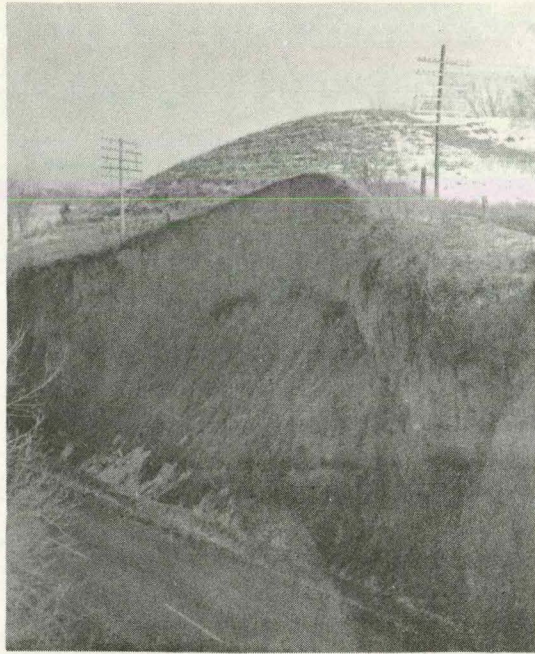
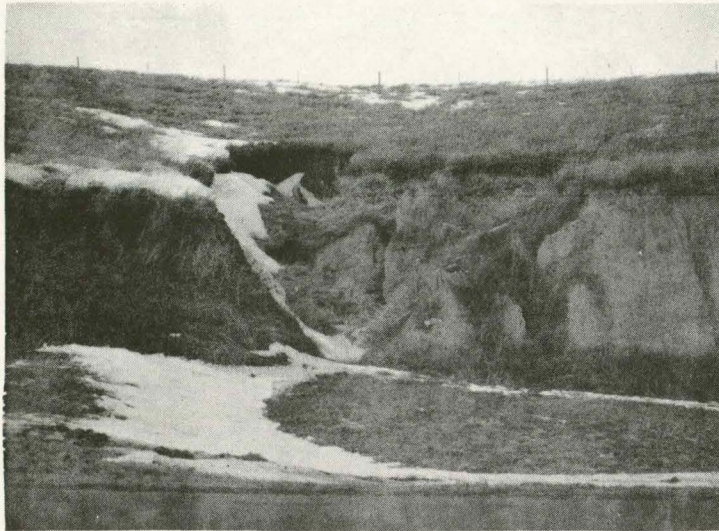
Typical failures in loess backslopes resulting from erosion and weakening near the base. Top-U.S. 30A near Honey Creek, Iowa. Bottom - Iowa State Highway 37 near Soldier, Iowa.

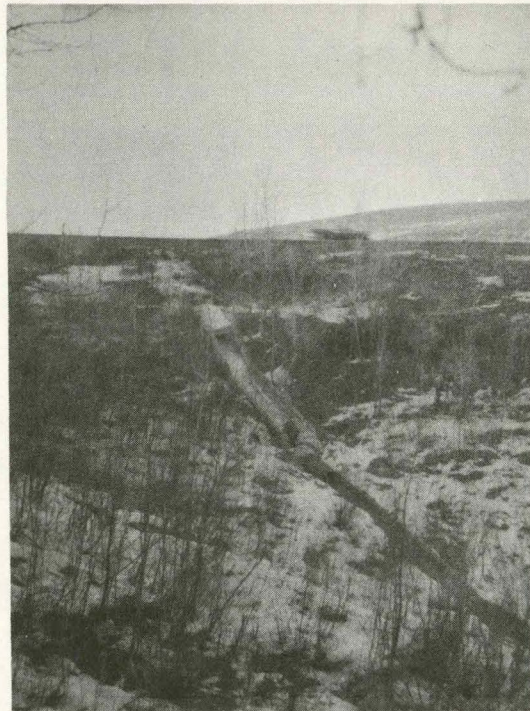
Plate 7

Seepage forces on the water in the ravine slope are due primarily to an elevation head and are commonly in evidence as surface seepage near the base of the slope. Any fill material which is placed on top of a ravine slope such as this will almost inevitably become saturated in time. The low saturated strength of loess makes it a weak foundation material unless it is properly confined or drained. As the material of the fill becomes saturated its shear strength is reduced and its ability to confine the weak loess is lessened. Hence, a failure of the slump-earth flow type is imminent.

Typical foreslope failure resulting from elevated water table in loess. Note displacement of flume. Iowa State Highway 37 near Soldier, Iowa.

Where a situation such as the one described here occurs in the field preventative slide control measures may be warranted even though the elevated water table is not in evidence at the time of investigation or construction. Future wet seasons or changes in the character of the ground water table could result in the same conditions as those in the diagram.

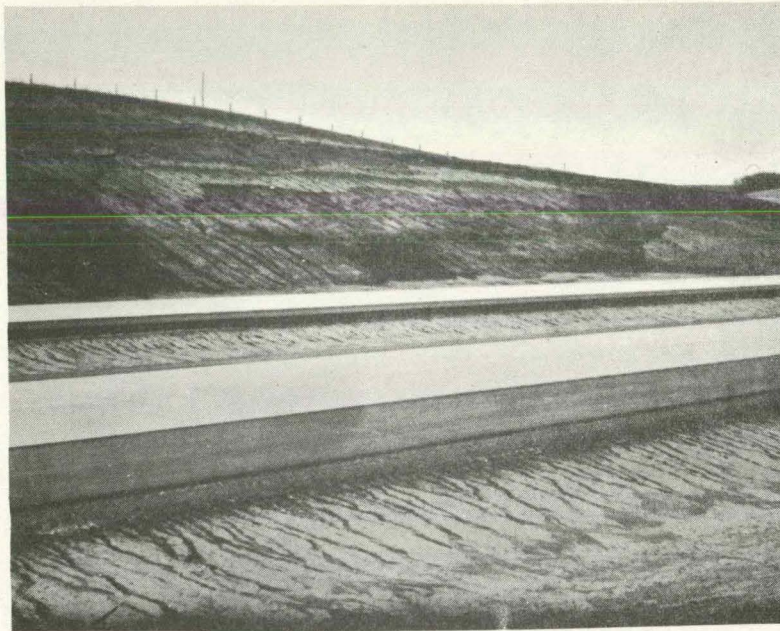
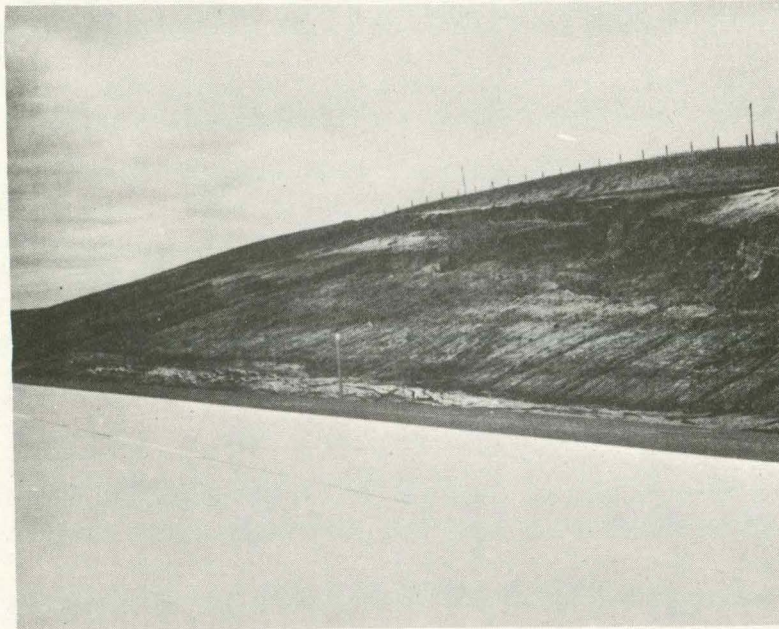
Highway backslope failures on Interstate 80 near Atlantic, Iowa interchange resulting from water trapped in sand lenses. Top-water seeping out onto slope from pockets of sand in glacial clay. Bottom - Main slide area with slump blocks at top and plastic earth flow at toe.

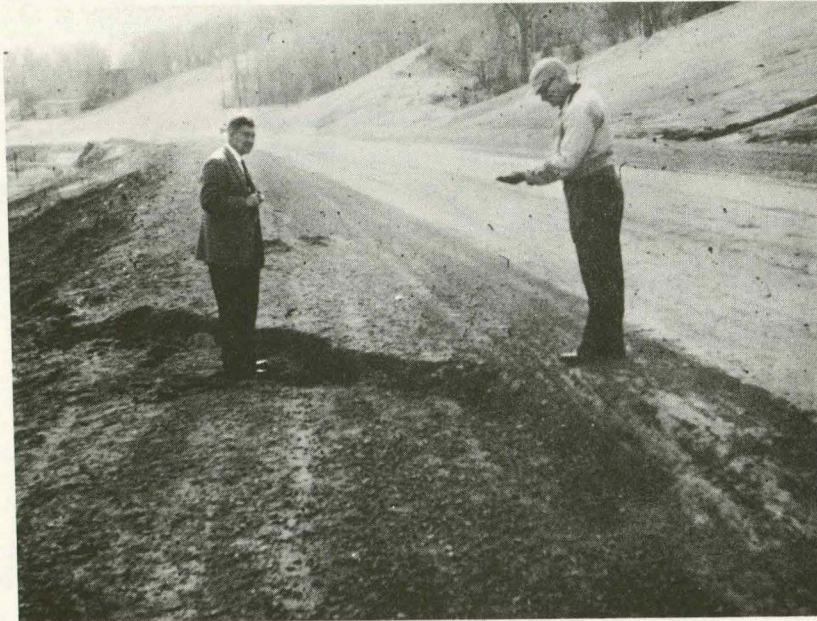
Plate 9

Roadway shoulder which has failed as a result of
foreslope movement on a sloping clay shale surface.
U.S. 67 south of LeClaire, Iowa.

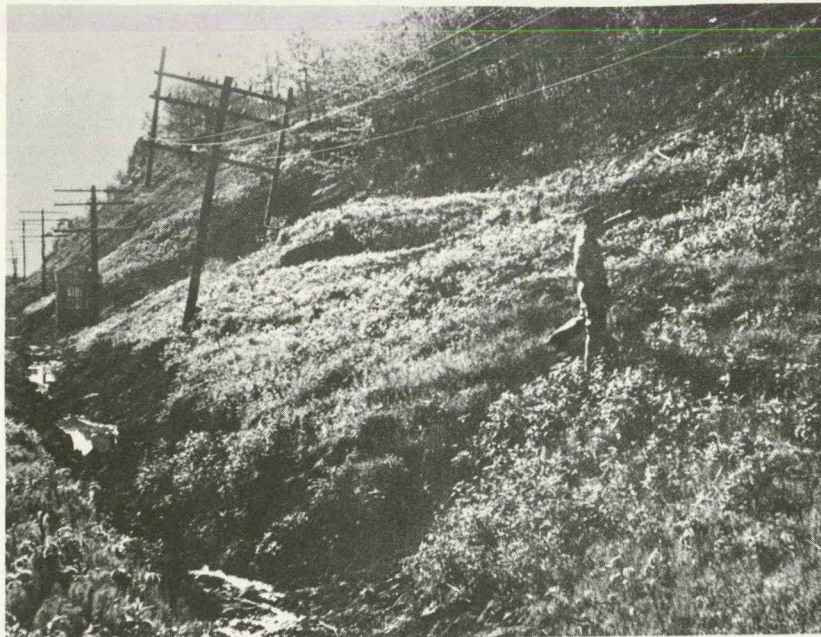
Plate 10

Failure in a foreslope overlying a sloping rock surface.
Iowa State Highway 22 north of Muscatine, Iowa.

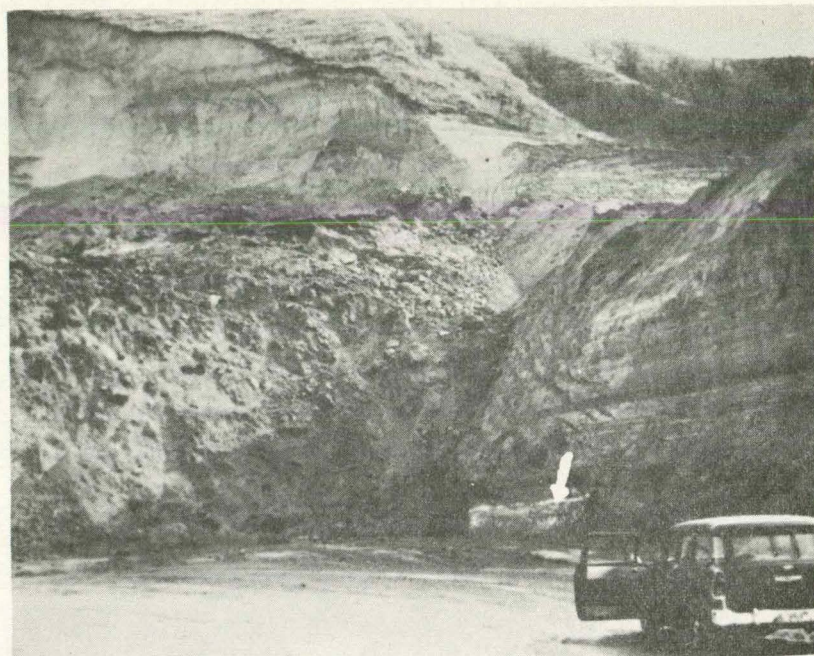
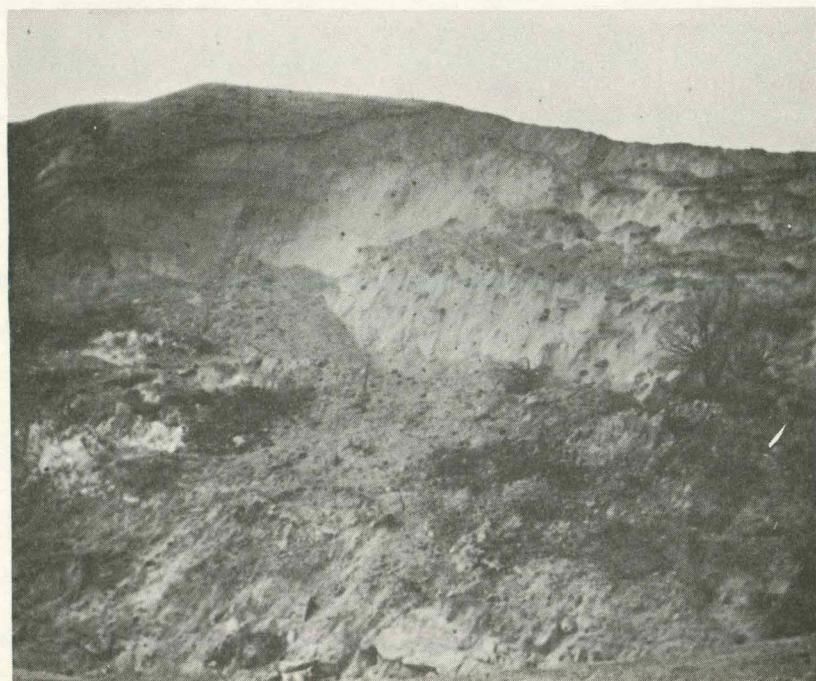
Large loess slide in gravel pit near Little Sioux, Iowa. Failure began as block glide along weak layer of volcanic ash (arrow).
