Vibration Monitoring of Luminaires on the Burlington Cable-Stayed Bridge

The Iowa Department of Transportation

Iowa DOT
Kenneth F. Dunker

August 5, 2002

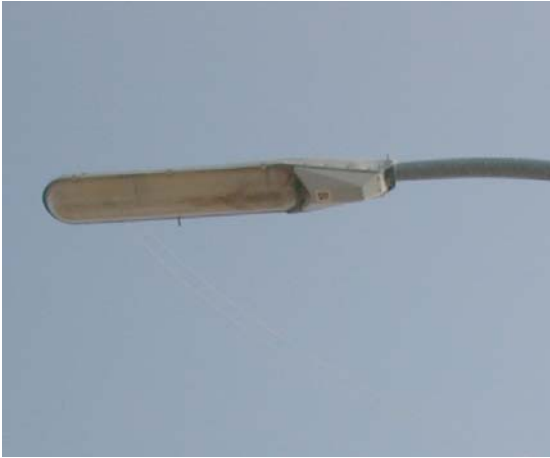
(a) Existing LPS Luminaire

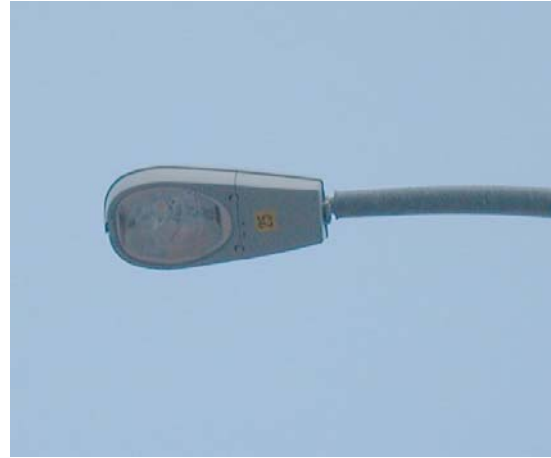
(b) New HPS Luminaire

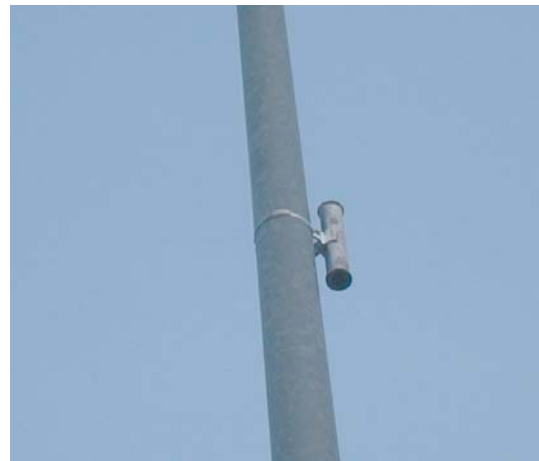
This suggests that the damper was ineffective in reducing accelerations for the existing LPS luminaire and pole installation.

(d) Damper
