Report on
Evaluation of Interstate 80 Sign Truss

**Office of Bridges and Structures
The Iowa Department of Transportation**

Terry J. Wipf
Brent M. Phares

September 25, 2002

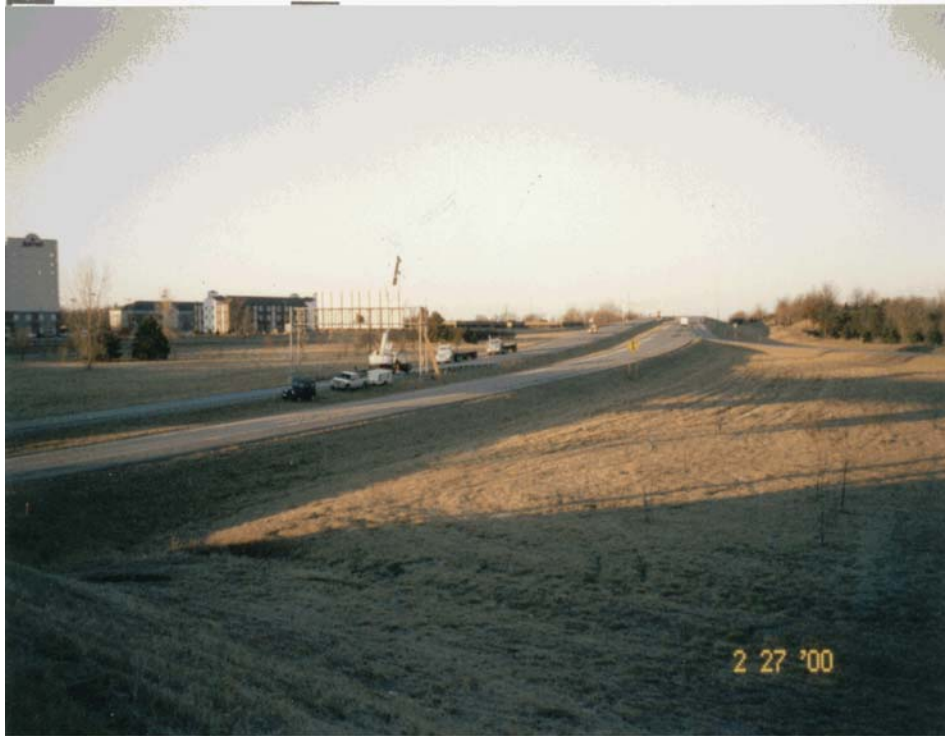
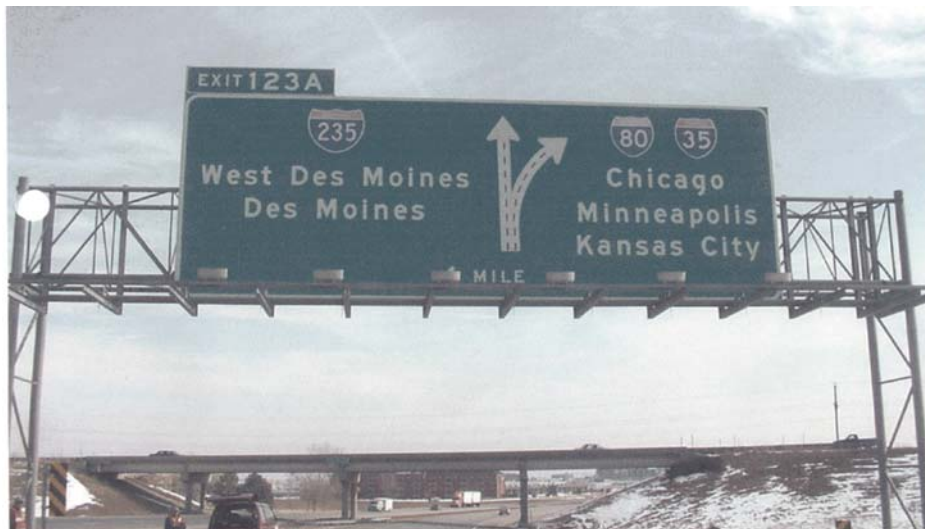
Figure 1. Photographs of Sign Truss before Removal.

The truss is a galvanized steel, four chord truss with a span of approximately 60 ft and carries a single 14 ft x 40 ft sign and associated lighting as shown in Fig. 1. Figure 2 shows a photograph of the deterioration of one of the bottom chord members near mid span.

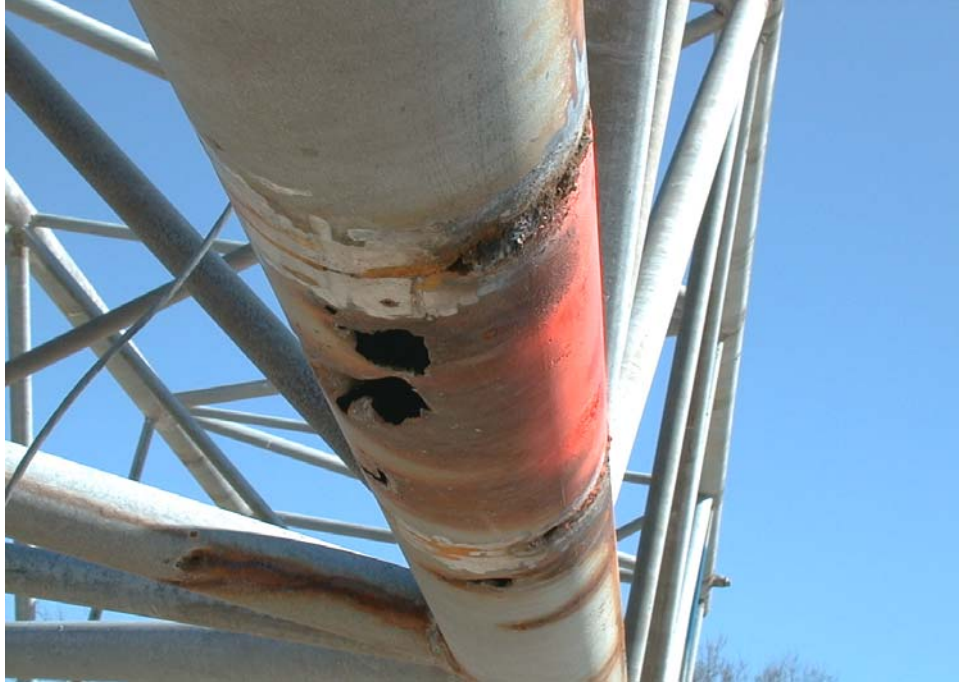
Figure 2. Deterioration of Bottom Chord Member of the Truss

A sign support truss over eastbound I-80 about 2 miles west of the west I-35/I-80/I-235 interchange near Des Moines, IA was removed in the spring of 2000. A routine inspection of the truss found that one of the bottom chord members was severely deteriorated. Corrosion of the bottom chord has caused significant thickness loss of cross section area of many members. This deterioration led to a concern about the structural adequacy of the truss.

The investigated truss had a badly corroded bottom chord member located at mid span. Many other members were also corroded. This damage likely affects the performance of the truss. However, the experimental tests and an analytical investigation indicated that the truss did not need to be removed due to potential structural inadequacy. It was found that the truss has redundant load paths that allow redistribution of the loads. Due to this load path redundancy, if one or more members were to fail due to corrosion or other means (e.g., over height vehicle impact, etc.), the load will likely be redistributed to other members. From these tests, it was found that after load redistribution, the strain levels in other members were still below the yield strain of steel. It appears that for the subject truss, it may have been sufficient to simply repair the corroded member. However, in general, the extent of corrosion damage must be accurately assessed. The structural performance of the damaged structure can then be evaluated using an analytical model similar to the one discussed herein.

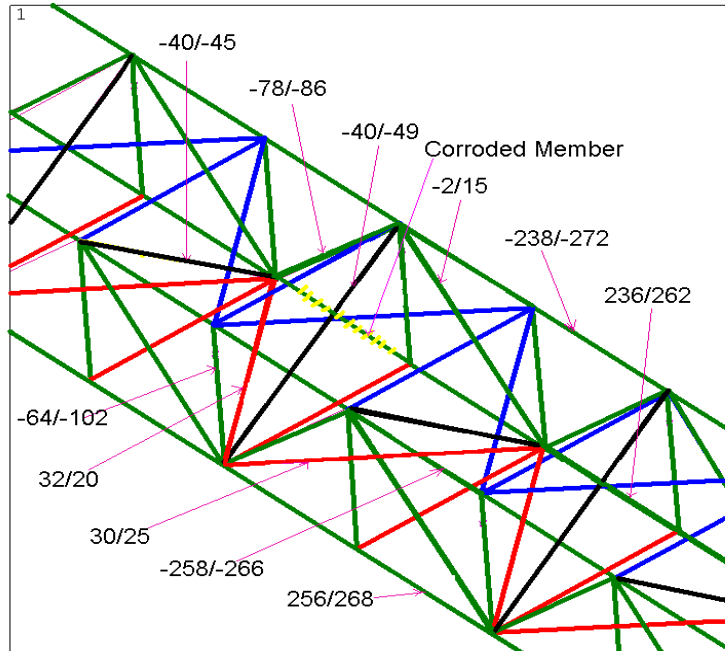
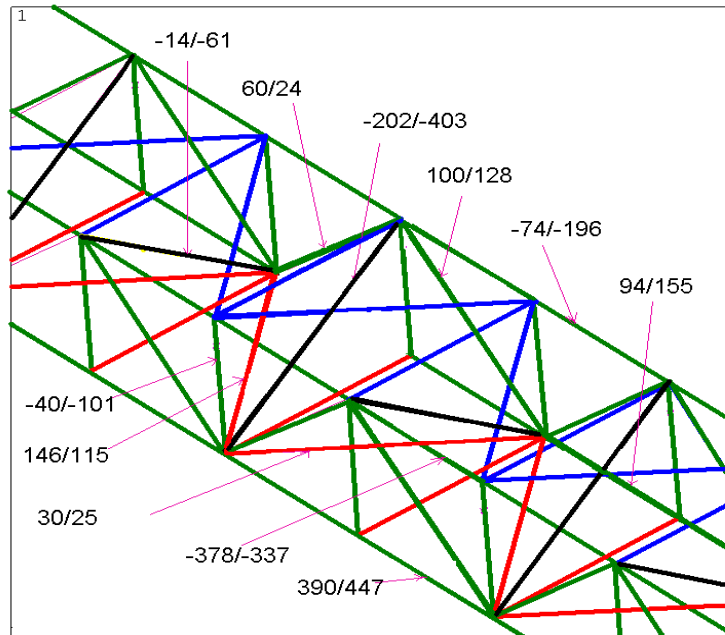
One objective of this project was to develop an analytical model that accurately represents the structural behavior of trusses so that the performance can be evaluated. To accomplish this, the results of the developed analytical model were validated using strain measurements from the load tests. Table 3 shows the experimental and analytical results before and after the bottom chord element cut. Figures 9 and 10 show the results in the vicinity of the cut member.

The difference between the field and analytical results may be attributed to several factors. First, many members of the truss were corroded. This means that the theoretical values of section properties used in the analysis (which are taken from the design plans) are likely less than their actual values. Variations in elements properties would result in a load distribution different from that predicted from the analysis. More accurate analysis results may be obtained by modifying the properties of the corroded members in the
