# EVALUATION OF A STEEL GIRDER BRIDGE STRENGTHENED USING FRP PLATES

CTRE Project

**Final Report • November 2005**

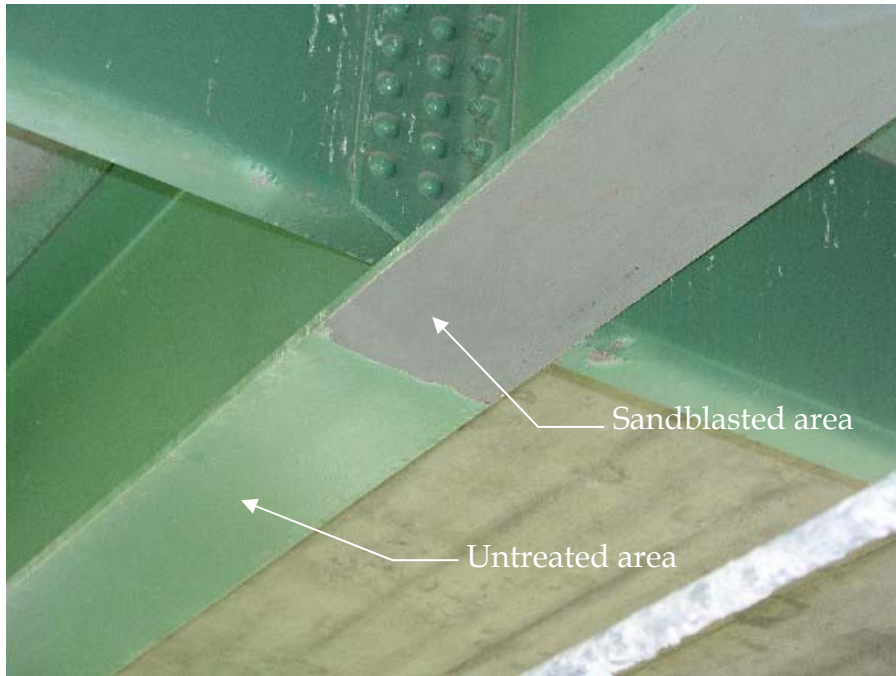
**Figure 11. Sandblasted girder surface.**

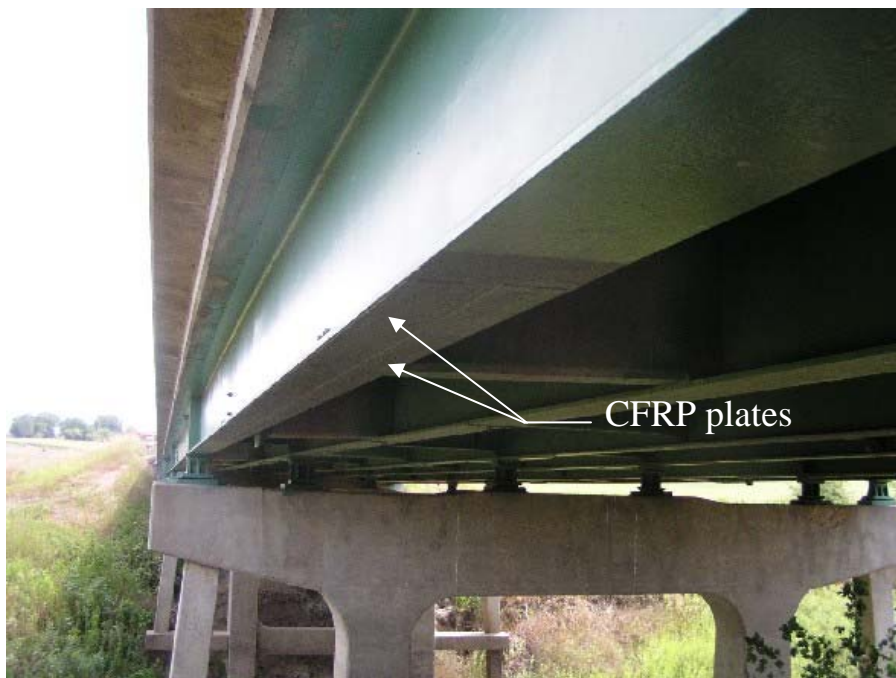
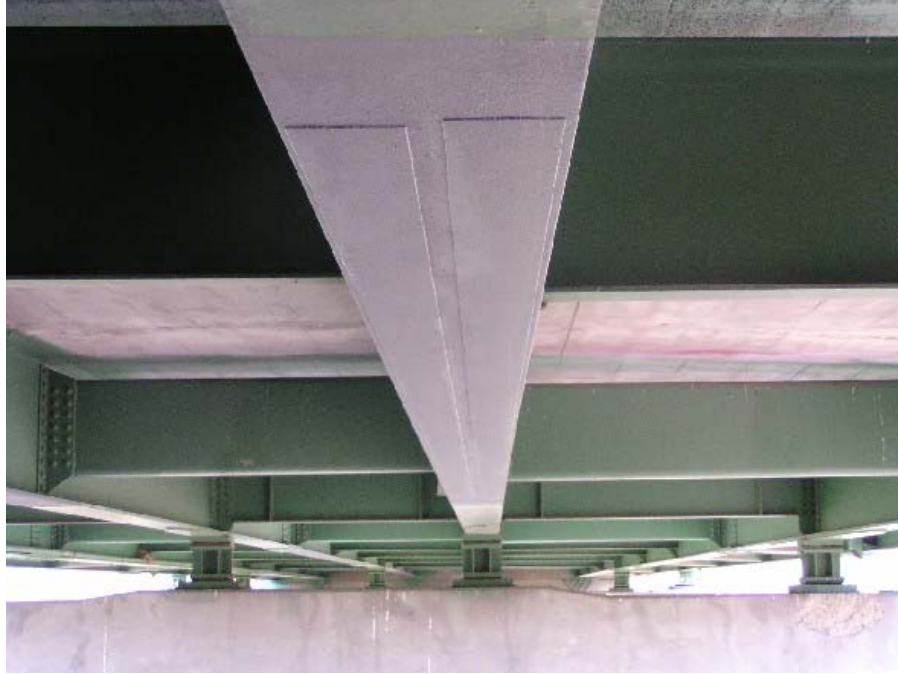
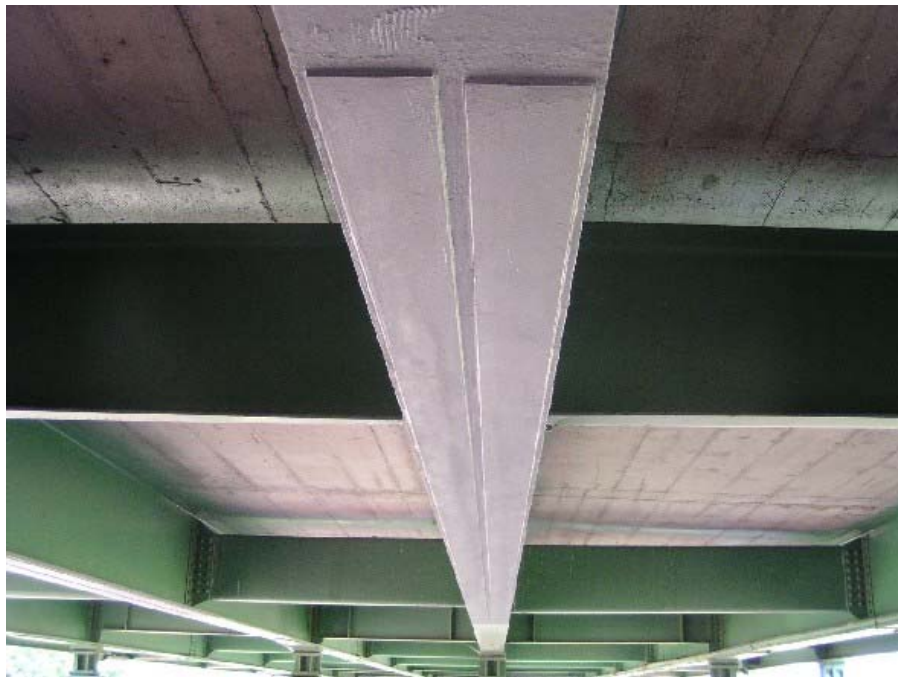
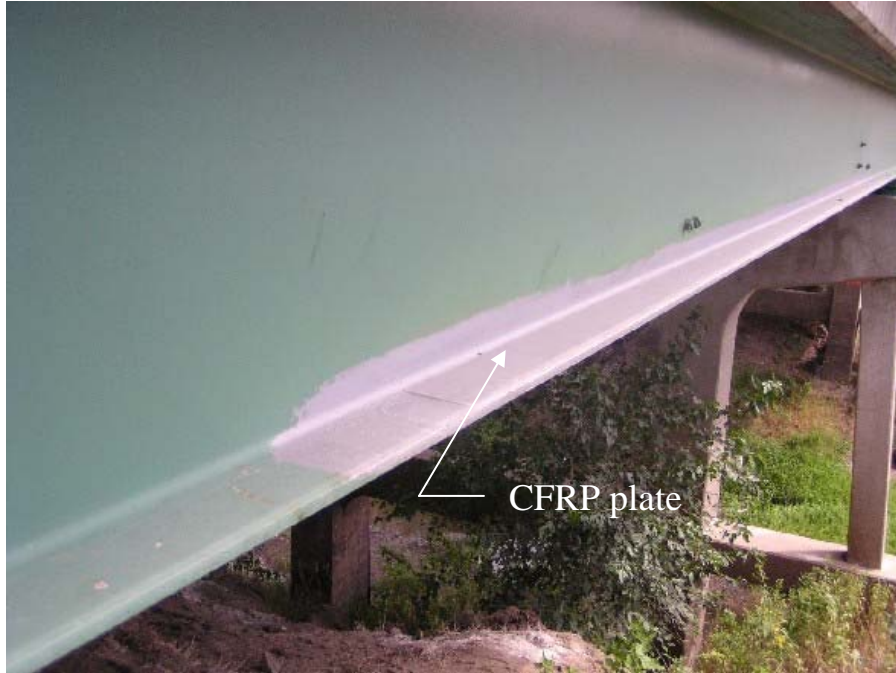
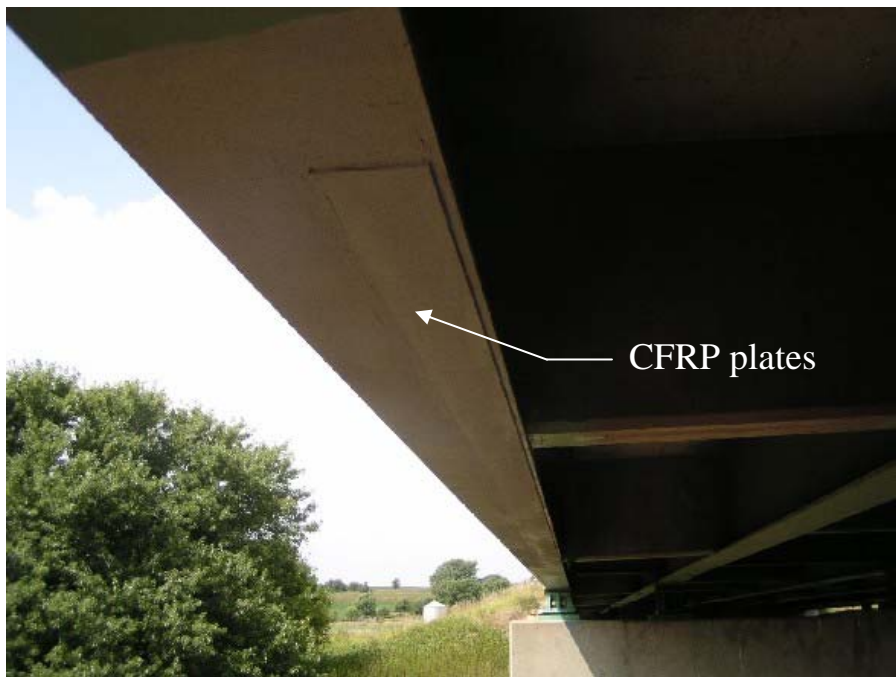
**Figure 21. Photographs of the completed installation.**

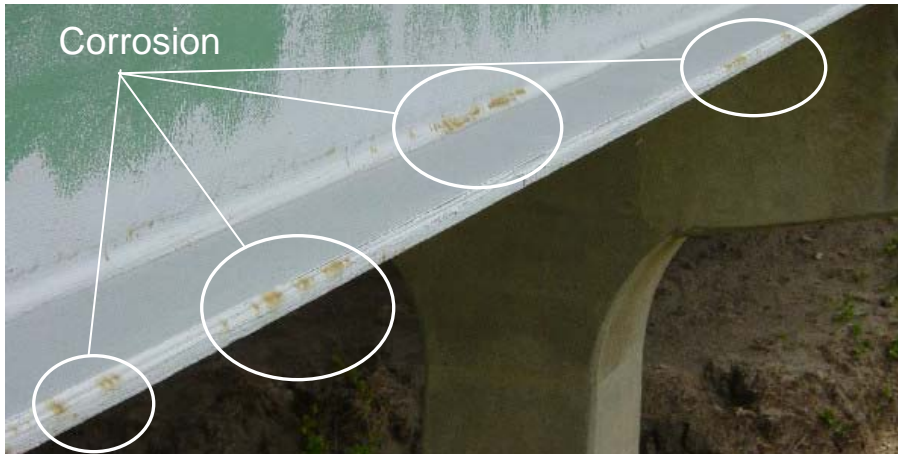
some corrosion was observed on the top of the bottom flange of Girder 6 in all three spans. It was initially expected that the coating of paint applied after the installation of CFRP plates would be good enough for corrosion protection. After the visual inspections, however, it was speculated that the applied paint was too thin or had some defects and that rain or snow might have penetrated the protective coating. Therefore, it is recommended that thicker or a proper coatings of paint or other water-proof material be applied to prevent the weather-induced corrosion and, thereby, protect the integrity of the strengthening system.

All CFRP plates installed on both the exterior and interior girders were visually inspected approximately one and two years after installation (May 2004 and 2005, respectively) to observe any degradation or other changes that may have an influence on the integrity of the strengthening system. In general, no obvious debonding was observed and the condition of the CFRP plates seemed intact. However, some corrosion in the steel girders was observed, as shown in Fig. 36, on the top of the bottom flange of Girder 6 in all three spans. It was initially expected that the coating of paint applied after the installation of CFRP plates would be adequate for corrosion protection. After the visual inspections, however, it is speculated that the applied paint was too thin or had defects and that rain or snow might have penetrated the protective coating. Therefore, it is recommended that thicker or more coatings of paint or other water-proof material be applied to prevent weather-induced corrosion and, thereby, protect the integrity of the strengthening system.

**Figure 36. Corrosion on the top of the bottom flange of Girder 6.**

- Paint coating applied after the installation may not have been sufficient enough to protect the strengthening system from direct environmental exposure (e.g., rain, snow, etc.); minimal to moderate corrosion had occurred on the top of the bottom flange on the top of the bottom flange on Girder 6 and the CFRP plates. Therefore, it is recommended that thicker or more coatings of paint or other water-proof coating be applied to prevent the weather-induced corrosion and, thereby, protect the integrity of the strengthening system.
