EVALUATION OF THE BETTENDORF BRIDGE, IOWA

**Final Report
July 2006**

A report from
Center for Transportation Research and Education

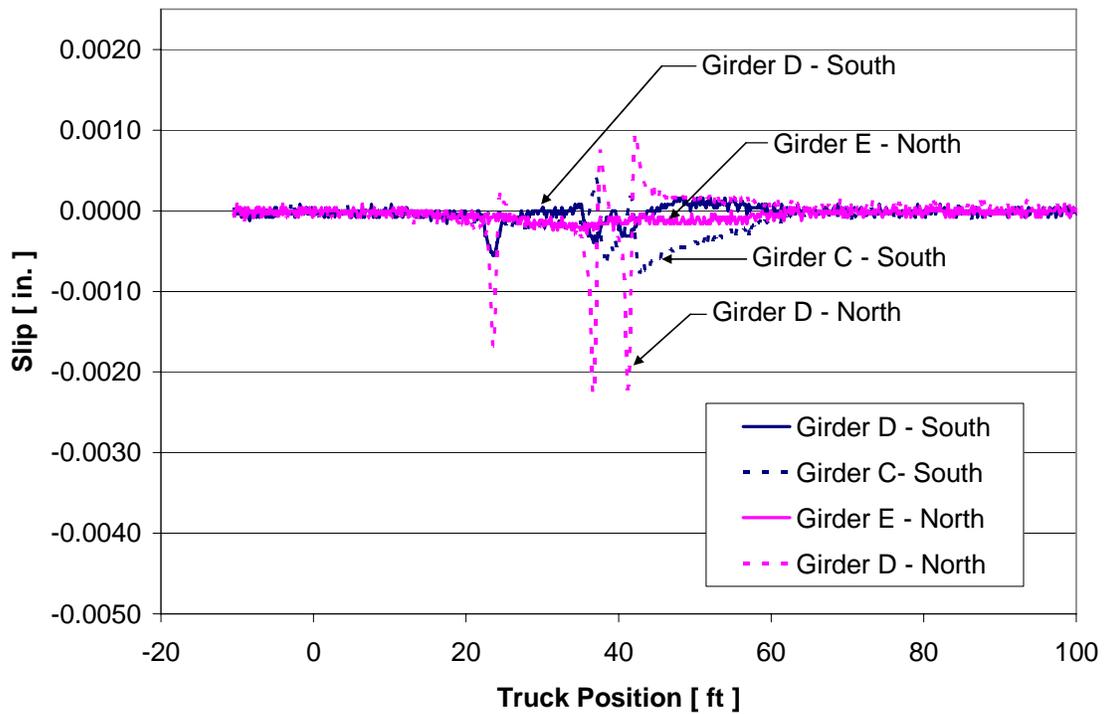
**Figure 52. 2003 Path Y2 Deck-to-Girder Slip**

During the 2003 test, the peak measured slip, as shown in Figure 52, was 0.00226 in. and occurred when a truck tire was immediately over the instrumented section. Previous laboratory testing on the beam-to-slab connection (Wood et al, 2001) used in this bridge indicated that this level of slip (i.e., 0.00226 in.) corresponded to a horizontal shear force of approximately 9.8 kip or 26% of the connection’s measured ultimate strength. It should be pointed out that the testing by Wood et al (2001) was completed on simple push out samples which can vary significantly from flexural members. Likewise, during the 2004 test, the maximum slip found was 0.004501 in. on Girder D North. The associated horizontal shear force was 19.5 kip, about 52% of the measured ultimate strength (Figure 53). Table 2 summarizes the differential deflections (i.e. slip) measured during the two-year tests for Girders C and D for Path Y2 which was the most critical case.

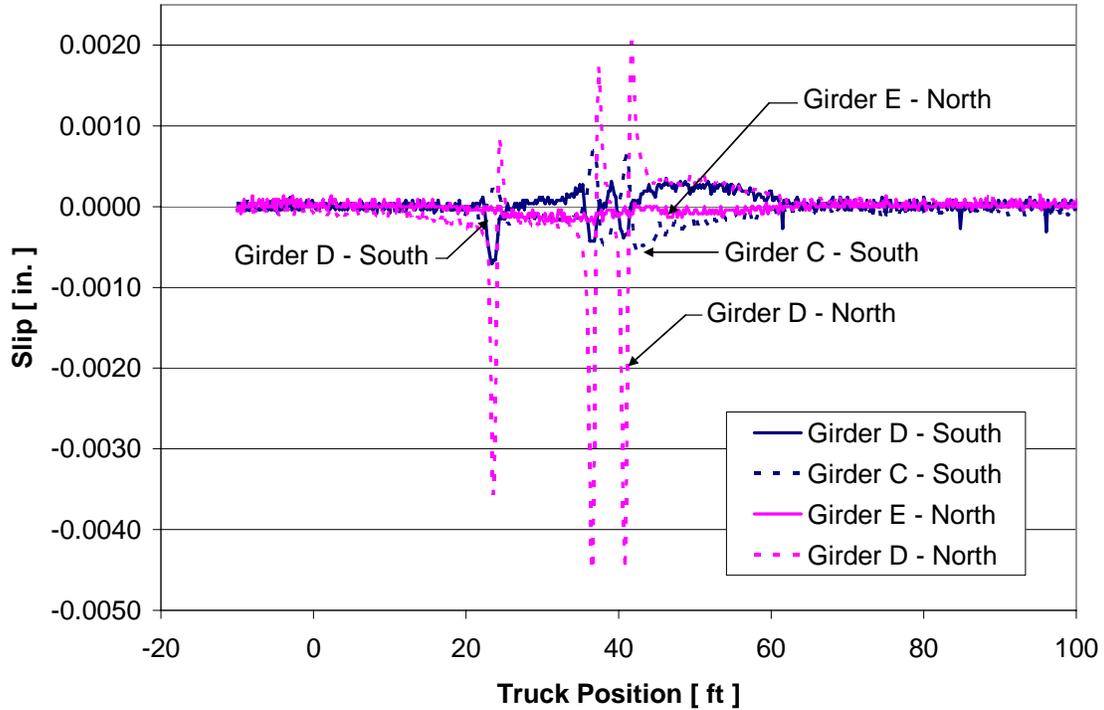
Figure 53. 2004 Path Y2 Deck-to-Girder Slip

The maximum differential horizontal displacement between the concrete girders and the FRP panel deck doubled from 2003 to 2004. The maximum slip in 2004 was 0.004501 in. When

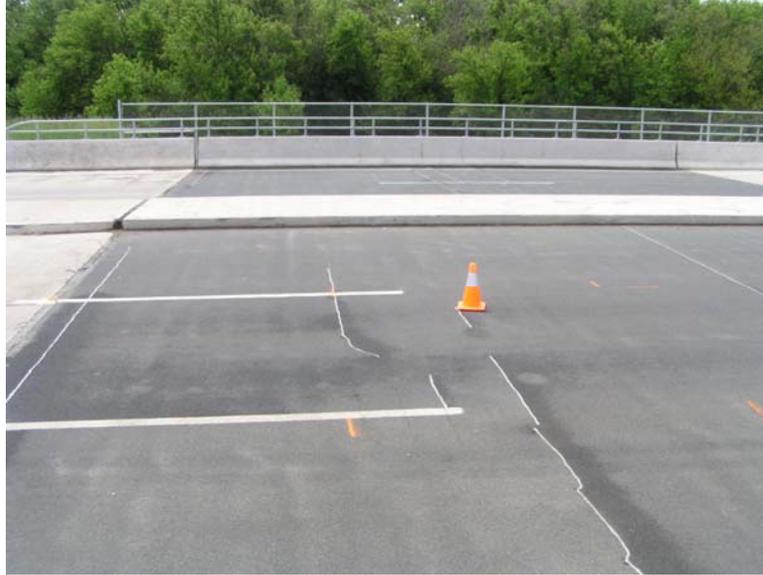
Figure 54. Transverse Cracks in North Traffic

A walk-through inspection of the FRP deck, in 2004, revealed clear signs of cracking in the transverse direction. These cracks were found to be regular and are likely resulting from differential displacements between panels resulting from failed panel-to-panel connections.

During a walk-through inspection of the FRP deck in 2004, clear signs of cracking in the transverse direction of the traffic were found (see Figure 54 and Figure 55). Even though the joints cracked, the measured responses over time indicate that there was no significant loss of stiffness in the FRP deck. Thus, it is unclear what impact this cracking will have on the long-term bridge behavior.

- After one year of service, clear signs of cracking in the transverse direction to the traffic were observed. Those cracks run parallel with the FRP tube components of the panels.
- No damage of the girders was observed.

- It does not appear that any unusually large loads crossed the bridge during the two year monitoring period. Thus, the observed deterioration is likely due to structural behavior effects and not loading effects.
