Testing and Evaluation of the Iowa DOT FRP Temporary Bypass Bridge

Bridge Engineering Center

Final Report • March 2008

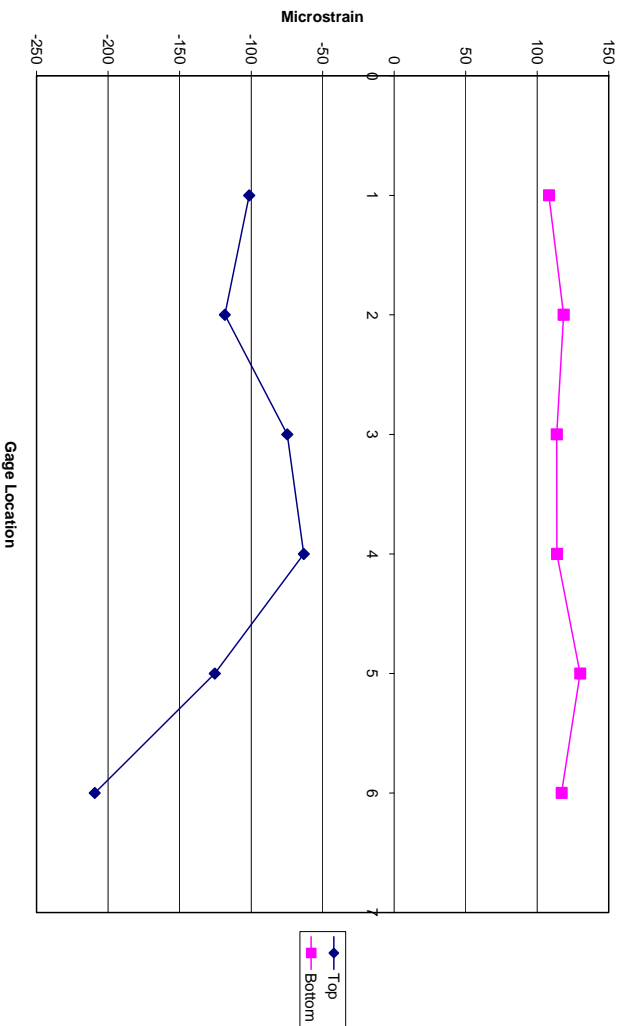
Illustrated in Fig. 24 is the strain profile for the top and bottom gages at mid-span for load case 2 (LC2) for Test 1, which is a symmetrical transverse truck position, and is generally representative of all three load cases for Test 1. Figure 24 indicates that there may be some discrepancy at gage location SG6 (T). Illustrated in Figs. 25 and 26 are panel strain readings from Test 1 and Test 2, respectively, in the area around gage SG6. Based on these two figures, it would appear that the strain measured at SG6 (T) for Test 1 is suspect. It is unclear whether this is due to localized effects from the close proximity of the rear axles, gage bonding issues, or other effects.

Figure 24. Top and Bottom strain profile at mid-span, LC2.

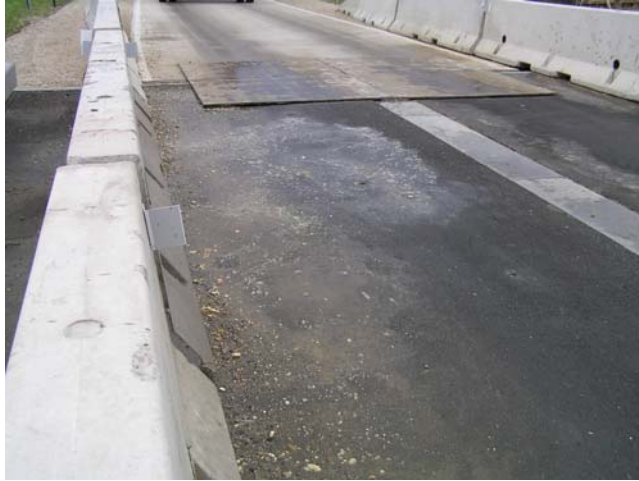
Figure 33. Jersey barrier and steel plate on FRP Bypass Bridge.
