# Low-Cost Rural Surface Alternatives Phase III: Demonstration Project

Final Report April 2022

**Sponsored by** Iowa Highway Research Board (IHRB Project TR-721) Iowa Department of Transportation (InTrans Project 17-604)

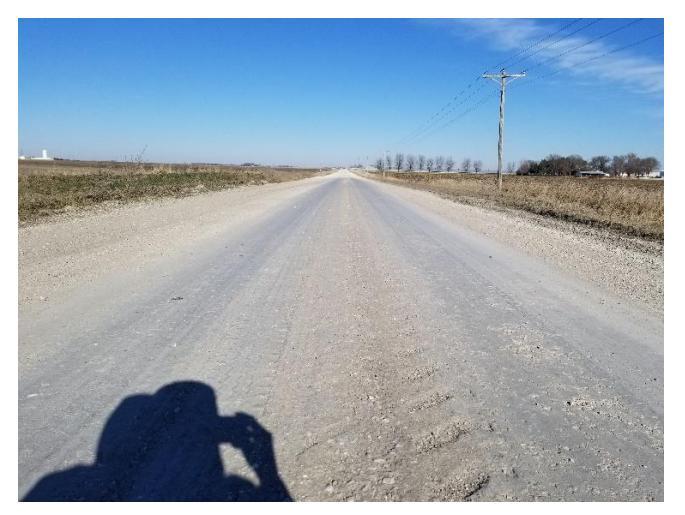
Figure 127. Rutting in EMC SQUARED section in Hamilton County during spring 2019

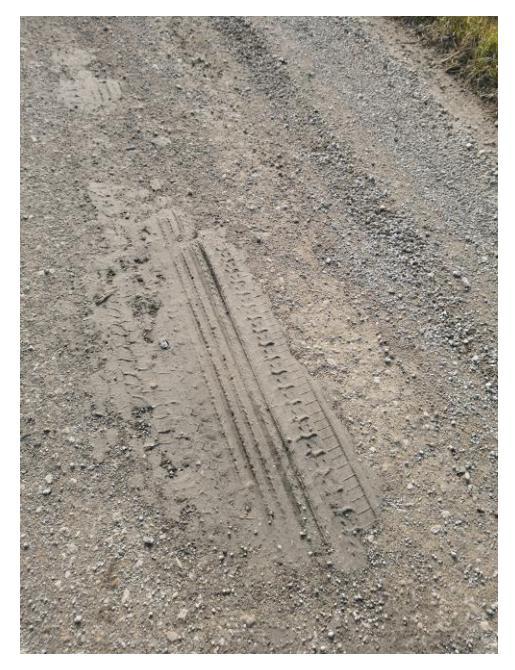
Figure 129. Clay on the surface in Hamilton County Claycrete section

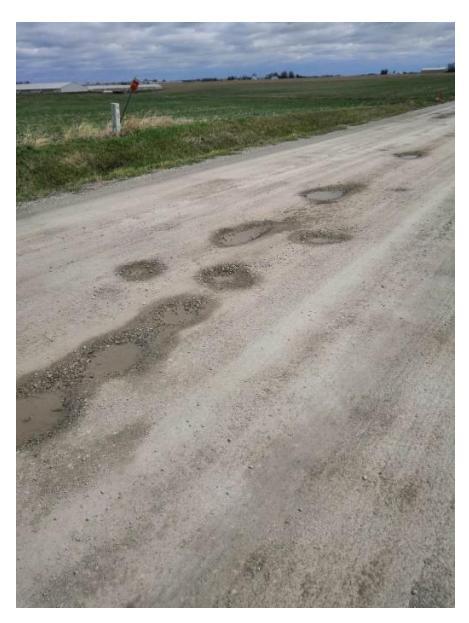
Figure 130. Potholes in control section in Washington County during spring 2020
