## Analysis of Existing Work-Zone Devices with MASH Safety Performance Criteria

Final Report February 2009

## MIDWEST ROADSIDE SAFETY FACILITY

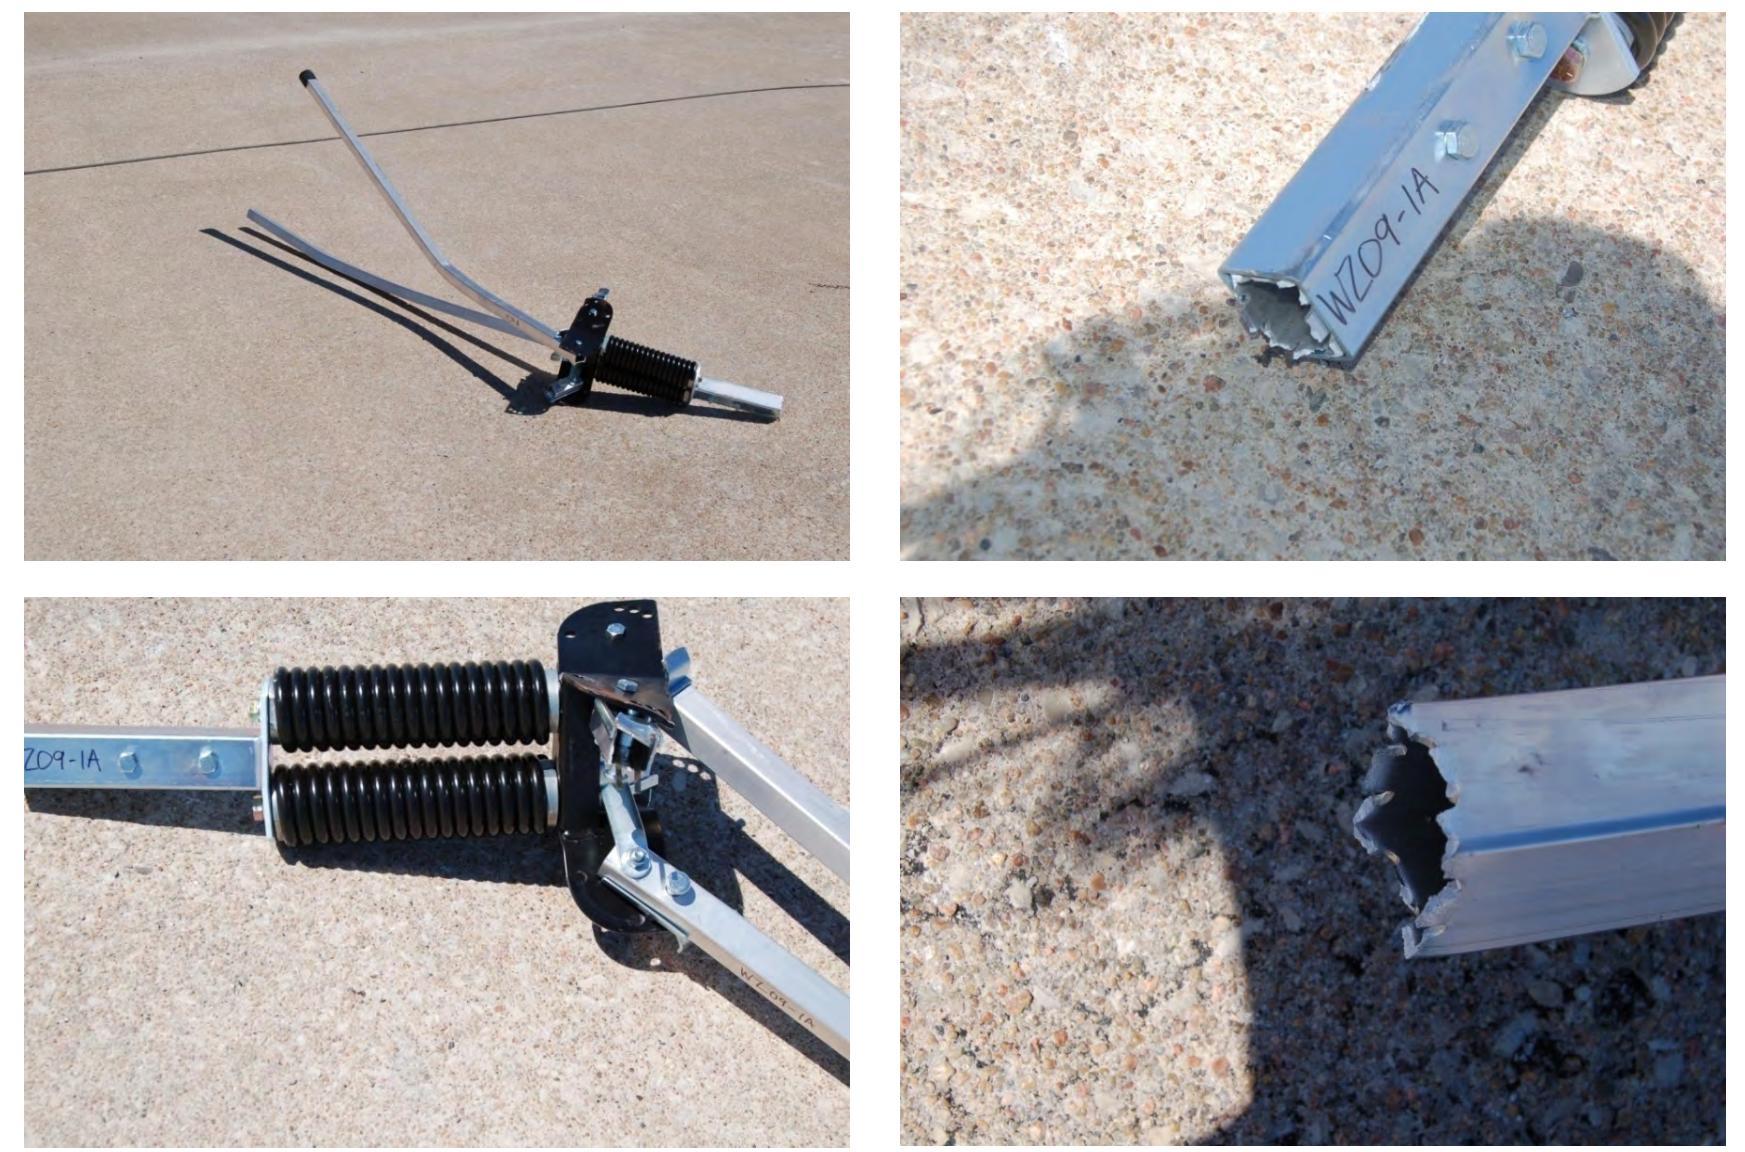
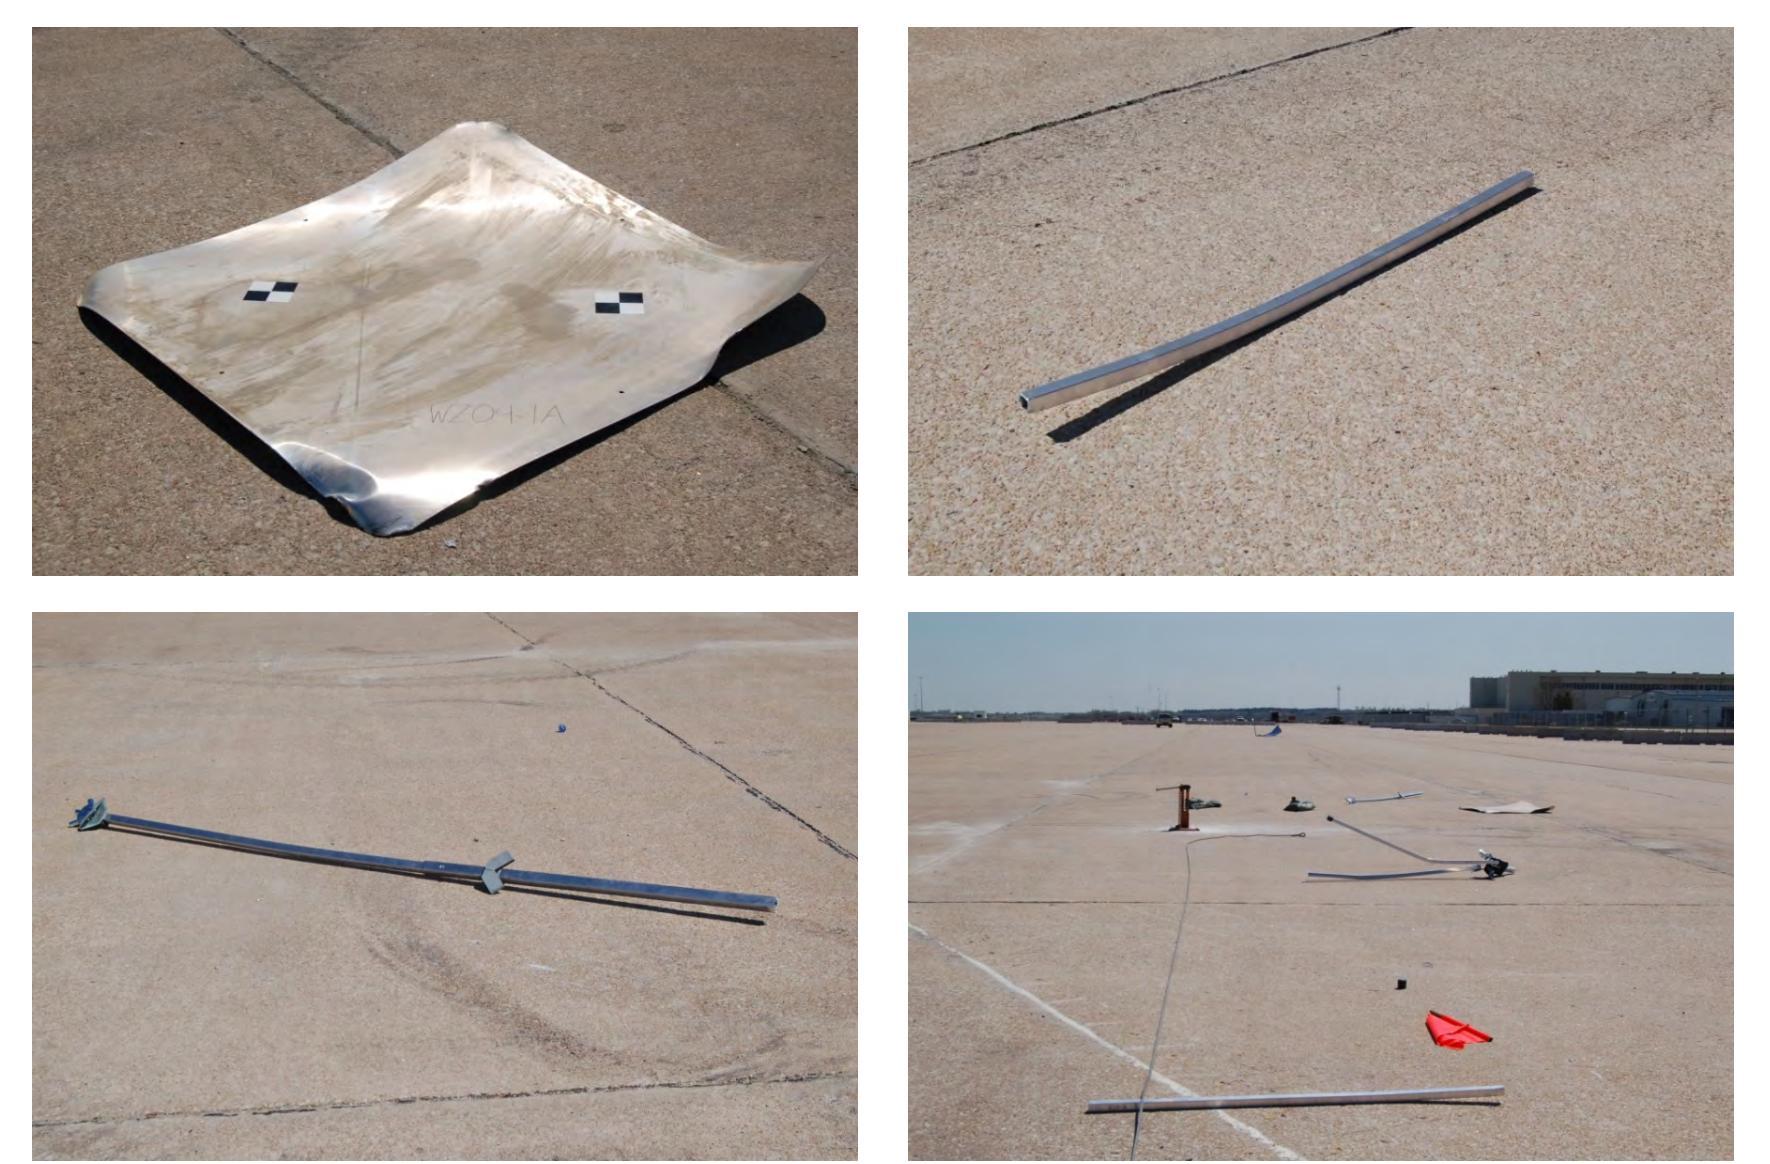
Figure 53. System Damage, Test No. WZ09-1A

Figure 54. System Damage, Test No. WZ09-1A

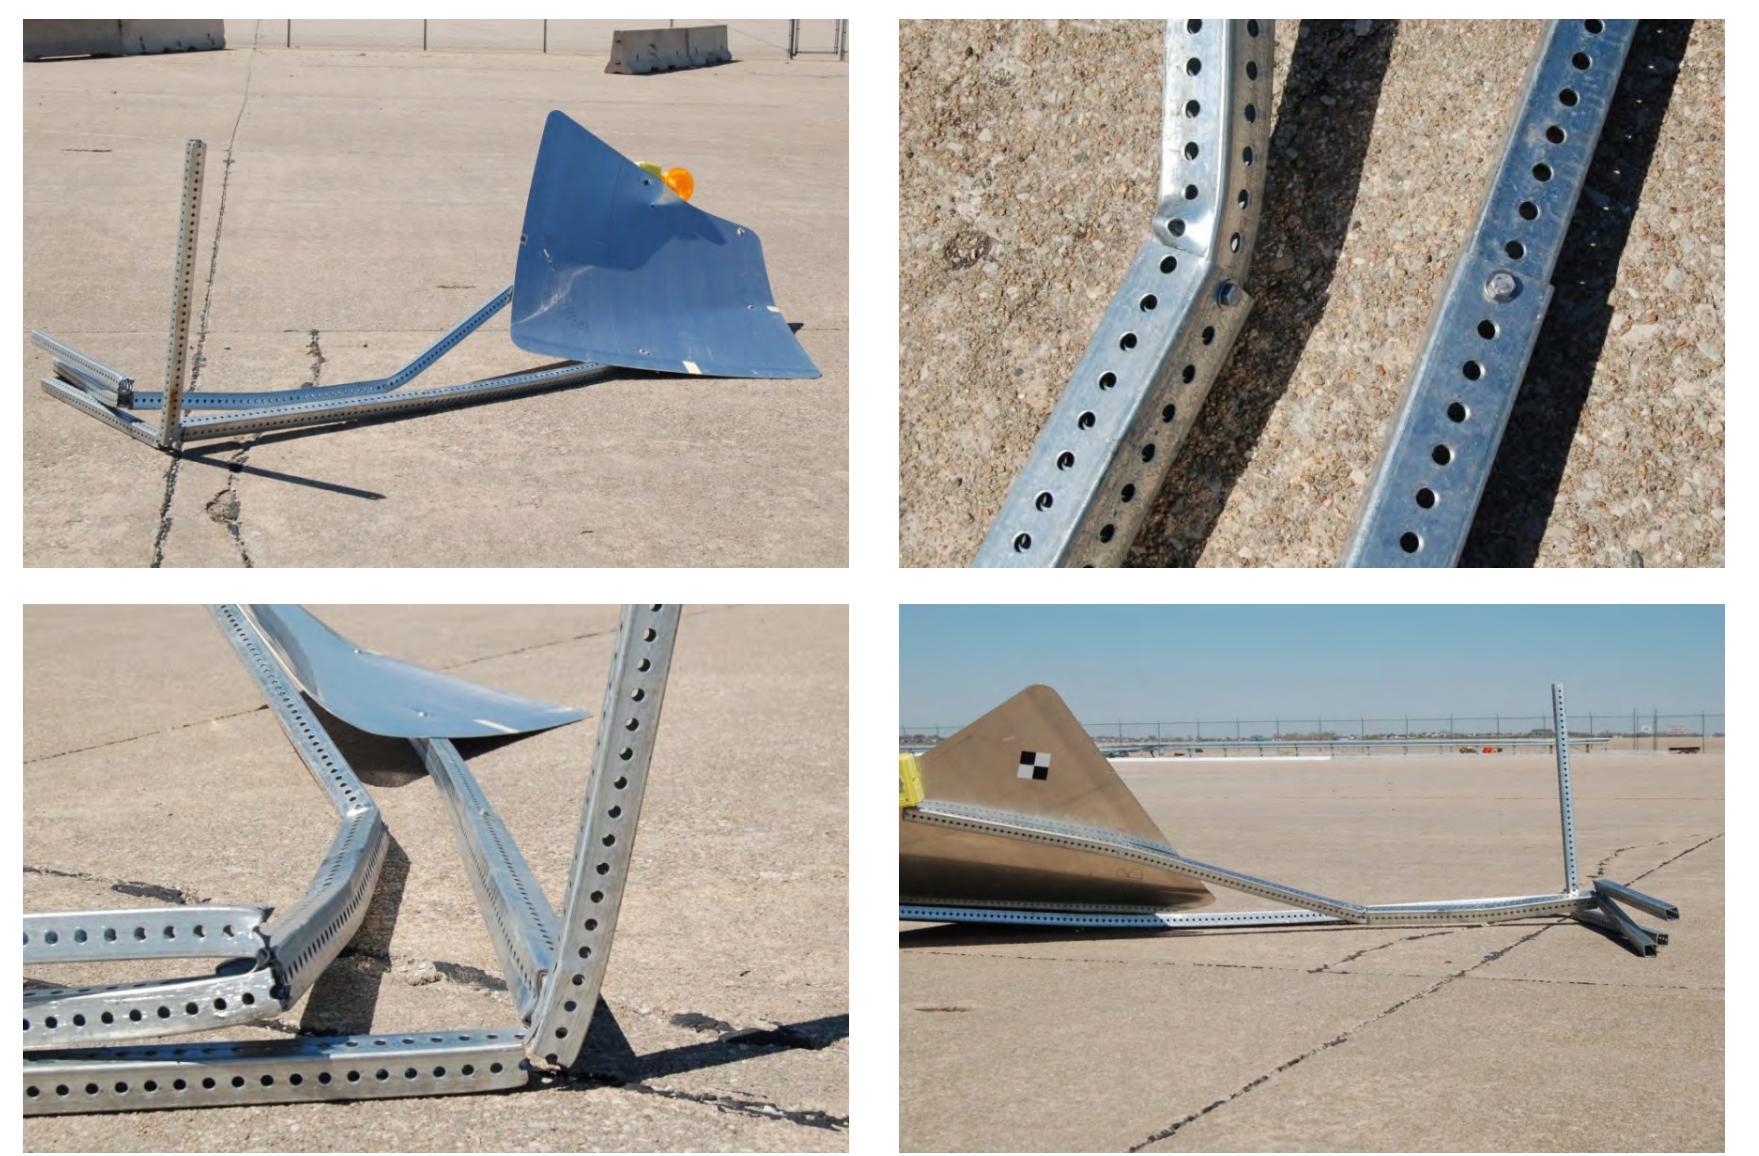
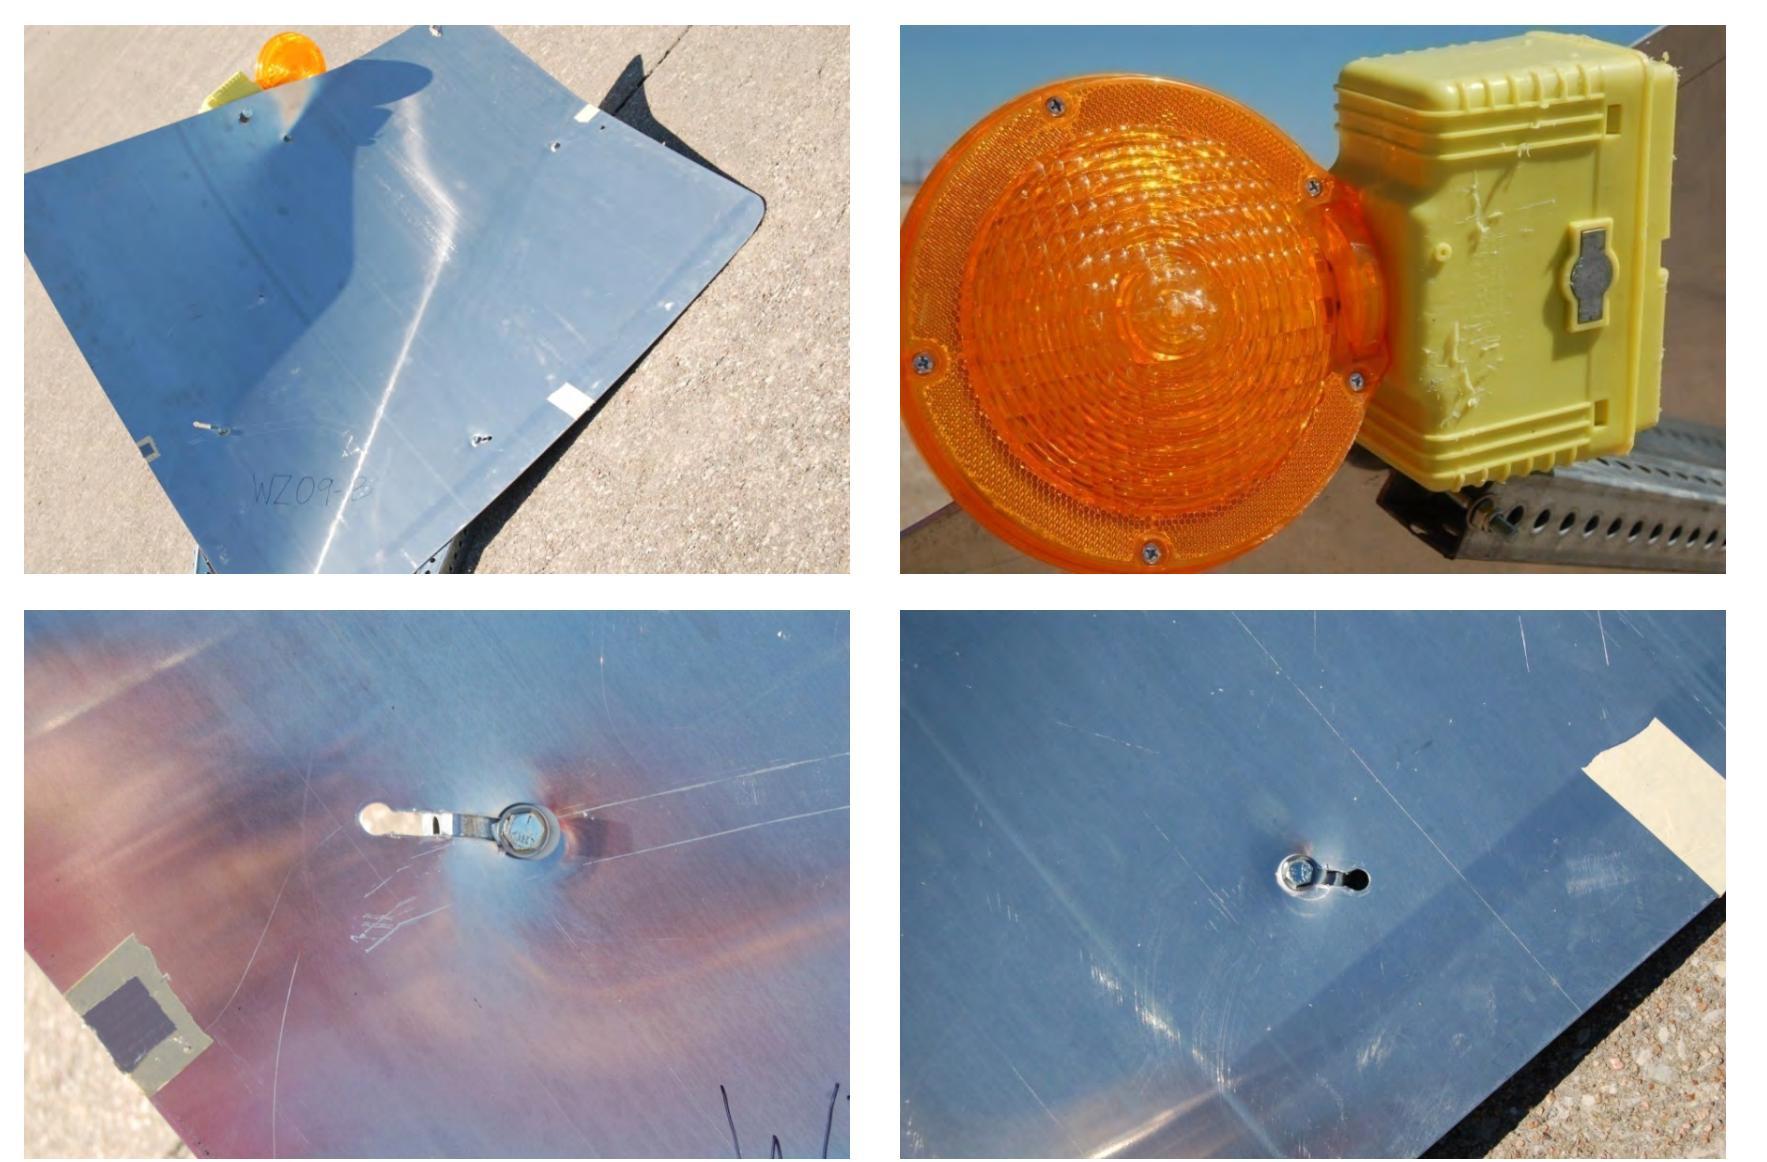
System No. 1B was also determined to be unacceptable according to the MASH criteria due to the light and mast penetrating the windshield, windshield indentation greater than 3 in. (76 mm), and significant windshield cracking, which caused the obstruction of driver visibility and the loss of structure in both glass layers in the windshield. Deformations of, and intrusion into, the occupant compartment did occur as System No. 1B penetrated into the occupant compartment near the upper-center region and upper-left corner of the windshield when the light, mast, and sign panel contacted the windshield. The vehicle's trajectory did not intrude into adjacent traffic lanes.

Figure 55. System Damage, Test No. WZ09-1B

Figure 56. System Damage, Test No. WZ09-1B

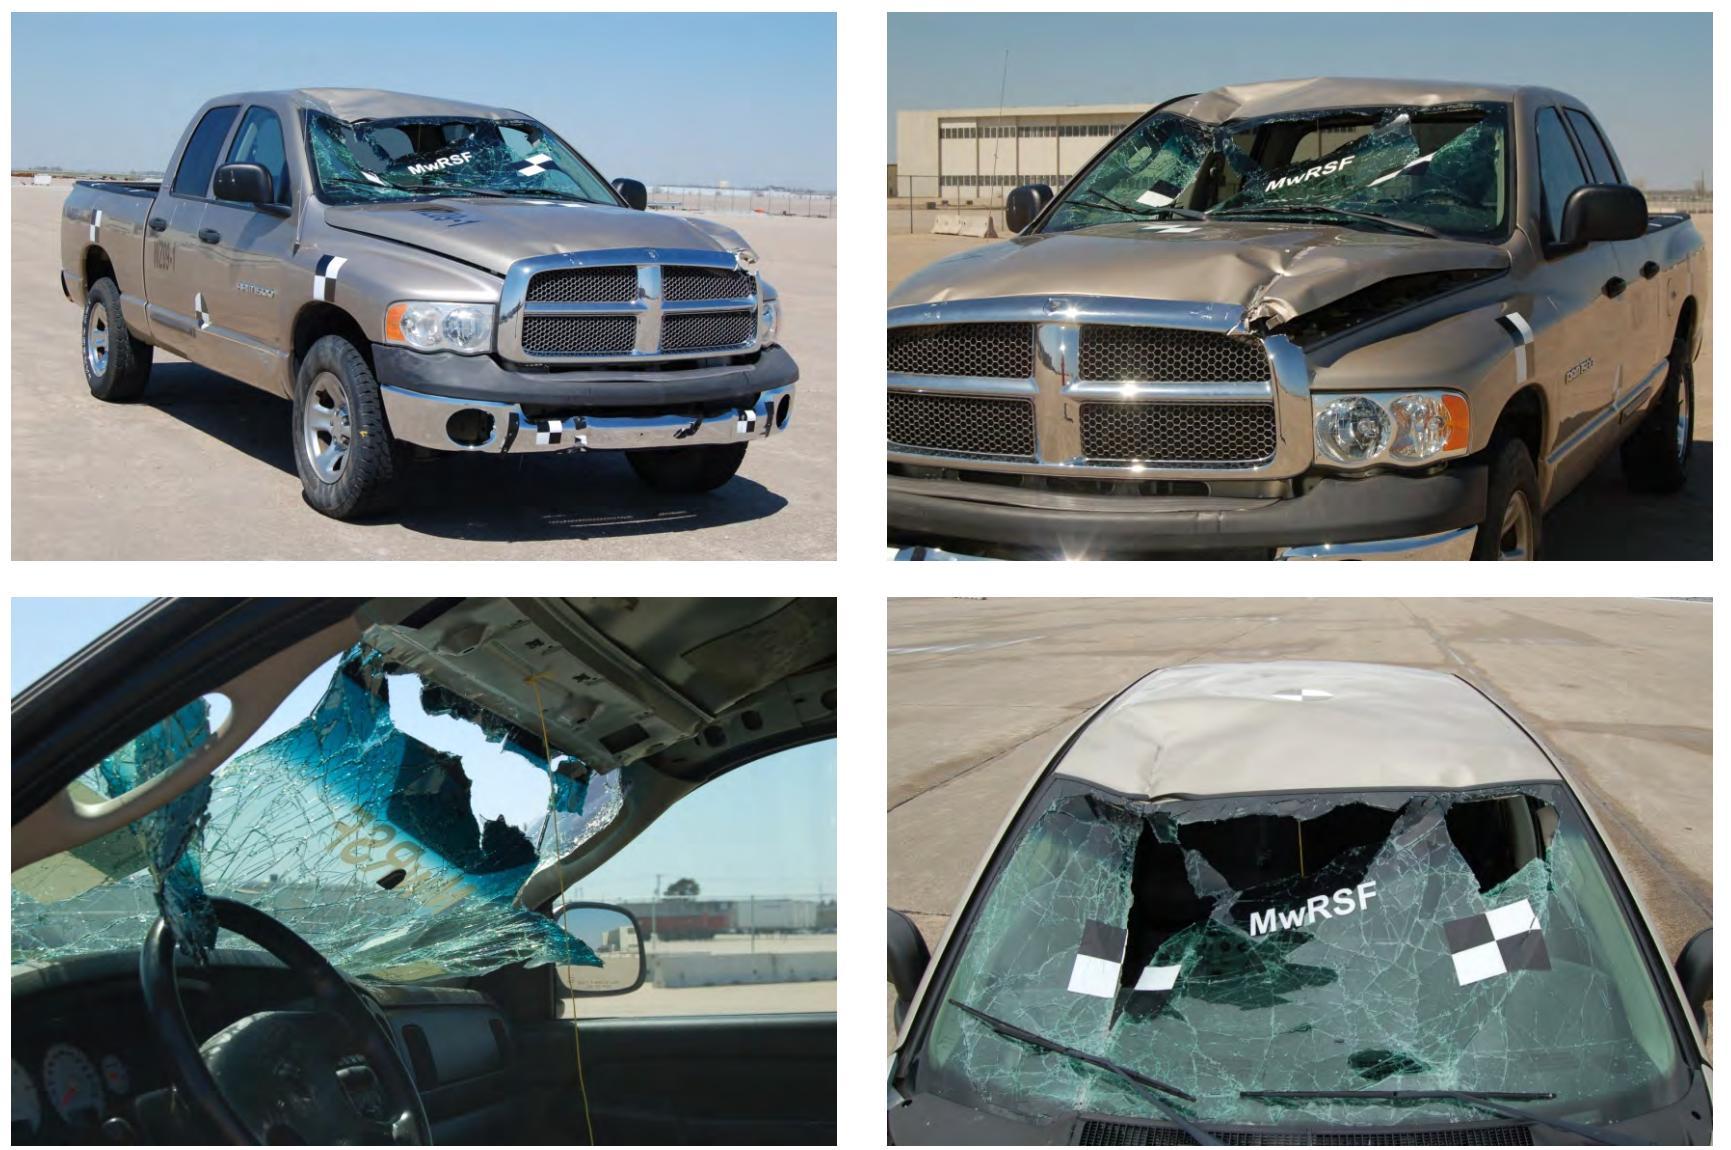
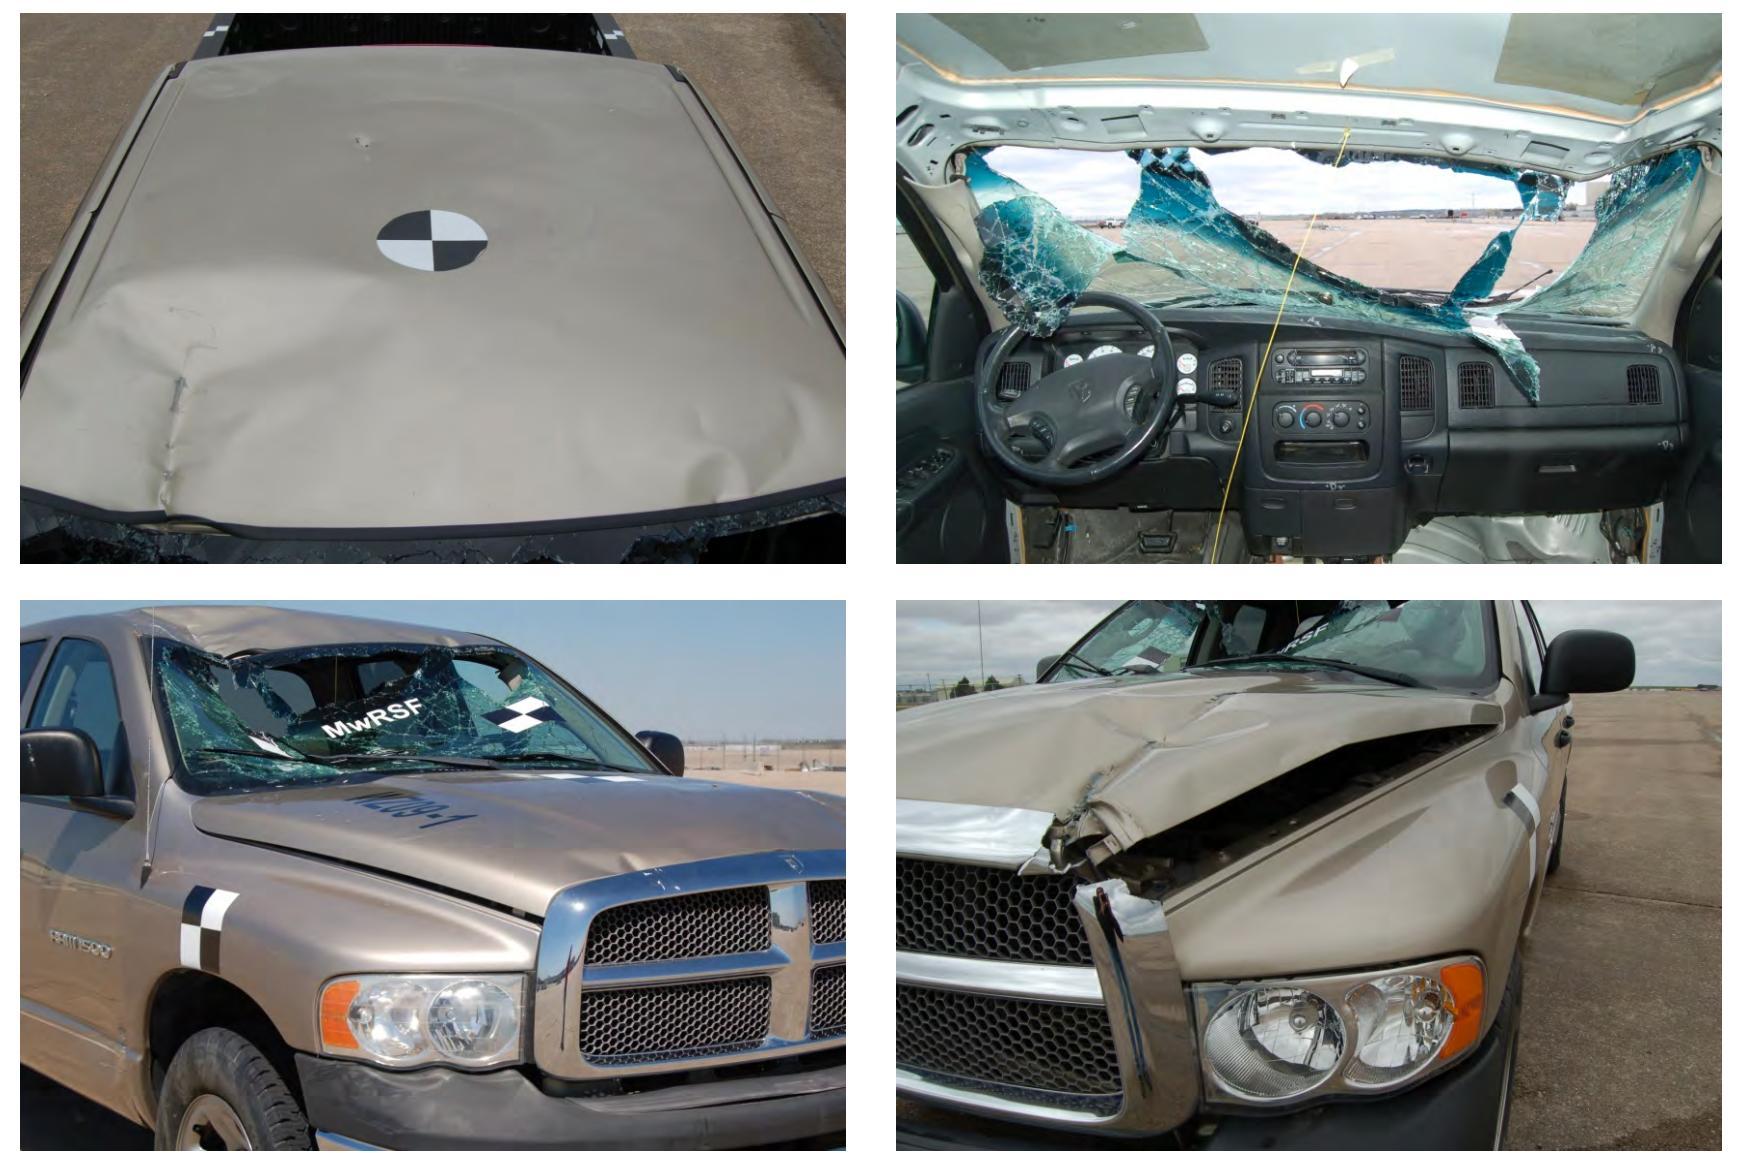
Figure 57. Vehicle Damage, Test No. WZ09-1

Figure 58. Vehicle Damage, Test No. WZ09-1

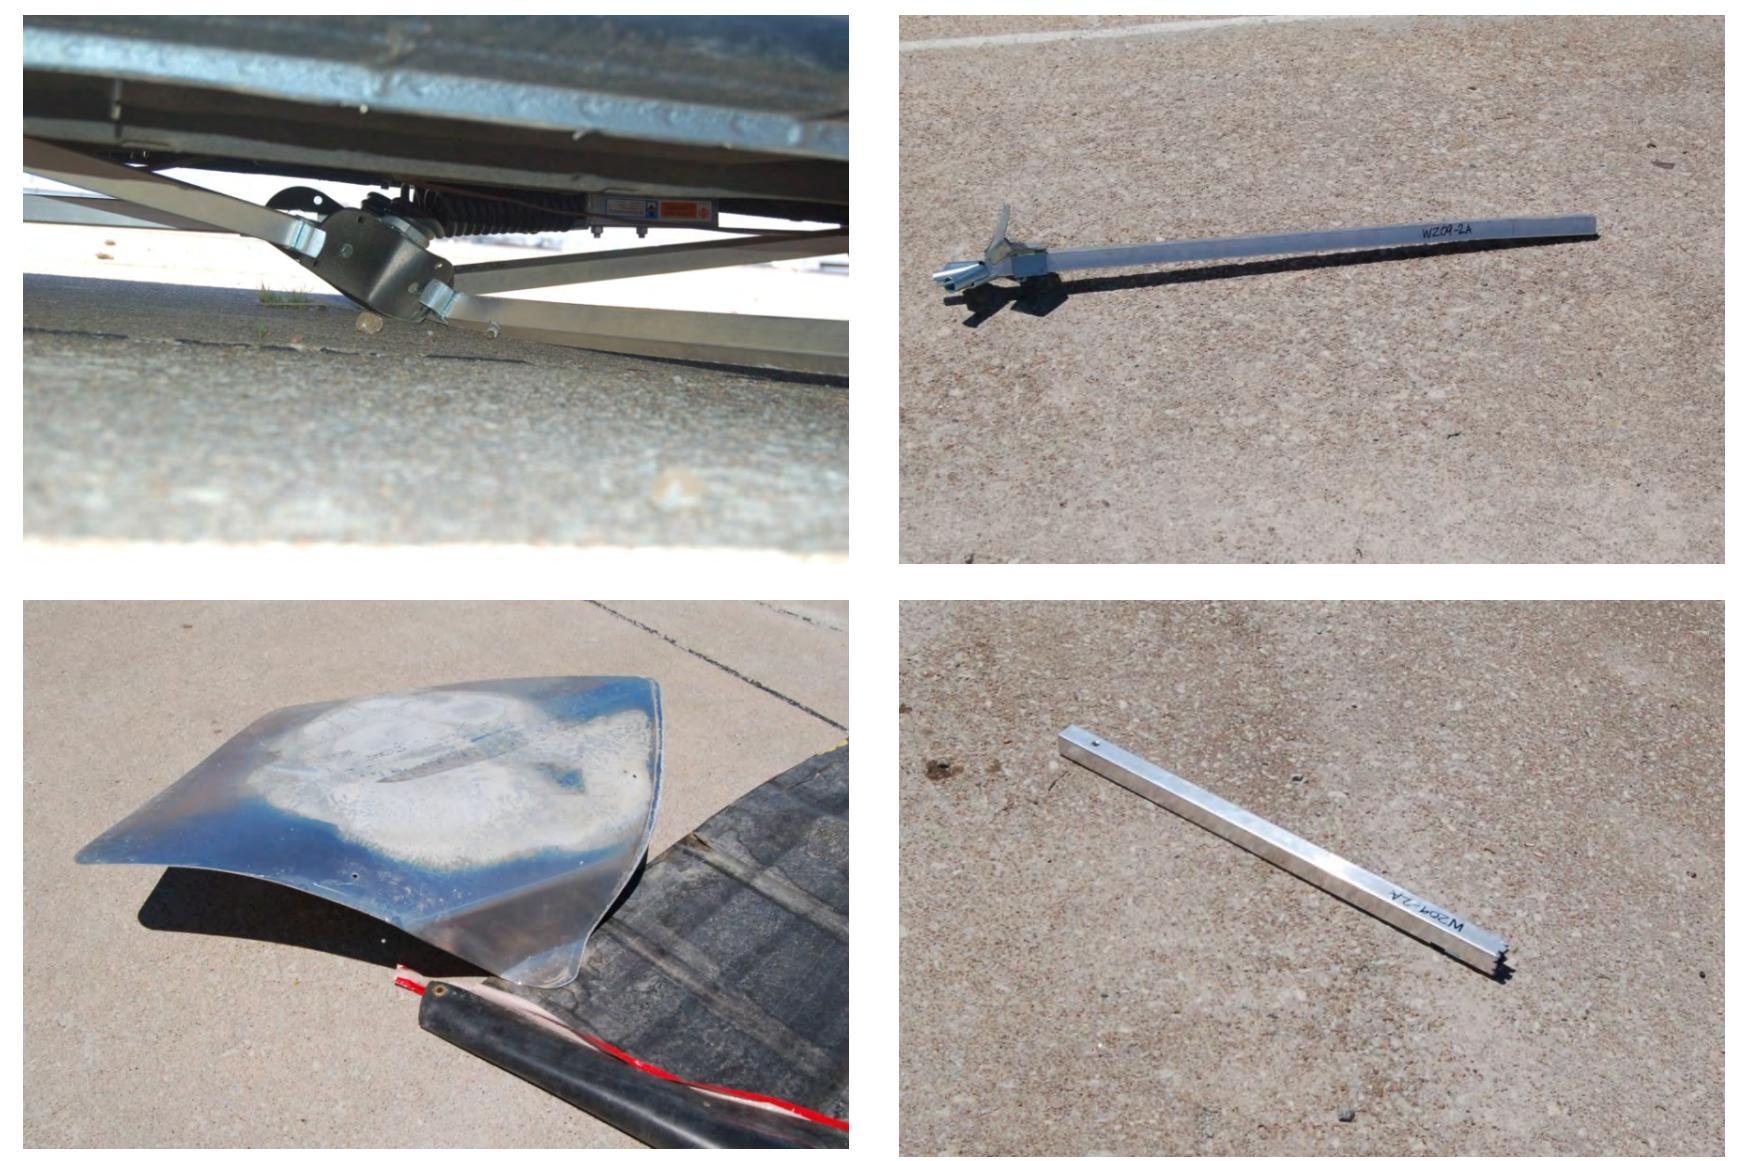
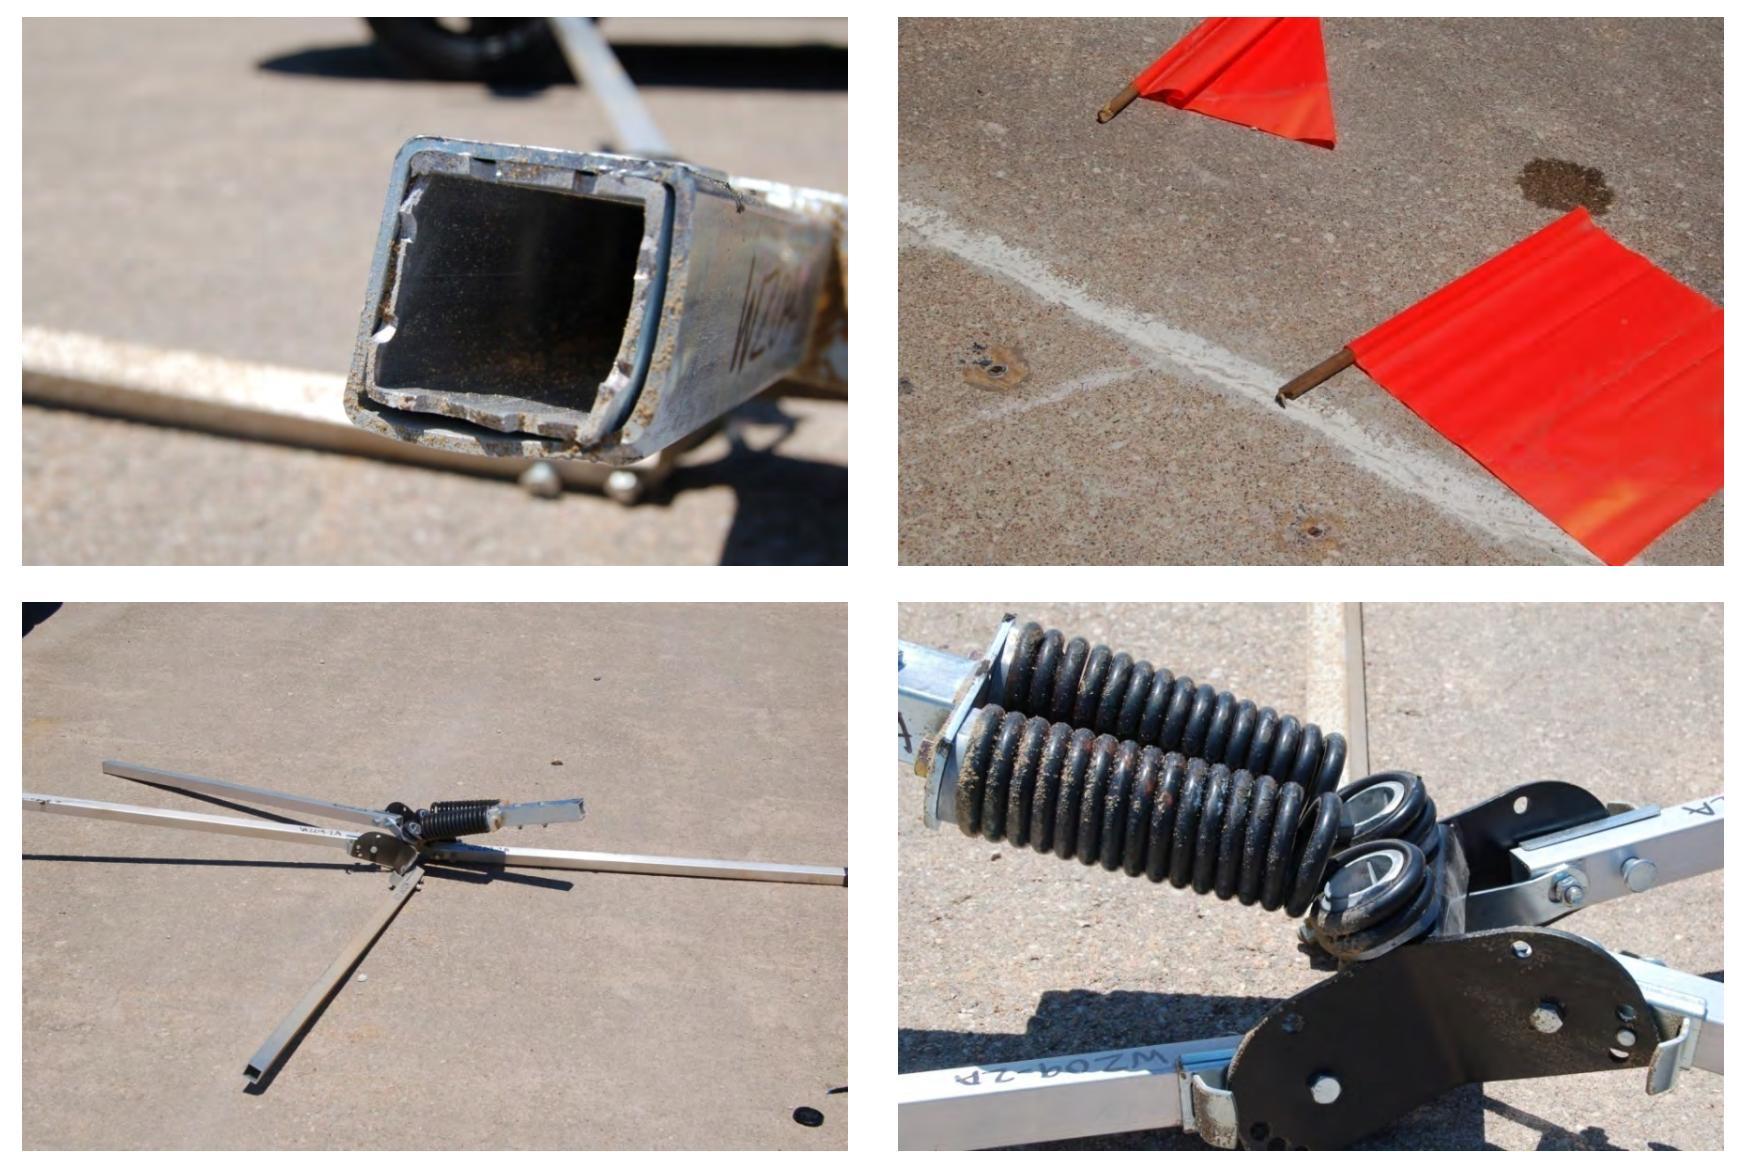
Figure 67. System Damage, Test No. WZ09-2A

Figure 68. System Damage, Test No. WZ09-2A

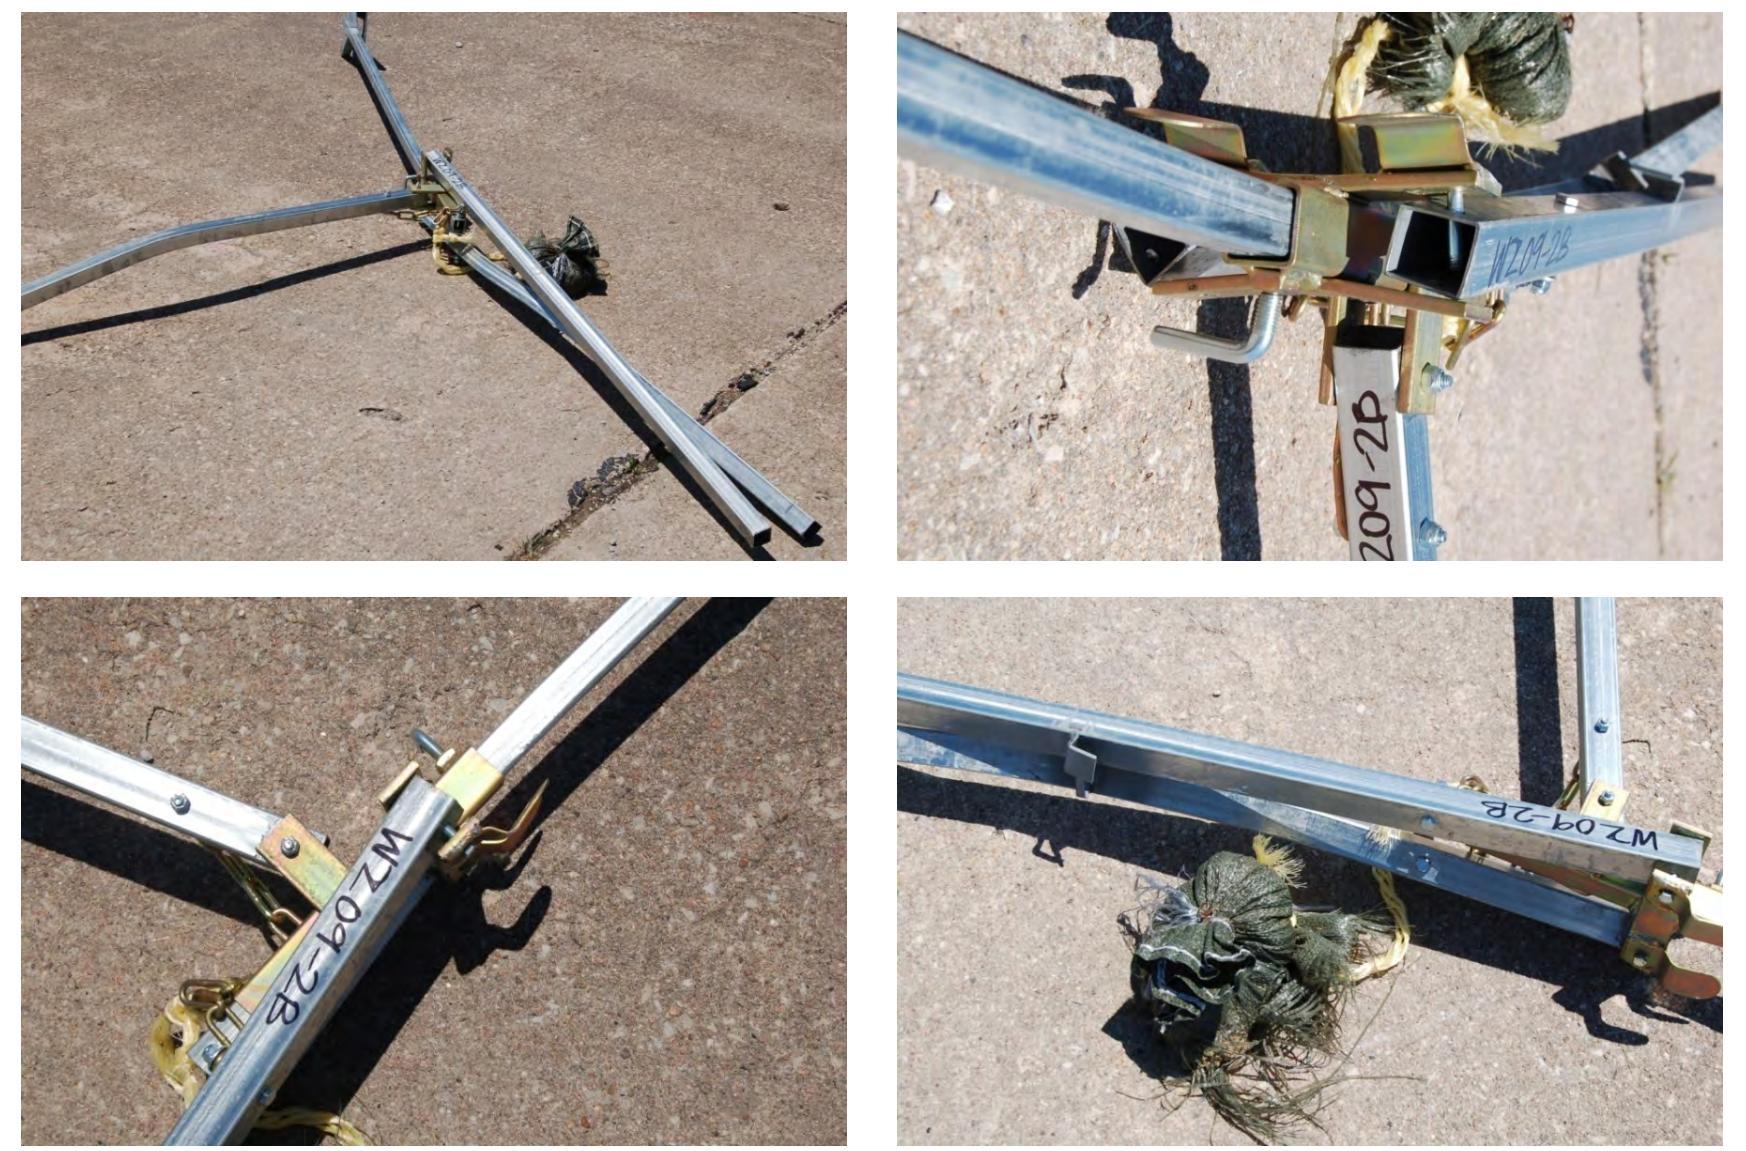
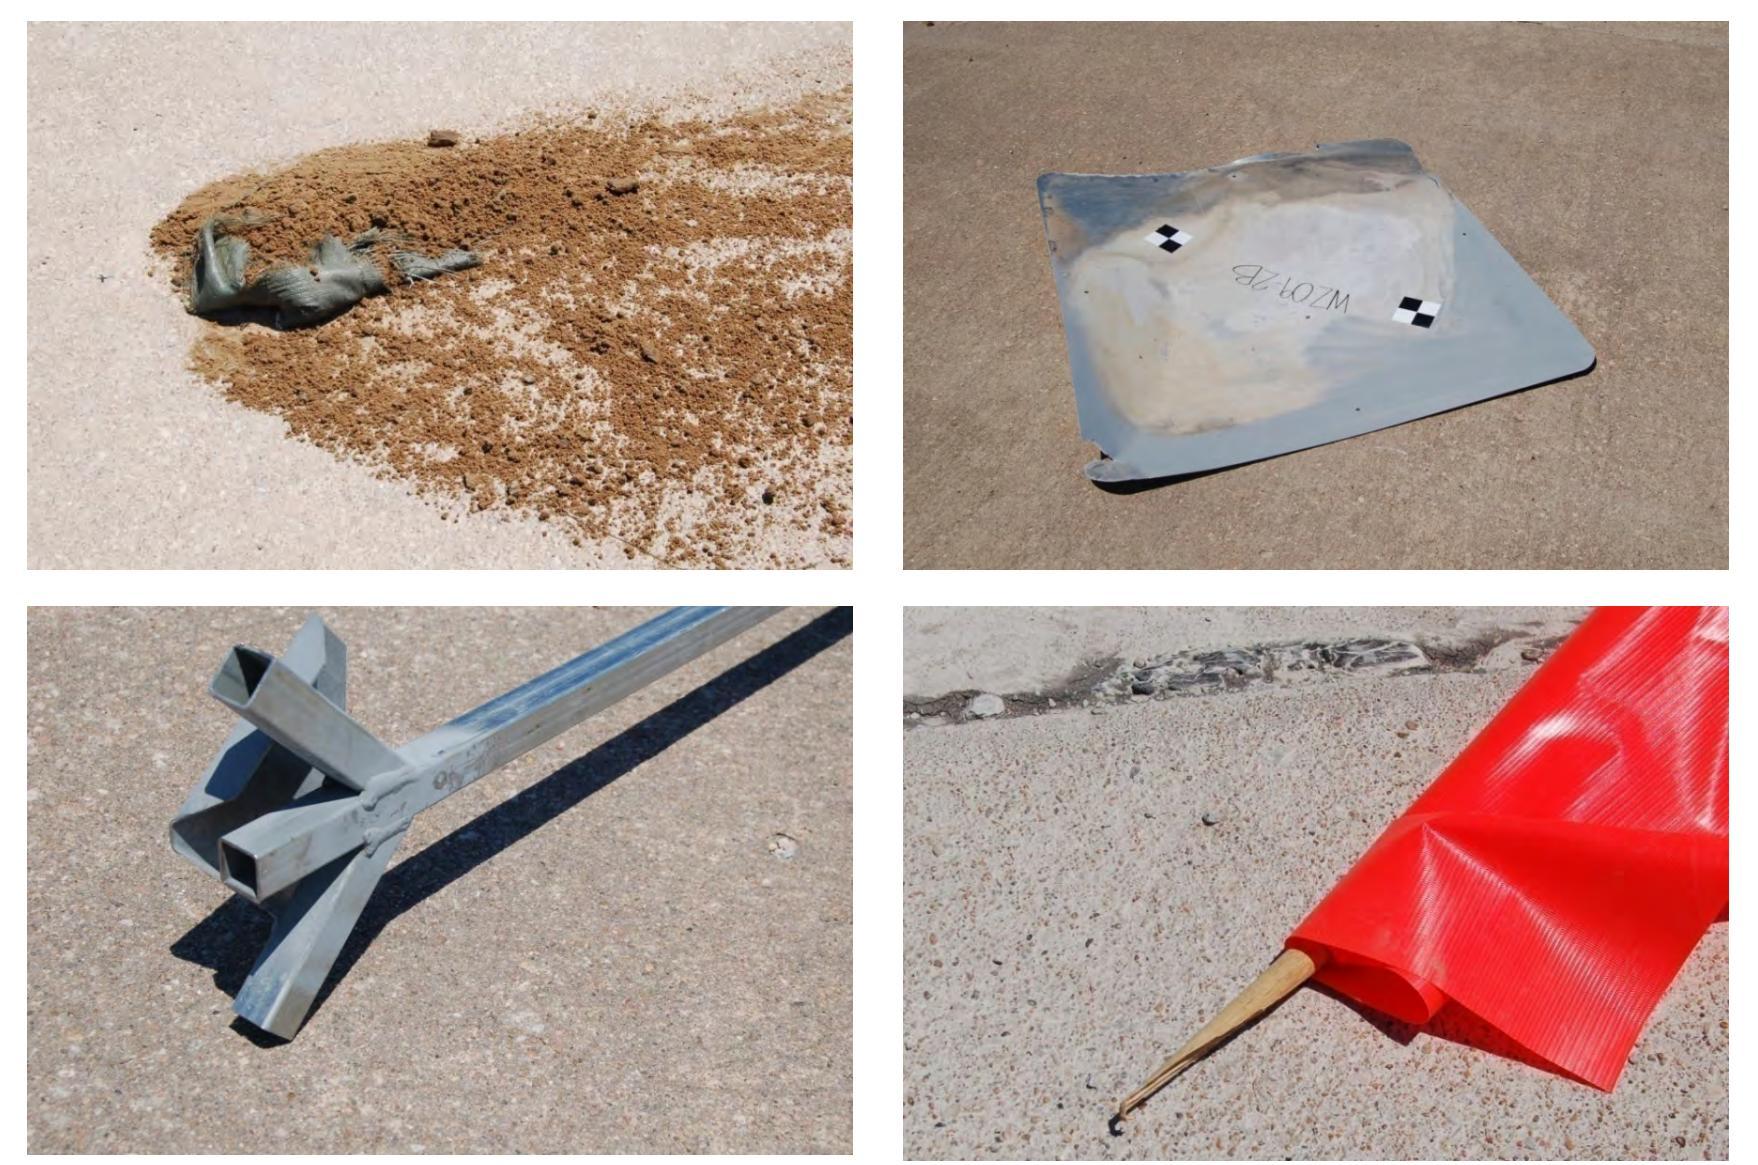
Figure 69. System Damage, Test No. WZ09-2B

Figure 70. System Damage, Test No. WZ09-2B
