## Analysis of Existing Work-Zone Devices with MASH Safety Performance Criteria

Final Report February 2009

## MIDWEST ROADSIDE SAFETY FACILITY

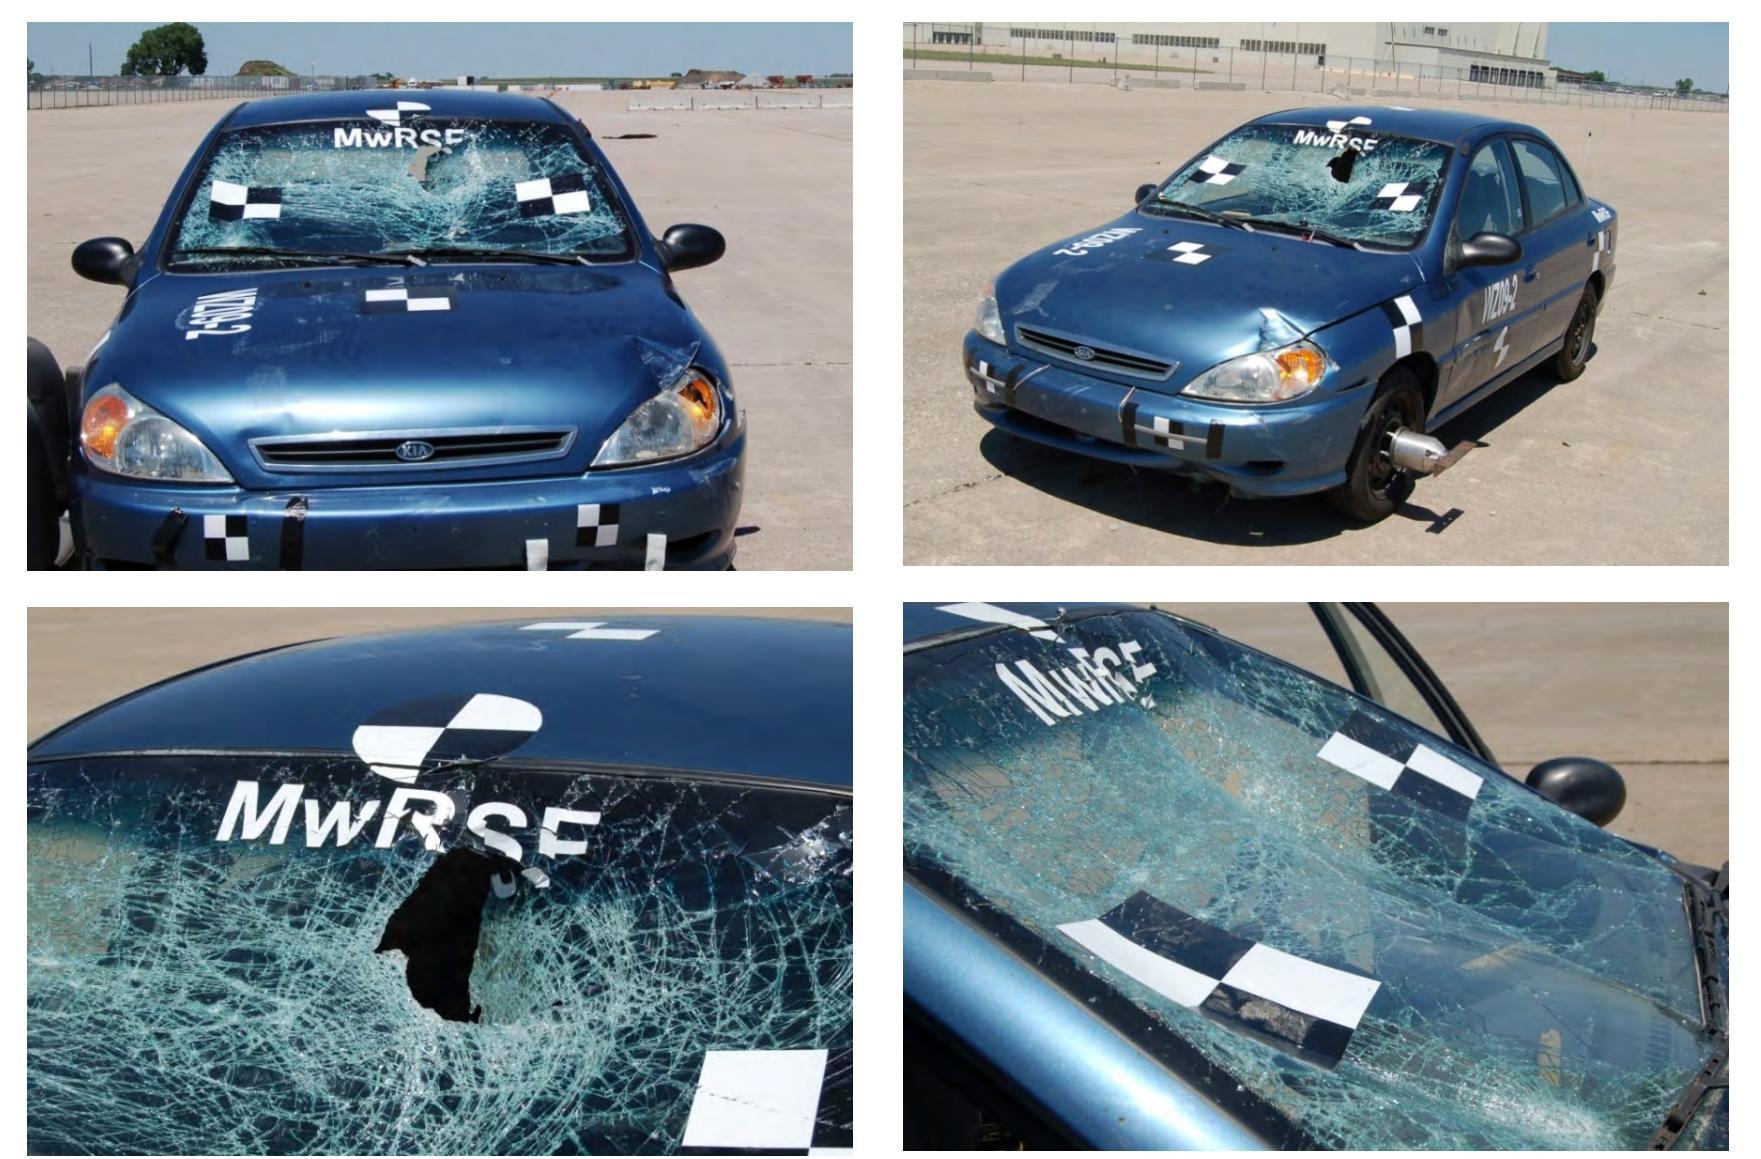
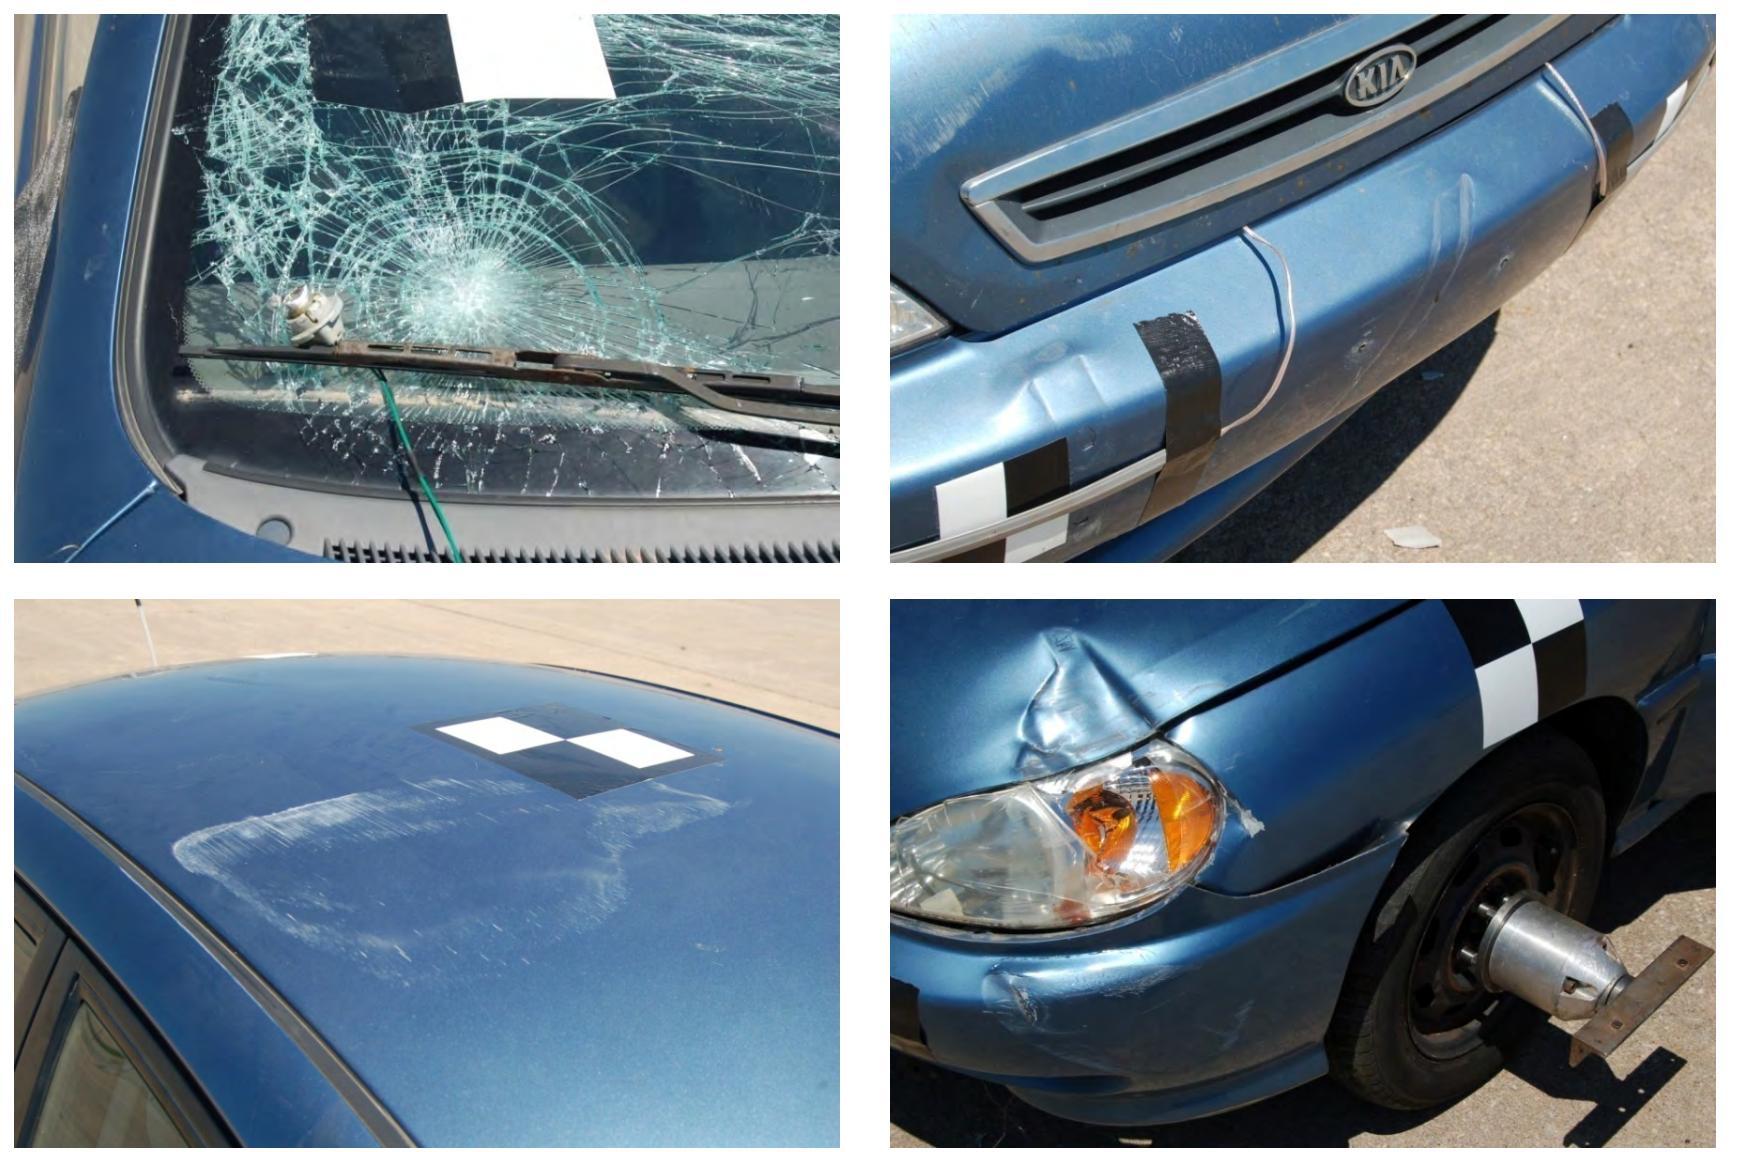
Figure 71. Vehicle Damage, Test No. WZ09-2

Figure 72. Vehicle Damage, Test No. WZ09-2

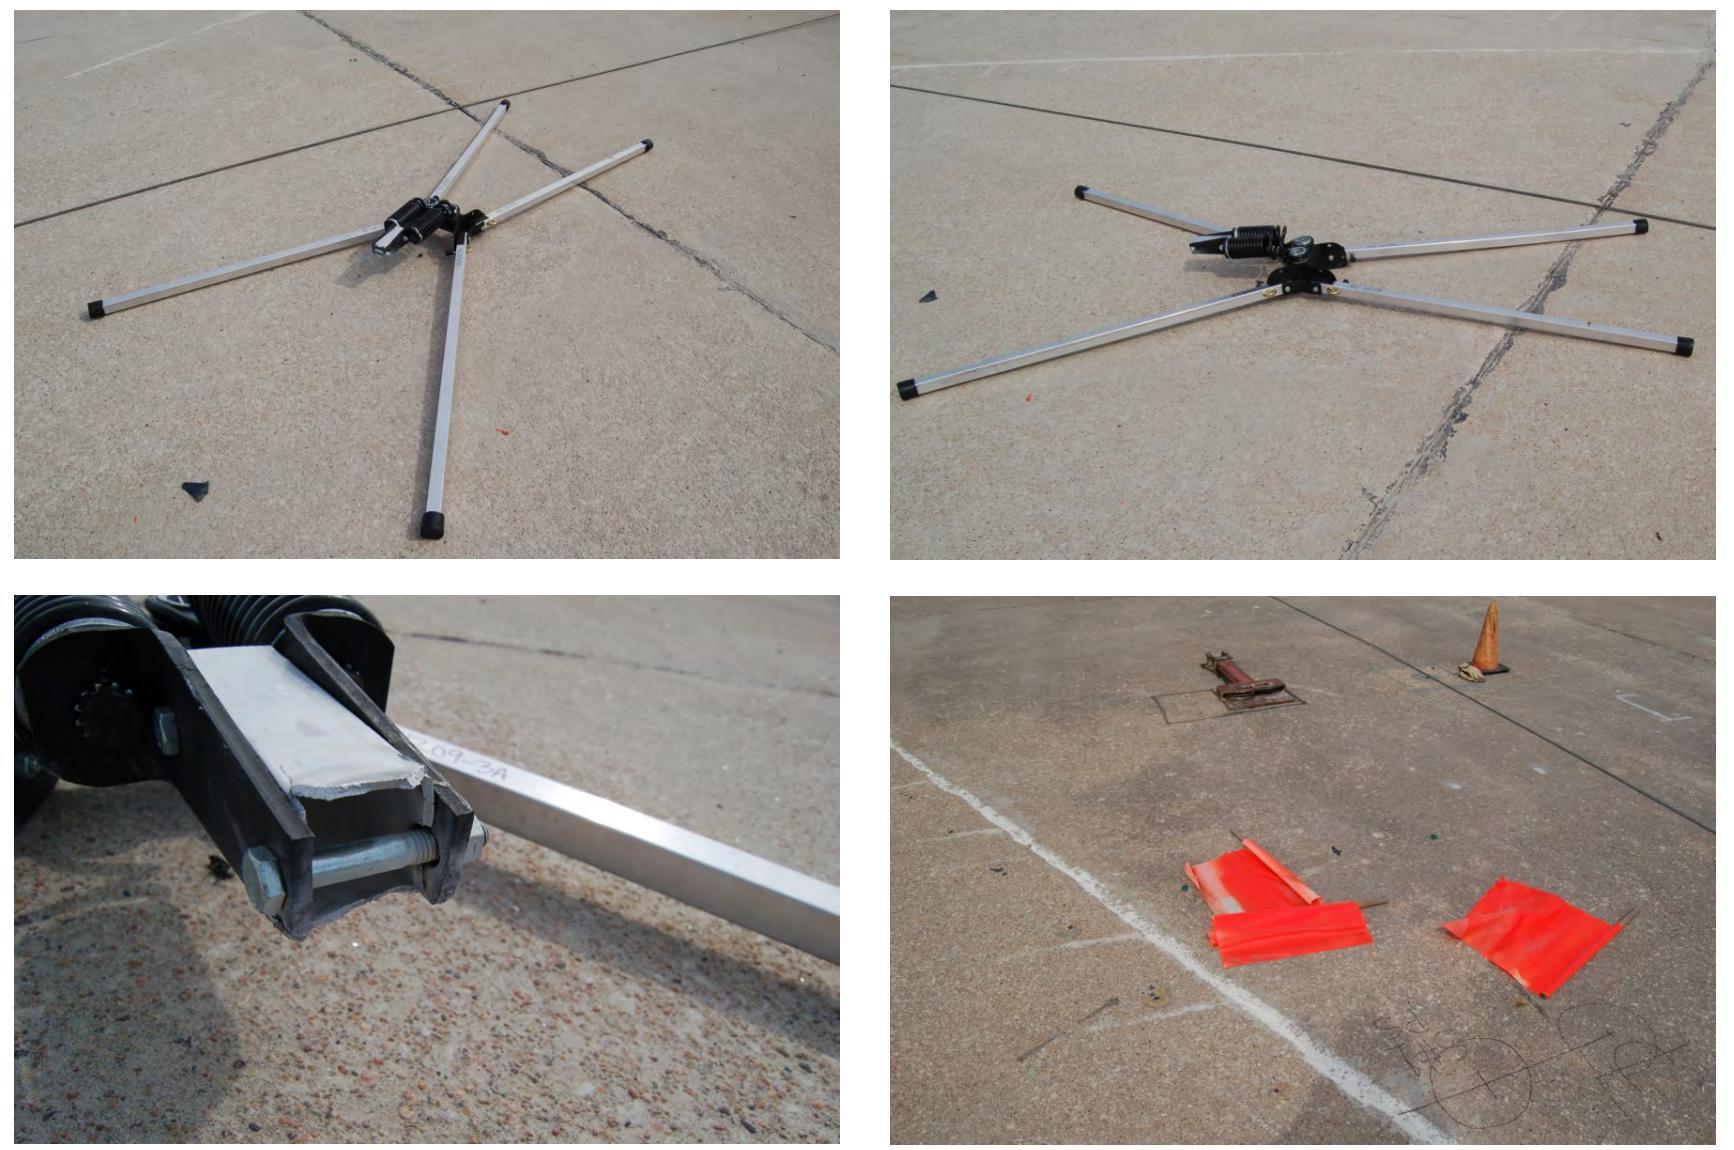
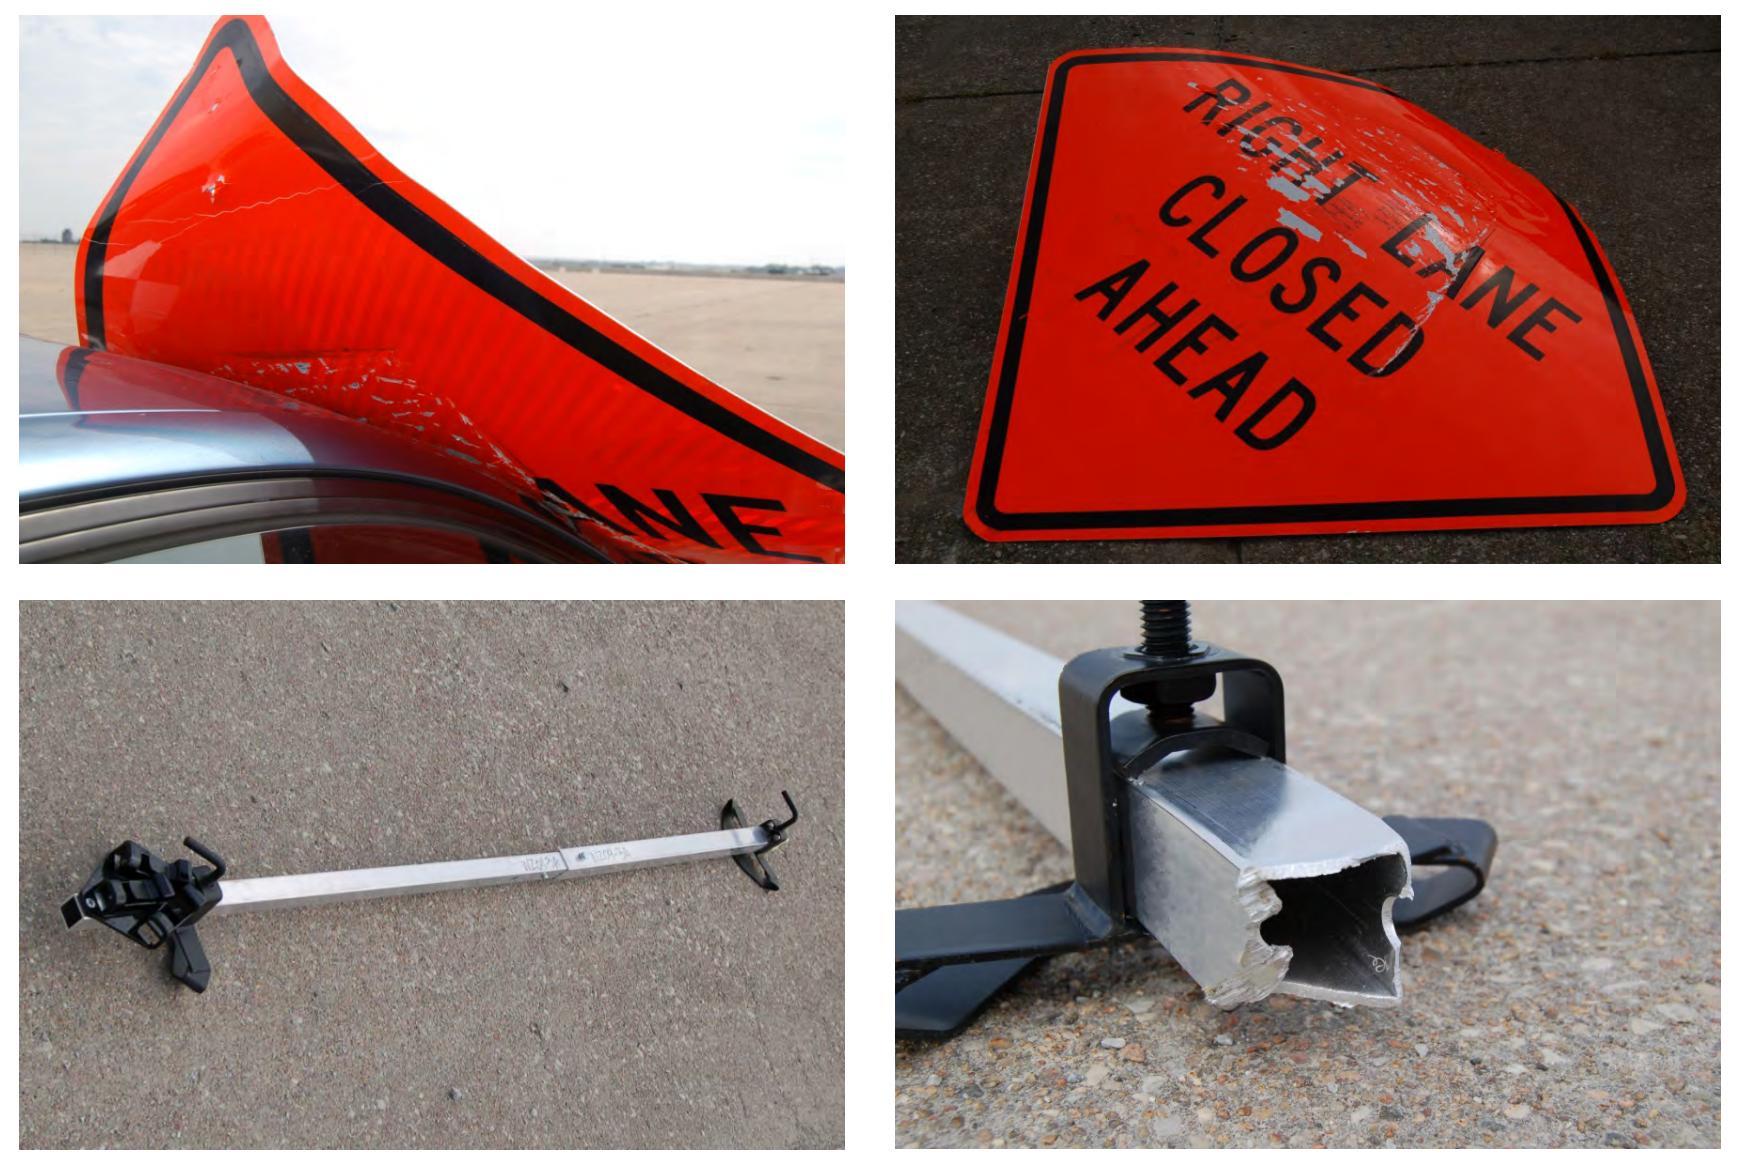
Figure 82. System Damage, Test No. WZ09-3A

Figure 83. System Damage, Test No. WZ09-3A

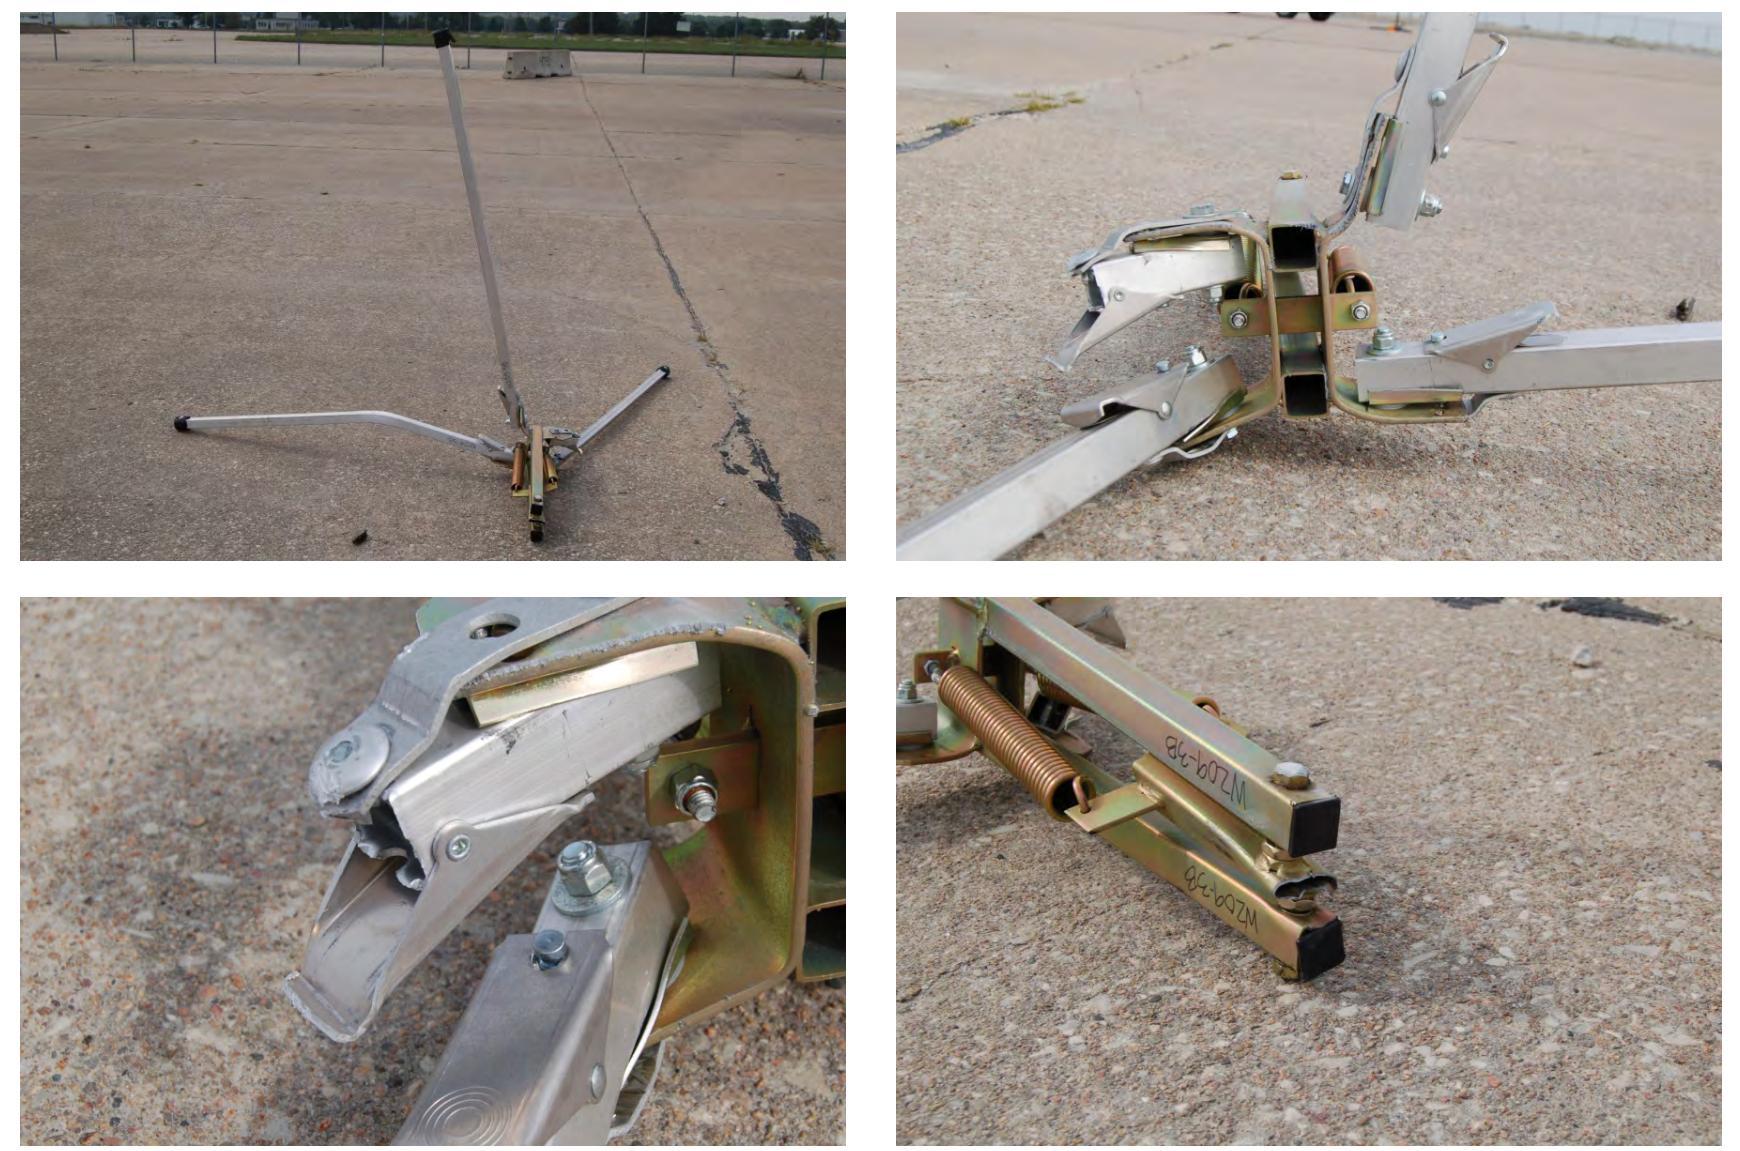
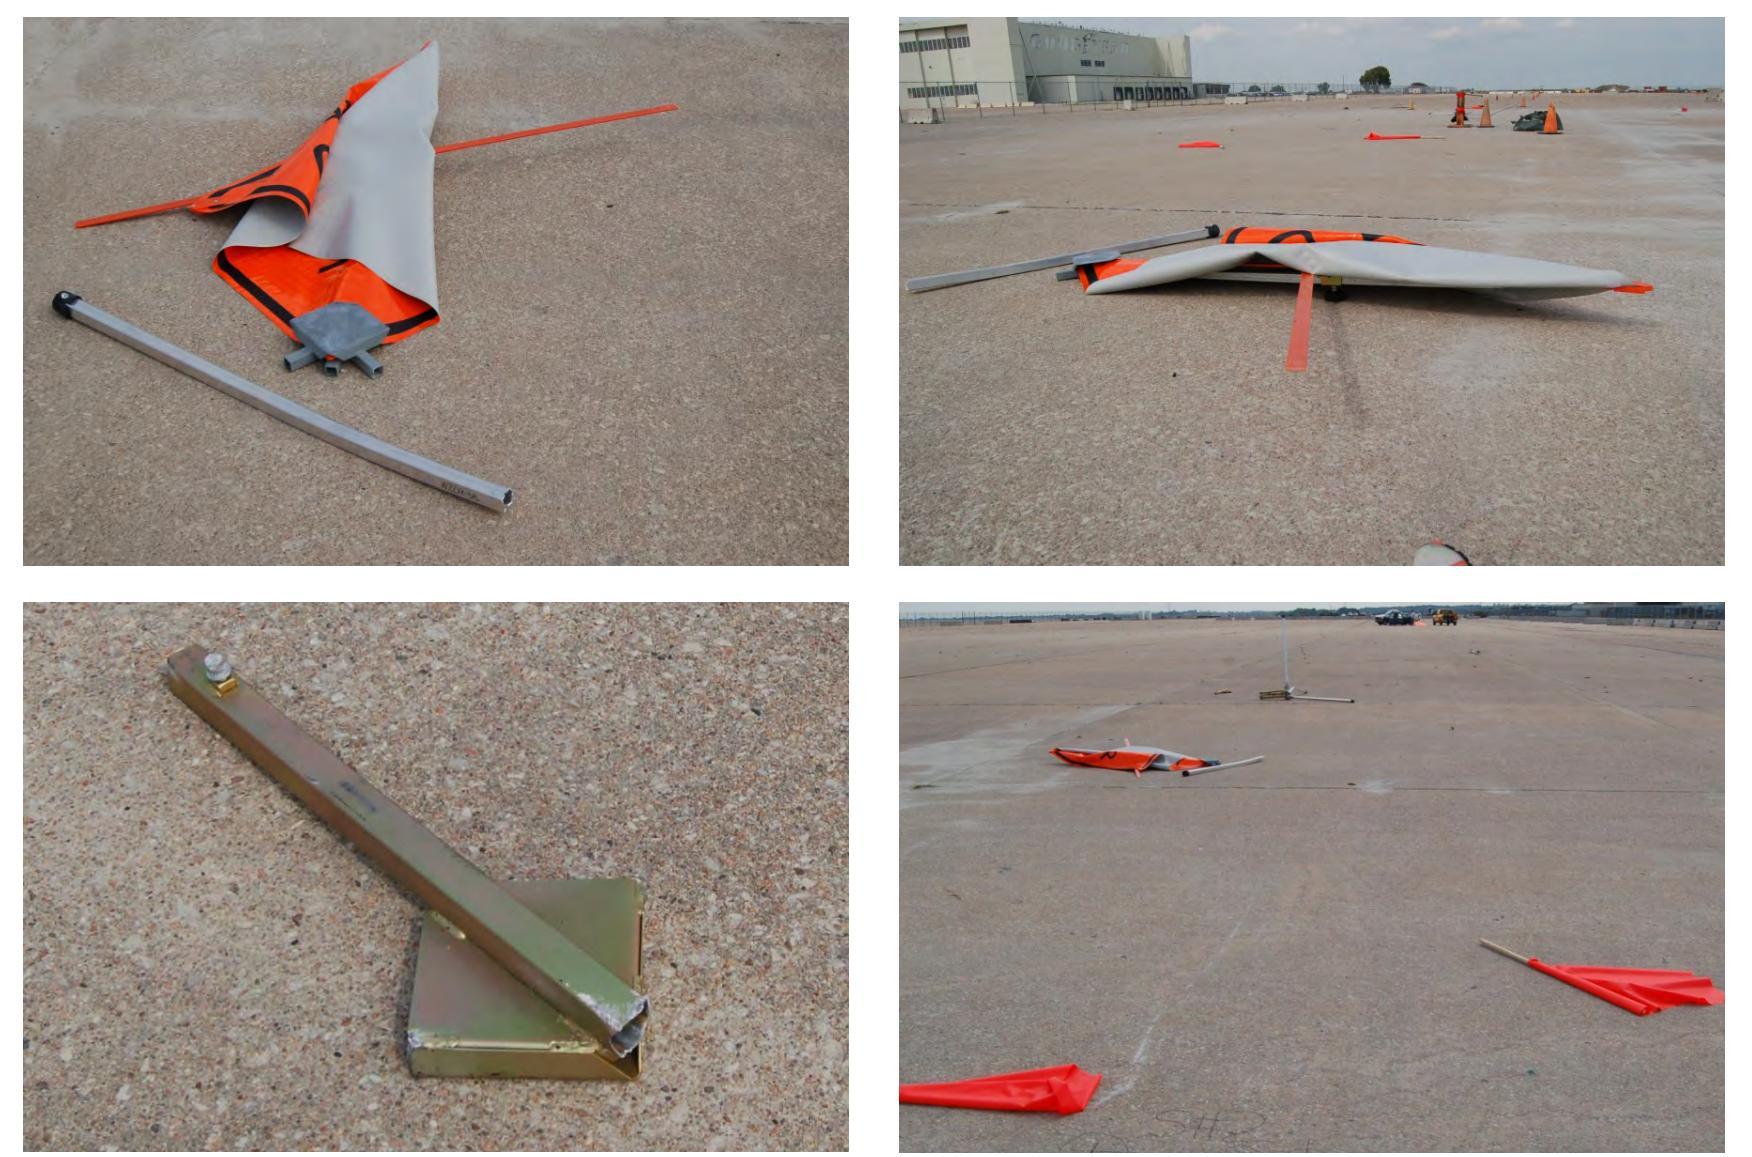
Figure 84. System Damage, Test No. WZ09-3B

Figure 85. System Damage, Test No. WZ09-3B

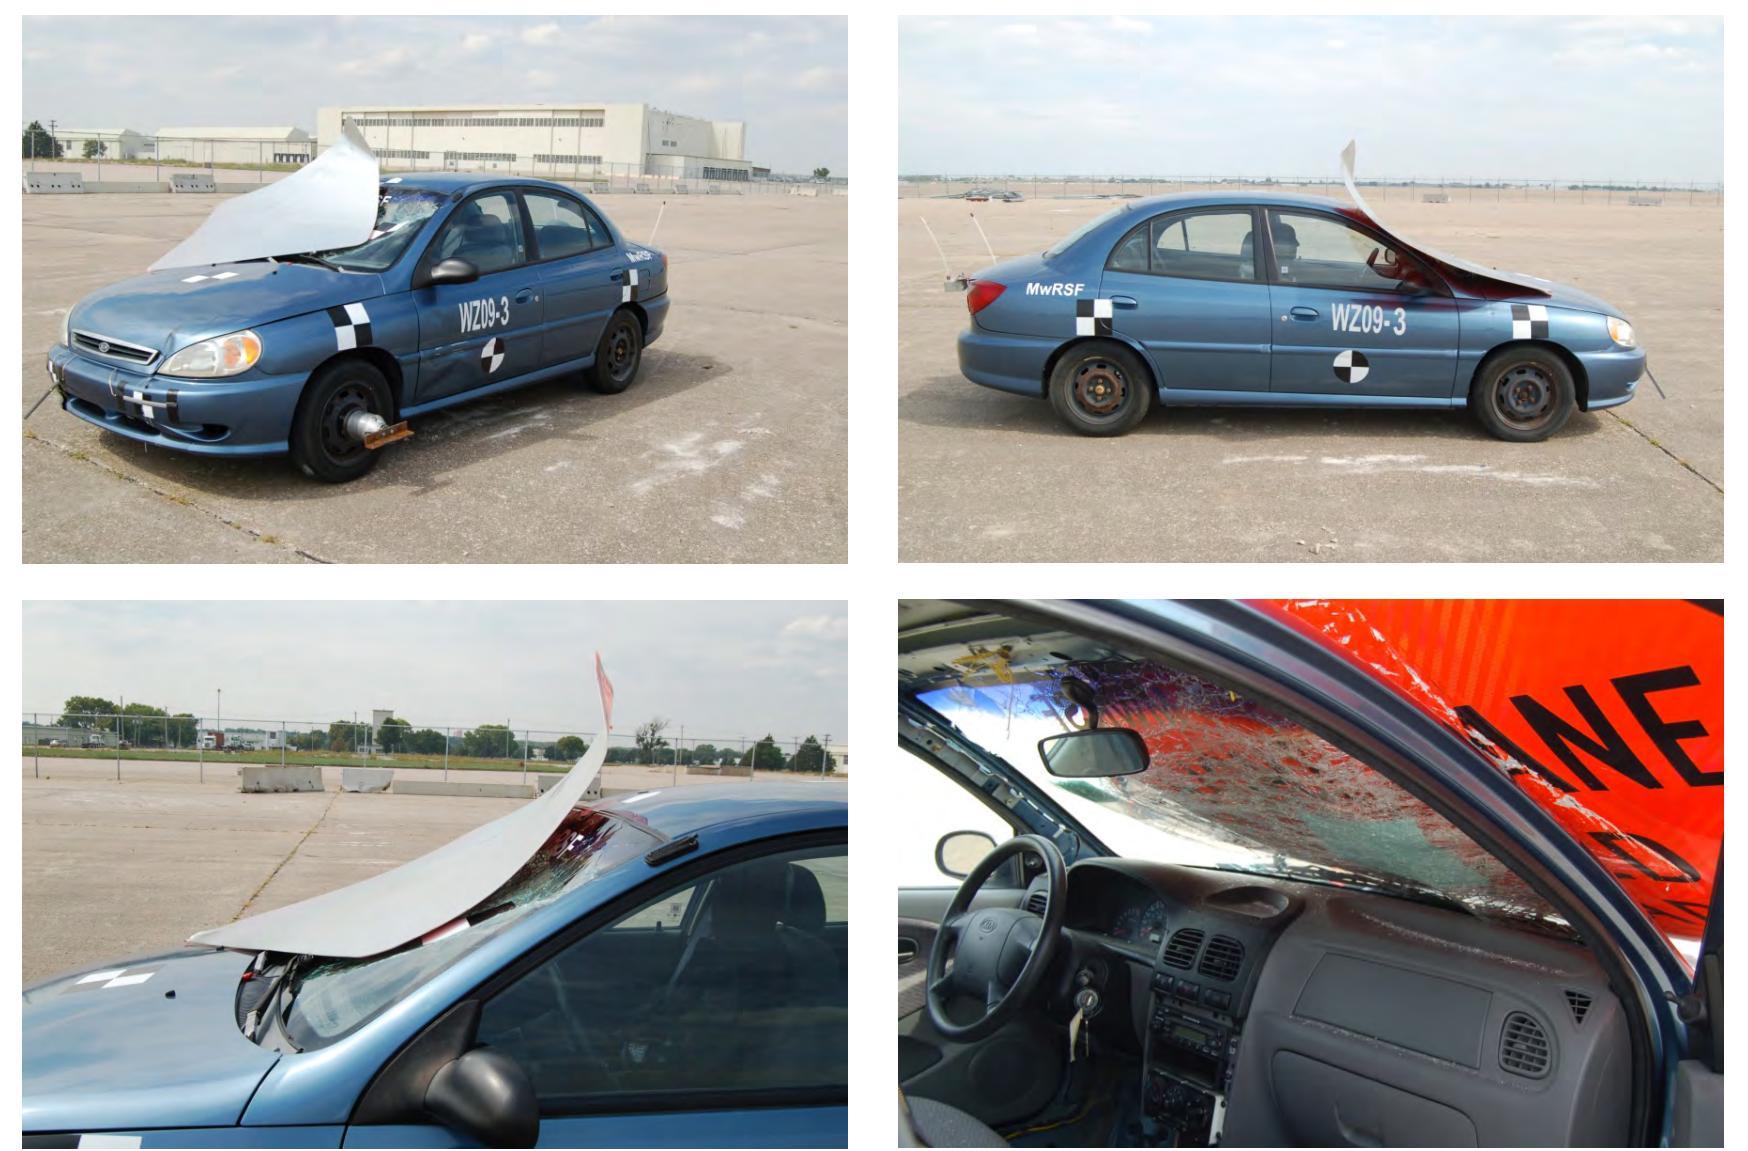
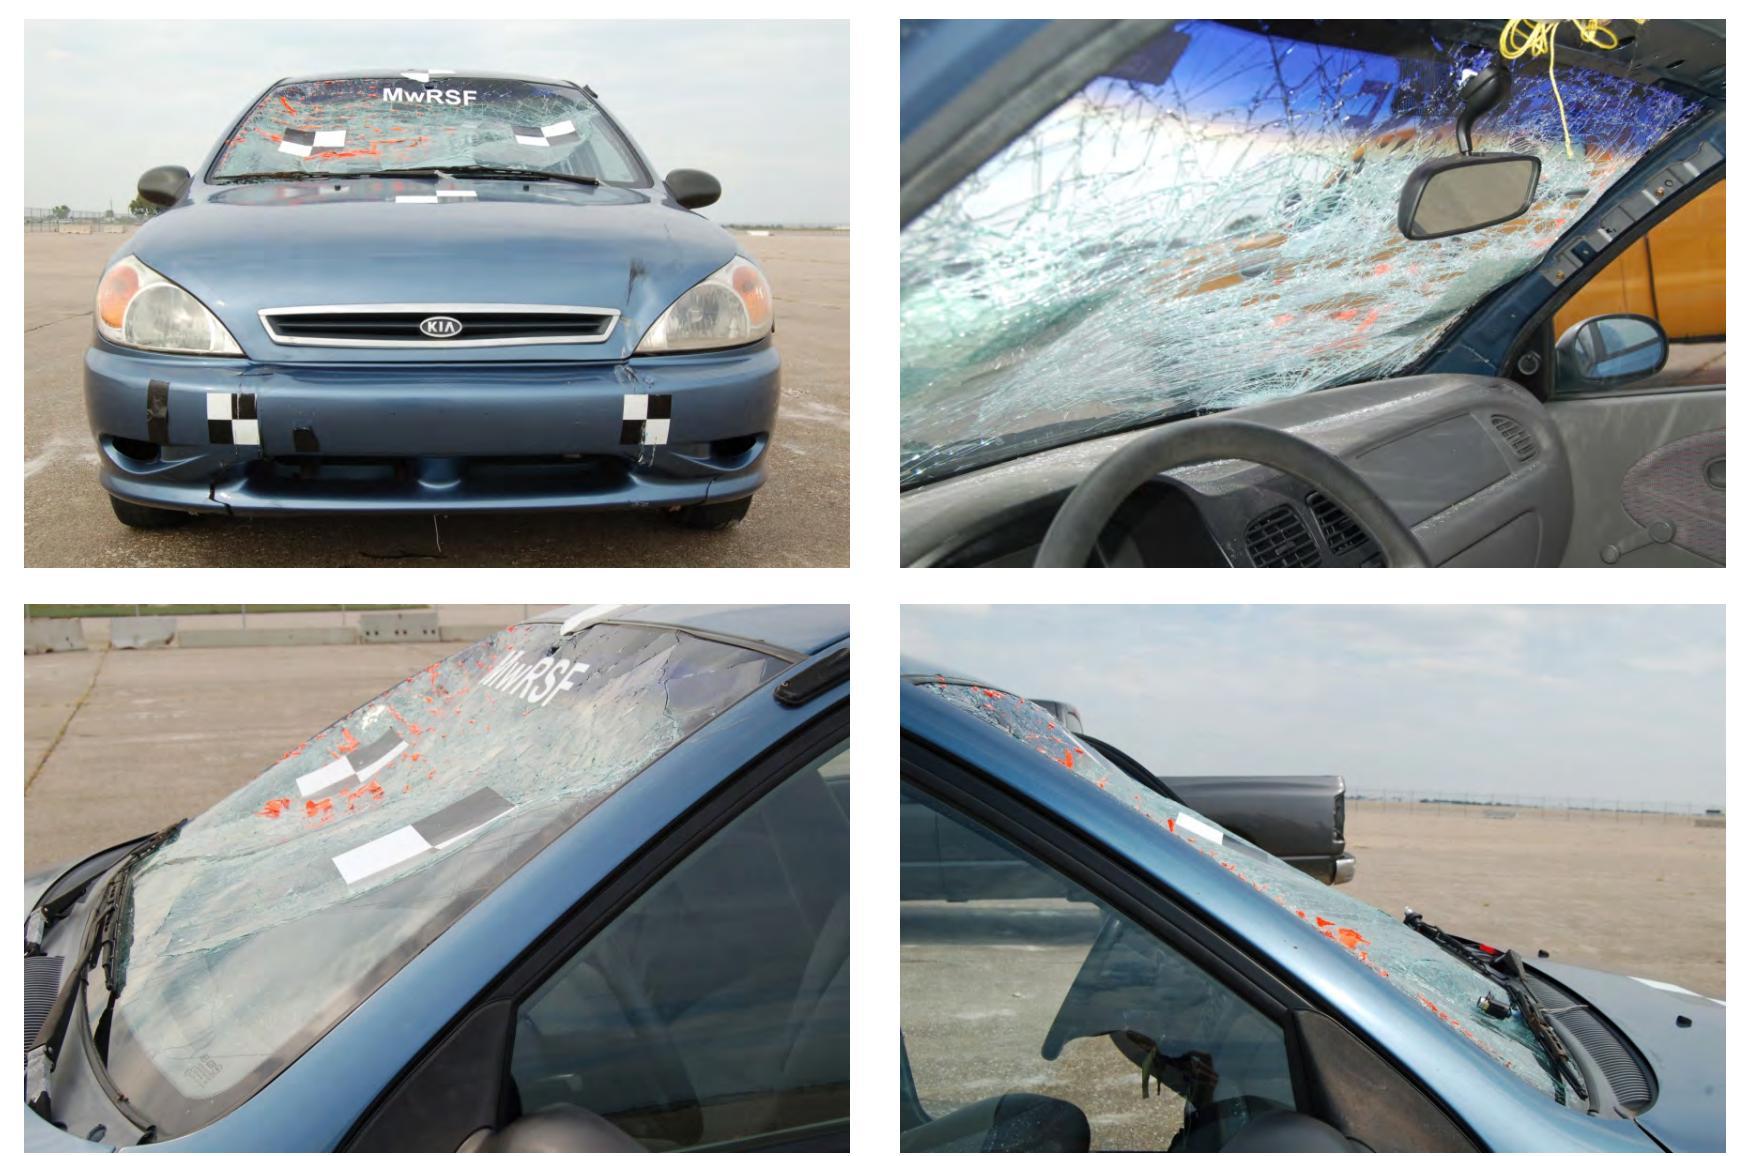
Figure 86. Vehicle Damage, Test No. WZ09-3

Figure 87. Vehicle Damage, Test No. WZ09-3

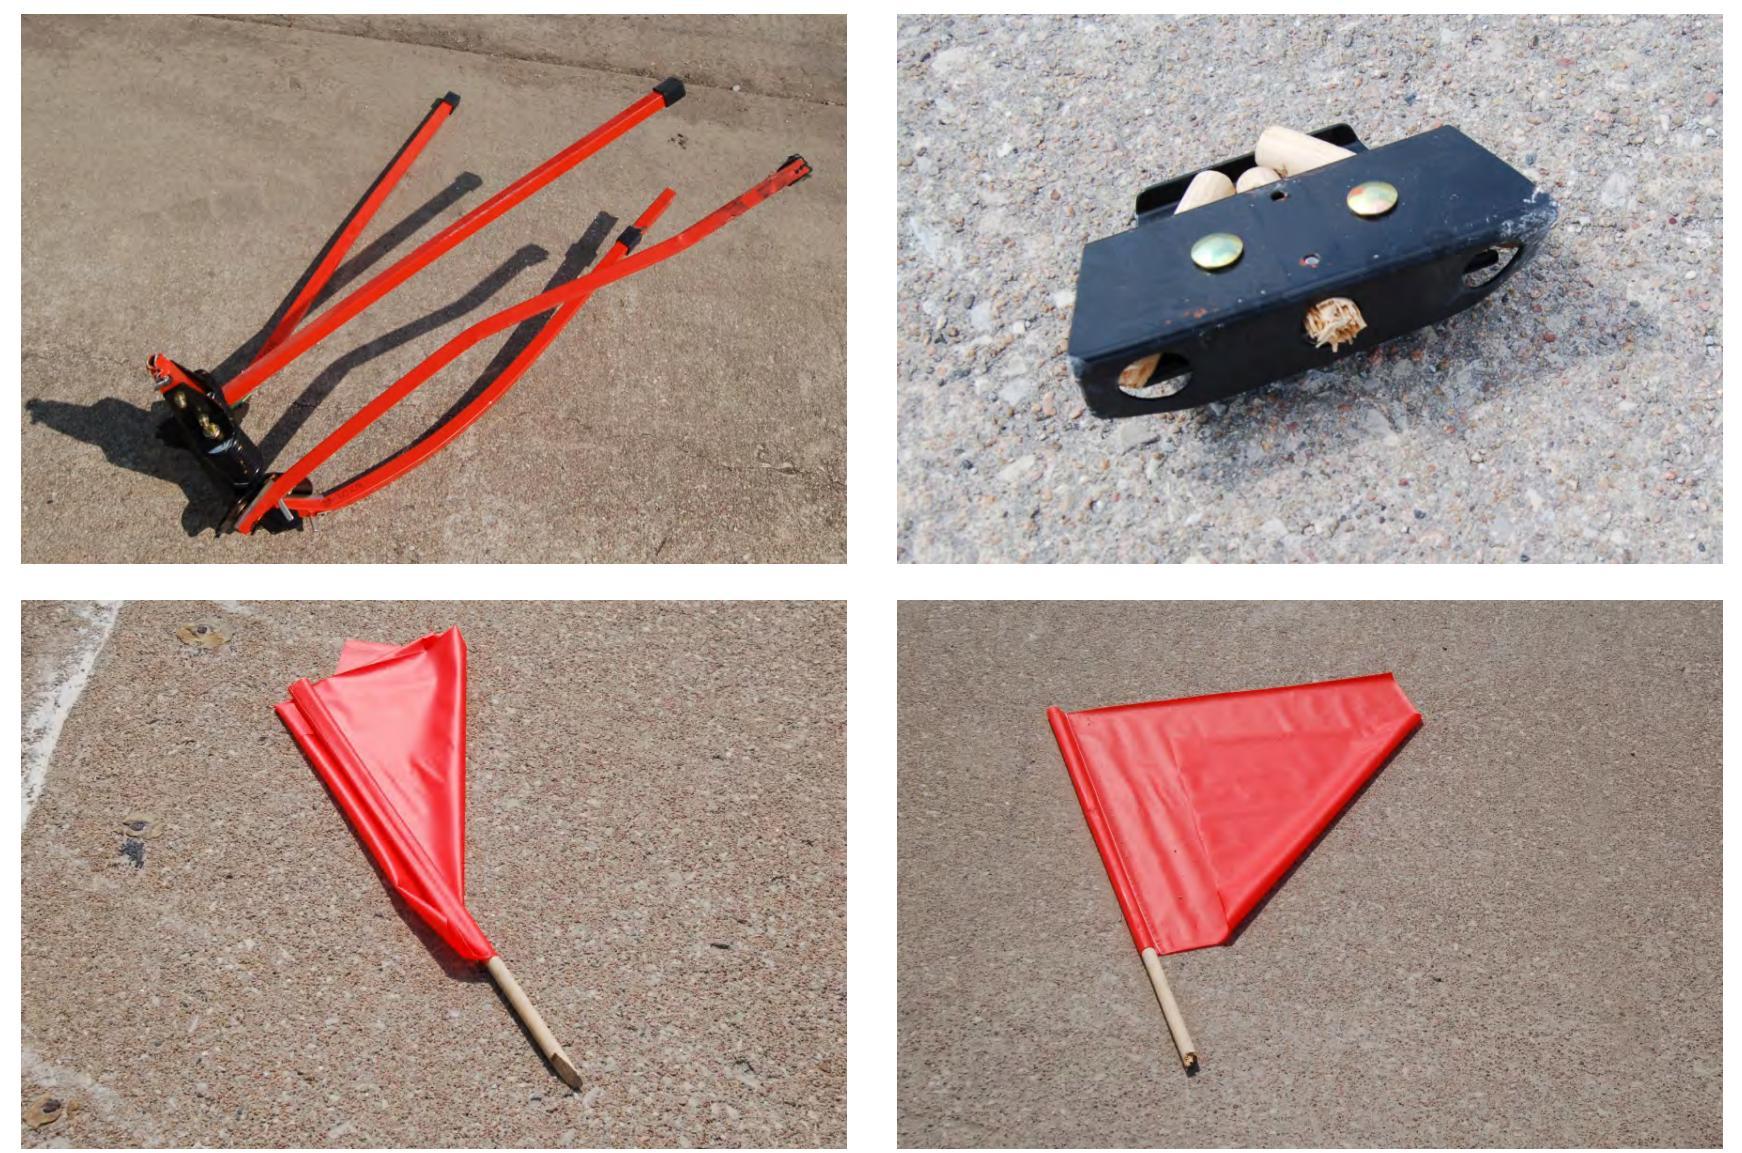
Figure 97. System Damage, Test No. WZ09-4A

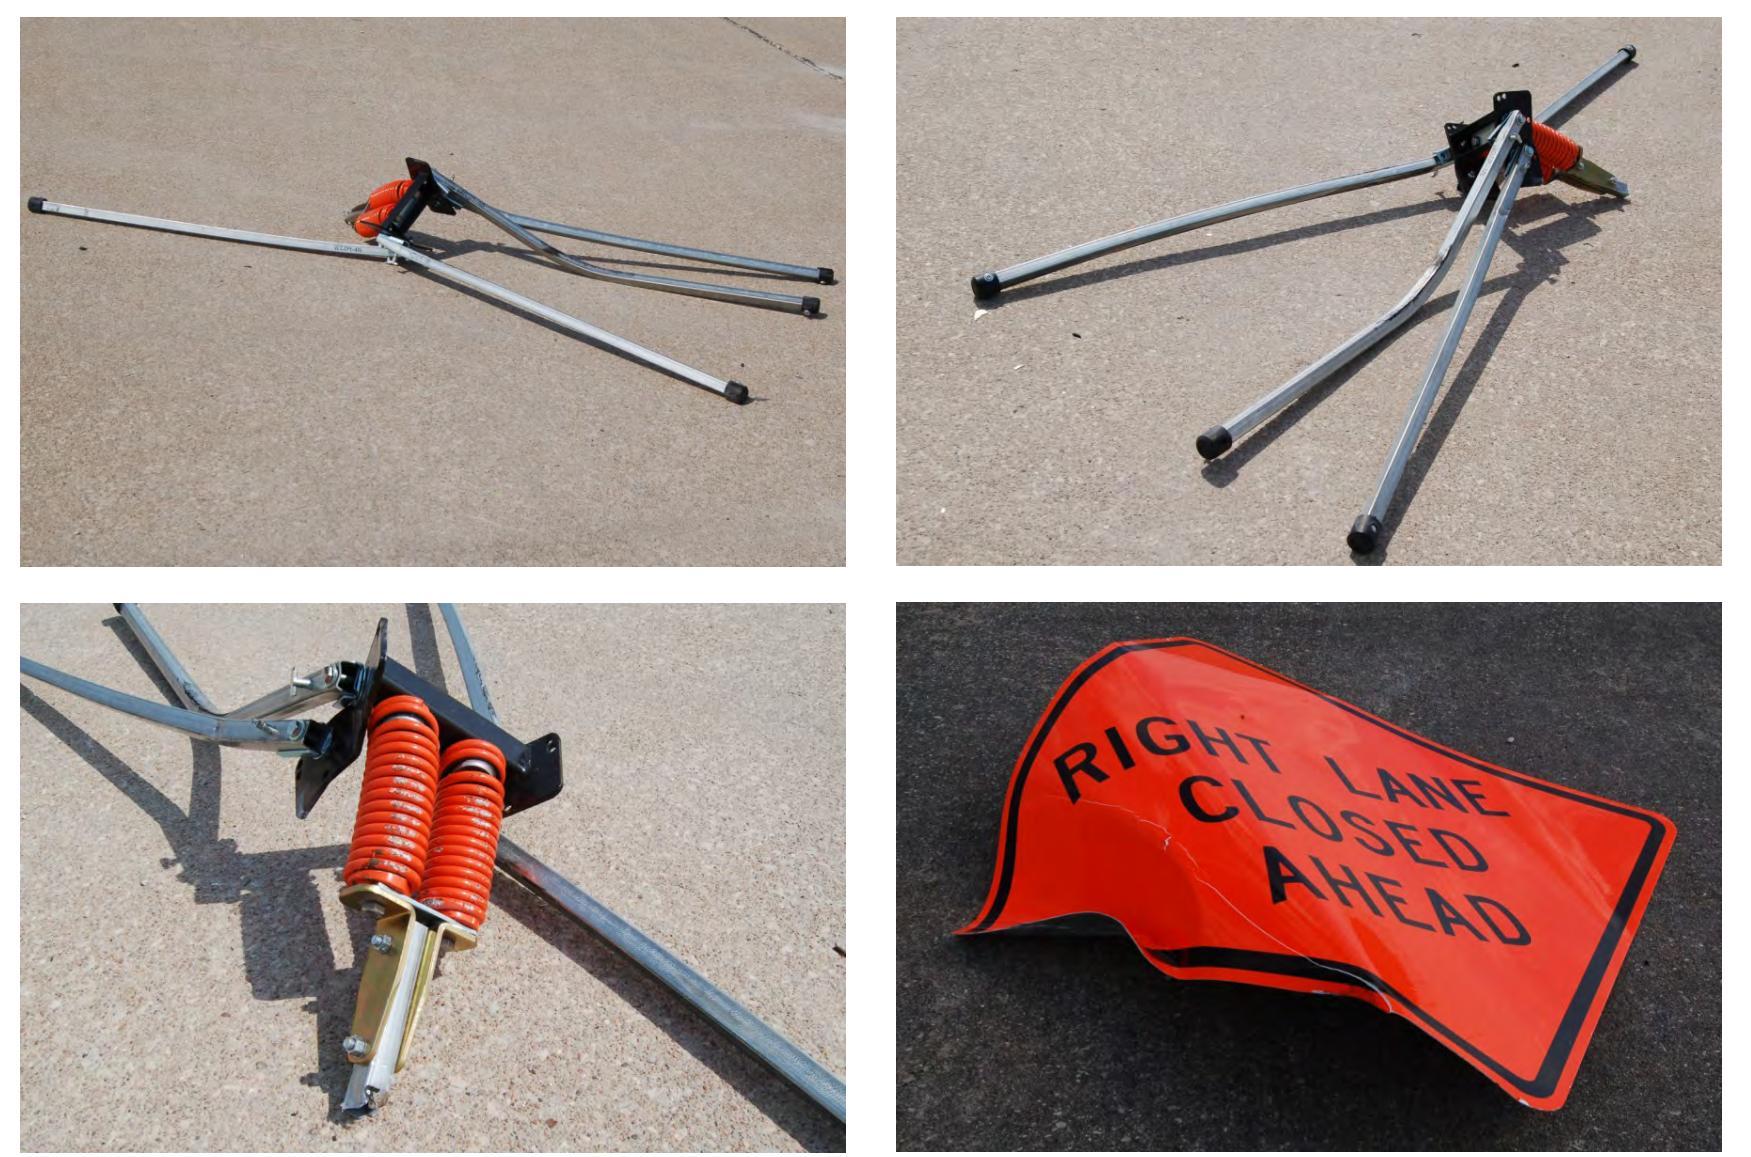
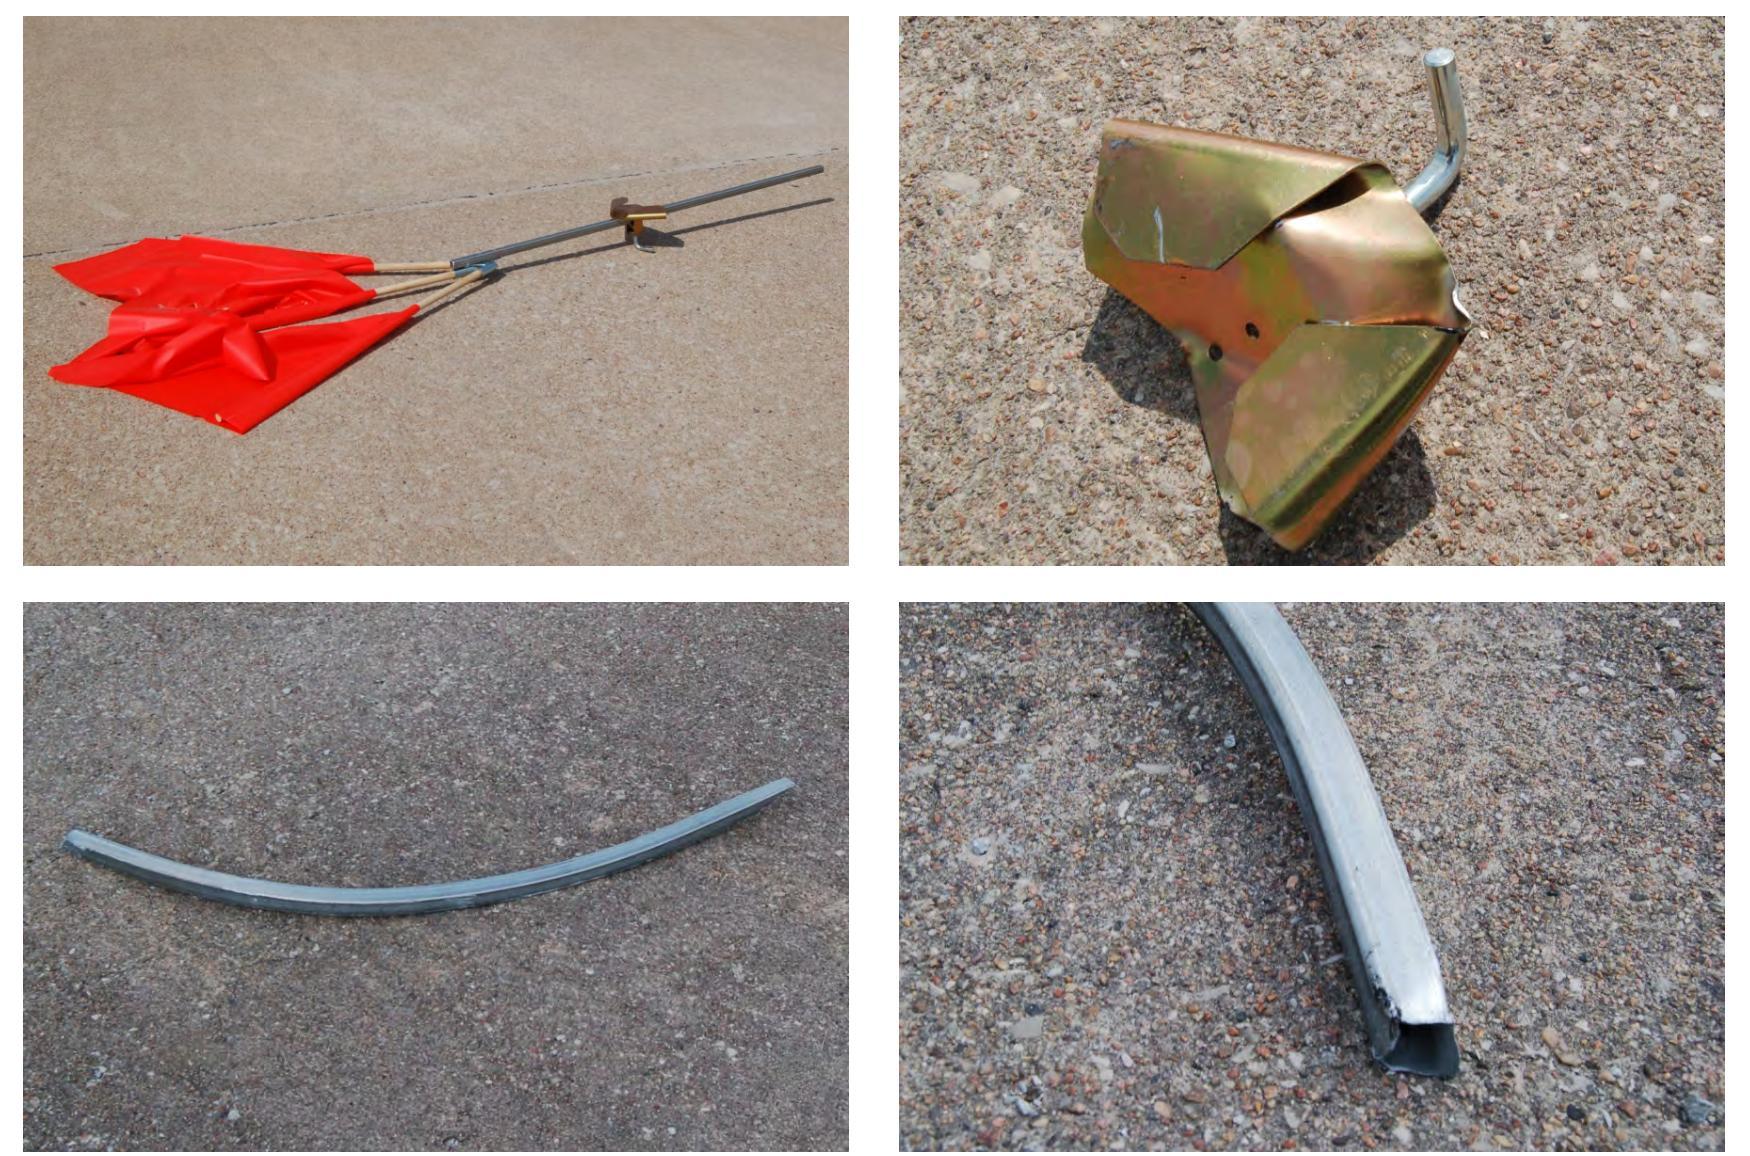
Figure 98. System Damage, Test No. WZ09-4B

Figure 99. System Damage, Test No. WZ09-4B
