## Analysis of Existing Work-Zone Devices with MASH Safety Performance Criteria

Final Report February 2009

## MIDWEST ROADSIDE SAFETY FACILITY

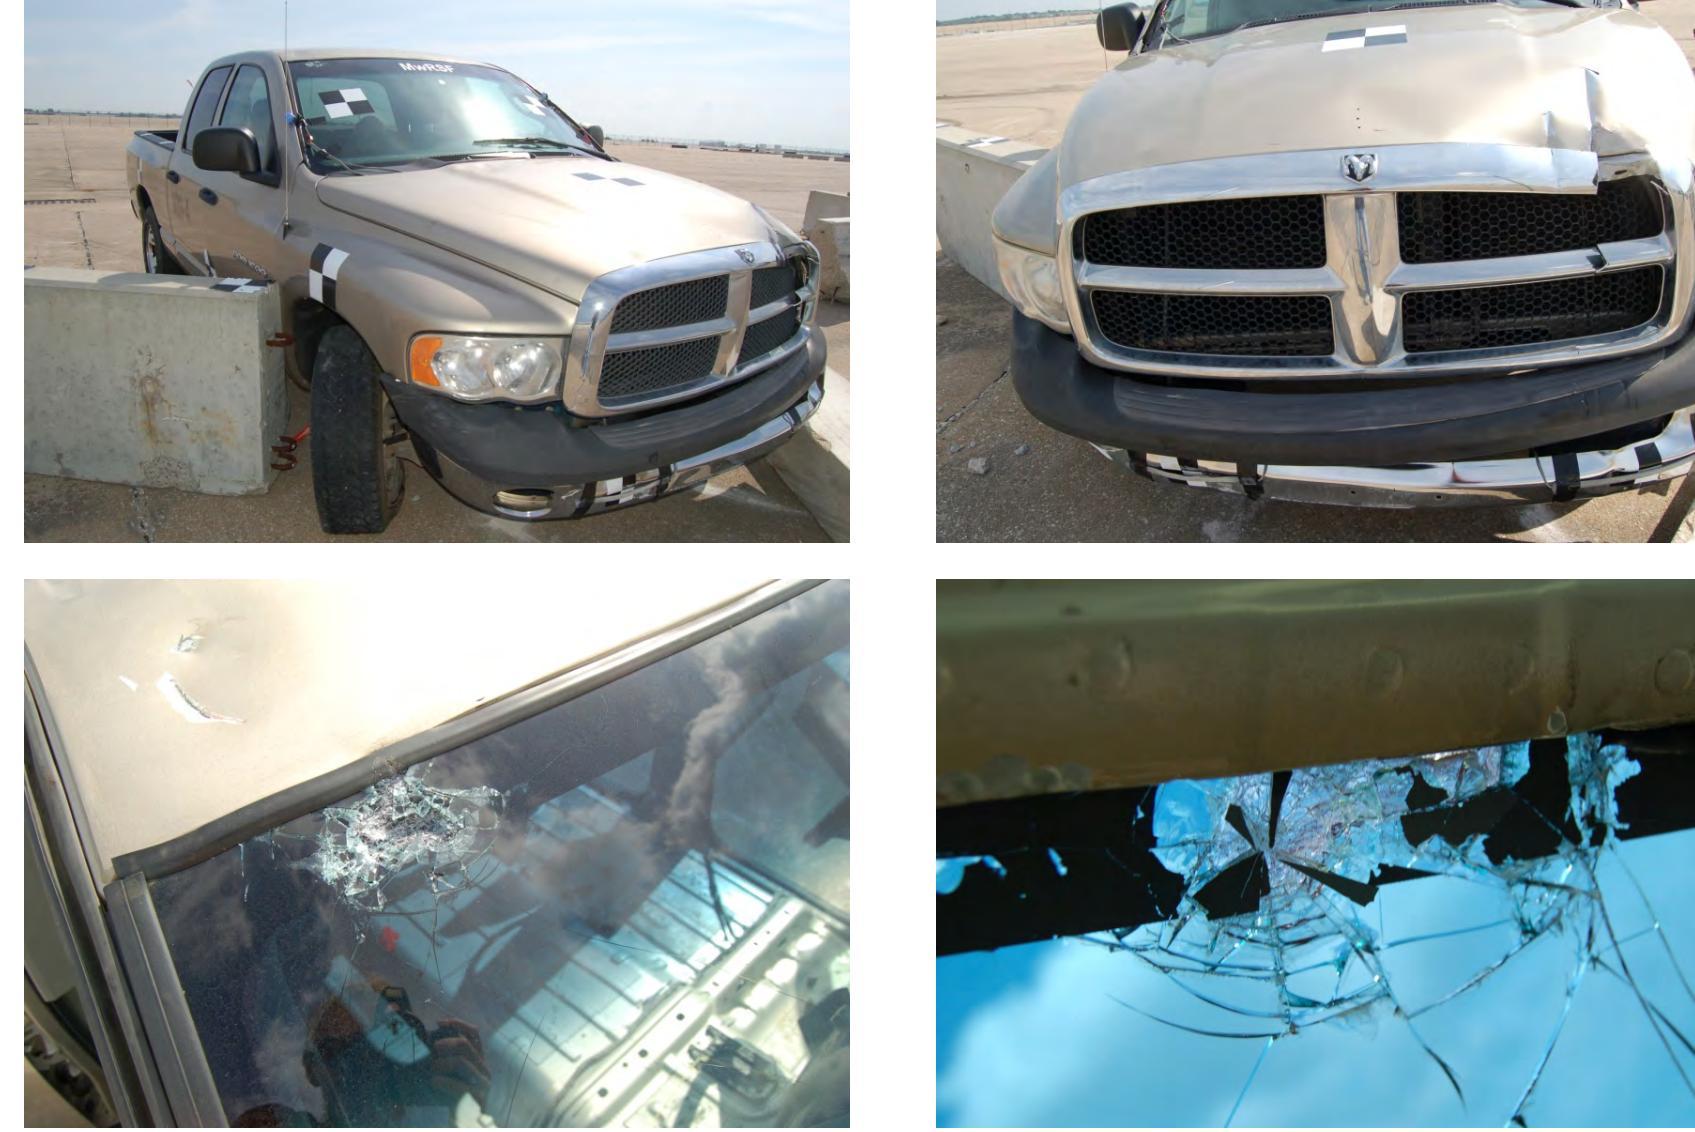
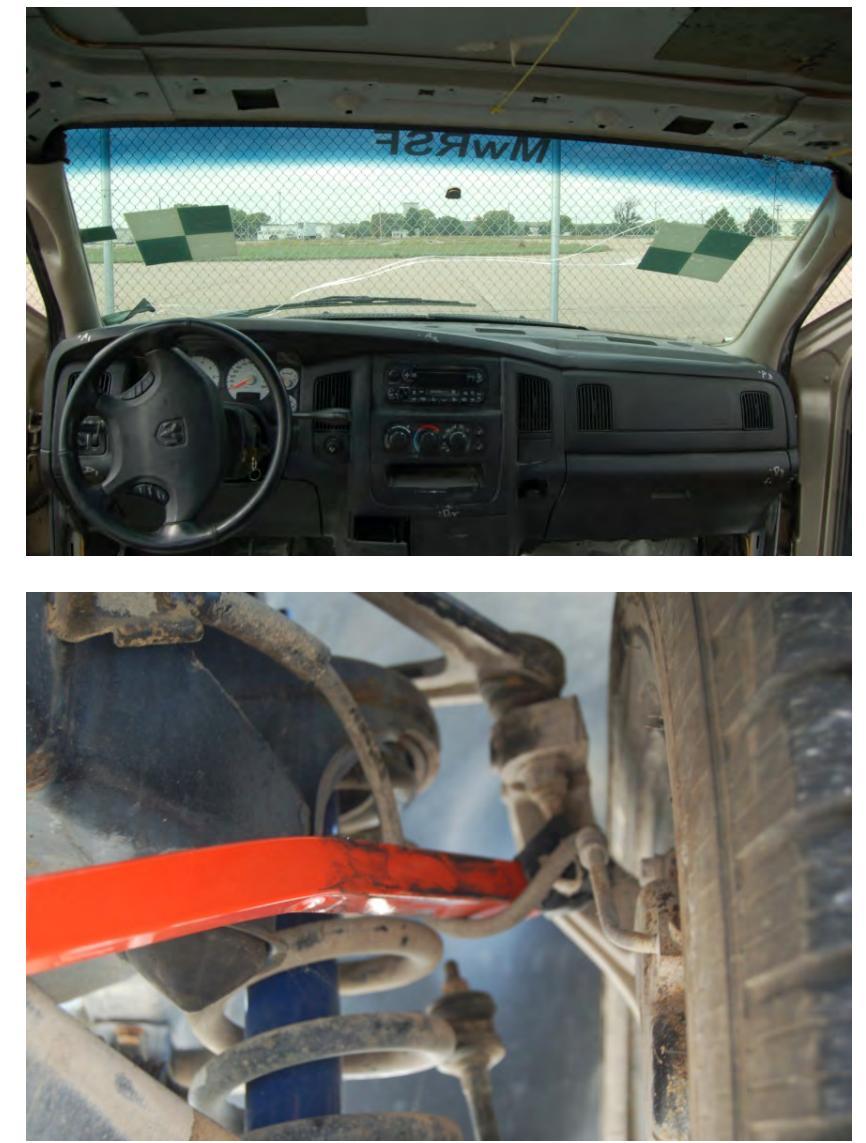
Figure 100. Vehicle Damage, Test No. WZ09-4

Figure 101. Vehicle Damage, Test No. WZ09-4

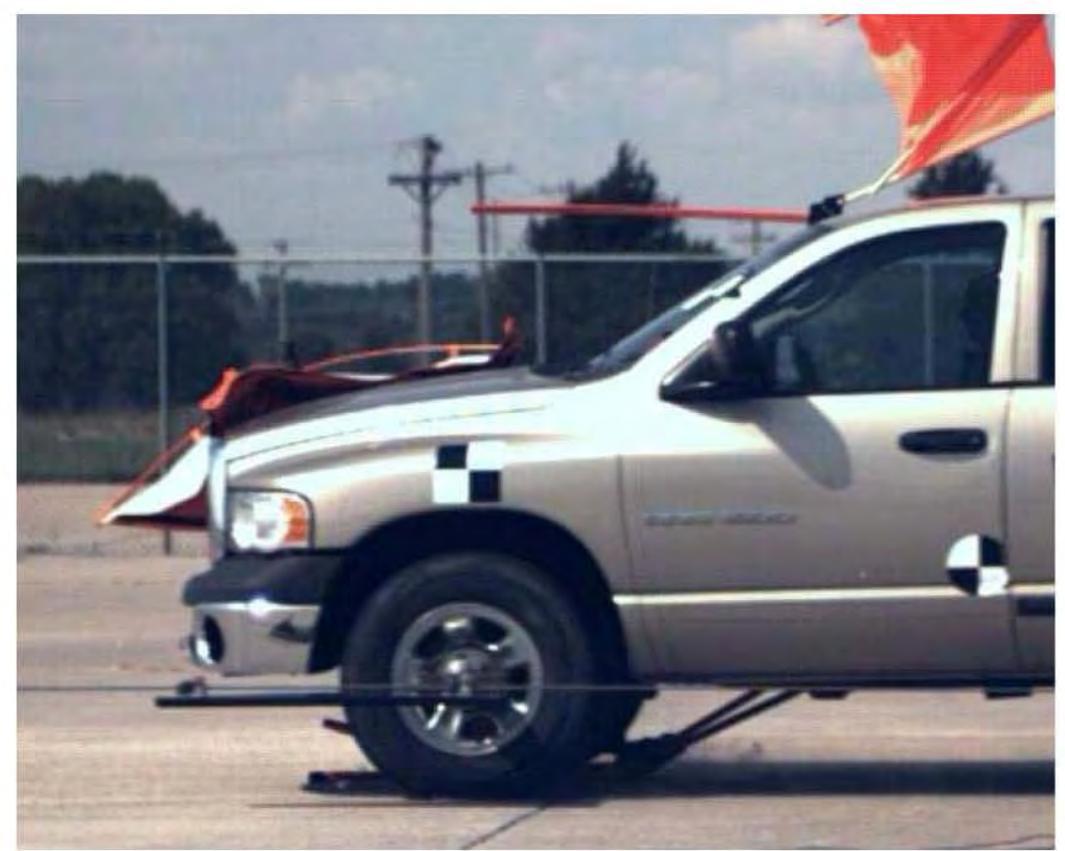
Figure 102. System No. 4A, X-Footprint Base Floorboard Penetration

A mast with a frangible base reduces the amount of flex that develops in the sign panel and mast (System Nos. 1A, 2A, 3A, and 4A). This relatively quick release of the mast from the stand allows the sign panel and mast to fall upon the vehicle with little additional force than what normally occurs through the impact event, as shown in Figure 103. However, this force can still be sufficient to cause indentation or penetration of the windshield. On the other hand, when base bending occurs, as shown in Figure 104, the sign panel and the top of mast are accelerated downward into the windshield (System No. 1B). When the mast was unloaded, the sign panel and mast have the tendency to "whip" downward onto the vehicle. In addition, a base-bending

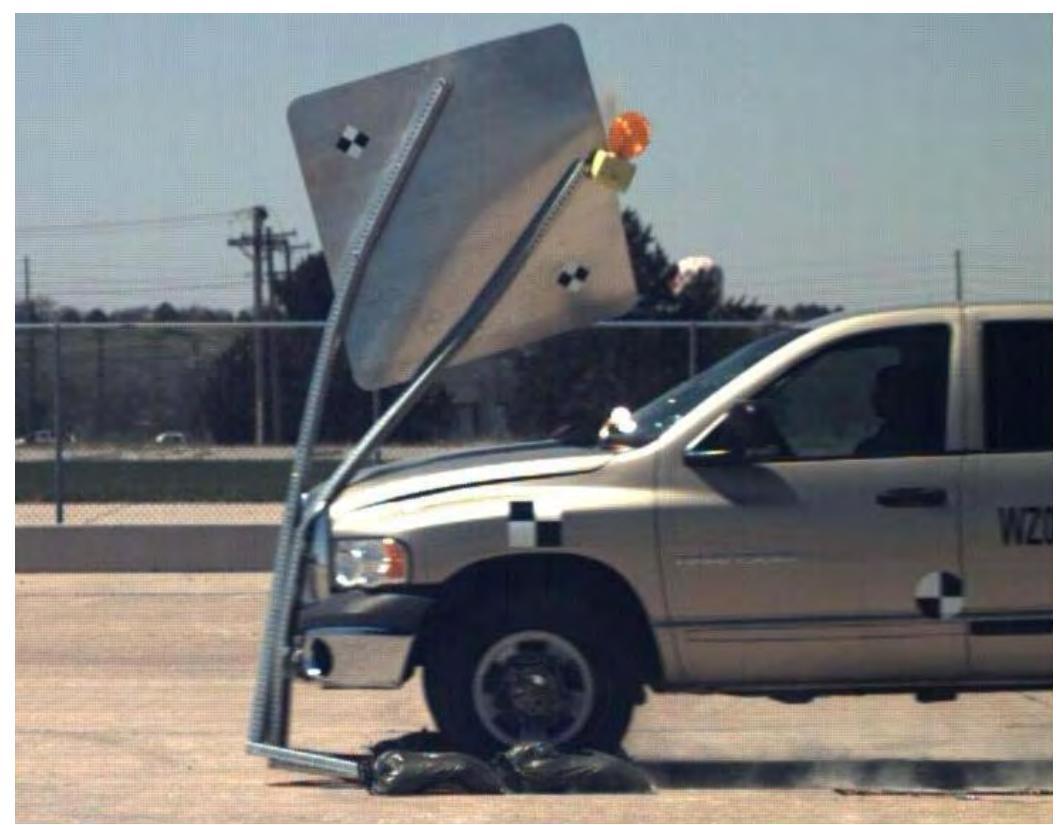
Figure 104. System No. 1B, Base-Bending Mast

mast typically releases from the stand late in the event, if at all, which adds to the amount of flex in the sign panel and mast. When the mast bends or has a delayed fracture, it is more likely that the sign panel or flag assembly will impact the windshield at a high rate of speed. When the connection between the upper and lower masts fails upon impact, the mast and sign panel cause insignificant damage (System Nos. 3B and 4B).

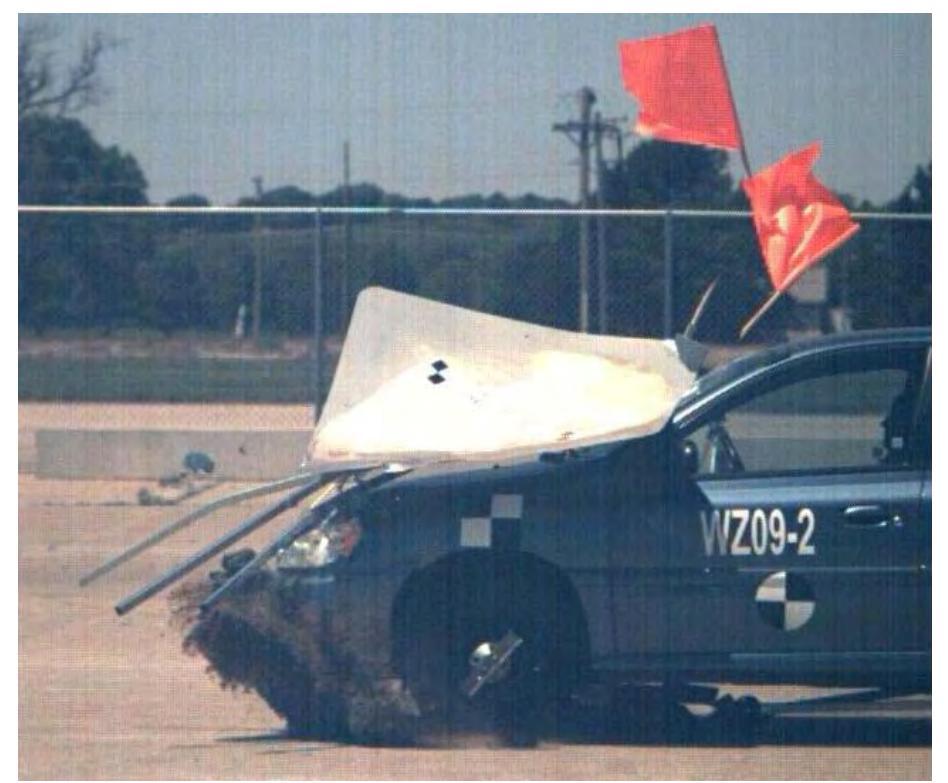
Figure 105. System No. 2B, Tripod Oriented at 90 Degrees

Sign stands that resemble a tripod shape when oriented 90 degrees to the vehicle were found to have a potential to rotate and rise into the air, resulting in the top of the support impacting and penetrating the windshield, as shown in Figure 105 (System No. 2B). Since the legs and mast were not intended to breakaway or yield significantly, the motion and weight of the entire system had the potential for significant windshield damage.

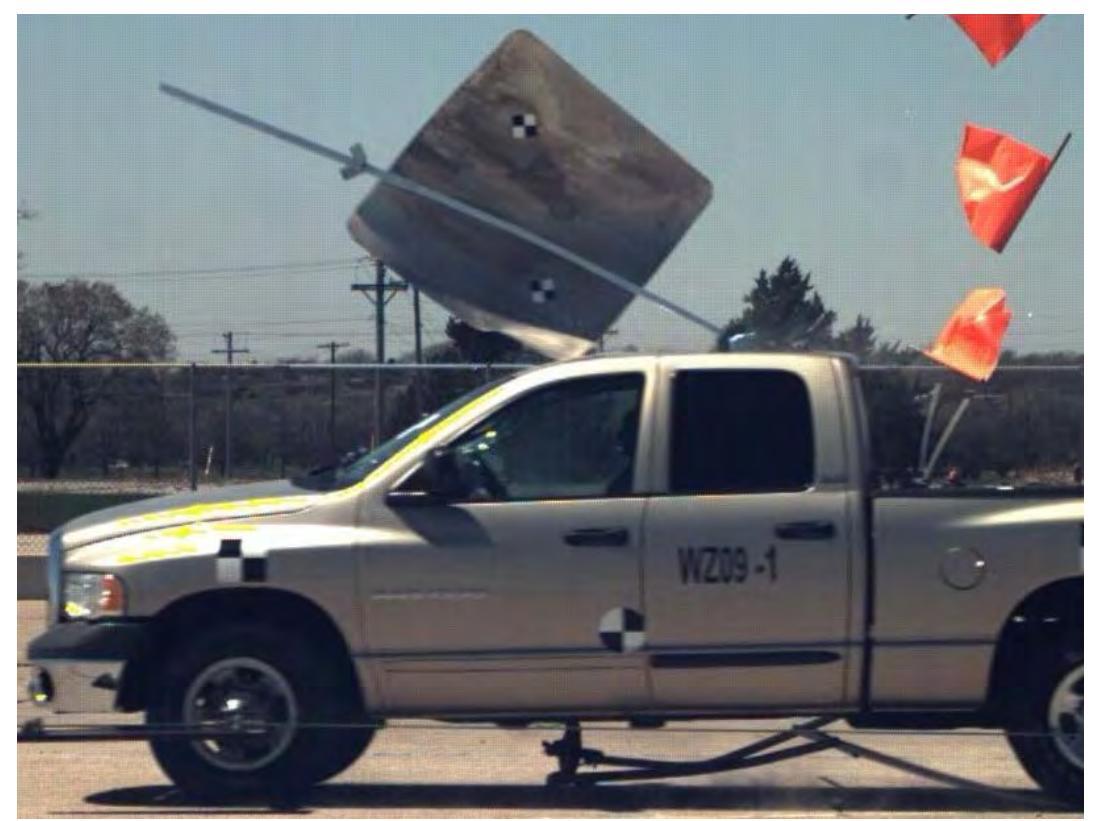
Figure 106. System No. 1A, Flag Holder Penetrating the Roof

mast end exposed with the potential to rotate into and penetrate the roof, as shown in Figure 106 (System Nos. 1A). Some of the wood dowels fractured in their holders, thus disengaging the flags. However, the flags and the exposed flag holder did not show any potential for vehicle damage (System No. 2A). Some flag holders did not disengage the flags upon impact; therefore, these flags and holders followed the trajectory of the mast (System No. 4B). Most of the time, the addition of flags did not negatively affect the safety performance of a work-zone traffic control device. However, if the wood dowels fracture as the flag holder or mast penetrates the windshield, the fractured ends become flying debris and a potential hazard to the occupants of vehicles (System No. 2B). Fiberglass flag staffs would have performed in a different manner than the wood-dowel flags, but it is unclear what effect they would have on the safety performance of any of the work-zone traffic control devices.
