Regional Approach to

Landslide Interpretation and Repair

March, 2001

lowa DOT Project TR 430

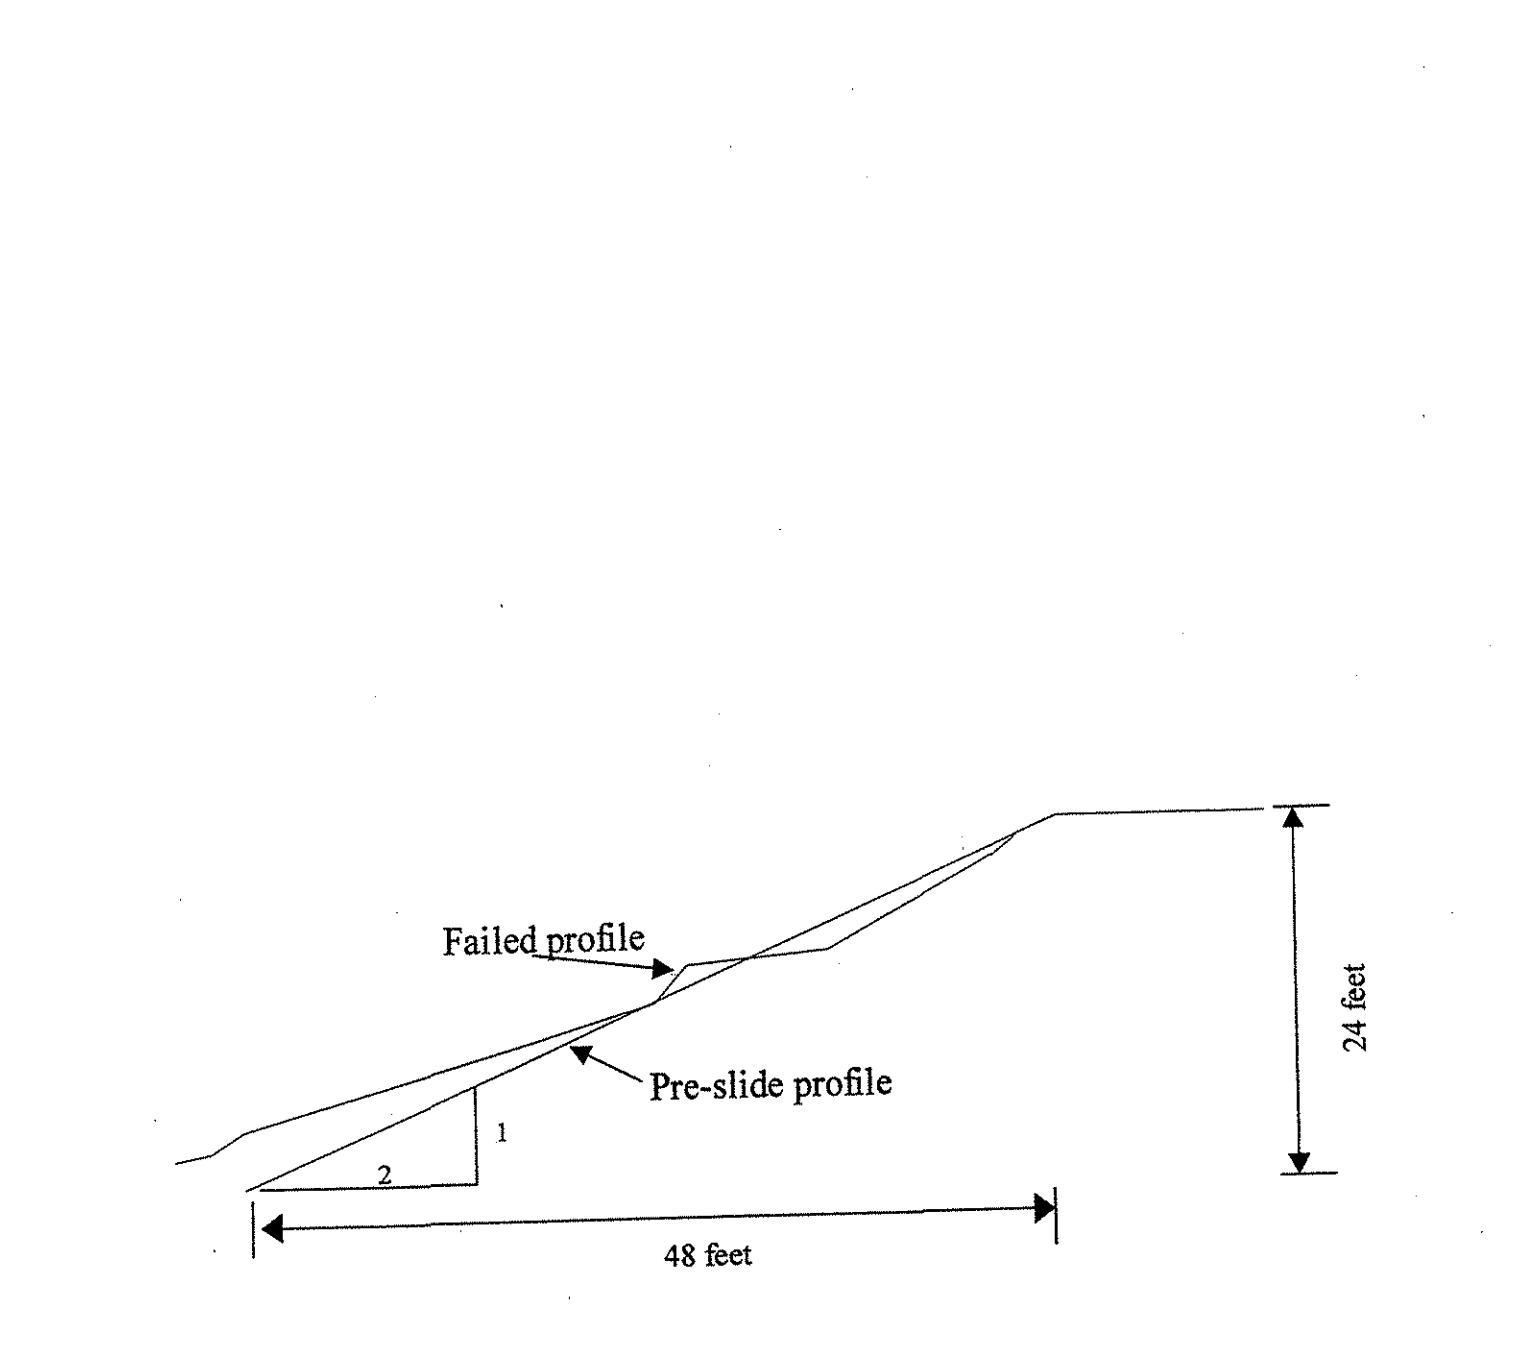
The foreslope, shown in Figure 9.1, is 24 ft (8 m) high at a 2:1 slope. The slide is classified as a translational slide in which a few blocks of fine grained soil have failed along a shallow failure plane about 2.5 feet (0.75m) deep. The failure plane is approximately parallel to the slope of the existing embankment. During fieldwork in April 1999, it was observed that the soil in the failure zone appeared wetter and with an aggregated structure that differed from the soil samples collected from the borings and the soil on the surface adjacent to the slide.

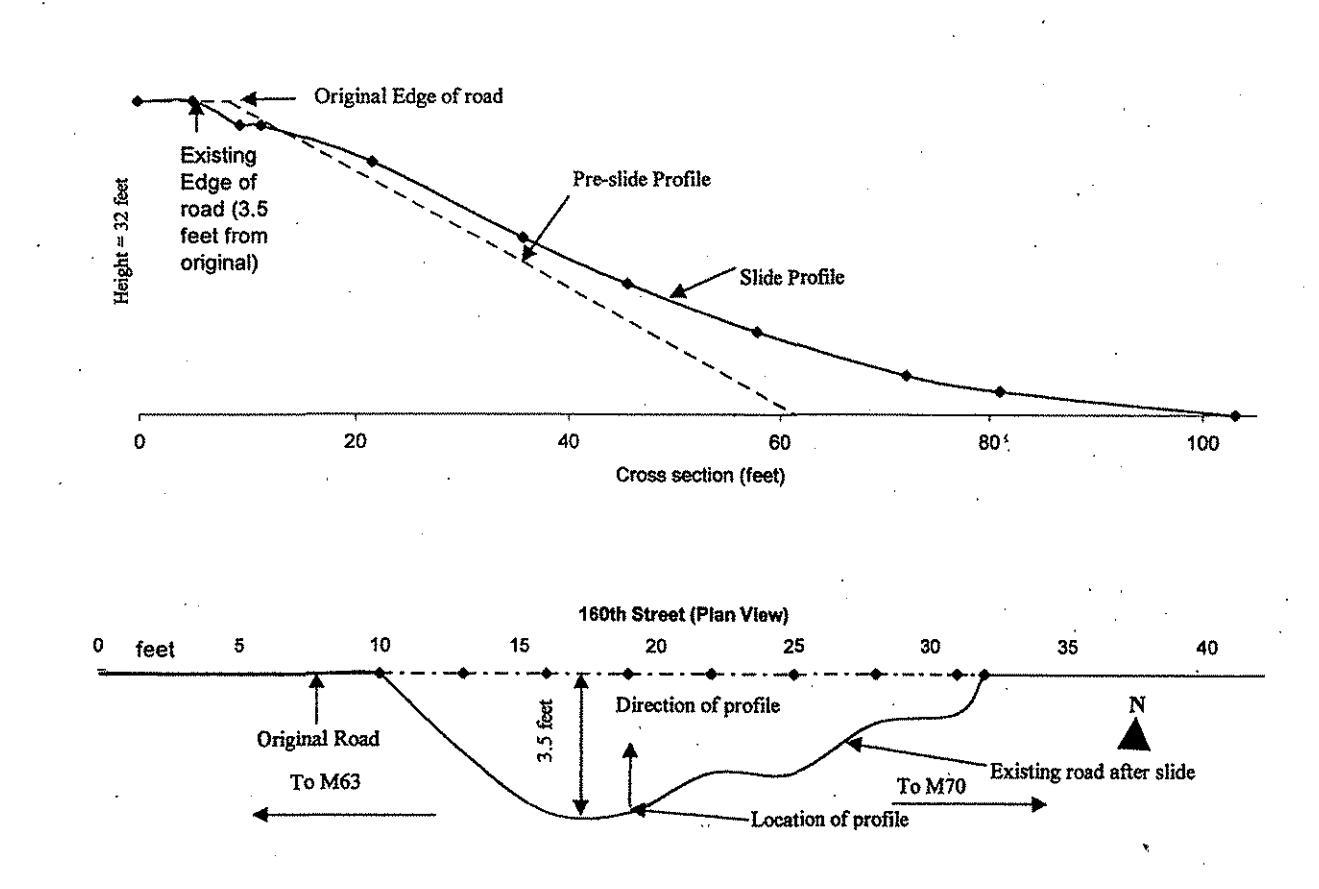
A wet area approximately 10 feet (3 m) wide parallel to the road and 21 feet (6.5 m) in length, perpendicular to the roadway, was observed over the failure zone about 56 feet (17 m) down the slope. This was anomalous because of the low amounts of precipitation in 1999 and 2000. The source of the moisture is not known.

A corrugated metal pipe about 12 inches (0.3 m) in diameter has its outlet at the toe of the slope. This pipe was observed to be dry during four site visits in the summers and falls of 1999 and 2000. The location of the inlet of the pipe is not known. According to Mr. Jim Christensen, County Engineer, Page County, the slope had failed previously, and the pipe was installed parallel to the slope to drain the slope. The time of the installation is not known as it was prior to Mr. Christensen's tenure as county engineer, but it can be safely assumed to be at least ten years old. The water in the embankment at the base of the slide and the dry pipe indicated that the drain is not functioning properly.

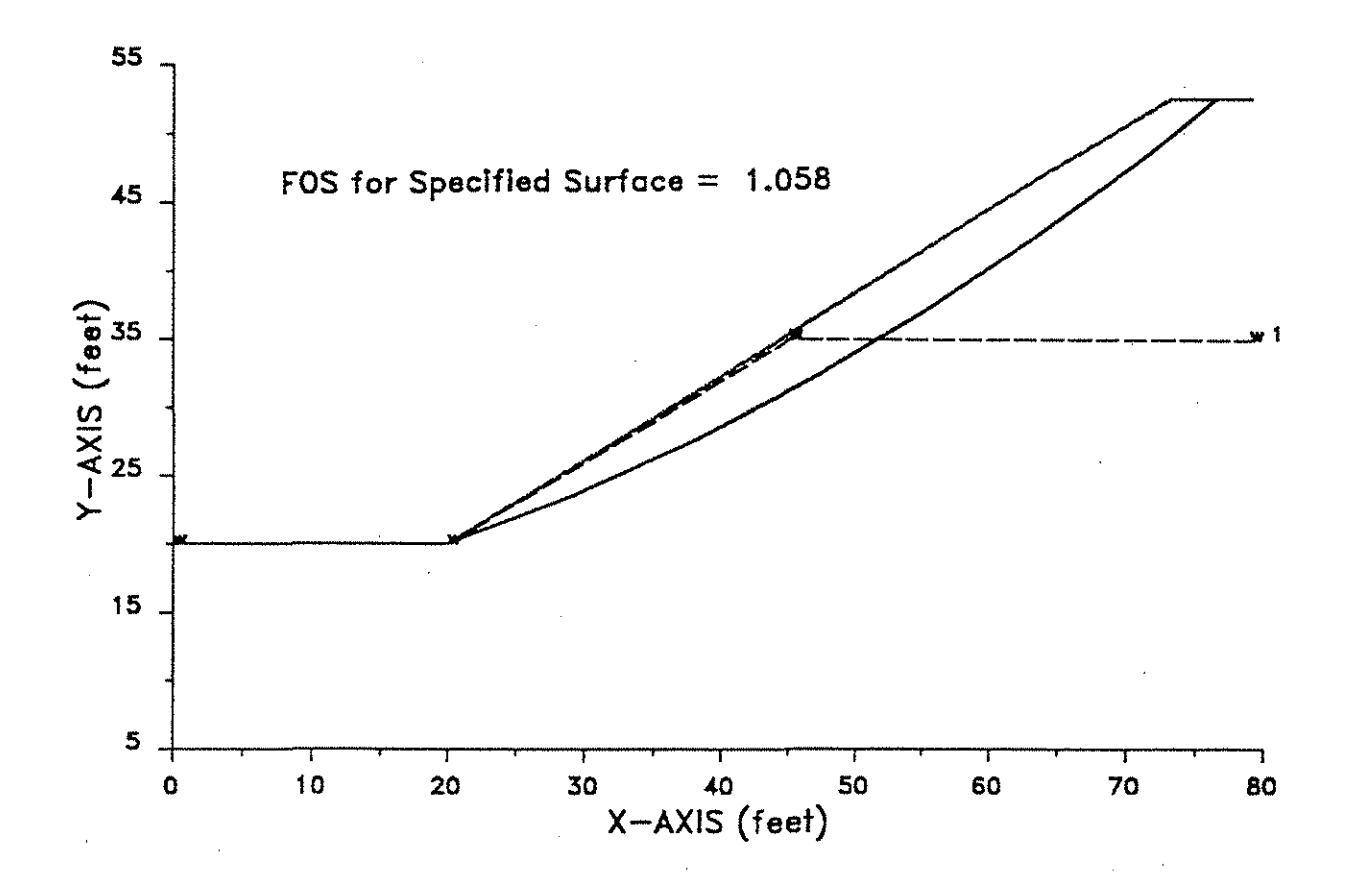
Figure 9.7 XSTABL results for 160th St. assuming watertable at midheight in the embankment

The slope was analyzed by XSTABL software using the Simplified Bishop Method which generates a circular failure surface. A shallow failure surface based on field observations was used in the analyses. The analyses were conducted for a moist slope and a slope with the elevation of the water table at mid-height of pre-slide slope. Total unit weight was used for the analysis of the moist slope, whereas saturated unit weight was used for the analysis with water table at mid-height. The minimum factors of safety from the XSTABL analysis are 1.3 and 1.1 for the natural moisture and water table at mid-height condition, respectively. The entire results of the analysis are in Karnik (2001). Figure 9.7 shows the analysis result for water table at mid-height.

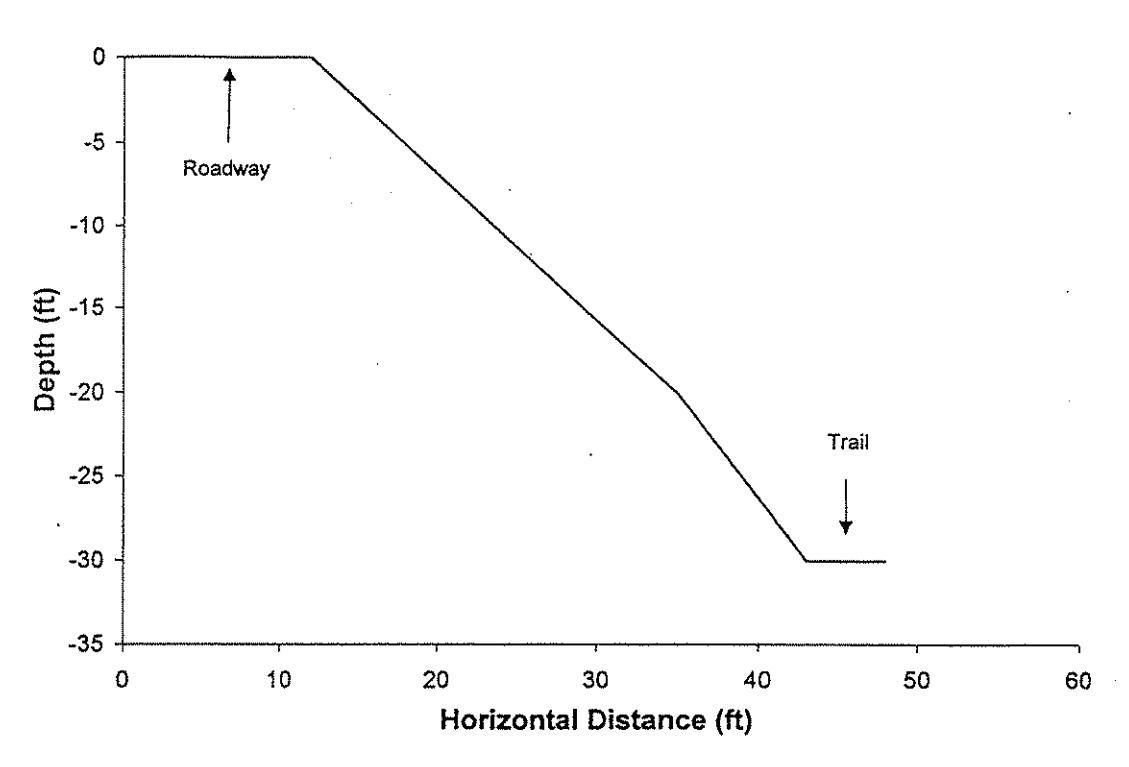
Figure 9.11 Original slope profile at Murray Hill slide

The site is 170 feet (52 m) above the Missouri River floodplain, near the upper part of the upland bluffs. The slopes adjacent to the roadway are vegetated with grasses and trees. During the site investigation carried out by ISU in June 1999, a longitudinal crack was observed along the edge of the existing asphalt pavement, and a minor settlement of 3 inches (8cm) was observed. A horizontal ledge interpreted as an old trail was observed at the bottom of the slope failure, about 25 feet (7.5 m) below the roadway. Slope profiles were measured along the slide and adjacent to it. The original slope profile is 33 feet (10 m) high with angles of 41° in the upper portion and 51° in the lower portion (Figure 9.11). The slope profile in the failed region is shown in Figure 9.12.

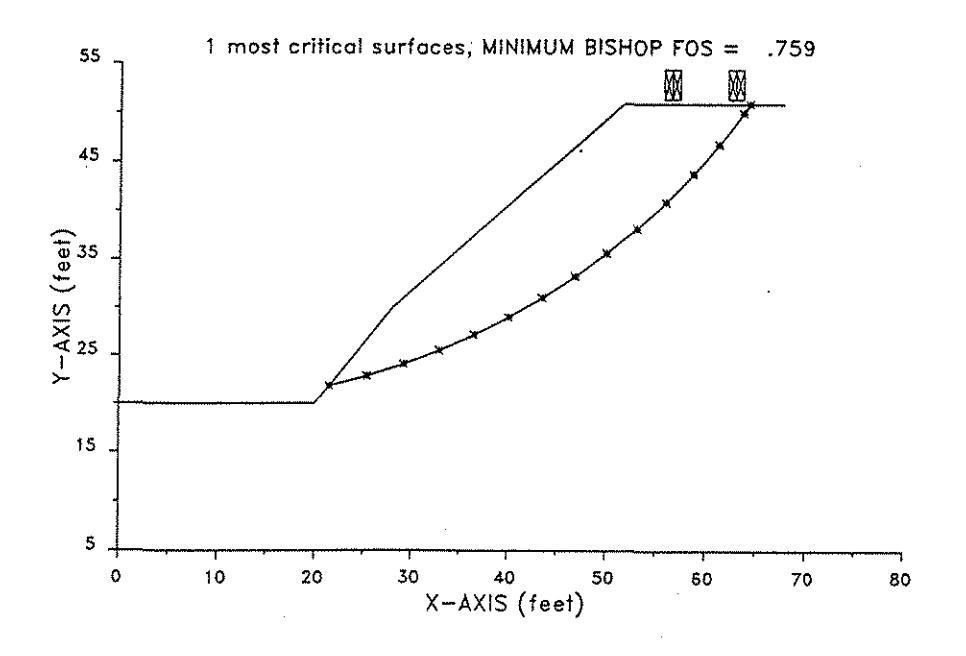
Figure 9.15 XSTABL results for Murray Hill slide with truck surcharge.

During fieldwork, trucks were observed to pass close to the edge of the road with their tires tracking through the depression in the pavement. Therefore, XSTABL analyses with a surcharge load from the trucks were performed. The vehicle surcharge loading represented a tandem truck; a stress of 17000 psf (814 kPa) was applied on each tire in the location shown in Figure 9.15. The minimum factor of safety decreases to 0.8 when the surcharge is included with the load at the shoulder; the failure surface shown by the analysis, however, extends further back below the roadway than suggested by the cracks observed on the pavement. It is interpreted that the slope without surcharge is at a metastable condition; and instability results from the surcharge load of passing trucks.
