GALVANIZED BRIDGE DECK REINFORCING

FINAL REPORT FOR Iowa Department of Transportation Project HR-504

DECEMBER 1992

Iowa Department of Transportation

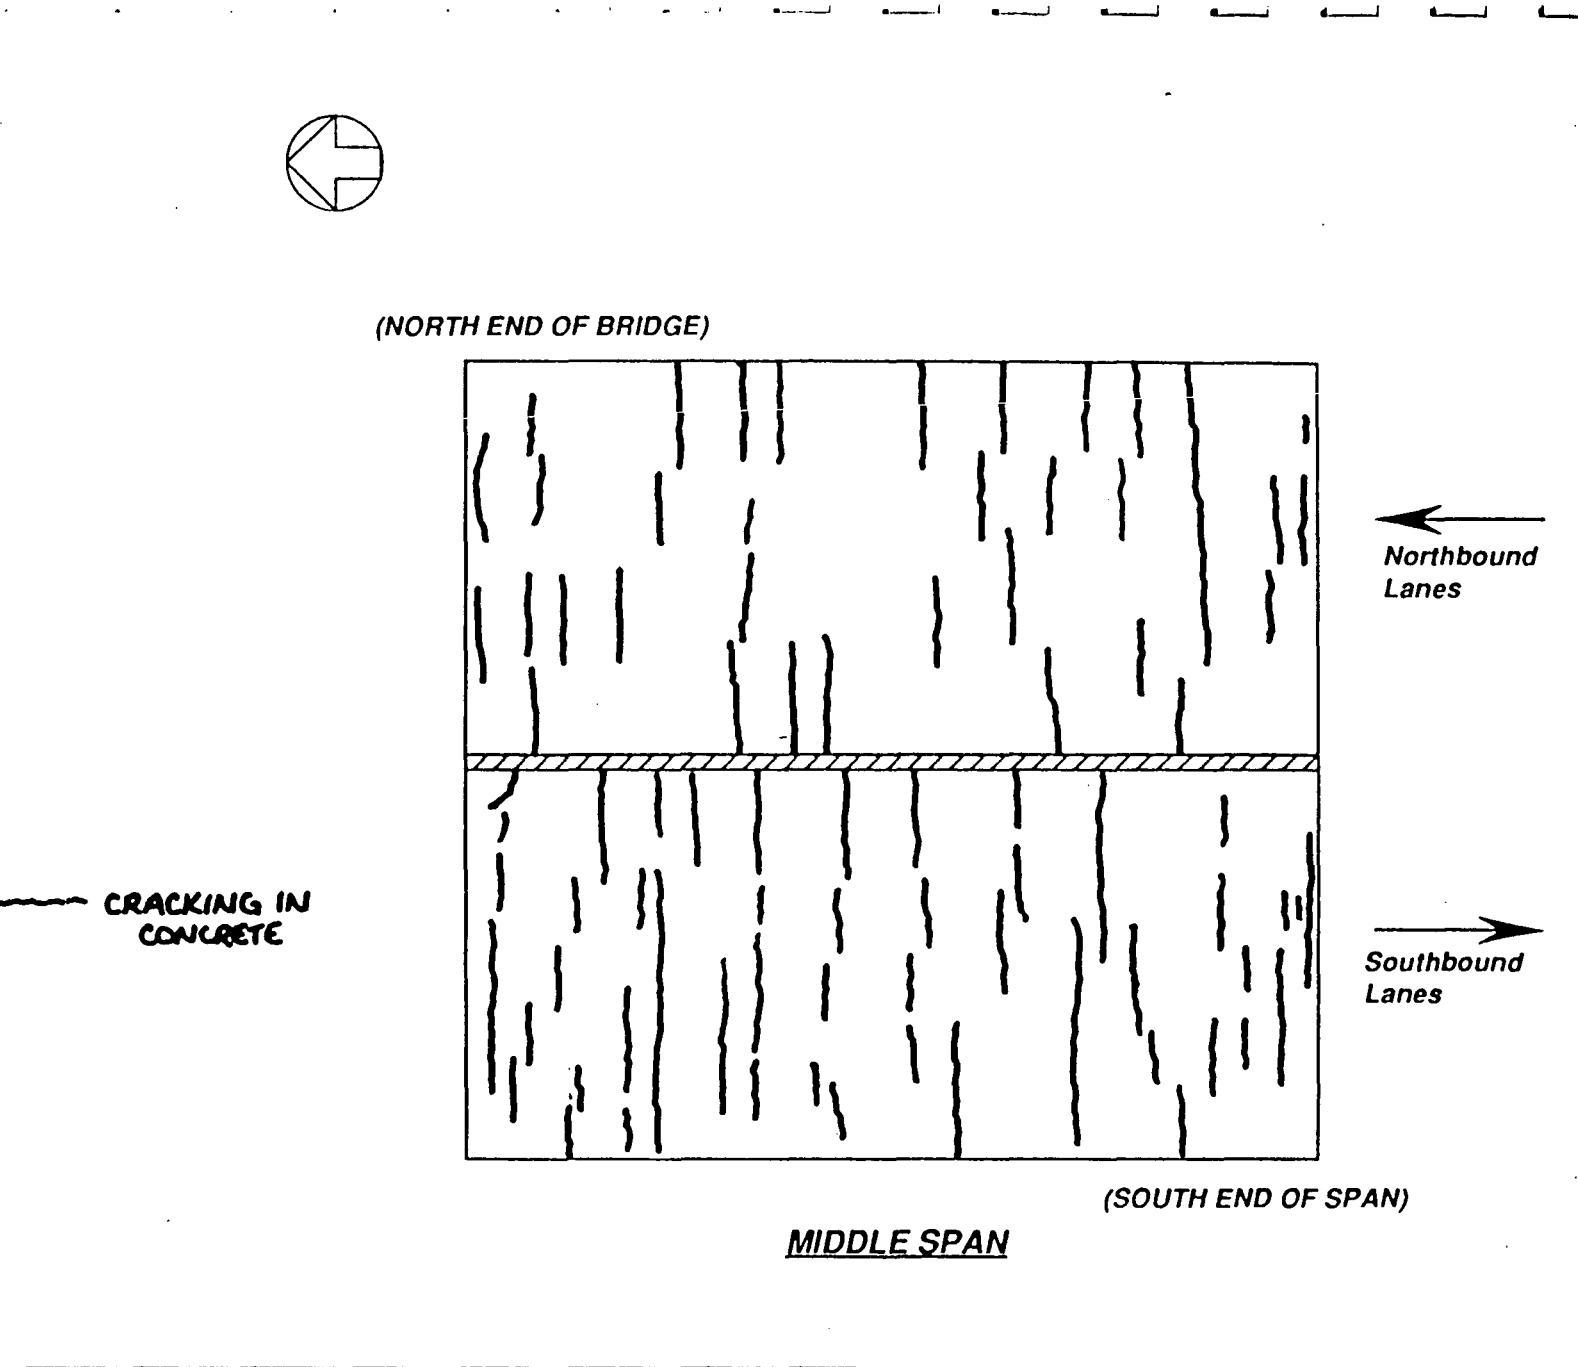
AMES BRIDGE (I-35 over Long Dick Creek) FIG A.2(h)

Concrete deterioration in the form of cracking was observed on exposed deck surfaces. Concrete cracking oriented in the transverse direction is shown in Figs. A.2.(g - i). In some instances, cracks occur over embedded steel reinforcement.

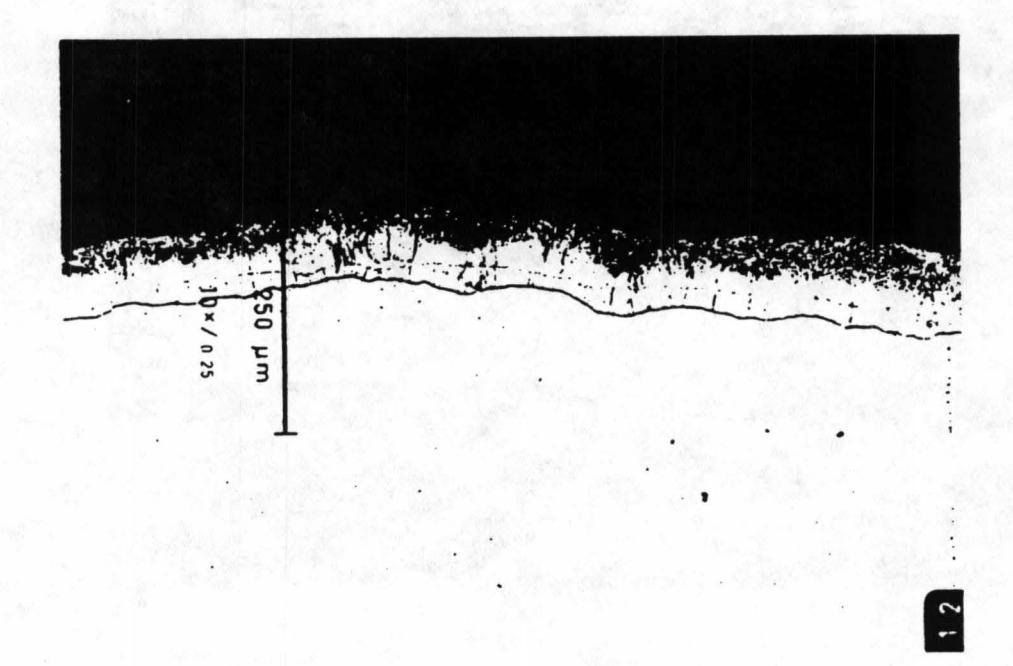
PHOTO A.2(f): Magnification of No. 6 Bar removed from Core Sample L-6 (galvanized coating thickness of 3.8 mils).

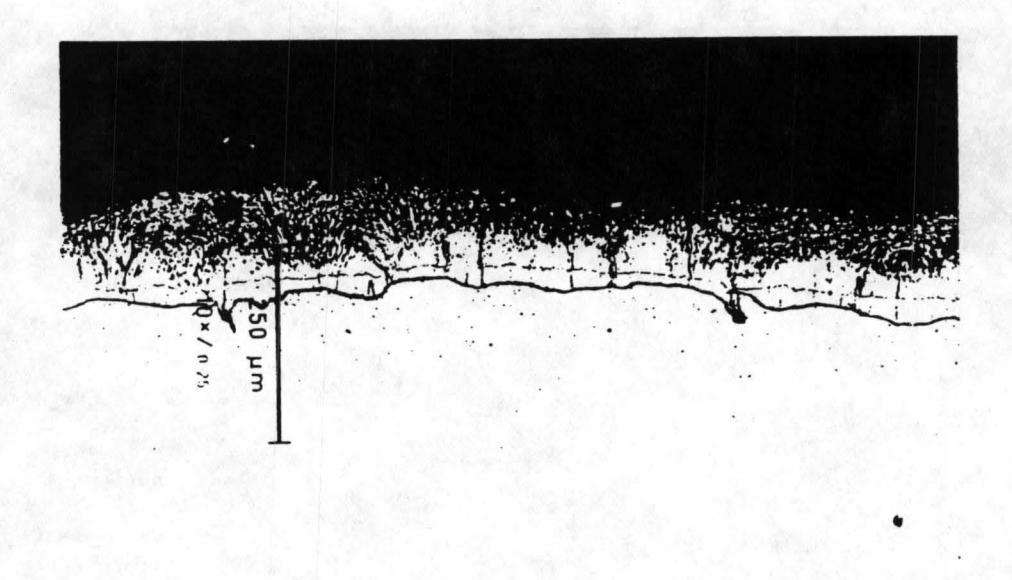
PHOTO A.2(h): Magnification of No. 5 Bar removed from Core Sample L-10 (galvanized coating thickness of 4.7 mils).

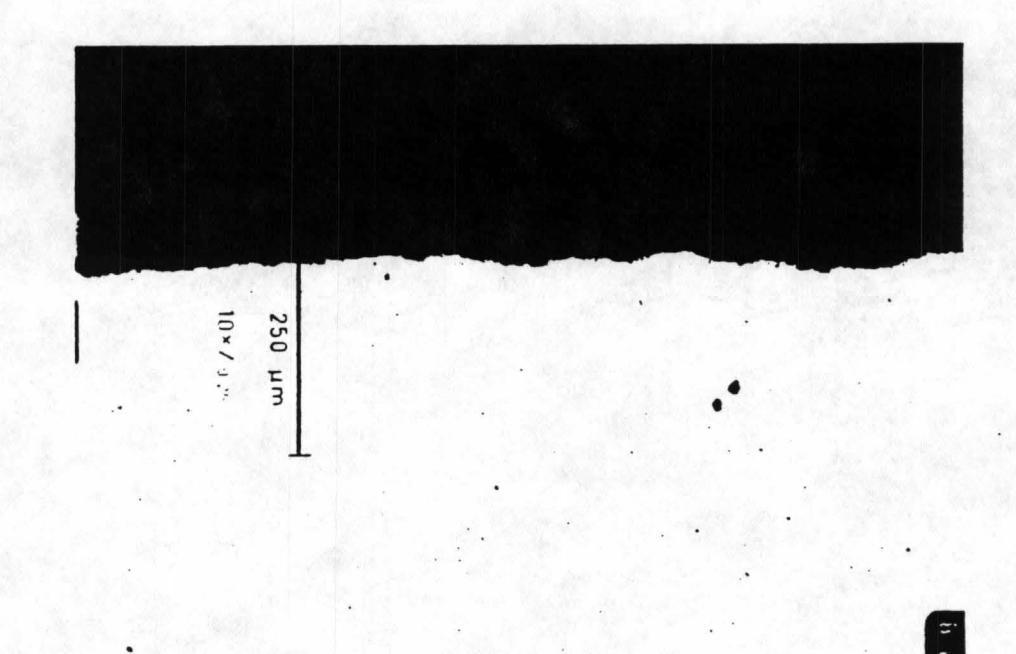
PHOTO A.2(j): Magnification of No. 6 Bar removed from Core Sample L-14 (steel reinforcement is uncoated).

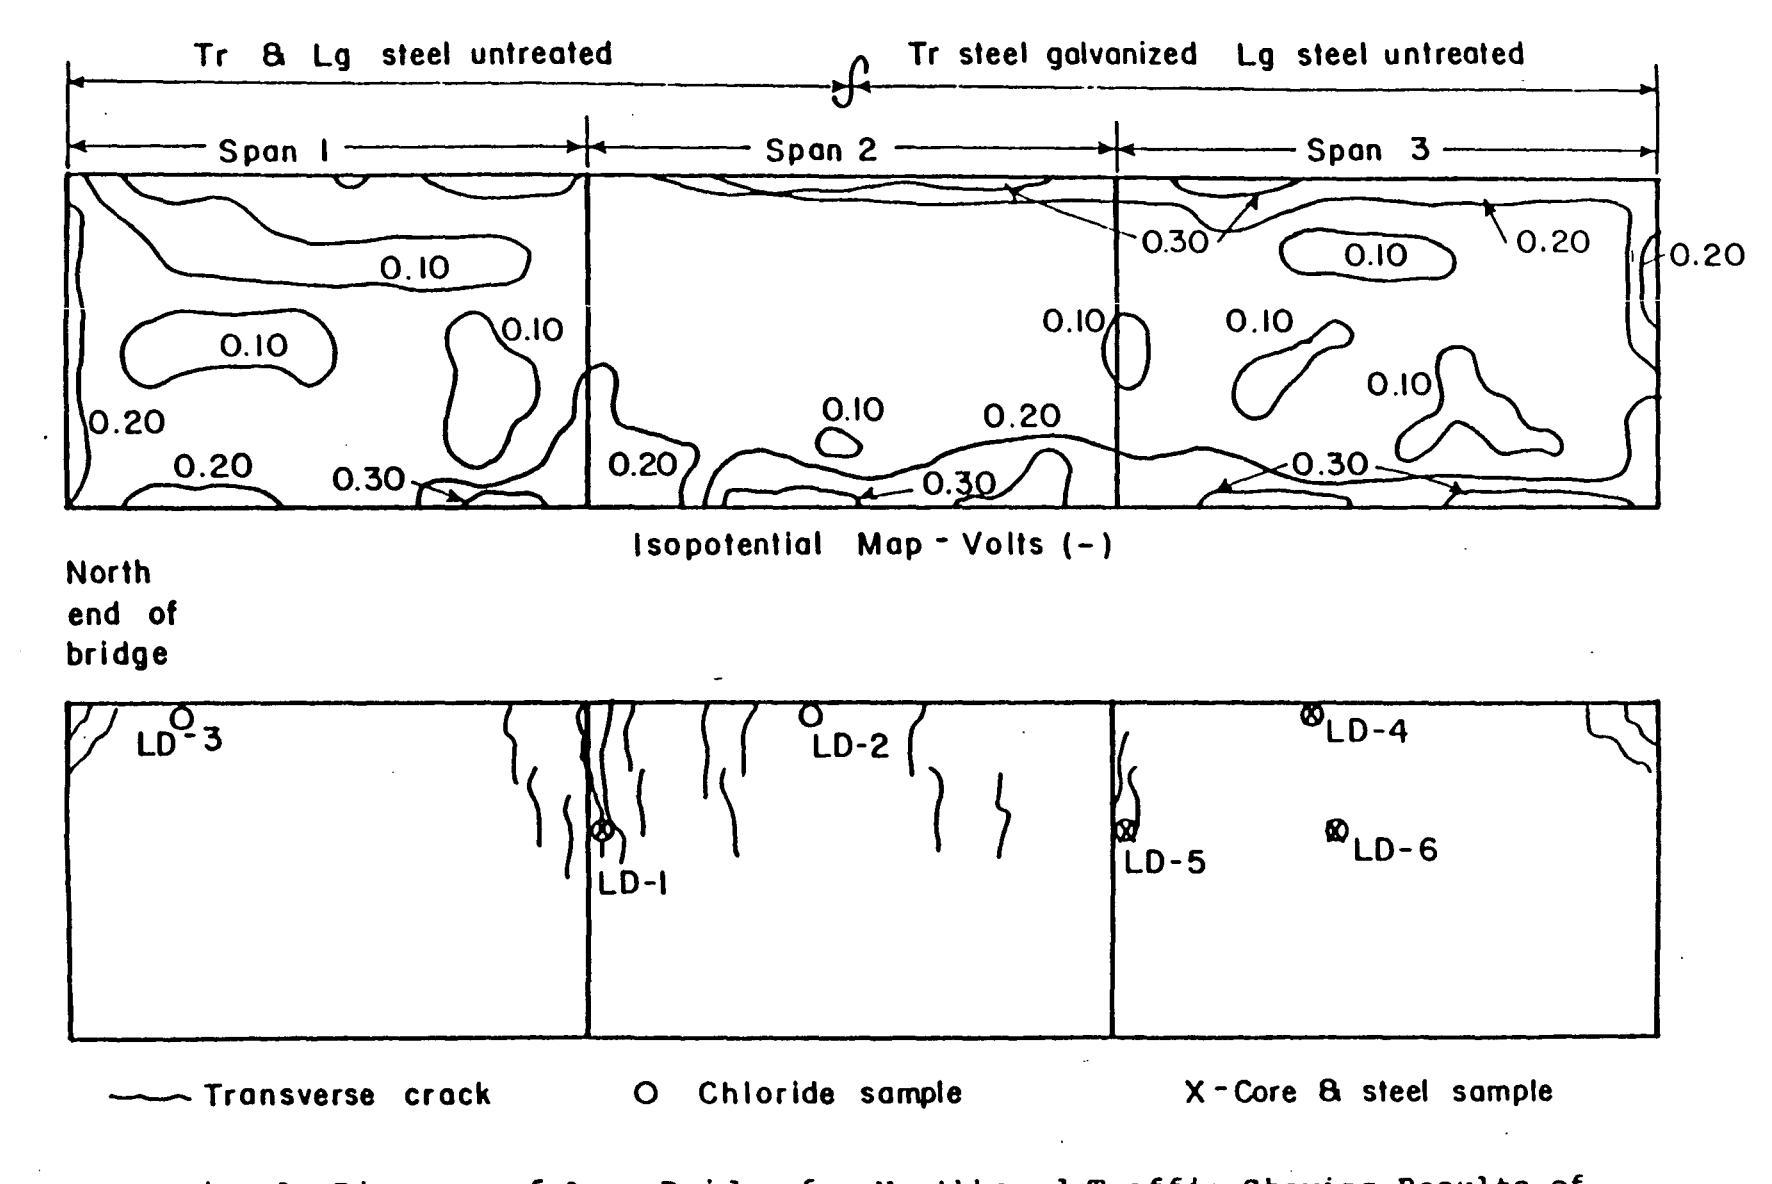
Fig. 1 Diagrams of Ames Bridge for Northbound Traffic Showing Results of Potential Measurements, Crack Survey, and Locations of Test Samples.

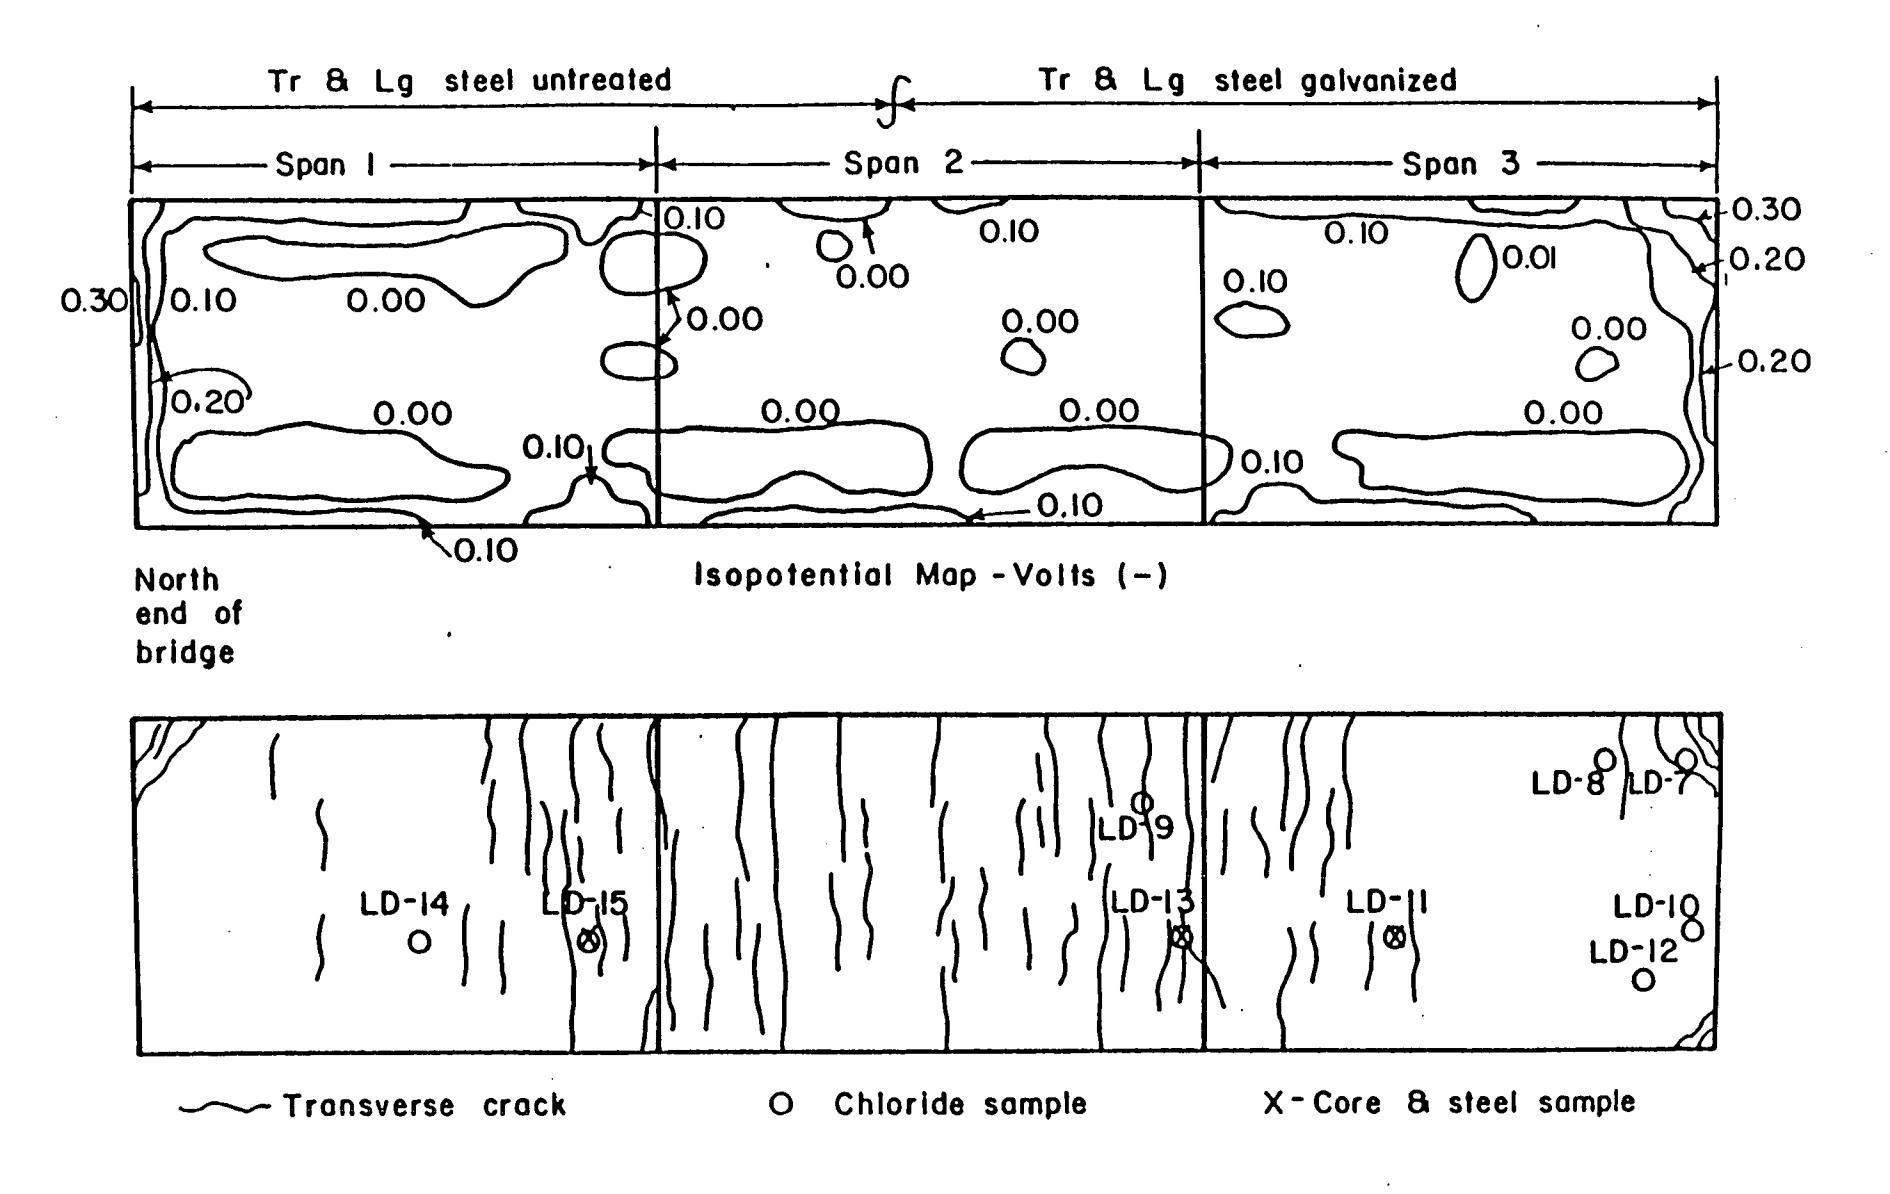
Fig. 2 Diagrams of Ames Bridge for Southbound Traffic Showing Results of Potential Measurements, Crack Survey, and Locations of Test Samples.
