Performance Evaluation of Concrete Pavement Granular Subbase— Pavement Surface Condition Evaluation

Final Report July 2008

Sponsored by Iowa Highway Research Board IHRB Project TR-554

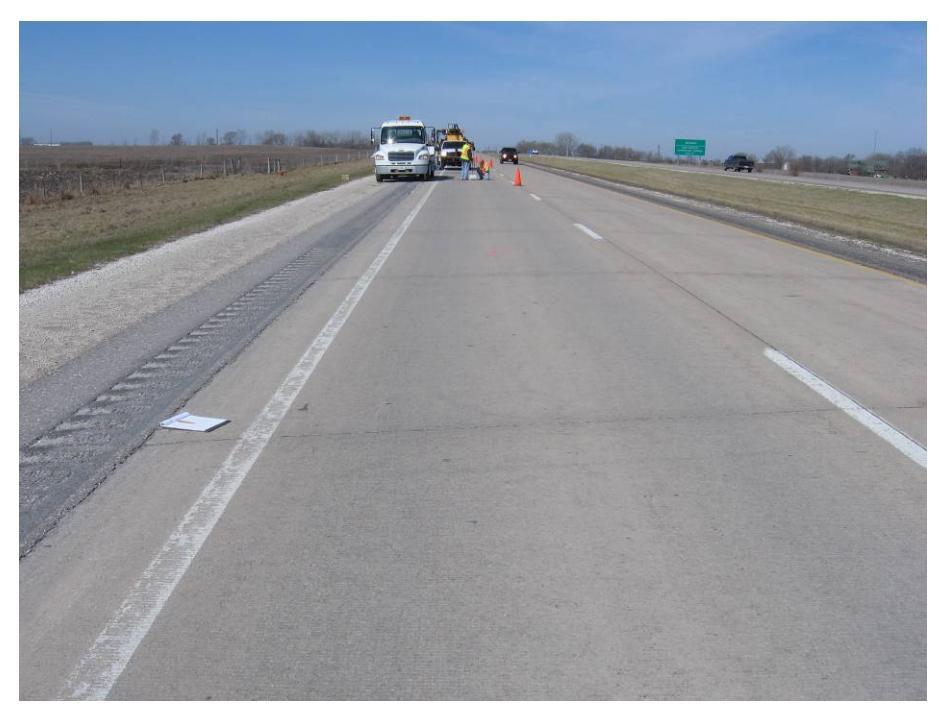
Figure 21. Picture of US-20 (W) pavement section in Webster County (Mile Post No. 122.50–122.55)—virgin aggregate subbase section

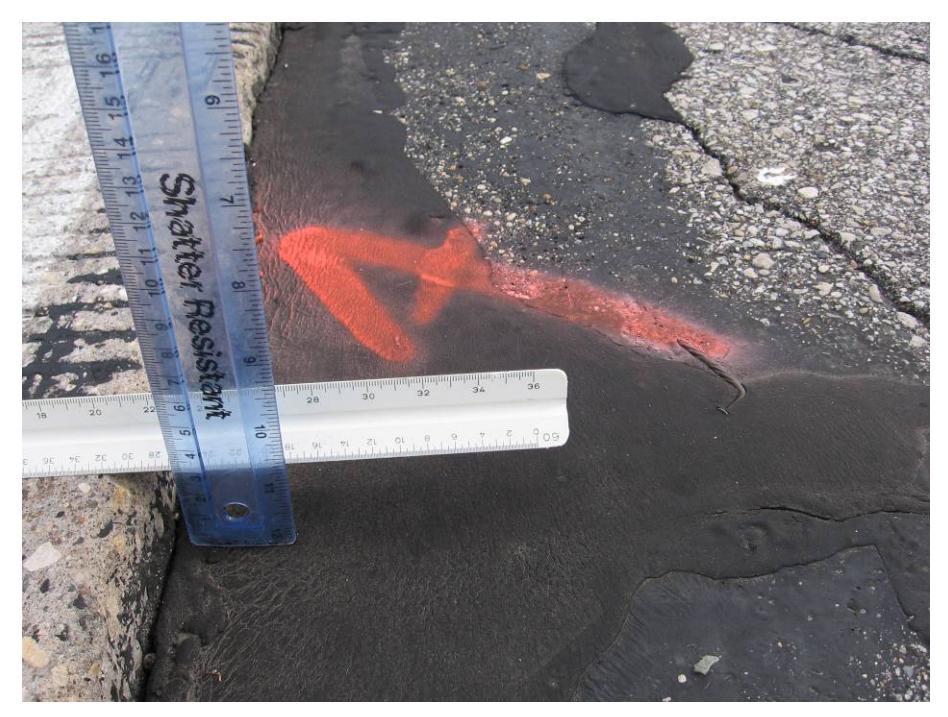
Figure 24. Lane to shoulder drop off on I-35(N) in Hamilton County (Mile Post No. 131.40–131.45)—RPCC subbase section

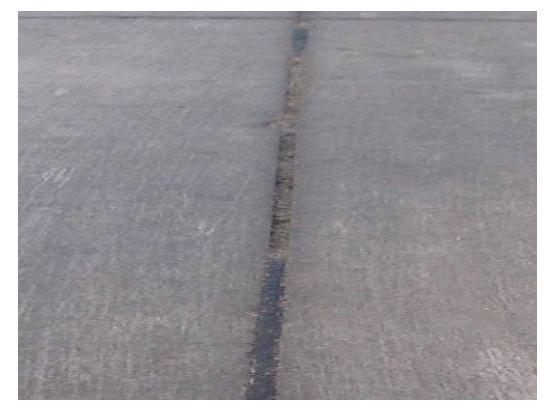
(c) Joint sealing damage of longitudinal joint at slab #2

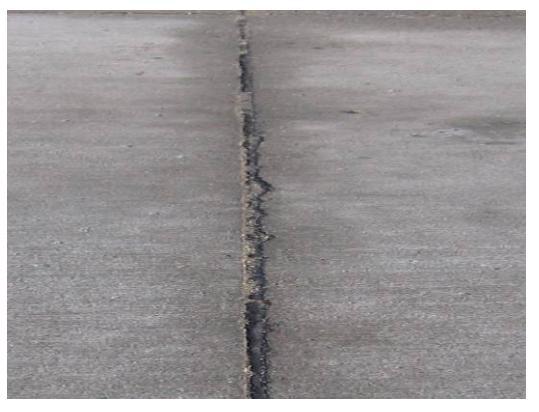
(d) Joint sealing damage of transverse joint at slab #2

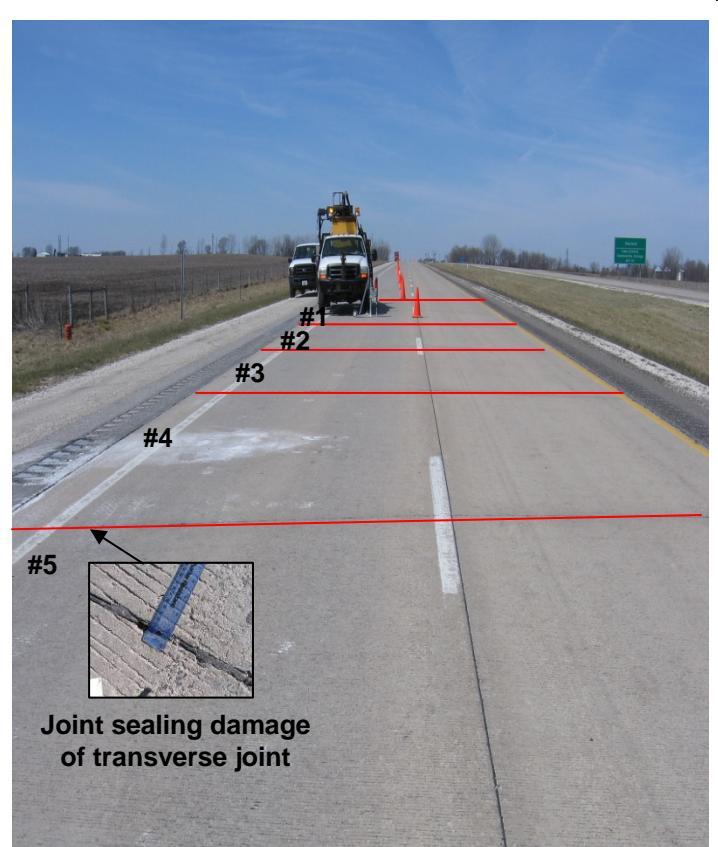
(a) Overall surface distress condition from slab #1 to #5

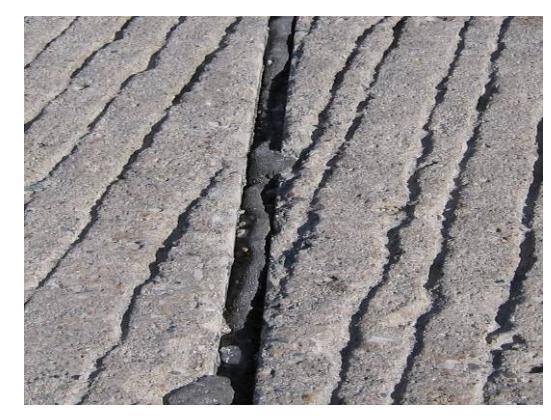
(b) Joint sealing damage of transverse joint at slab #6

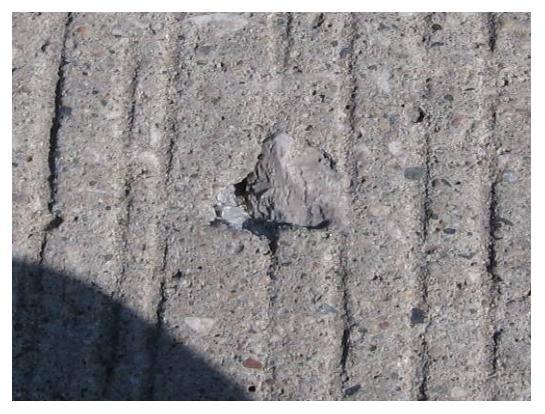
(c) Popout at slab #9

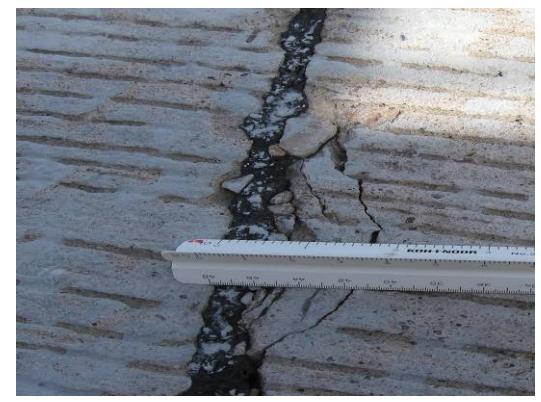
(c) Spalling of Transverse joint at slab #6

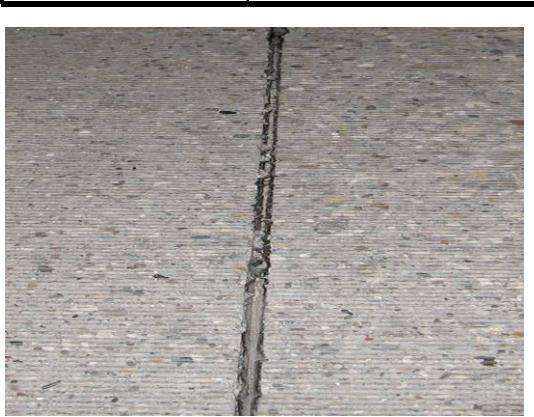
(a) Joint sealing damage of transverse joint at slab #2

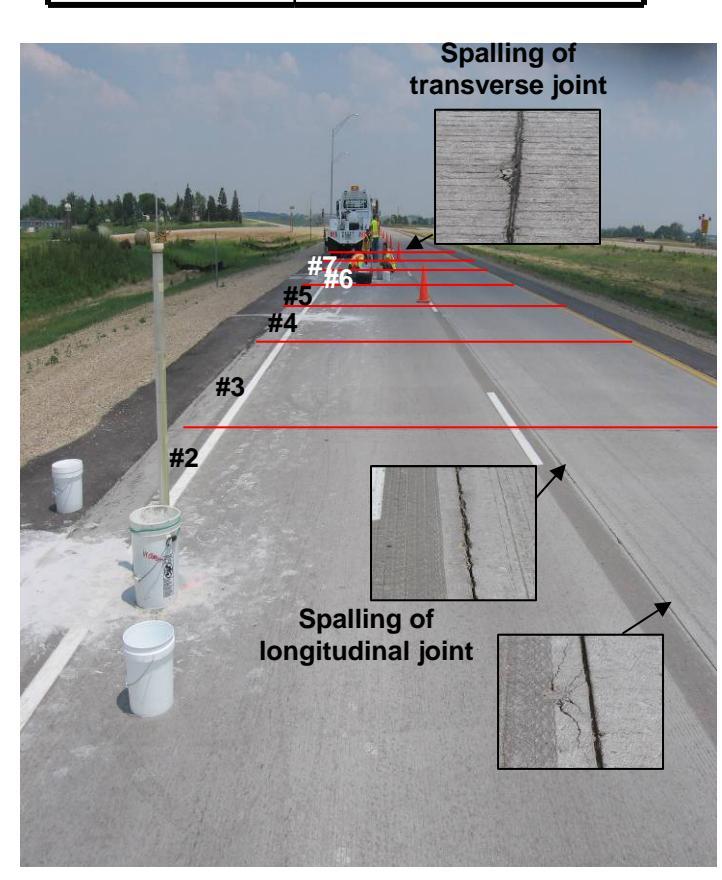
(a) Overall surface distress condition from slab #2 to #8

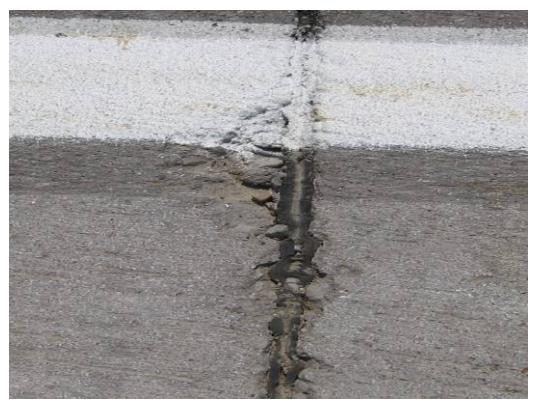
(b) Spalling of transverse joint at slab #12

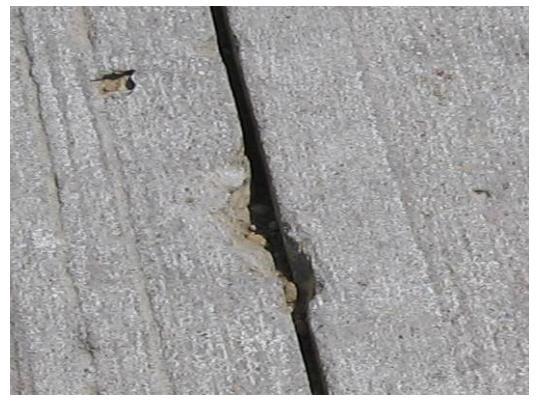
(c) Spalling of longitudinal joint at slab #15

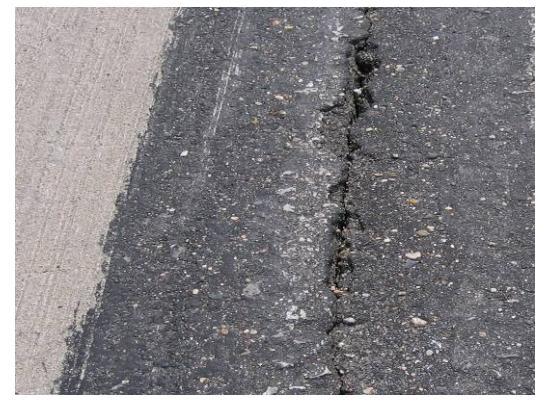
(c) Lane to shoulder separation at slab #11

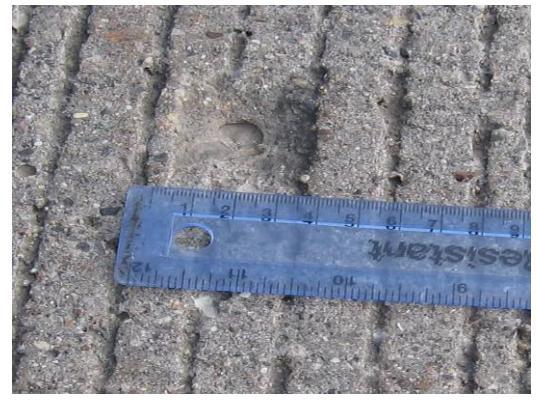
(b) Popout at slab #6

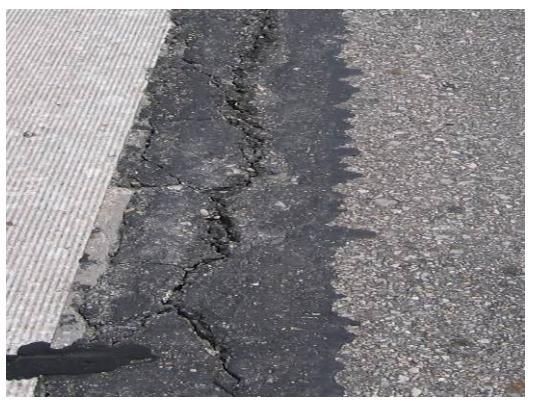
(d) Lane to shoulder separation at slab #18

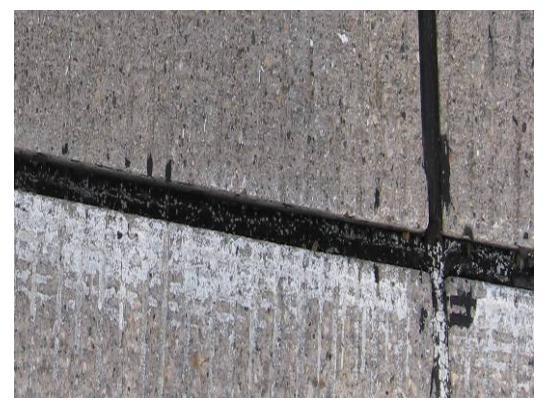
(b) Joint sealing damage of longitudinal joint at slab #5 (c) Overall surface distress condition from slab #6 to #10

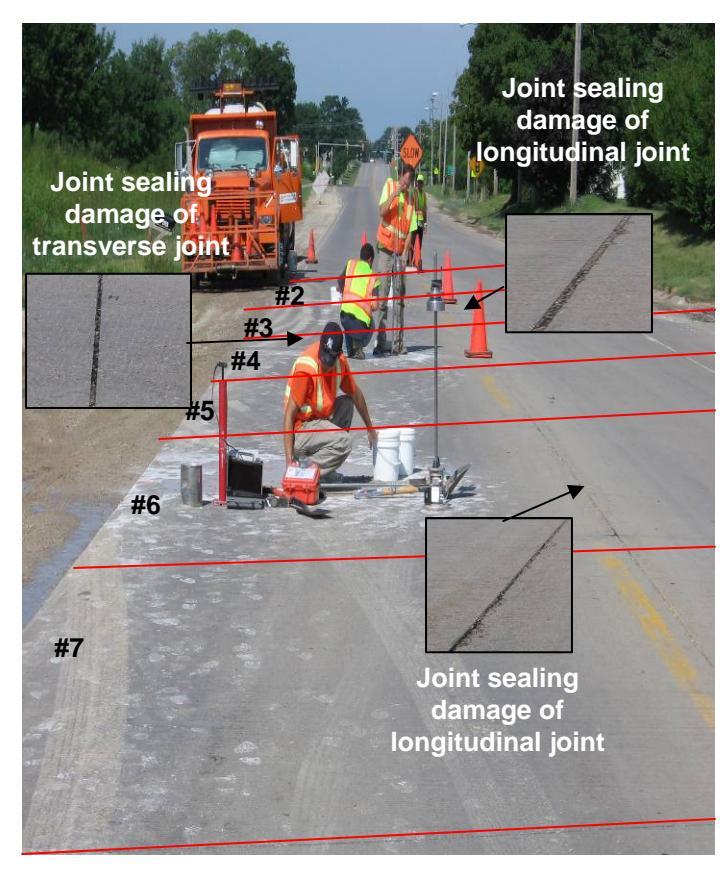
(a) Overall surface distress condition from slab #2 to #7

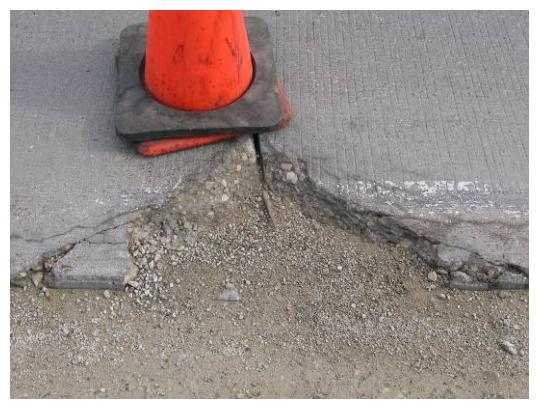
(b) Corner break at slab #12 and #13

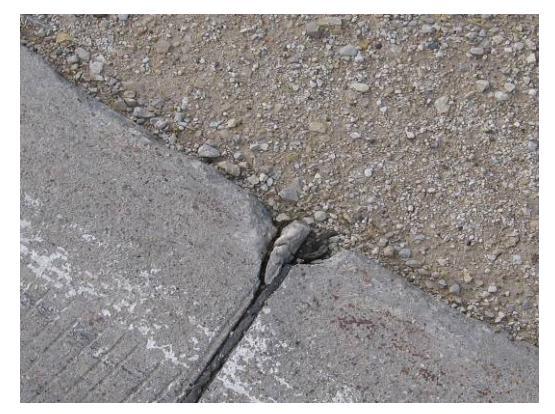
(c) Spalling of transverse joint at slab #14

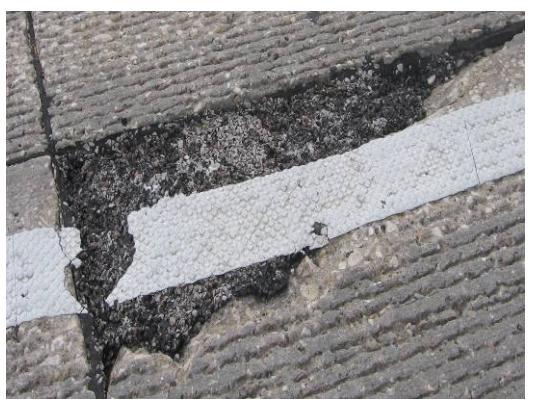
(d) Patch at slab #13

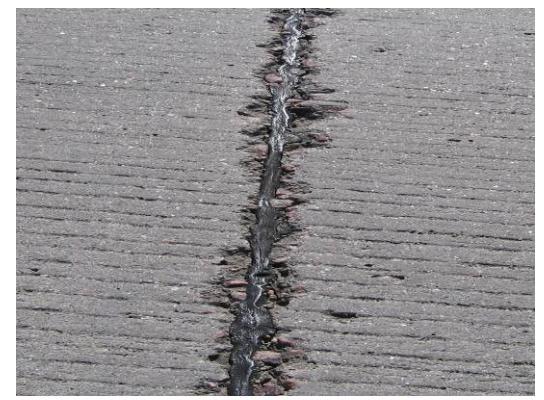
(c) Spalling of transverse joint at slab #7

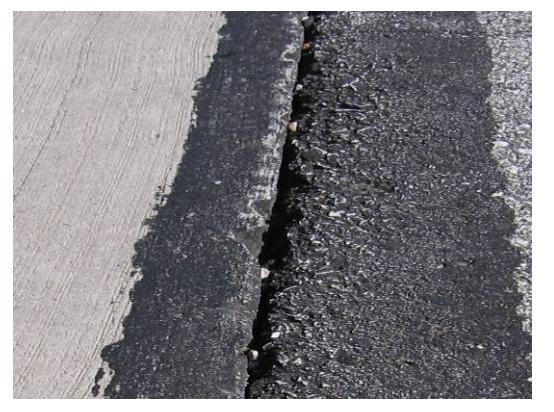
(d) Lane to shoulder separation at slab #10

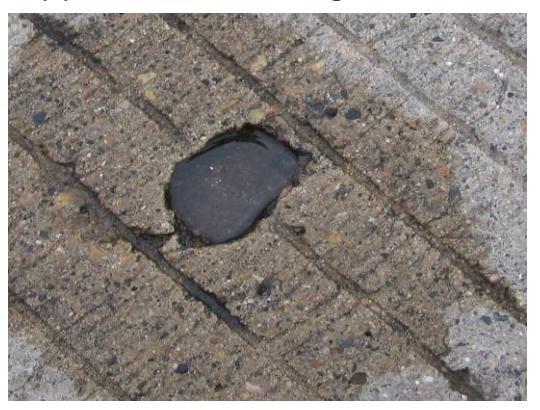
(d) Popout at slab #13

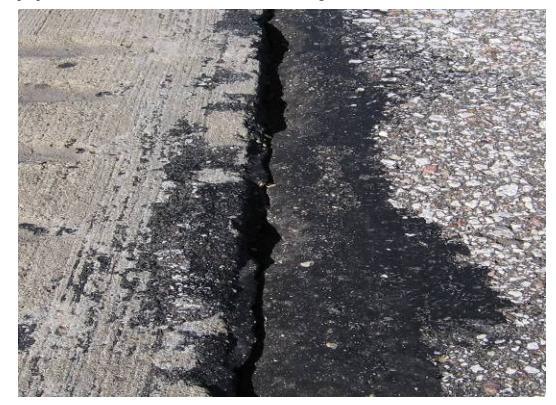
(c) Lane to shoulder separation at slab #15

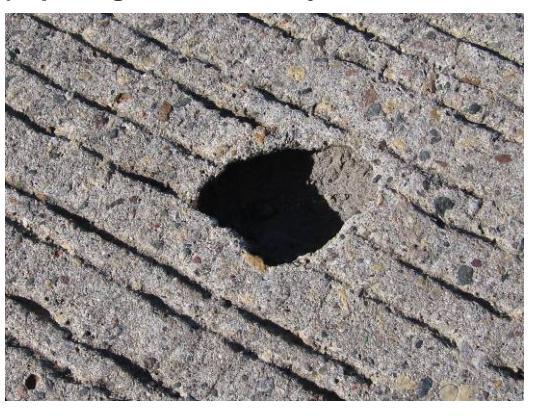
(d) Popout at slab #16

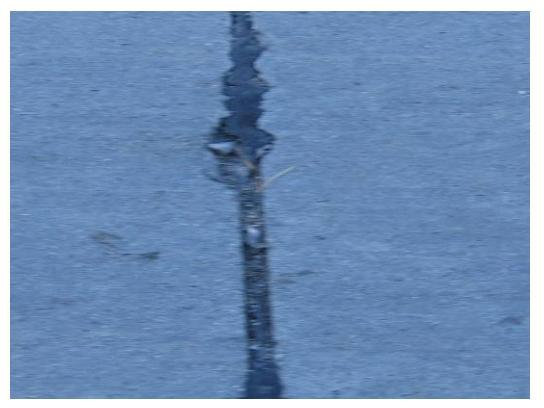
(a) Joint sealing damage of transverse joint at slab #3

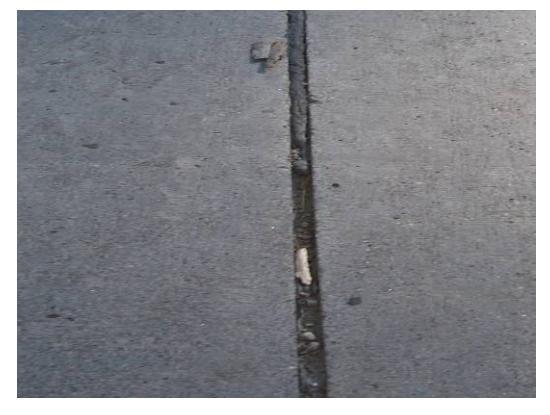
(c) Joint sealing damage of longitudinal joint at slab #8 (d) Joint sealing damage of transverse joint at slab #12

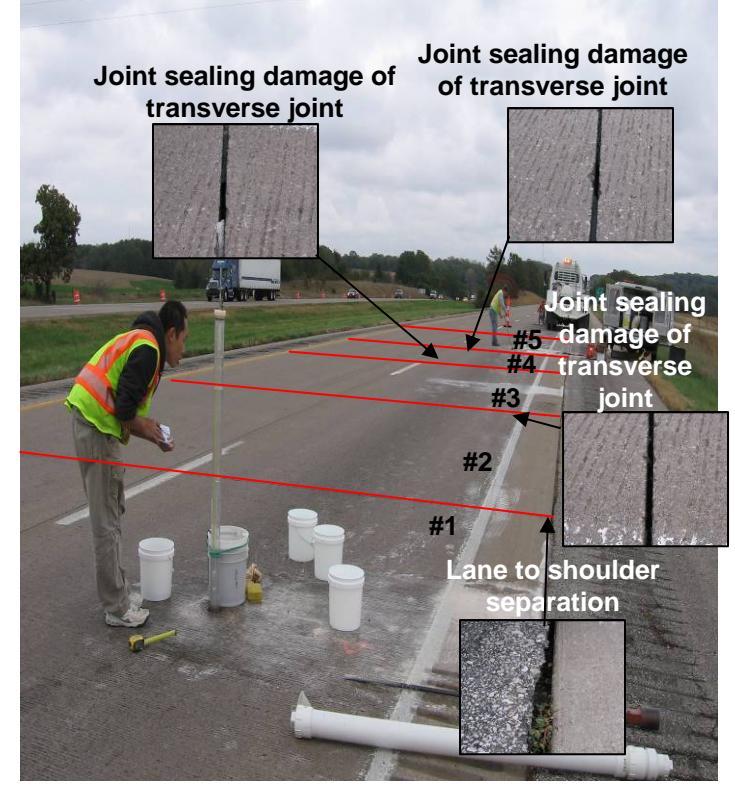
(a) Overall surface distress condition from slab #1 to #5

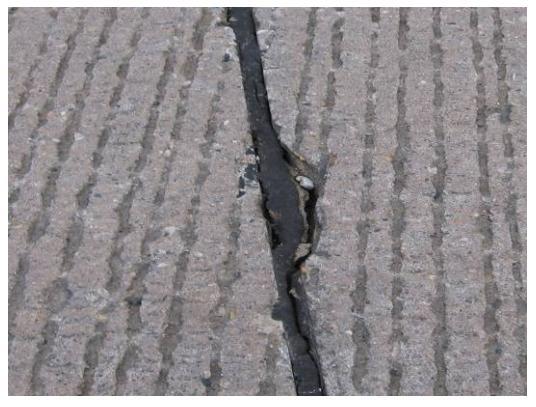
(c) Spalling of transverse joint at slab #17

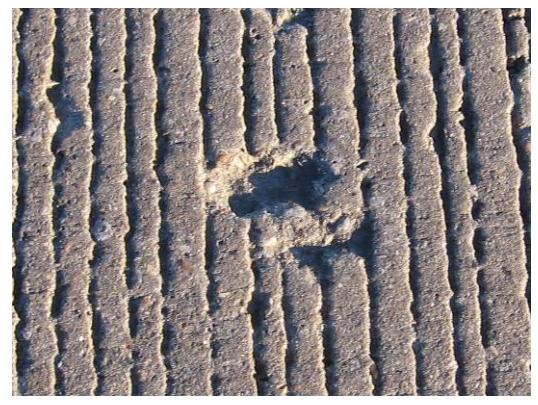
(c) Popout at slab #8

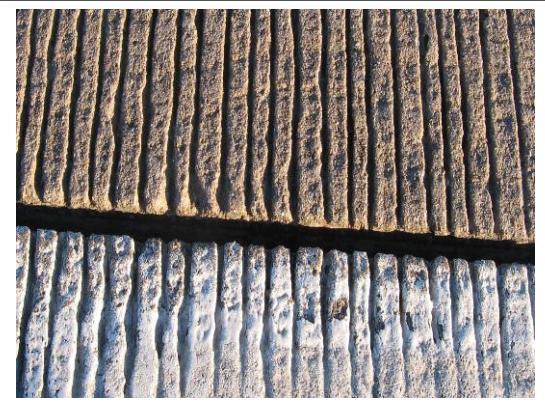
(b) Joint sealing damage of longitudinal joint at slab #4

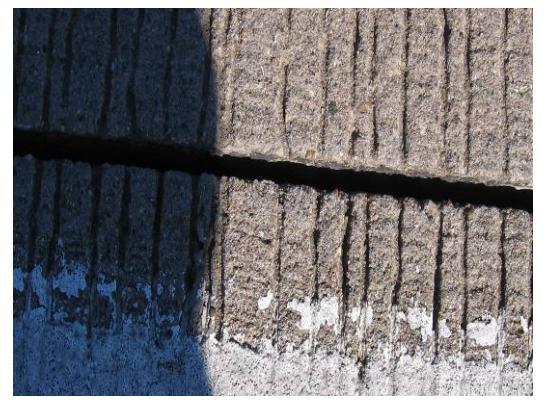
(c) Joint sealing damage of longitudinal joint at slab #8

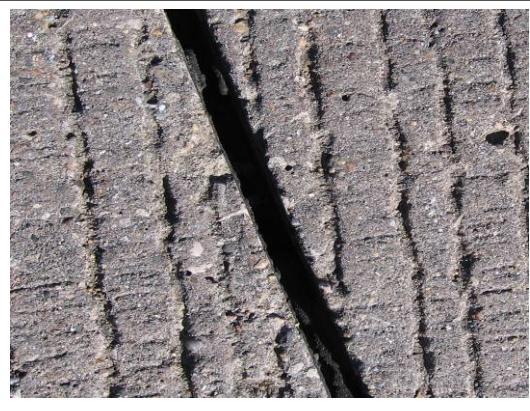
(b) Joint sealing damage of transverse joint at slab #5

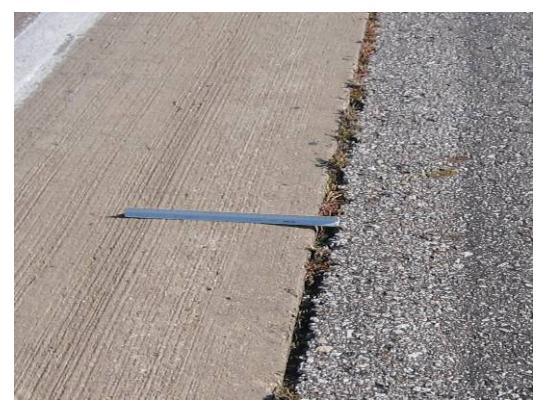
(d) Lane to shoulder separation at slab #15

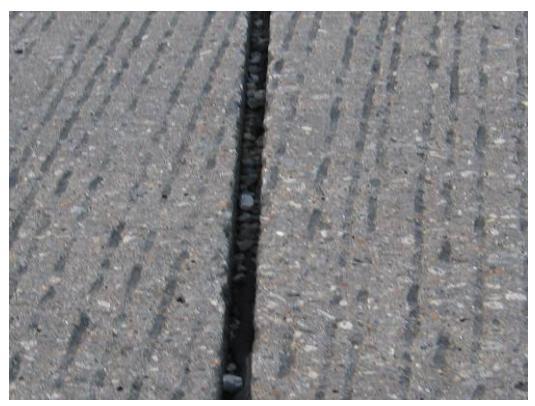
(a) Joint sealing damage of transverse joint at slab #1

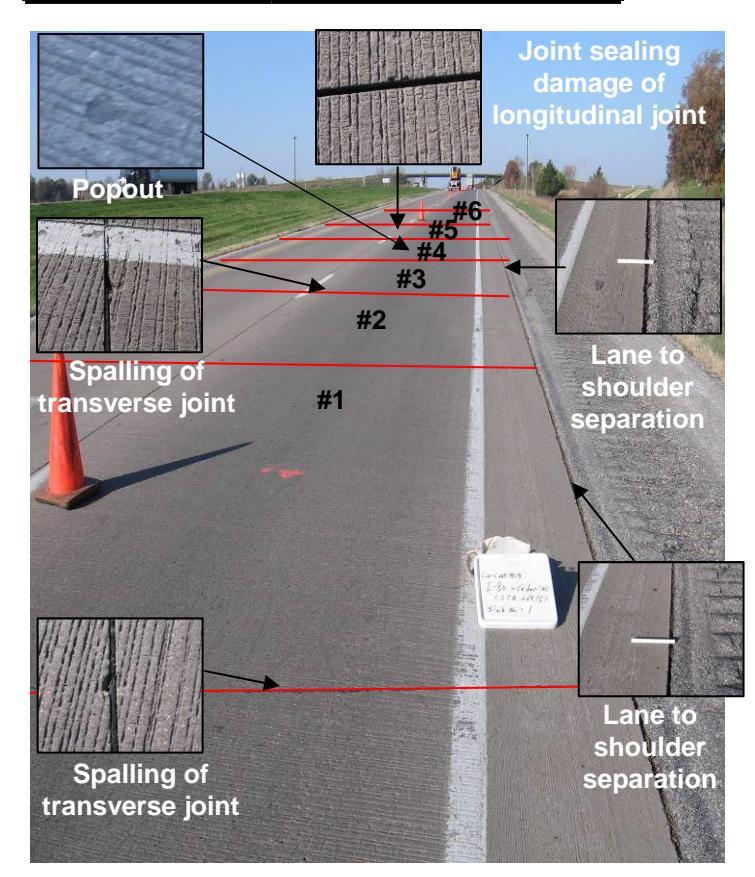
(a) Overall surface distress condition from slab #1 to #5

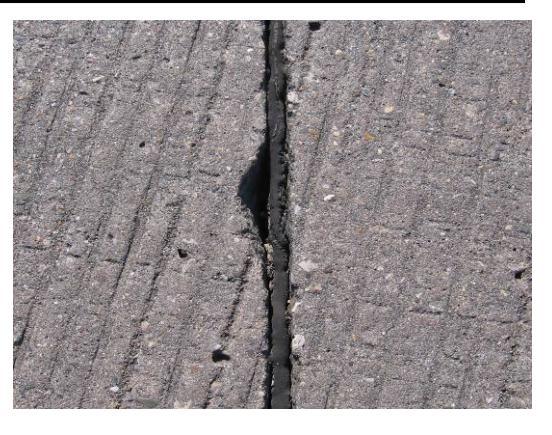
(b) Spalling of transverse joint at slab #12

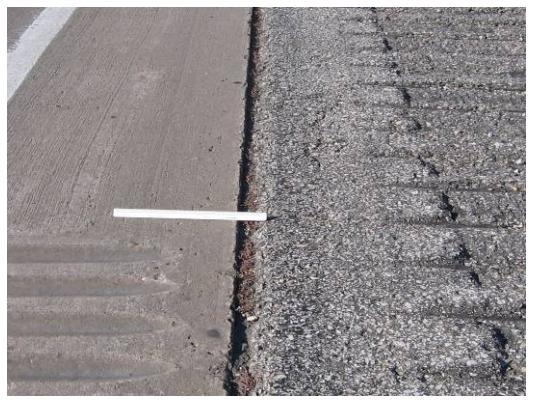
(c) Lane to shoulder separation at slab #17

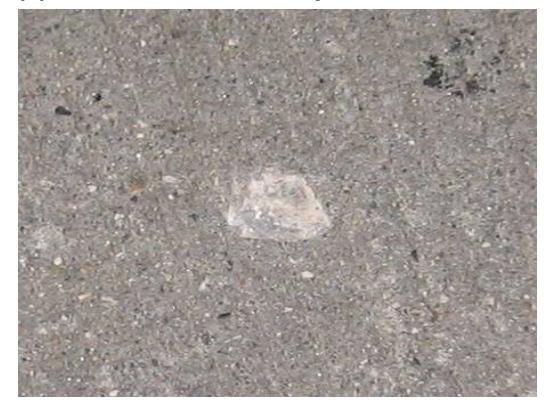
(c) Popout at slab #3

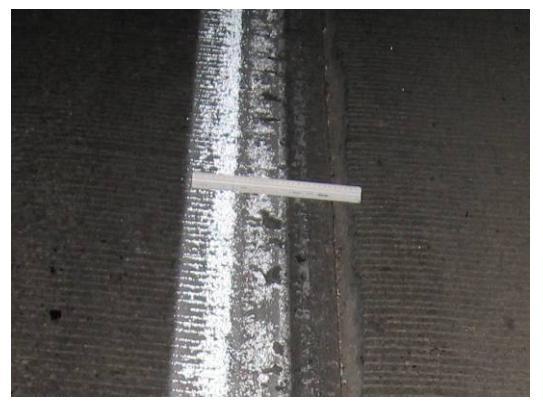
(d) Lane to shoulder separation at slab #9

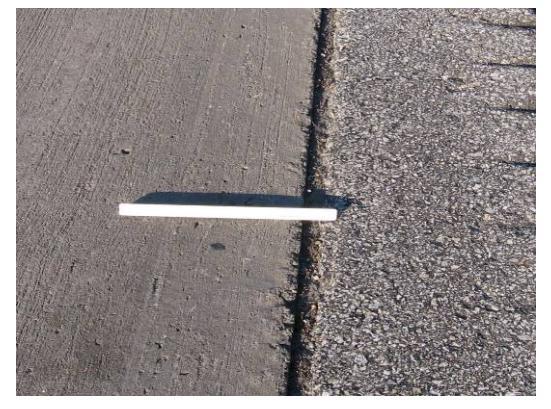
(c) Lane to shoulder separation at slab #12

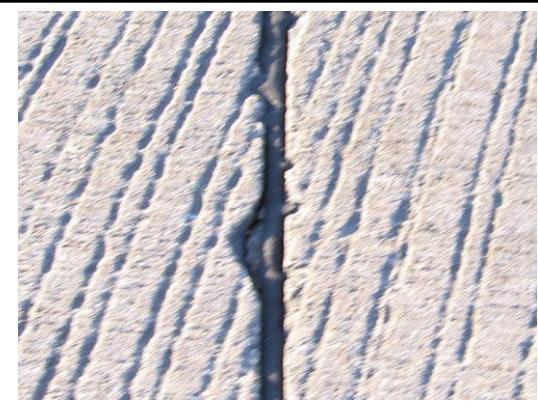
(b) Spalling of transverse joint at slab #7

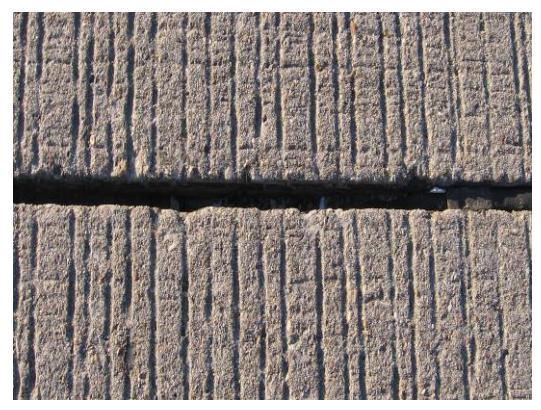
(d) Joint sealing damage of longitudinal joint at slab #15

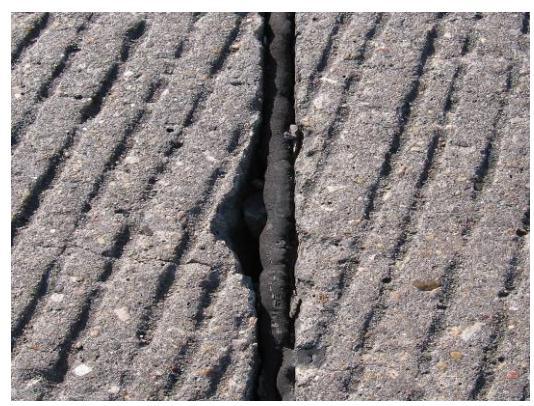
(a) Spalling of transverse joint at slab #1

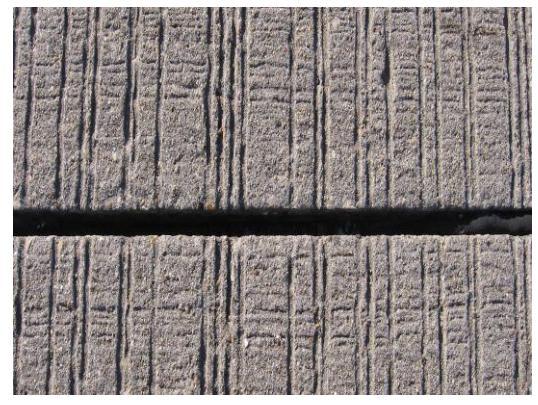
(c) Joint sealing damage of longitudinal joint at slab #9

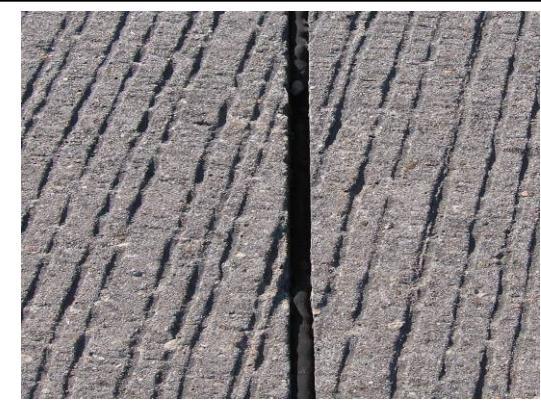
(b) Joint sealing damage of transverse joint at slab #5

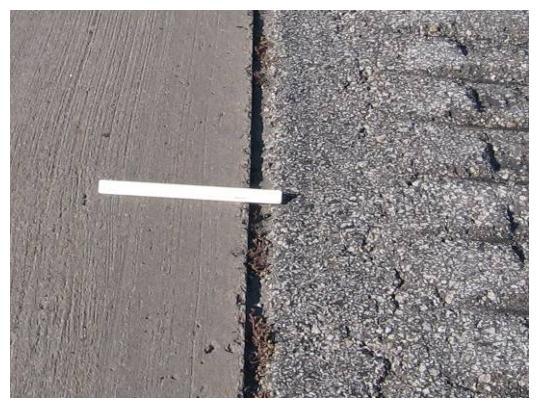
(d) Lane to shoulder separation at slab #18

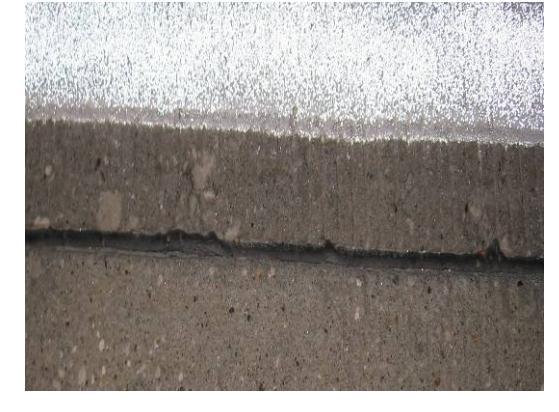
(a) Spalling of longitudinal joint at slab #1

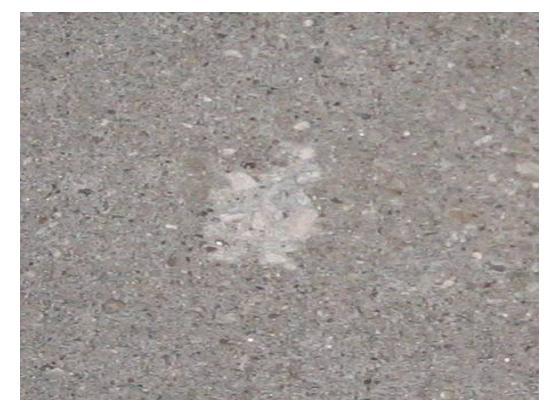
(c) Popout at slab #11

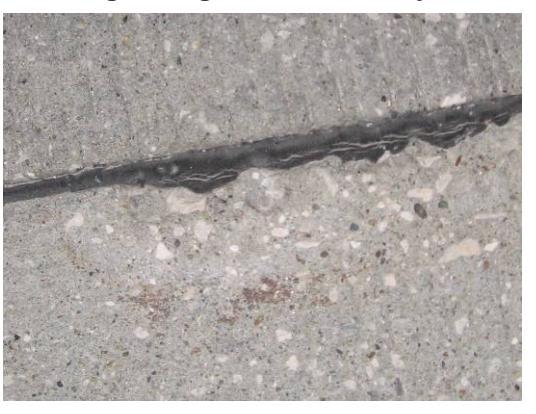
(d) Spalling of transverse joint at slab #15
