## Timber Abutment Piling and Back Wall Rehabilitation and Repair

### Final Report September 2012

Institute for Transportation

**Sponsored by** Iowa Highway Research Board (IHRB Project TR-616) Iowa Department of Transportation (InTrans Project 10-372)

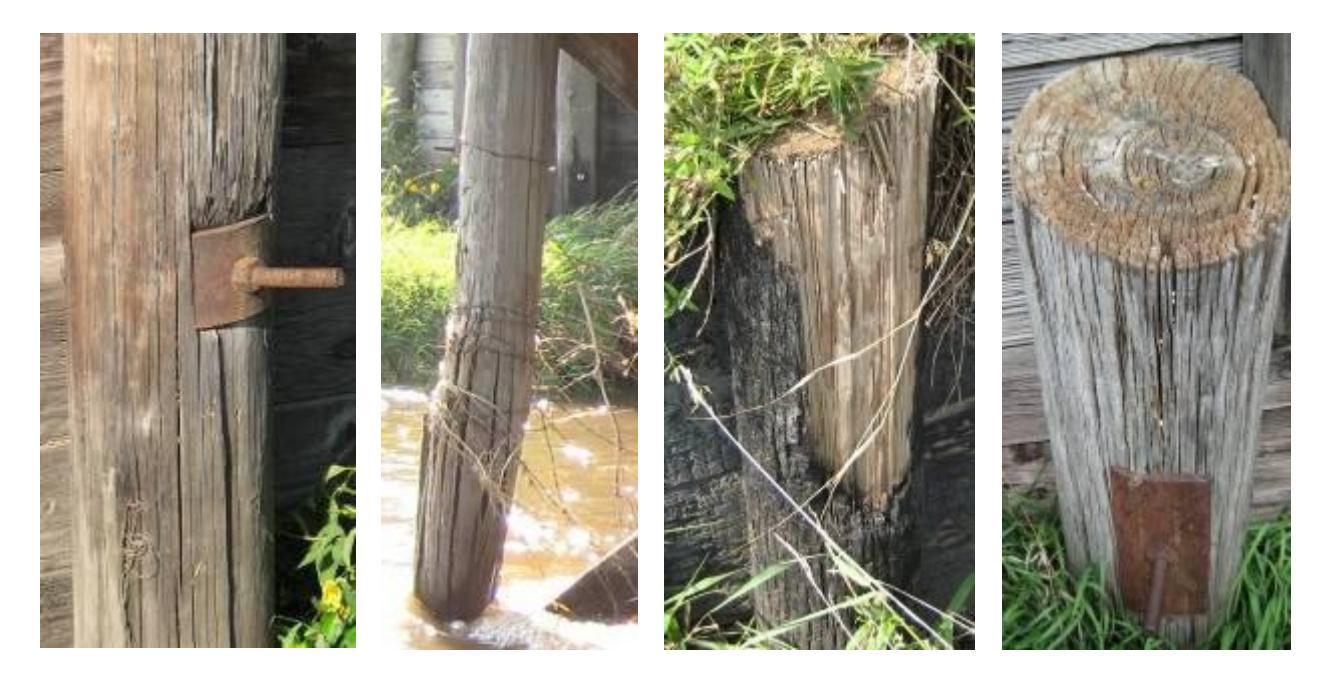
### Figure 2-1 Breaks in preservative barriers by exterior damage leads to premature decay (Bigelow et al. 2007)

There are several forms of physical deterioration that occur in timber bridge piling and back walls, as shown in Figure 2-1. In almost all cases, the physical deterioration causes exterior damage that breaks down the protective preservative barrier and allows entry of biological decay mechanisms into the untreated wood. One of the most common types of physical deterioration is abrasion or debris damage. This generally occurs by the impact of floating debris and/or ice in a channel (White et al. 2007). The velocity of water moving past the pile and the quantity, shape, size, and hardness of particles being transported have been linked to the rate of abrasion (U.S. Army Corps of Engineers et al. 2001).

(a) Mechanical Damage

(b) Debris Damage

(c) Fire Damage

(d) Weathering/UV Damage

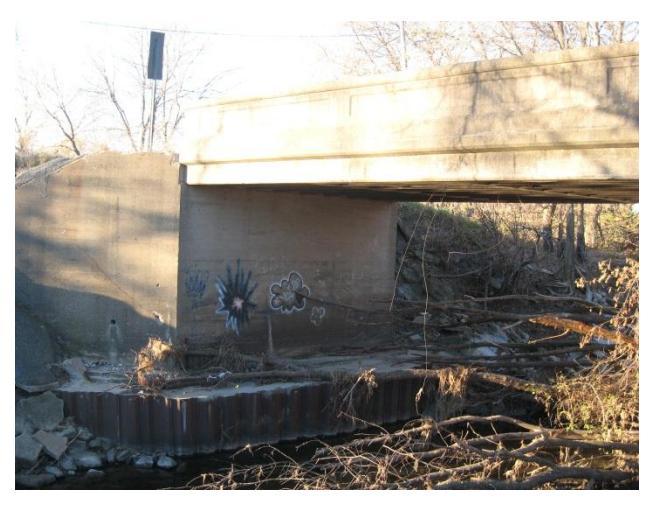
Figure 6-7 Sheet piling at abutment foundation

Polk County has used steel sheet pile to protect bridge abutments from scour problems. Bridge BR2433 with sheet pile placed to prevent scouring of the foundation is shown in Figure 6-7. Although the abutment in this bridge was reinforced concrete, the same solution can be applied to timber abutments. The sheet pile is placed on the stream side of the abutment. The area between the existing abutment and sheet piling was backfilled and capped with concrete to prevent erosion of the backfill material.

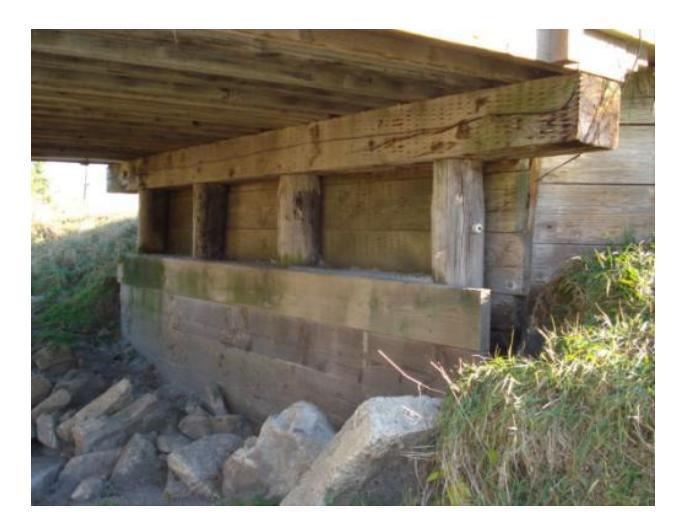
Figure 6-8 Abutment repair on stream side of existing timber abutment

Polk County has also used timber planks nailed to the front of the existing timber abutments to help protect from scour and deterioration of the existing backwall. Figure 6-8 shows the timber planks on the front of the existing timber abutment. The space created between the existing backwall and new backwall planking was filled with concrete. Additional rip-rap was placed on the stream bank and in front of the abutment to help prevent additional scour.

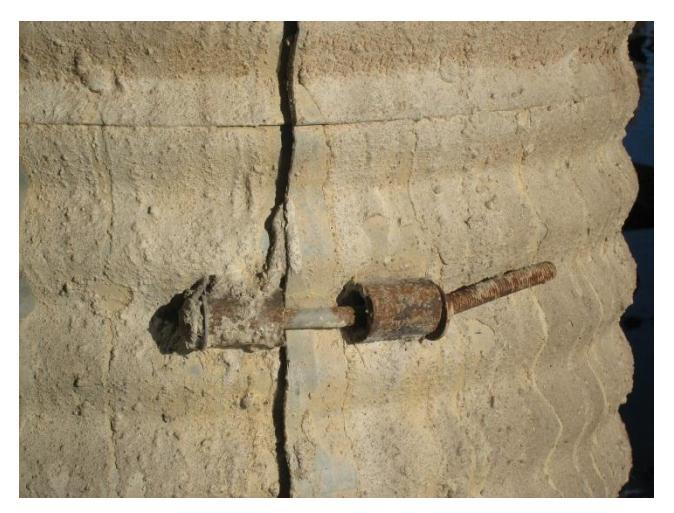
Figure 6-9 Corrugated metal pipe form connector

Polk County has used a combination of splicing and concrete encasement to repair deteriorated timber piles. The repair involves the removal of the decayed portion of the pile up to the pile cap. A new section is placed and is connected to the existing pile with four steel straps. The steel straps, approximately 1/4 in. thick, 1-1/2 in. wide, and 2 ft long, are spaced equally around the pile. The straps are lag screwed with 3 to 4 screws above and below the joints. The splice is then encased with concrete. A corrugated metal pipe (CMP) cut in half and clam shelled around the pile is used for the form. The two halves are connected together using pipe and bolts (Figure 6-9) spaced along the vertical seams of the CMP on approximately 32 in. spacing. The CMP form is extended below the splice straps a minimum of 1 ft and the annular space between the CMP form and the pile is then filled with C-4 concrete. The diameter of the CMP form is approximately 32 in. providing annular space around a 12 in. diameter pile of 10 in. The county did not place reinforcing in the annular space, however, did recommend it for future repairs. One drawback to the repair method stated by the county engineer was the pier bracing had to be reconfigured due the larger diameter of the encased piling. The finished repair is shown in Figure 6-10; this repair was completed in 2000 and is still in good condition.

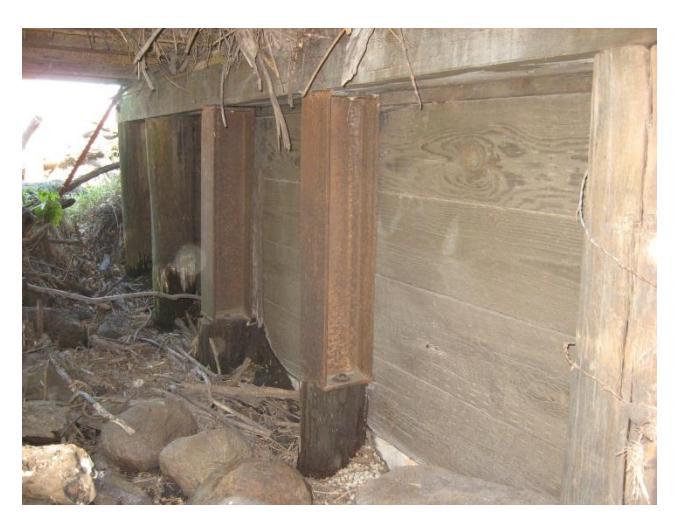
Figure 6-11 Posted piles using steel W shapes

Buchanan County has used steel "W" shapes to splice or post decayed or damaged piles. Figure 6-11 shows two repaired abutment piles. The deteriorated sections are removed and replaced with a "W"-shaped steel section with cap plates welded on each end. The steel section is lag screwed to the remaining pile and to the cap beam with two screws top and bottom. Buchanan County has used this repair on several bridge piles and has seen repairs lasting over 10 years. The one drawback, noted by the county engineer, is a reduction in lateral load capacity and concerns that the abutment could push the wall out. Buchanan County has also used timber sections for repair, however, the longevity of using new timber pile sections was found to be less than that of the steel sections.

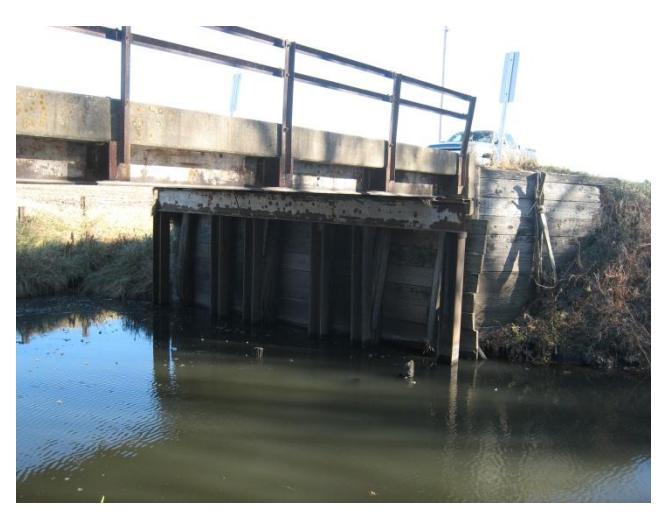
Figure 6-12 Steel piles driven

the openings. The new piles, however, did not provide lateral support for the bridge back wall. The backwall was not shimmed against the new piling. After sufficient deterioration of the existing timber piles took place, the back wall buckled. The county engineer suggested the piles be driven as close to the back wall as possible and shims placed between the new piles and existing backwall in order to prevent the backwall movement.

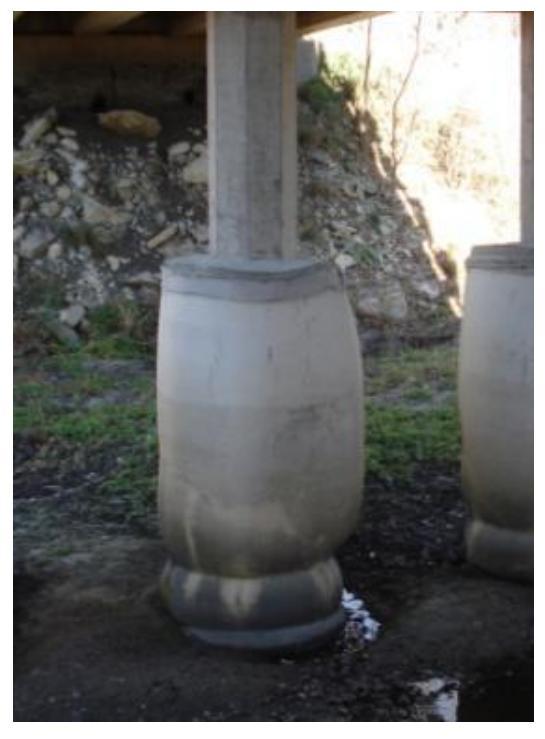
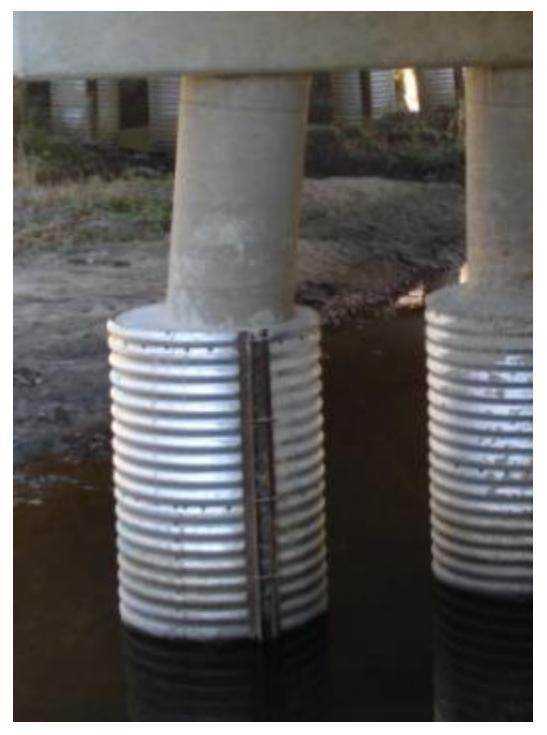
Buchanan County also uses concrete encasement for repairing deteriorated piles. Figure 6-13, shows the encasements the County has completed on concrete piles, however both systems can be applied to timber piles. The repair seen in Figure 6-13a uses a fabric sock that is placed around the pile and filled with concrete. The cost of using the fabric sock concrete encasement with the exclusion of excavating around the pile was approximately \$1800/pile in 1998; the fabric sock encasement was completed in 1998 and is still performing well. Similar to Polk County, Buchanan County also repaired piles using CMP as forms for concrete encasement. Figure 6-13b shows the CMP cut in half, reconnected using an angle welded to the CMP, then bolted together. The CMP encasement was completed circa 1998 and is also still performing well.

(a) Concrete repair sock

(b) CMP repair

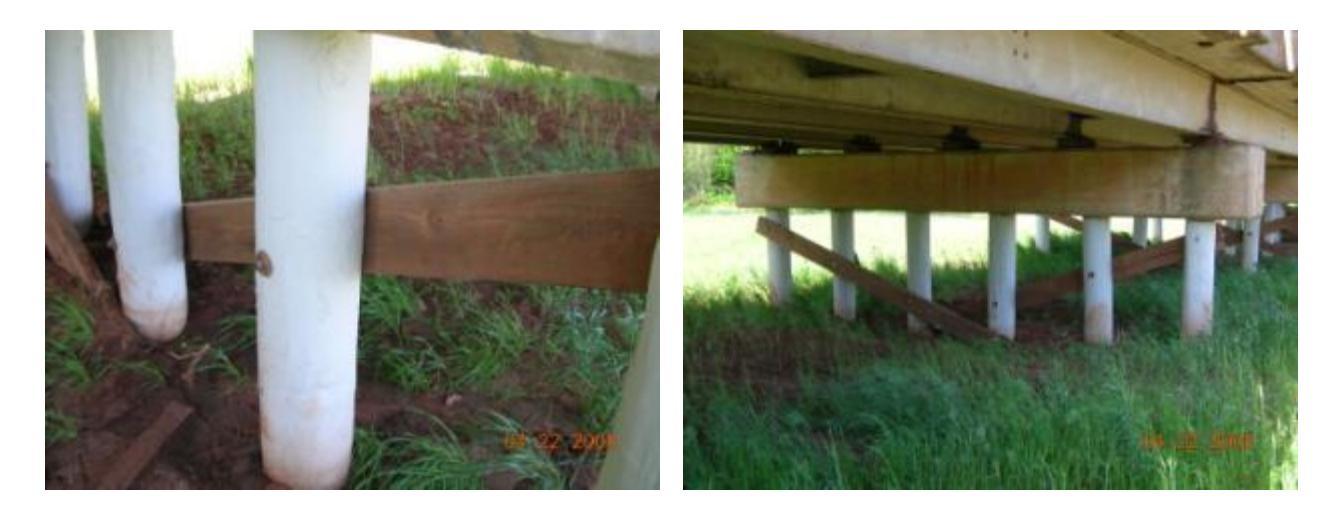
The Oklahoma Department of Transportation (2010) has had timber pile repair success with FRP wraps; however, they have only used the repair technique on pile bents and not on abutment piles. The technique was developed by personnel at the Oklahoma DOT and was studied by Emerson (2004) as described previously in this report. The piles are excavated below the ground line to expose a minimum of 2 ft of sound piling. Then, 3 inch-diameter holes are drilled through the outer shell of the hollow or damaged section to clean the interior of the pile. The holes are spaced to allow for cleaning and future placement of fill material in the pile. After both the surface and interior portion of the pile are cleaned, the timber is allowed to drain and dry; the timber is then remedially treated with borate fungicide, which is placed in drilled and then plugged holes above and below the damaged section. The voids in the timber pile are then filled with aggregate to lessen the amount of epoxy required and the heat from the epoxy exothermic. Two wraps of FRP material are then placed around the pile and set with fabric impregnation resin. After the resin has set, the injection port holes are drilled and spaced so that travel of epoxy between ports is assured. After the epoxy resin mortar has cured, the ports are removed. Lastly, an ultra-violet resistant coating is applied to the pile. Two views of FRP repaired piles at an Oklahoma bridge are shown in Figure 6-30.

a) Close-up of single pile b) Completed repairs on entire pier Figure 6-30 Completed Oklahoma DOT injected and FRP repaired timber piles
