Carroll, Iowa

TRAFFIC SAFETY STUDY

HENNINGSON, DURHAM & RICHARDSON

PRELIMINARY

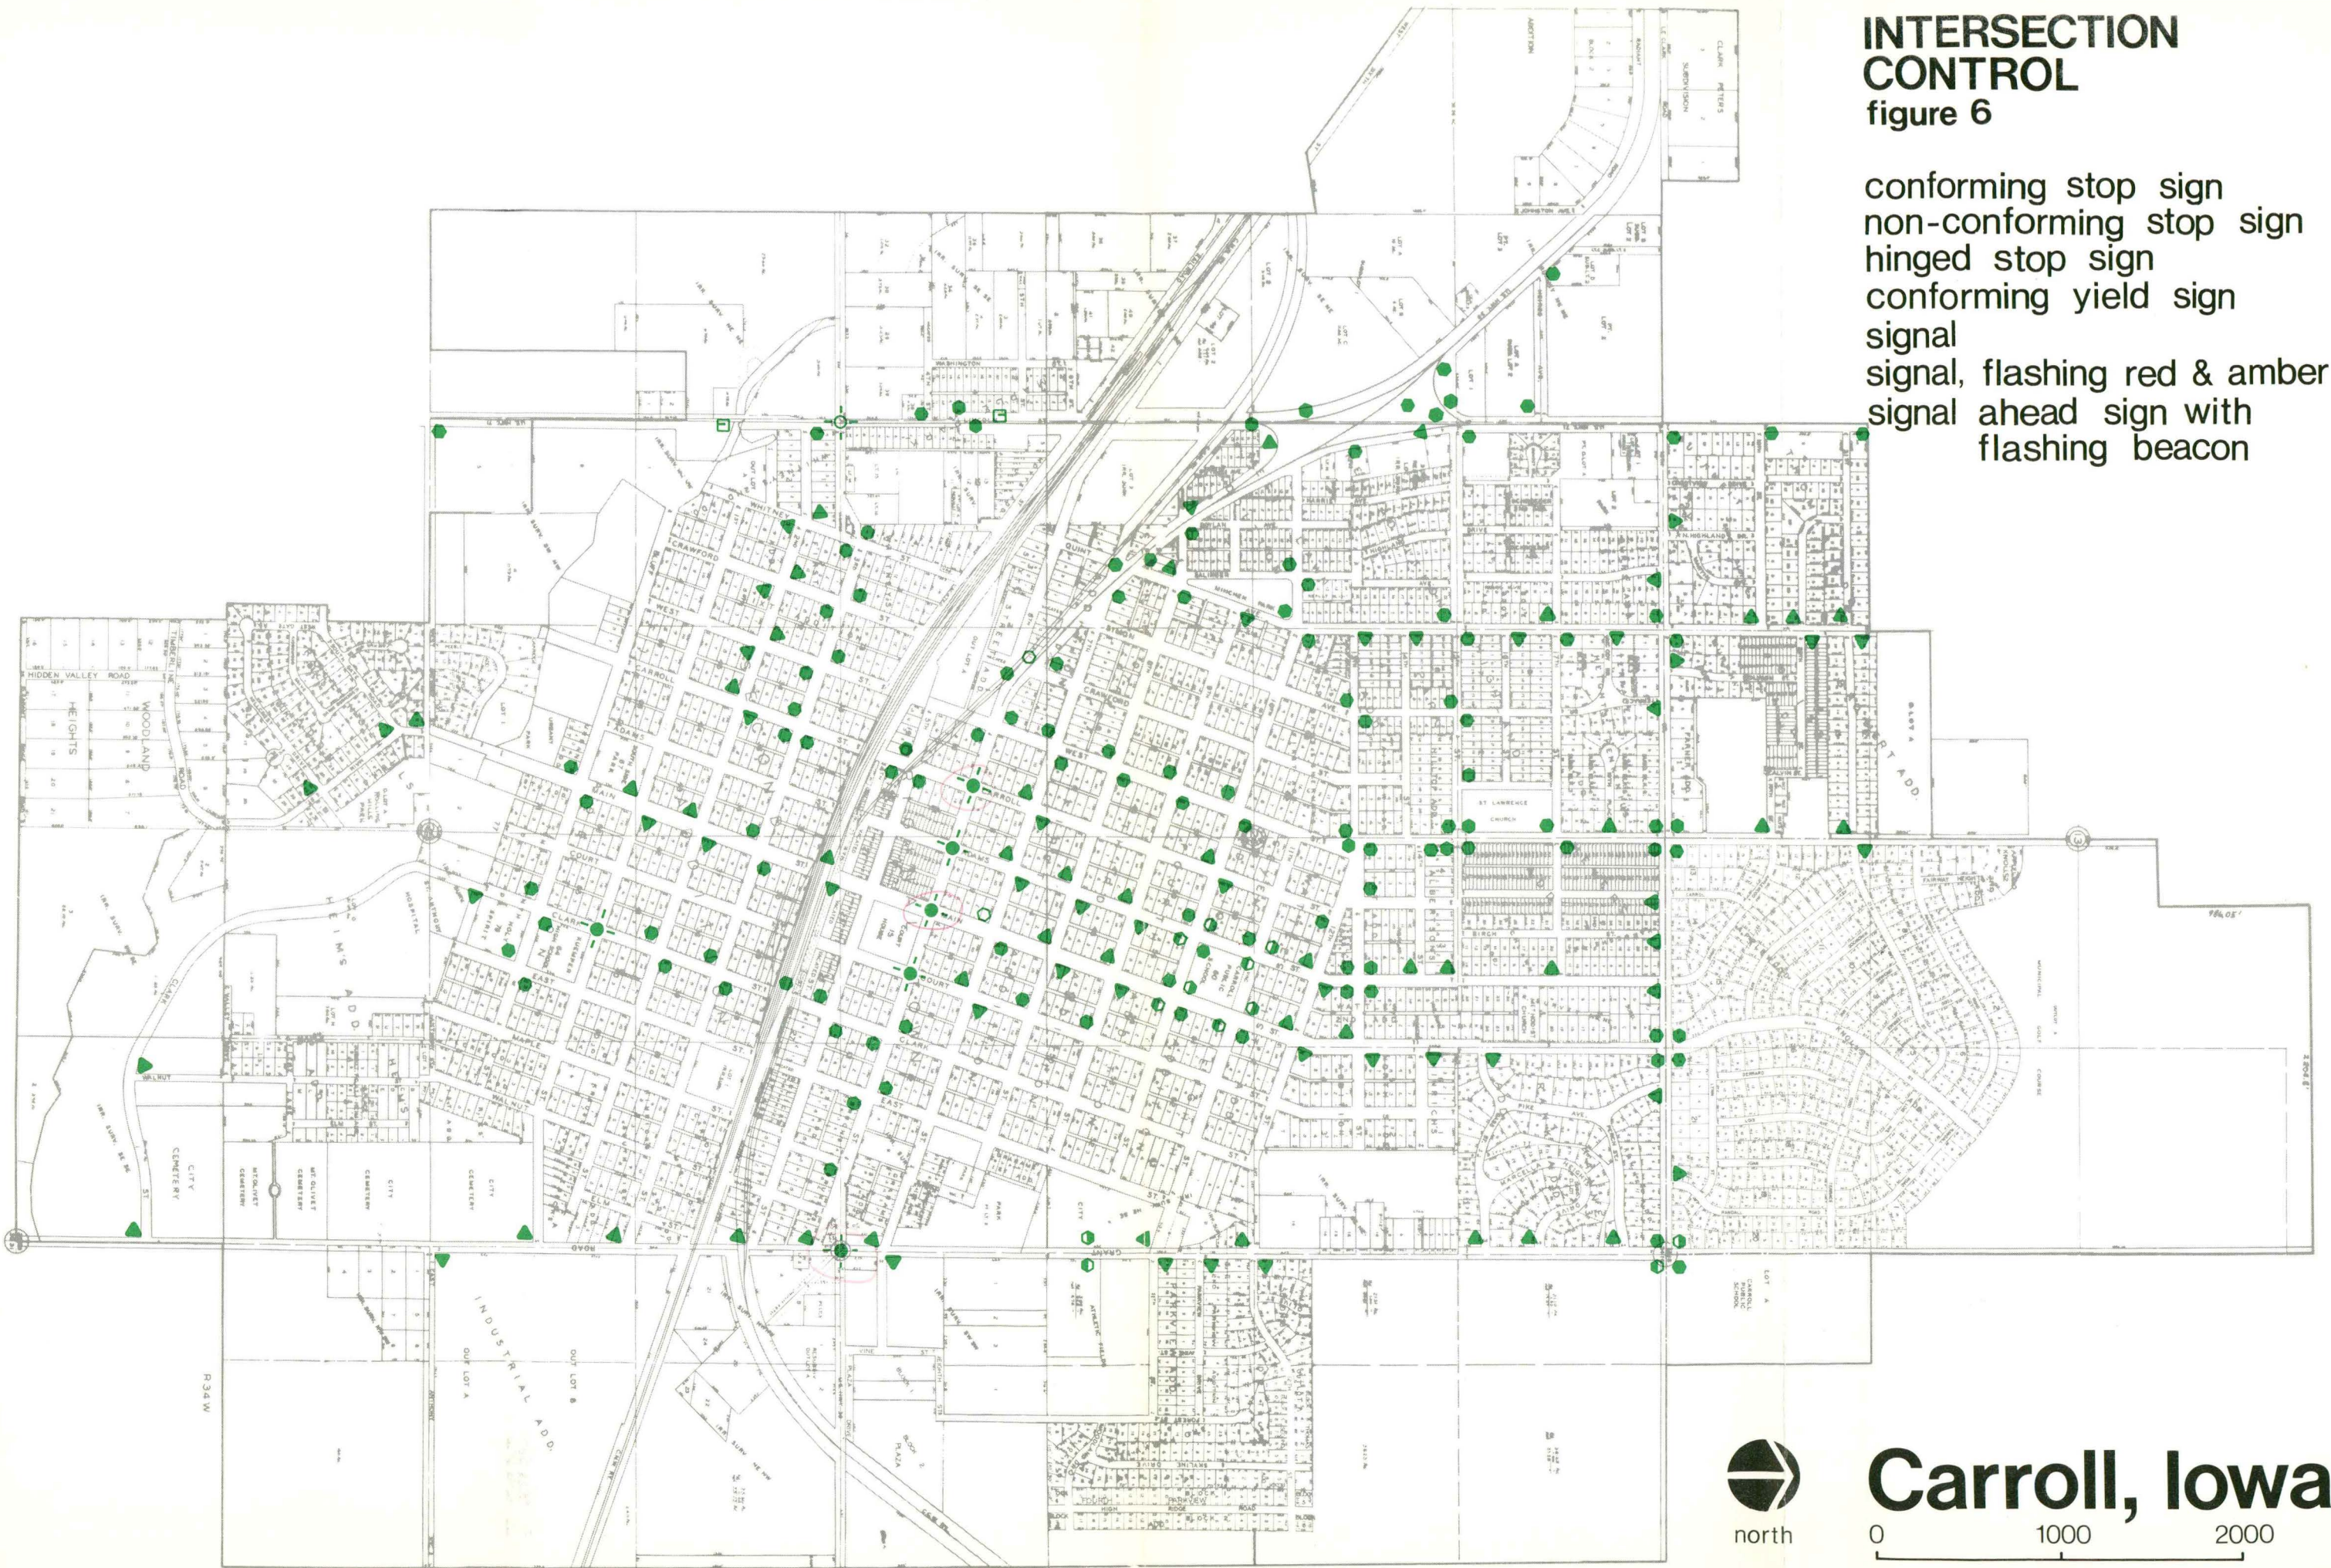
figure 6

Generally speaking, intersection controls conform to the MUTCD. However, non-conforming installations were found in several areas. Folding stop signs have been installed at six intersections, four around Carroll Public High, a fifth at Fairview and a sixth at the municipal swimming pool on Grant Road. Two locations combine stop and yield signs in the same intersection - Quint and 8th and 17th and Quint. Two intersections are controlled with stop signs on one leg only. They are 8th and ^{Court}Clark and 9th and ^{Court}Clark. A non-conforming stop sign was found at the southwest corner of 7th Street at Main.

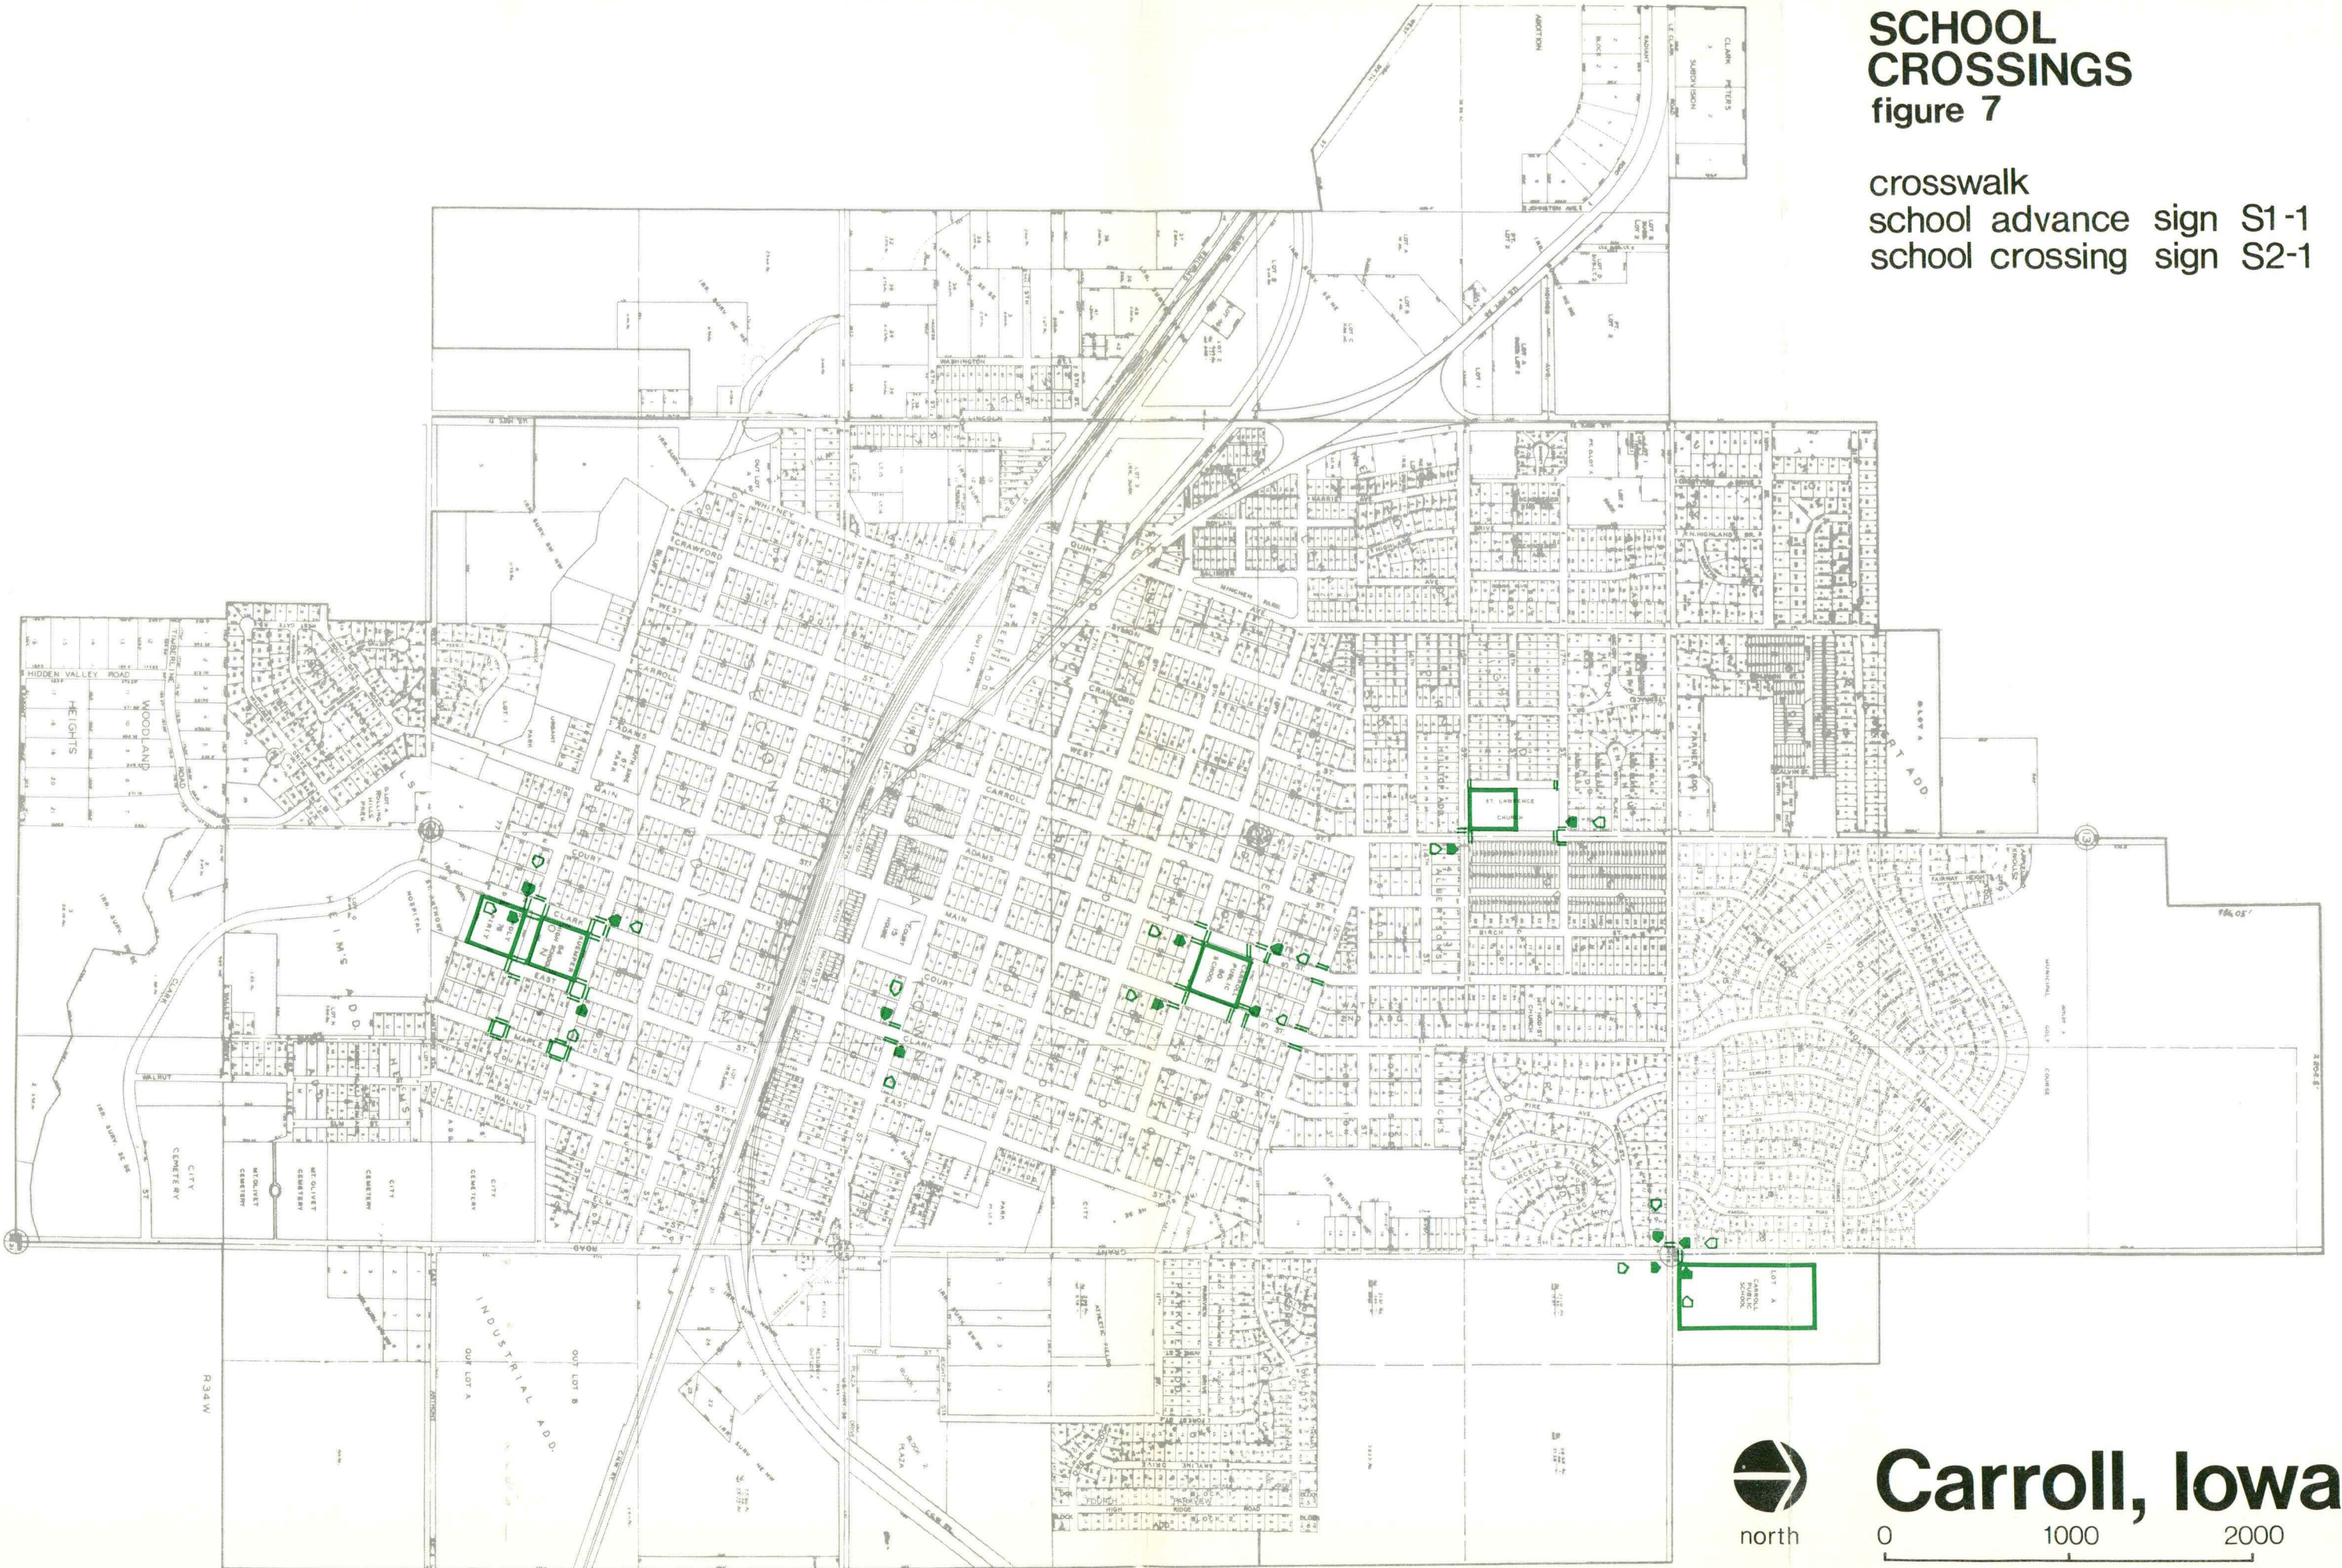
figure 7

Advanced warning signs are located on routes approaching school crossings and are located according to the MUTCD. School crossing signs are placed at all crosswalks including those with stop sign control. Such placement is contrary to the MUTCD in that proper placement of both signs with respect to the crosswalk is not possible. In some cases the improperly placed crossing sign obscures the correctly located stop sign.

The crossings themselves are in many cases obscured by on-street parking in the vicinity of the schools. Intersections where sight distance problems at school crossings were observed are Clark and Bluff, Clark and 1st, Main and 11th, Adams and 11th and to a lesser extent at Adams and 10th.

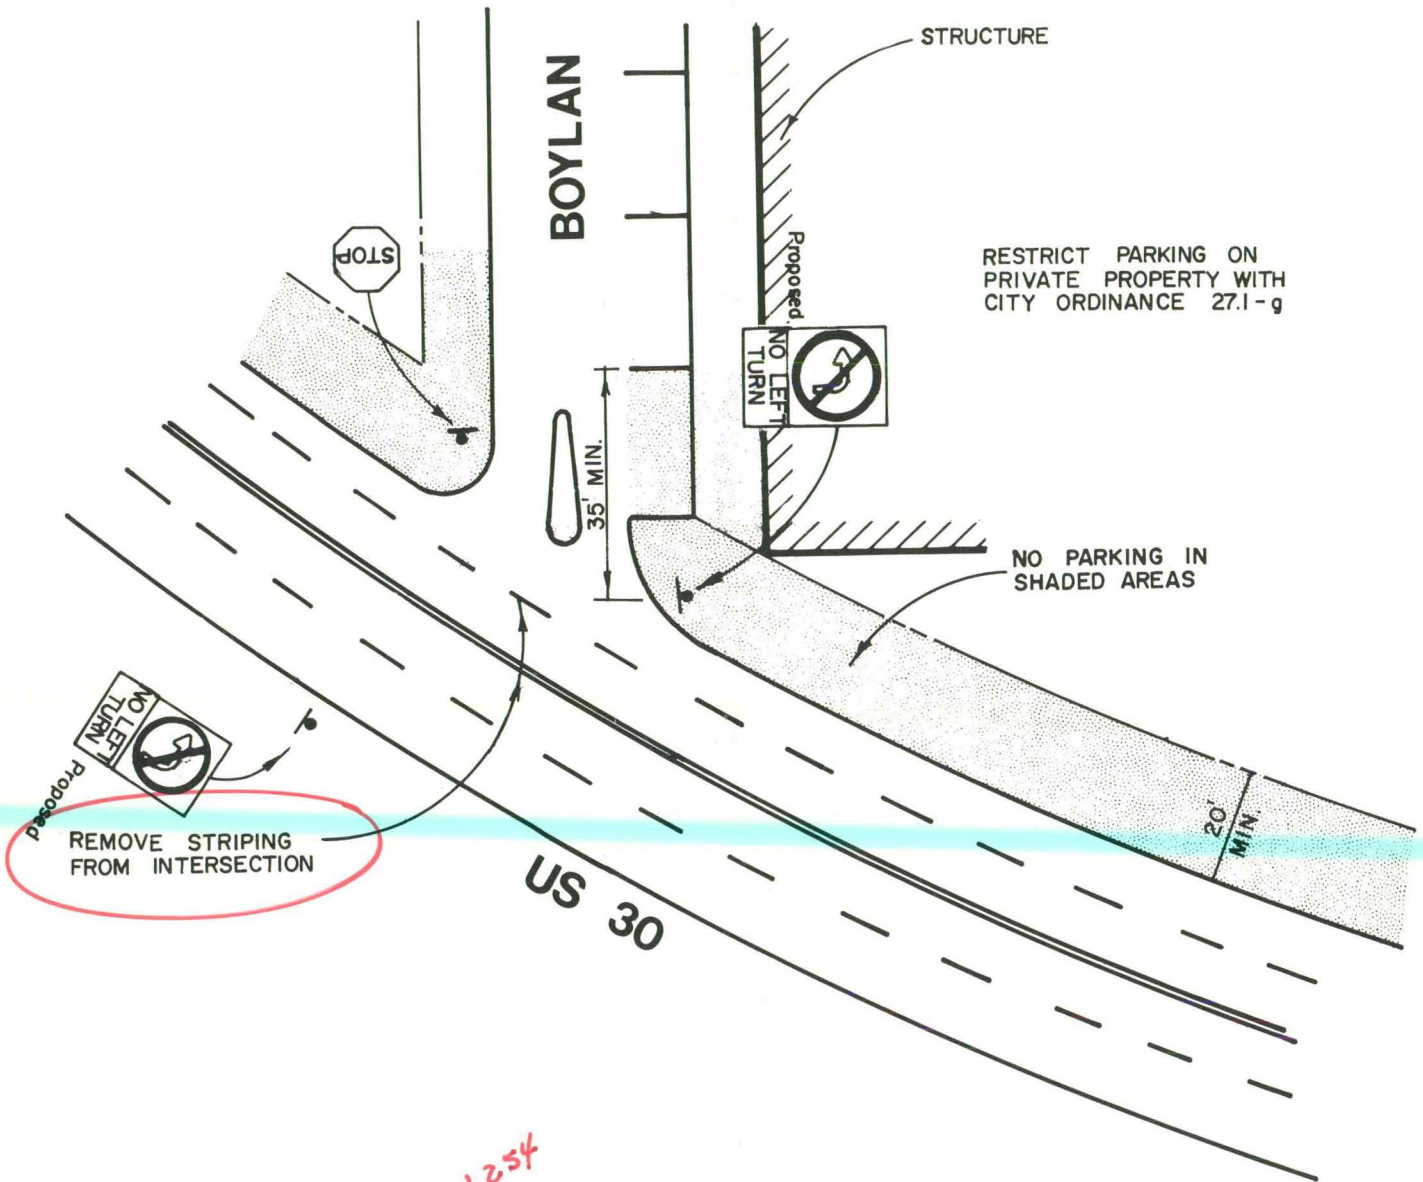
US 30 and Boylan. Accident history indicates a high frequency of rearend accidents on the east approach of US 30 at this location. Inspection of the site indicates that several factors contribute to a sight distance problem.

It was observed that pavement striping on US 30 is carried through the intersection at this and other intersections. This practice should be stopped.

Very little can be done about the sight distance along US 30. However, the visibility of the intersection at Boylan can be improved by removing the parking. It is therefore recommended that parking be prohibited within the US 30 right-of-way on the northeast corner of Boylan. Also parking should be prohibited on either side of Boylan for a distance of 35 feet from the curblines of US 30 as shown in FIGURE 12.

REMOVE STRIPING
FROM INTERSECTION

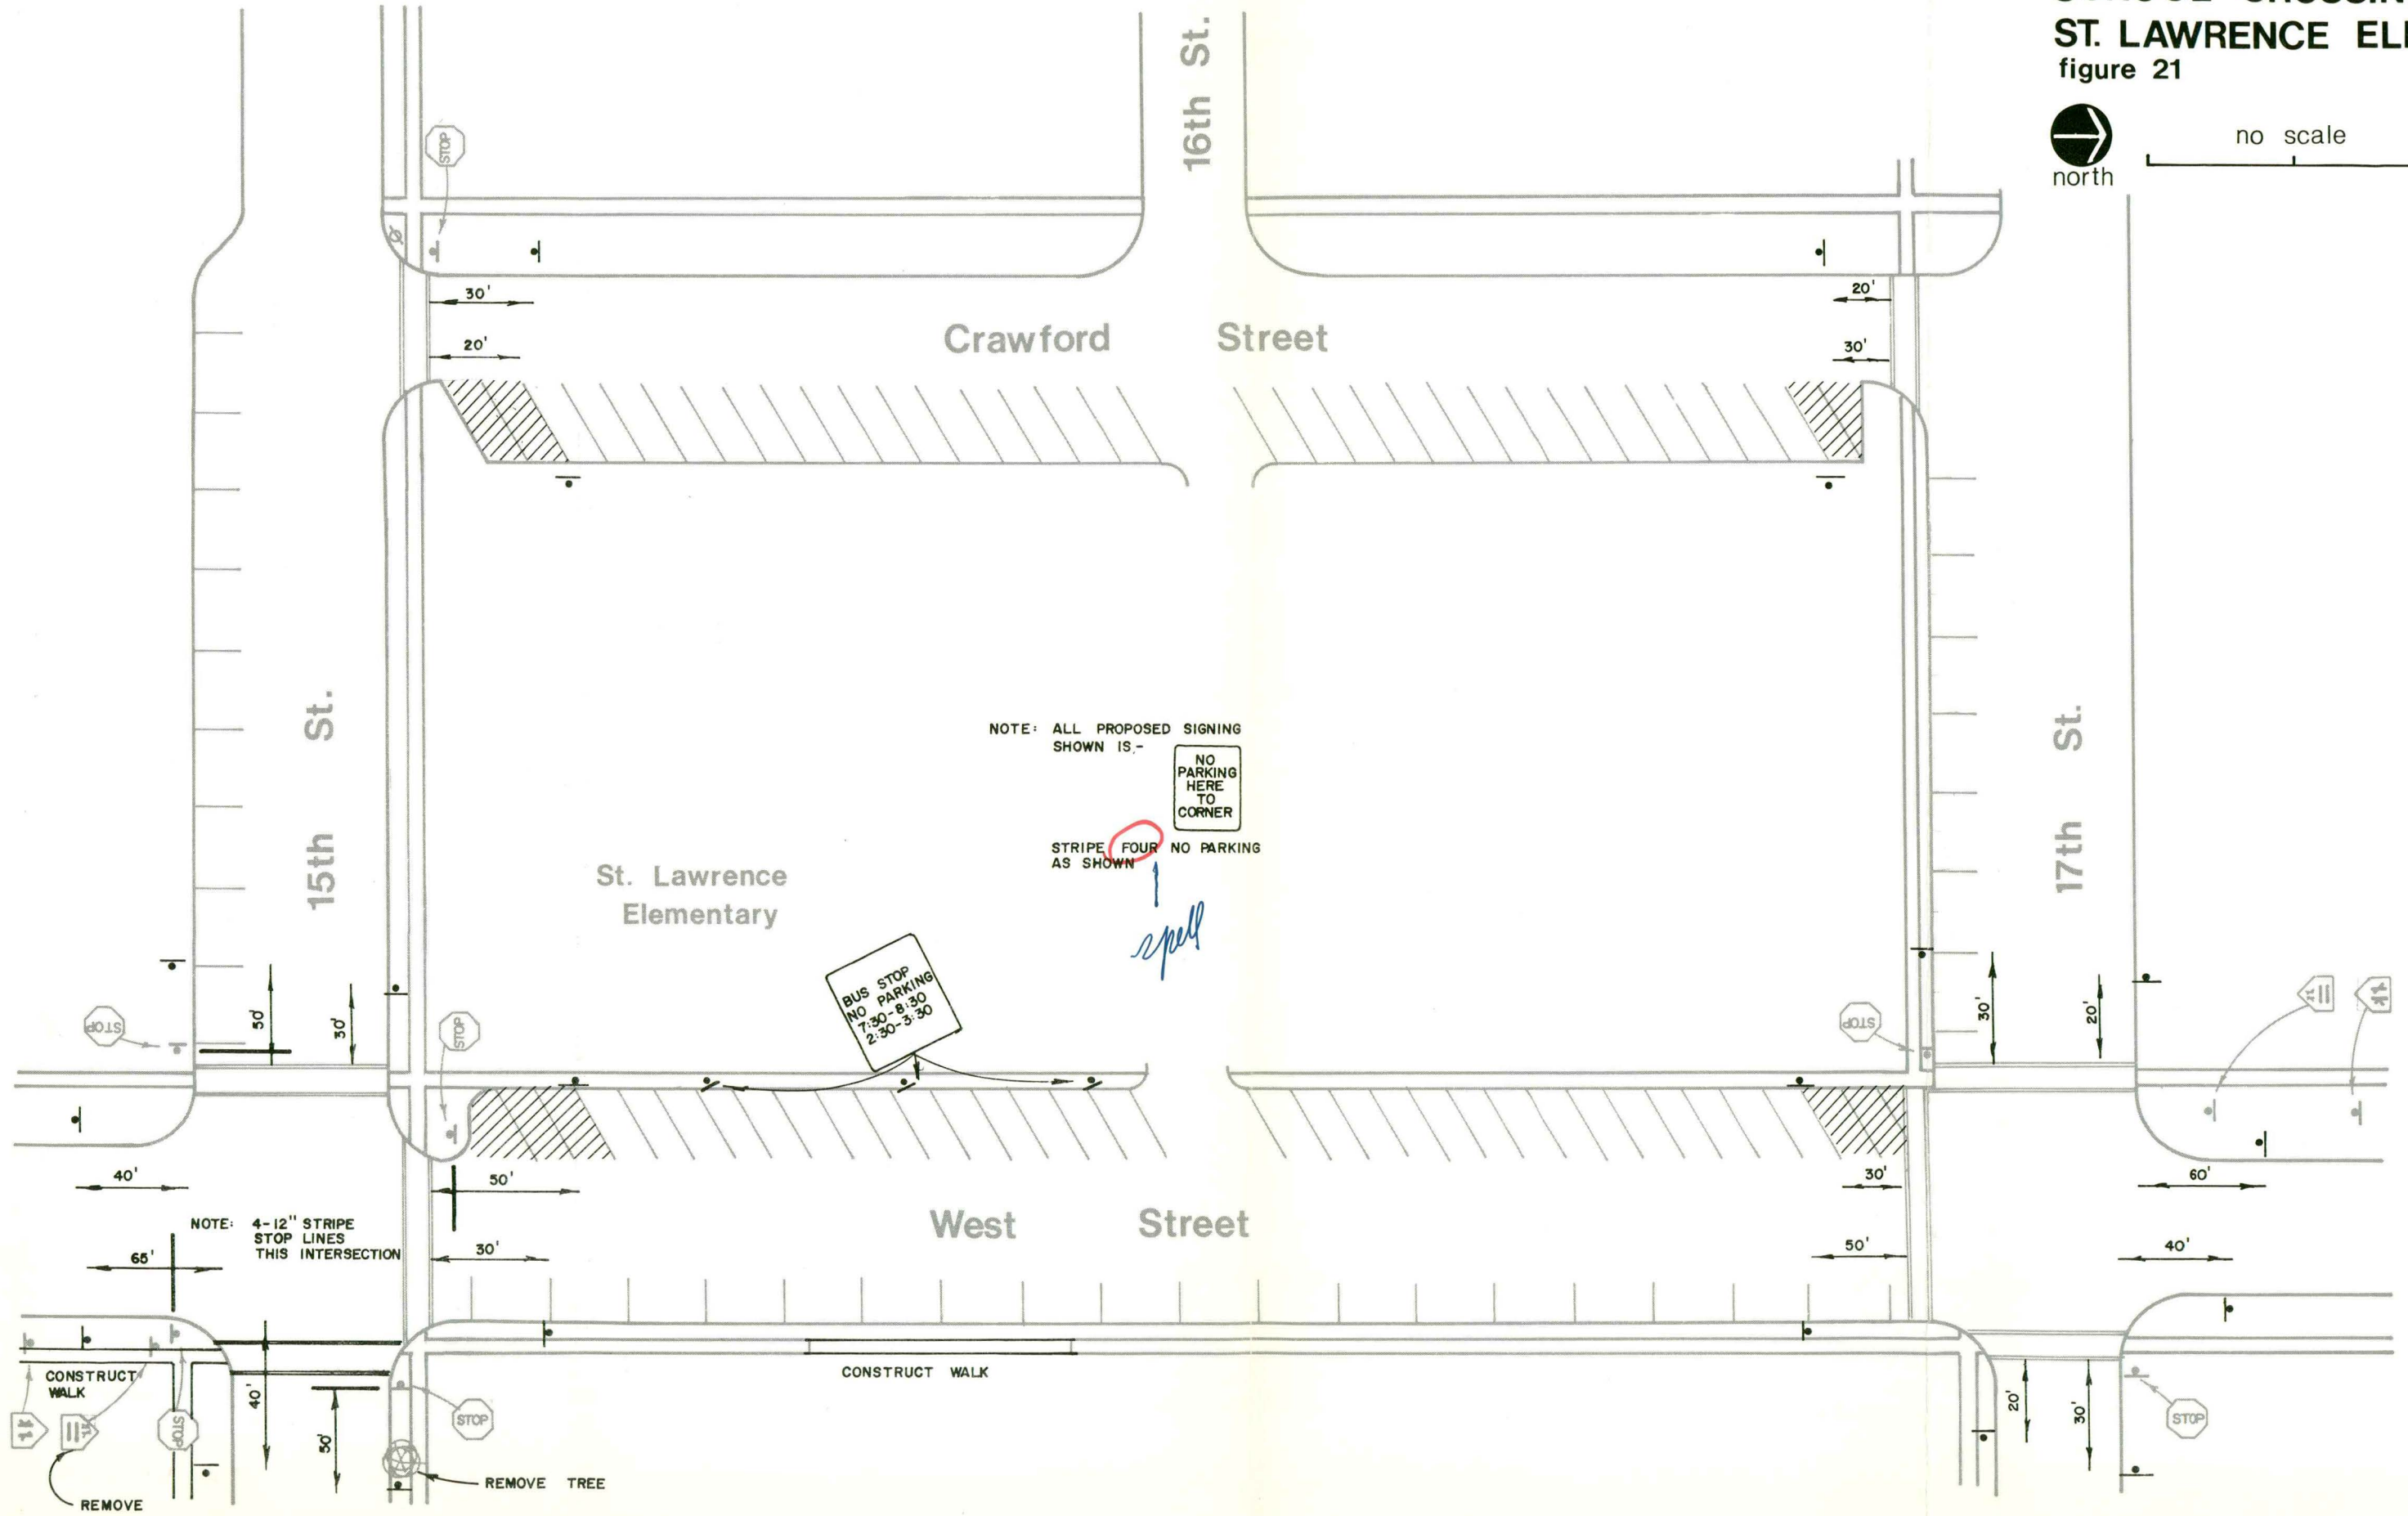
SCHOOL CROSSINGS
ST. LAWRENCE ELEM.
figure 21

school. The full utilization of this parking prohibits the free flow of traffic and in many cases obscures the view of crosswalks.

Visibility is a prime factor in providing a safe crosswalk. Therefore, it is recommended that parking be removed from all areas near crosswalks as indicated in FIGURE 21 and that these areas be strictly patrolled by the City Police when school hours coincide with church functions.
