TRAFFIC SAFETY STUDY

Muscatine, Iowa

TRAFFIC SAFETY STUDY MUSCATINE, IOWA #25-80

Final Report January, 1981 1

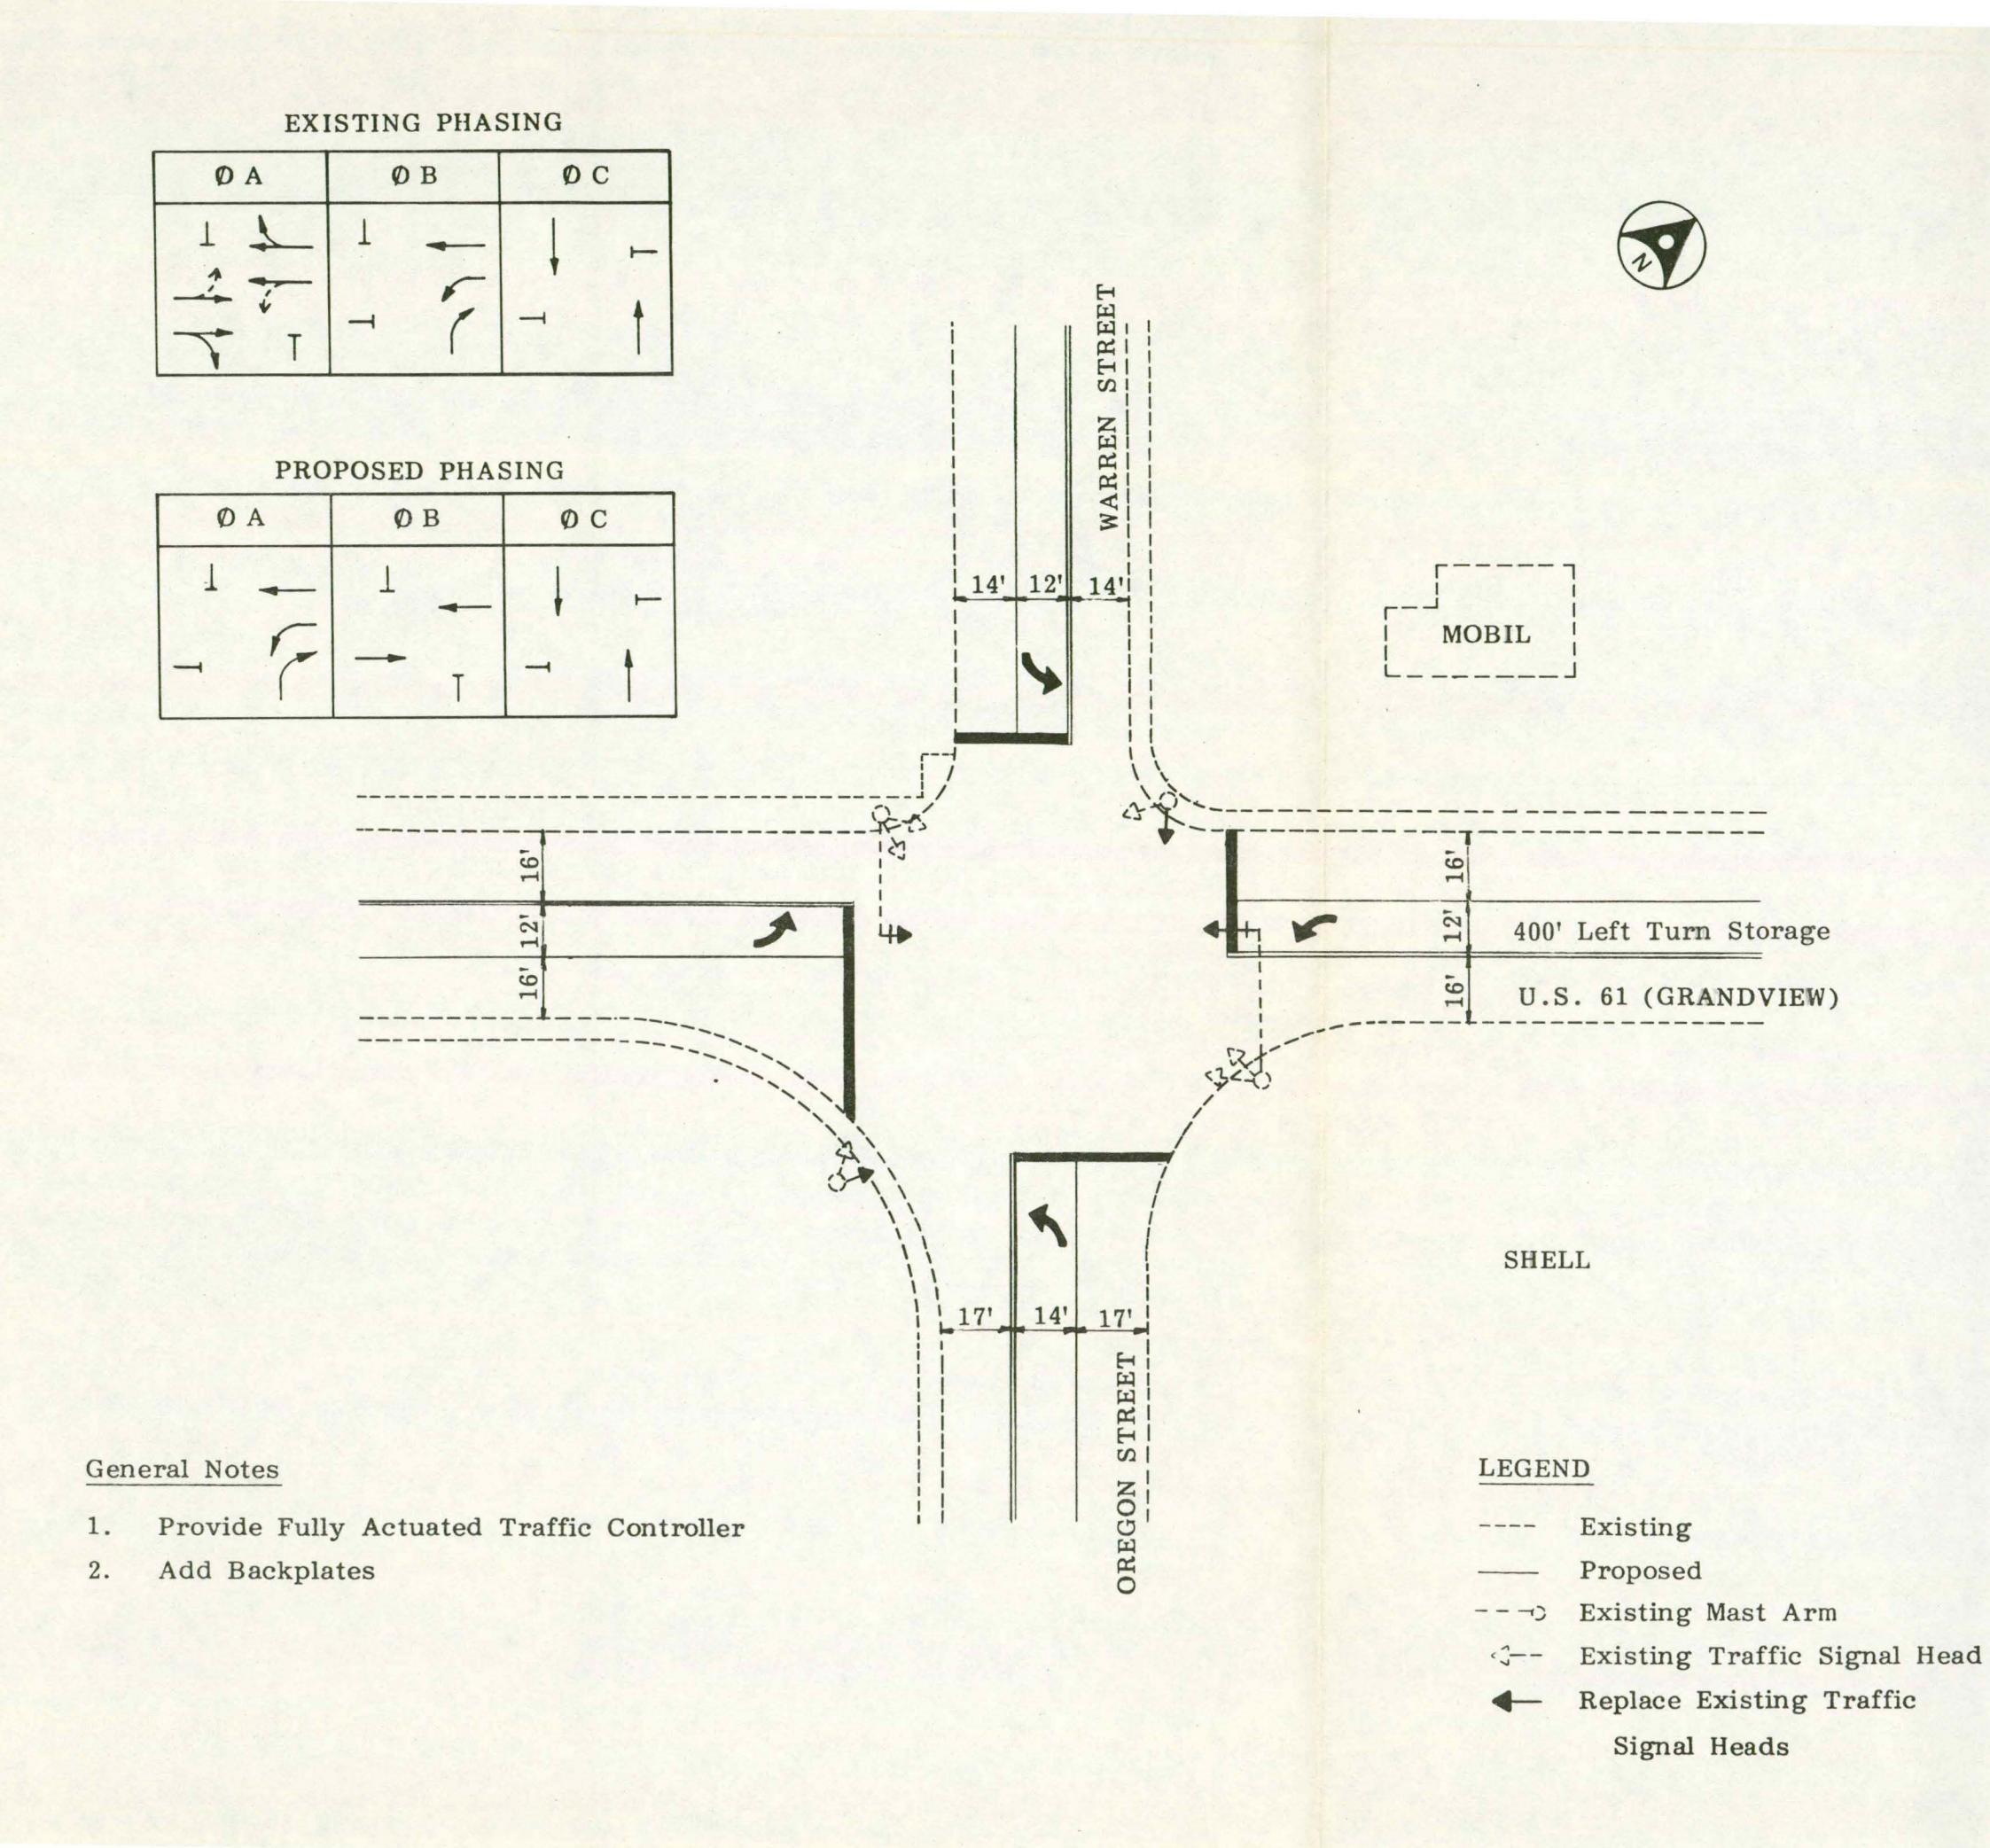
EXHIBIT 15 PROPOSED IMPROVEMENTS U.S. 61 (GRANDVIEW) & WARREN

> Traffic southbound on U.S. 61 approaching the Warren intersection has two traffic lanes. At the intersection, the traffic using the inside lane is required to turn left while thru traffic is required to use the right or outside lane. As noted earlier, the signal operates under three traffic phases. The second phase being a lagging left for the southbound left turns. A review of the a.m. peak hour indicates that approximately 403 cars during the a.m. peak hour make this left turn while at the same time 333 vehicles proceed straight through this intersection. The moving of thru traffic to the right lane appears to be confusing the motorists and may be a contributing accident factor. At the same time, traffic from the east leg to the north is extremely heavy. This would account for the right turn overlap on the existing phasing.

This intersection should be redesigned in order to provide fully actuated traffic movements. This is based on the analysis of the traffic counts which shows that there are approximately 12 hours during the day when the approach volumes on U.S. 61 range between 700 and 1100 vehicles per hour. The remaining hours range between 72 and 400 vehicles per hour. It should be noted that approximately 55% of the daily traffic occurs within an eight hour time period at this location (9:00 a.m. to 5:00 p.m.).

In order to reduce the number of accidents at this location and at the same time improve the safety of this intersection, the following recommendations are presented and illustrated in Exhibit 15.

• Revise the traffic signal phasing at this location to allow for a leading left indication for southbound traffic. The north leg should be striped to provide a three lane cross section with 400 feet of left turn storage for southbound traffic. From this point north

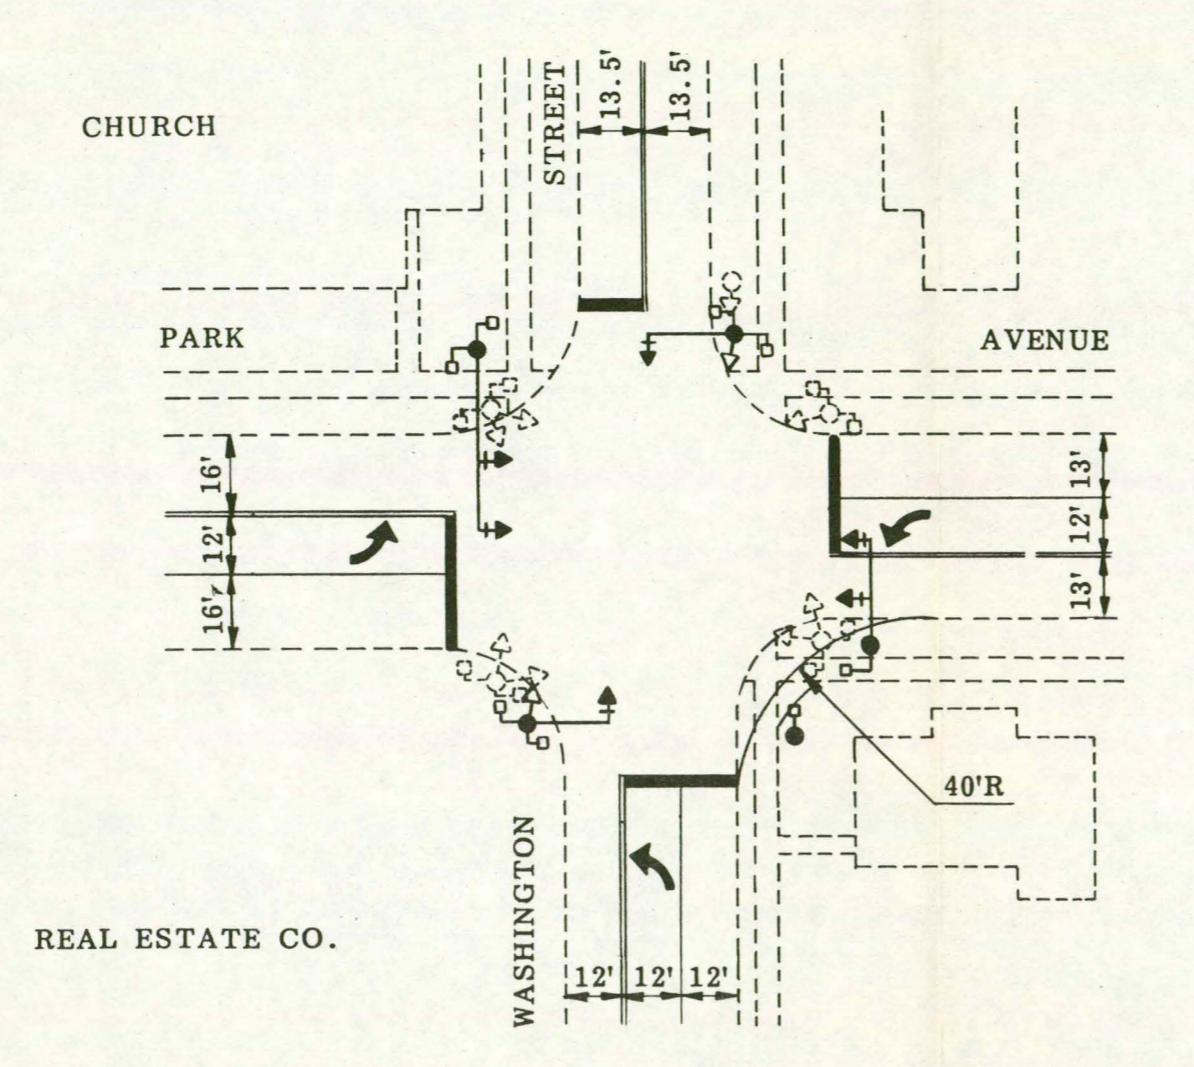
EXHIBIT 17 PROPOSED IMPROVEMENTS PARK AVENUE & WASHINGTON STREET

Field observations and review of the volume data indicate that there may be several reasons why this intersection is the highest accident location within Muscatine. The south leg has two approach lanes and many times right turning vehicles delay thru traffic in the outside lane. In a like manner, left turning vehicles often delay thru movements in the inside lane. These two conditions probably cause most of the rear end collisions. In addition, the present two phase signal is not responsive to the existing heavy traffic movements. Therefore, in order to reduce accidents and improve safety at this intersection, as well as increase capacity, the following recommendations are made:

• Move the southbound vehicles into the outside lane approximately 500 feet north of this intersection so that the cross section for the north leg would be a three lane approach similar to that which has been recommended for the south leg.

- The intersection should be interconnected into the Park Avenue progression which will be discussed later under Park Avenue improvements.
- Replace the existing controller with a standard semiactuated traffic controller. The master coordinating unit for the Park Avenue interconnect system should be located at this intersection.

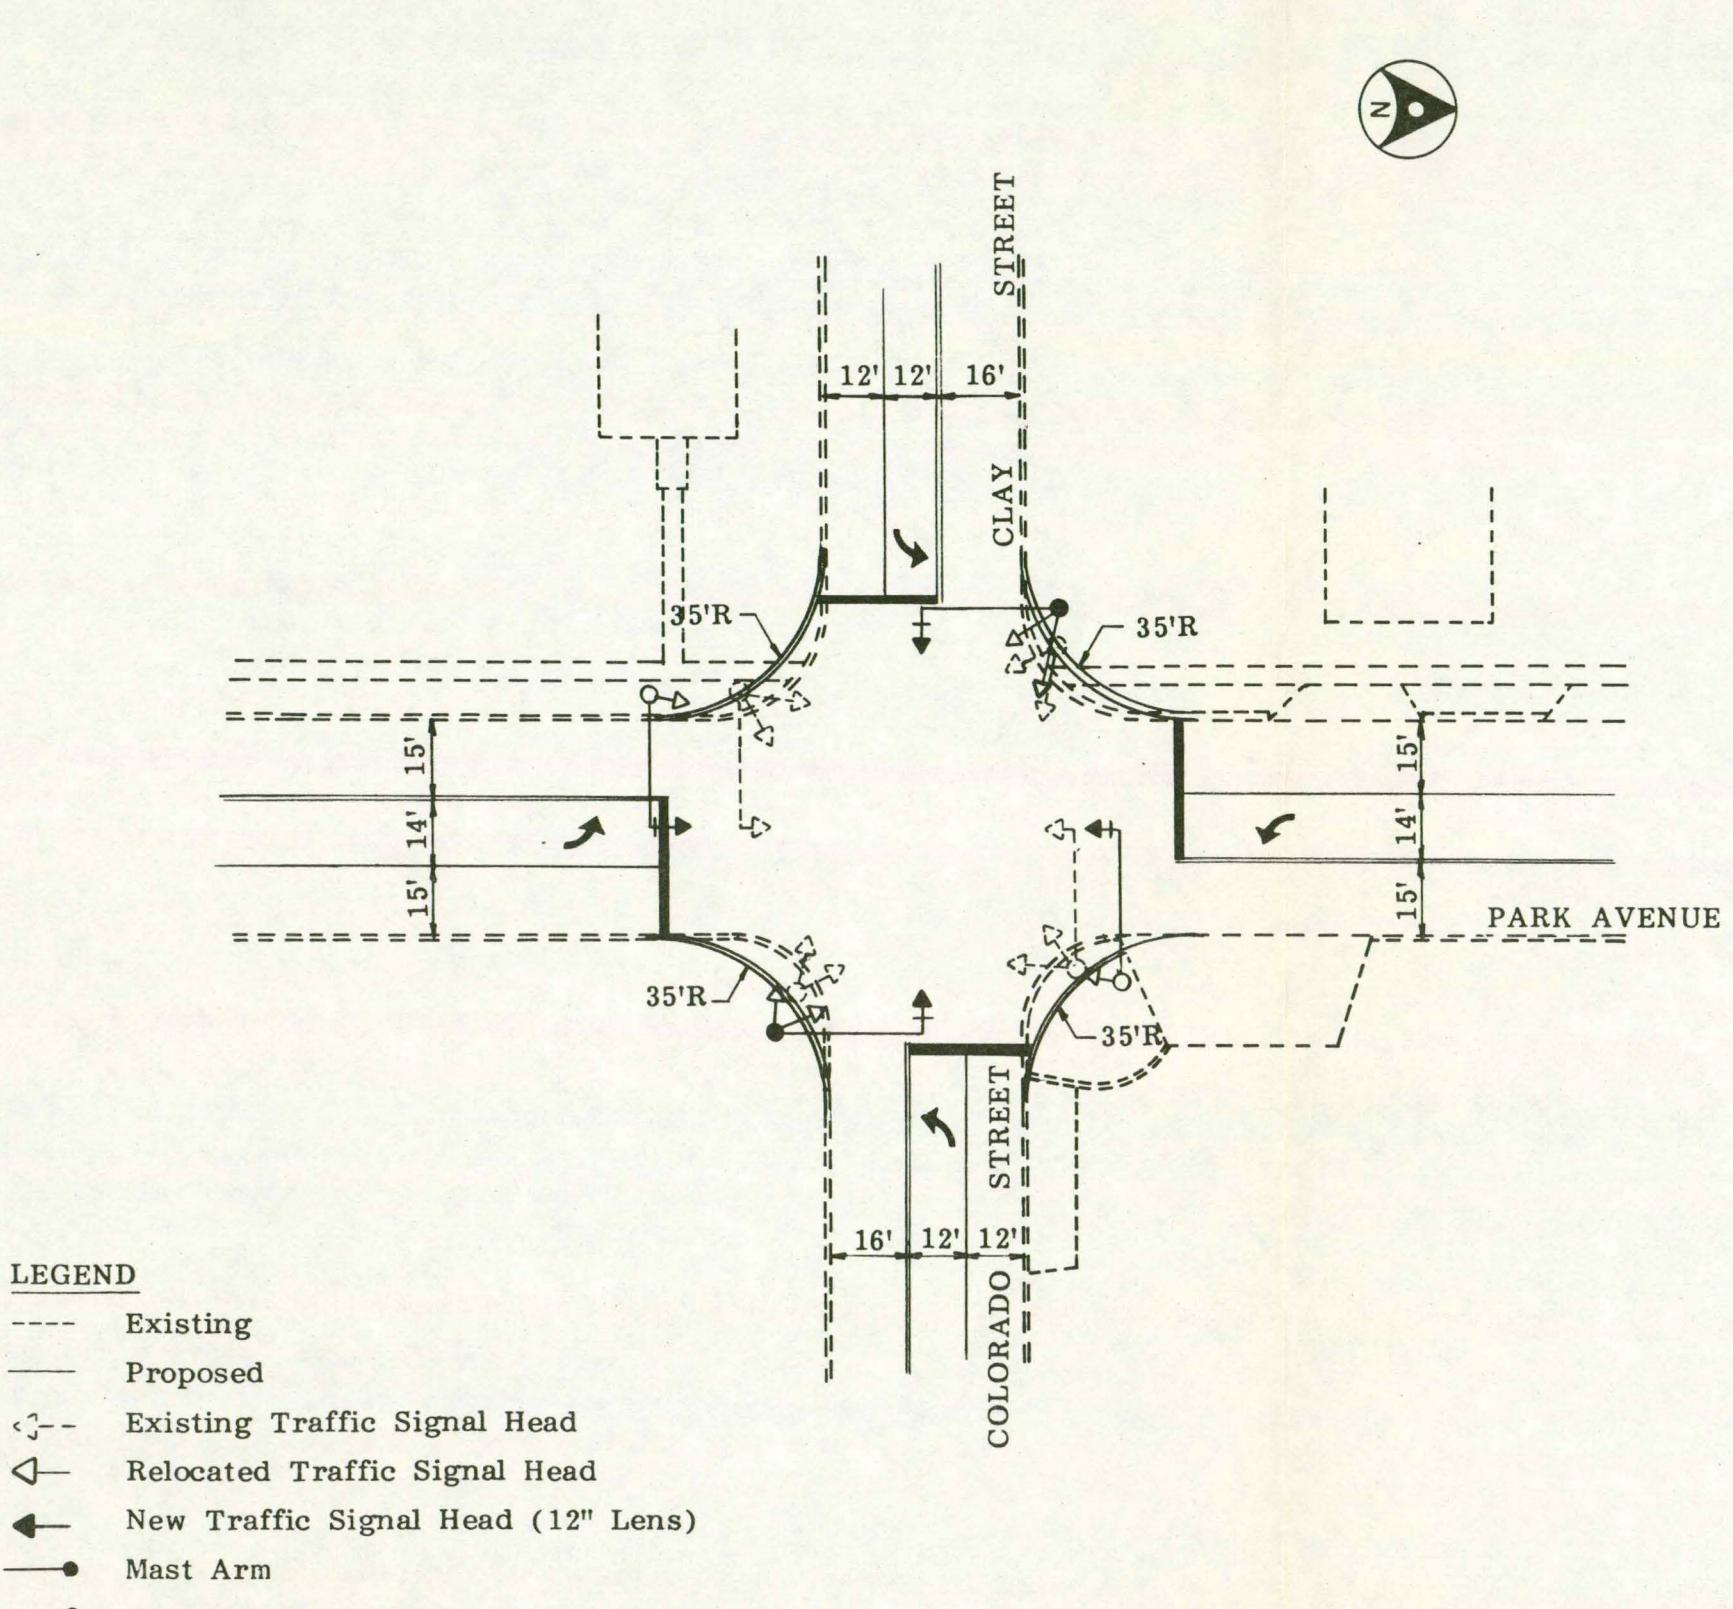
EXHIBIT 18 PROPOSED IMPROVEMENTS PARK AVENUE AND CLAY-COLORADO

A review of the accident data indicates that 10 collisions have occurred at this location during a two year period of which four are of the "unknown" type. Of the remaining accidents, two involved rear end collisions on the south leg; two left turning accidents; and two right angle collisions. Based on the above data, the following recommendations are made and illustrated in Exhibit 19.

With the recommendation of the three lane section through the Clay-Colorado intersection, it is proposed that the concrete median on the south leg of Park and Harrison be removed so that a left turn storage lane can be provided for northbound left turning vehicles.
The two thru green arrows located on the mast arms for the north and southbound traffic on the outside lanes should be removed.

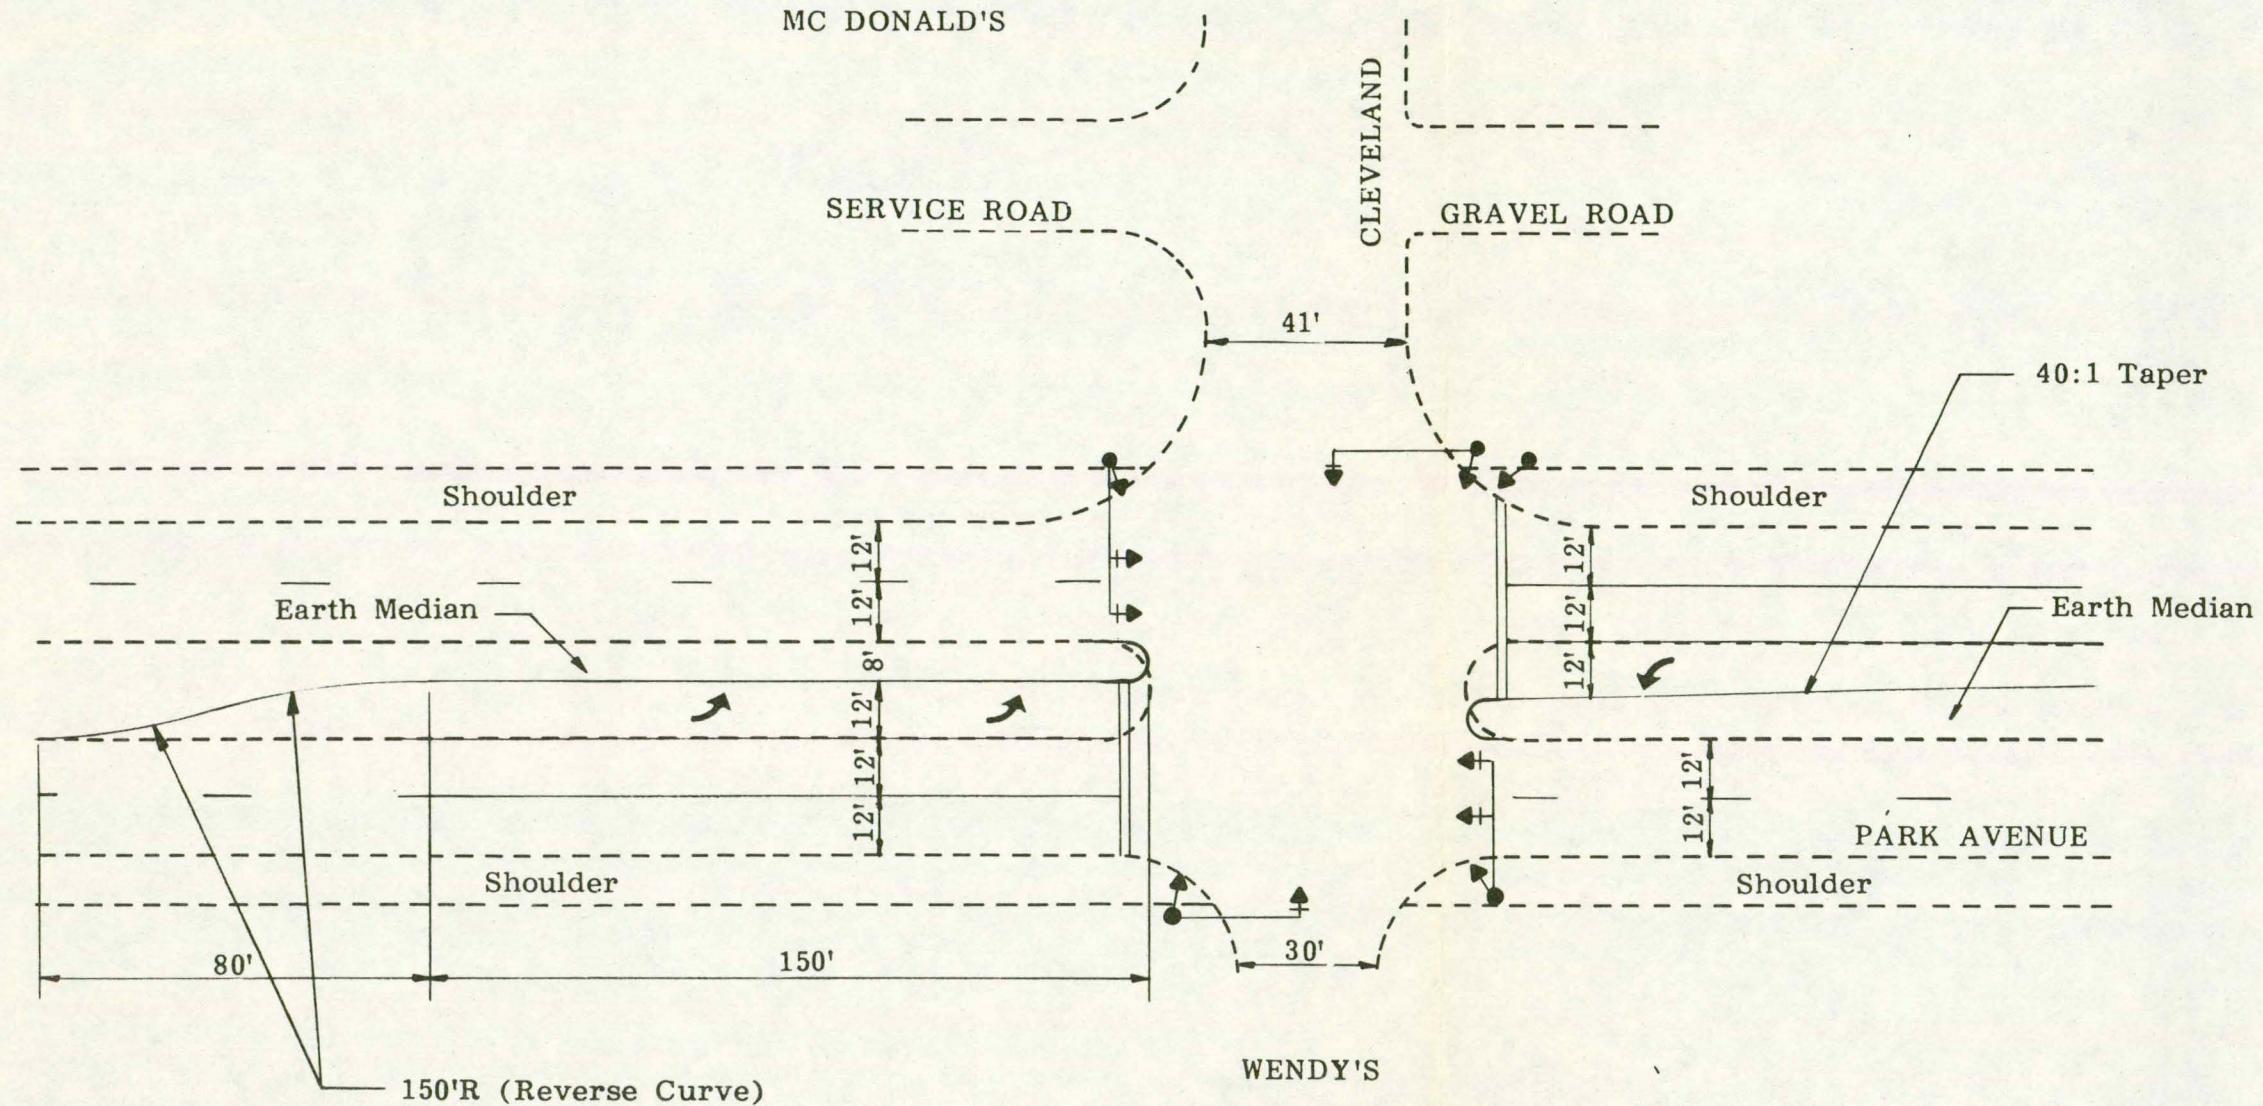
Based on this, it would appear that this intersection would meet the Systems Warrant. The analysis of the traffic signal progression along Park Avenue included this intersection. This intersection does fit into the Park Avenue progression, and, therefore, would not create any adverse delay for traffic. In addition to the installation of signals at this location, it is recommended that a minimum of 150 feet of left turn lane be installed on the south leg and a 75 foot turn lane be constructed on the north leg. Exhibit 25 illustrates these recommendations.

- Install Traffic Signals 1.
- 2. Construct Northbound Left-Turn Lanes
- Construct Southbound Left-Turn Storage 3.
