FULL-SCALE VEHICLE CRASH TESTS ON THE IOWA RETROFIT CONCRETE BARRIER RAIL

TRANSPORTATION RESEARCH REPORT TRP-03-015-88

January, 1989

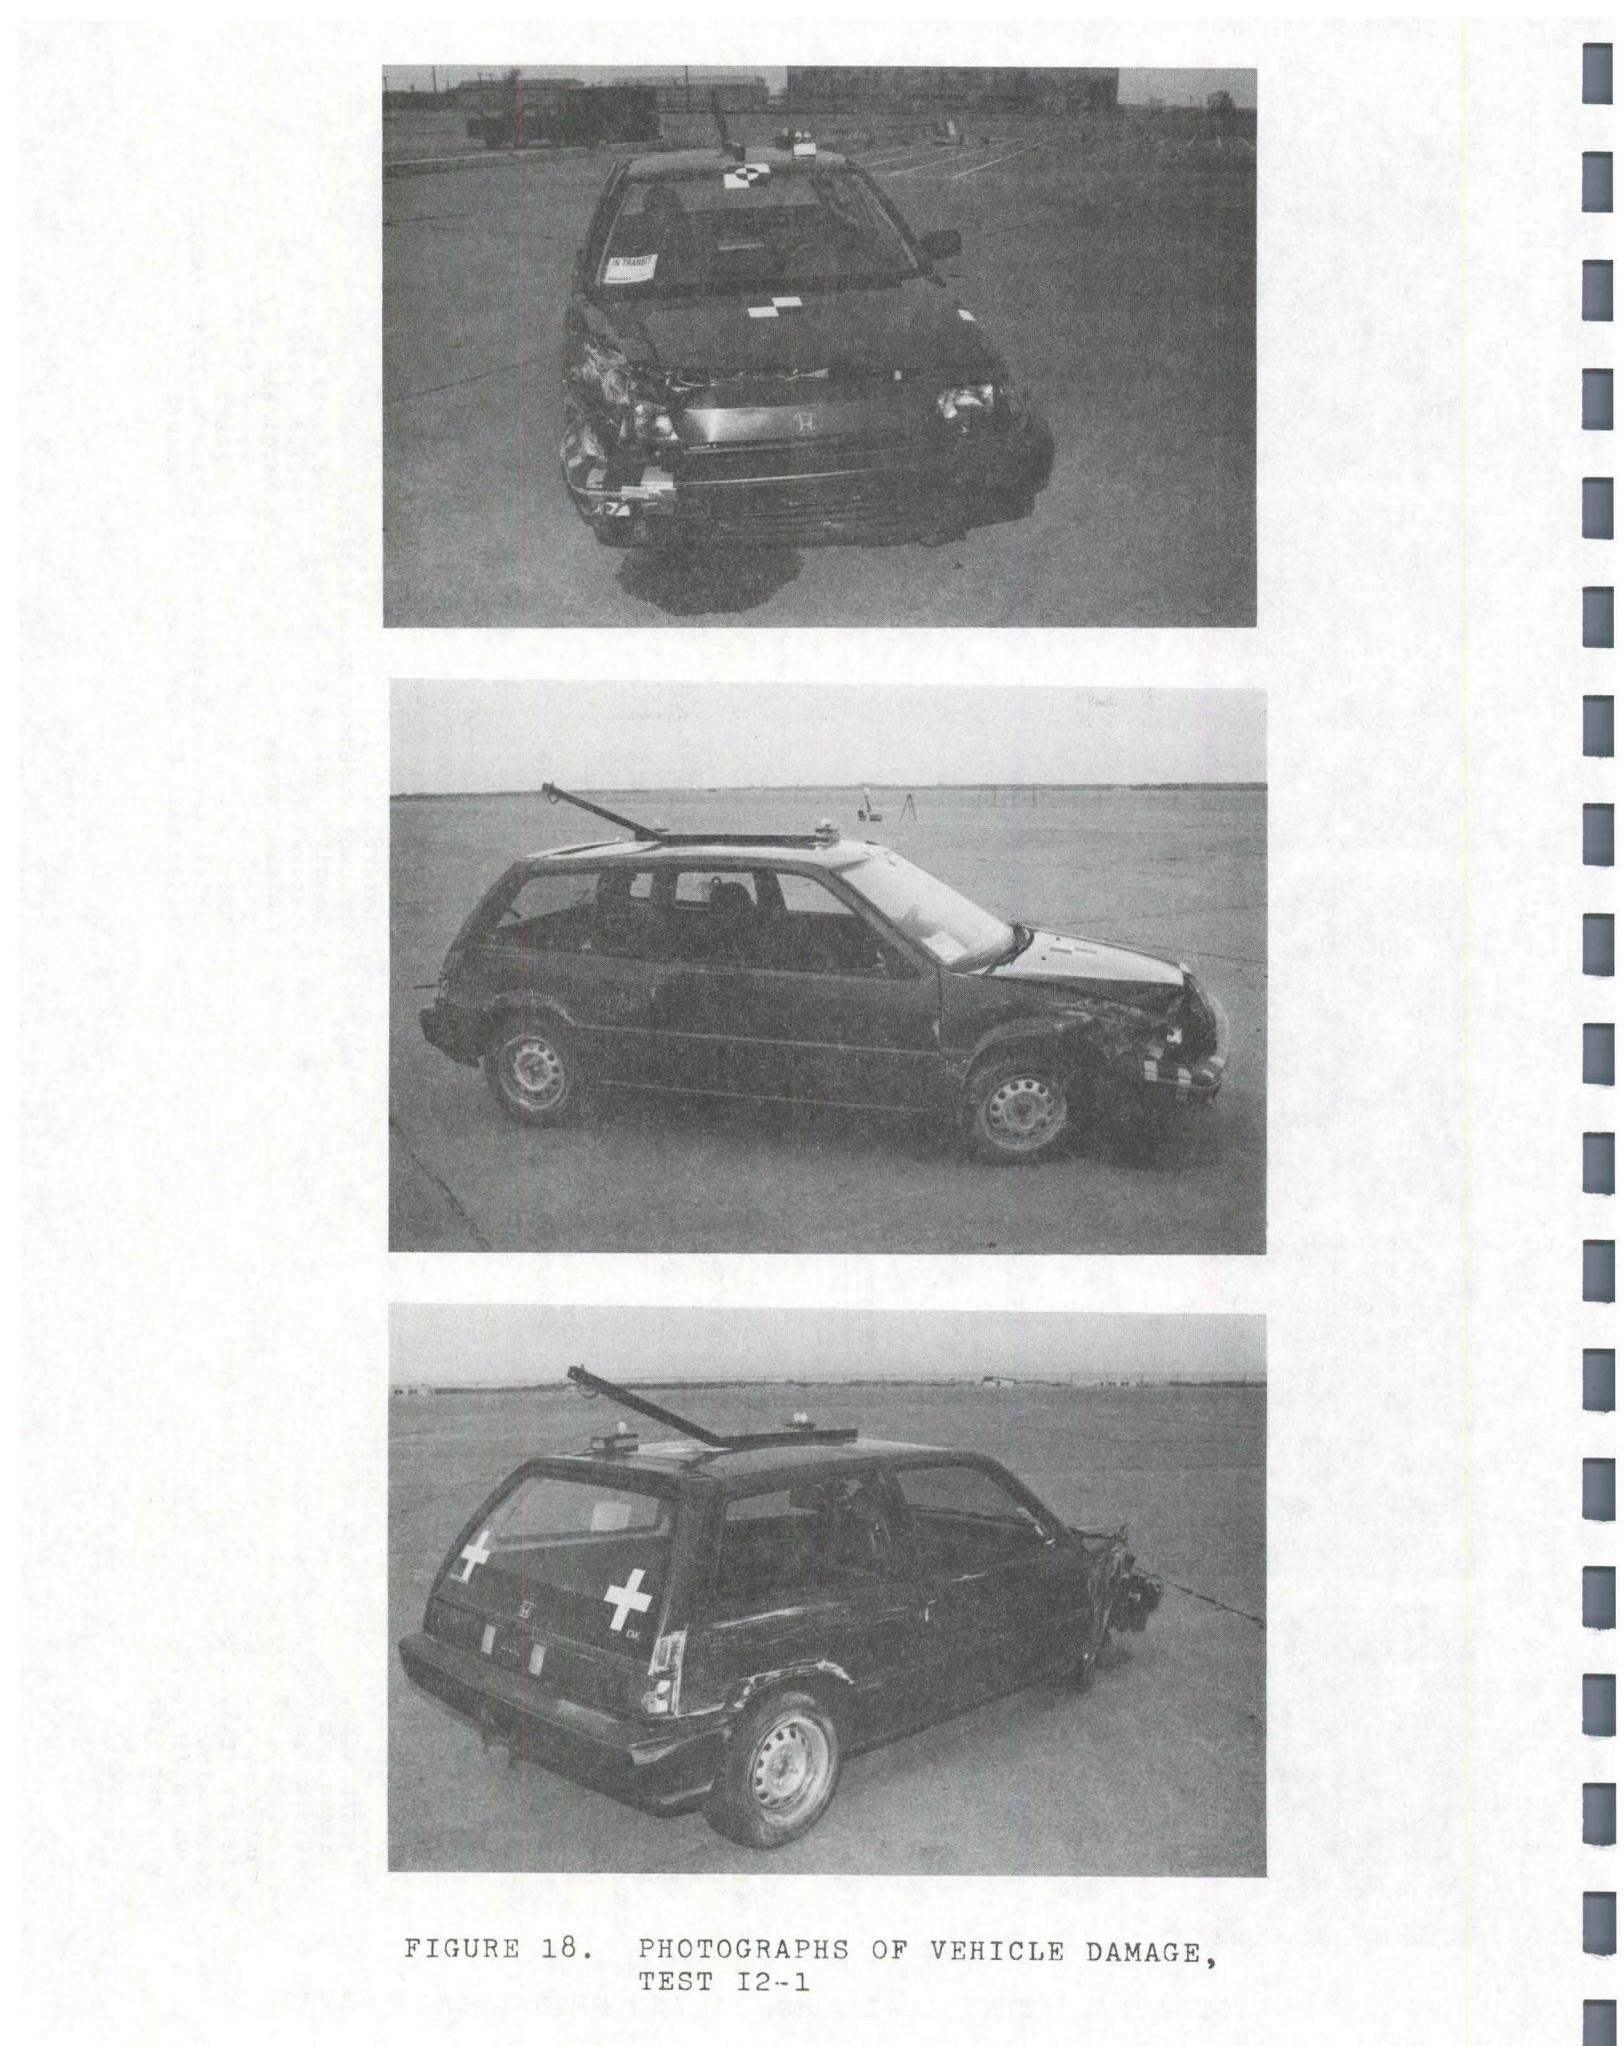
Photographs of the vehicle damage are shown in Figure 18. As evident, the vehicle damage was marginal. The TAD and VDI damage classifications are shown in Figure 17. Photographs of the minimal damage to the retrofit concrete barrier rail are shown in Figure 19. Only paint and tire marks were evident.

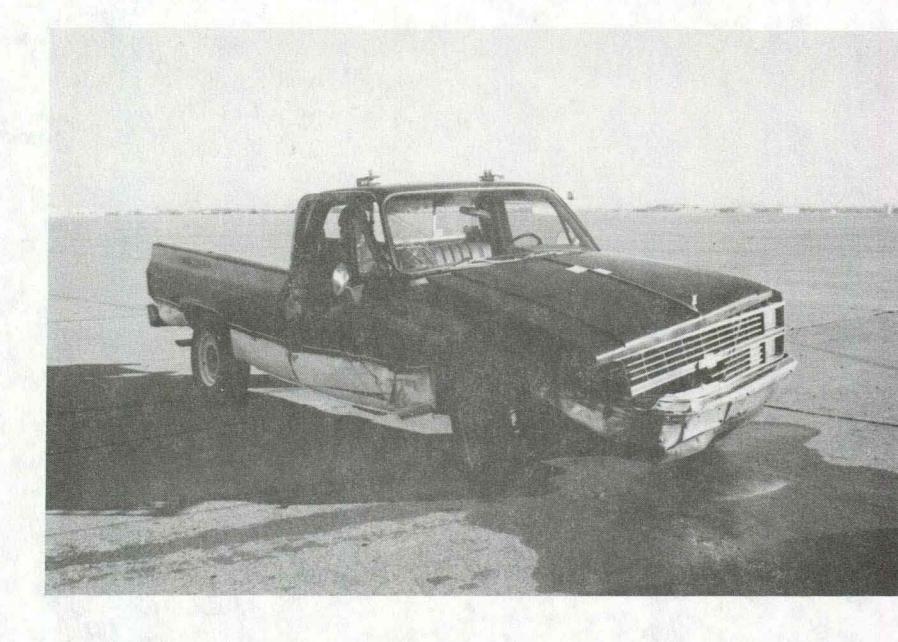
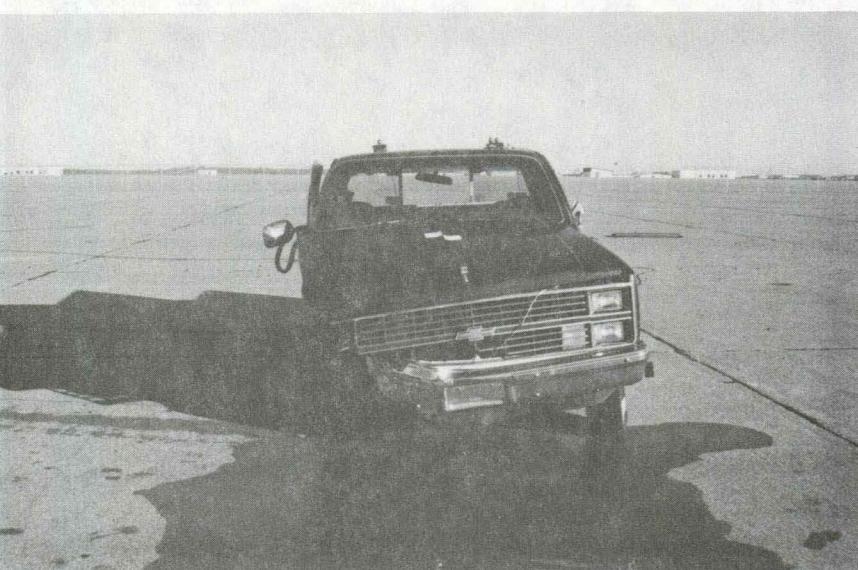
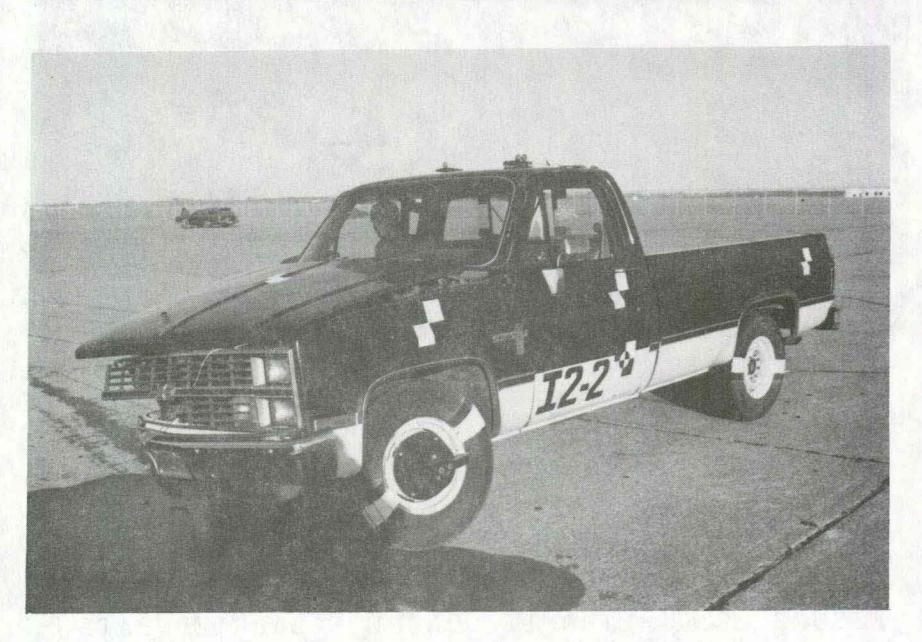
FIGURE 21. PHOTOGRAPHS OF VEHICLE DAMAGE, TEST I2-2

Photographs of the vehicle damage are shown in Figure 21. As evident, the vehicle damage was marginal. The TAD and VDI damage classifications are shown in Figure 20. Photographs of the minimal damage to the retrofit concrete barrier rail are shown in Figure 22. Minor concrete spalling and paint and tire marks were evident.

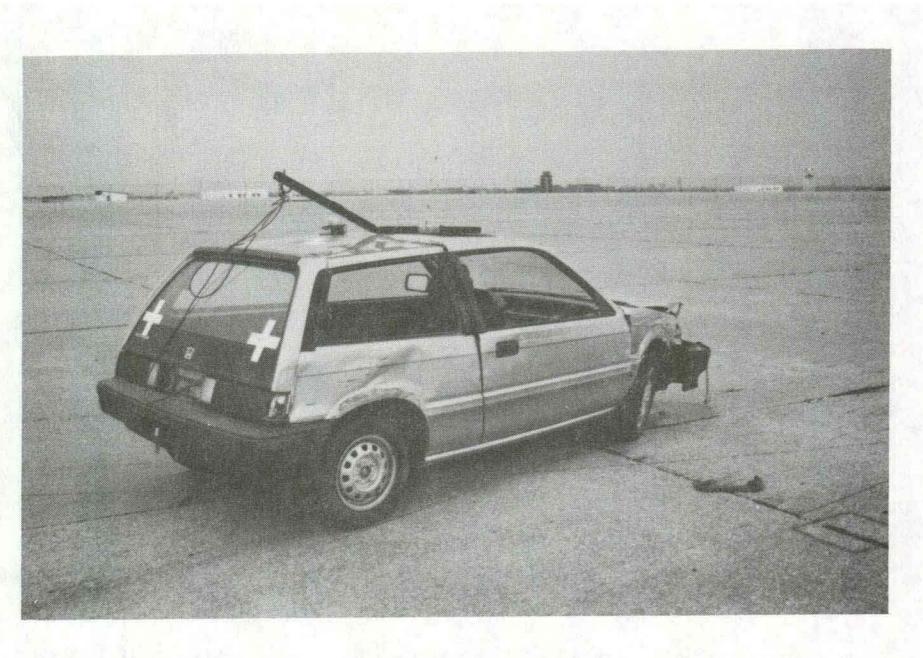
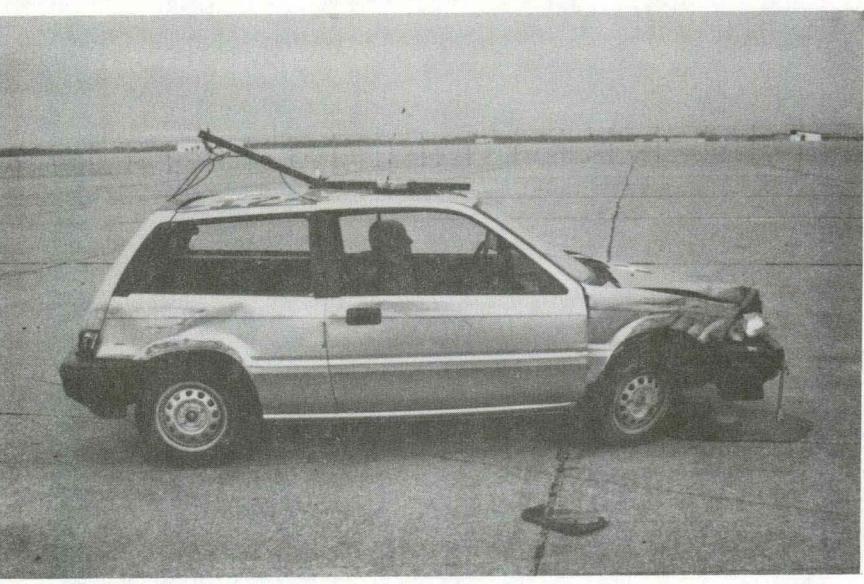
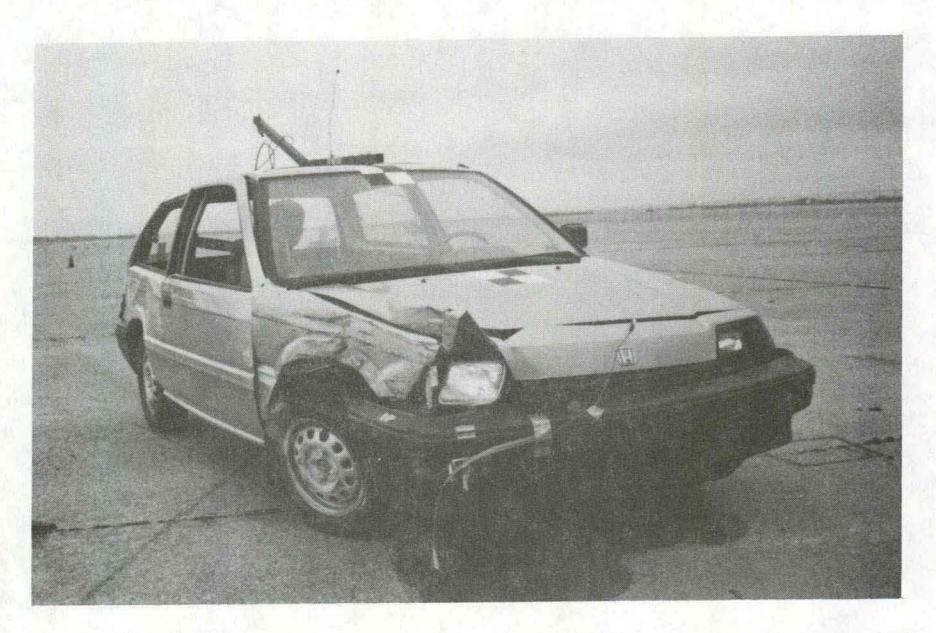
FIGURE 24. PHOTOGRAPHS OF VEHICLE DAMAGE, TEST I2-3

Photographs of the vehicle damage are shown in Figure 24. As evident, the vehicle damage was marginal. The TAD and VDI damage classifications are shown in Figure 23. Photographs of the minimal damage to the retrofit concrete barrier rail are shown in Figure 25. Only paint and tire marks were evident.
