Test and Evaluation Report

Load Test to Assess Fatigue Detail Performance on Westbound I-80 Bridge over the Cedar River

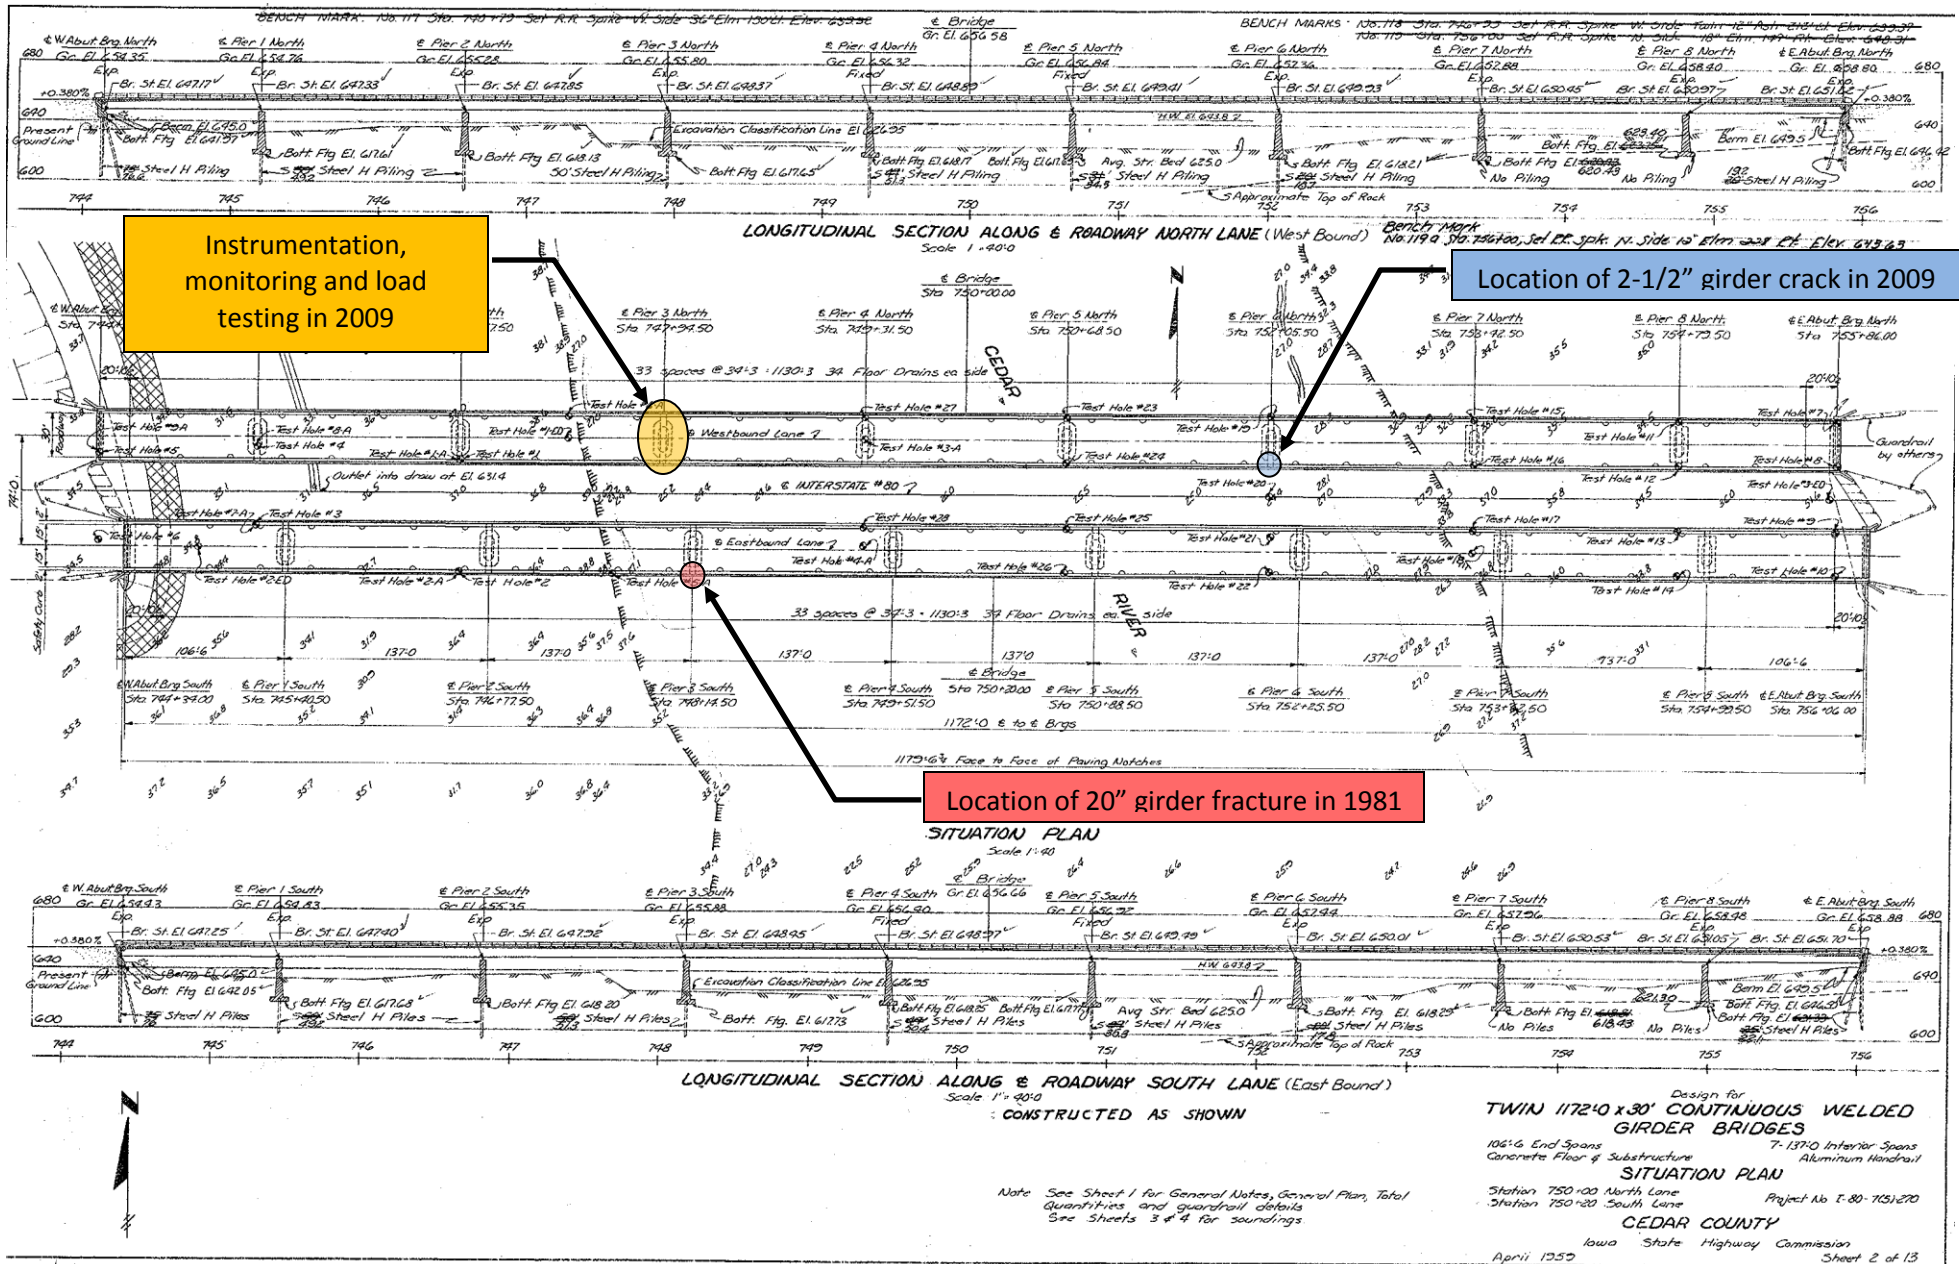
Figure 1. Situation Plan of twin bridges on the I-80 Bridge over the Cedar River.

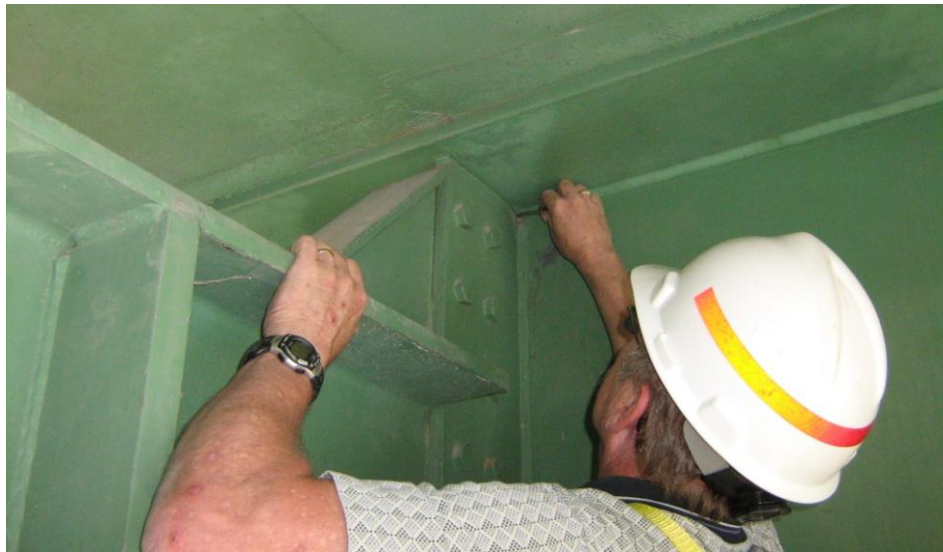
Figure 8. Inspection and measurement (with feeler gage) of pier bearing stiffener fit with top flange of girder.

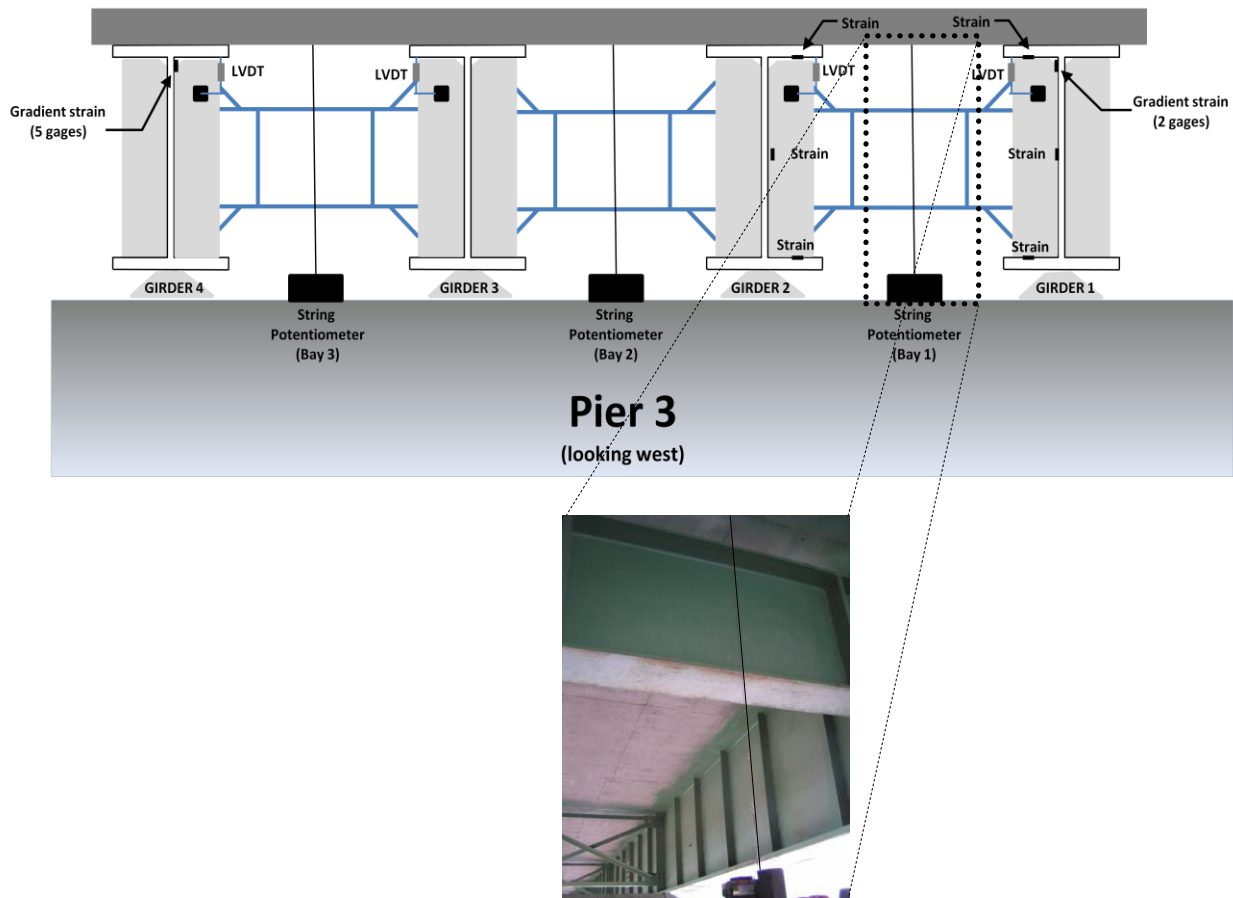
Figure 9. Schematic of the load test instrumentation at Pier 3 (looking west). Note that the three deck bay vertical displacements were made relative to the top of the pier cap beam.

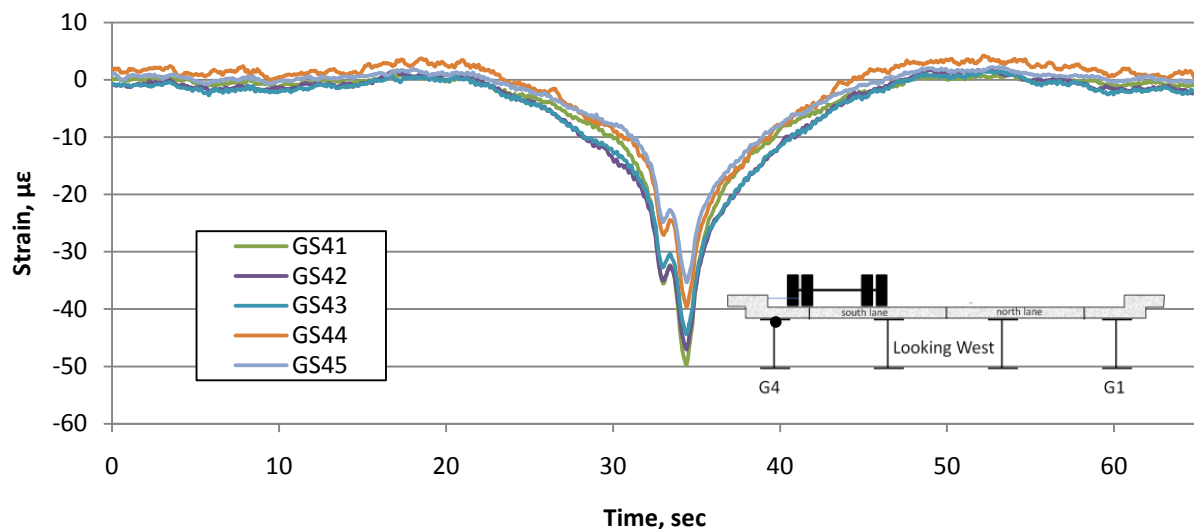
Figure 19. Girder 4 gradient strains for Load Case 9: Truck 1 in south lane positioned 2 ft from the curb.

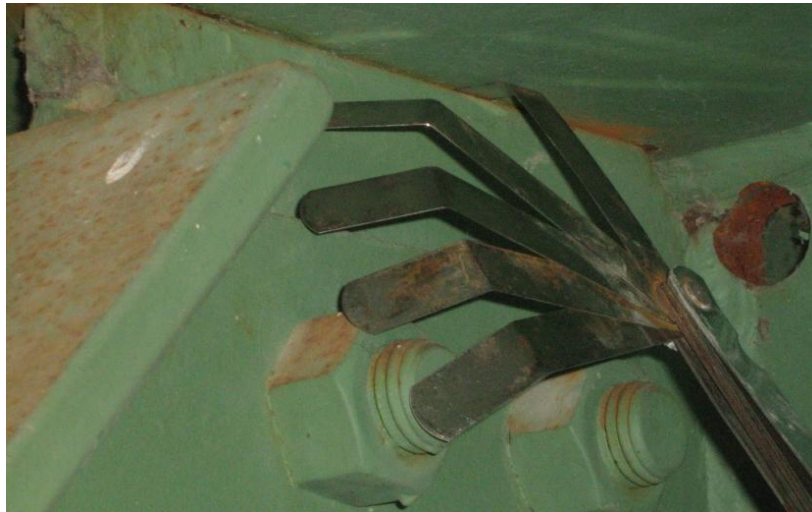
Figure 20. Feeler gage inserted between top of bearing stiffener and Girder 4 top flange at Pier 6. Note the corrosion between the interfaces and also note the retrofit hole that had been previously drilled to arrest a fatigue crack in the girder web.

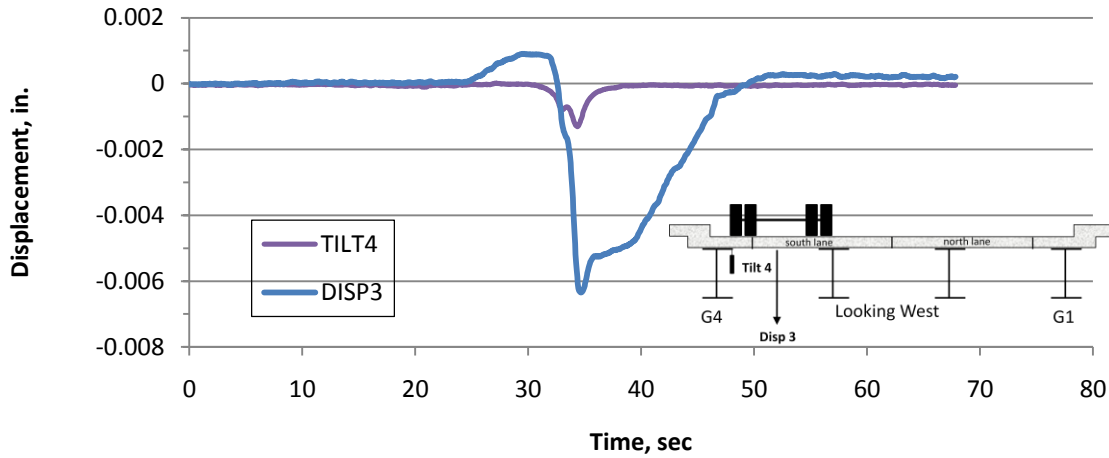
a. Flange tipping displacement for Girder 4 and deck displacement in Bay 3 at Pier 3
