Use of Railroad Flat Cars for Low-Volume Road Bridges

Sponsored by the
Iowa Department of Transportation
Project Development Division and the
Iowa Highway Research Board

Iowa DOT Project TR-421

REPORT

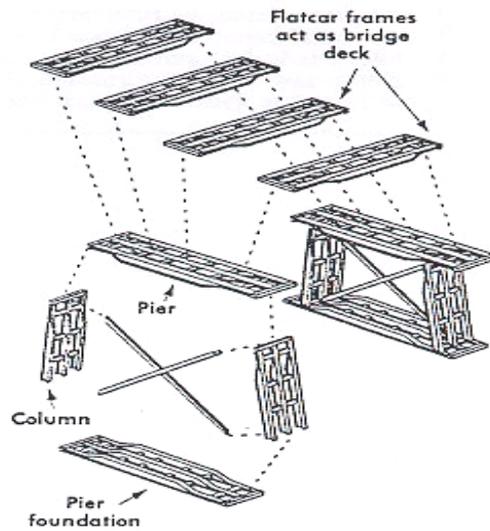
Figure 2.1. Single span of Caltran's emergency bridge system [3].

The bridge system, shown in Figure 2.1, incorporates salvaged 53.5 ft railroad flatcars. A single car is placed on the ground upside down to act as a footing. Another car is cut transversely in half, each half then being placed vertically at the ends of the footing flatcar to make up the two columns. These footing and column elements are then topped with a single flatcar, placed right side up, on top of the column elements. This method, using a total of three railroad flatcars and miscellaneous attachment clips and cross bracing, forms a bent system. These bent systems serve as abutments or piers that support the superstructure of the bridge, which is made of four flatcars placed side-by-side. Together, the bents and the superstructure complete a 42 ft wide by 53.5 ft long single span of the temporary bridge system. A modular open-grid steel deck is specified for speed of erection, but heavy steel plate or a less expensive

Caltrans tested the as-built modular bridge with a static load of 110 metric tons (242 kips) at the center of the span [4]. The observed maximum vertical deflection was only 0.3 cm (0.12 in.). W. H. Wattenburg, a scientist with Lawrence Livermore National Laboratory who proposed the bridge idea to Caltrans, constructed a finite element model of the modular bridge system to understand its behavior due to earthquake aftershocks using ground motion data from the Petrolia-Cape Mendocino earthquake. The analytical behavior of the modular bridge showed little amplification of ground motion in the transverse direction. In the longitudinal direction, the behavior was close to that measured in permanent conventional bridges during the Petrolia-Cape Mendocino

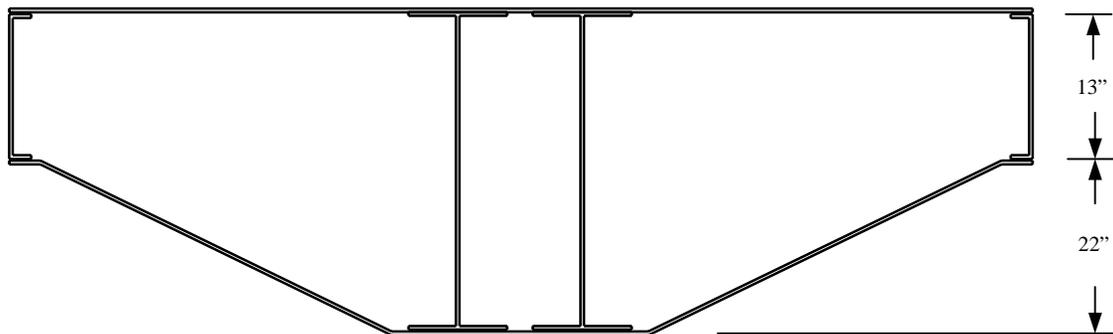
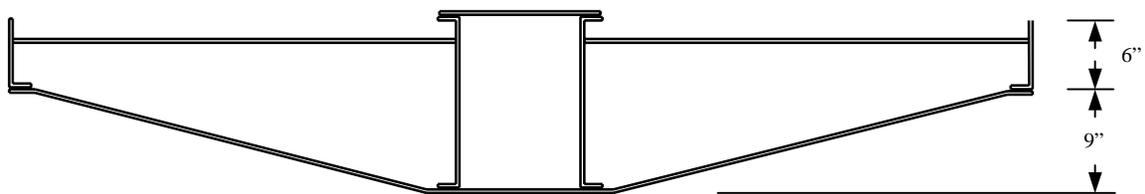
a. Redundant cross-section

b. Non-redundant cross-section

Figure 2.2. Comparison between two types of flatcar cross-sections.

After the field load testing of three RRFC bridges, BDI concluded that railroad flatcars appear to be an adequate solution for a bridge superstructure on low volume roads if the railroad cars with appropriate geometry are selected and maintained. From the three load tests, it can be concluded that the effectiveness of railroad flatcar bridges depends greatly on the particular design and style of car. Flatcars with relatively deep main girders and significant exterior stringers appear to function very well under legal loads, as determined in the first two load tests. Flatcars with shallower main girders and non-redundant designs should be avoided, as seen in the third bridge test. Shown in Figure 2.2 are general cross-sections of the two types of flatcars discussed. Presented in Figure 2.2a is the redundant cross-section found in the first two bridges tested with its deep interior and exterior girders. In this particular situation, redundancy refers to a RRFC design in which more than one longitudinal load path is present (i.e., exterior

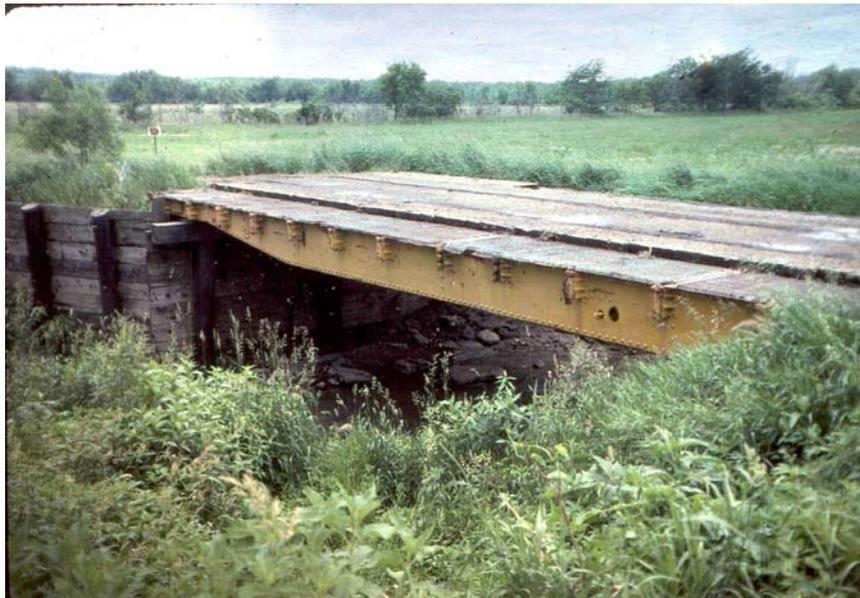
Figure 3.2. Elevation view of TCB and south abutment (Note that the girder extends past the abutment cap beam).

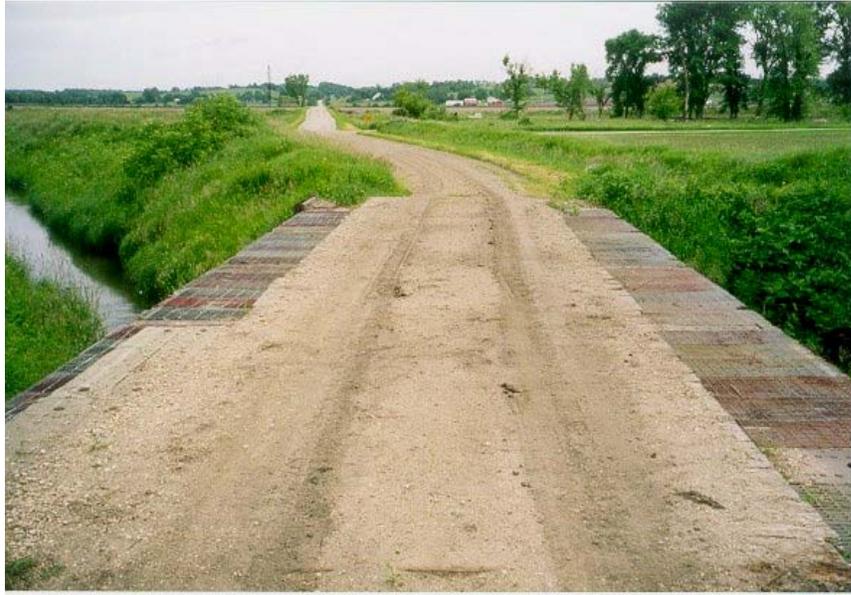
Figure 3.3. Top view of TCB looking north (Note the metal grating and transverse timber planks over center width of bridge).

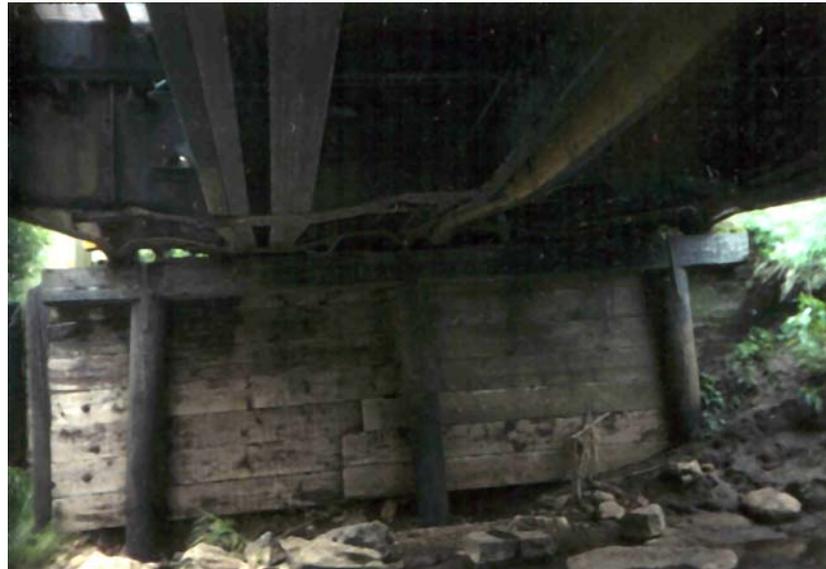
Figure 3.4. South abutment and underside of TCB superstructure.

This bridge consists of two RRFC set side-by-side on timber abutments that span 42 ft over a small creek on a Class B, rural gravel road. Located approximately two miles east of Chelsea, Iowa, the bridge provides access to farming fields and a state wildlife recreation area. A map showing the location of the TCB is provided in Figure 3.1. The actual flatcars that make up the TCB are 51 ft in length but are supported at the bolster locations thus creating a span of 42 ft center to center of abutments. At each end of the flatcars, the remaining 4 ft – 6 in. sections bear directly on the ground. Each RRFC has a width of 9 ft with an 8 in. space between the flatcars. The bridge deck consists of metal grating over the entire bridge surface that is topped by 4 in. x 12 in. timbers across the center 12 ft width of the bridge to create a driving lane. An overview of the bridge is shown in Figures 3.2 and 3.3. As seen in the photographs, only one lane of traffic is possible, no guardrails exist on the bridge, and the bridge is located in a rural setting. A view from underneath the bridge showing the flatcar members and timber abutments is provided in Figure 3.4.

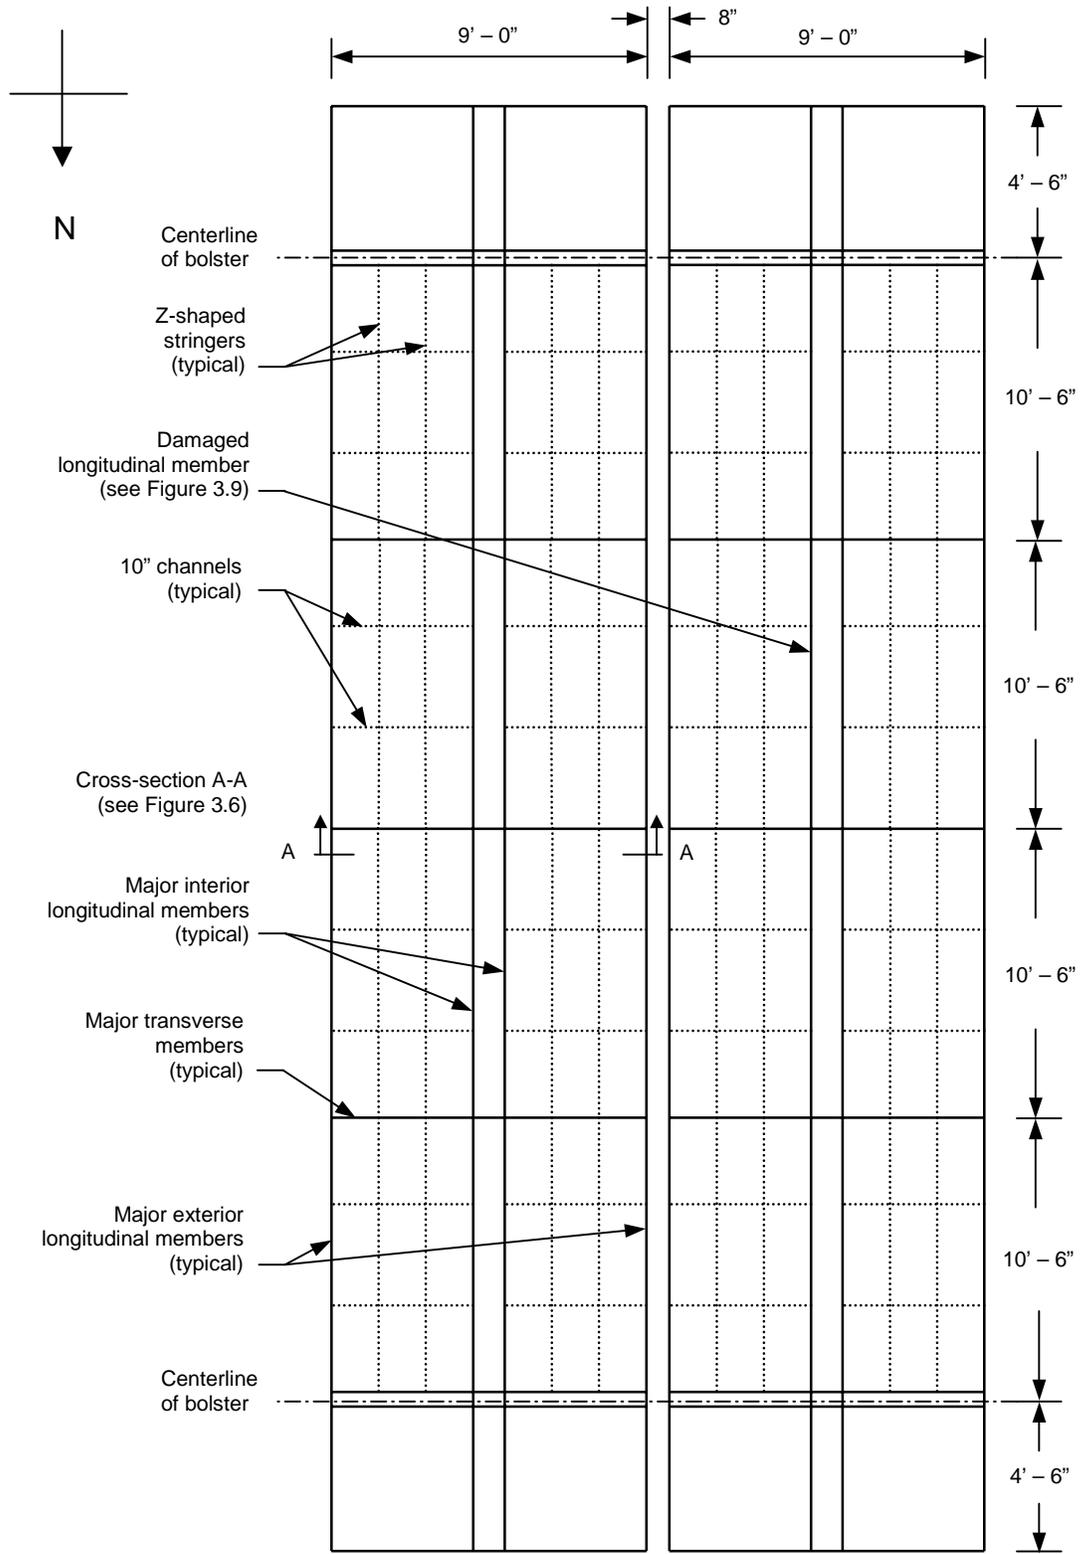
Figure 3.5. Plan view of TCB (Note that timber deck is not shown).

A plan view of the flatcars that identifies the transverse and longitudinal members is shown in Figure 3.5; each RRFC contains four major longitudinal members and six major transverse members. The exterior longitudinal members of each RRFC are built up C-sections composed of a plate for the web and angles riveted to the top and bottom of the web for the flanges. Each exterior member has a depth of 24 in. at the center of the bridge and tapers to 12 in. at the abutments. Two main interior longitudinal members of each RRFC consist of built up I-sections; each I-section is composed of a plate for the web and four angles riveted to the web for the top and bottom flanges. Each interior member has a depth of 30 in. at the center of the bridge and also tapers to 12 in. at the abutments. A detailed drawing showing the tapering of the longitudinal members is provided in Figure B.1 of Appendix B. A cross-section view (cross-section A-A in Figure 3.5) of one flatcar is shown in Figure 3.6, which includes member sizes and flatcar dimensions.

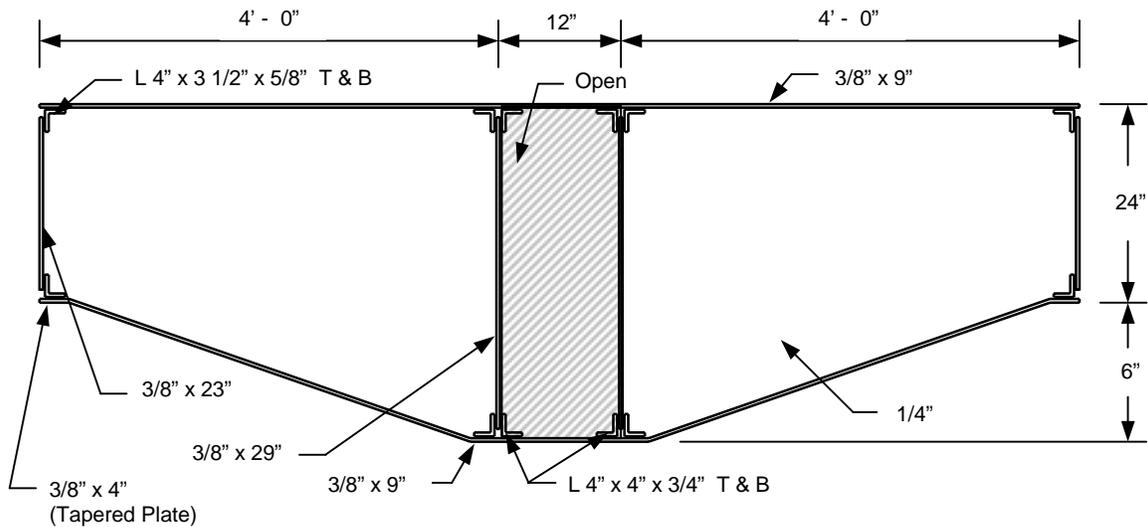
Figure 3.6. Cross-section view A-A (see Figure 3.5).

Each RRFC has six major transverse members that are built up I-shapes consisting of a 1/4 in. web plate attached to a top and bottom flange. The web of the transverse members is also connected to the webs of the major longitudinal members. A 3/8 in. x 9 in. plate that runs the entire width of the flatcar makes up the top flange of the transverse members. This plate also connects the top flange of the four major longitudinal members. The bottom flange is a 3/8 in. plate which also runs the entire width of the flat car but varies in width, 4 in. at the exterior longitudinal members to 9 in. at the interior longitudinal members. At the exterior longitudinal members, the transverse web has a depth of 24 in. and

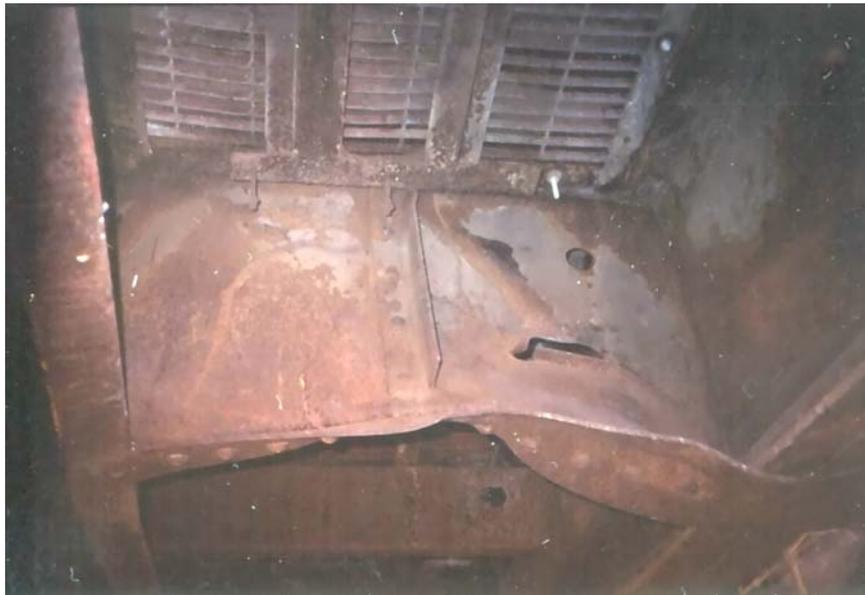
Figure 3.7. Damaged transverse member in west flatcar.

damage did not result from being used as a bridge. Several major transverse members of each RRFC have severe out-of-plane deformations. A damaged transverse member in the west flatcar is illustrated in Figure 3.7. Of the 12 major transverse members in the two flatcars, six are damaged. Three of the six damaged transverse members have damage similar in magnitude to that shown in Figure 3.7. The out-of-plane damage in the other three members is not as severe. In the west flatcar, the exterior longitudinal member located along the longitudinal center of the bridge has significant out-of-plane bending along the entire length of the bridge. This damaged member can be seen in Figure 3.8 along with its undamaged counterpart in the east flatcar. An interior longitudinal member of this same flatcar also has major damage as is shown in Figure 3.9 (See Figure 3.5 for location of this member). The member in Figure 3.9 has

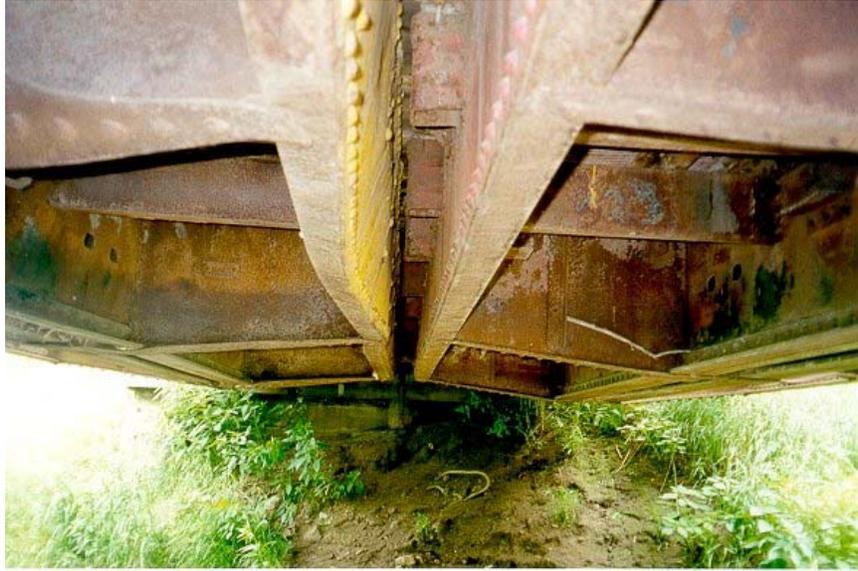
Figure 3.8. Damaged exterior member of west flatcar at center of bridge looking north.

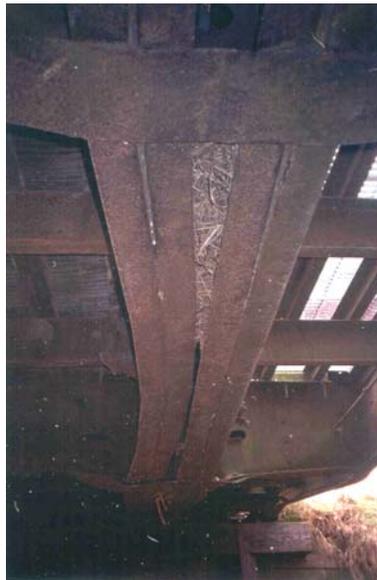
Figure 3.9. Damaged interior longitudinal member in the west flatcar looking south.

out-of-plane bending in its web and bottom flange for the 10 ft – 6 in. between the transverse members. Not only are the structural members in poor condition, many rivets in critical connections are either loose or missing. From the photographs of the damaged members (Figures 3.7, 3.8, and 3.9), it can be seen that the members have undergone horizontal and upward deformations. These types of deflections would not be caused from gravity bridge loads and support the assumption that the flatcars were damaged before installation.

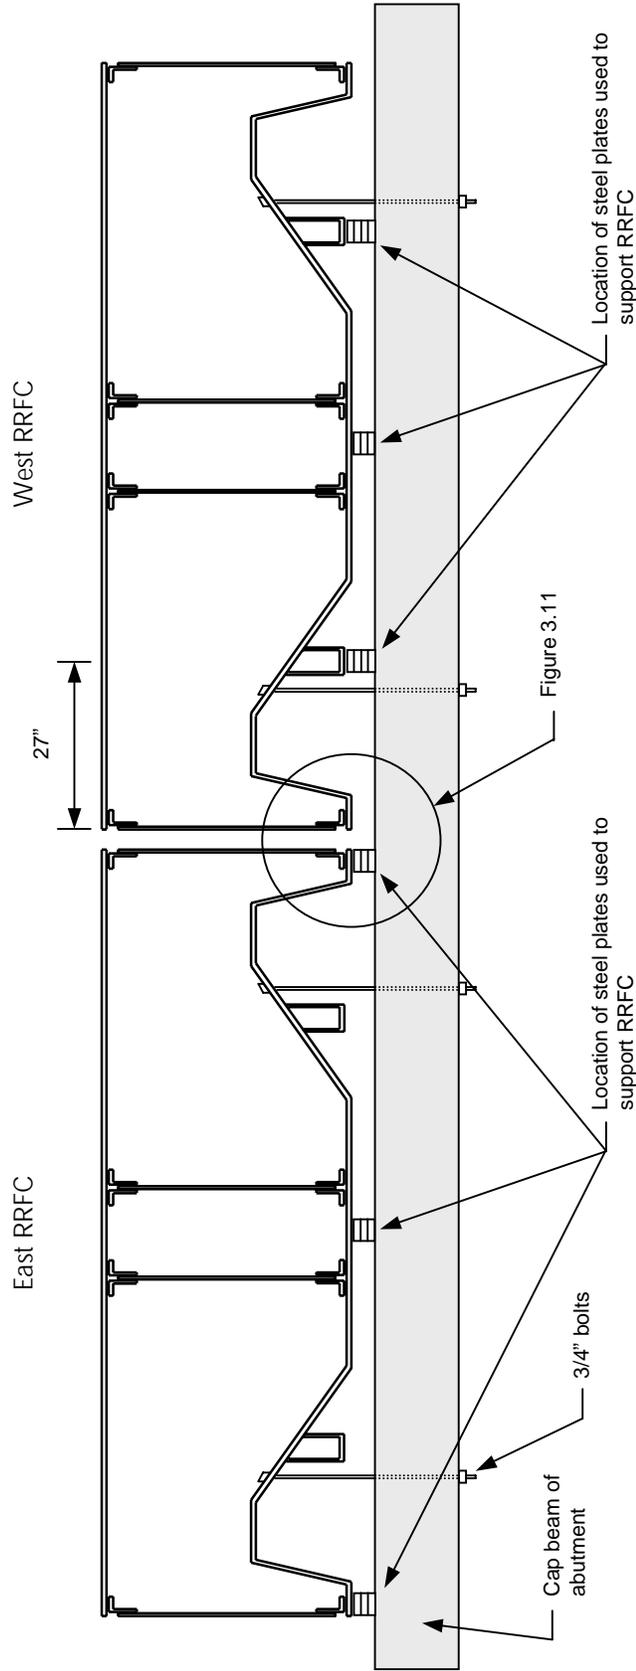
Figure 3.10. Location of TCB abutment bearings.

The transverse abutment support locations are different for each flatcar. At the supports of both flatcars, several steel plates (12 in. x 2 1/2 in. x 3/4 in.) are placed between the bolster of the flatcar and the timber abutment at three locations as shown in Figure 3.10. Both the north and south ends of the TCB are supported as shown in Figure 3.10. Steel plates supporting the east flatcar are located at the center and edges of the flatcar; the west flatcar is supported at the center and 27 in. from the both edges. The support conditions for the exterior longitudinal members of the east and west flatcars at the center of the bridge are shown in Figure 3.11. Notice that one longitudinal member is supported by steel plates while the other is not. Because of these support differences, the west car likely has less torsional stability than the east car. Both flatcars are bolted to the timber abutments with two 3/4 in. diameter bolts at each abutment. The location of these bolts is also shown in Figure 3.10. It should also be noted that some of the gravel fill behind the south abutment had been washed out and caused rutting just beyond south abutment from truck loads.

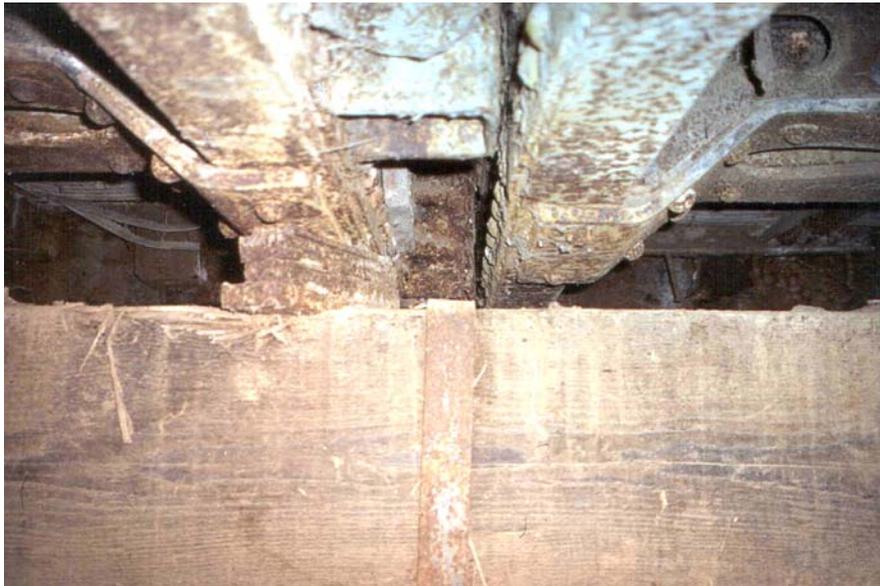
Figure 3.11. Transverse abutment support locations differed between the east and west flatcars (see Figure 3.10).

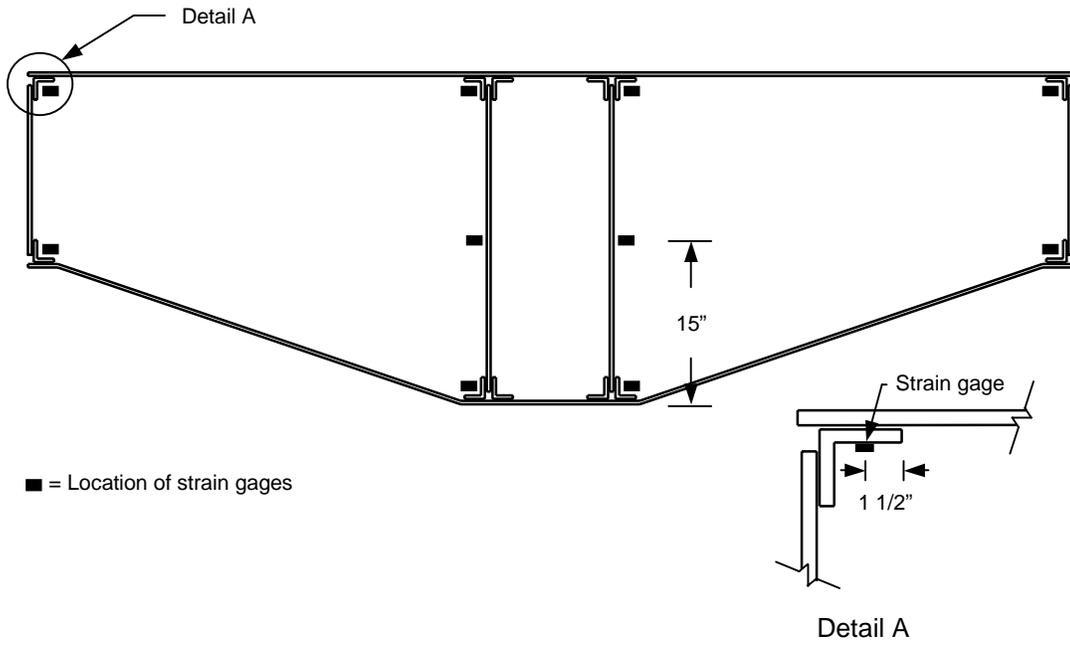
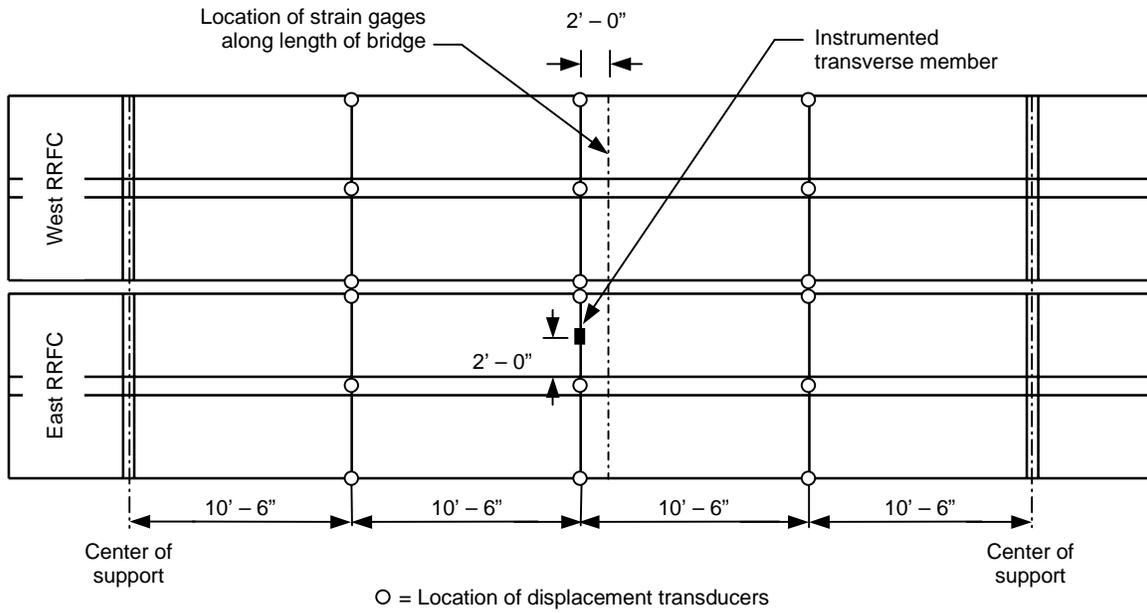
a. Strain gage location in cross-section of flatcar 2 ft from midspan

b. Instrumentation location along length of bridge

Figure 4.1. Instrumentation location for TCB load test.

With simple supports, the maximum stresses were expected to occur at the midspan of the bridge. For this reason, 20 strain gages were placed on the main longitudinal members of both flatcars at the bridge midspan. The location of the strain gages in a cross-section view of the flatcar is shown in Figure 4.1a. Both flatcars have this same instrument placement. On each longitudinal member, strain gages were placed on the top and bottom flanges as well as the web of the interior members. To avoid potential localized strain effects of the connections between the longitudinal members and the transverse members, the strain gages were placed 2 ft from the midspan of the bridge (see Figure 4.1b). In addition to the longitudinal members, two strain gages were also placed on the top and bottom flange of a major transverse member of the east flatcar. This member was the only undamaged transverse member at the midspan of the

bridge and was instrumented 2 ft from the interior longitudinal member. The transverse member and location of strain gages are identified in Figure 4.1b.

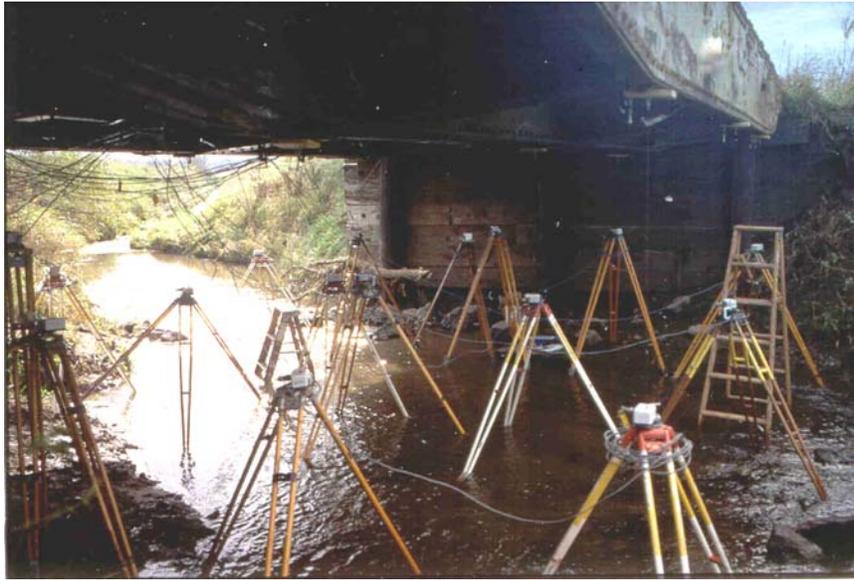
Figure 4.2. Displacement transducers used during field load test of TCB.

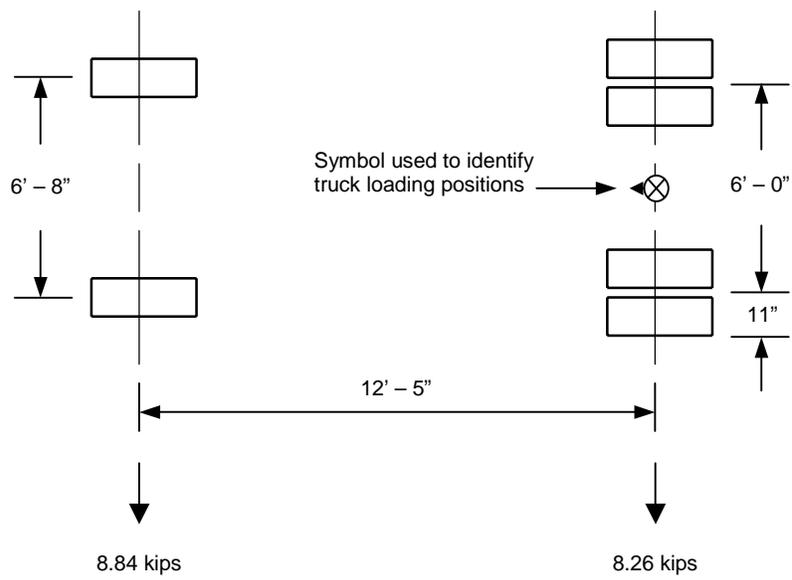
Figure 4.3. Single-axle truck dimensions and axle weights.

For the first load test, a single-axle Tama County dump truck with an empty weight of 17.30 kips was used. Dimensions and axle weights of this truck are shown in Figure 4.3; a photograph of the truck is provided in Figure 4.4. After this initial load test, as previously noted, the experimental results indicated that the bridge had sufficient strength to support the fully loaded rear tandem-axle truck. Dimensions of the tandem-axle truck and its axle weights are presented in Figure 4.5; a photograph of the rear tandem-axle truck is shown in Figure 4.6. The total load of the second truck was 52.14 kips. For each load test, strain and deflections were recorded with the truck in nine positions on the bridge. These positions (A1, A2, A3, B1, B2, B3, C1, C2, and C3) are shown in Figure 4.7. A symbol (see Figures 5.3 and 5.5) was used to show the location of the rear axle and the direction the truck is heading. The nine positions correspond to the position of the rear axle both across the width and length of the bridge. At the 1/4, 1/2, and 3/4 spans (identified in Figure 4.7), the truck's rear axle is positioned at the center and at the two edges of the timber road surface as shown in Figure 4.8. Truck weights and positions from the field test were used in the computer model so that analytical and experimental data for each truck position could be compared. These comparisons and the results of the field testing of the TCB, as previously noted, are presented and discussed in the Chapter 6.

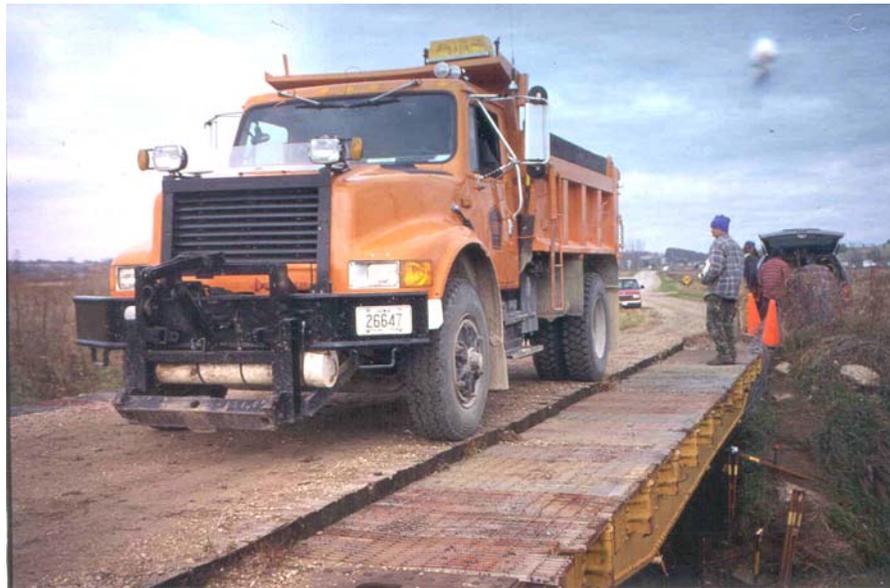
Figure 4.4. Photograph of single-axle test truck.

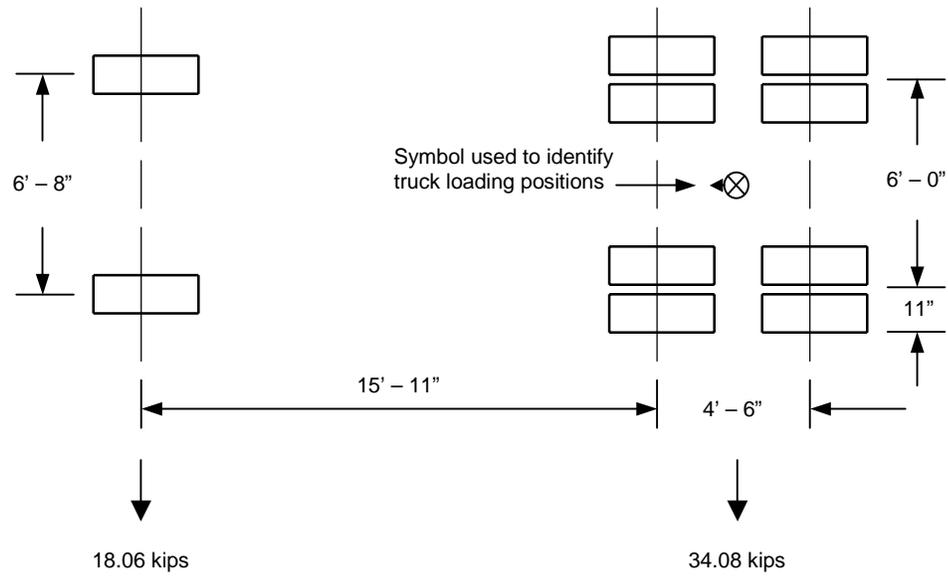
Figure 4.5. Rear tandem-axle truck dimensions and axle weights.

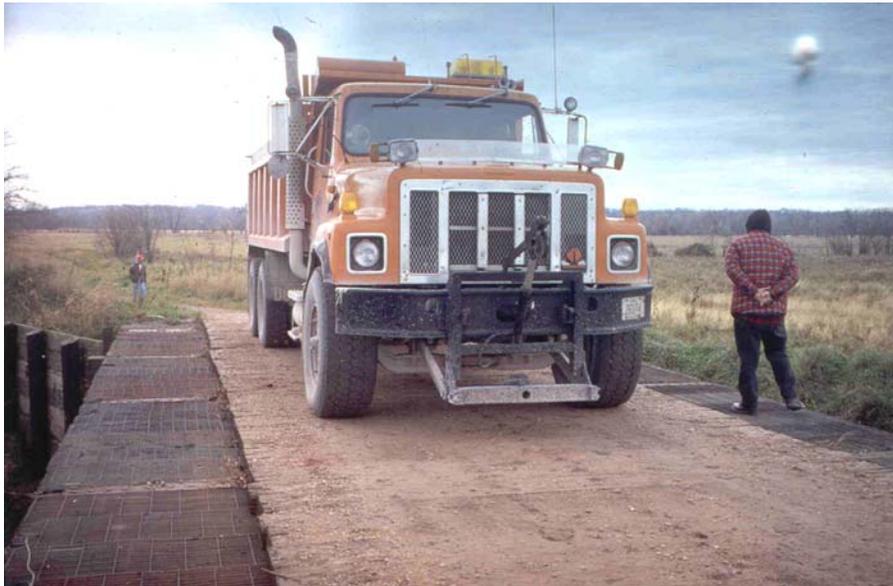
Figure 4.6. Photograph of rear tandem-axle test truck in position C2.

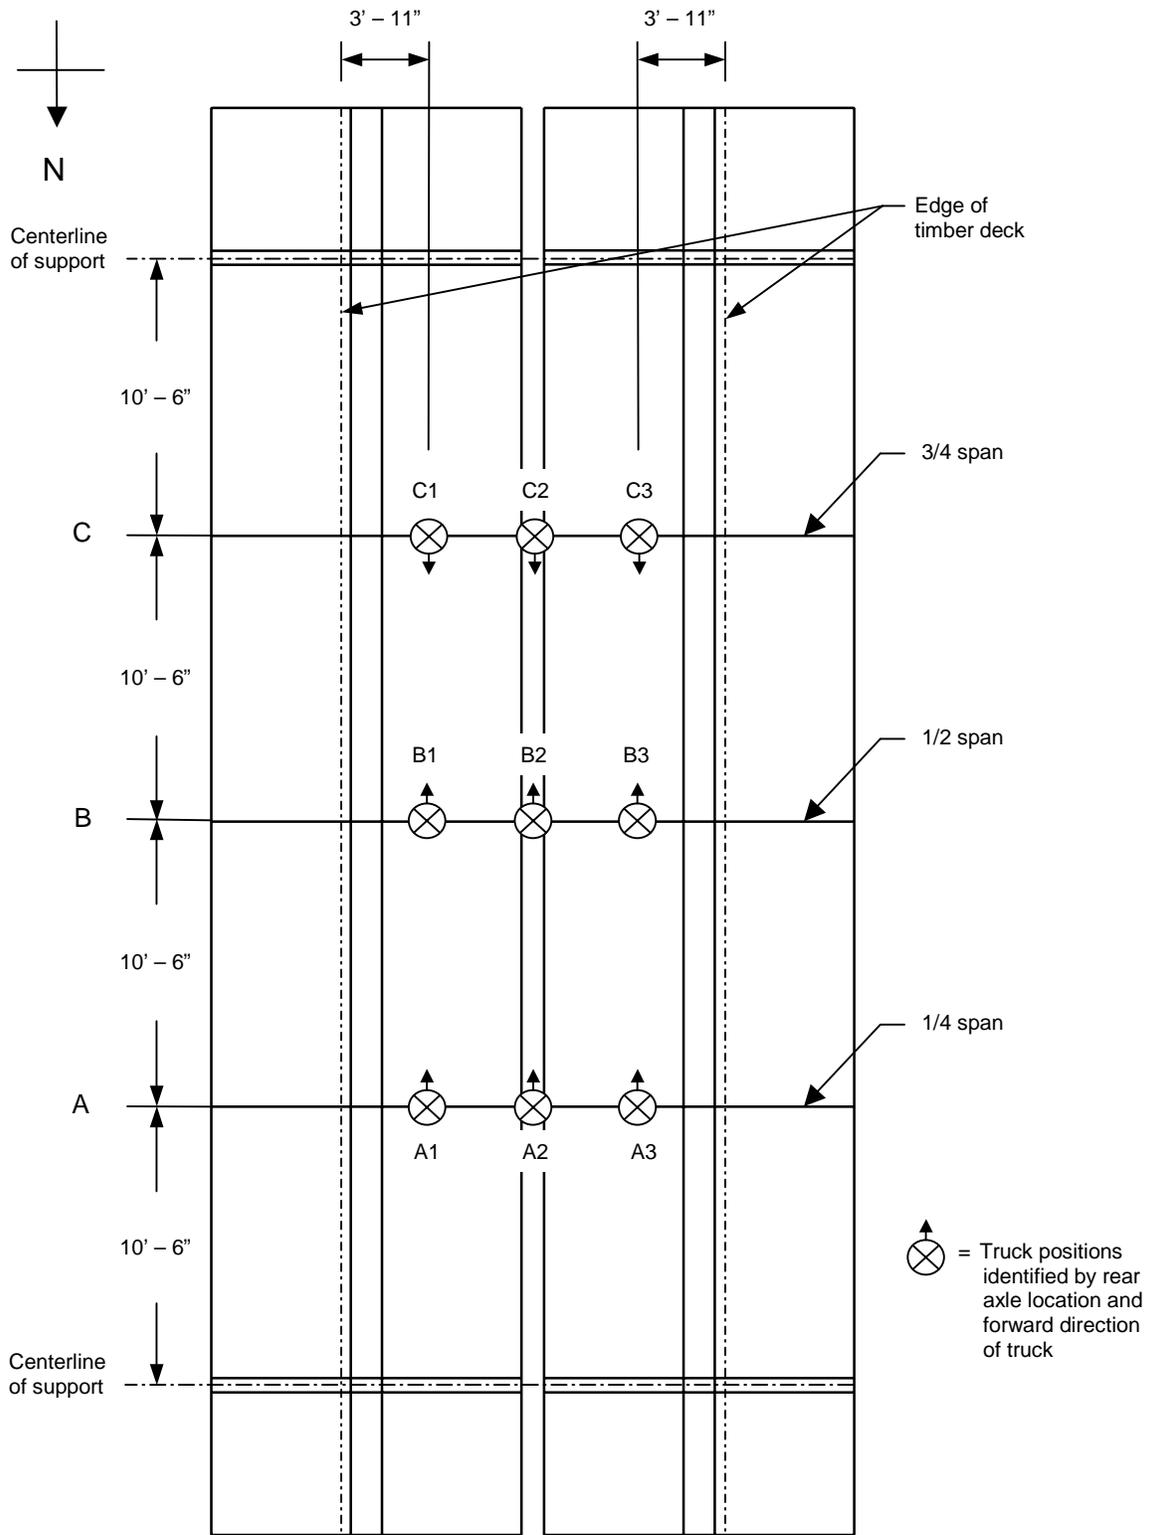
Figure 4.7. Plan view of TCB showing truck load positions.

The midspan deflections and bottom flange strains are presented in Figures 6.1, 6.2, and 6.3 for truck positions B1, B2, and B3 (see Figure 4.7), respectively due to the fully loaded rear tandem-axle truck (52.14 kips). These three truck positions produced the maximum strain and deflection results. From Figures 6.1, 6.2, and 6.3, it can be seen that the strains and deflections were low for the three truck positions. The maximum deflections were 0.32 in., 0.31 in., and 0.31 in. for truck positions B1, B2, and B3, respectively, compared to the

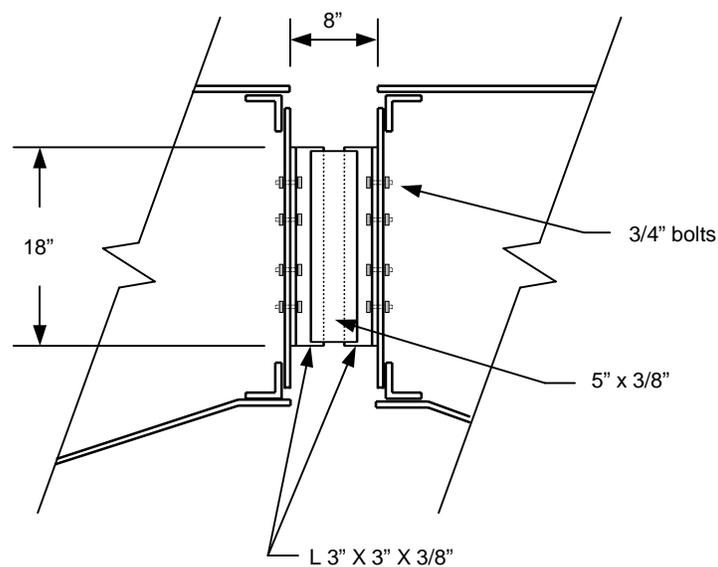
Figure 4.9. Angle-plate connection added between flatcars.

As described in Chapter 3, the timber planks of the bridge deck provide the only connection between the two RRFC in the TCB. While the testing instrumentation was in place, angle-plate connections were made between the two RRFC. The bridge was re-tested using the same truck and same truck positions. A detail of the connections is shown in Figure 4.9. Holes were drilled into the web of an exterior longitudinal member of each flatcar and angles were attached to each flatcar using 3/4 in. bolts. A 3/8 in. plate was welded to each angle to complete the connection. These connections were added at the 1/4, 1/2, and 3/4 span locations along the bridge (see Figure 4.7). A photograph of

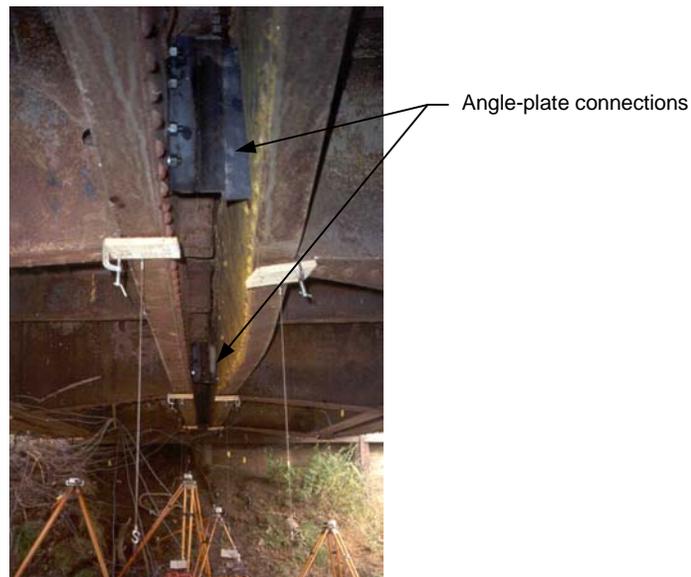
Figure 4.10. Photograph showing angle-plate connection added between flatcars.

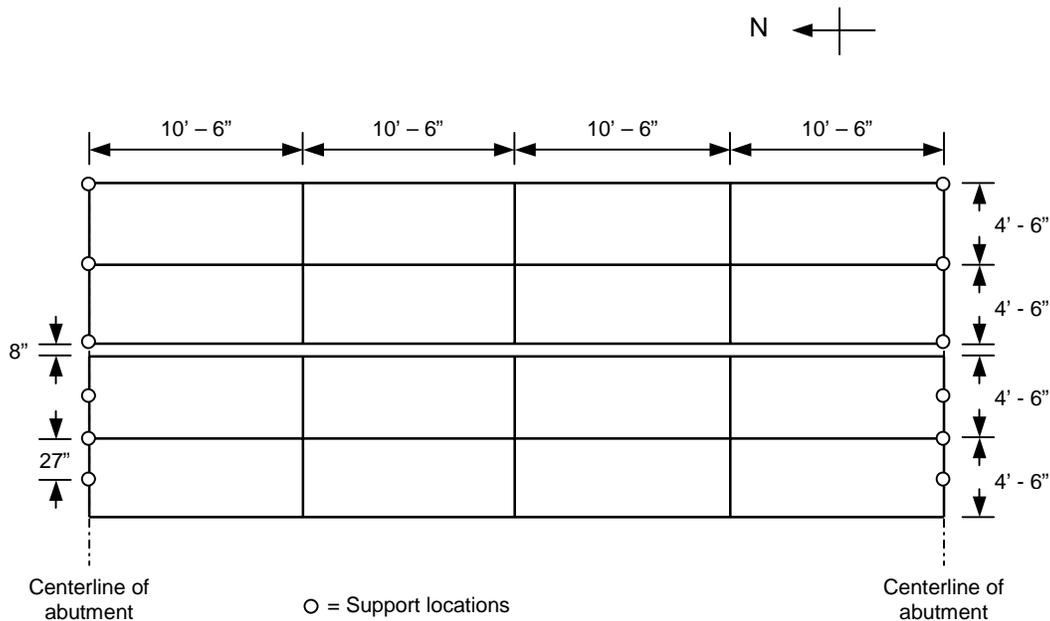
Figure 5.1. ANSYS grillage model of TCB (Note that the support locations for each flatcar are different).

The ANSYS model was developed by creating three longitudinal members (as previously noted, the two interior longitudinal members of each RRFC were modeled as one member) and six transverse members for each RRFC. Each longitudinal member was composed of a fine mesh of 48 elements; this allowed input of the properties in the tapered regions of the member. At the abutment locations of each flatcar, elements were added to represent the transverse support beams. As previously noted, there was an 8 in. space between the two flatcars. The analytical model of the TCB is presented in Figure 5.1. Note that the bridge span was modeled based on its span length of 42 ft (center-to-center

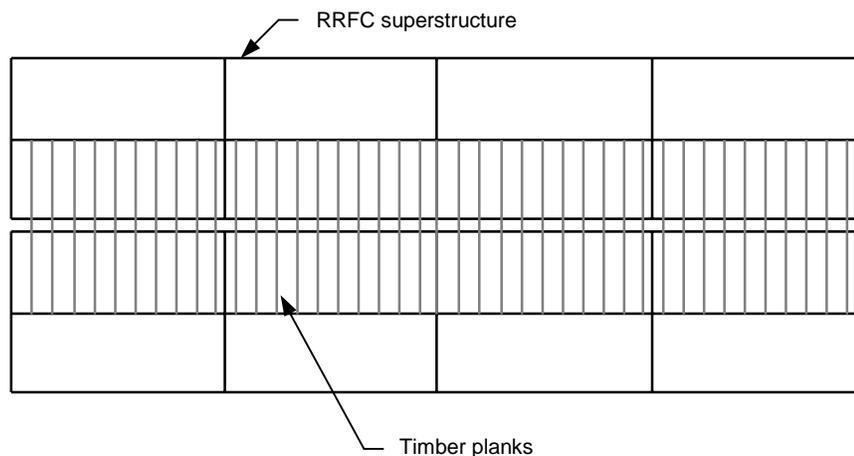
Figure 5.2. ANSYS model of TCB with a fine mesh grillage of the timber deck.

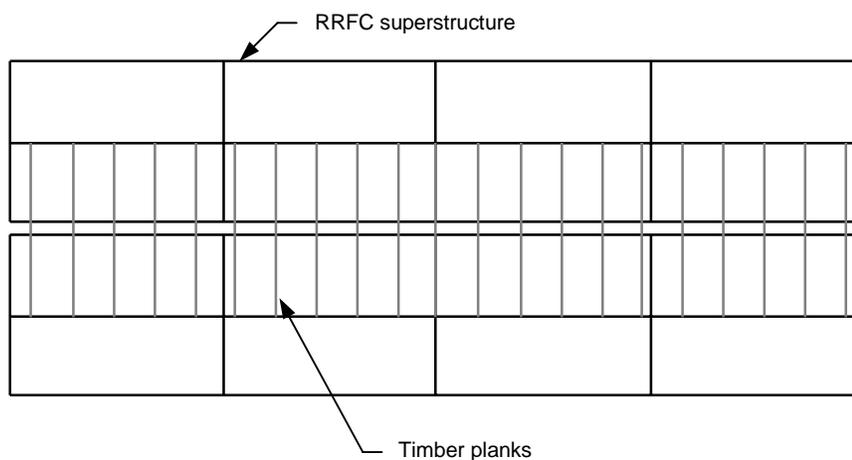
Figure 5.3. ANSYS model of TCB with a coarse mesh grillage of the timber deck.

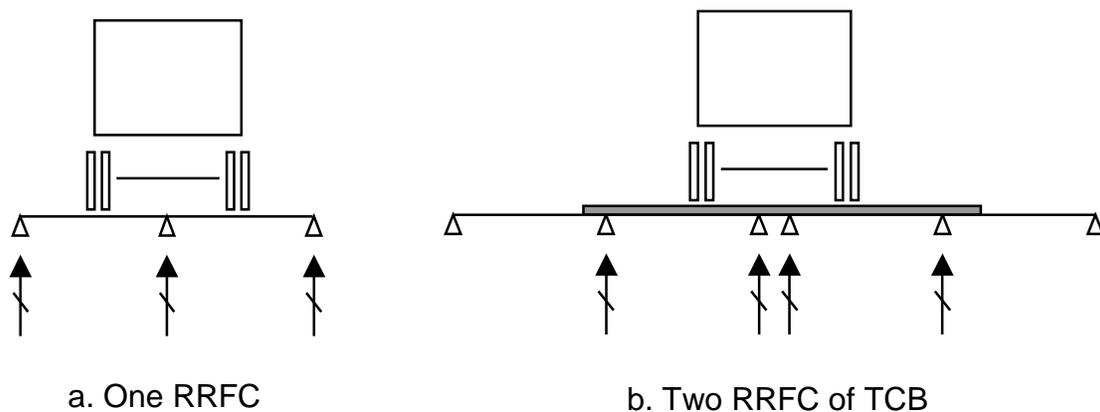
Figure 5.4. Reactions from truck loads that were applied to the ANSYS model.

the main longitudinal members of the RRFC ANSYS model. The configurations used to determine the loads applied to the ANSYS model is shown in Figure 5.4. When modeling a truck supported by only one RRFC, a two-span continuous system was used to determine the loads that would be applied to the RRFC grillage model as shown in Figure 5.4a. When modeling a truck supported by two RRFC, as is the case with the TCB, a three-span continuous system was used as shown in Figure 5.4b. When two RRFC carry the truck loads, the outer members were assumed to carry no truck loads directly since the timber deck does not extend to the exterior longitudinal members. Therefore, only reactions for the center four longitudinal members, which support the timber deck, were determined. Reactions were found for both the front and rear axle loads of a truck. In the ANSYS model, nodes were placed at the exact wheel locations along the length of the bridge so that no longitudinal distribution of wheel loads was required.

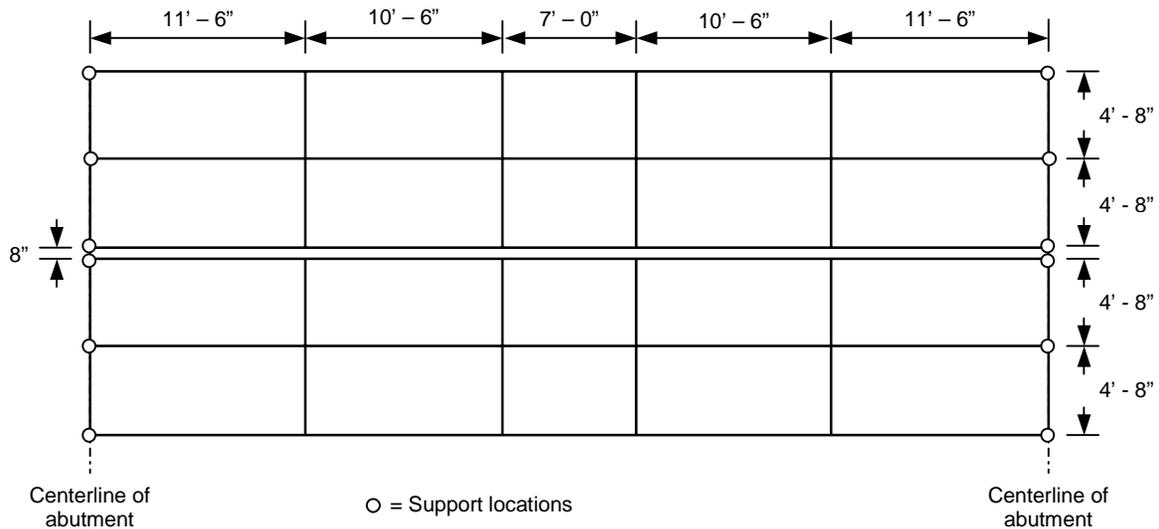
Figure 5.6. ANSYS bridge model of the Thrall flatcar.

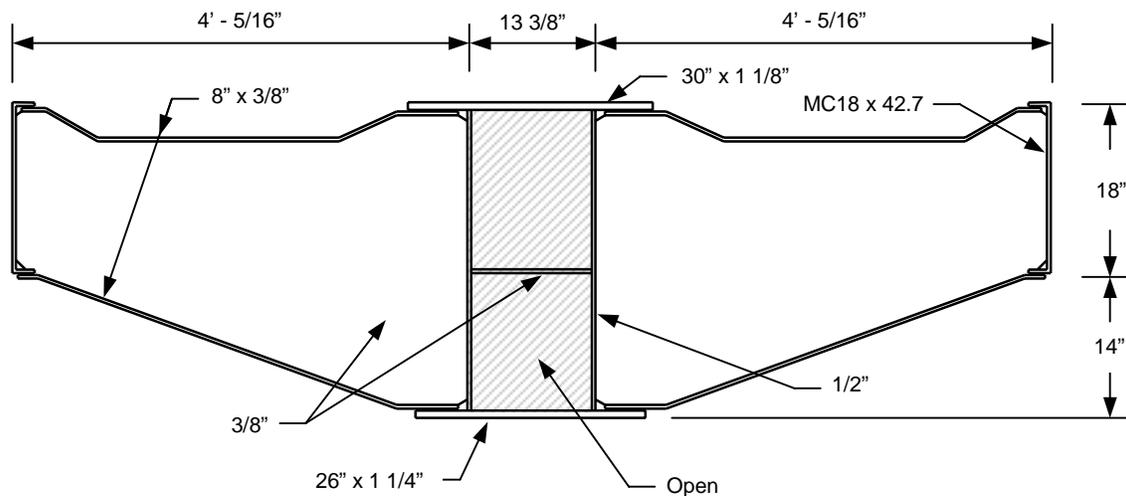
Figure 5.7. Midspan cross-sectional view of the Canadian National flatcar.

Manufacturing. The flatcar is composed of three main longitudinal members (two exterior and one interior) and eight major transverse members. A centerline cross-sectional view of the flatcar is shown in Figure 5.7; the member properties are presented in Table 5.3. Again, the main girder has a much larger moment of inertia than any other member does in the flatcar. From Table 5.3, it can be noticed that the interior longitudinal girder has the largest moment of inertia of any flatcar discussed. Like the Thrall flatcar, the exterior longitudinal members of the Canadian National flatcar are MC18 x 42.7 channels and remain a constant depth for the entire length of the flatcar. The interior longitudinal member is a built up I-section with two 1/2 in. plates for the web and 1 1/8 in. and 1 1/4 in. plates for the top and bottom flanges, respectively. As in the previous two types of flatcars, there are tapered transverse members with a depth of 18 in. at the exterior of the flatcar and increases to 32 in. at the interior. An elevation drawing

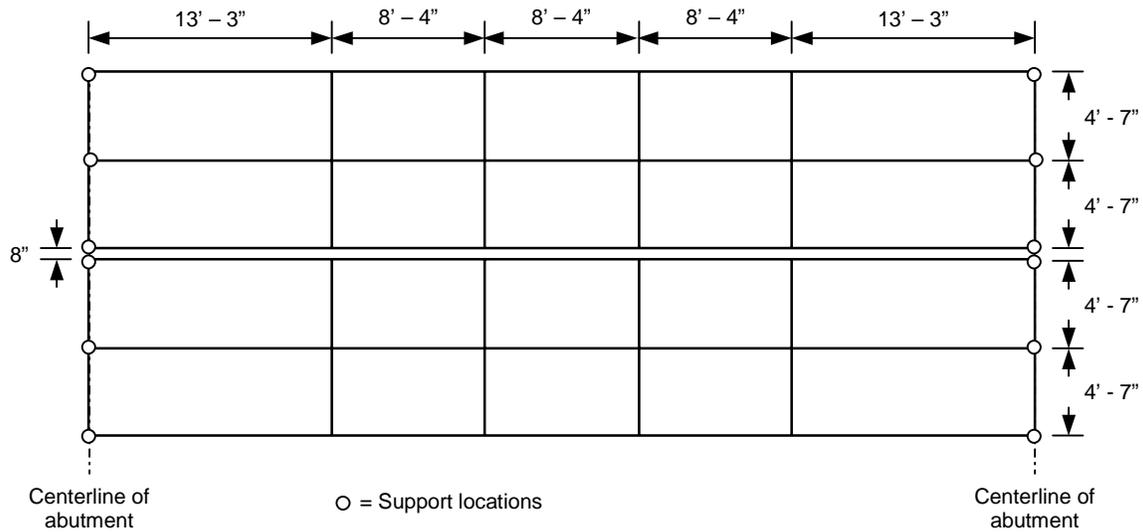
Figure 5.8. ANSYS bridge model of the Canadian National flatcar.
