Use of Railroad Flat Cars for Low-Volume Road Bridges

Sponsored by the
Iowa Department of Transportation
Project Development Division and the
Iowa Highway Research Board

Iowa DOT Project TR-421

REPORT

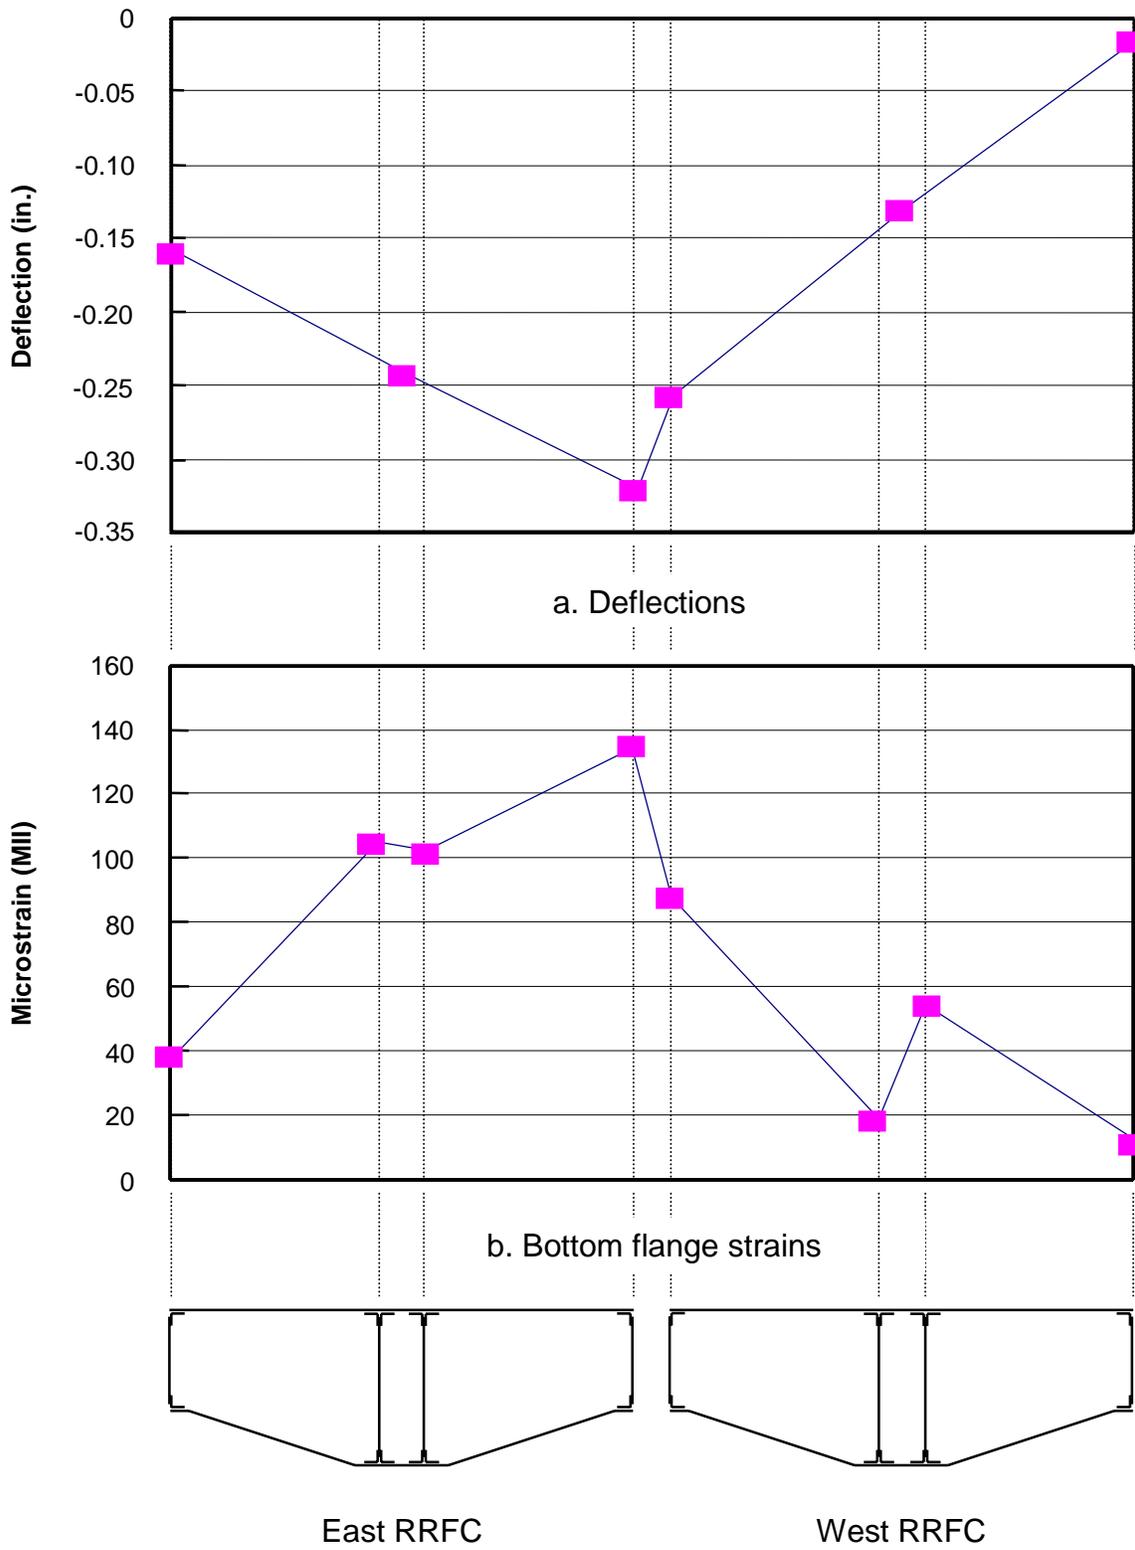
Figure 6.1. Midspan deflections and strains from field load test for truck position B1.

The midspan deflections and bottom flange strains are presented in Figures 6.1, 6.2, and 6.3 for truck positions B1, B2, and B3 (see Figure 4.7), respectively due to the fully loaded rear tandem-axle truck (52.14 kips). These three truck positions produced the maximum strain and deflection results. From Figures 6.1, 6.2, and 6.3, it can be seen that the strains and deflections were low for the three truck positions. The maximum deflections were 0.32 in., 0.31 in., and 0.31 in. for truck positions B1, B2, and B3, respectively, compared to the

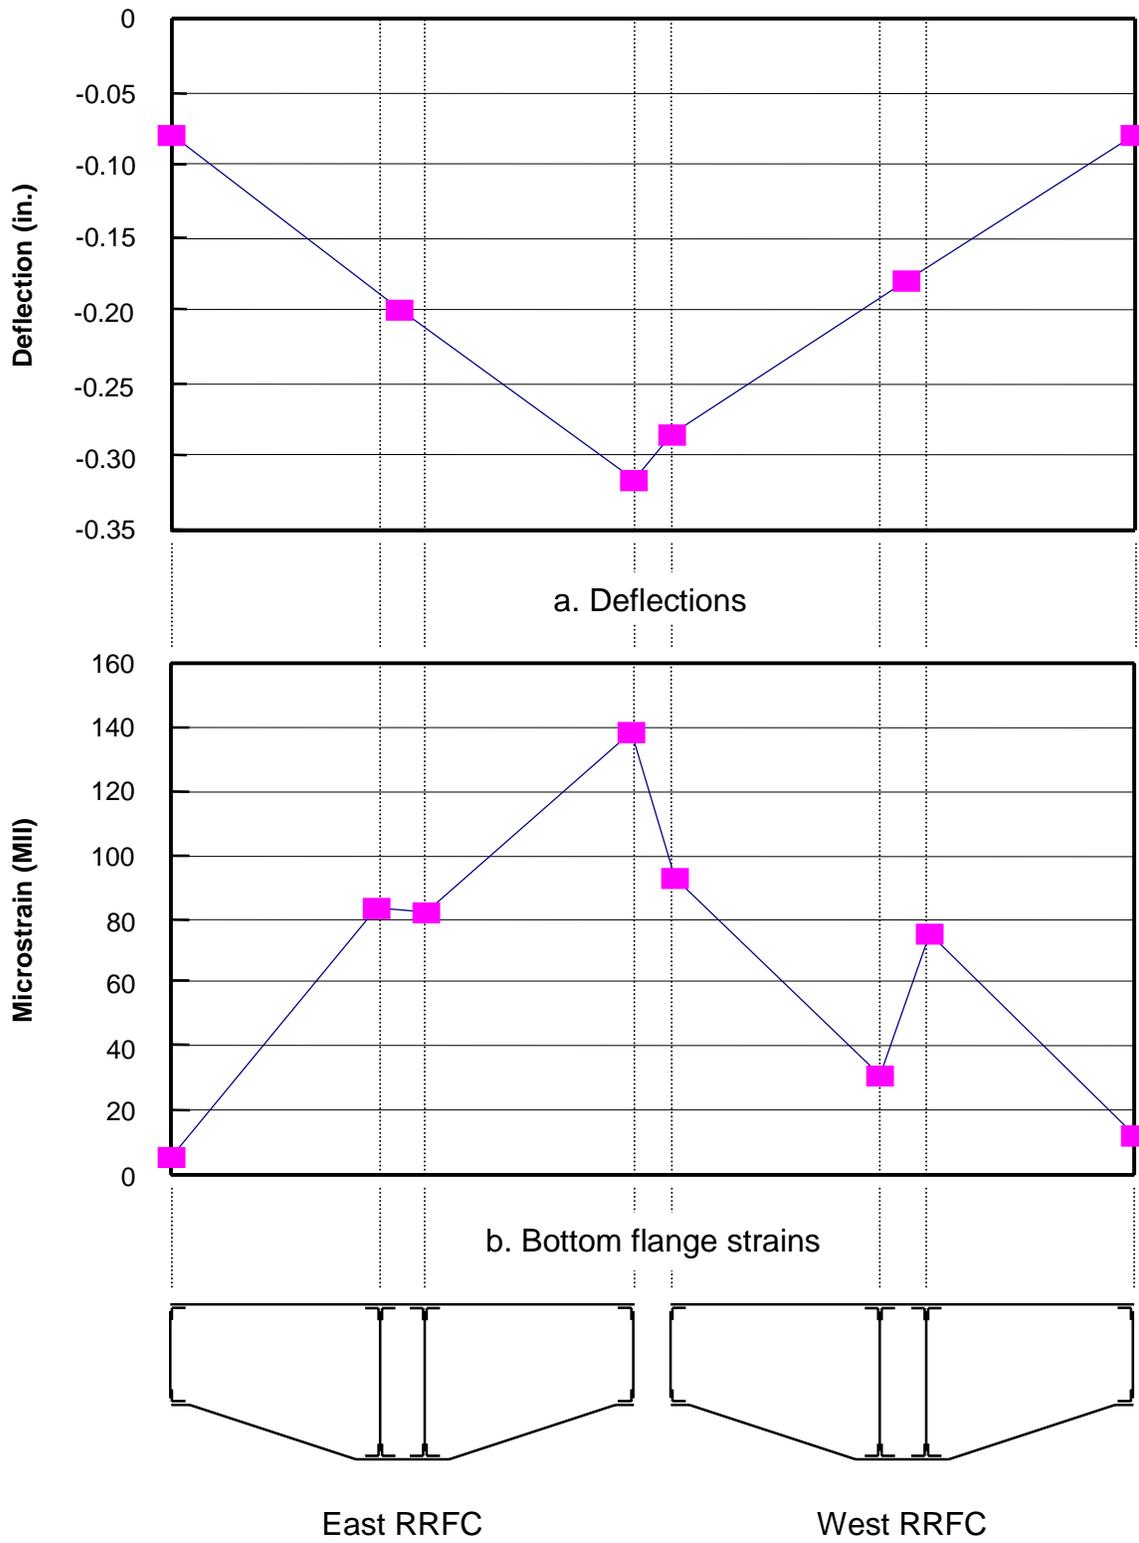
Figure 6.2. Midspan deflections and strains from field load test for truck position B2.

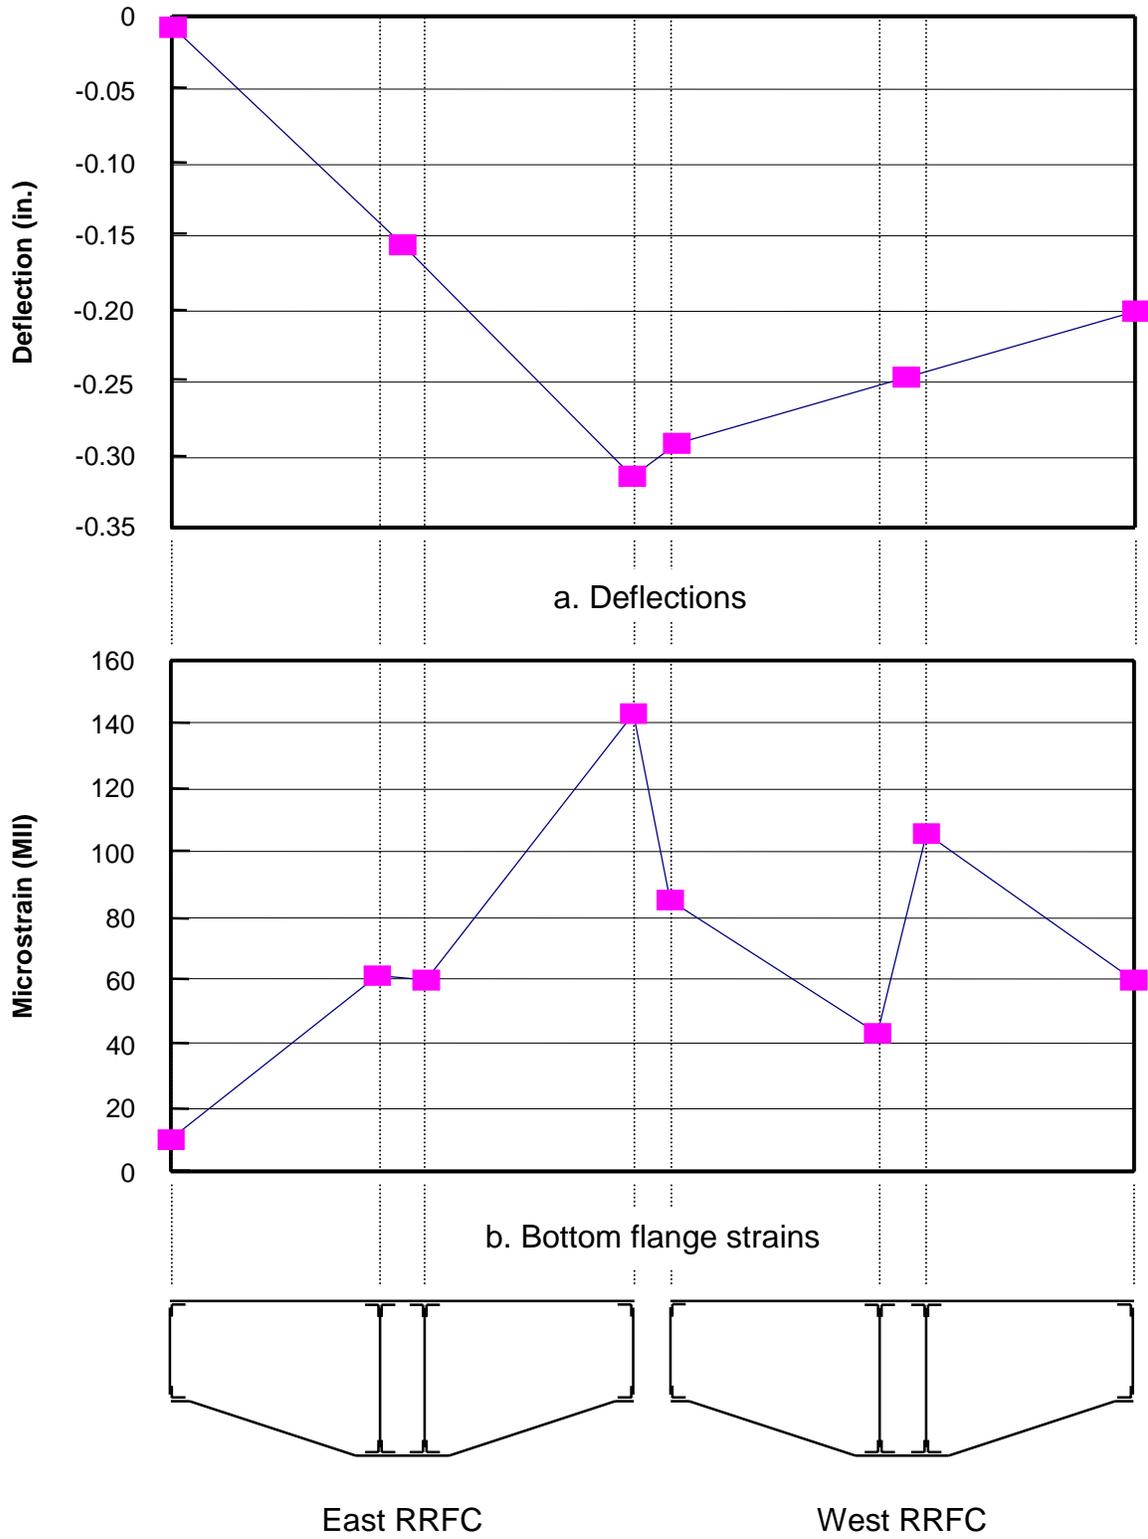
Figure 6.3. Midspan deflections and strains from field load test for truck position B3.

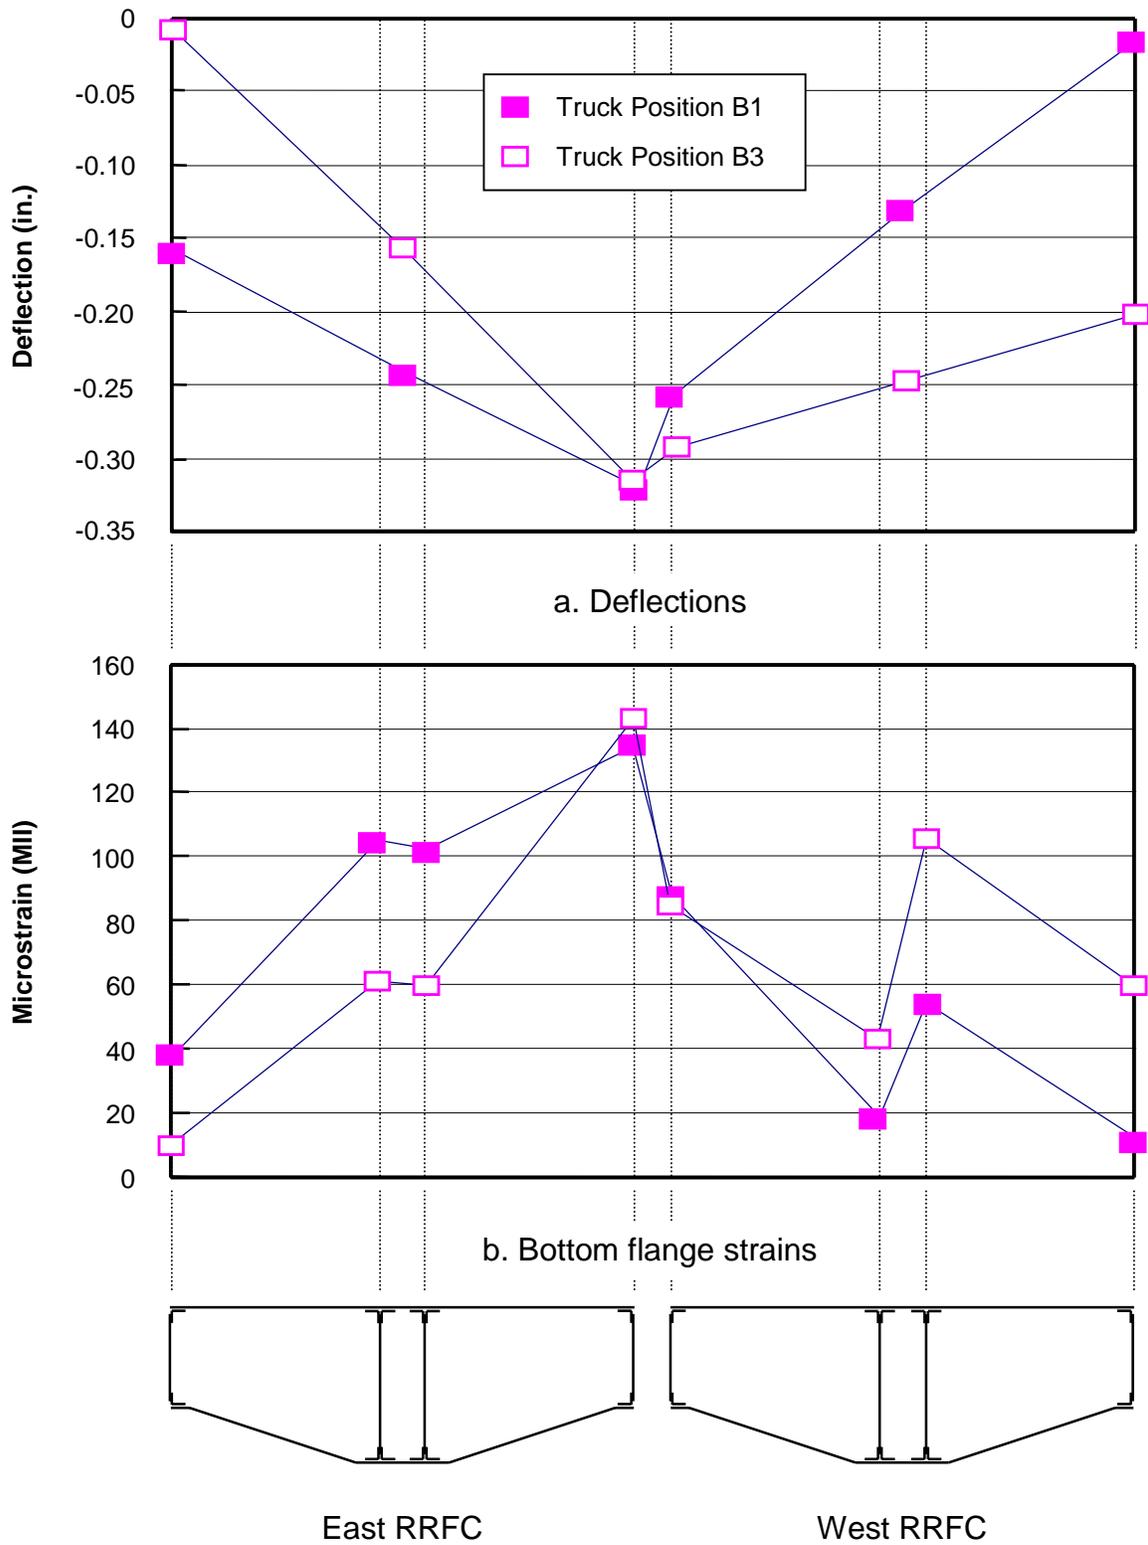
Figure 6.4. Midspan deflection and strain comparisons for truck positions B1 and B3.

In all figures, the strains of the east RRFC have a similar pattern as the corresponding deflection data; the strains increase as the deflections increase. However, this is not evident in the west flatcar where two irregularities in the strain data are noticed. Different strains were recorded for the two interior

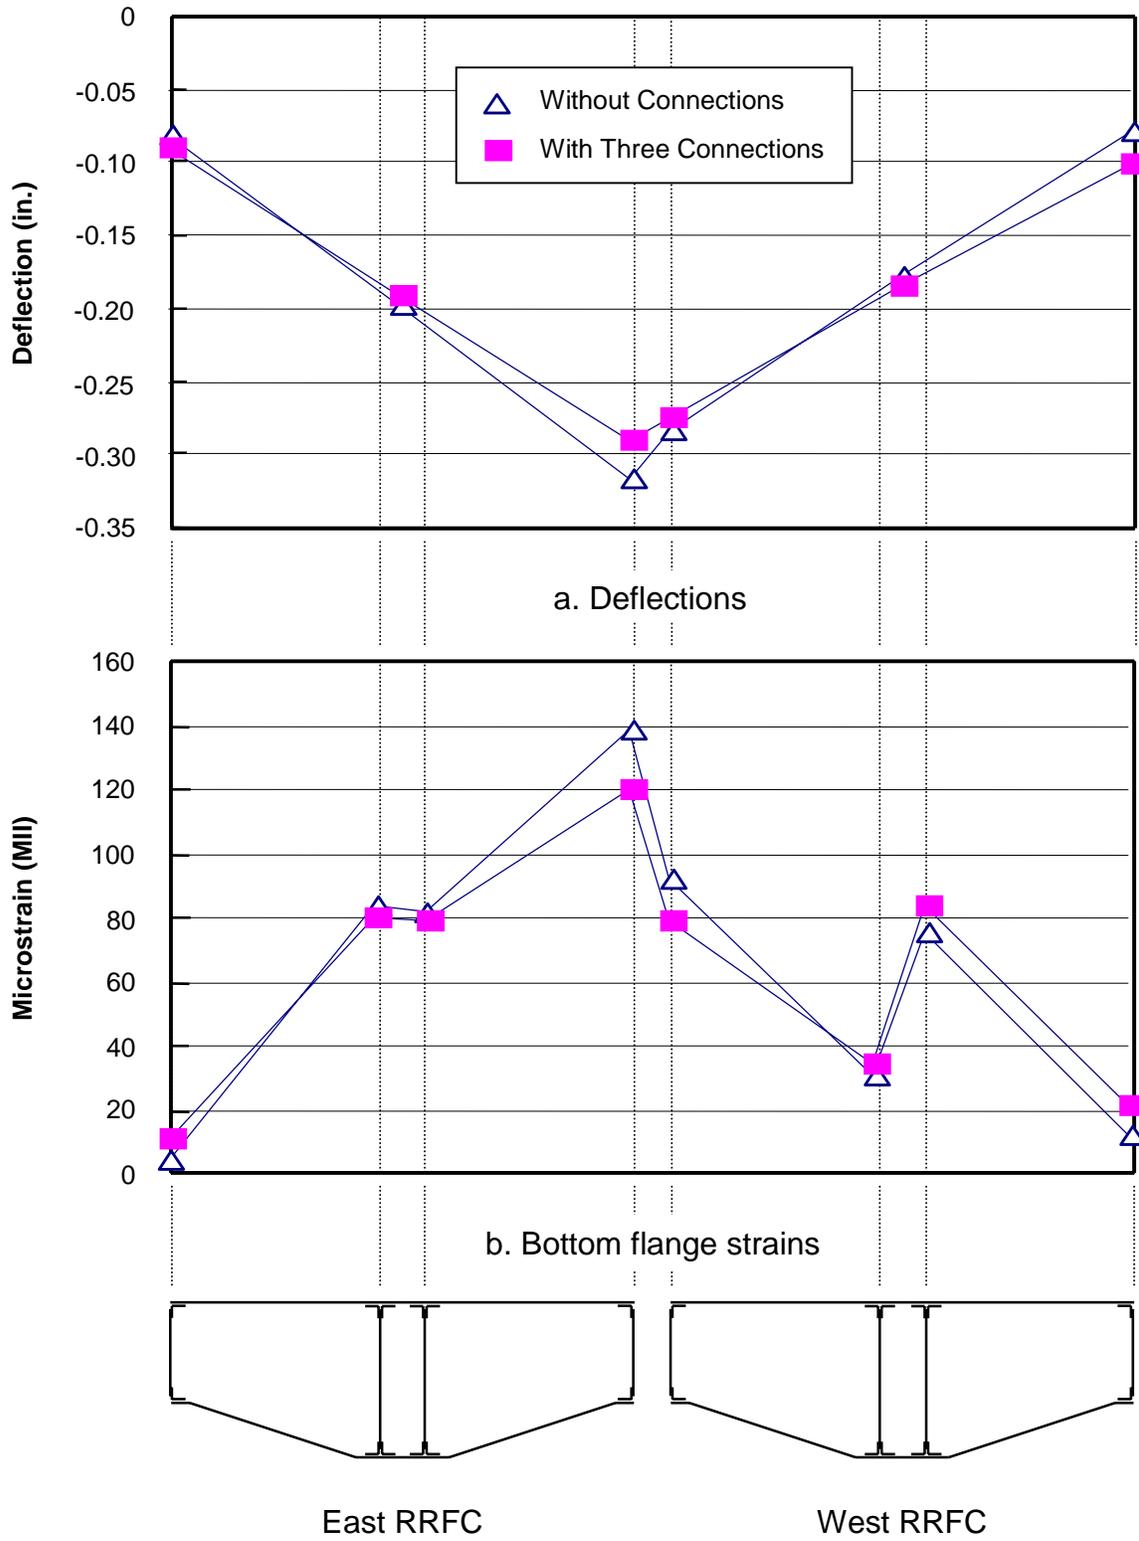
Figure 6.5. Midspan deflections and strains for truck position B2 with three connections made between flatcars.

A second aspect of the load test consisted of making angle-plate connections between the flatcars and re-testing the bridge. Figure 6.5 provides

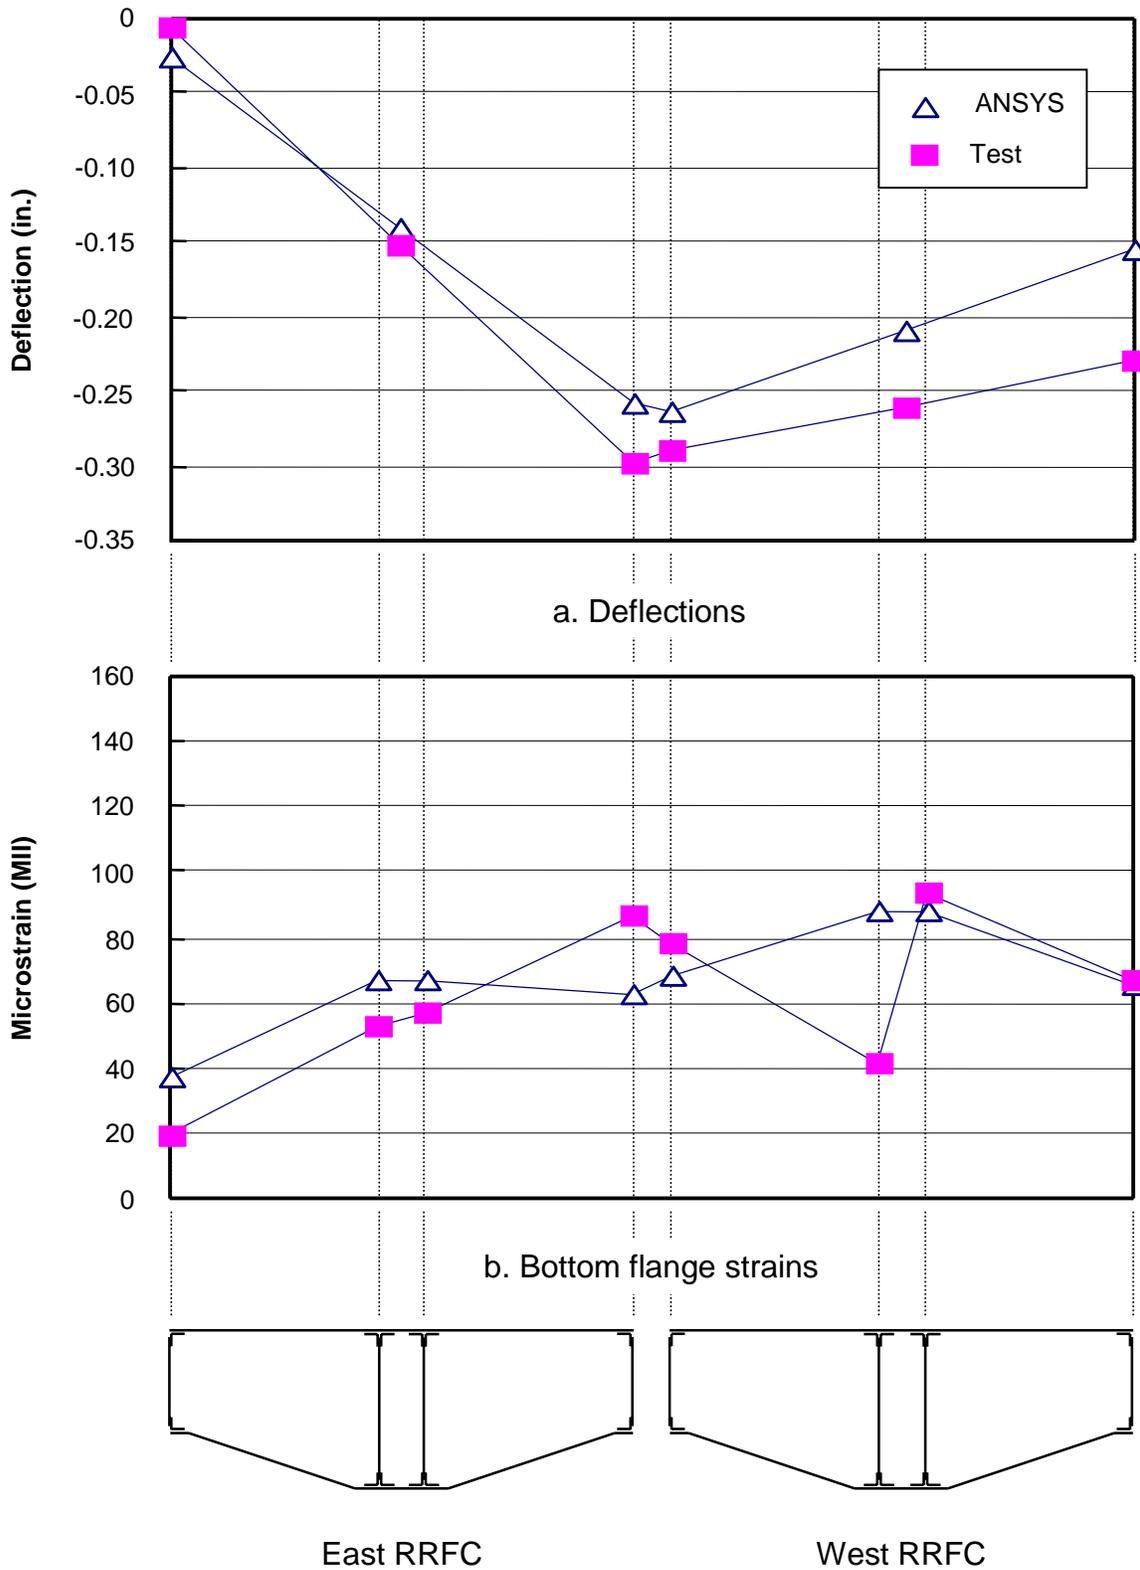
Figure 6.8. Midspan deflection and strain results for truck position A3.

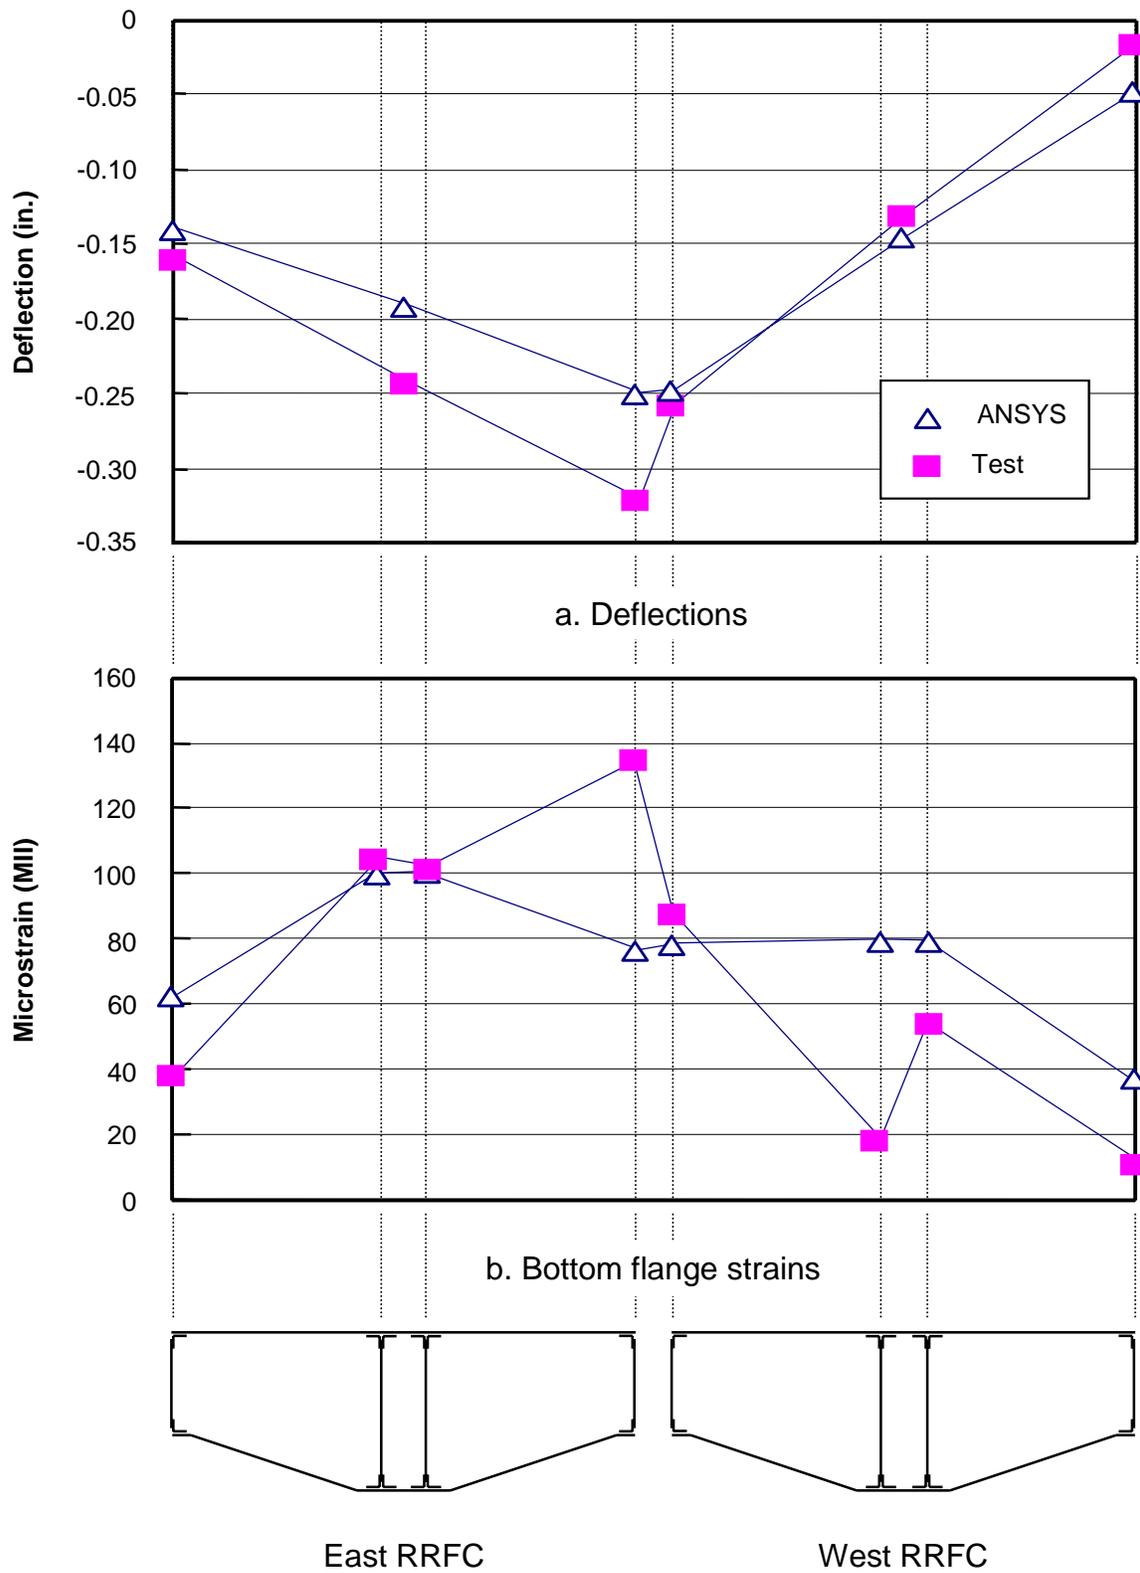
Figure 6.9. Midspan deflection and strain results for truck position B1.

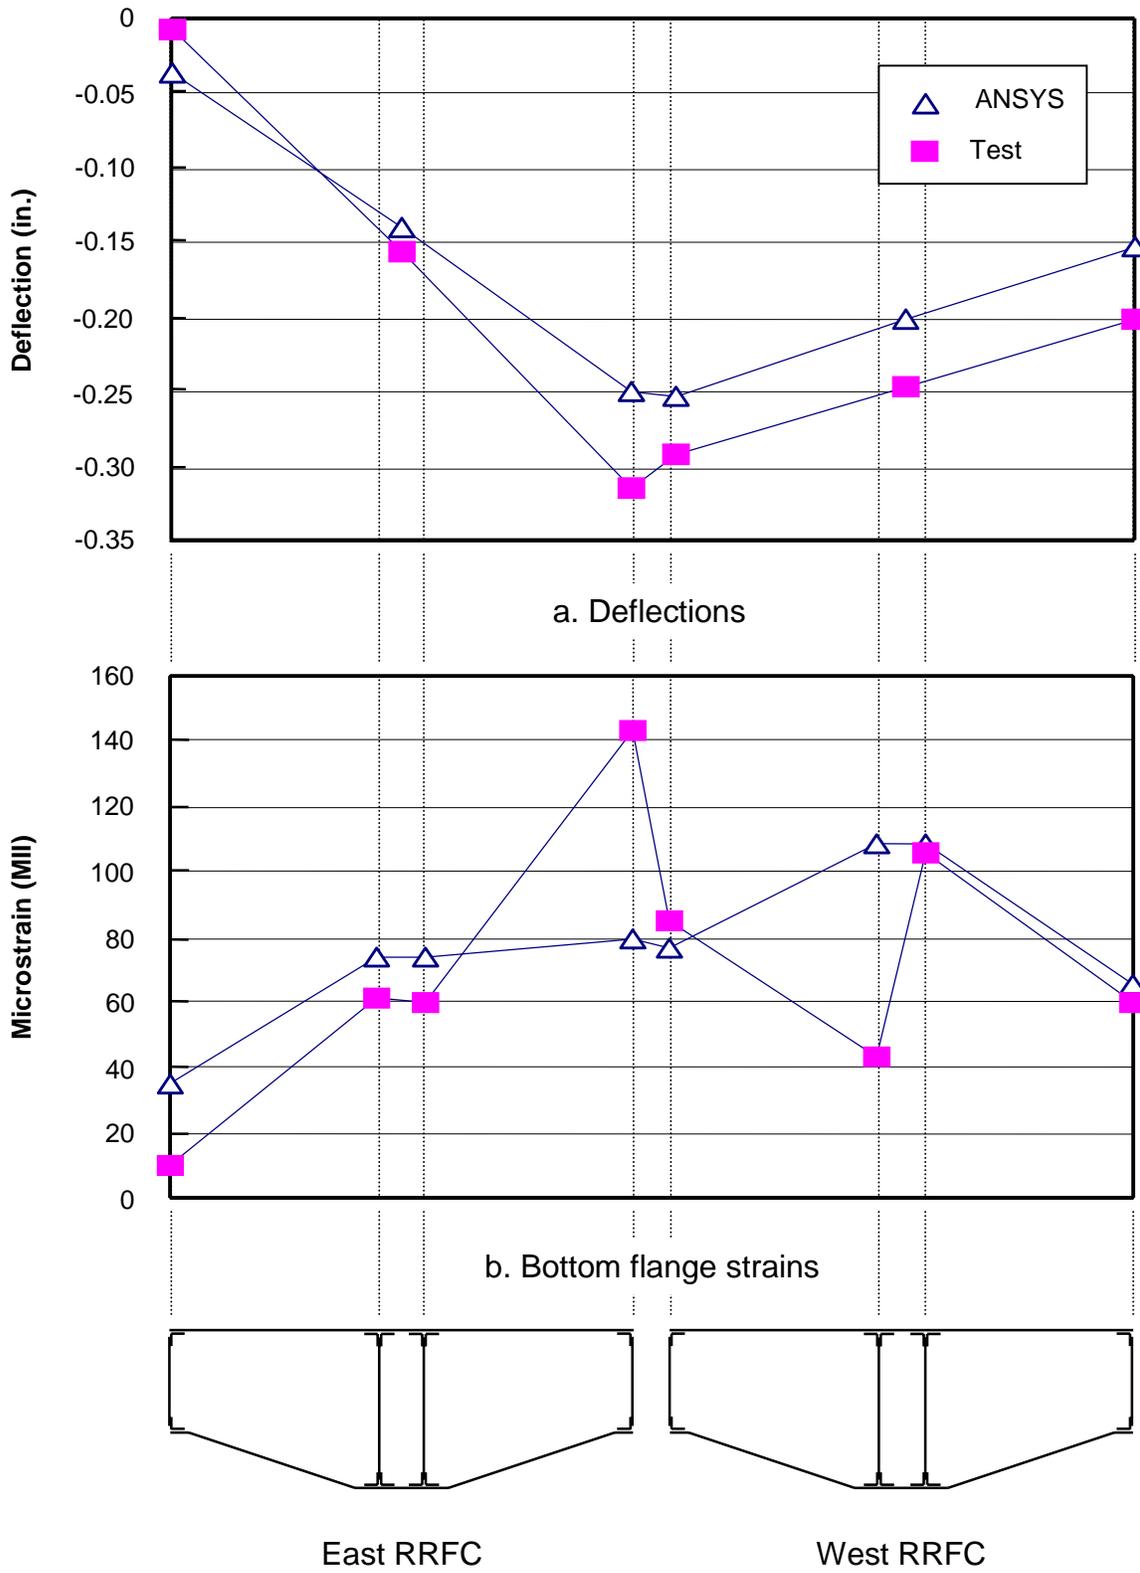
Figure 6.11. Midspan deflection and strain results for truck position B3.

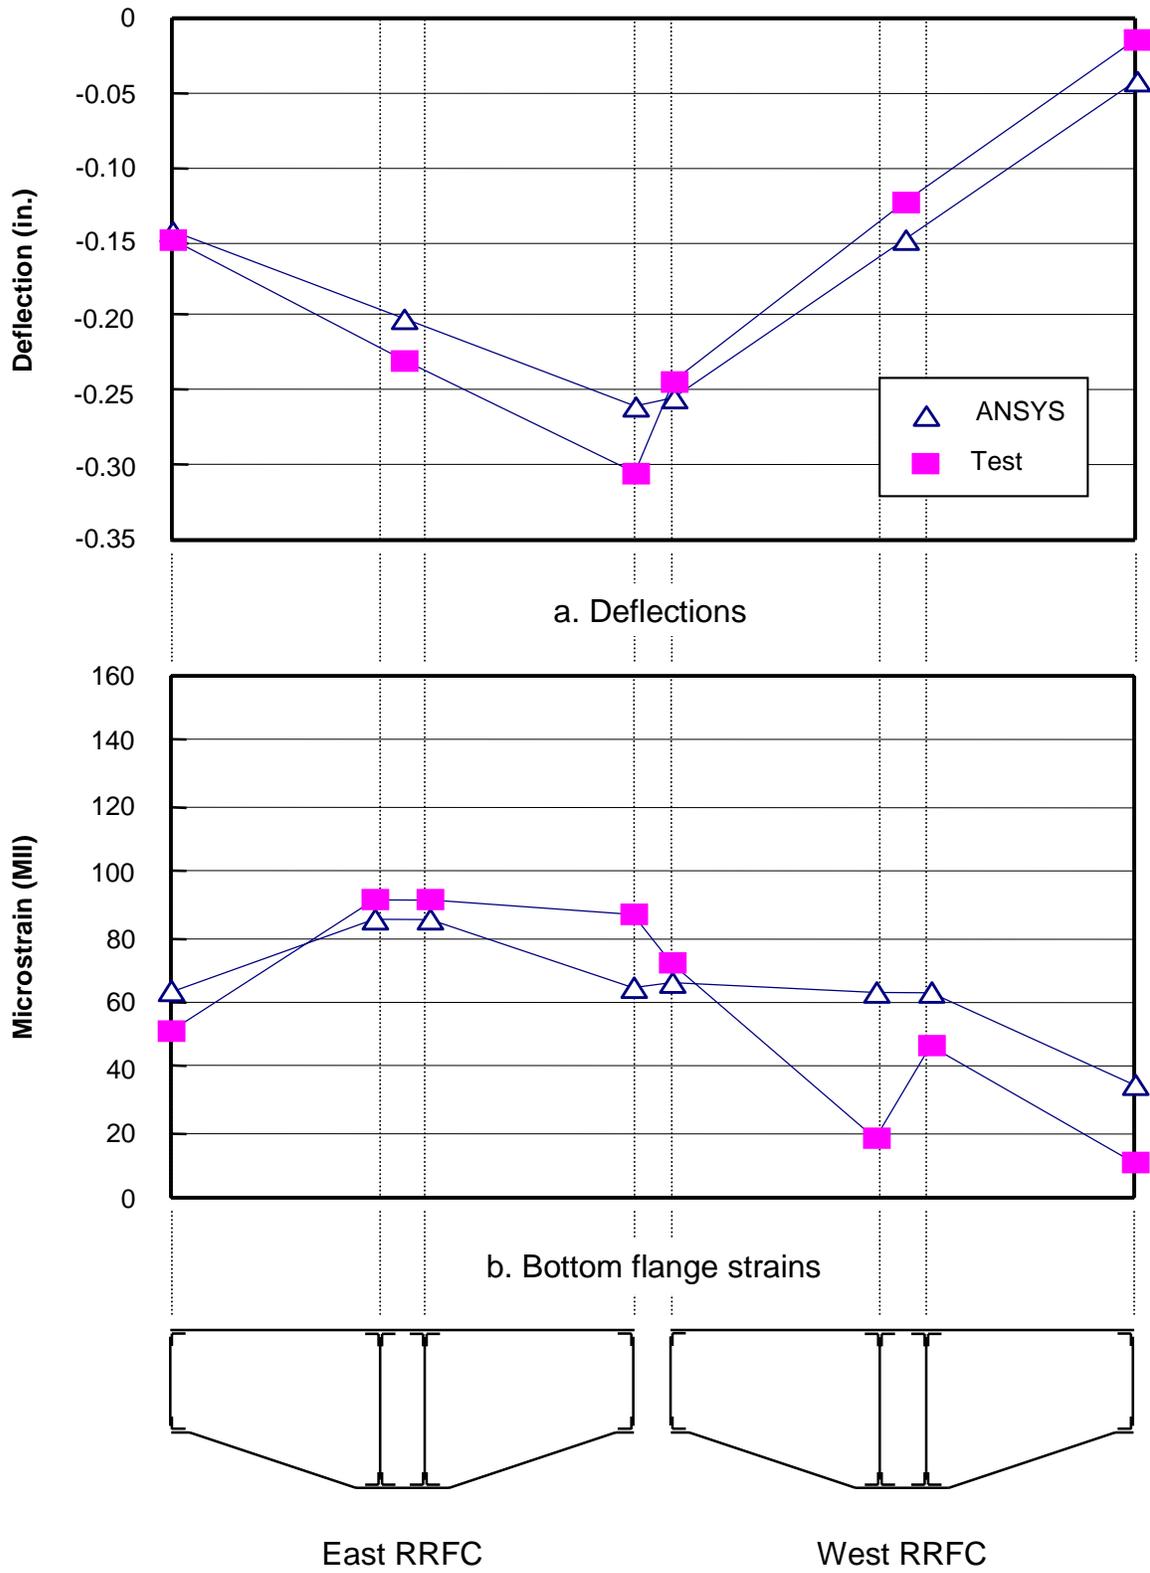
Figure 6.12. Midspan deflection and strain results for truck position C1.

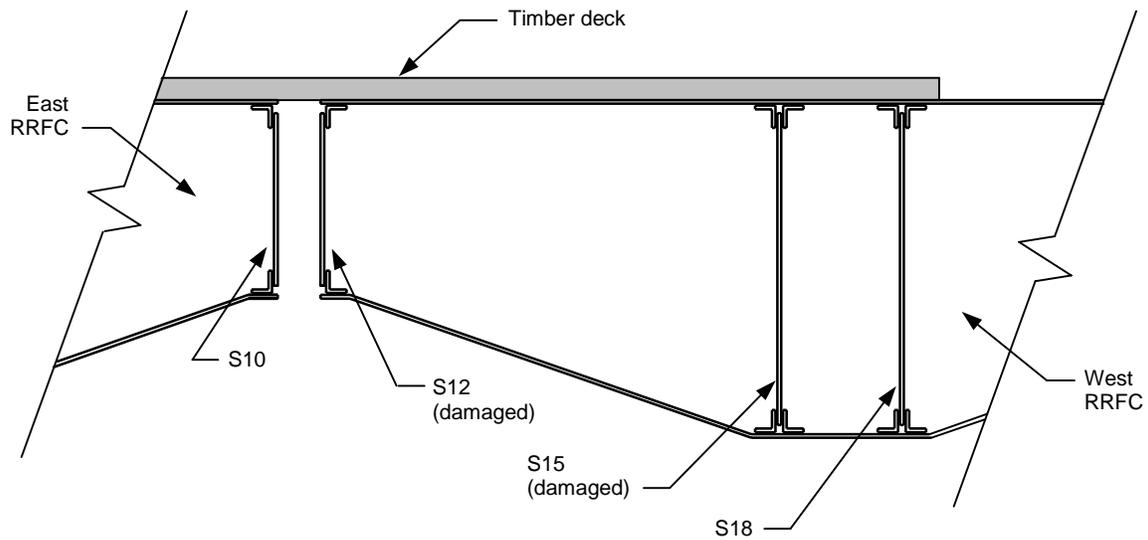
Figure 6.14. Member labels in region of questionable strains.

The portion of the TCB cross-section where the two questionable strain readings noted above occurred is shown in Figure 6.14. For truck positions B1, B2, and B3 (Figures 6.9, 6.10, and 6.11), the strains from the field test are significantly higher than the analytical results at the west exterior longitudinal member of the east flatcar. The strains from the field test are significantly lower than the analytical results at the east interior longitudinal member of the west flatcar for all truck positions. These two locations have been labeled S10 and S15 in Figure 6.14 for ease of discussion; the labels correspond to the strain gage number used in the field test. The east exterior longitudinal member of the west car (S12) and the west interior longitudinal member of the west flatcar (S18)

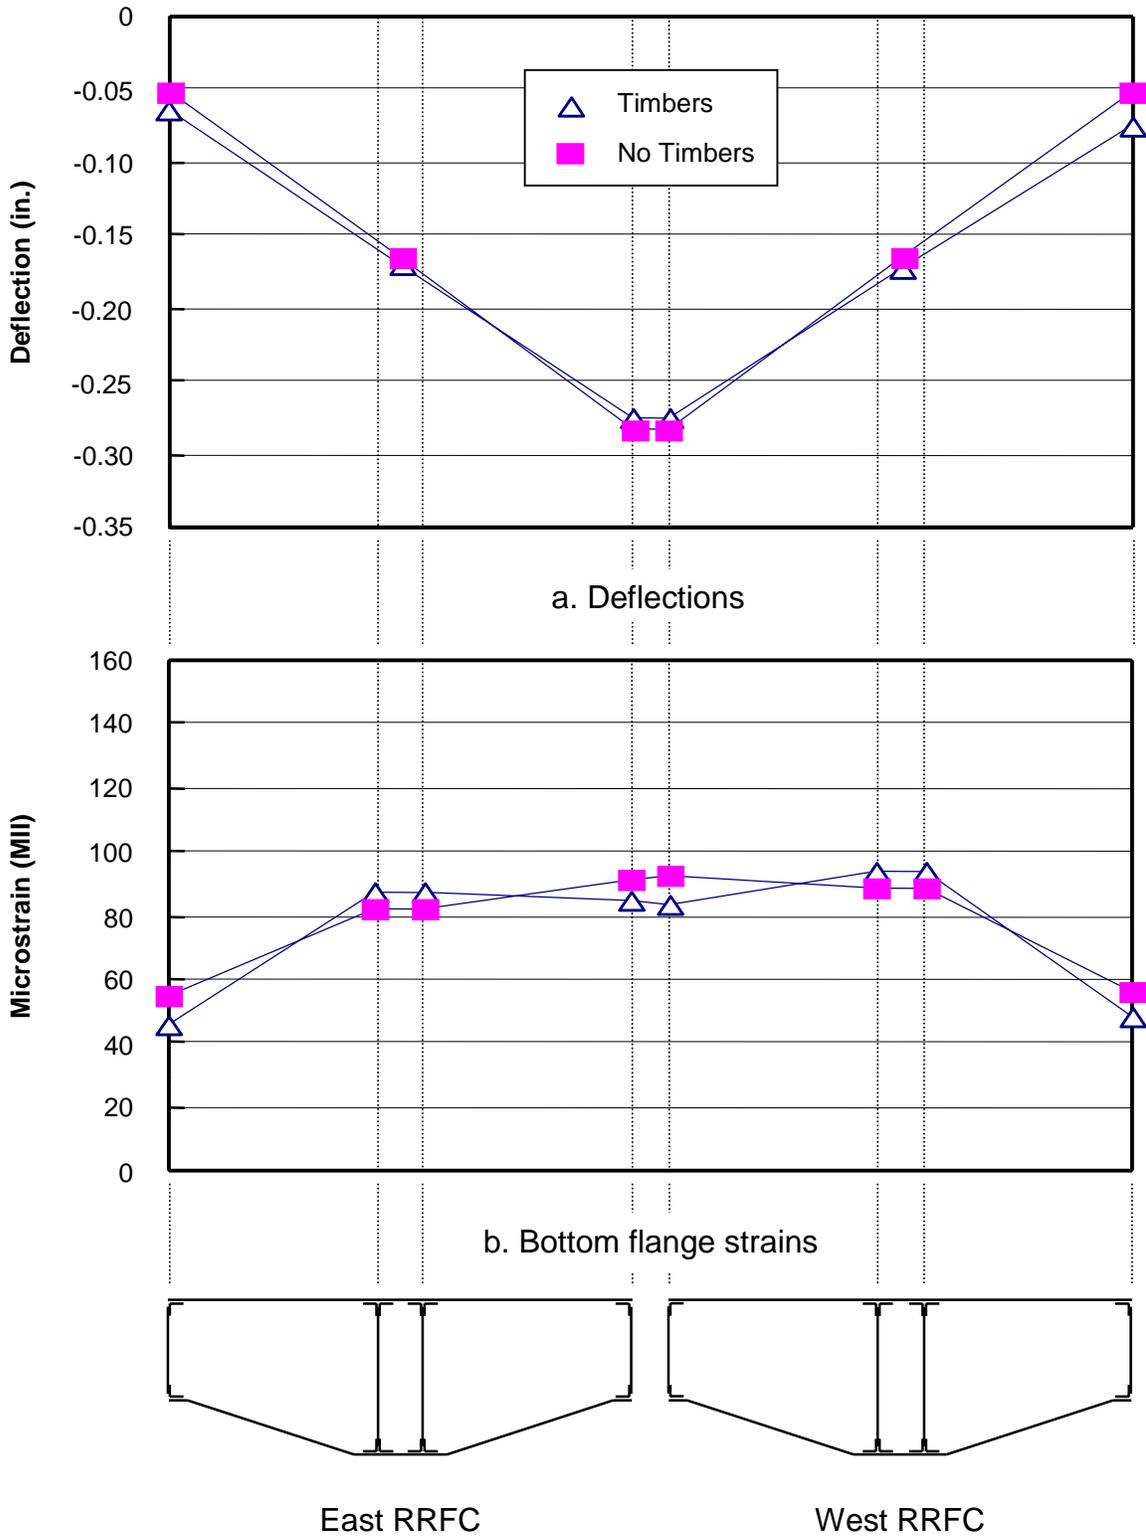
Figure 6.15. Analytical midspan deflections and strains for truck position B2 using two approaches to model the effect of the timber deck.

In addition to the nine truck positions that were used during the field test, analytical results were also determined for the case when only one RRFC supports the entire truck weight. From the questionnaire that was discussed in Chapter 2, many states reported the existence of RRFC bridges that consist of only one flatcar. For this analytical case, truck loads were applied to one flatcar and all connections between the flatcars were removed. Loads were applied that

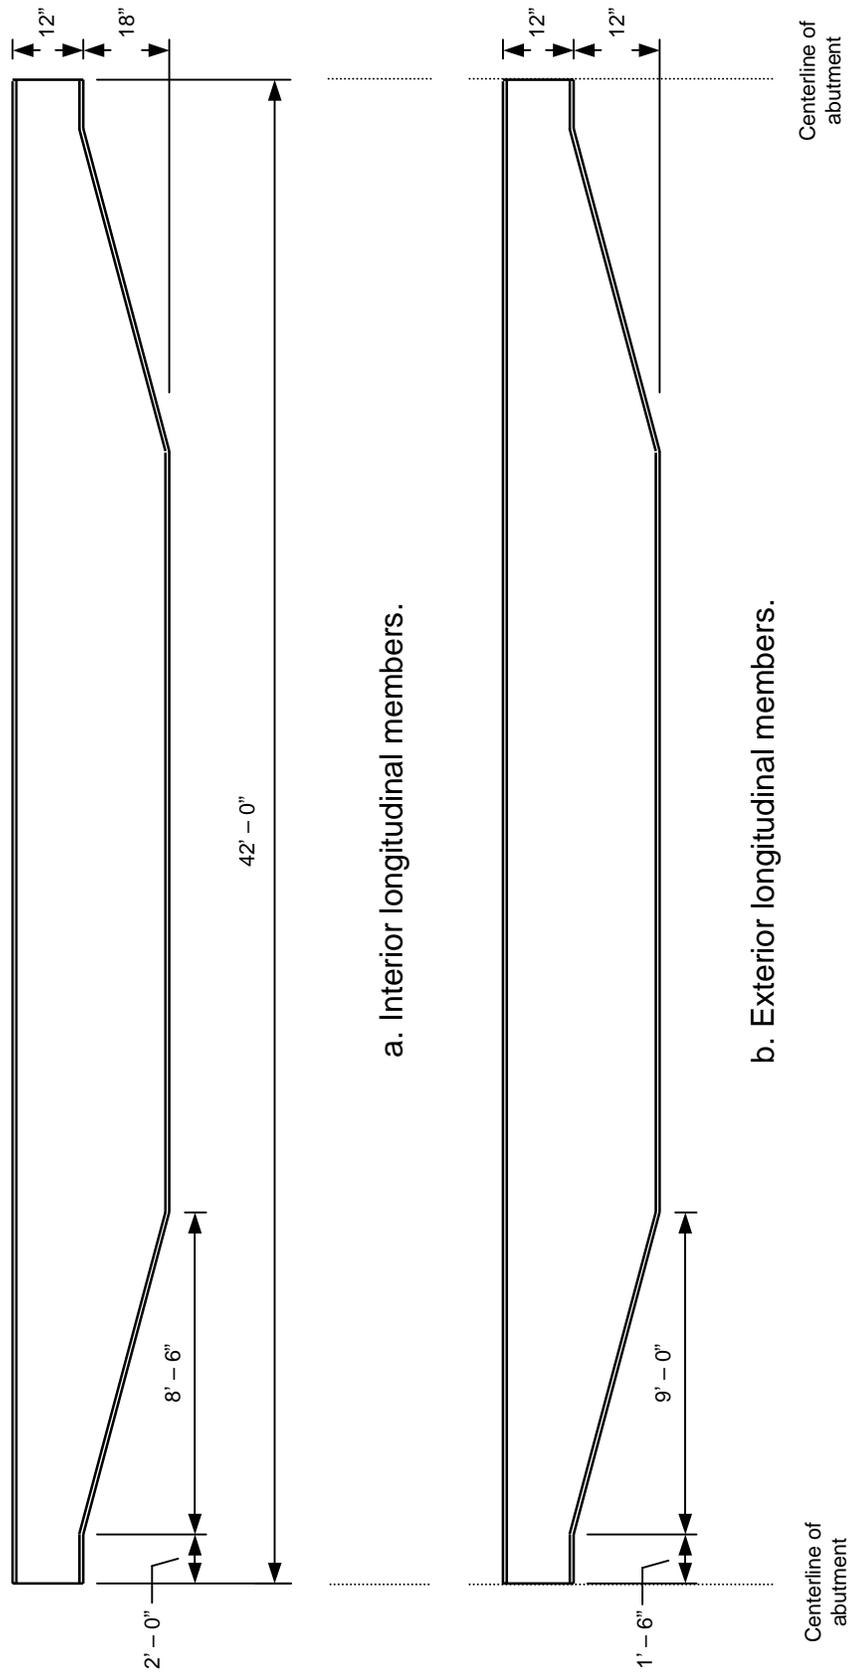
Figure B.1. Tapered regions in the longitudinal members of the Tama County flatcar.

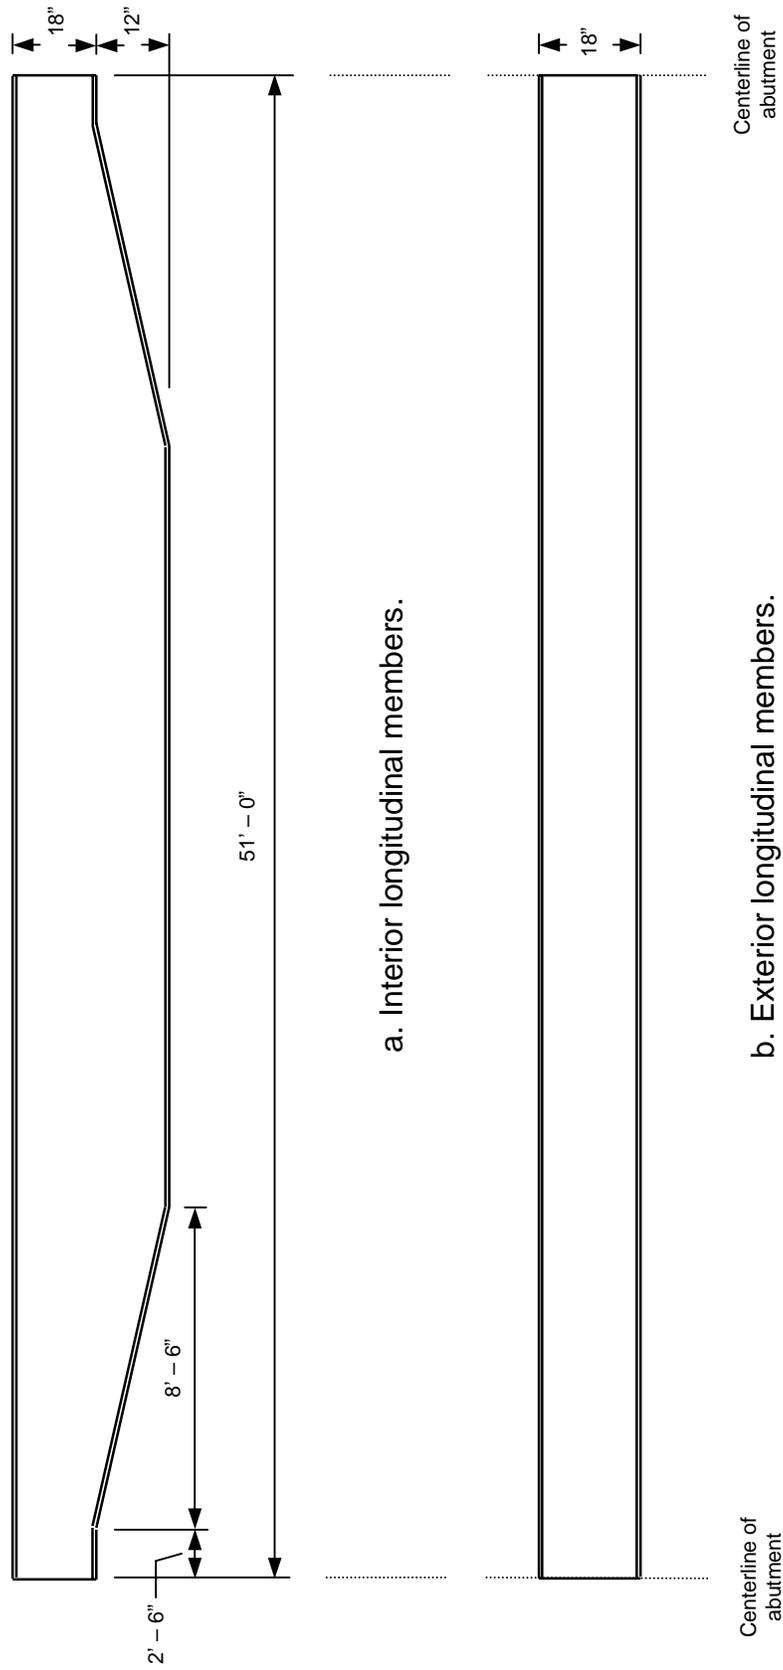
Figure B.2. Tapered regions in the longitudinal members of the Thrall flatcar.

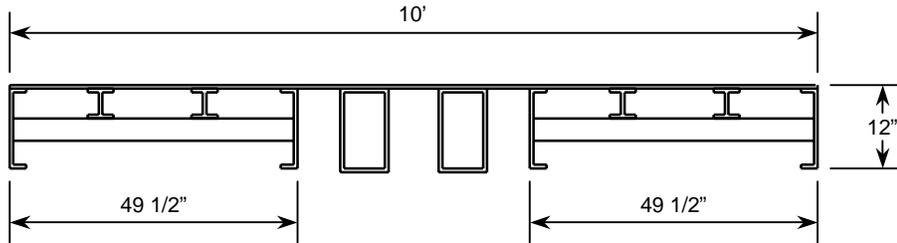
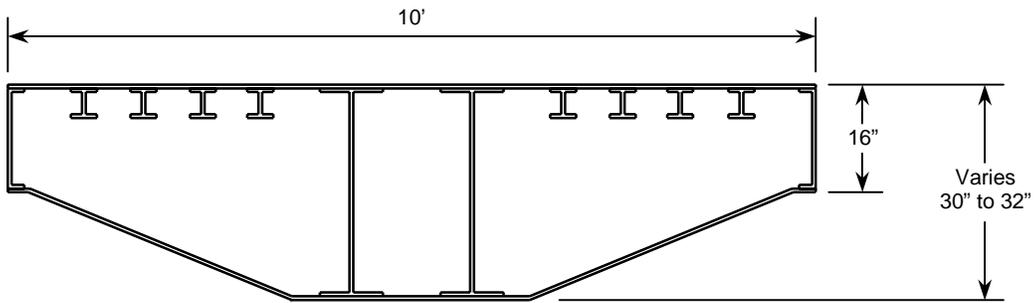
a. Cross-section 1

b. Cross-section 2

Figure E.1. Typical cross-sections found in Oklahoma RRFC
