Use of Railroad Flat Cars for Low-Volume Road Bridges

Sponsored by the
Iowa Department of Transportation
Project Development Division and the
Iowa Highway Research Board

Iowa DOT Project TR-421

REPORT

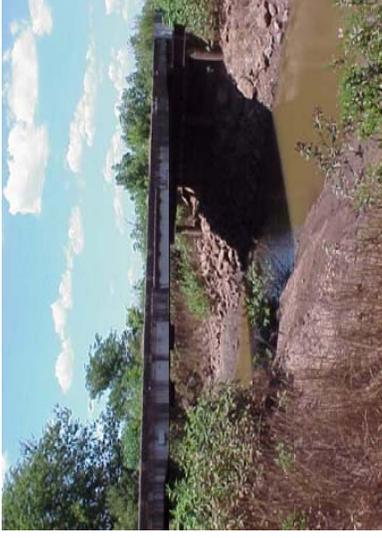
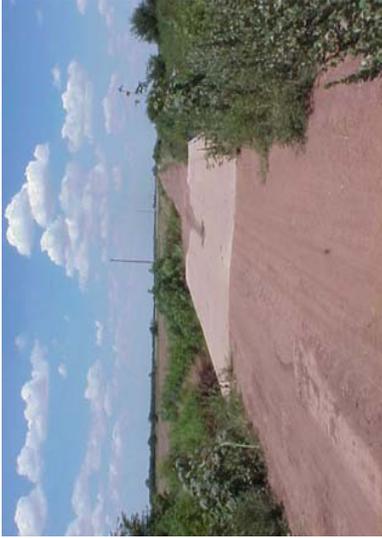
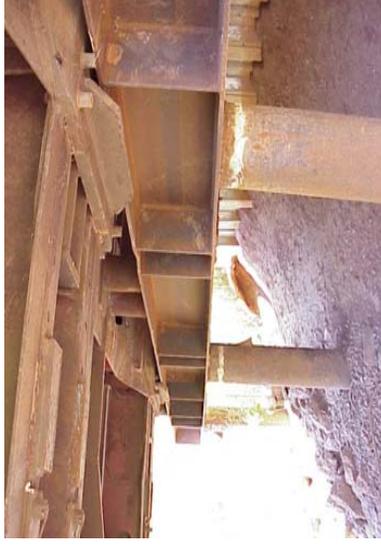
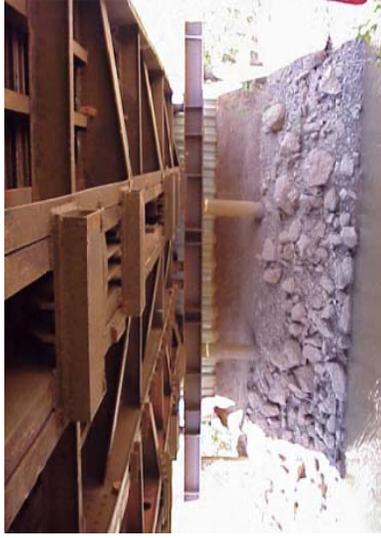
Figure E.2. RRFC Bridge 1: Concrete deck bridge in Grant County, Oklahoma

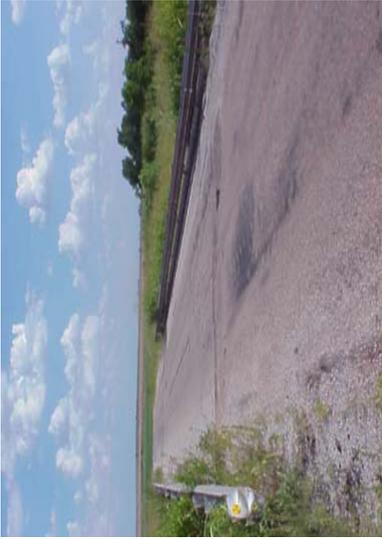
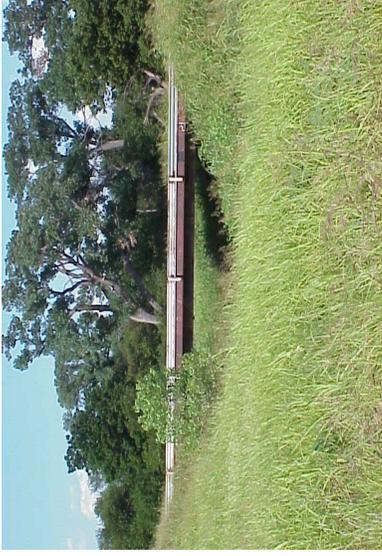
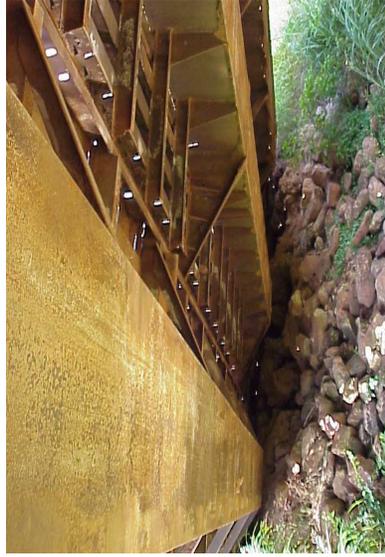
Figure E.3. RRFC Bridge 2: Asphalt surface deck bridge in Grant County, Oklahoma
