Interim Guide for Optimum **JOINT PERFORMANCE** of Concrete Pavements

1. Report No.	2. Government Accession No.	3. Recipient's Catalog No.	
4. Title and Subtitle <i>Interim Guide for Optimum Joint Performance of Concrete Pavements</i>		5. Report Date September 2011

The purpose of this guide is to help practitioners understand how to optimize concrete pavement joint performance through the identification, mitigation, and prevention of joint deterioration.

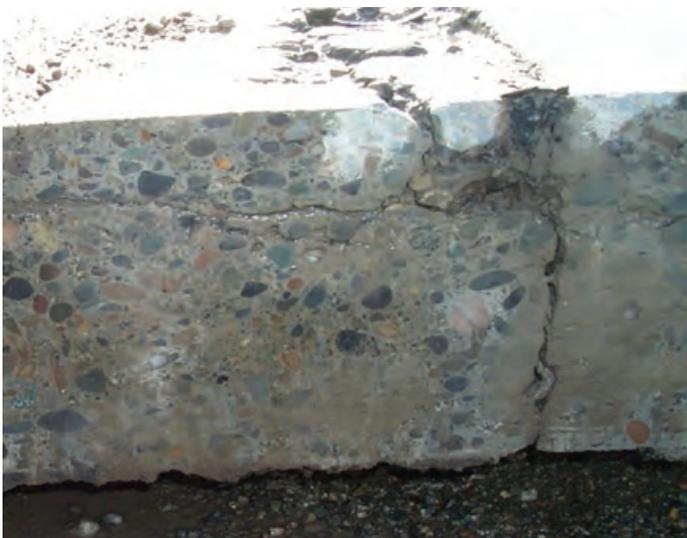
Figure 4. Example of delamination spalling (Source: Washington State)

One potential mechanism for joint deterioration begins with adverse conditions during concrete placement; the related joint damage may not become evident until years later. As reported by McCullough et al., drying from high evaporation rates during placement (1) results in large differences in moisture content through the depth of the concrete slab. Differences in slab moisture may lead to stresses that are high enough to cause fine horizontal cracks (delamination). In areas where these horizontal cracks intersect vertical cracks or joints, concrete material can break free, and “flat bottom” or delamination spalling can occur. The severity and timing of delamination spalling varies with the severity of moisture loss at an early age, along with traffic and climate factors. This process is illustrated in Figure 3 and the result is shown in Figure 4.

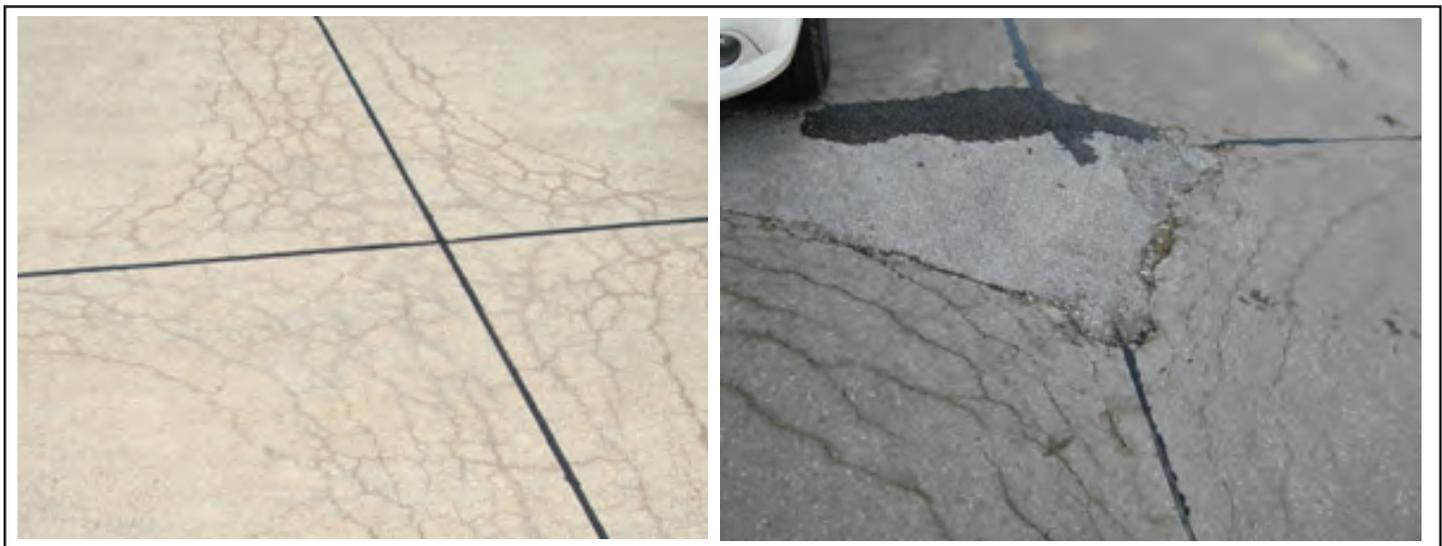
Figure 5. D cracking of low severity (left) and high severity (right) (Source: The Transtec Group)

D cracking is a type of joint deterioration caused by expansive freezing of water trapped inside some types of aggregate particles. The damage normally starts near joints and forms a characteristic crack pattern (Figure 5). The

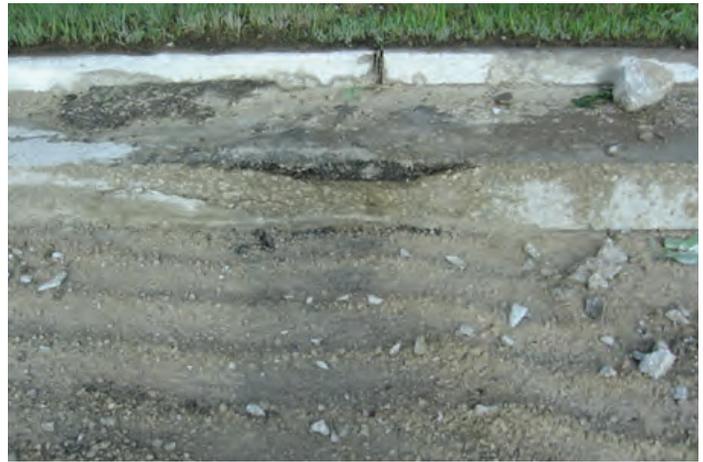
Figure 7. Typical saturated foundations under a shadowed section (Source: Snyder and Associates)

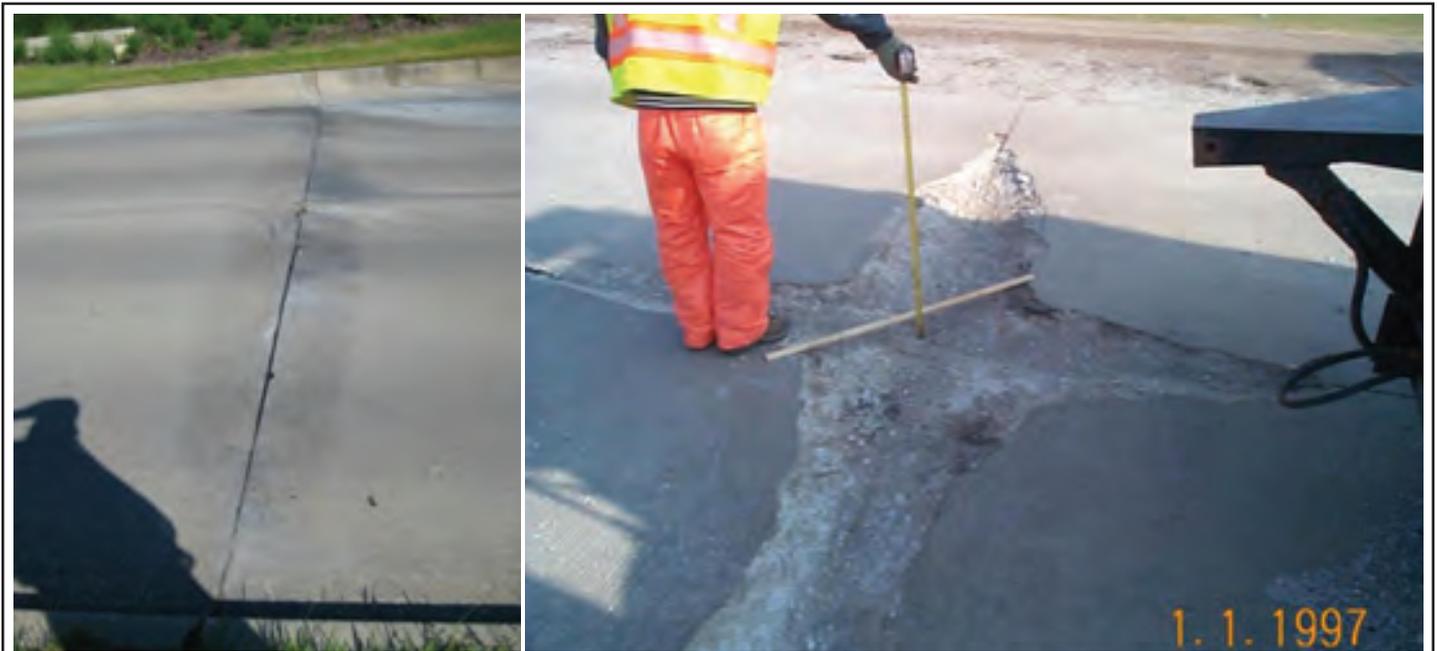
Figure 6. Evolution of joint deterioration from shadowing (left) to high severity (right)

Joint deterioration from frost damage is sometimes first observed as shadowing or darkening of a zone a few inches on either side of a joint. This effect is the result of a fine network of microcracks that develop near and parallel to the joint. The cracks trap water, which lead to the darker color. Over time, the concrete begins to crumble, and significant loss of material may occur. This evolution is shown in Figure 6.

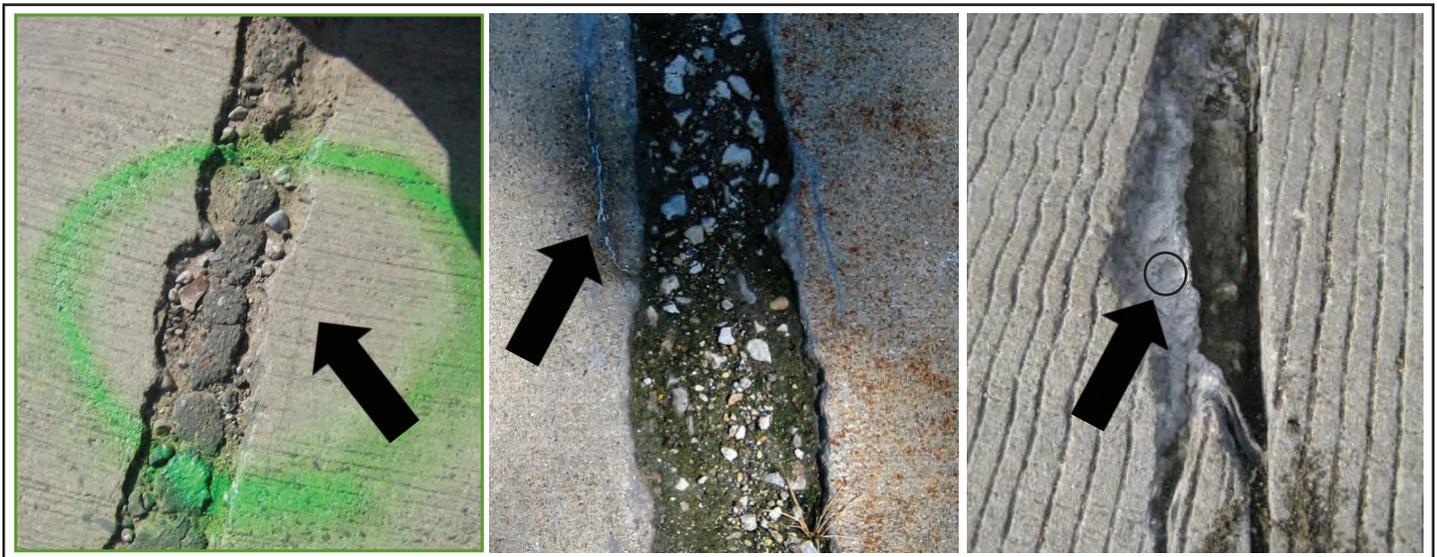
Figure 9. Typical incremental cracking: Note (left to right) the crack parallel to the already patched face, the signs of water passing through the crack, and the exposed aggregate remaining in the concrete

Joint deterioration due to frost action can also be seen as parallel cracks that form at approximately one-inch increments starting from the joint face (Figure 9). The concrete between the crack and the free face is normally sound, as is the remaining concrete next to the crack.

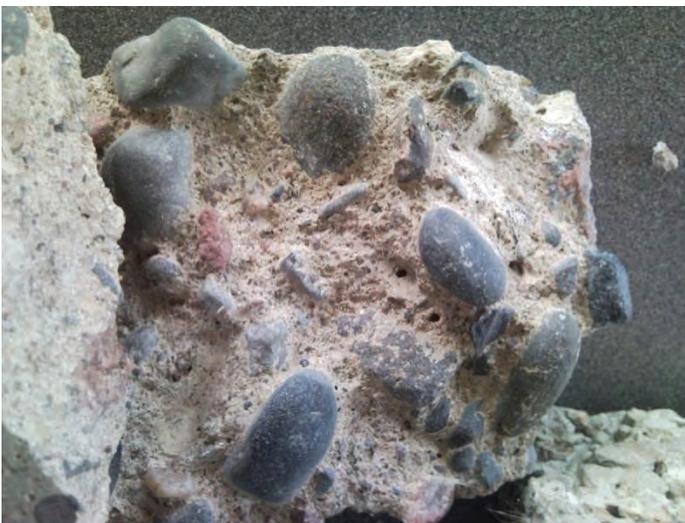
Figure 10. Coarse aggregate exposed by damage to the paste

The coarse aggregate still embedded in the concrete is often free of adhering mortar on the exposed face (Figure 10). This indicates a mechanism that is attacking the paste alone.

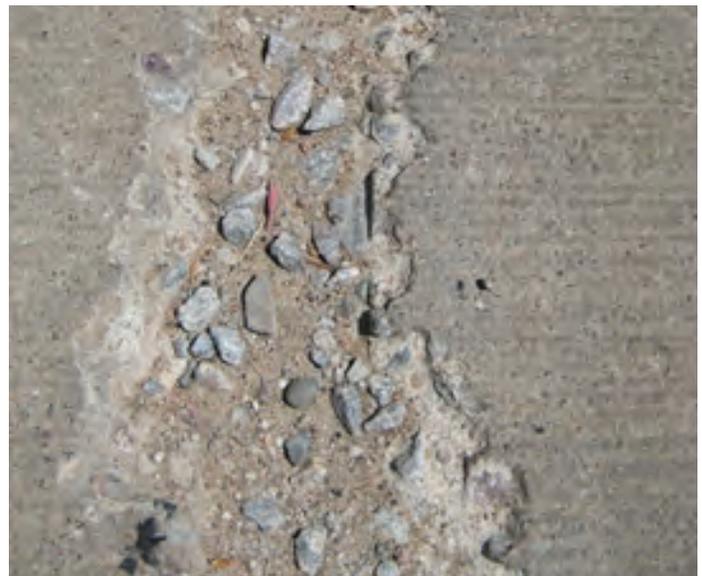
Figure 11. Shallow joint damage

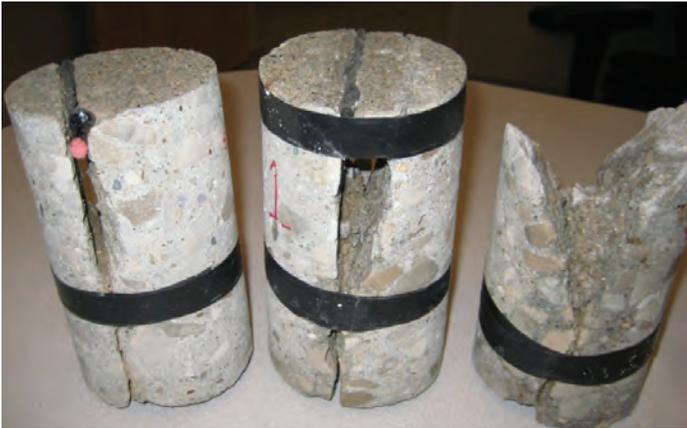
Figure 12. Three cores illustrating progression of distress from bottom-up moisture

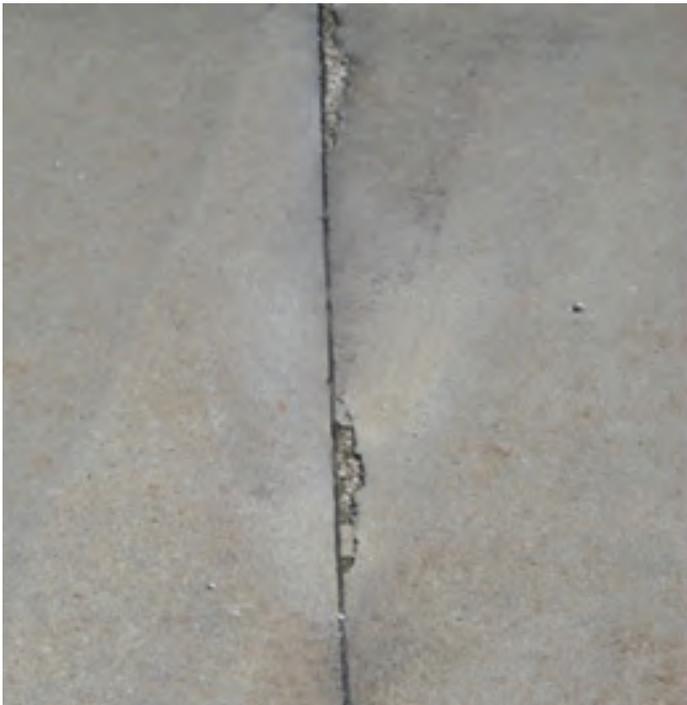
Figure 13. Water flow through joints from a high water table (bottom-up moisture); note staining on surface

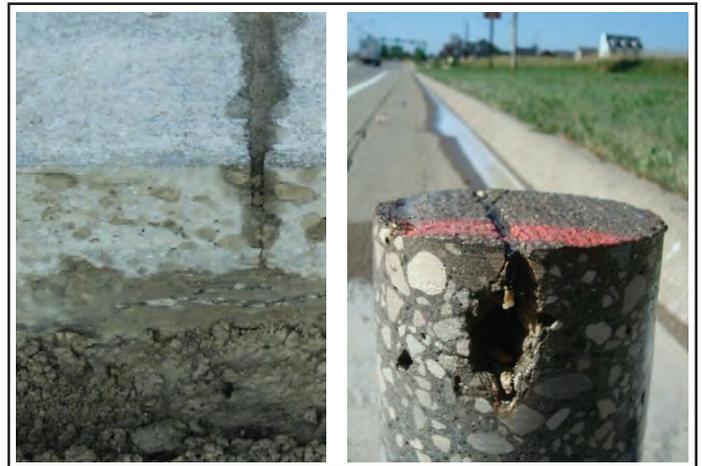
Figure 15. Saturated soils due to inadequate drainage and roadside irrigation (left) leading to joints showing frost damage (right) (Source [left]: Snyder and Associates)

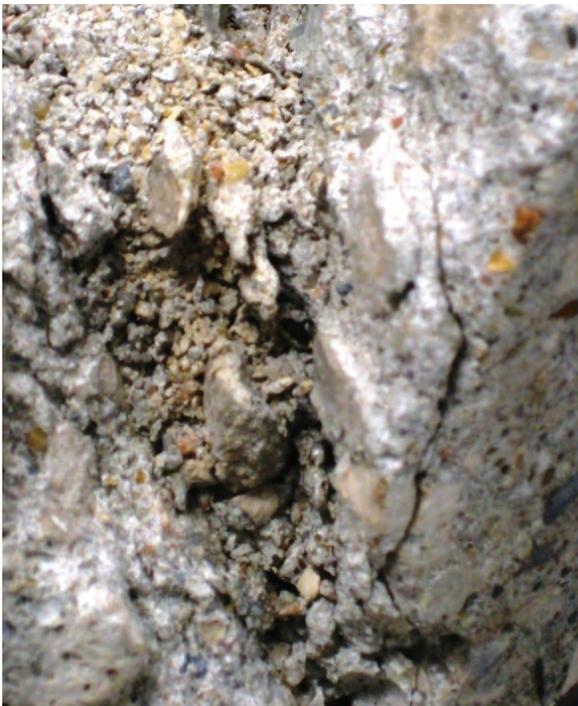
Figure 16. Typical slivers from freezing and thawing cycles

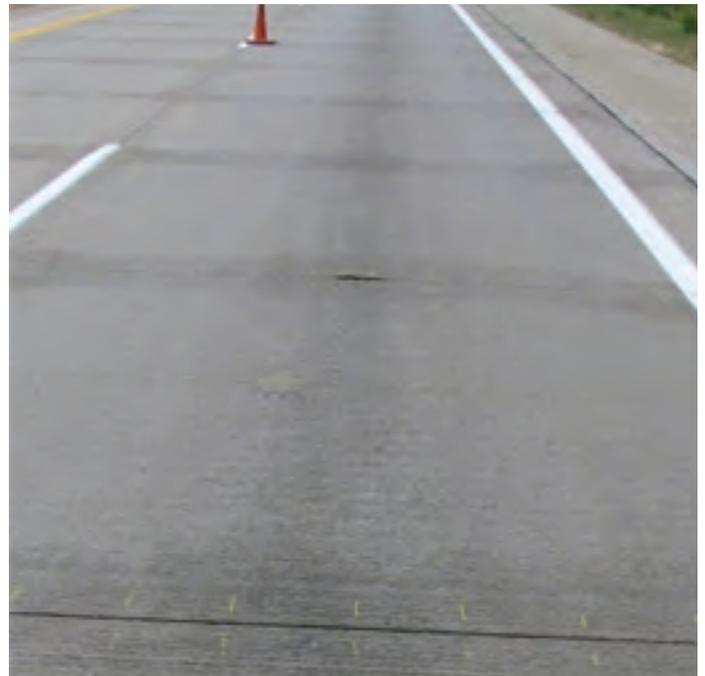
Figure 17. Shadowing at the joints, which is commonly followed by loss of material

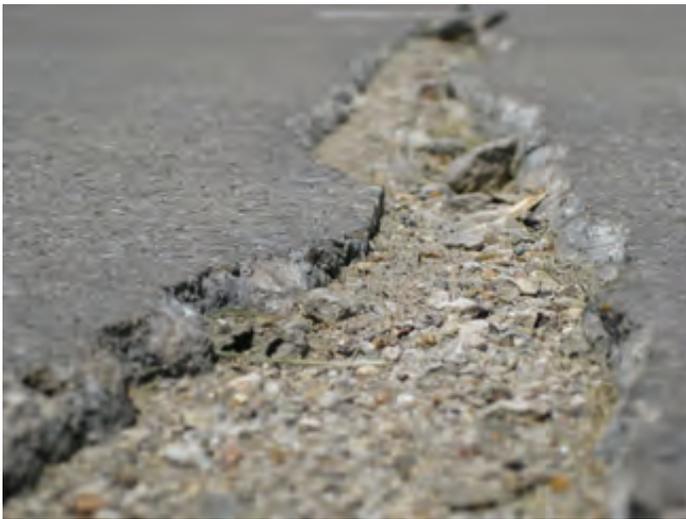
Figure 18. Top-down joint distress, with vertical edges and shallow depth

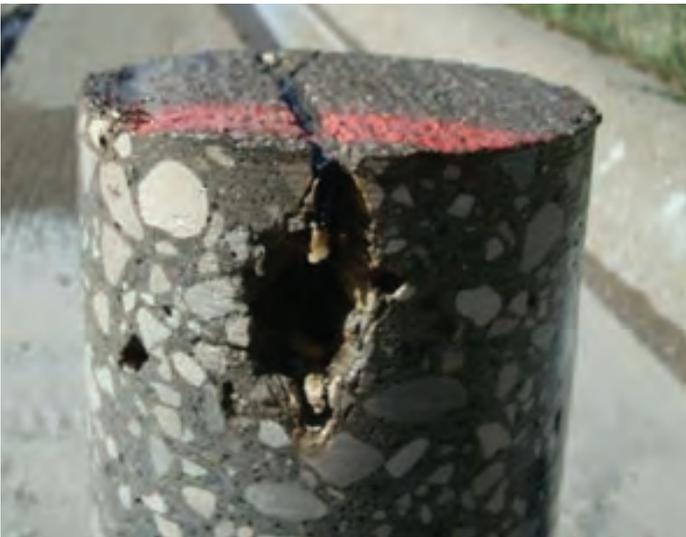
Figure 19 Joint deterioration evident below the joint sealant

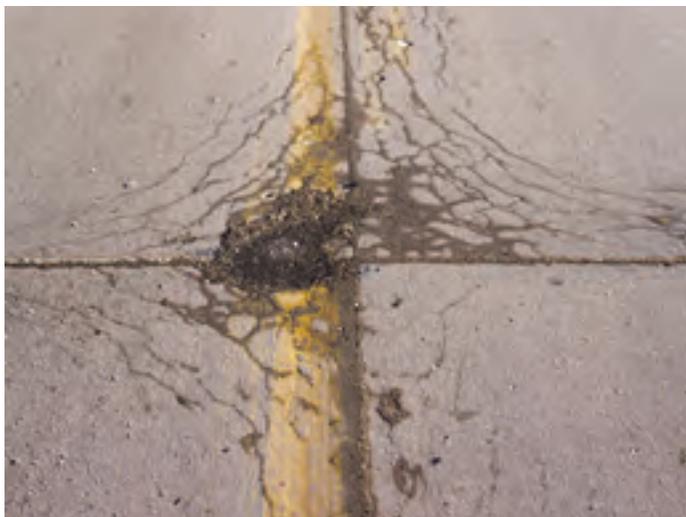
Figure 20. Deterioration due to D cracking

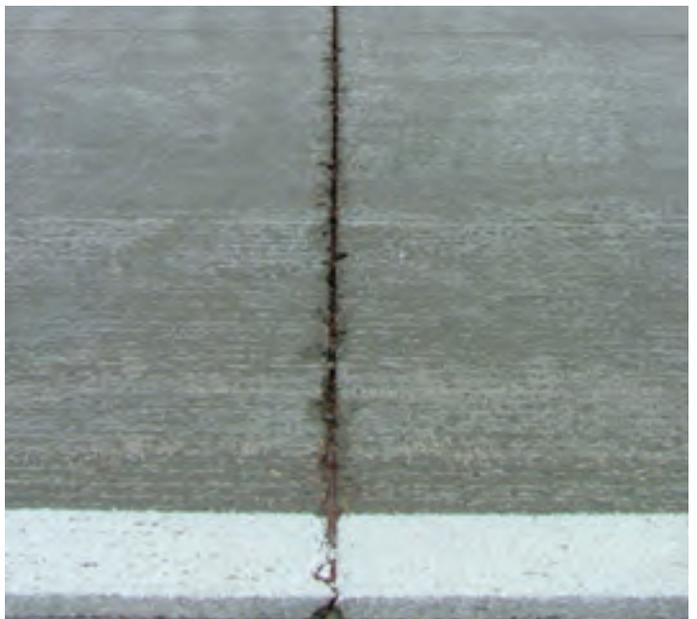
Figure 22. Joint deterioration due to raveling from improper saw-cut procedures

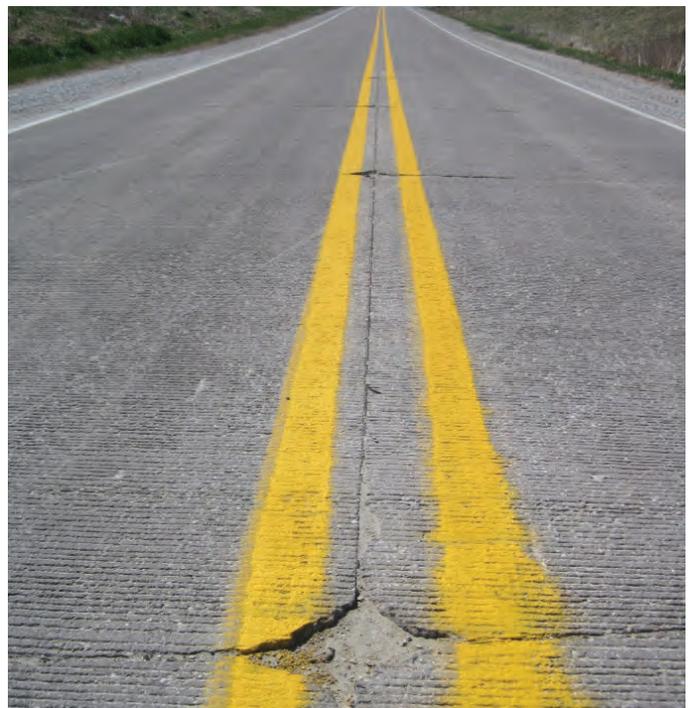
Figure 23. Damage starting at joint intersections

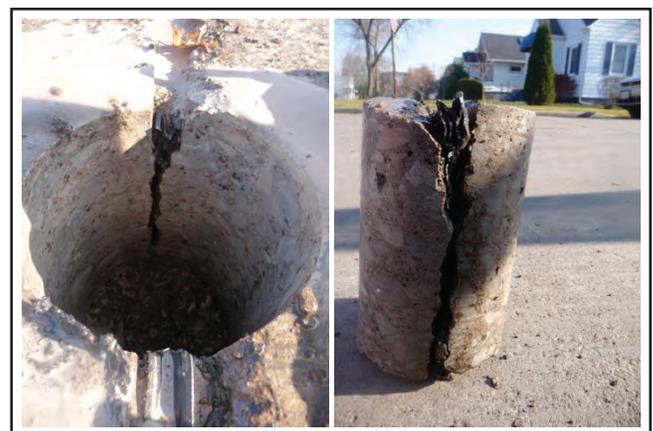
Figure 24. Coring at deteriorated joints to help identify causes of failure

Ideally, cores should be extracted from several locations:

- Over a distressed area of a joint.
- Over the same joint, but at the end of the distressed area in an attempt to identify damage early in its development.
- In the slab, a few inches from the joint, in order to characterize the concrete near the joint.
- At the center of the slab, to assess variability in the mixture and placement.
- From a nearby section that is not exhibiting distress in order to determine why one section is distressed and the other is not.

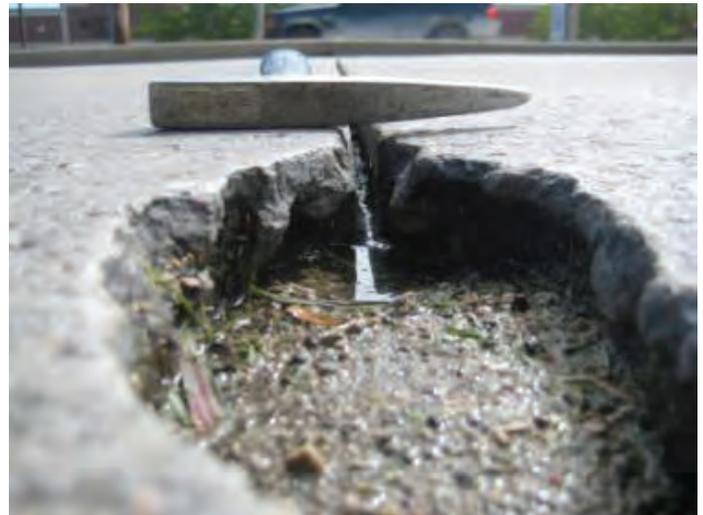
Figure 25. Example of a poorly draining pavement

- Provide stable and drainable base layers (evidence of the lack of this is shown in Figure 25). It should be noted that because the amount of water that penetrates

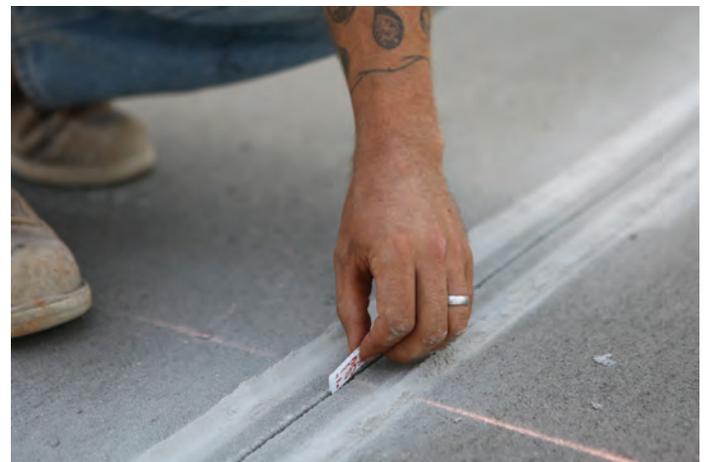
Figure 28. Using temporary joint spacers to protect and minimize damage due to early entry sawing (Source: Husqvarna)

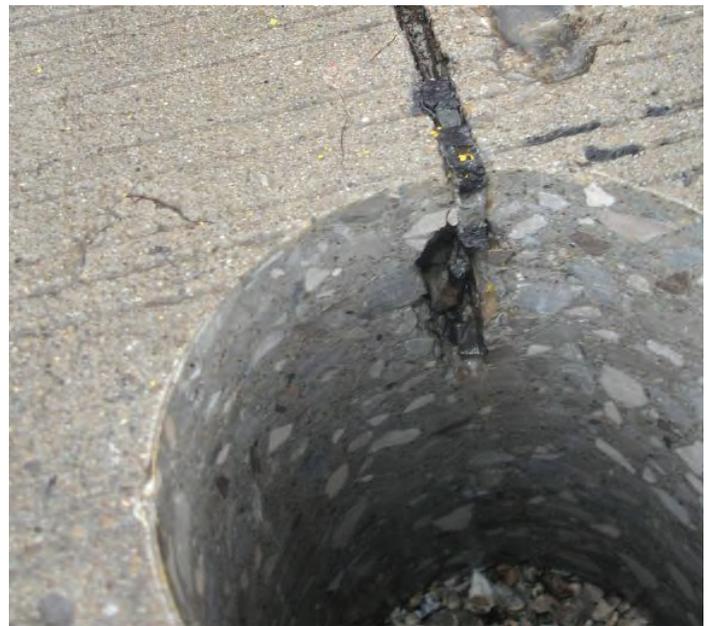
Figure 29. Evidence of saturation within joint beneath seal (Source: Purdue)

However, there have been numerous examples of pavements exhibiting premature joint deterioration where water has been trapped in the joint, particularly below a seal in a tight or uncracked joint, as illustrated in Figure 29.

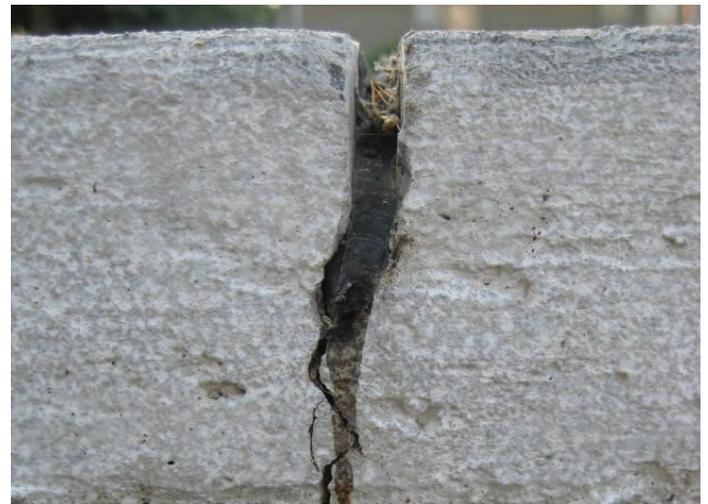
Figure 30. Joint filled with hot pour sealant (Source: The Transtec Group)

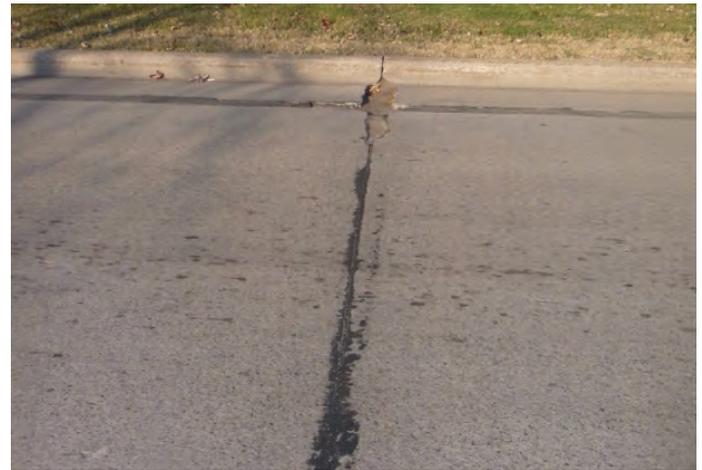
Figure 31. Failing transverse joint associated with poor drainage at gutter

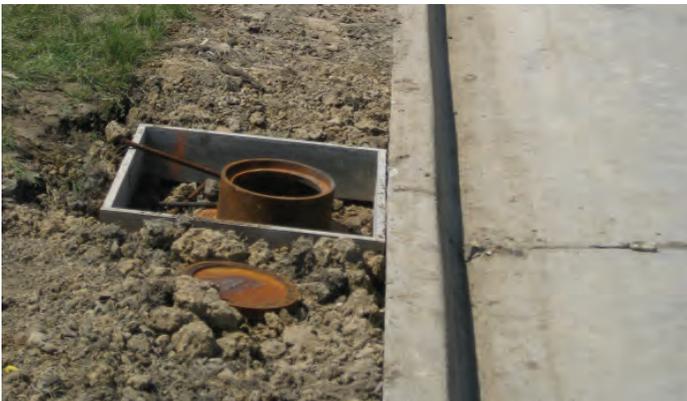
Figure 33. Subdrain retrofit operation including clean out (The Transtec Group)

groundwater tables. If a source of excess water is identified and cannot otherwise be mitigated, edge drain retrofit can be considered. A retrofit is shown in Figure 33. It should be noted that this process requires careful project evaluation, design, installation, and maintenance. The presence of existing utilities can be particularly problematic during the retrofit process. Retrofitting edge drains is not recommended for sections exhibiting severe joint deterioration. More guidance on this topic can be found in the *Concrete Pavement Preservation Workshop Reference Manual* (14).

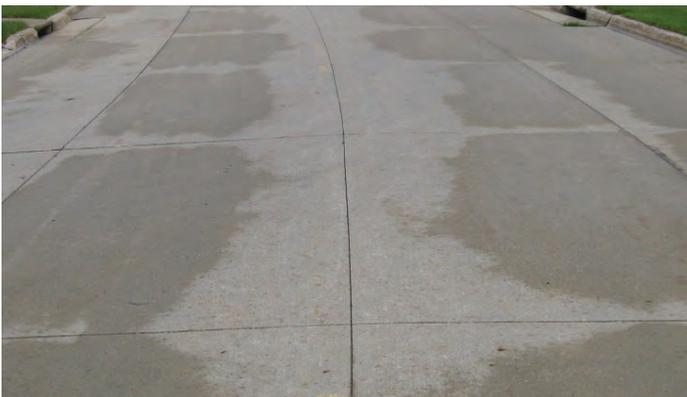
Figure 34. Example of effective drainage of unsealed joints

One technique to determine if there are drainage issues is to observe the pavement surface immediately after a rain event, noting whether the joints or the rest of the slab dries first. Figure 34 shows a pavement with unsealed joints after measurable rain. It can be observed that the water is effectively exiting the system and the joints are drying before the rest of the slab. This pavement is in good condition after 10 years in service.

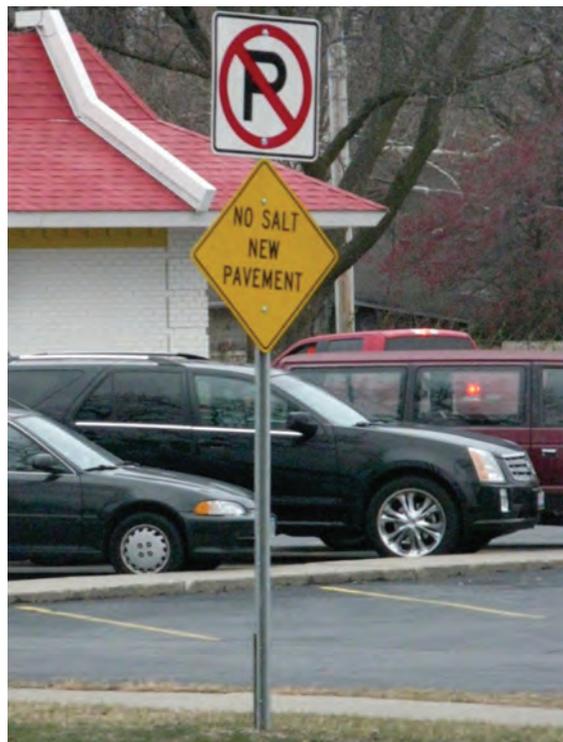
Figure 35. Signage to help avoid salting of new pavement

An additional recommendation from Transportation Pooled Fund TPF 5(042) (5) is to employ a minimum 30-day or one-winter “drying period” before applying deicing chemicals to new concrete (Figure 35).

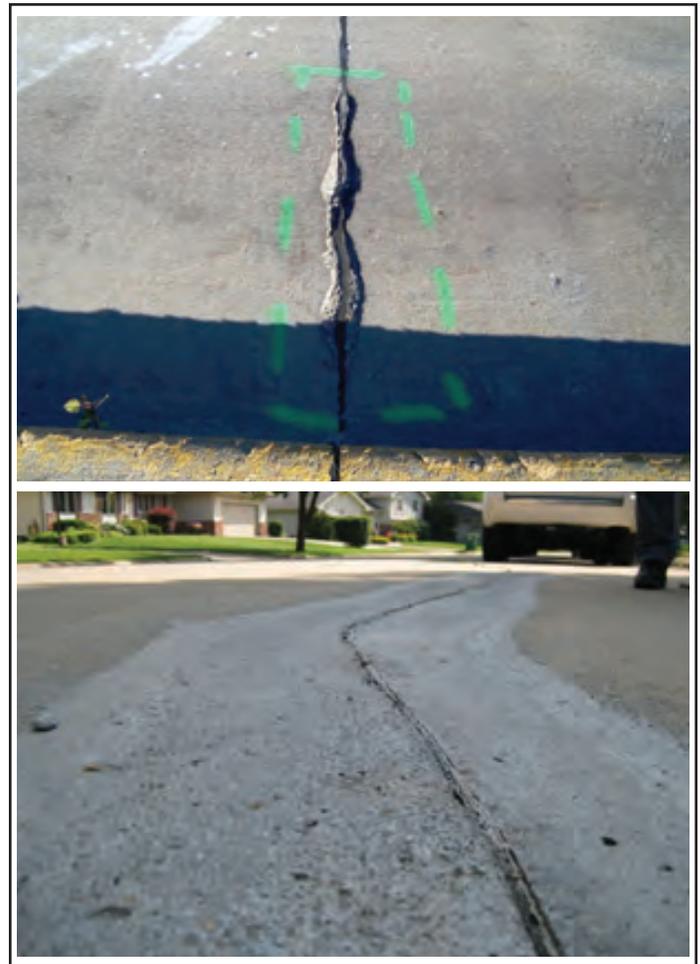
Figure 37. Delineation of spalled area for partial-depth repair (top) and a completed patch (bottom) (Source [bottom]: The Transtec Group)

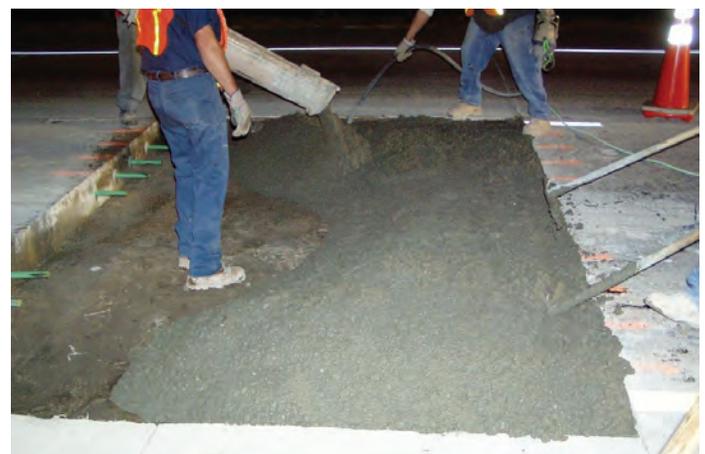
Figure 40. Full-depth patching
