Fifth Judicial District Department of Correctional Services

Facility and Site Study | Final Report
December 12, 2008

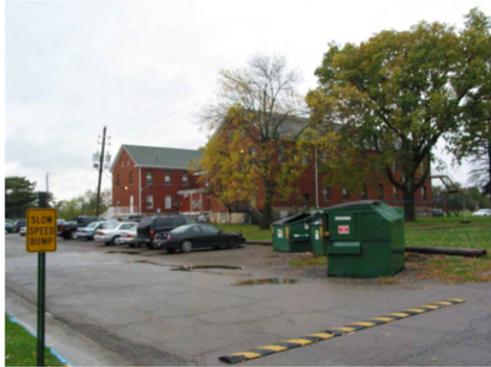
1

1. 65/66 viewed from SE.
2. 68/69/70 viewed from North.
3. Loading at 69.
4. Existing mechanical systems at 68/70.
5. Kitchen storage at 69.
6. Non code compliant railing at kitchen
7. Replacement windows at 65/66 are not historically correct.

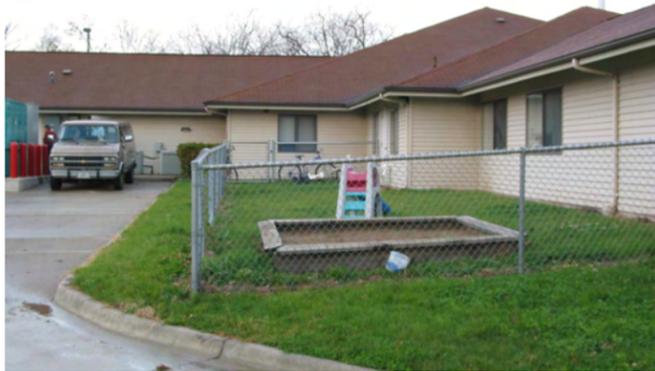
1

1. The existing structure is an economically constructed wood frame building.
2. Typical sleeping room in a 20 person wing.
3. The central administration area is well positioned and functional.
4. The facility is the only in Iowa that provides opportunity for mothers to be housed with children.
5. Dining area.
6. The systems include back-up power.

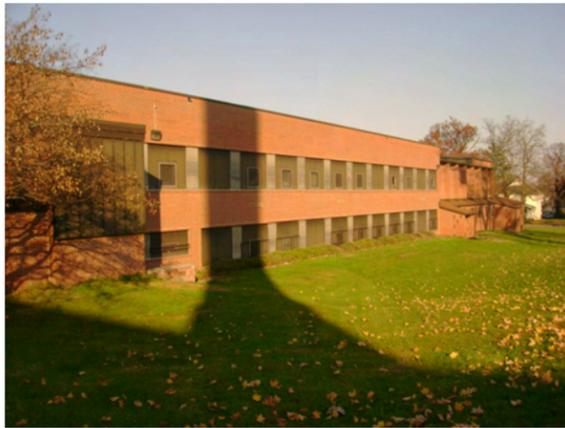
1

1. The facility has a professional appearance.
2. The interior spaces have had excellent care.
3. Existing roofs are near the end of useful life.
4. Existing air handlers are near the end of useful life.
5. The 1991 entry addition requires additional site work to allow for full accessibility.
6. Window replacement has left the building with limited daylight.

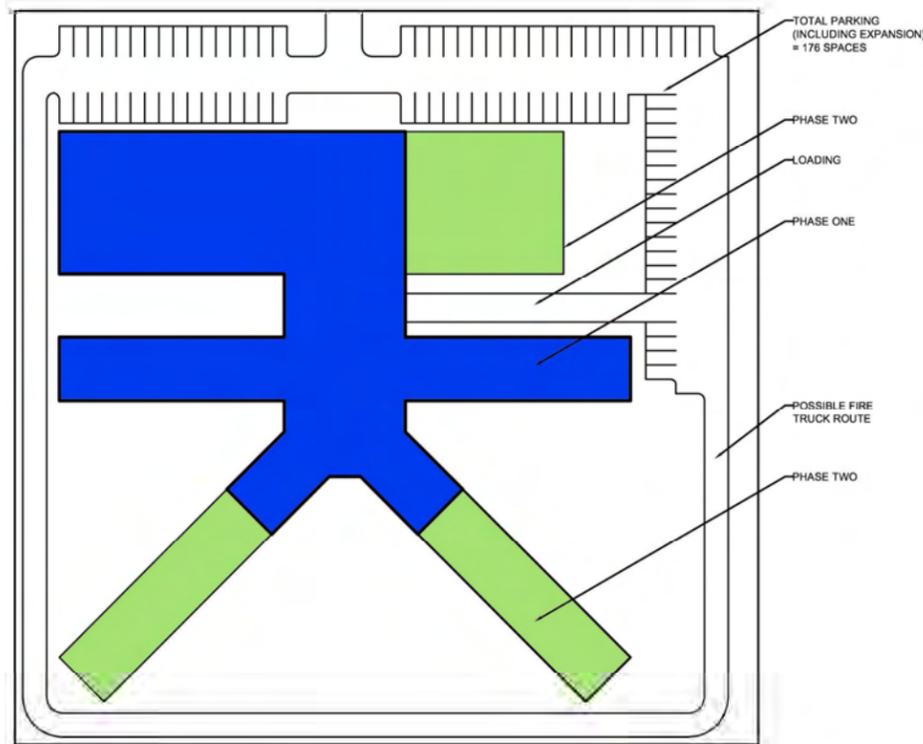
170 BED ROOMS - 2 STORY
5.00 ACRES
50% EXPANSION

Plans show the minimum site required for a one and two story configuration. The sites are estimated as square geometry. Other geometries will effect the economics of land use.

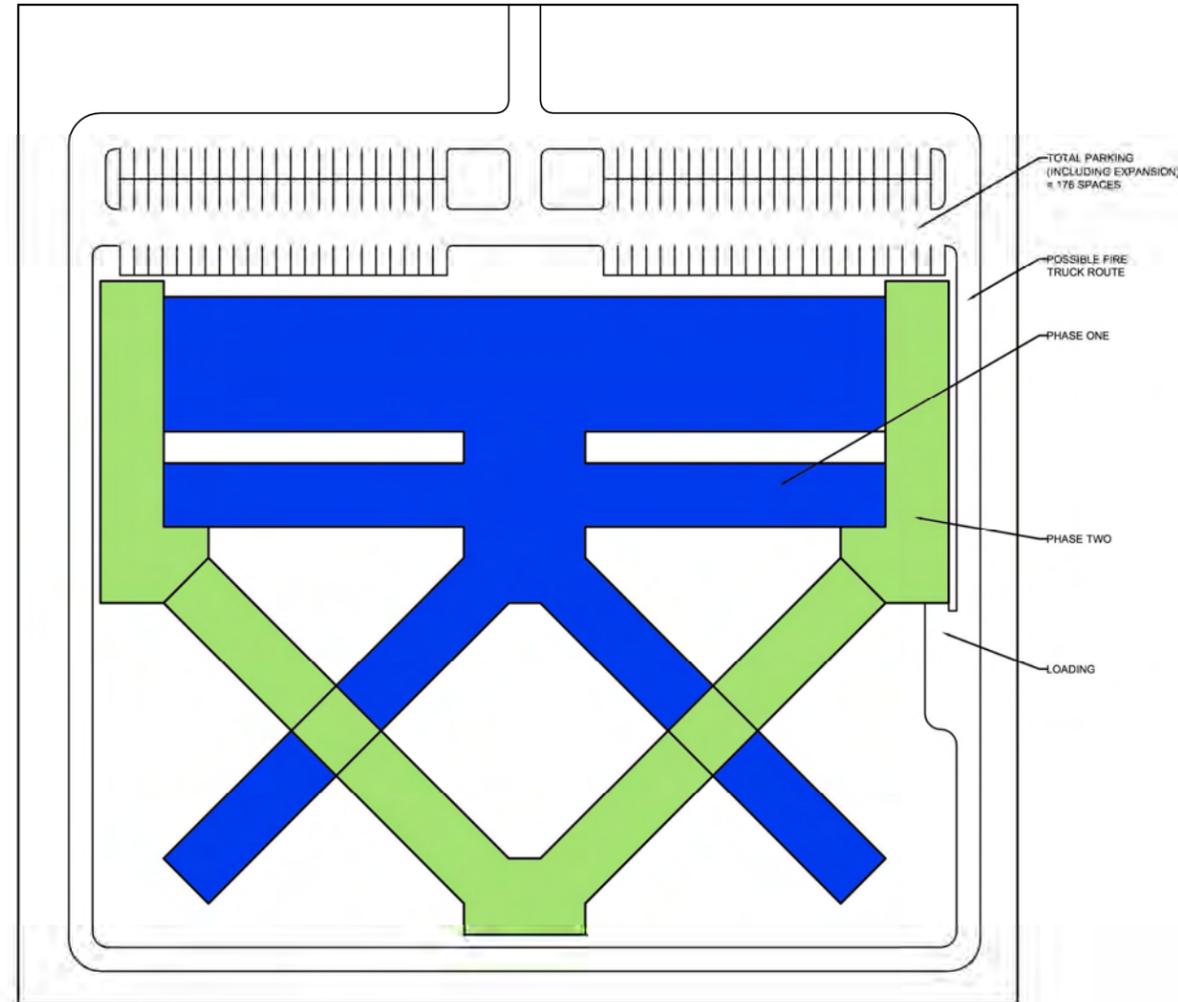
170 BED ROOMS - 1 STORY
7.15 ACRES
50% EXPANSION
