Precast Concrete Elements for Accelerated Bridge Construction

Volume 2. Laboratory Testing, Field Testing, and Evaluation of a Precast Concrete Bridge: Madison County Bridge

Final Report
January 2009

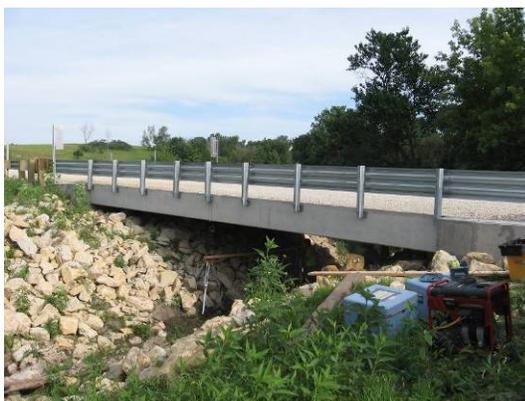
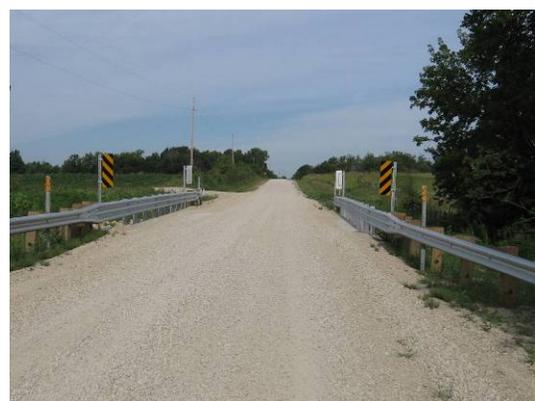
Figure 2.2. Photographs of Madison Co. precast bridge

a. elevation

b. end view

The subject bridge is located on a low volume road in the southern part of Madison Co., Iowa, as shown in Figure 2.1. Elevation and end view photographs of the completed bridge are shown in Figure 2.2. The bridge is a single span precast box girder bridge with a span length of 46 ft-8 in. from center-to-center of support, as illustrated in Figure 2.3. The bridge has an out-to-out deck width of 24 ft-1 in. and an out-to-out length of 47 ft-10 in. A crushed rock wearing surface is present on the bridge.

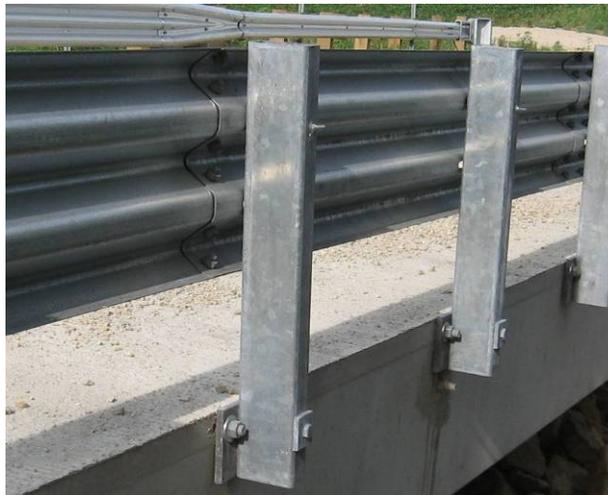
Figure 2.4. Photograph of bridge guardrail system

The bridge guardrail consists of the galvanized steel post and three beam extending the full length of the bridge shown in Figure 2.4. The guardrail posts are bolted to the exposed face of each exterior girder with two 1 in. diameter embedded bolts. No curbs are present on the bridge.

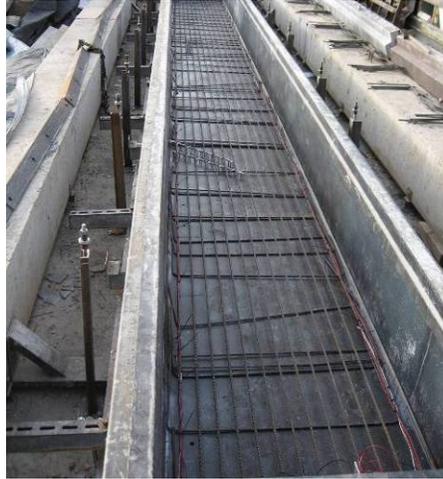
Figure 2.7. Photograph of box girder form with bottom pretension strands

For convenience, two box girders were cast at a time and occurred in one prestressing bed, with bulkheads separating the two girders. Thirteen prestressing strands can be seen in the bottom of the form in Figure 2.7. Strands were run the entire length of the form for both girders and stressed to a total initial force of 390 kips.

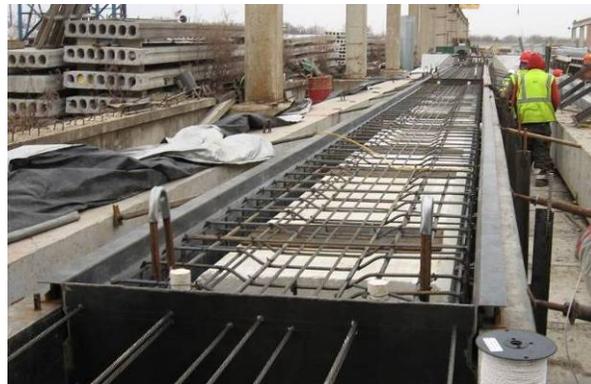
Figure 2.8. Photograph of top of beam reinforcing and foam core

Figure 2.8 shows the top reinforcing steel and the foam block used to form the girder core. The foam core formed the hollow box shape within the girder without having a significant impact on the box girder properties. Also seen in the figure are steel plates placed across the foam core. These plates provided ballast to keep the foam from rising during concrete placement.

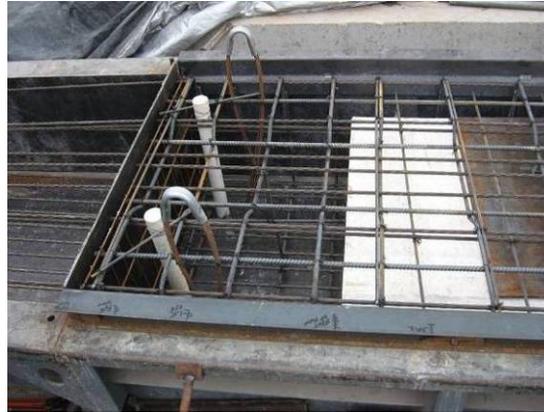
Figure 2.9. Photograph of end reinforcing and lift points

Two lifting loops were cast into the ends of each girder and are shown in Figure 2.9. The lifting loops consisted of two 1/2 in. 270 ksi strands placed 1 ft-3 in. from the girder ends. The lifting loops were to be cut off at or slightly below the girder surface once the girders were set in place at the bridge site. Also seen in Figure 2.9 is the end reinforcing steel and the termination of the foam core at approximately 2 ft-6 in. from the girder end.

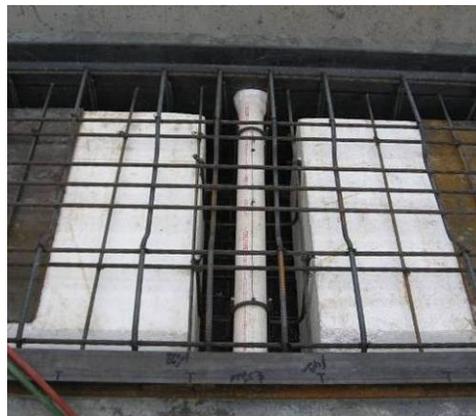
Figure 2.10. Photograph of midspan transverse tie duct

The midspan transverse tie duct is shown in Figure 2.10. A duct with an inside diameter equal to 3 in. was used. The duct provided a space for the 1 in. diameter threaded rods used for lateral post-tensioning of all box girders.

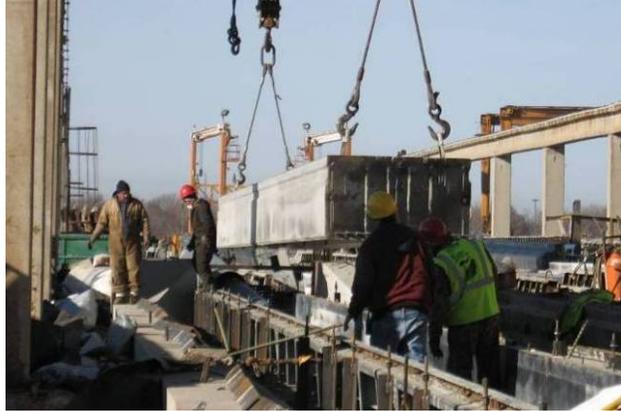
Figure 2.11. Photograph of crew lifting girder out of forms

The box girders were cured for 18 hours prior to releasing the prestressing force. The concrete was to have a compressive strength equal to at least 3,587 psi at release. Heat was provided at the ends of the formwork and blown along the length of the girders during curing. The relative humidity during curing was specified to be 75%. A girder being removed from the forms after curing is shown in Figure 2.11.

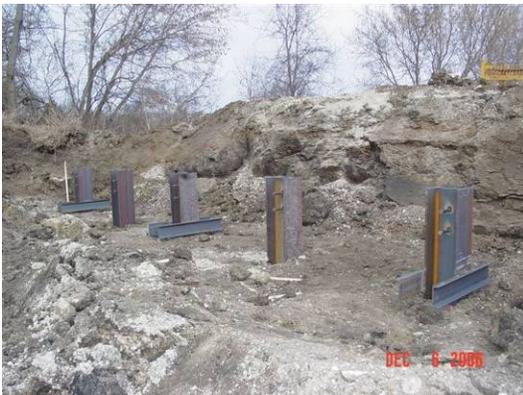
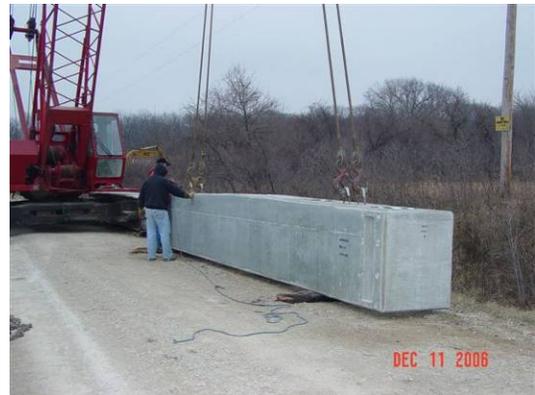
Figure 2.12. Photographs of precast pile cap beam installation

a. finished installation of steel piles

b. lifting of precast abutment cap

The research team was not present during the construction of the precast abutment cap beam. However, the contractor stated the placement of cap beam went relatively quickly and no major problems were encountered. The contractor did state when driving the piles that close attention must be paid to the location and tolerances of the pile head. Pile heads could not deviate from the specified plan locations more than 3” in any direction in order to allow easy installation of the precast beam. **Figure 2.13** displays some of the steps required to install the precast pile cap beam.

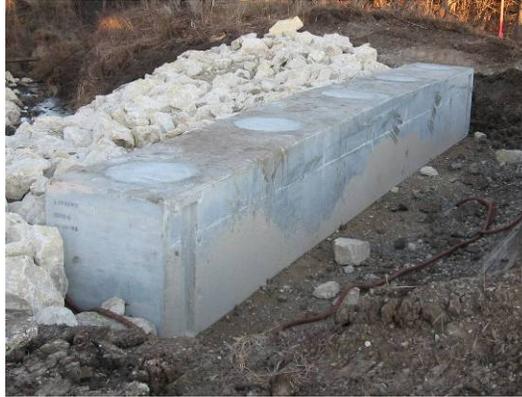
Figure 2.13. Photographs of precast pile cap beam installation

c. finished precast abutment

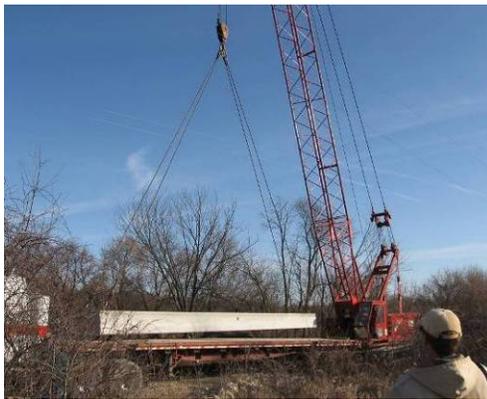
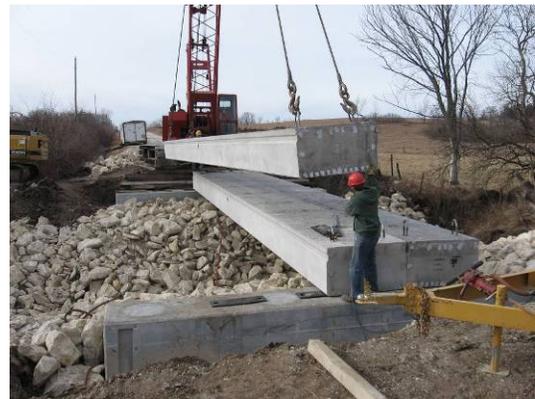
Figure 2.14. Photographs of box girder placement sequence

a. delivery of box girder to site

b. moving box girder into place

Figure 2.15 shows some of the processes involved in erecting the box girders. The girders were delivered individually to the site on a flatbed trailer. Fifteen to twenty minutes were spent unloading and placing each girder. The longest process during erection was eliminating any difference in elevation at the joints of adjacent girders by adding neoprene pad shims between the girder and cap beam. After each successive girder was placed, the transverse tie rod was thread through the girder. When the placement of all the girders was complete the tie rod was hand tightened to apply a transverse post-tensioning force to the girders. The girders were secured to the abutments by two vertical dowel bars that were drilled and placed in the abutment cap beam. Erection completed with the grouting of the longitudinal keyways, dowel bars connections, and transverse tie rod duct.

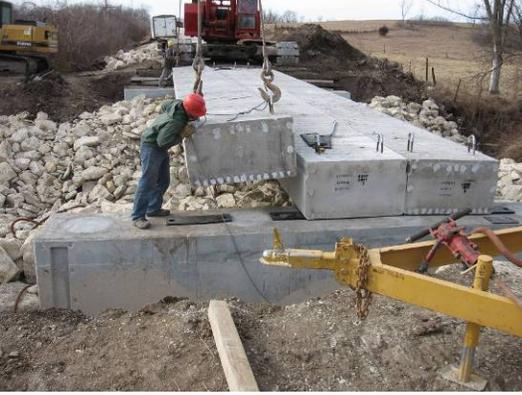
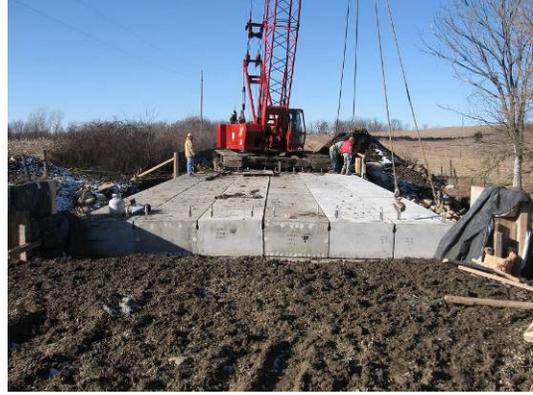
Figure 2.15. Photographs of box girder placement sequence

c. placing girder into final position

d. box girders in final position

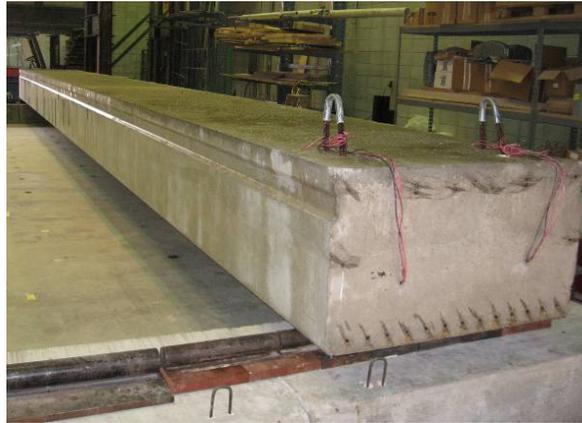
Figure 3.1. Photograph of a precast box girder used for laboratory testing

Laboratory testing conducted during this work included concrete material testing, testing to determine the influence of transverse post-tensioning, flexural capacity testing, shear capacity testing, and guardrail connection strength testing. One of the two precast box girders used for this testing sequence is shown in Figure 3.1.

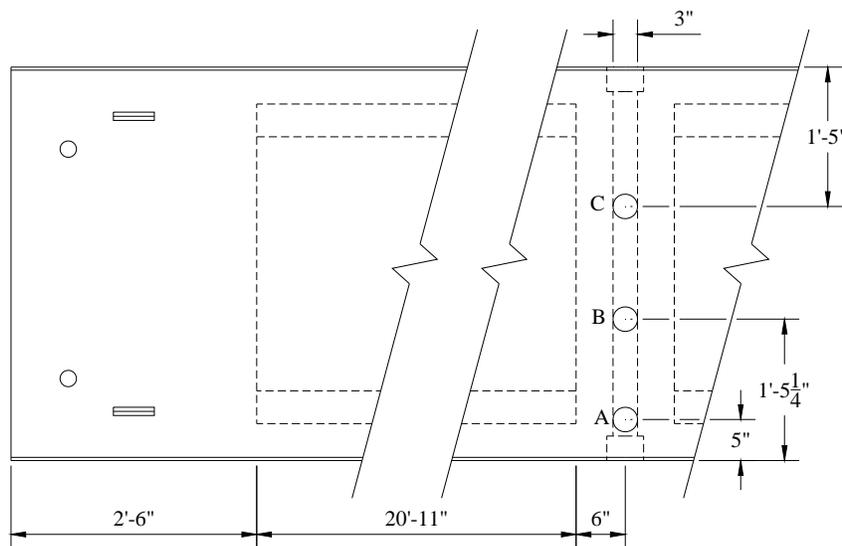
Figure 3.2. Box girder concrete core locations

Three concrete cores were obtained to determine the concrete compressive strength of the box girders. Cores were taken once all subsequently described tests were completed. Locations of the cores are shown in Figure 3.2 (labeled as “A”, “B”, and “C”). All cores were taken from the midspan of the girder at locations above the post-tensioning duct. This location allowed a specimen of the appropriate length to be obtained and easily removed after coring.

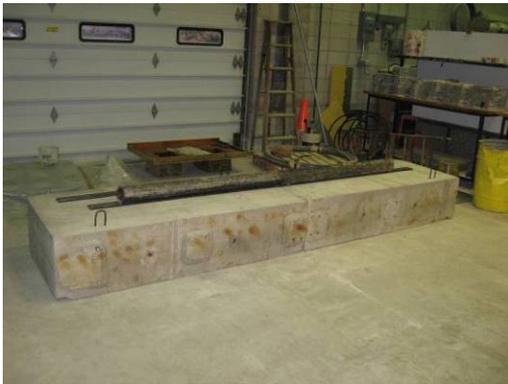
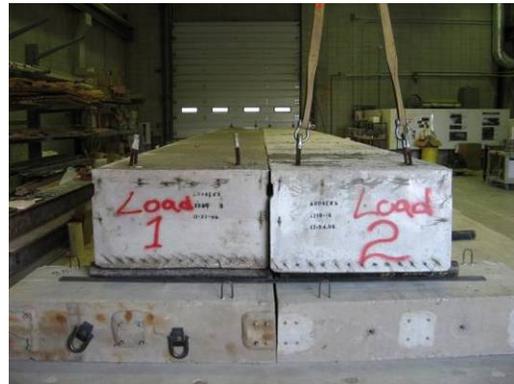
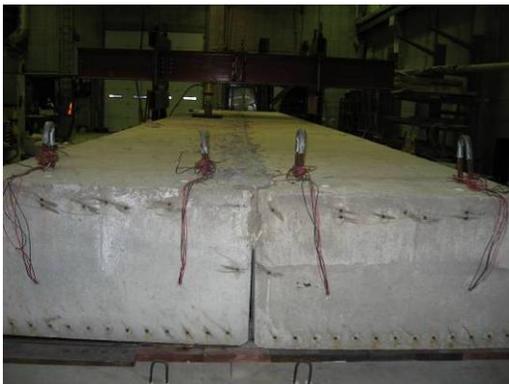
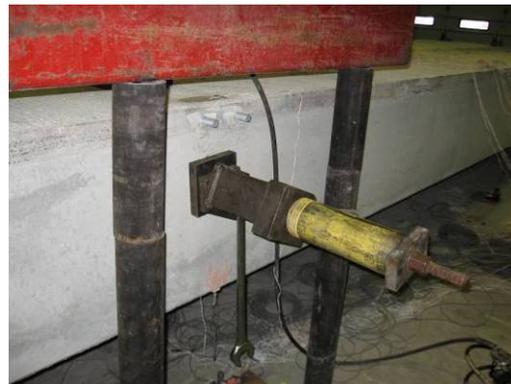
Figure 3.3. Photographs of laboratory setup for variable post-tensioning force tests

The objective of the variable post-tensioning force test was to determine the amount of post-tensioning force required to reduce or eliminate differential displacement between adjacent box girders and to improve the lateral load transfer between adjacent girders. Figure 3.3 illustrates the setup for this testing. First, abutments allowing sufficient space for deflection transducers below the girders were positioned to provide the desired span length. Once the abutments were set, pin and roller connections were placed. Two box girders were then positioned as shown in Figure 3.3b. Next, a shear key was cast. In this case Five Star Grout was used for the shear key. After allowing the shear key adequate time to cure and obtain a constant compressive strength equal to 7900 psi, the post-tensioning force was applied at midspan.

a. abutment and roller placement

b. placement of girders on supports

c. girders with the shear key cast.

d. post-tensioning bar and jack

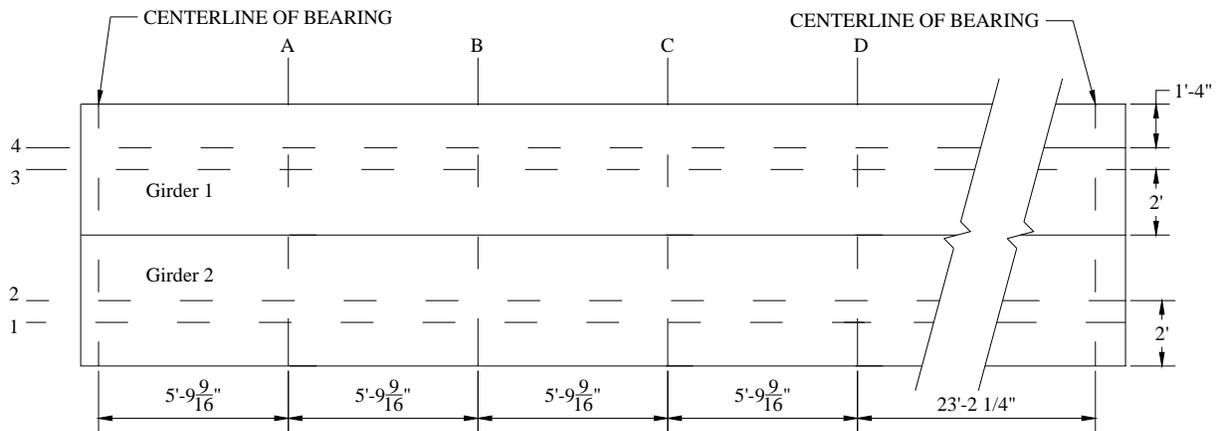
Figure 3.4. Variable post-tensioning loading locations

Point loads were applied at 1/8, 1/4, 3/8, and 1/2 the length of the span longitudinally (sections A, B, C, and D in Figure 3.4). Transversely, the loads were applied at the center of each girder and at a distance of 1 ft- 4 in. from the exterior edge of the girder (positions 1, 2, 3, and 4 in Figure 3.4). With this arrangement 16 load positions were evaluated. The designation of each of these load locations is given in Figure 3.4. The 1 ft- 4 in. distance was chosen to place the load as close as possible to the girder edge without being directly on a concrete strain gage.

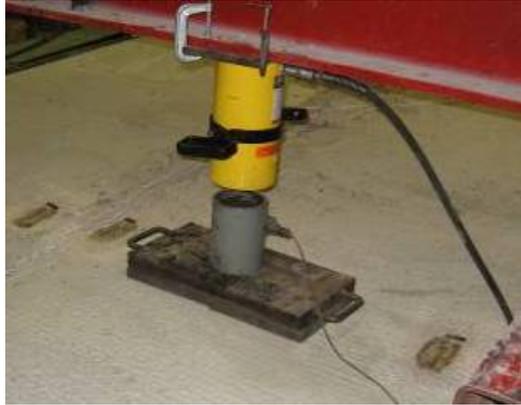
Figure 3.5. Photograph of tandem wheel footprint used during the variable post-tensioning force tests

A 10 in. by 20 in. steel plate was used to transfer the load to the box girders for this series of tests. This footprint was selected to simulate that of the tandem truck wheel. Neoprene pads were placed between the steel plate and the girder in an attempt to more equally apply the load to the girder surface. The tandem wheel footprint along with the load cell and hydraulic load cylinder are shown in Figure 3.5.

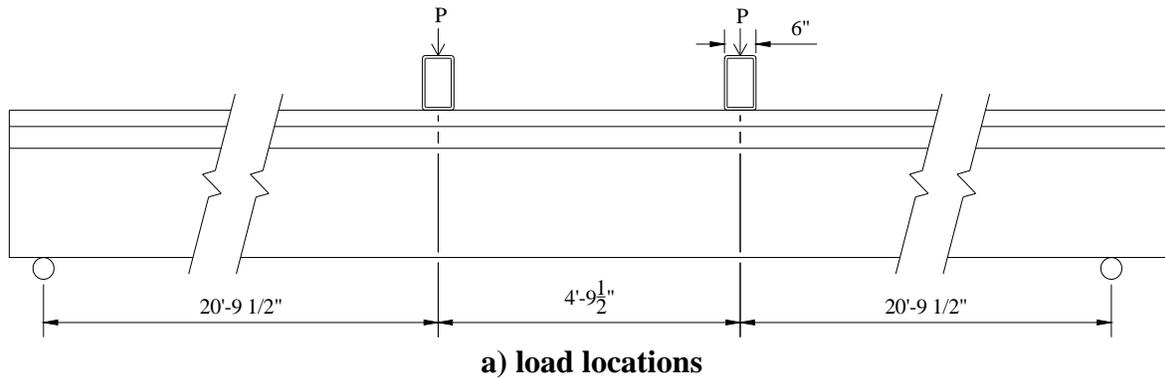
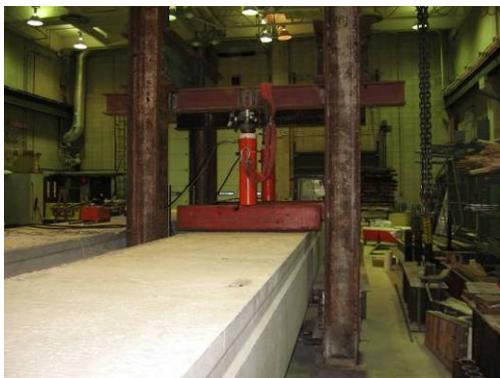
b. photograph of test setup

The goal of this testing was to experimentally determine the flexural strength of a single box girder. In order to test the box girder in a moment only condition, two line loads were applied equidistant from the supports. By doing this, a region of constant moment and zero shear was developed between the applied loads. Loads were positioned 20 ft-9.5 in. from the supports and

4 ft-9.5 in. apart. An HSS10x6x1/4 served as the footprint for the line load. The setup and spacing of loads for the flexural strength test is shown in Figure 3.7.

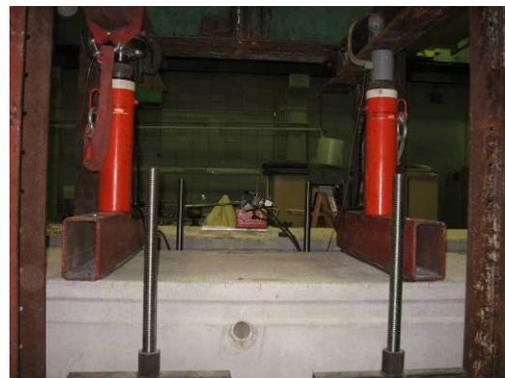
Figure 3.7. Laboratory setup to test flexural strength of a box girder

c. photograph of load points

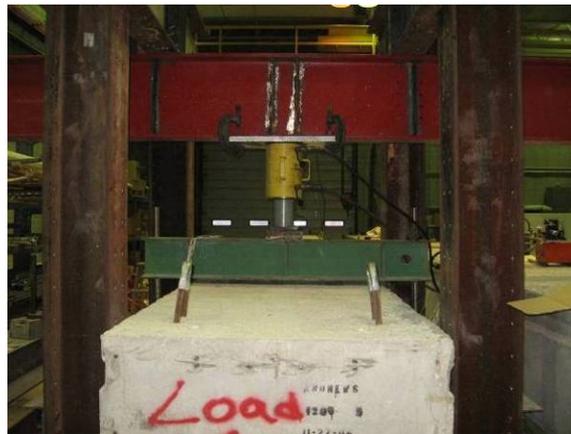
Figure 3.9. Shear strength test setup

HP10x42 beam was used to apply a line load to the girder a distance of 5 ft-3.75 in. from the support. Figure 3.9 shows the load location and general setup for the test.

b. photograph of test setup

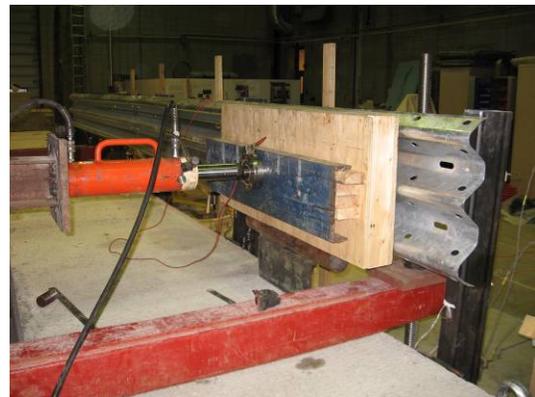
Figure 3.13. Guardrail connection test setup

Load was applied at a height of 20 in. above the box girder surface, as shown in Figure 3.13. A timber box with a 48 in. length, 20 in. width, and 5 in. depth was used to apply the load to the guardrail. The box was 48 in. long to meet AASHTO requirements for transverse design forces for guardrails. Figure 3.13 shows the test setup.

b. photograph of laboratory setup

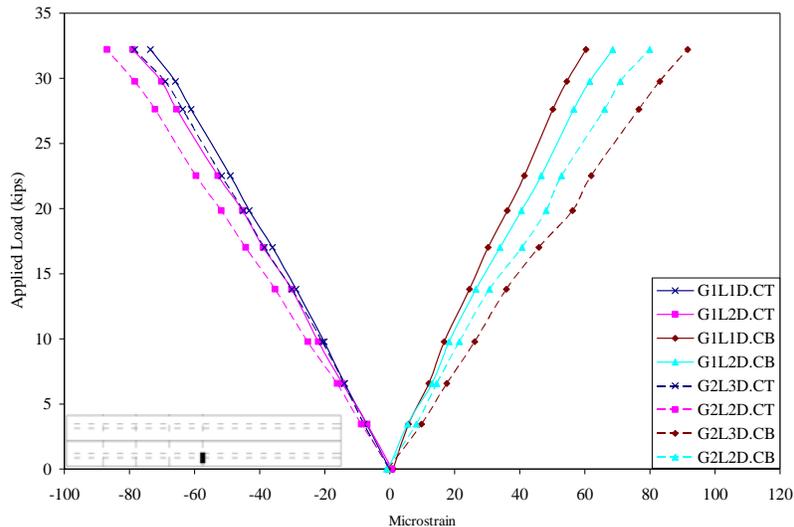
Figure 4.1. Total strain at midspan with load at D1 and a post-tensioning force of 17 kips

Figure 4.1 presents the strains at midspan for the case of a load applied at location D1 (see Figure 3.4) and a post-tensioning force of 17 kips. The 17 kip results are representative of the results for any post-tensioning force, as the strain did not vary significantly with the post-tensioning force. Loading along line “D” resulted in the highest magnitude strains.

From Figure 4.1, one can see the induced strains were small in magnitude. Cracking did not occur during this test (or any of the variable post-tensioning tests). Strains along line 2 were similar in magnitude from girder 1 to girder 2, which shows the load is being transferred between the girders.

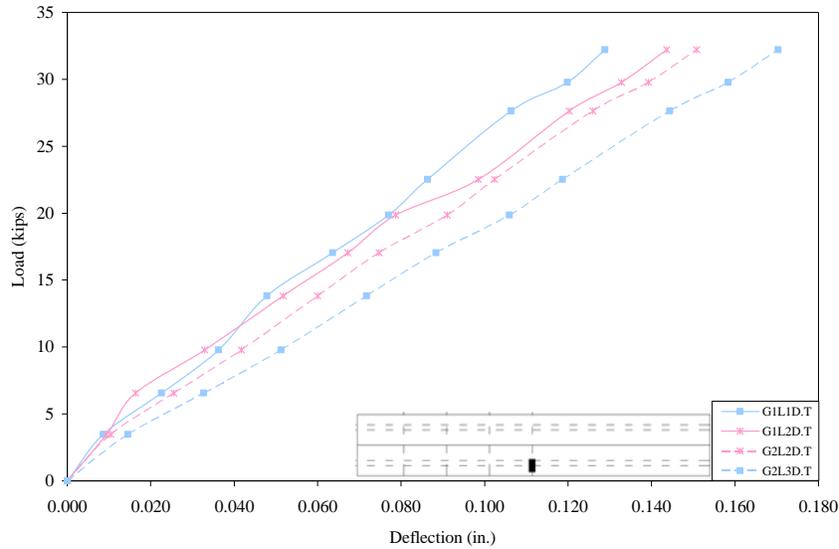
a. deflections at midspan

Measured deflections for a load at D1 and post-tensioning force of 17 kips are shown in Figure 4.2. As with the strain results, results for this location are typical of all combinations of load along line “D”.

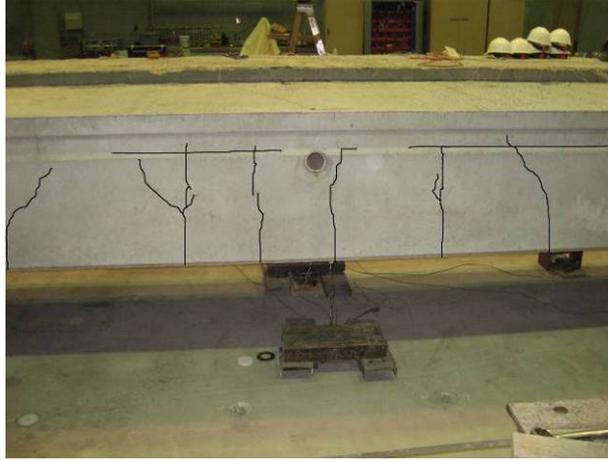
Figure 4.7. Photograph of flexural cracking after flexure test

A photograph of the cracked box girder after testing is shown in Figure 4.7. The first cracks were observed at a load of 56.5 kips, which is equivalent to a moment of 781 kip*ft. Cracks tended to progress horizontally after reaching the shear key. Coincidentally, this is approximately the location where the chamfer began and the thickness of the web increased.

Table 4.4 presents the theoretical and experimental cracking moment values. The Iowa DOT calculated the theoretical cracking moment to be 721 kip*ft. Two different experimental cracking moments were calculated. One was calculated using the strains measured during loading and Hooke’s Law, while the other value was based on the moment due to the measured applied load. Using the measured strain value, cracking occurred at a moment of 856 kip*ft. Similarly, a cracking moment of 781 kip*ft was calculated from the applied loads. Both of the experimental values exceed the theoretical crack moment. Note that the theoretical cracking moment was calculated assuming a concrete strength of 5,000 psi.

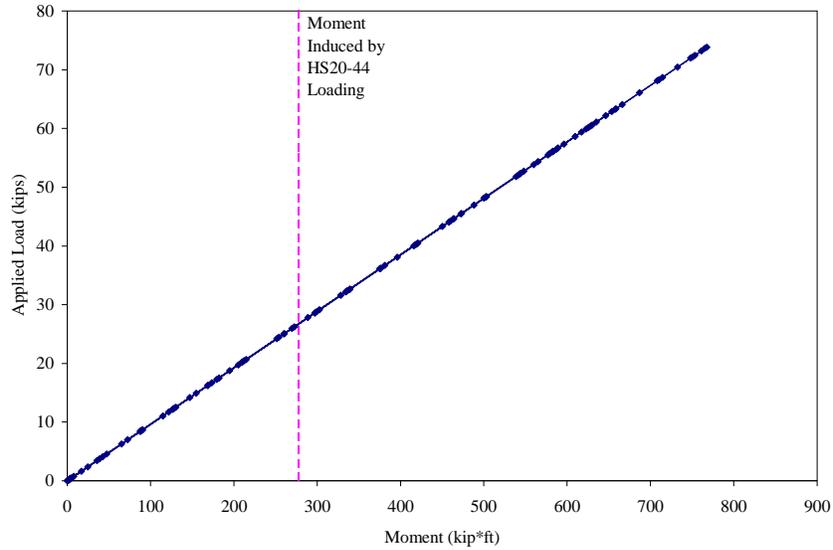
Figure 4.8. Moment at midspan of the box girder

The moment at midspan due to the applied loading is plotted in Figure 4.8. Also plotted is the moment induced by the design HS20-44 loading. HS20-44 loading with half the load acting on the box girder and a 14 ft wheel spacing will develop a maximum moment equal to 278 kip*ft. The midspan moment exceeded the HS20-44 moment at a load equal to 26.7 kips.

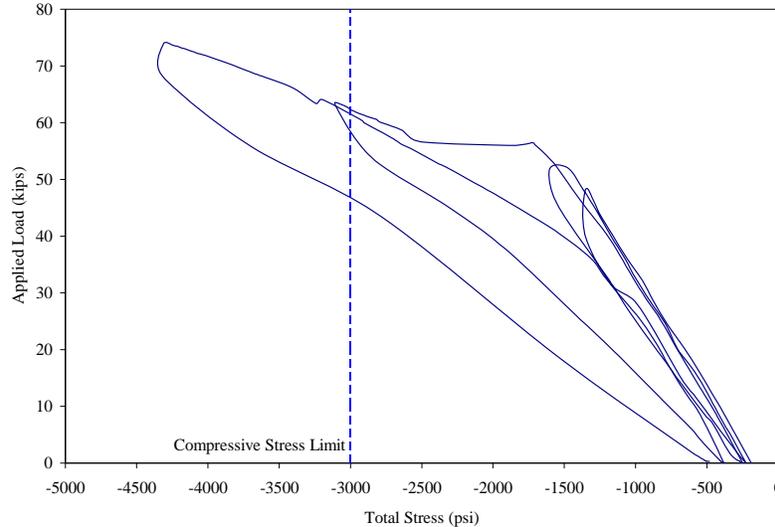
Figure 4.10. Total compressive stress at midspan of the box girder

Figure 4.10 shows the total compressive stress at midspan versus the applied load. The total compressive stress is due to the applied load, self weight, and prestressing force. Stresses were calculated by assuming prestress losses related to elastic shortening, creep, concrete shrinkage, and relaxation equal to 29.6 ksi and the using an empirical relationship to calculate the modulus of elasticity. Compressive stresses were a maximum in the top fibers at midspan. AASHTO specifies a maximum compressive stress equal to 3,000 psi for the service limit state and a concrete compressive strength of 5,000 psi. The service level compressive stress was first exceeded at an applied load of 62 kips and at lower loads during subsequent load cycles due to nonlinear behavior.

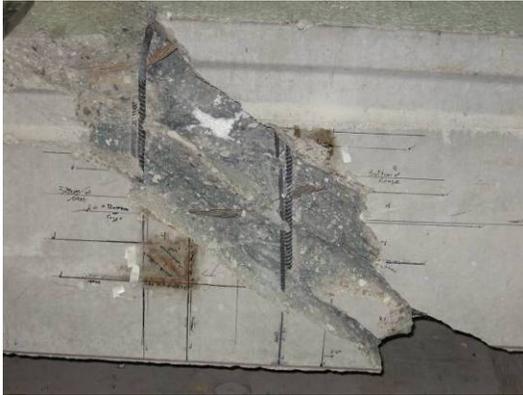
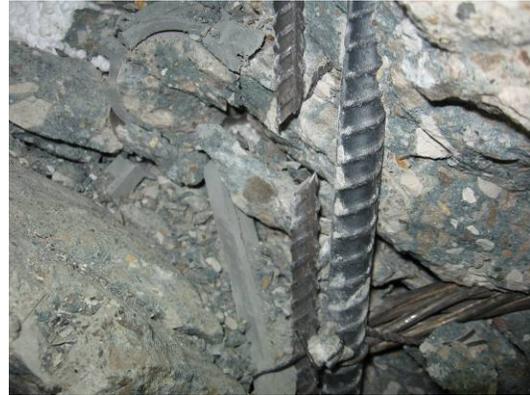
Figure 4.13. Photographs of box girder after shear failure

Figure 4.13a shows the shear crack after testing concluded. The angle of the shear crack was measured to be approximately 45 degrees. Inspection of the failure afterwards revealed a #3 stirrup fractured at the time of failure. This can be seen in Figure 4.13b.

a. shear crack after failure

b. fractured stirrup

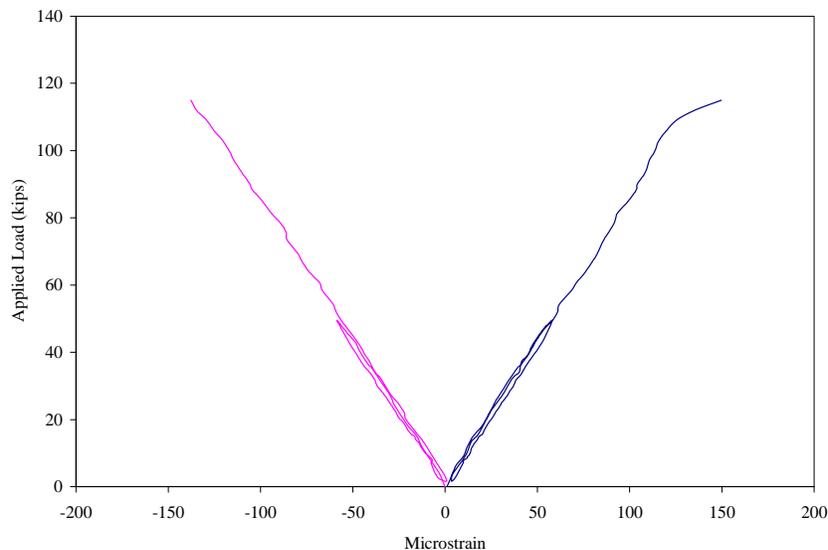
Figure 4.15. Principle strains due to applied load at rosette 2N during shear strength testing

The principle strains at rosette 2N due to the applied load are plotted in Figure 4.15. Strains for rosettes at the same height and on opposite webs were the same. As shown in the figure, the tensile and compressive strains were similar for equal loading until just prior to cracking. Prior to cracking the tensile strain increased suddenly, whereas the compressive strain still exhibited linear behavior. The maximum compressive strain was 138 microstrain, and the maximum tensile strain was 150 microstrain.

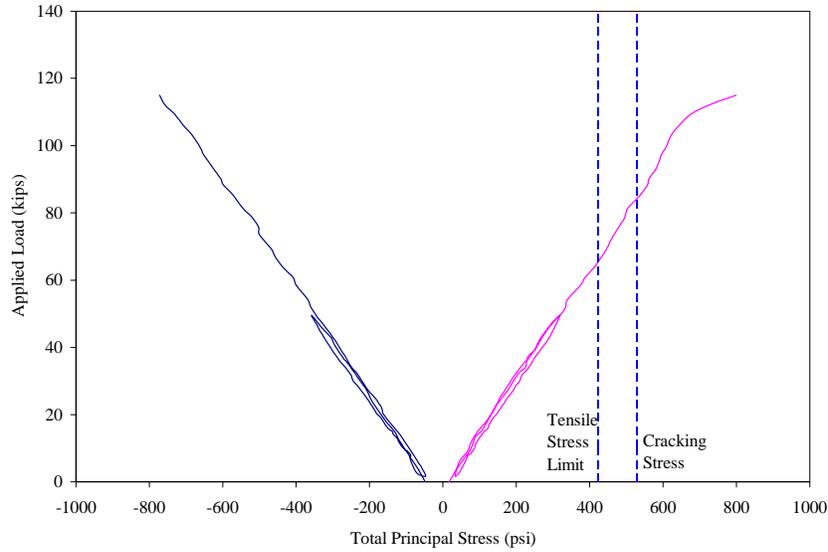
Figure 4.16. Principal stresses due to the total load at rosette 2N

Figure 4.16 displays the total principal stress plotted against the applied load for rosette 2N. Stress calculations required assumptions regarding prestress losses related to elastic shortening, creep, concrete shrinkage, and relaxation (the same assumptions used previously were made here). An empirical relationship was used to calculate the modulus of elasticity. At a load of 63.5 kips, the total tensile principal stress exceeded the AASHTO maximum allowable tensile stress for the service limit state, 424 psi. The theoretical cracking stress calculated by the Iowa DOT was 530 psi and was reached at a load of 85 kips. Cracking actually occurred at 115 kips. The difference between when cracking was predicted to occur and when cracking occurred is a

function of the theoretical value using a concrete compressive strength equal to 5,000 psi. Maximum compressive stresses specified by AASHTO for the service limit state were not approached during the shear test.

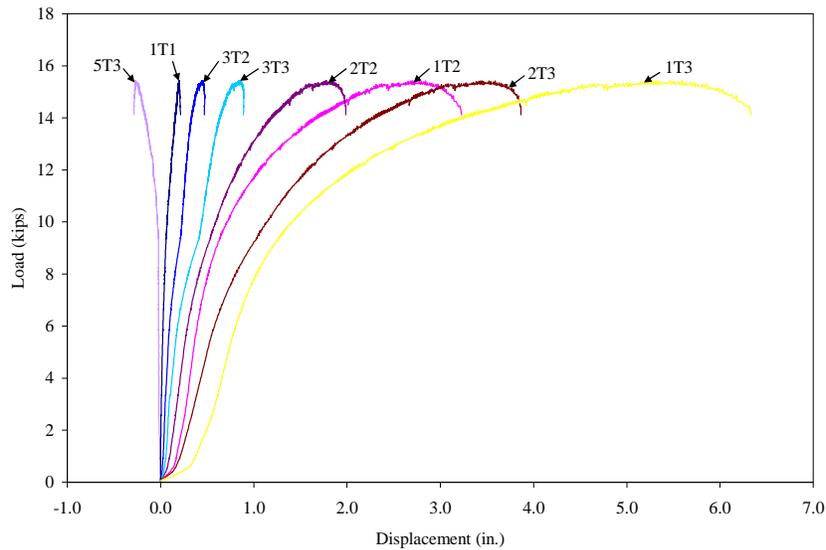
Figure 4.20. Post deflections during test 1

Figure 4.20 shows the post deflections during test 1. Post 1 underwent the largest deflection, reaching 6.34 in. prior to failure. Posts 1, 2, and 3 deflected outward from the box girder, whereas posts 4 and 5 deflected inward 0.28 in. Deflections for posts 4, 5, and 6 were excluded from the plot because they were approximately zero. Deflection 5T3 was plotted because this was the largest inward deflection, equaling 0.285 in. Minimal load reached post 6, with the post deflected outward 0.003 in. at failure. The deflected shape of the top of the guardrail immediately prior to failure is plotted in Figure 4.21.

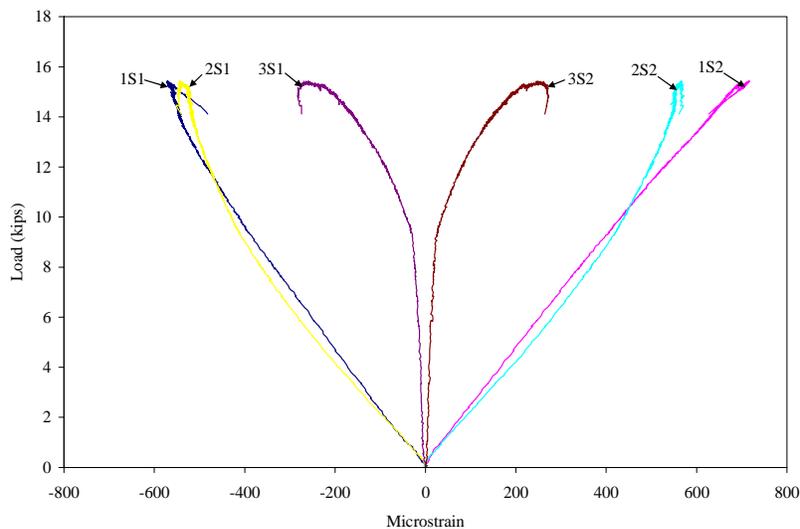
Figure 4.22. Post strains during test 1

Post strains recorded during test 1 are plotted in Figure 4.22. All strains exhibited a linear response under loading. Posts 1 and 2 carried the majority of the load. Post 3 did not carry any load until the applied load reached 8 kips. The maximum strain equals a stress of 20.7 ksi in post 1, which is less than the 46 ksi yielding stress. Strains for posts 4, 5, and 6 were insignificant when compared to the strains of posts 1, 2, and 3.

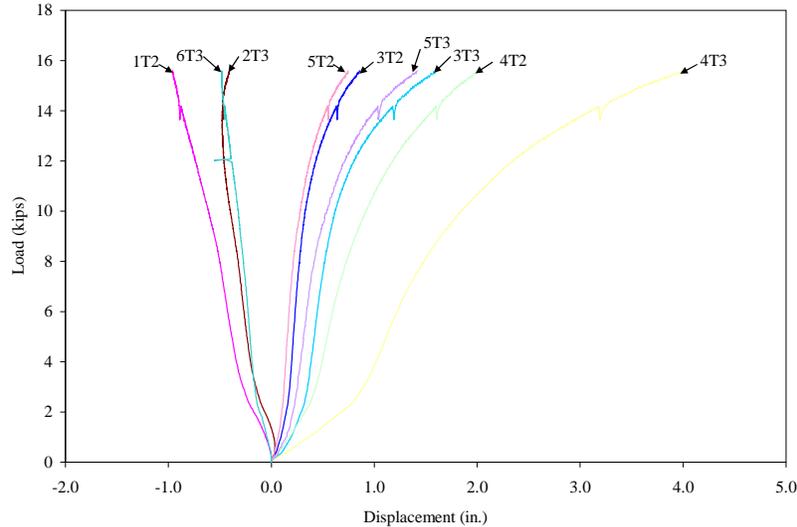
Figure 4.23. Post displacements for test 2

Displacements for each post during test 2 are plotted in Figure 4.23. All deflections approximately equal to zero were removed from the plot for clarity. Post 4 exhibited the greatest deflections, reaching 3.99 in. Equal deflections were measured for posts 3 and 5. This was expected because the posts are located on either side of and equidistant from post 4.

Deflections in the field may actually be greater than those recorded because testing had to be done in two cycles. During the first cycle, once a 15.6 kip load was applied the box girder moved horizontally. Testing was halted when this occurred and the girder was further secured to the ground. When testing resumed, the guardrail was loaded to failure. Yielding of the 3/4 in. bolt was observed following the first test cycle; therefore some of the plastic deformation capacity was used.

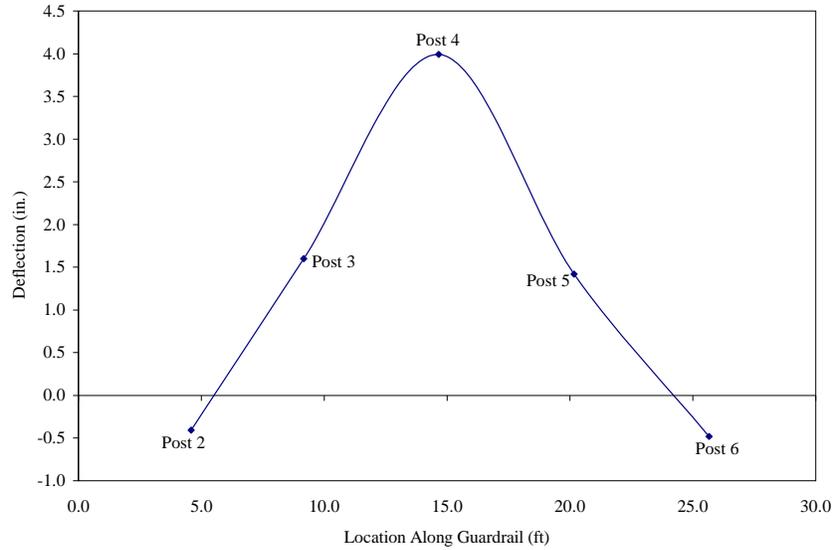
Figure 4.24. Deflected shape of the guardrail during test 2

The deflected shape of the guardrail at a load of 15.6 kips is shown in Figure 4.24. The plotted deflections are the deflections measured at the top of each post. Post 1 is not included in the plot because the transducer measuring displacement at the top of the post had been removed after test 1. The deflected shape of the rail is symmetric. Posts 3, 4, and 5 deflected outward and away from the girder, with post 4 deflecting the farthest. Posts 2 and 6 deflected inward to a position over the girder. Figure 4.25 is a photograph showing the deflected shape of the guardrail during testing.

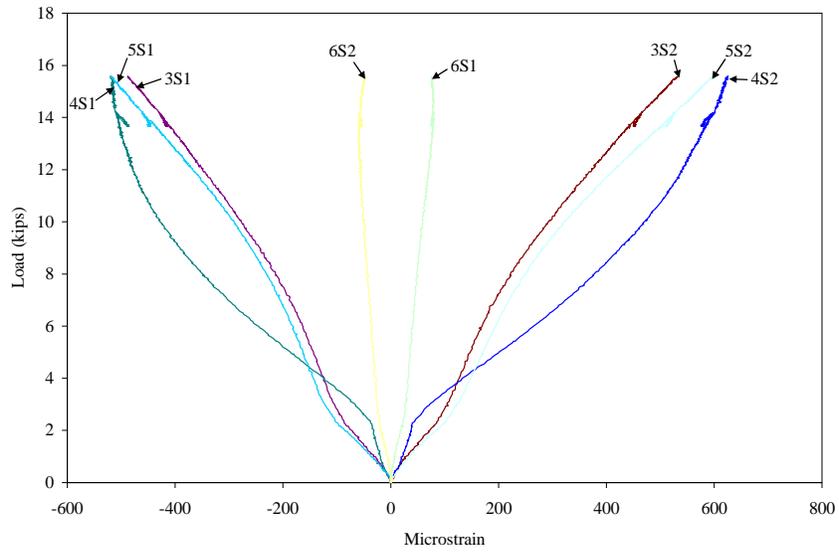
Figure 4.26. Post strains during test 2

Strains measured in the posts are plotted in Figure 4.26. Posts 1 and 2 are not plotted for clarity because the strains were less than 20 microstrain. As expected, post 4 experienced the largest strains. The strains in posts 3 and 5 were similar during loading, with post 5 strains approaching that of post 4 near the end of the test. Posts 1, 2, and 6 were lightly strained. The maximum strain is equivalent to a stress of 18.2 ksi, which is less than the yield stress of 46 ksi.

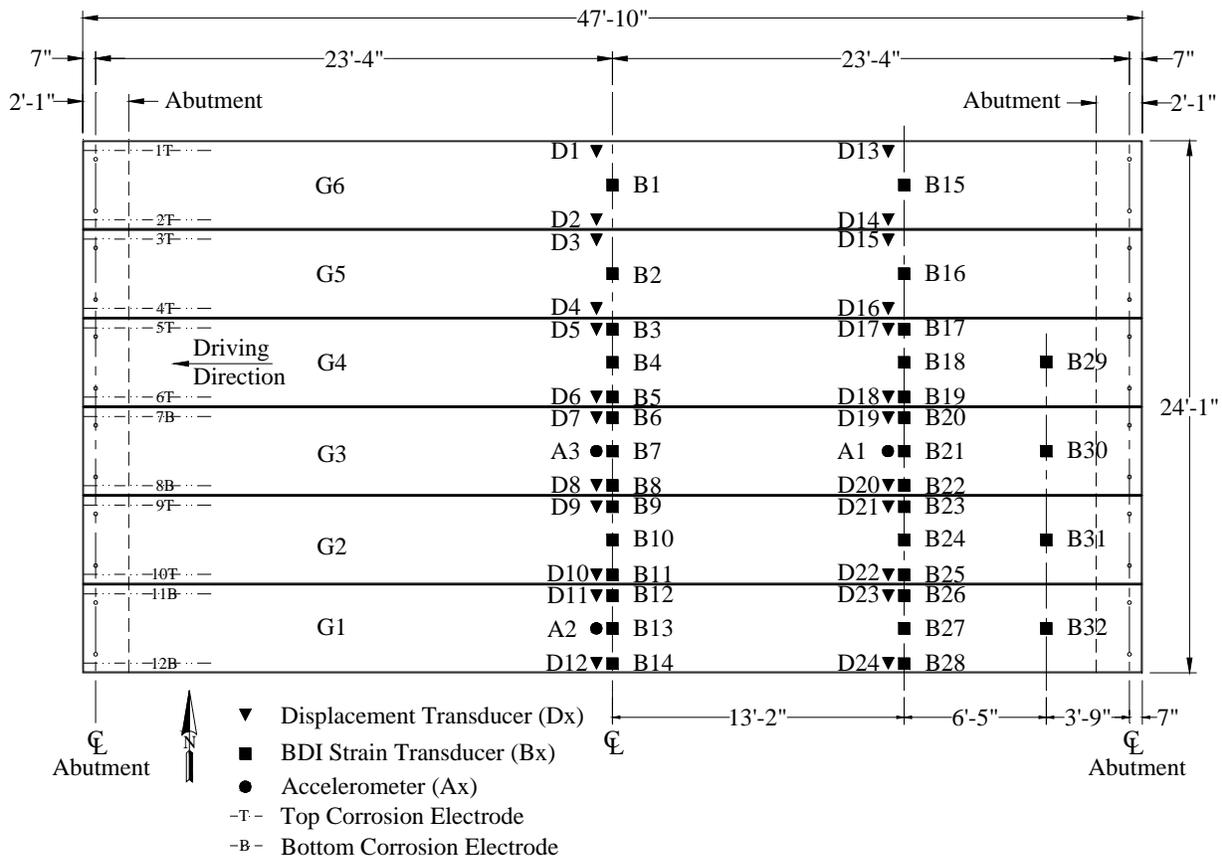
Figure 5.1. Instrumentation layout

Instrumentation was placed at important locations to collect deflection, strain, acceleration, and corrosion data. Figure 5.1 illustrates the instrumentation layout of the bridge. Corrosion electrodes were permanently installed on two strands in each girder prior to casting. The strands that were instrumented with corrosion electrodes are located in the top corners or the bottom corners of the girder. Figure 5.1 show the electrode number and top or bottom designations of the strand location.

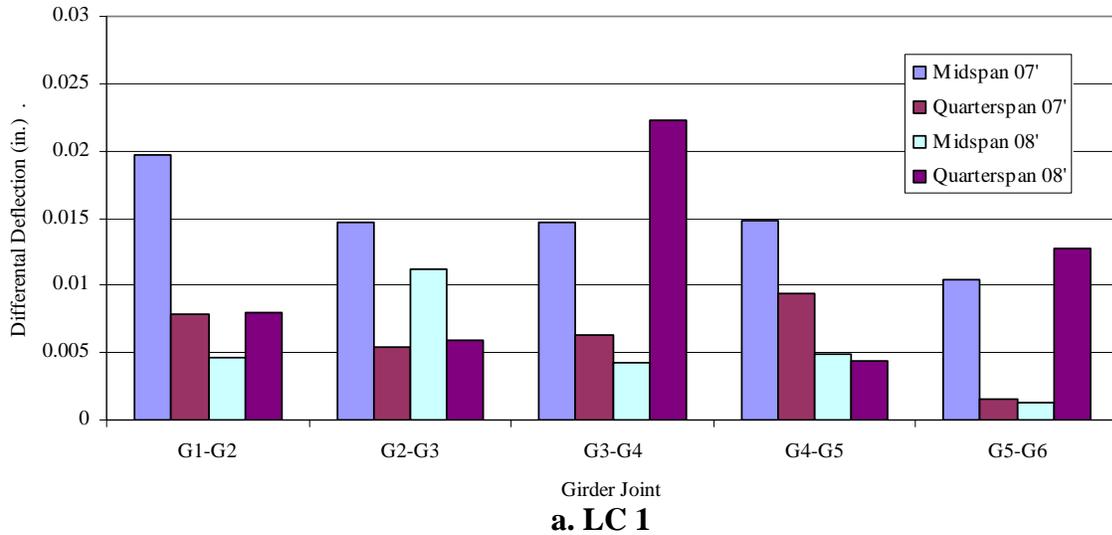
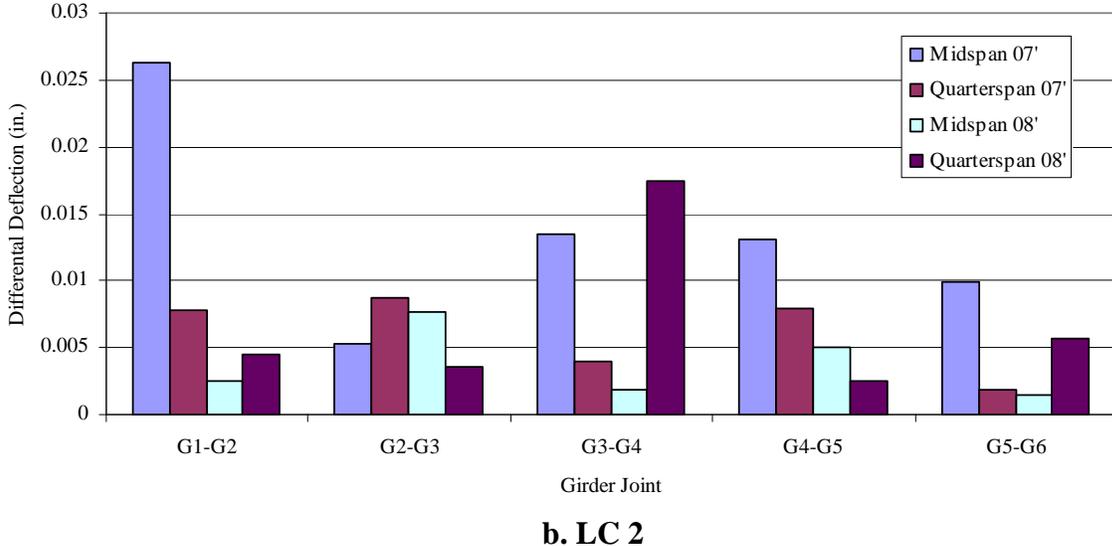
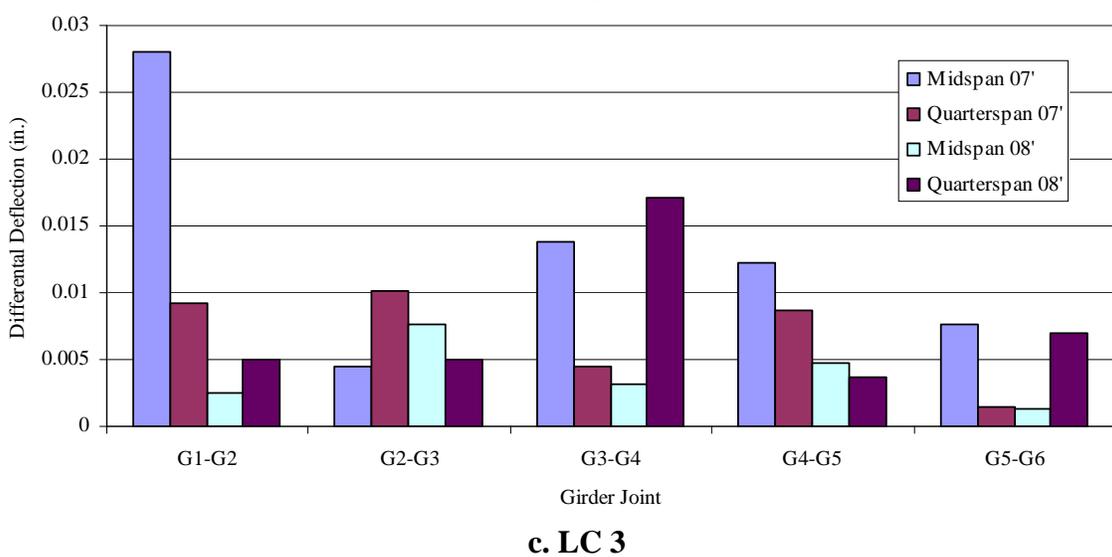
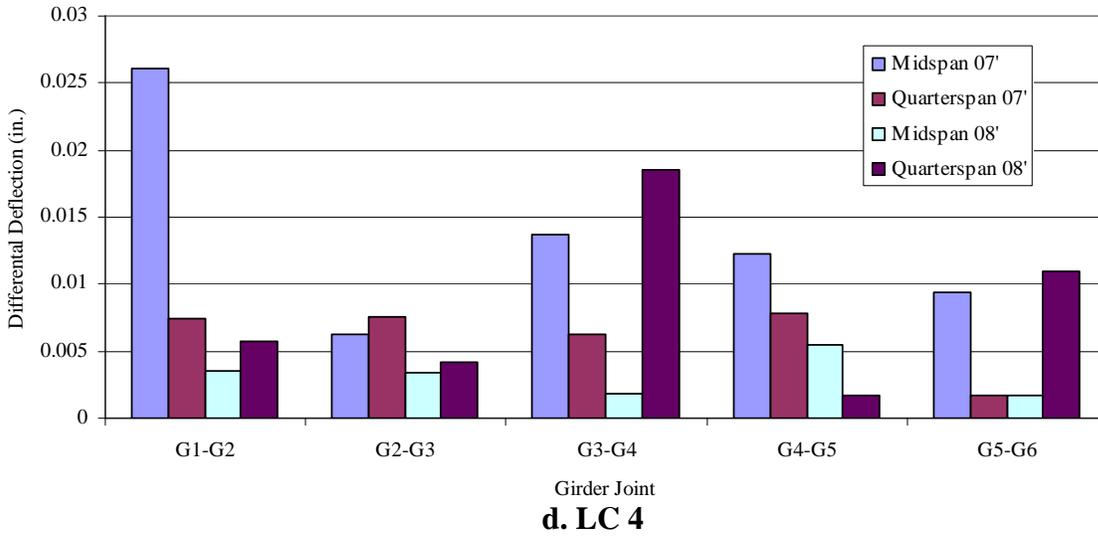
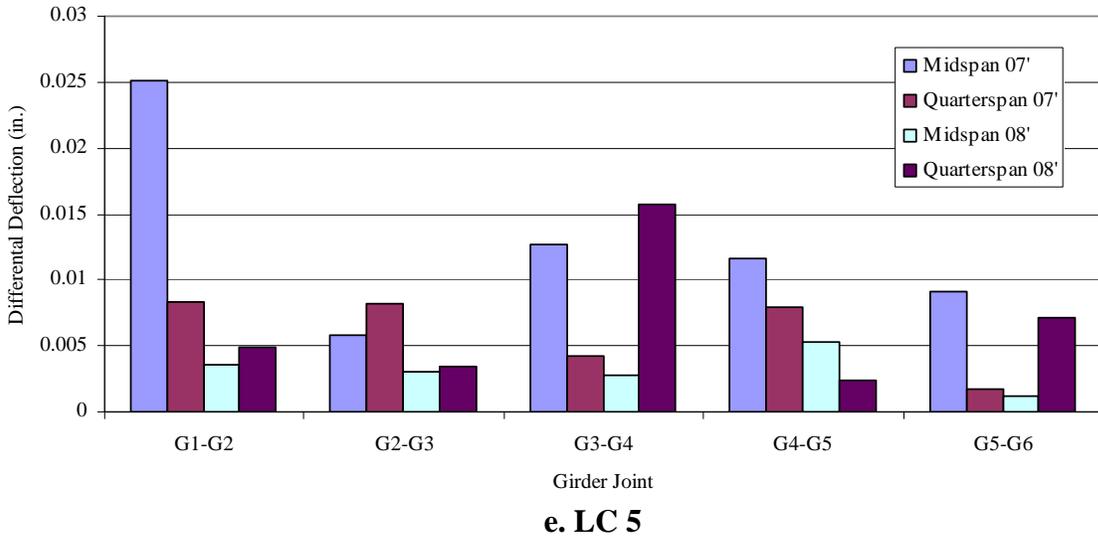
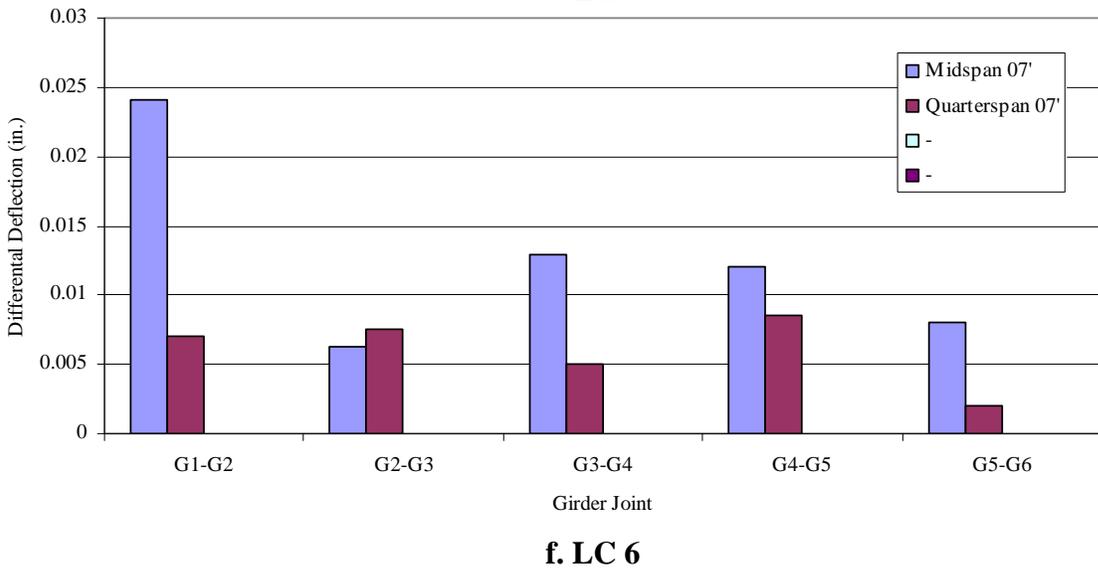
Figure 6.3. 2007 and 2008 differential deflections

Figure 6.3 shows the absolute maximum differential deflection at midspan and quarterspan for each of the 2007 and 2008 load cases. Again, the 2008 differential deflections were normalized to the 2007 load truck weight. The obtained differential deflections for both testing periods were less than 0.03 in. During the 2007 testing, the differential between girder G1-G2 was the largest for all load cases. The differential deflection at G1-G2 was also nearly constant for all load cases and appears to be independent of the load truck position. The largest difference occurred for LC 3 with a magnitude of 0.028in. The 2008 testing had maximum differential deflection of 0.023 in., which occurred at the quarterspan joint of G3-G4 for LC1. This location showed the same phenomenon as the 2007 G1-G2 joint, in which the differential deflection seems to be independent of load truck position. It is uncertain why the constant differential deflection occurred at these locations and why it was not consistent during both testing periods. In general, when comparing the midspan differential deflections, the 2007 results showed larger values than 2008 values. The quarterspan location had similar differential deflection results for both years, with the exception of G3-G4. Overall the deflections were small leading one to believe the grouted shear key and hand tight post tensioning rod are adequate for load transfer and limiting problems with wearing surfaces deterioration. This limited testing does not allow for conclusions to be drawn as to whether or not this behavior would continue throughout the bridge life.
