Precast Concrete Elements for Accelerated Bridge Construction

Volume 2. Laboratory Testing, Field Testing, and Evaluation of a Precast Concrete Bridge: Madison County Bridge

Final Report
January 2009

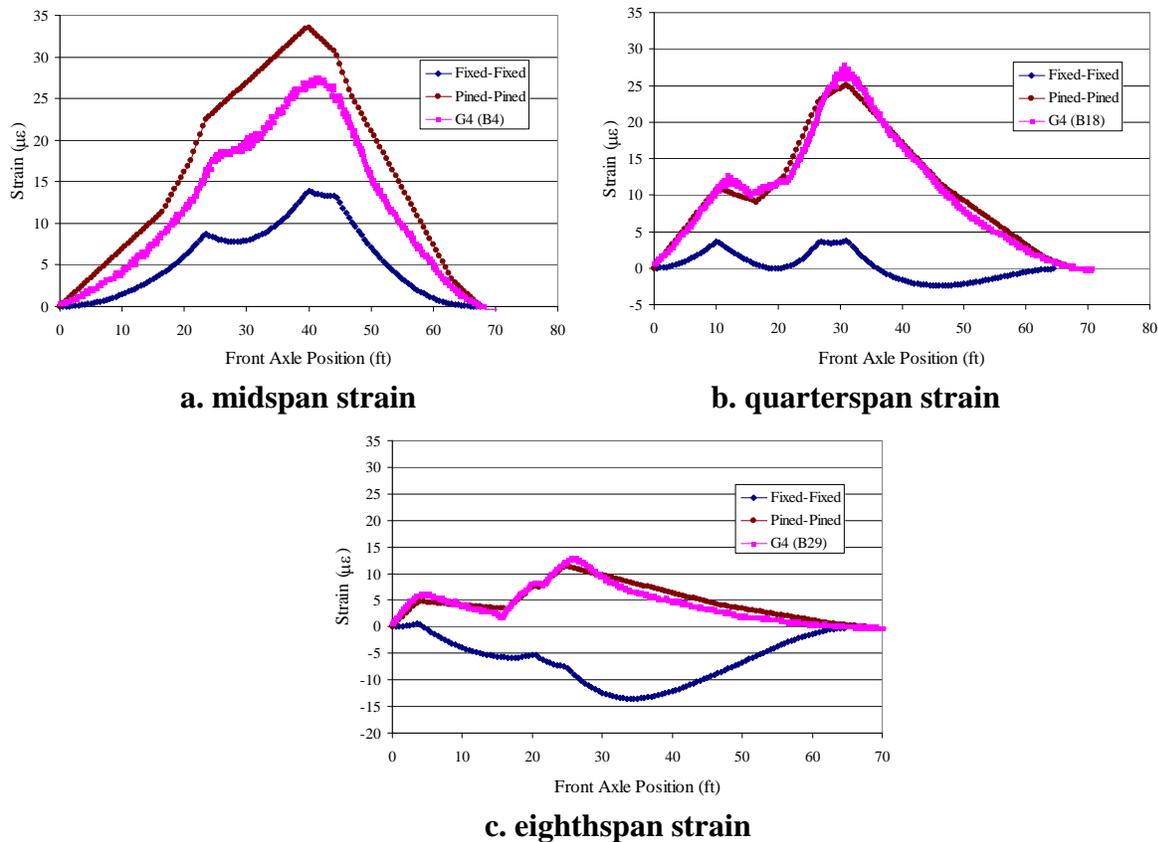
Figure 6.6. 2007 Experimental and analytical strain comparison; LC 3

The experimental strain measurements were compared with analytical strains. The analytical strains were computed using the material properties obtained from the laboratory results and load fraction values discussed herein. The analytical and experimental results were compared using data obtained from girder G4 during LC3. This load case and girder were selected because the load case represents the most likely load path the bridge will encounter while in-service on a low volume road and the girder was directly influenced by the load truck. Figure 6.6 and 6.7 show the 2007 and 2008 respective results for the comparison between analytical and experimental strain. From Figure 6.6 it can be seen that the midspan behavior of girder G4 lies between “pinned-pinned” and “fixed-fixed”, however, when the same comparison is made at the quarterspan and eighthspan the experimental results are nearly identical to the analytical results. Similar results are shown for the load test conducted in 2008 in Figure 6.7. The comparisons indicate the girders exhibit very little rotational restraint at the supports and act as simply supported beams.

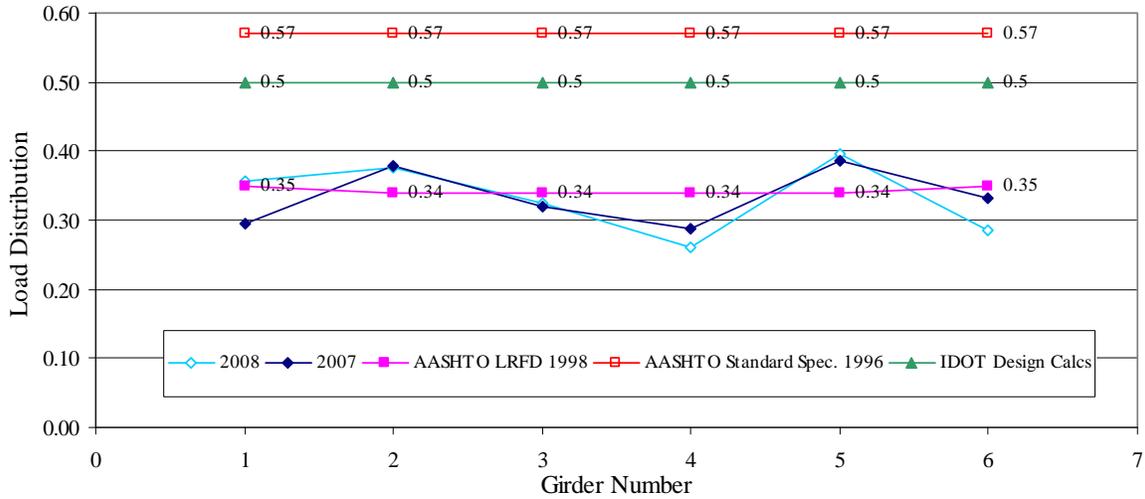
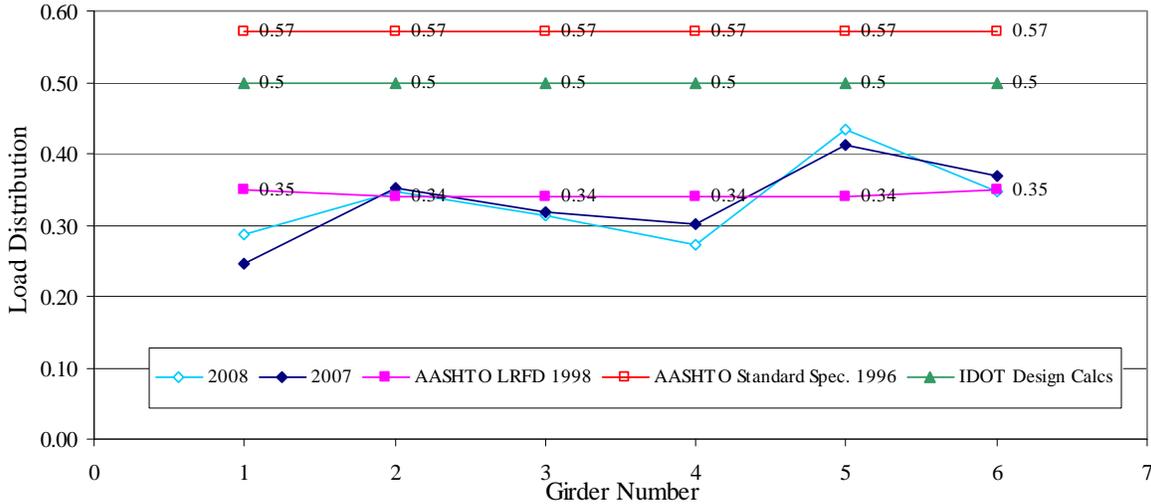
Load distribution was determined experimentally by adding the load fractions of two complementing load cases. Combining LC 1 plus LC 5 and LC 3 plus LC 7 provided proper lane loads for determining load distribution. Figure 6.9 shows the 2007 and 2008 experimental load distributions along with the design value used by the Iowa DOT, and code distribution factors from AASHTO LRFD 1998, and AASHTO Standard Specification 1996. The largest obtained load distribution factor was obtained during the 2008 combination LC 1 and LC 5 testing with a value of 0.43 at G5, however both 2007 and 2008 testing showed very similar results. The lowest value was 0.25 at girder G1. When comparing the experimental test results with the AASHTO LRFD load distributions, the experimental values exceed the codified distributions at the center of the driving lanes. When the experimental test results are compared with the Iowa DOT design values and the AASHTO Standard Specification recommendations, the experimental results show the bridge performance is conservative.

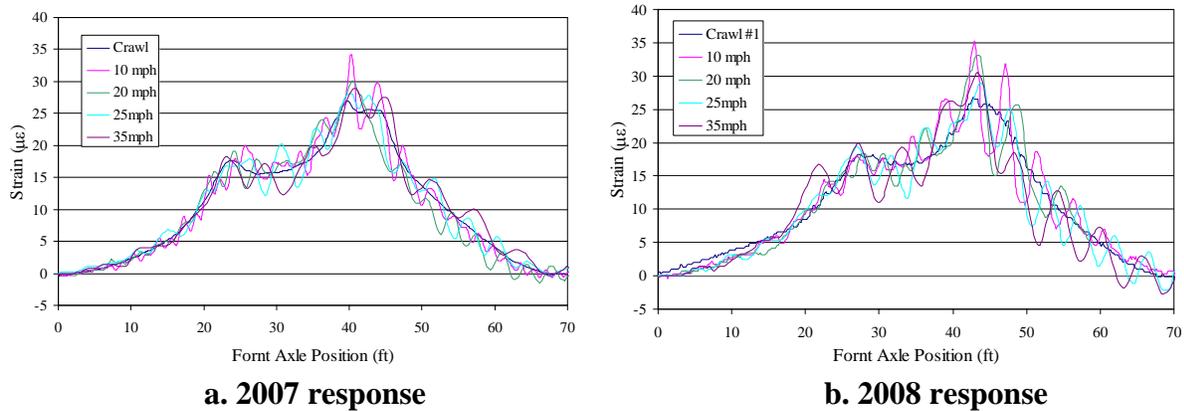
Figure 6.11. Transducer B6 dynamic response LC2

Figure 6.11 shows the dynamic B6 strains at the various speeds. The bridge's maximum DAF was obtained during the 2008 testing with a value of 1.30 at a 10mph speed. The B6 DAF for LC 2 testing can be seen in Figure 6.12. The maximum B6 DAF was 1.26 in 2007 at 10mph. In general the 2007 and 2008 B6 DAF plots for the bridge were very similar. The plot shows that at low speeds (<25mph) the DAF is largest starting at 10mph. As the speed increases, the DAF decreases until reaching a low DAF of 1.04 at 25mph. The DAF then increases at 35 mph.

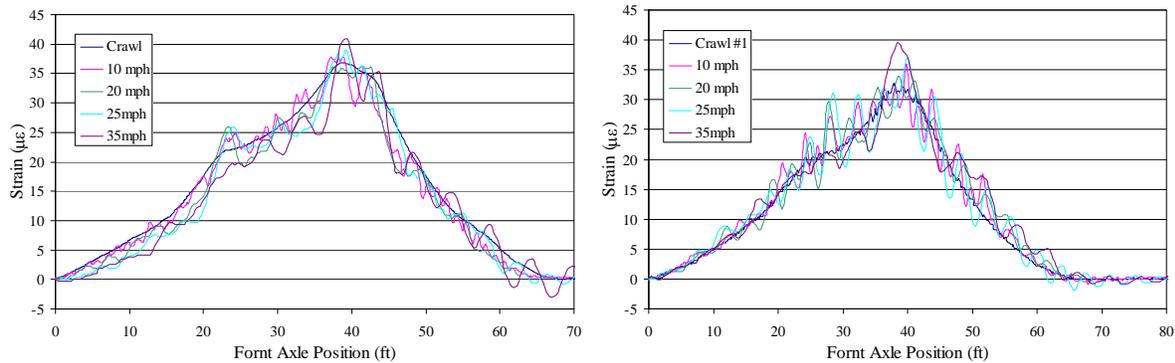
a. 2007 response LC7

Figure 6.13 shows the dynamic transducer B11 strains at the various speeds for load case LC7 in 2007 and LC4 in 2008. Due to road conditions during the 2008 testing the higher speed truck passes could not be completed for LC7, therefore, LC4 was used for comparative purposes. The maximum DAF obtained during the 2008 testing was of 1.23 at 25mph speed at transducer B7. The B11 DAF for load case LC7 and LC4 can be seen in Figure 6.14. In general the 2007 and 2008 B11 DAF had very similar patterns, however the 2008 testing had consistently a higher DAF (by approximately 0.10). The plot shows that as the DAF decreases from low speeds to moderate speeds and then increase as the speed increases to higher speeds.

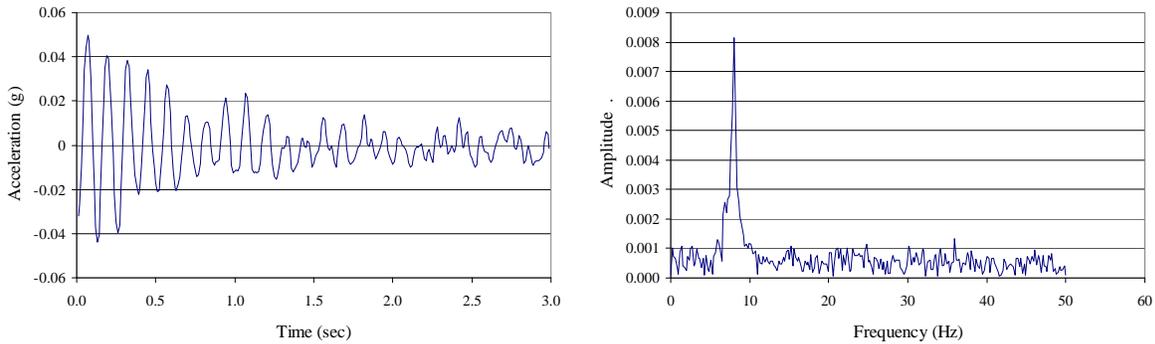
a. Free vibration record; A3; 35mph

From the free vibration records one vibration mode was identified. The free vibration record and FFT results showing the vibration modes can be seen in Figure 6.15 and 6.16 for the 2007 and 2008 testing respectively. The first flexural longitudinal frequency of approximately 8.0 Hz was found for the Madison County Bridge for both the 2007 and 2008 testing. The structural damping determined from the free vibration was recorded to be approximately 2.5% of critical.

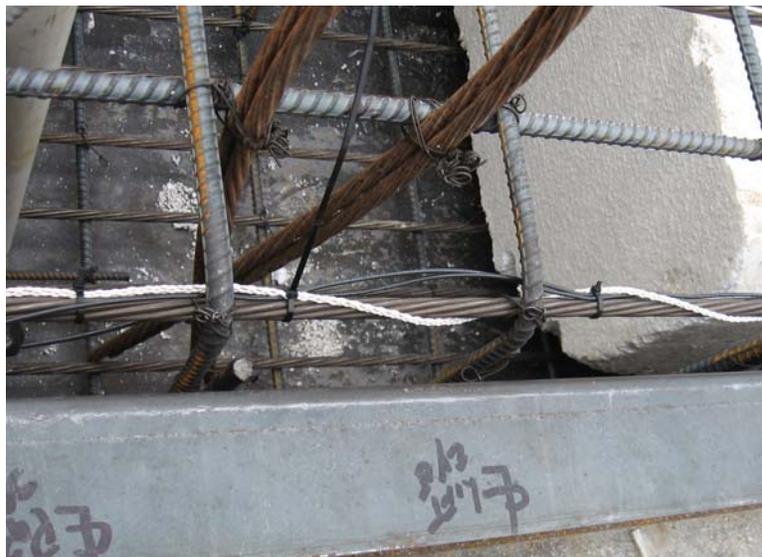
Figure 6.17. Corrosion electrode wrapped around strand

Corrosion monitoring of the strands was completed with the use of Vetek V2000 corrosion monitoring system. The V2000 braided silver electrode that is wrapped around the monitored strands can be seen in Figure 6.17. The V2000 monitor works by measuring the electric potential between the strand and the electrode with the pore water of the concrete acting as an electrolyte between the two. An increase in the electric indicates that corrosion activity is taking place. The electric potential is measured with a voltmeter with three different ranges of readings representing three different stages of corrosion. The three different stages are listed below in Table 6.5.
