Precast Concrete Elements for Accelerated Bridge Construction

Volume 3. Laboratory Testing, Field Testing, and Evaluation of a Precast Concrete Bridge: Black Hawk County

Final Report
January 2009

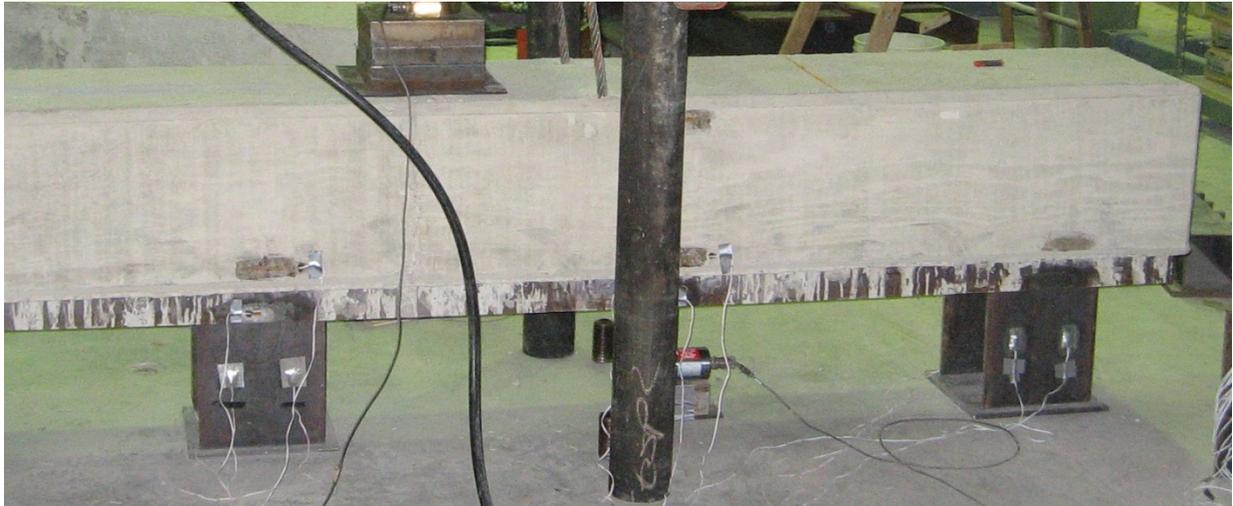
Figure 2.1. Precast abutment caps

The abutment caps designed by Black Hawk County Engineering Department were fabricated at the Black Hawk County yard by county forces. After fabrication, the abutment caps were shipped to the ISU structures laboratory for service and ultimate strength testing. Two abutment caps were tested; the first abutment cap (Cap 1) was fabricated using a W12x65 steel section (Figure 2.1a), and the second abutment cap (Cap 2) was fabricated with a W12x26 section (Figure 2.1b).

a) Cap 1 fabricated with W12x65

b) Cap 2 fabricated with W12x26

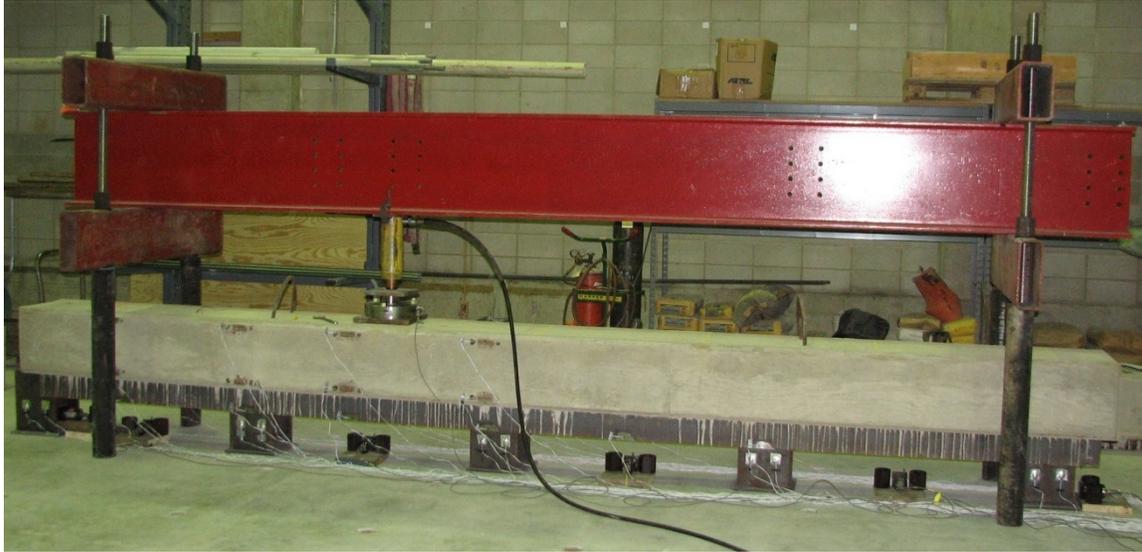
Figure 2.4. Cap 1 service test set-up

b) Photograph of service test

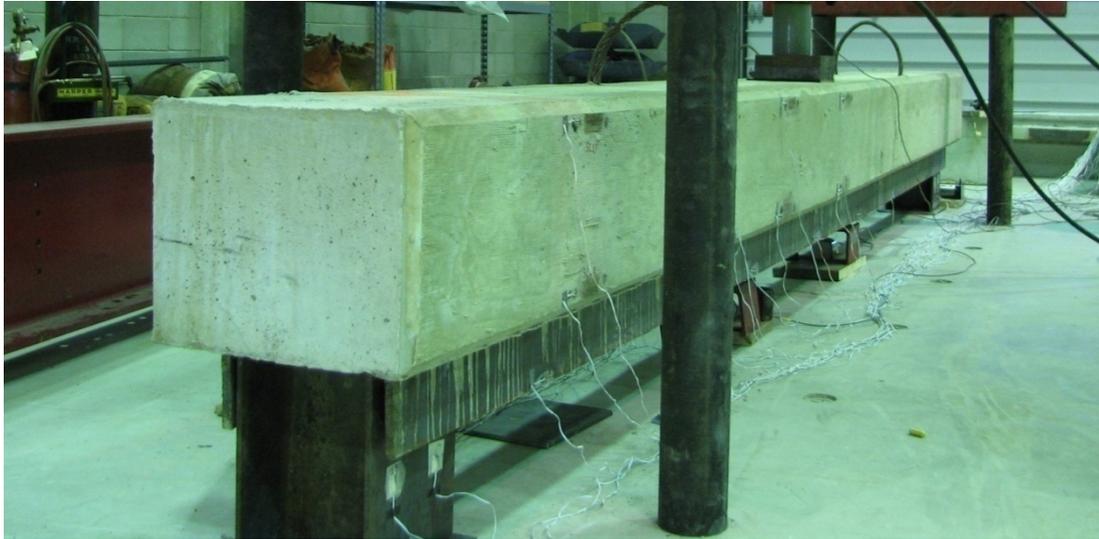
Figure 2.5. Positive ultimate strength bending test set-up

Due to a higher than anticipated capacity, the load frame for the positive ultimate strength test was not sufficient for failing the abutment cap. Thus, the negative ultimate bending strength was also investigated for Cap 1. The cap was placed within the load frame as shown in Figure 2.6. The actuator was placed on the floor, and pushed on the bottom of the cap, creating negative bending.

a) Positive strength test dimensions

b) Photograph of test

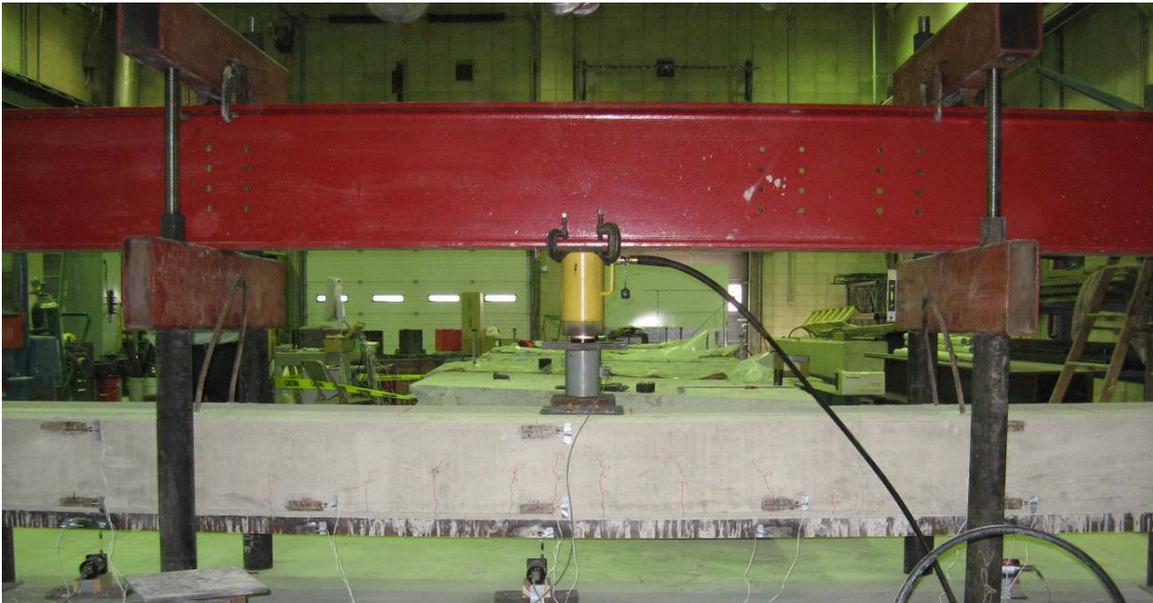
Cap 2 was tested for positive bending strength in the same manner as Cap 1. Two piles were used for supports, spaced at 15'-6''. A single point load was applied at the midspan of the abutment cap to produce positive bending as shown in Figure 2.9. A negative strength bending test was not performed on Cap 2 as the abutment cap was failed during the positive strength bending test.

a) Strength test dimensions

b) Photograph of test

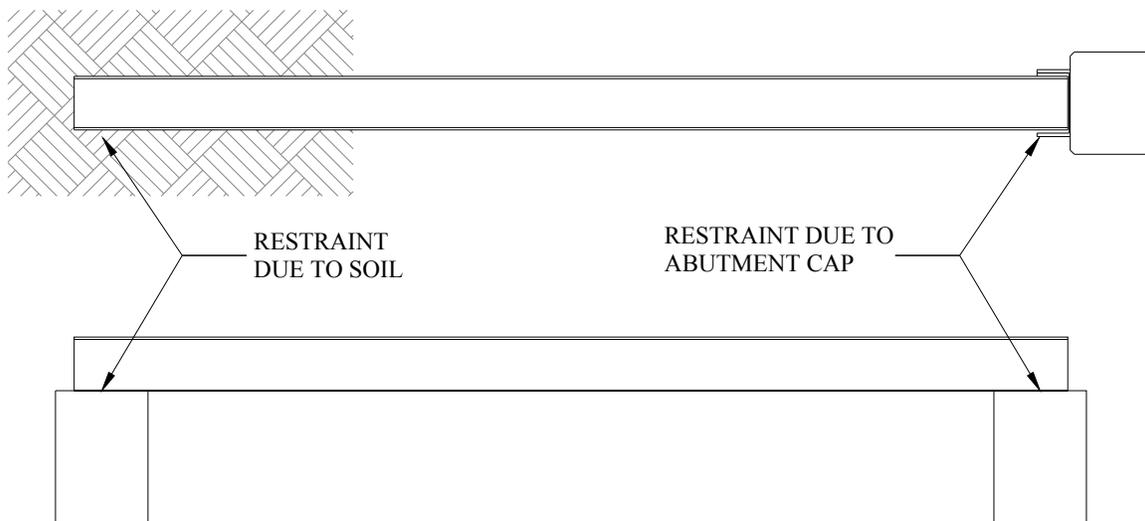
Figure 2.34. Correlation of field conditions to the laboratory set-up

In the field, the backwall is restrained laterally at its top edge by the dead weight of the bridge deck acting on the abutment cap, which sits on top of the backwall. At the bottom, lateral restraint is also present due to the soil surrounding the wall. For the laboratory testing, the backwall was modeled as simply supported at the top and bottom of the wall, with the long edges free. For the loading, it was assumed that the front of the wall was not supporting any soil, as would happen due to extreme scouring, and that the back of the wall was supporting a granular soil. Simulation of the field support conditions in the laboratory set-up are presented in Figure 2.34.

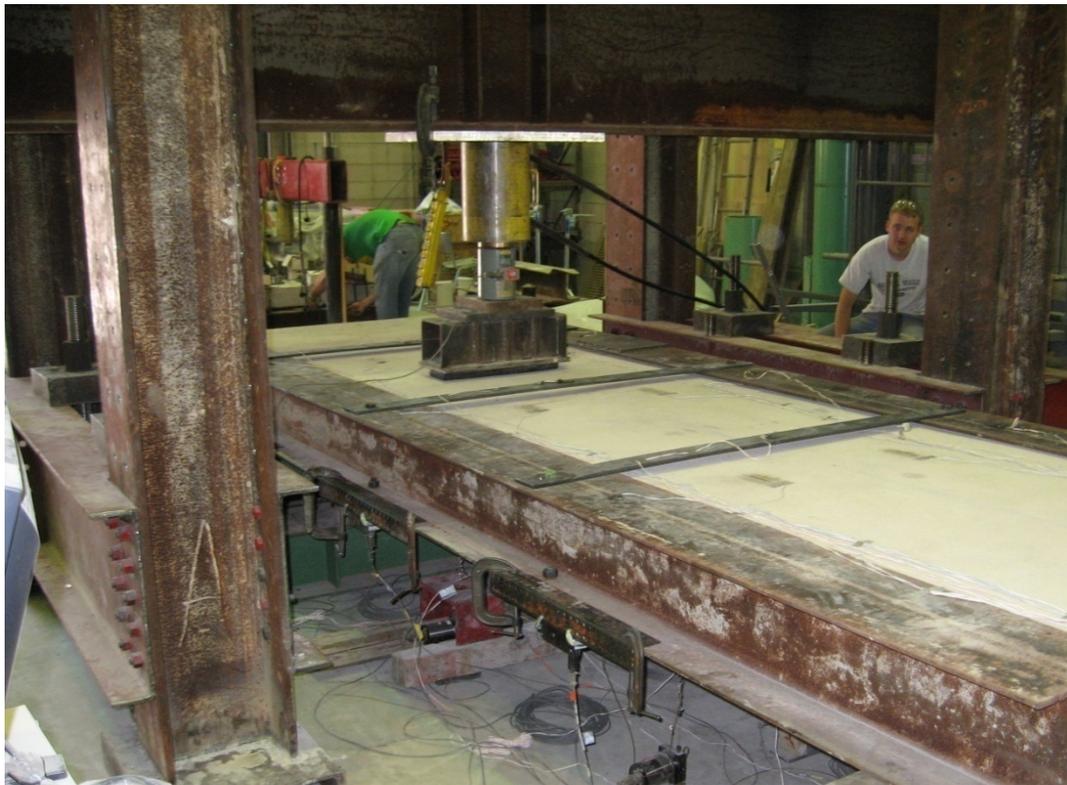
The position of the load in the ultimate strength test is 61.4 in. from the bottom of the wall, as shown in Figure 2.40. This location corresponds to the location of the resultant force due to worst case soil loading and five 5-ton axles spaced at 4.25' on the abutment. Load was applied at this location until the wall was unable to support the load.

a) Location of load for strength test

b) Photograph of test in progress

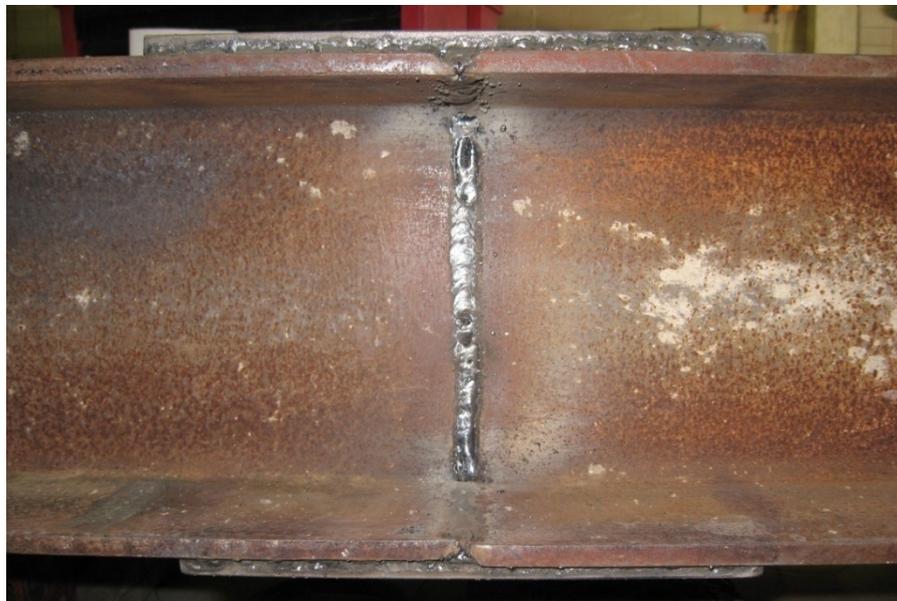
Figure 3.20. Repaired H-pile splice

An ultimate load test was performed by loading the slab at a single point 61.4 in. from the bottom of the wall. The slab was damaged during the first attempt when the spliced H-pile failed; the quality of the weld was poor, and the tension flange ruptured. At the time of the failure, the system was carrying 80 kips. The H-pile was repaired by welding plates to the exterior of each flange, and using a full-penetration weld along the web; the splice repair is shown in Figure 3.20.
