**Investigation of Two Bridge Alternatives for
Low Volume Roads - Phase II
Volume 1 of 2**

**Concept 1:
Steel Beam Precast Units**

Iowa DOT Project TR-410

Department of Civil and Construction Engineering

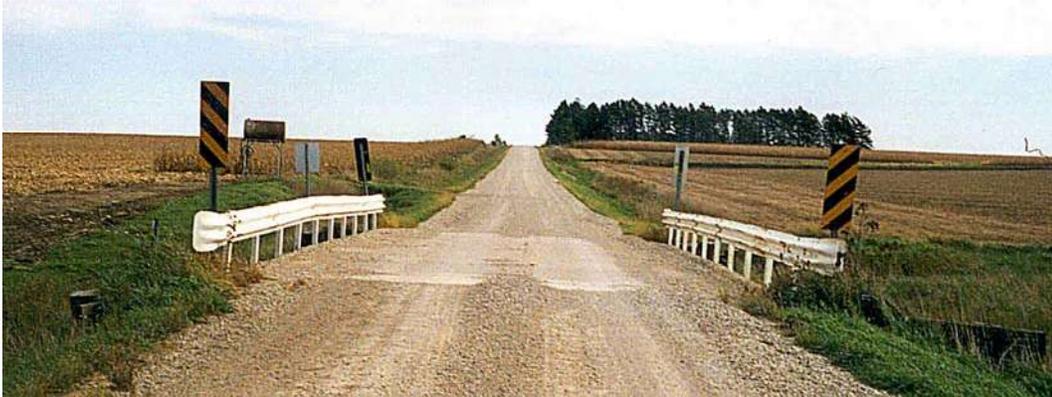
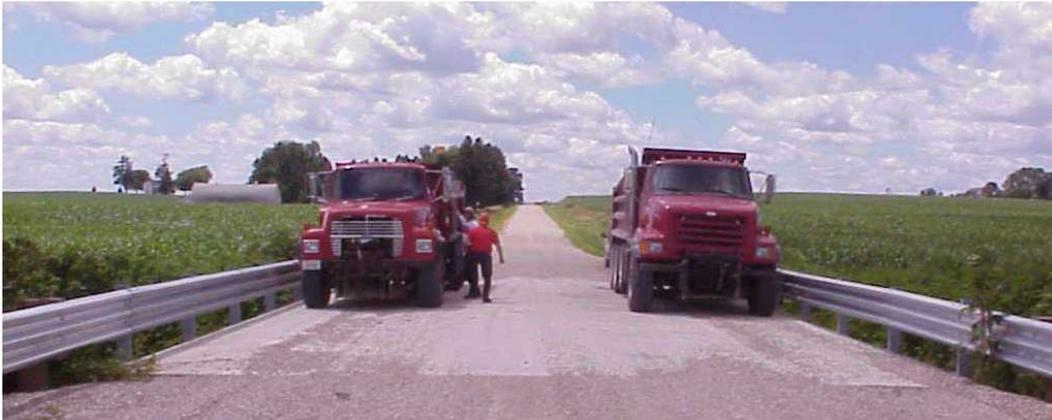
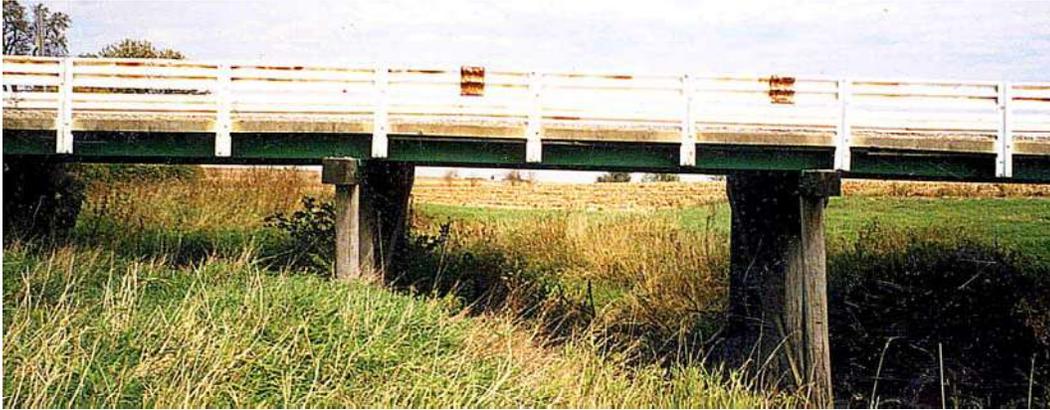
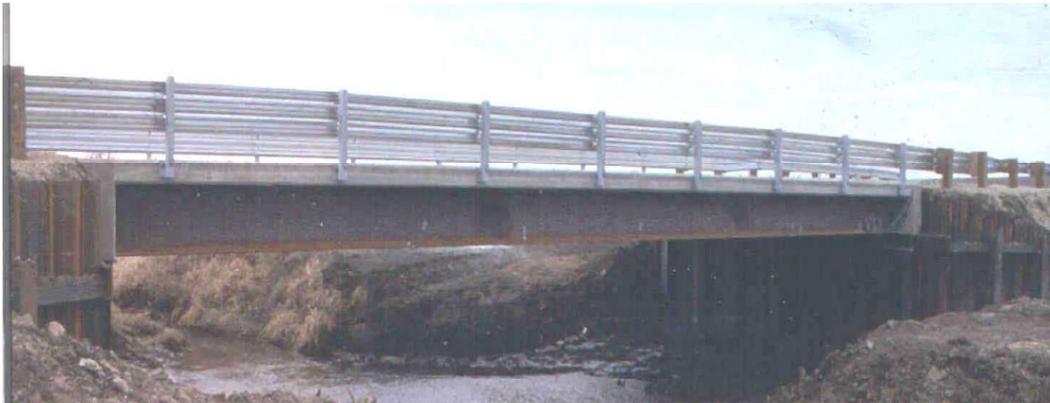
a. End view of original bridge

b. End view of replacement bridge during service load testing

Figure 1.1. Photographs of original and replacement bridges.

c. Side view of original span bridge

d. Side view of single span replacement bridge

Figure 1.1 shows the original replaced bridge as well as the replacement PCDT unit bridge. The original bridge was a 3 span I-beam bridge with overall dimensions of 58 ft in length and 20 ft in width. The replacement bridge was a single span bridge 64 ft long and 30 ft wide.

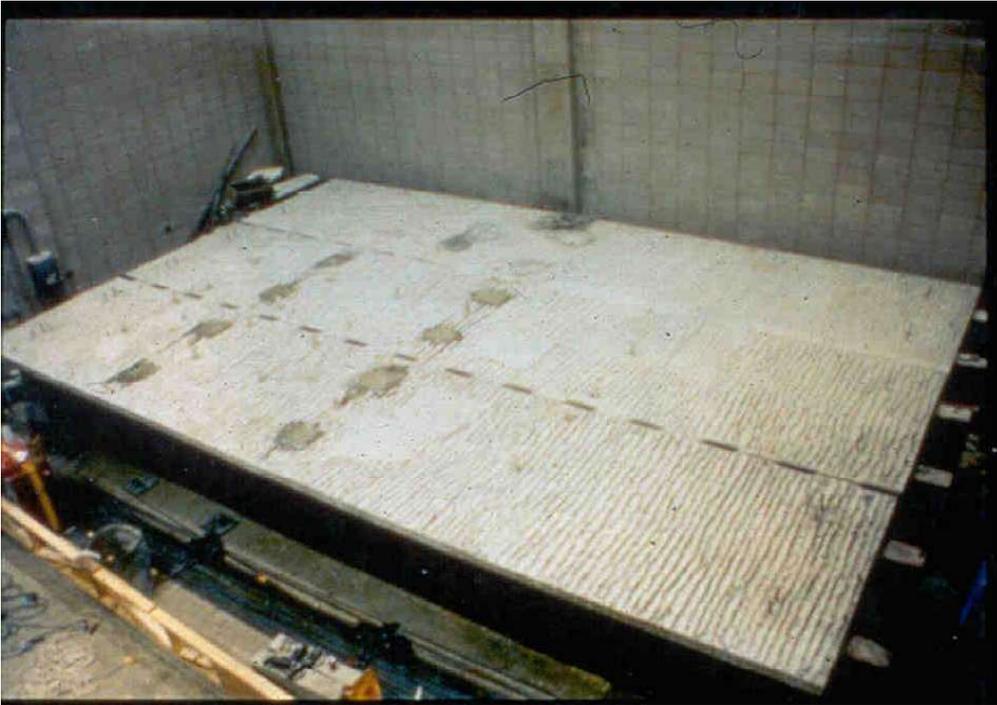
Figure 2.1. Photograph of laboratory PCDT unit bridge [4].

The steel-beam PC unit bridge system relies on composite action between the PC reinforced concrete deck and the steel beams as well as between the PC and the CIP deck [4]. Composite action between the PC reinforced concrete deck and the steel beams was accomplished with S3L 3/4 in. x 4 in. welded shear studs. The PC reinforced concrete deck was intentionally roughened ("grooves" placed in the wet PC concrete at 1 in. intervals to a

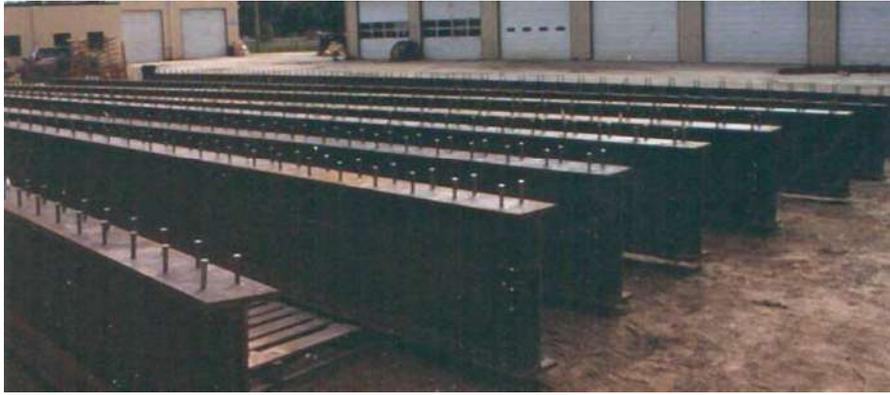
Figure 3.8. Photograph of shear studs used in PCDT units.

bend test consisted of bending a random stud to a 45° angle with respect to the beam flange; all welded studs tested passed this strength test. A photograph of the shear studs on the beams is shown in Fig. 3.8.

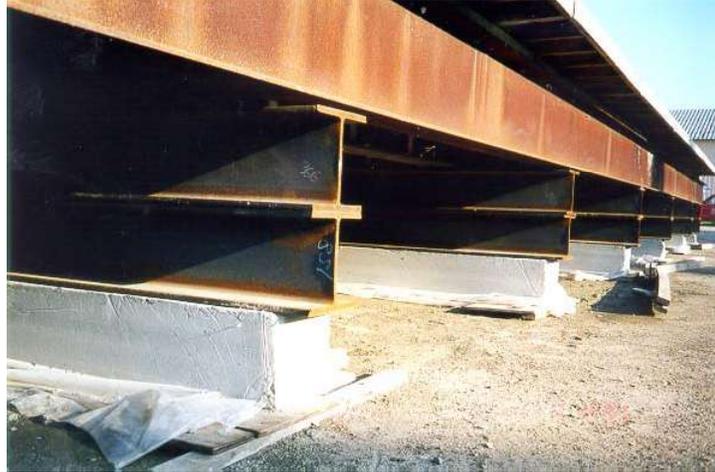
Figure 3.9. Photograph of the temporary supports used during fabrication of PCDT units.

All the units were fully shored and fabricated using normal construction procedures. As shown in Fig. 3.9, the shoring consisted of seven plain concrete cast beams 12 in. x 12 in. x 32 ft in length with two W12 x 79-32 ft long beams placed on top. These temporary supports were located on approximately 11 ft intervals. The approximate 3 ft height of the temporary supports allowed for easy access to the underside of the PCDT units during construction.

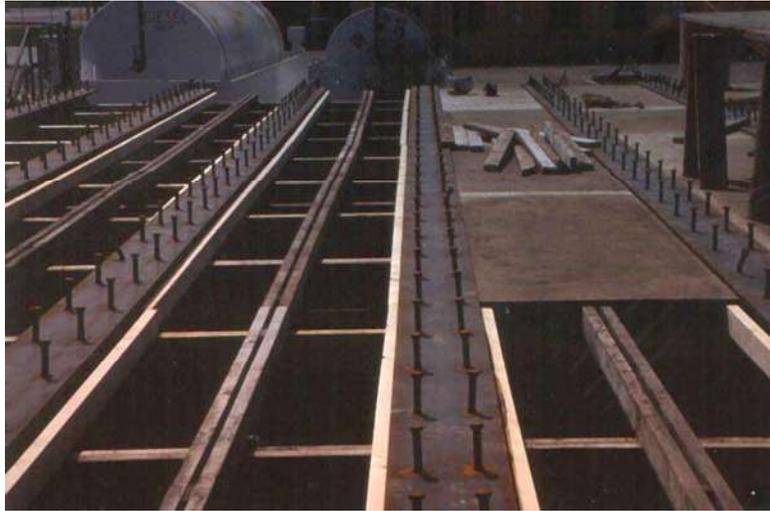
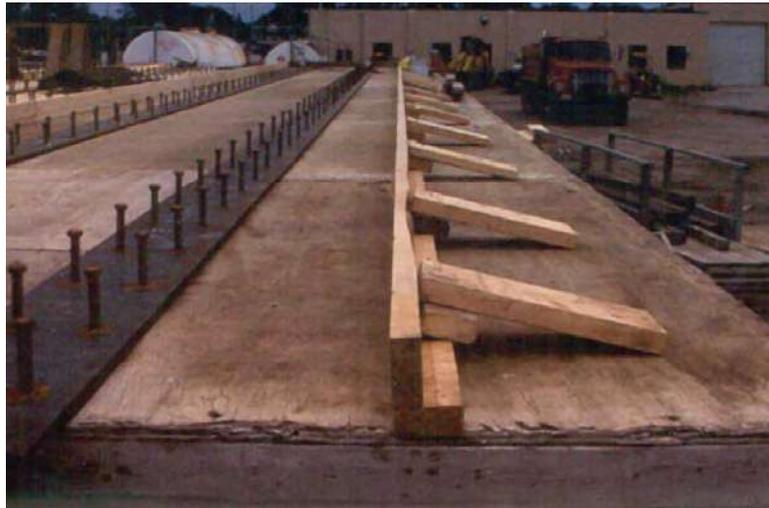
a. PCDT deck formwork

b. PCDT edge formwork

Figure 3.11. Photographs of formwork used for PCDT units.

The overhang for the exterior units was formed by utilizing W21 x 62 beams that were available at the county maintenance facility. These beams were placed on the temporary supports approximately 22.5 in. from the center of the outside W30 x 124 beams. Wall forms, 4 ft x 8 ft with 16 in. center to center stud spacing, were used as deck forms for the exterior flanges of the external units. A 2 in. x 4 in. wale was placed under the wall form (on top of the W21 x 62 beam) for strength and to provide a level surface. Support for the inside edge of the wall form was accomplished by wedging 2 in. x 4 in. studs on 32 in. centers between the flanges of the W30 x 124 beams. Photographs of some of the formwork are presented in Fig. 3.11.

Placement of concrete for each of the PCDT units was completed in one continuous pour. Units 1 and 3 (see Fig. 3.12) were cast in one day using the edge formwork shown in Fig. 3.11. Units 2 and 4 were cast one and two days later, respectively. The concrete edges of Units 1 and 3 provided the edge formwork during concrete placement operations of Units 2 and 4. A layer of 4-mil polyethylene film was placed between adjacent units in the longitudinal direction to provide a bond break. In addition, wood blockouts were placed on top of the PC connector channels to create a void in the concrete for placement of the weld plates later in the construction process (see Fig. 3.13). The concrete was transported from ready-mix trucks to the PCDT forms using a concrete bucket and mobile truck crane after which it was spread, and vibrated as necessary. Screeding of the top surface was performed to obtain the required deck thickness. Steel troweling followed the hand screed process to

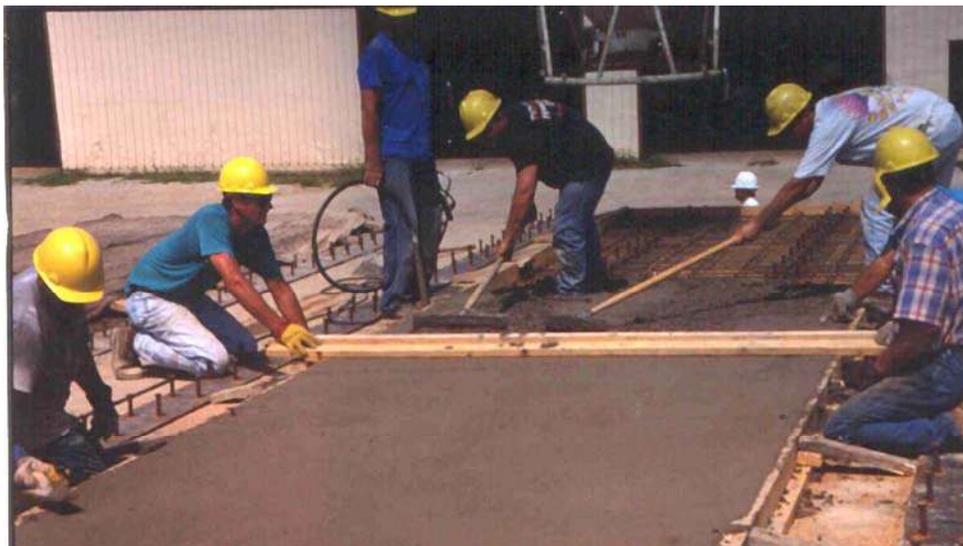
Figure 3.14. Concrete placement operation for PCDT units.

provide a hard, dense surface free of defects. As previously noted, composite action between the PCDT and CIP concrete slabs was critical in the design. Therefore, the top surface of the PCDT slab was intentionally roughened in the transverse direction to provide the shear transfer mechanism between the two slabs. The "grooves" were scarified in the wet concrete using a bull float with lumber strips, approximately 1/4 in. wide on 1 in. centers nailed to the underside. The concrete placement process operation is shown in Fig. 3.14, with the final product shown in Fig. 3.15.

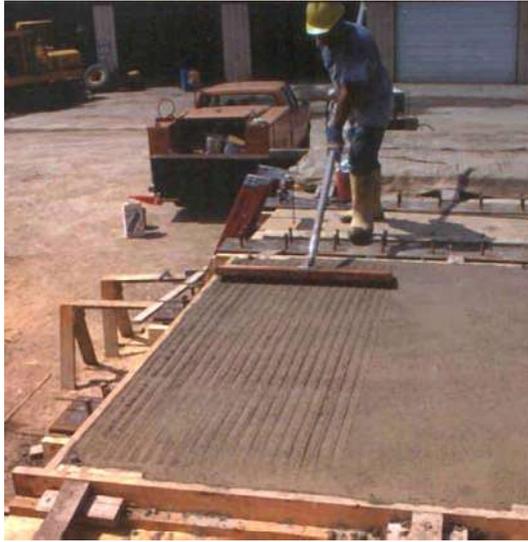
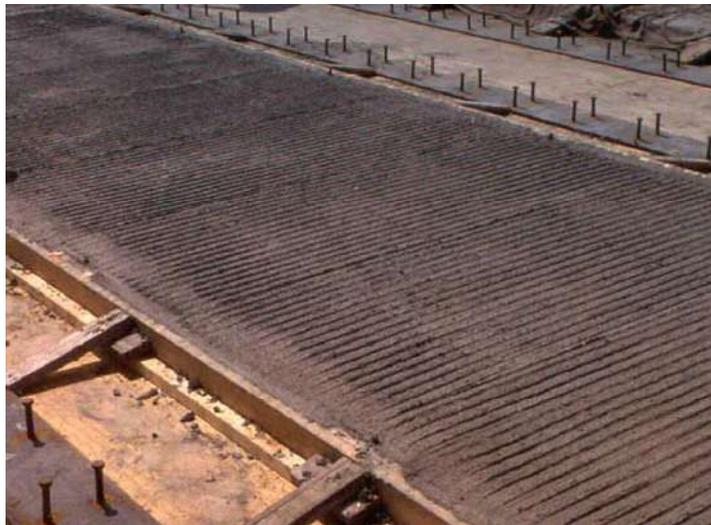
a. Placement of "grooves" for PCDT units.

b. Photograph of "grooves".

Figure 3.15. Intentionally roughened surface of PCDT units.

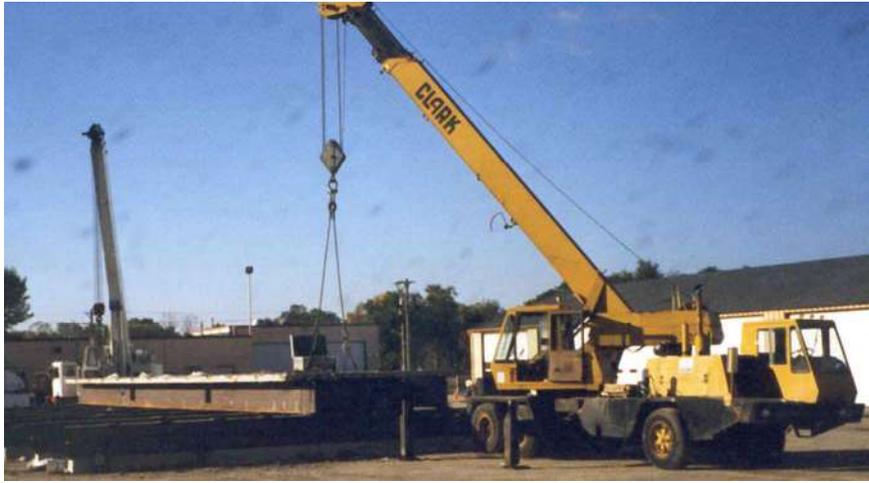
Figure 3.16. Photograph of lifting one PCDT unit at county maintenance facility.

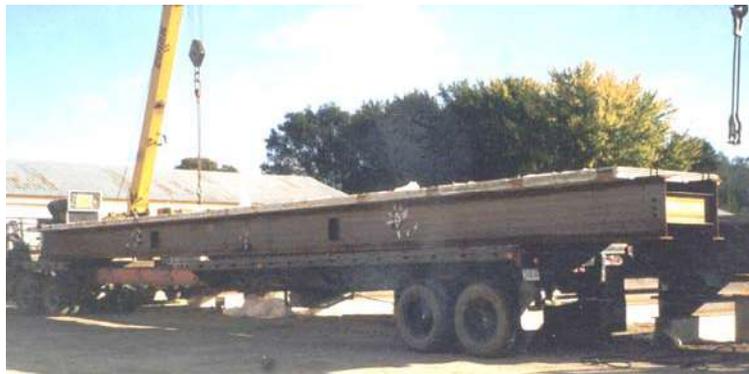
Figure 3.17. Photograph of one PCDT unit on flat bed.

The flat bed trailers were both extended to the length of 60 ft and were limited to a capacity of 80,000 lbs. and 100,000 lbs. based upon the number of axles (20,000 lbs./axle). The units, weighing approximately 46,400 lbs. each, were placed as close to the front of the trailers as possible. However, as shown in Fig. 3.17, each PCDT unit cantilevered approximately 4 to 6 ft off the back of the trailer.

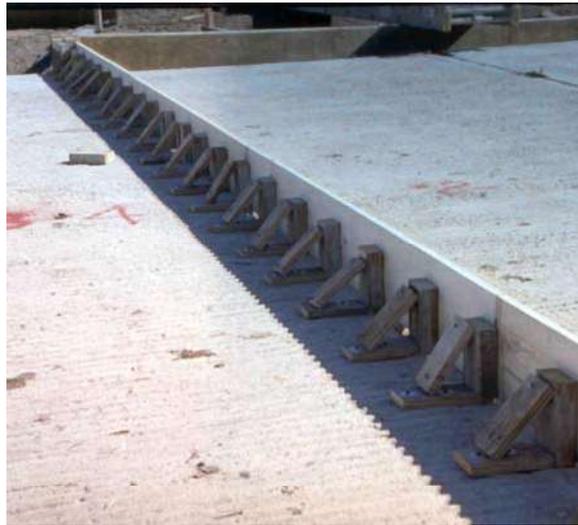
Figure 3.19. Formwork at bridge centerline for CIP deck placement.

Upon completion of welding the PCDT connectors, the units were ready for the CIP portion of the deck. The CIP deck was placed in two separate sequences. The longitudinal centerline of the bridge divided the two concrete placement operations (North and South). Formwork for lateral containment of the concrete on the outside edge of the exterior PCDT units (Units 1 and 4) was accomplished by attaching a 1 in. x 8 in. board with Tap-Con screws to the PCDT slab. The CIP deck thickness along each outside edge was 4 in. The formwork at the longitudinal centerline consisted of nominal 1 in. thick boards attached to vertical 2 in. x 4 in. boards at 12 in. intervals. The 2 in. x 4 in. vertical boards were attached to 3/4 in. nominal thickness plywood pieces used as bracing for the formwork (see Fig. 3.19). The CIP concrete depth at the bridge centerline was approximately 7 in. (2% slope). A 2 in. x 4 in. board was nailed onto the inside face of the longitudinal centerline

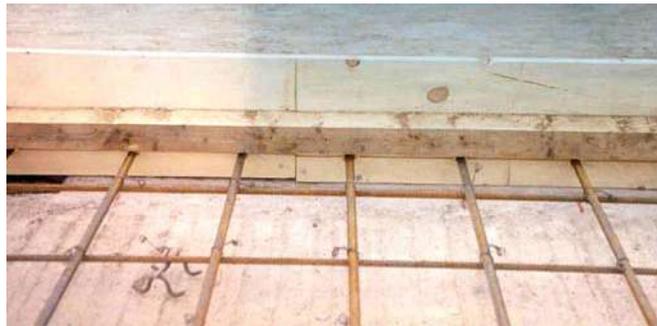
Figure 3.20. Photograph of the keyway placed on longitudinal formwork.

form to create a keyway for the next concrete placement (see Fig. 3.20). A keyway was also placed on the inside face of the formwork for each end diaphragm. Appropriate snap-tie spacing and bracing was utilized at the discretion of Cramer and Associates, Inc.

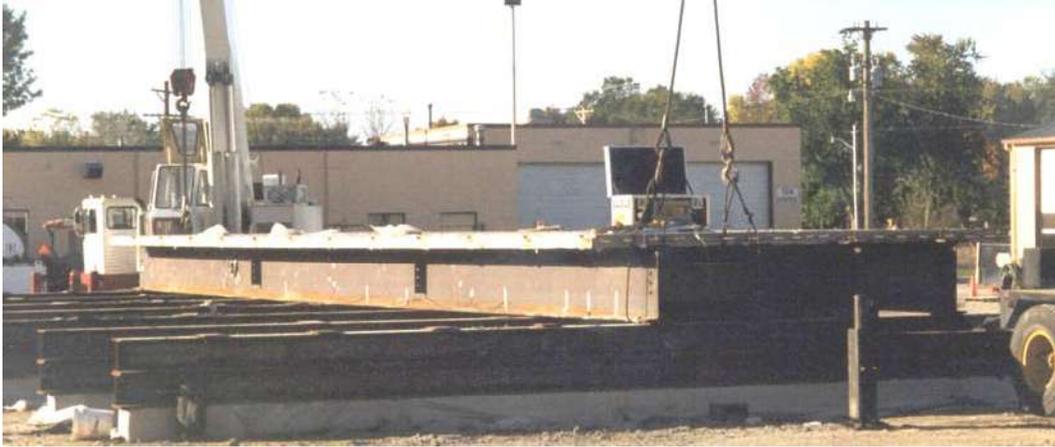
Figure 4.3. Data acquisition cargo box secured onto PCDT Unit 2.

cables. As shown in Fig. 4.3, the data acquisition system was placed in a protective cargo box on top of the PCDT concrete deck and held securely in-place with tie-down straps. This test was stopped once the PCDT unit was properly positioned on the transport unit.

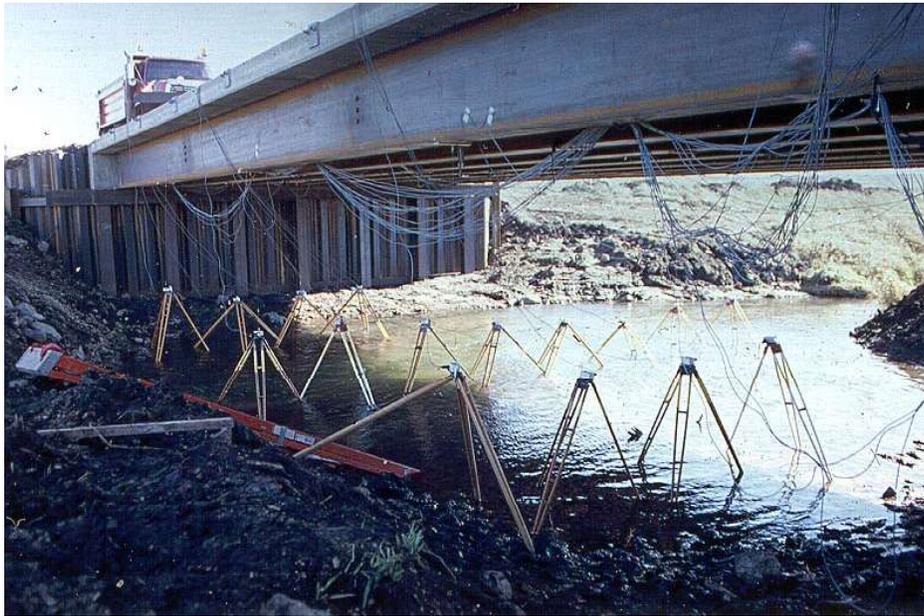
Figure 4.5. Photograph of displacement transducers on tripods during service load tests.

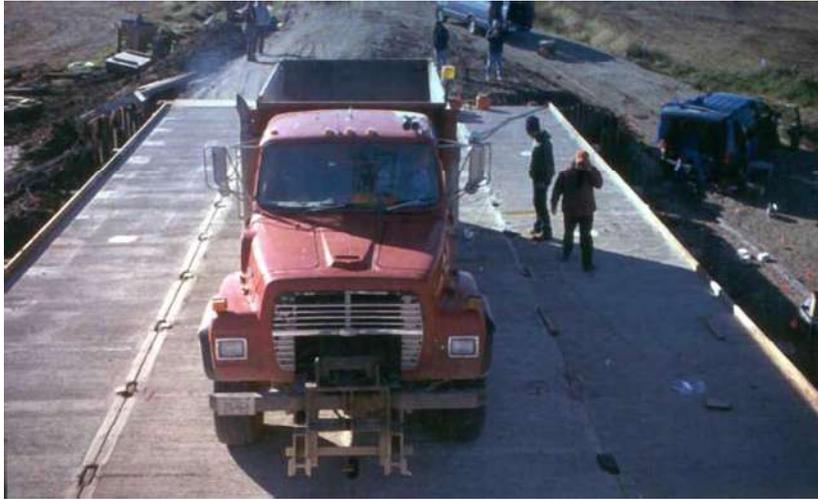
Fig. 4.8. First service load test, truck in position C3.

Prior to having the truck cross the bridge in one of the five lanes, all the strain gages and displacement transducers were initialized. The truck was then placed at the first position (B1) and all strain gage and displacement transducer measurements were read and recorded. Without re-zeroing the instruments, the truck was moved to the second and third positions (C1 and D1) and all instrument measurements were again read and recorded. The truck was then removed from the bridge and all instrument measurements were again read and recorded (i.e. final zero reading). This process was repeated for each of the remaining four lanes. A photograph taken during the first service load test is shown in Fig. 4.8.

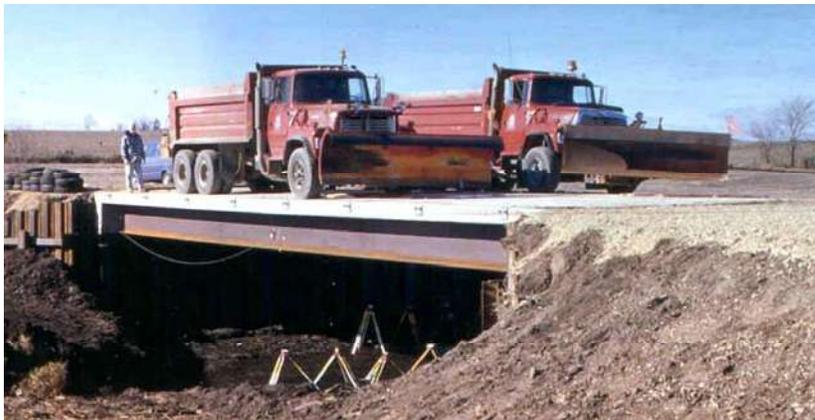
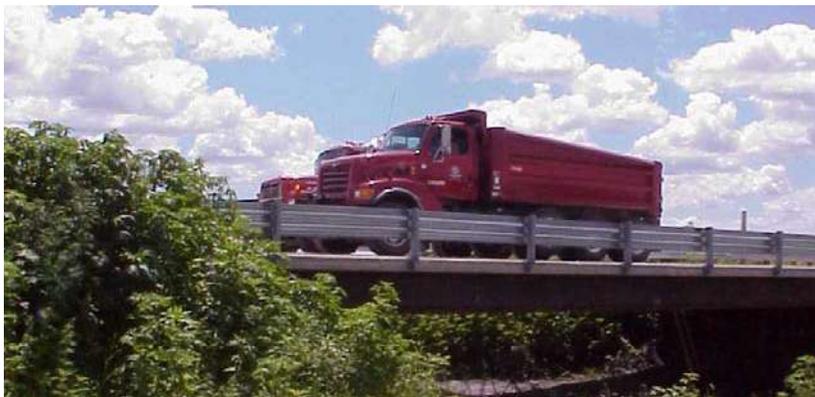
a. Trucks in Position B1 and B5

b. Trucks in Position C1 and C5

Figure 4.12. Second and third service load tests.

In both the second and third service load tests, after completing the testing involving one truck, two additional tests were performed in which both tandem axle trucks were placed on the bridge simultaneously. A photograph, Fig. 4.12a, taken during the second service load test shows the two rear tandem axle trucks at Positions B1 and B5; Fig. 4.12b was taken during the third service load test and show the trucks at Positions C1 and C5. Figure 4.13

illustrates the positions of the two rear tandem axle trucks as they crossed the bridge in 2 different lanes headed east. As shown in this figure, Truck No. 23 was positioned using the center of the left rear tandem axles, while Truck No. 35 (or Truck No. 38 in the third test) was positioned using the center of the right rear tandem axles; data were only taken when both trucks were at the same transverse section, that is at Sections B, C, or D. Thus, data were taken with each of the two trucks at 6 different locations on the bridge. Tests were identified by transverse section (B, C, or D) and longitudinal location (1, 2, 4, or 5). Thus, B1 and B5 indicates that Truck No. 23 was at Section B, Lane 1 with Truck No. 35 (or Truck No. 38) at Section B, Lane 5.
