EXPANSIVE MINERAL GROWTH AND CONCRETE DETERIORATION

Final Report
For Iowa DOT Project HR-384

Sponsored by the Iowa Department of Transportation
Project Development Division and
the Iowa Highway Research Board

September 1997

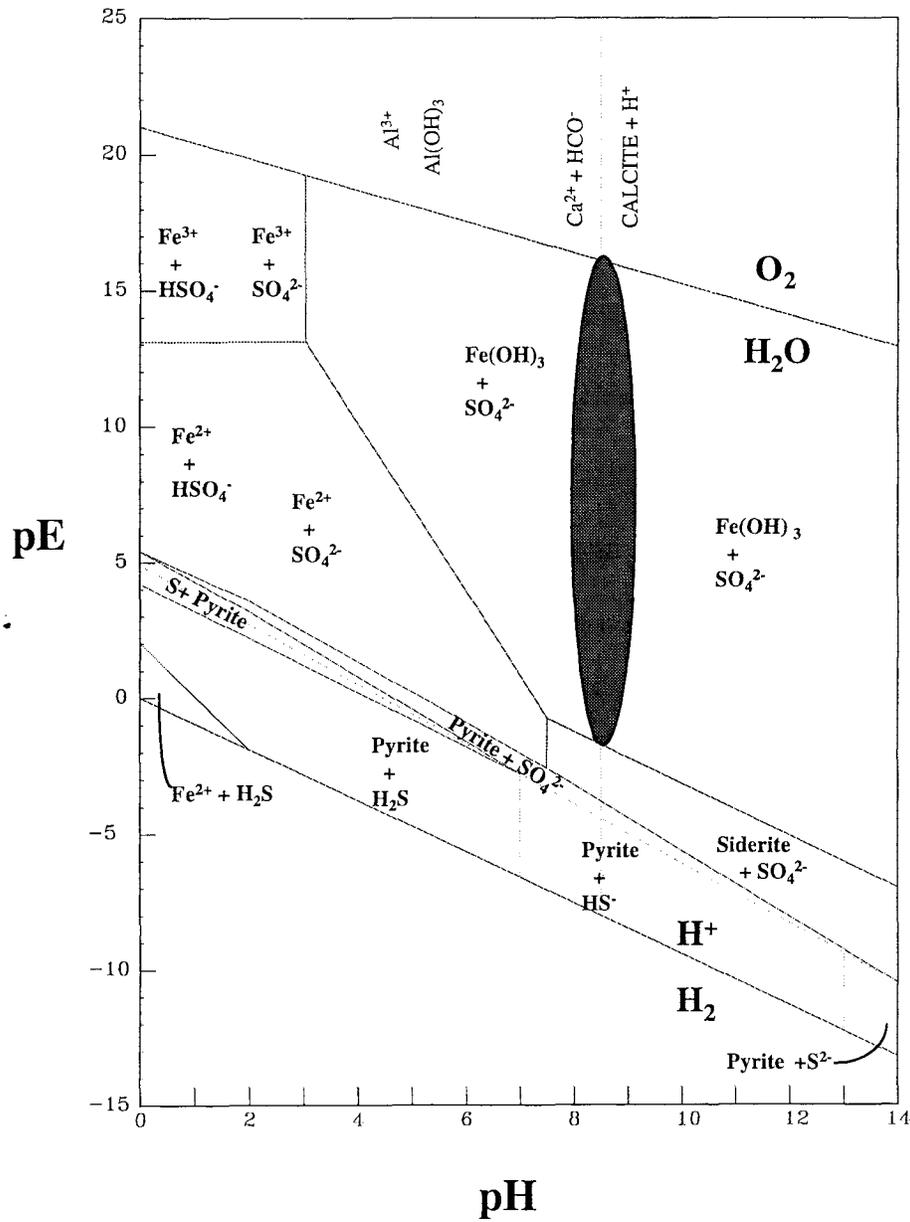
Fig. T1. A stability diagram for selected iron minerals at 25°C and $\Sigma Fe=10^{-4}$, $\Sigma S=10^{-2}$, $\Sigma Ca=10^{-4}$ mole/liter and $PCO_2=10^{3.5}$ bar. The shaded area indicates the probable pE - pH values associated with calcite dissolution in pore waters (after Chinchon et al. 1995)

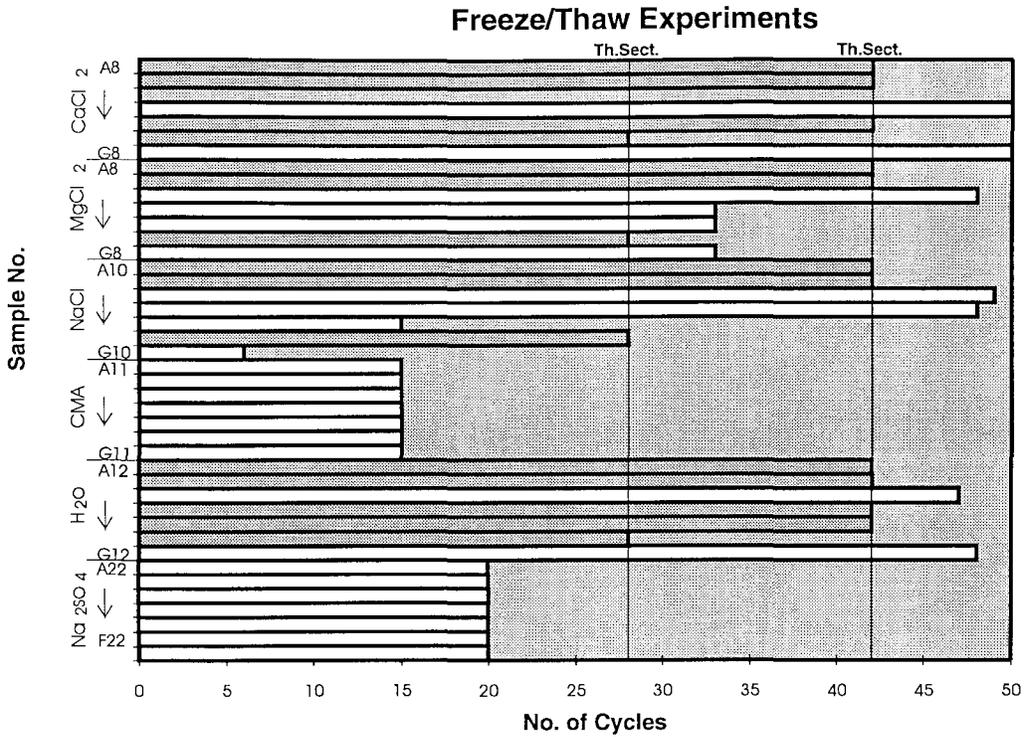
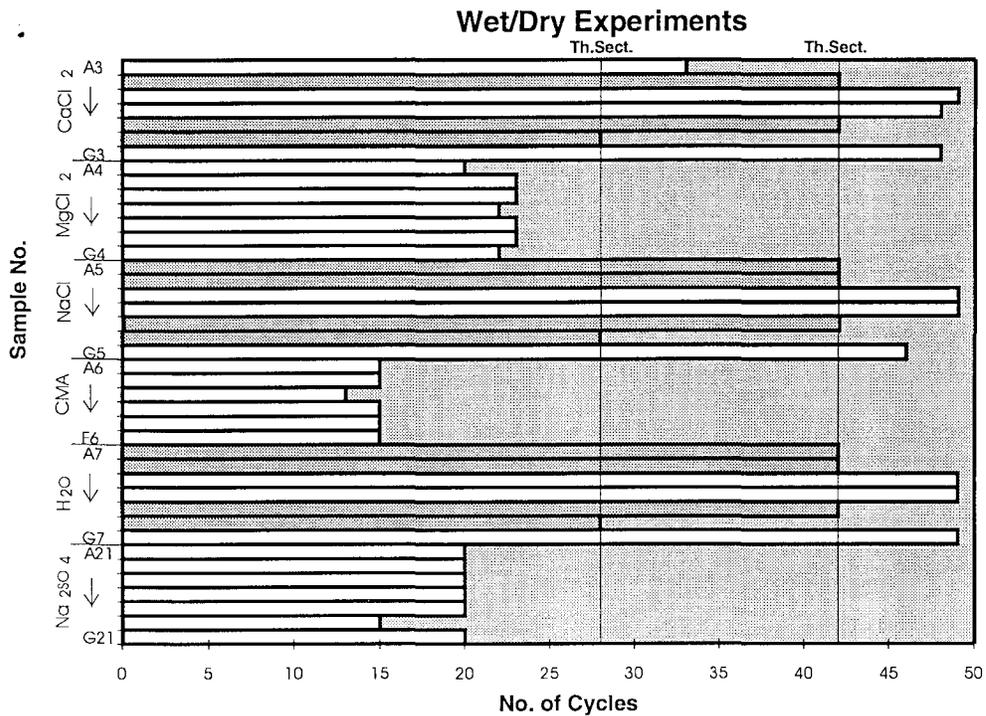
Fig. T2. Wet/dry and freeze/thaw cycling experiments. The dark bars represent experiments that were terminated early in order to make thin sections or for other reasons. Light bars represent experiments that were terminated because of significant sample deterioration. Th. Sec. = thin sections.

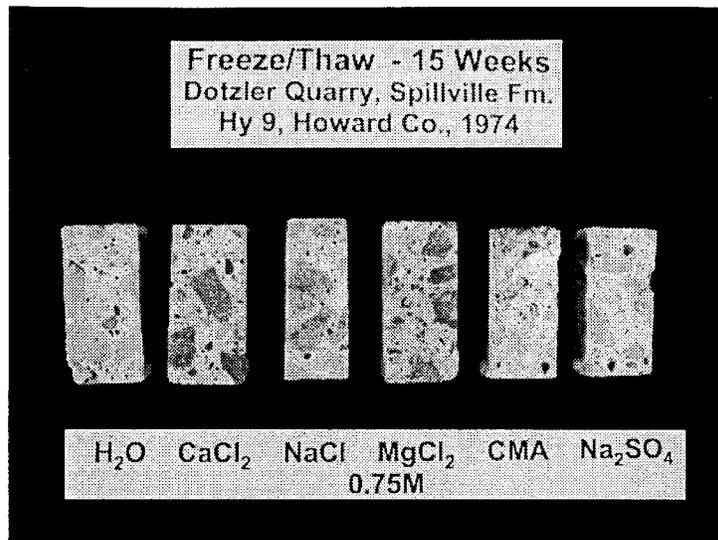
Fig. T3a. Experimental deterioration of concrete using freeze-thaw conditions for 15 cycles. Note that using the relatively dilute solutions with freeze/thaw cycling produces almost no visible damage to the concrete samples.

As shown in Figures T3a and T3b, it is apparent that CMA caused the most aggressive degradation of concrete in both W/D and F/T experiments. All CMA-treated samples showed deterioration by 15 cycles. Wet/dry cycle degradation was the worst, producing brown color, crumbling, failure of the paste-coarse aggregate boundary, and the general appearance of paste dissolution.

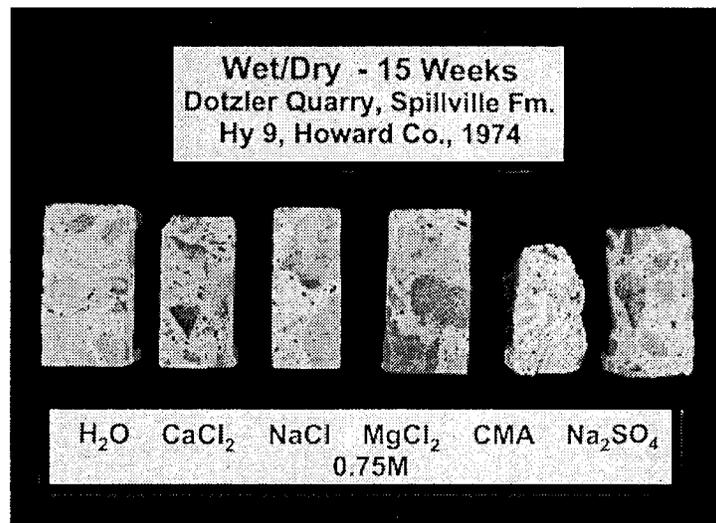
Fig. T3b. Experimental deterioration of concrete using wet/dry cycling for 15 cycles. Damage is especially noticeable with sodium sulfate and calcium magnesium acetate (CMA).

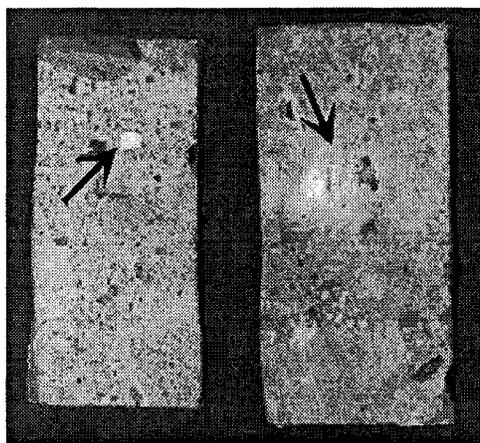
Fig. T4. Expansive white chert with secondary mineral formation. The photograph on the left shows pre-experiment white chert, and that on the right shows a similar chert particle after reaction during wet/dry cycling with NaCl.

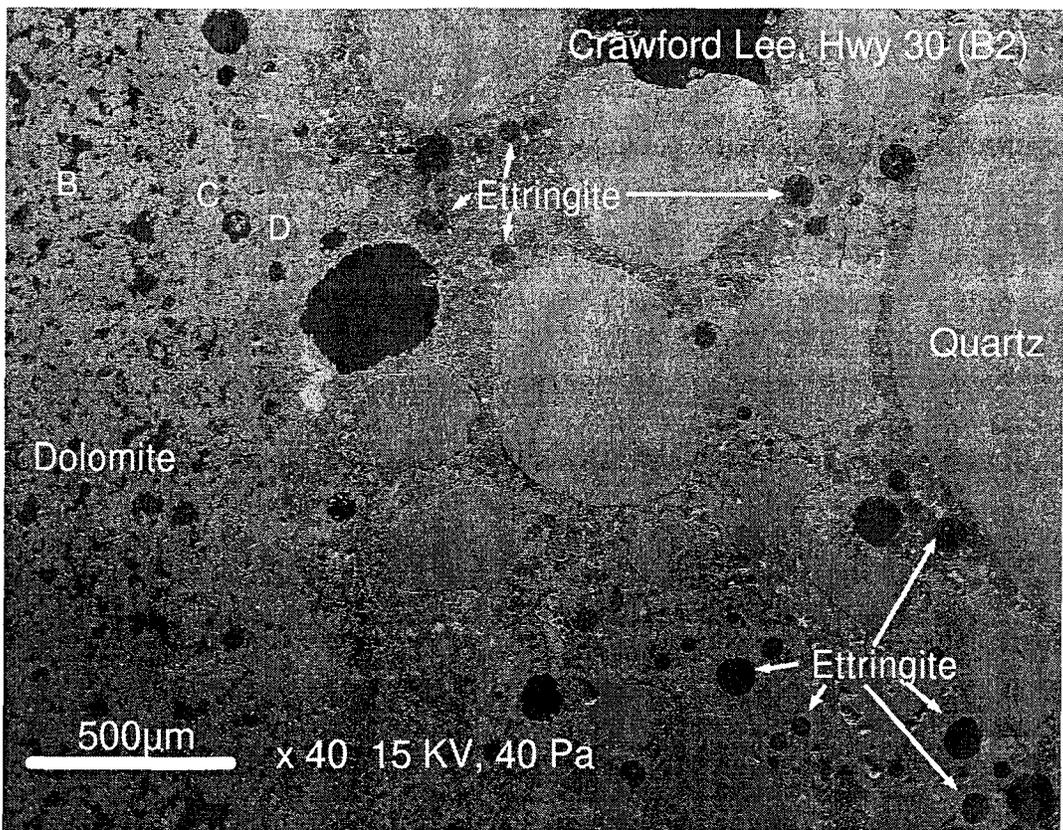
Fig. 1

US 30. Reactive dolomite coarse aggregate is shown on the left side of the SEM micrograph. It consists of poorly-crystallized, very small, dolomite crystals with abundant voids between the crystals. Reaction rims are observable in the dolomite aggregate and cement paste; interface type sequence is A+B+C+D+E, with Zone A lying outside the micrograph view. The rim zones are indicated on the photograph by the appropriate capital letter, for example Zone A is shown by the letter 'A'. Both void-fill and void-rim ettringite crystals are present in air-entrainment voids in the cement paste. There is more abundant ettringite in the paste outside the light-colored paste rim (Zone D) compared to the amount in the rim (D). EDAX area maps show that brucite is widely disseminated throughout the cement paste.

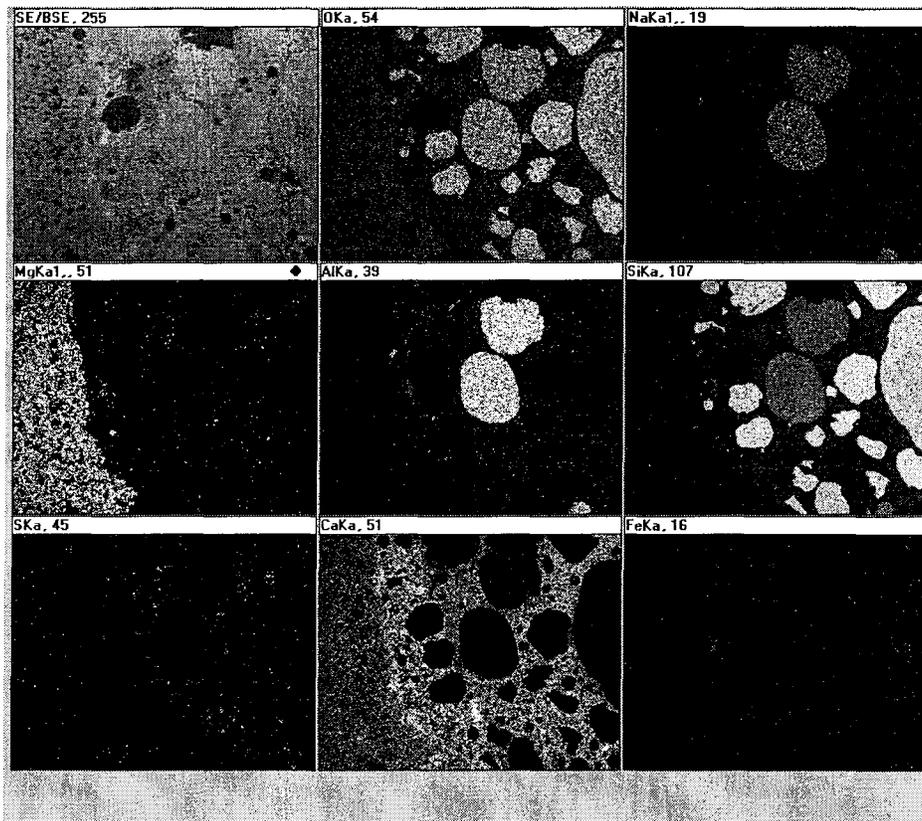
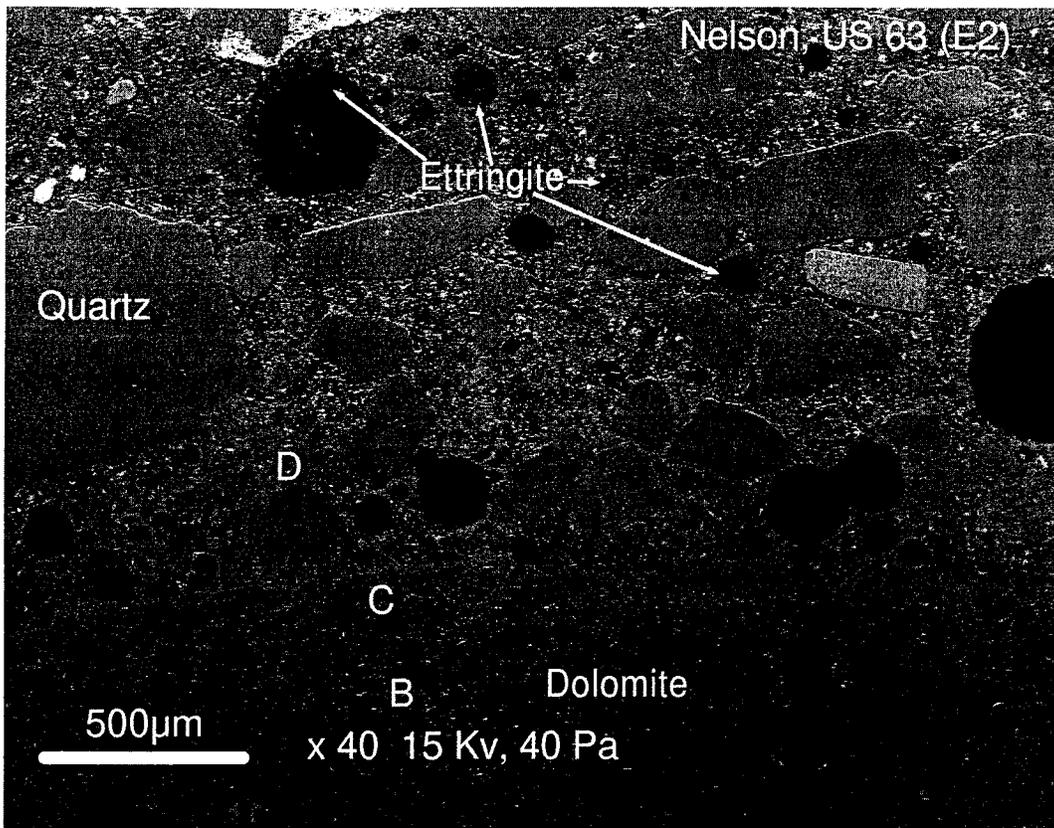
Fig. 2. SEM micrograph and EDAX area maps of Nelson quarry concretes from US

63. The SEM view shows the interface area between dolomite aggregate and cement paste. The reactive dolomite aggregate particles consist of poorly-crystallized, fine-grained, dolomite crystals with abundant voids. Well-developed reaction rims are clearly seen in the dolomite aggregate and cement paste; interface sequence is A+B+C+D+E, with Zone A lying outside of the micrograph. Note that no ettringite forms in air-voids in the light colored cement paste Zone E. Cracks are often spatially associated with ettringite void-fillings. Note also the calcium-rich cement paste region, Zone D, immediately outside the aggregate particle (evident in the Ca-map).

concrete voids (See Fig. 2 for comparison).

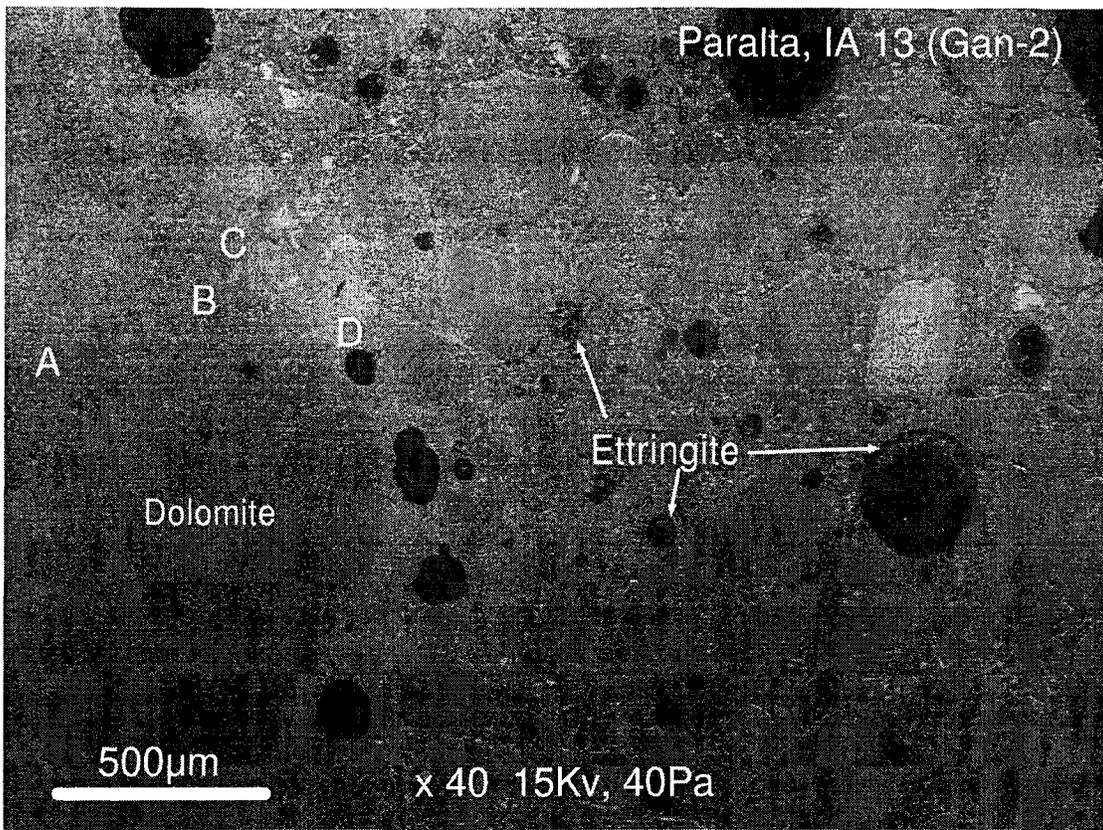
Fig. 3

13. Reactive coarse aggregate is composed of very small, poorly-crystallized dolomite. Well-developed reaction rims clearly seen in the aggregate and paste exhibit the sequence A+B+C+D+E. Ettringite is visible in air-entrainment voids in cement paste Zone E. The EDAX element maps show that abundant brucite crystals are disseminated throughout the paste. More abundant and larger-sized brucite crystals are present in the cement paste Zone E.

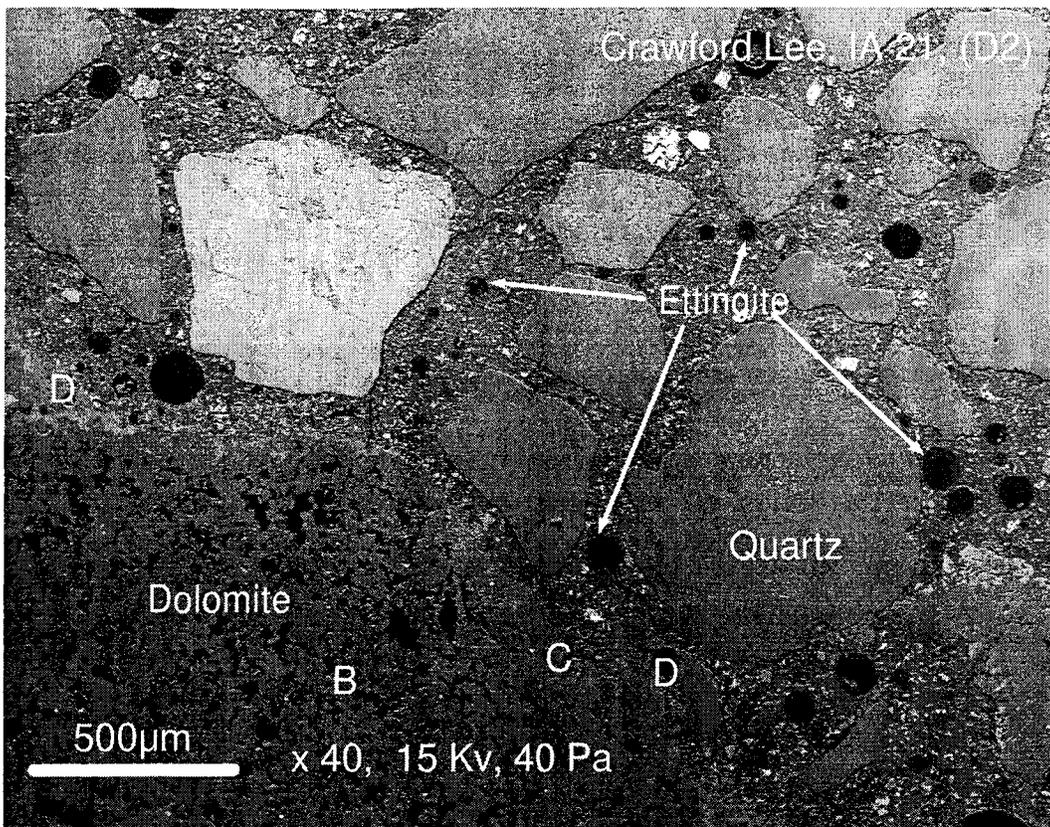
Fig. 4

Fig. 4. SEM micrograph and EDAX maps of Crawford Lee quarry concretes from IA 21. The SEM micrograph shows the dolomite aggregate-cement paste interface in highway concrete taken from IA 21, back-scattered electron image. Abundant voids are evident in the dolomite aggregate, and the interface sequence is (A or B)+C+D+E. Both void-fill and void rim ettringite occur in small air-entrainment voids in the cement paste. The corresponding EDAX maps show that brucite occurs throughout the cement paste. Ettringite is more abundant outside the light-colored paste rim (Zone D) than it is in this zone.

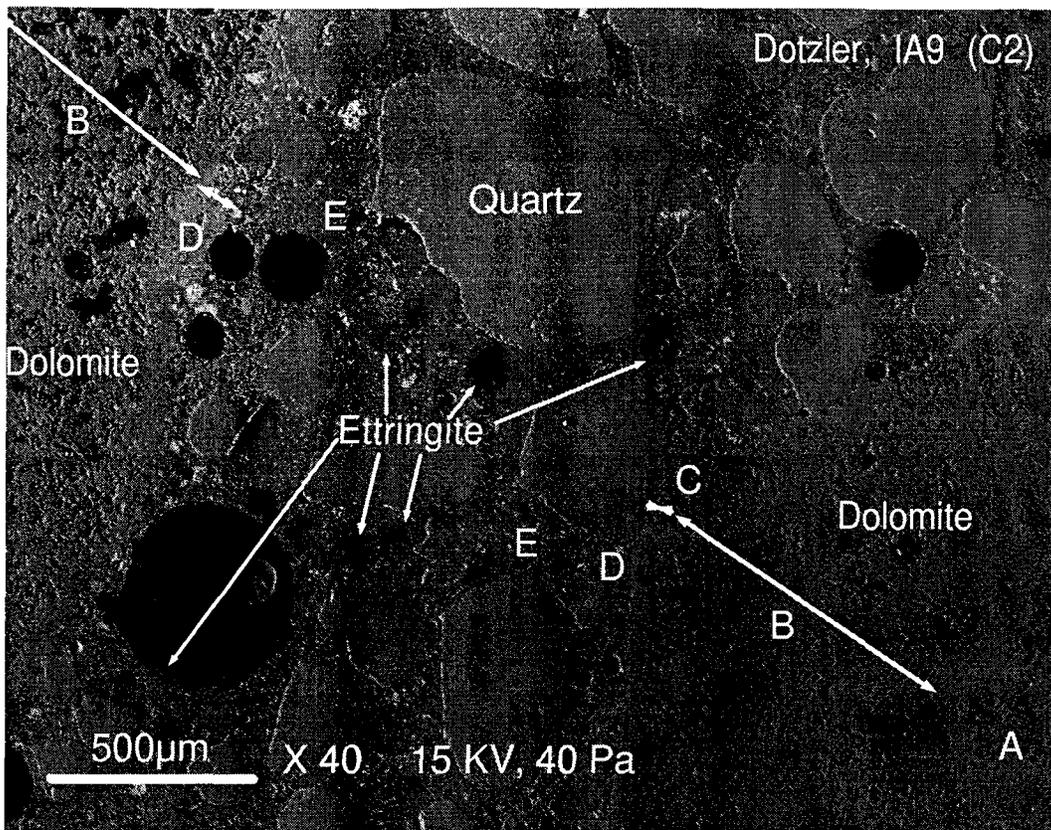
Fig. 5

Fig. 5. SEM micrograph and EDAX area maps of Dotzler quarry concrete from IA 9. The dolomite aggregate-cement paste interface area is shown in the back-scattered electron image and in corresponding EDAX area maps. The two reactive coarse aggregate particles consist of very fine-grained and poorly-crystallized dolomite. Reaction rims observable in the dolomite aggregate and paste show the sequence A+B+C+D+E and A+B+D+E, with Zone A lying outside of the micrograph. Both types of ettringite are present in air-entrainment voids in the paste Zone E. The Mg and O EDAX element maps show that abundant brucite crystals are disseminated throughout the paste.

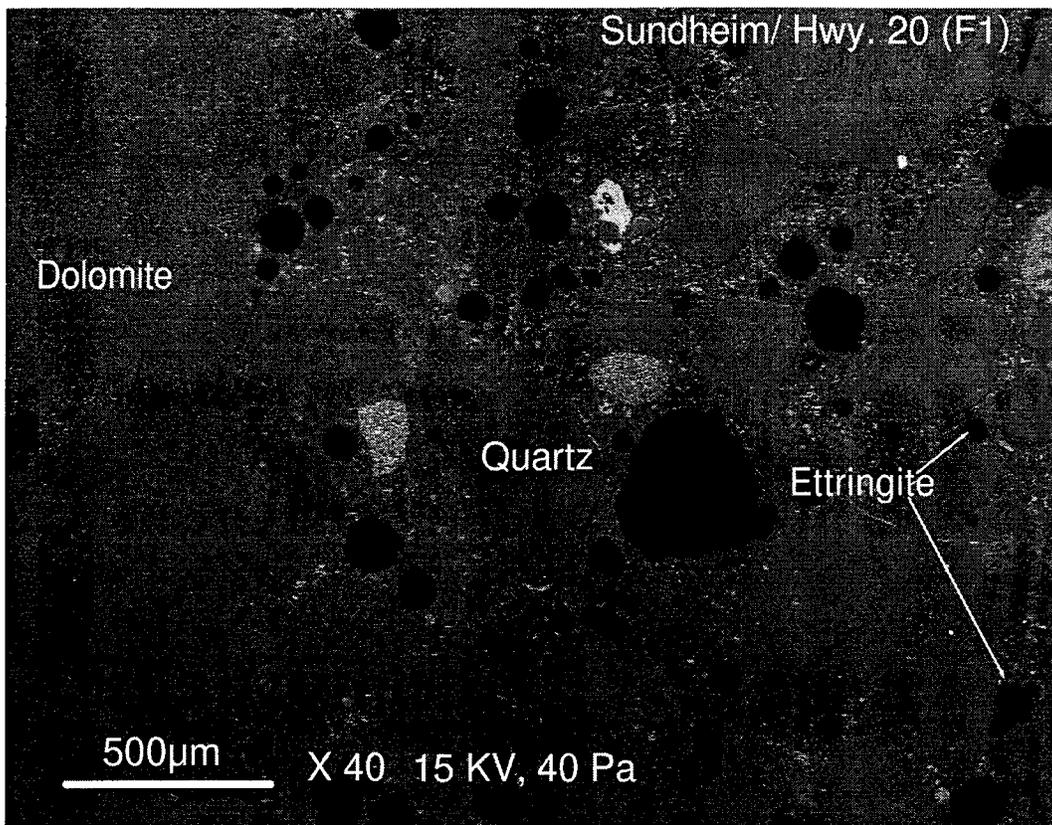
Fig. 6

Fig. 6. SEM micrograph and EDAX area maps of Sundheim quarry concrete from US 20. Non-reactive coarse aggregate is composed of coarse-grained, well-crystallized dolomite. No significant reaction rims are observable in the A+(D)+E sequence. Limited amounts of ettringite form in the very small air-entrainment voids in the cement paste. EDAX element maps show that a little brucite is present in the cement.

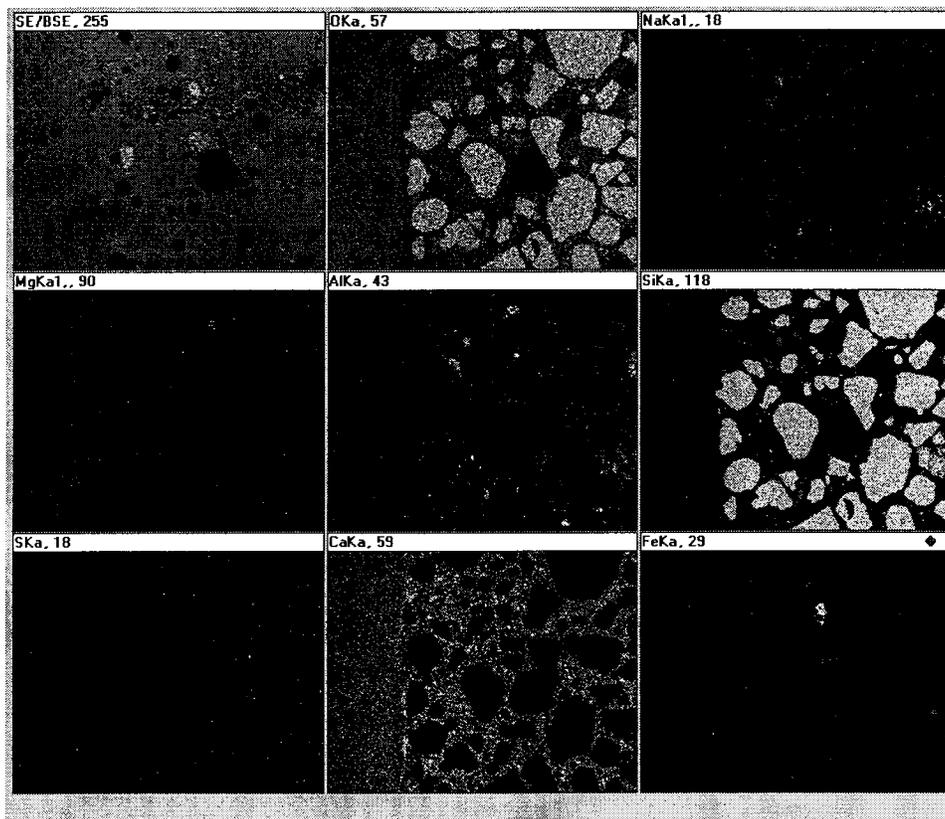
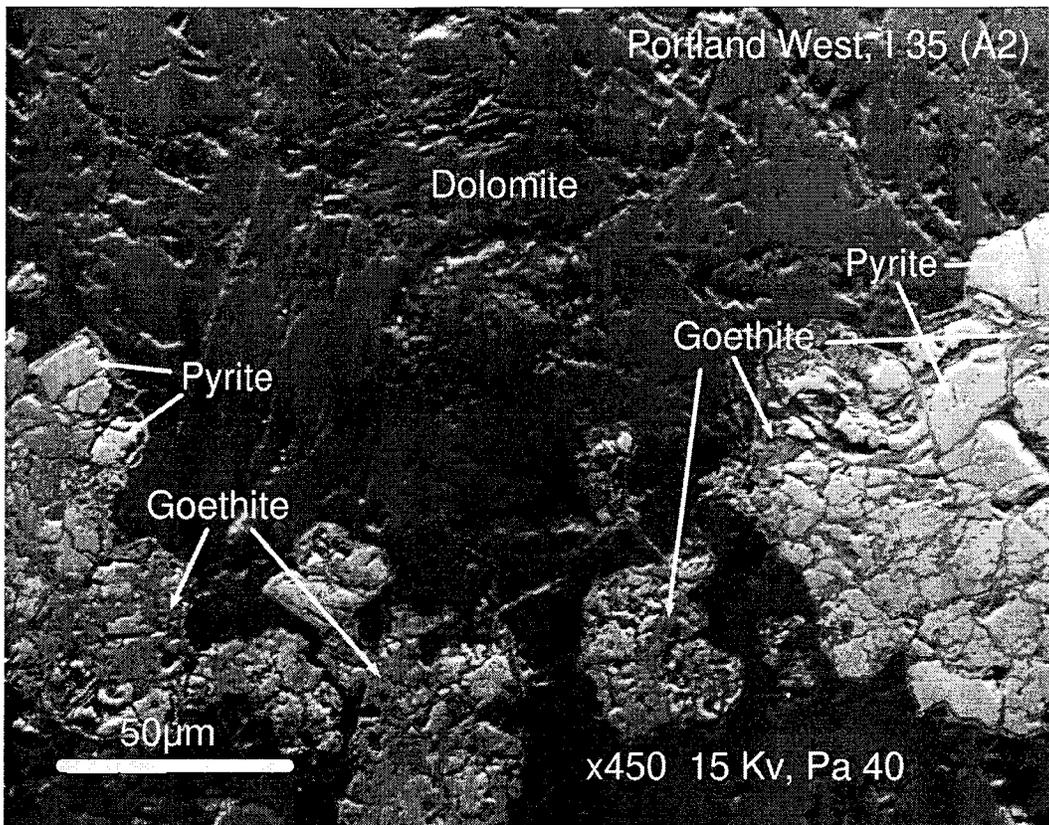
Fig. 7

Fig. 7. SEM micrograph and EDAX element maps showing the oxidation of large pyrite inclusions in dolomite aggregate from Portland West quarry, I 35.

Note the large pyrite mass on right side of photograph. Oxidation occurs on its outer surface and along fractures. The pyrite mass shown on the left side of photograph has been almost entirely replaced by goethite.

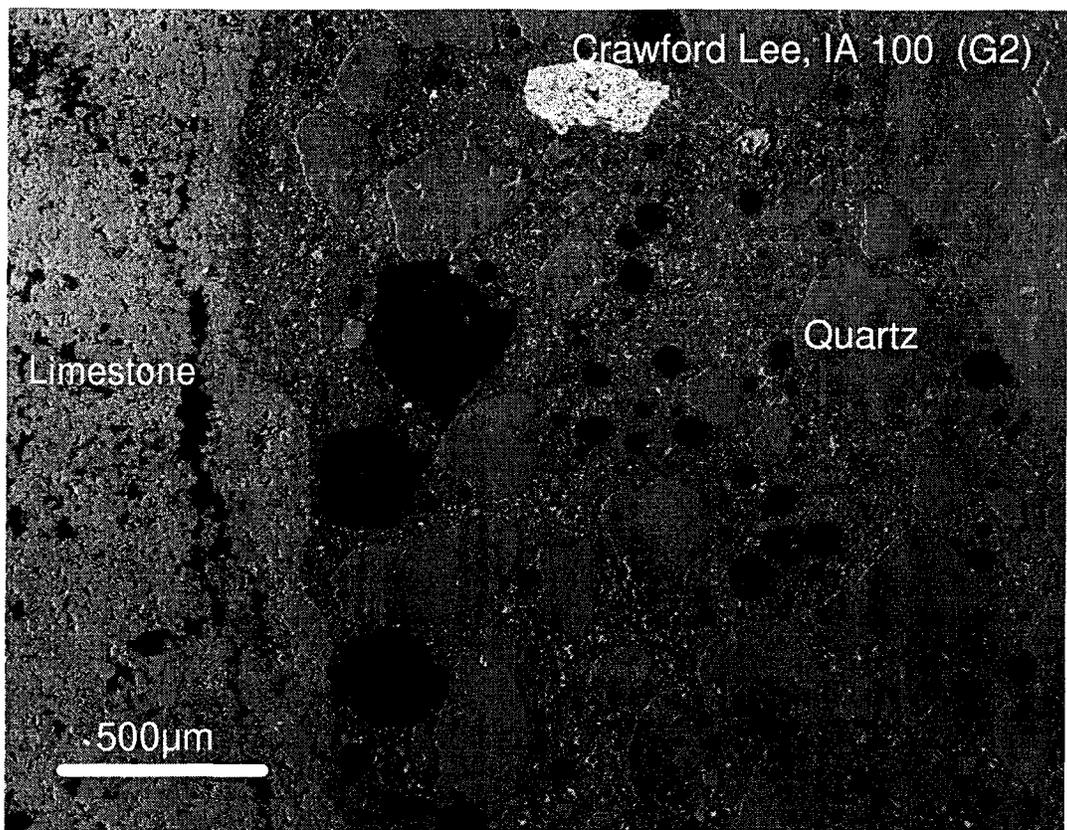
Fig. 8

Fig. 8. SEM micrograph and EDAX area maps of Crawford Lee quarry concrete from IA 100. The coarse aggregate is mostly limestone. No reaction rims are observable at the interface and this fact indicates that the aggregate is essentially non-reactive. Ettringite occurs in the extremely small air-entrainment voids and is evenly distributed in the paste. A very small amount of brucite is identified with the EDAX element maps.

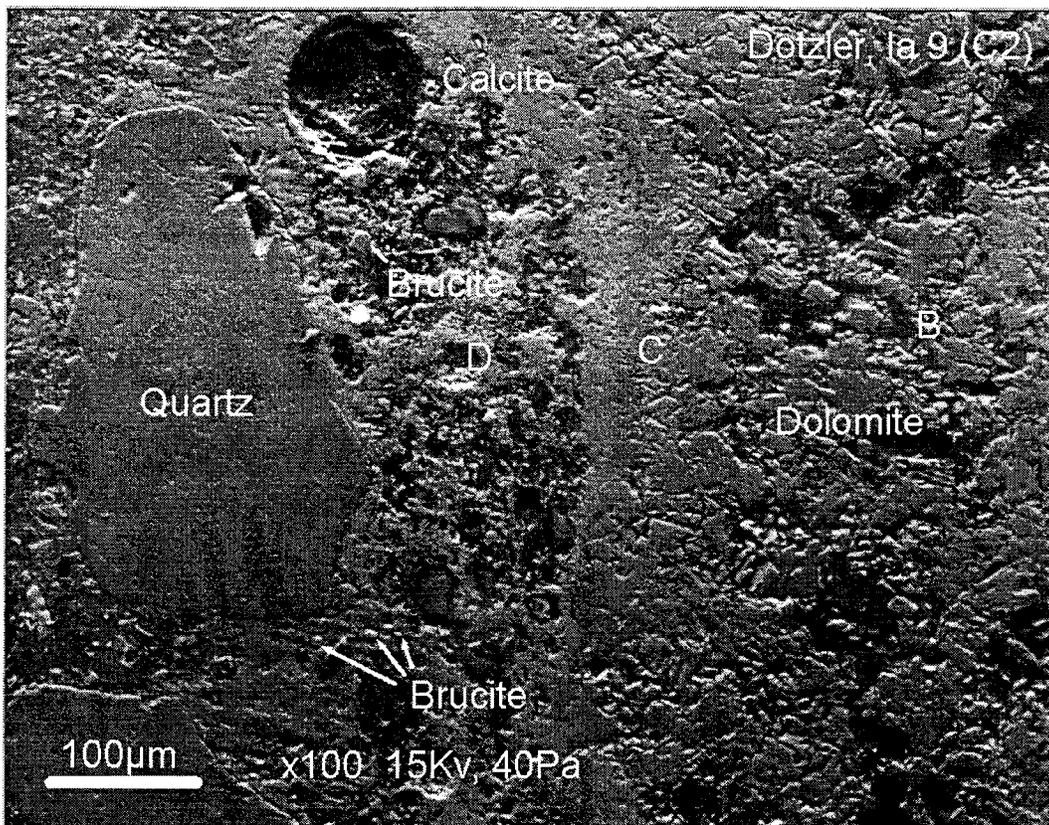
Fig. 9

Fig. 9. SEM micrograph and EDAX area maps showing brucite occurrence in the dolomite aggregate and cement paste. Relatively larger, euhedral to subhedral, brucite is present in the calcite-rich matrix of the light-colored cement paste rim (Zone D). The EDAX area maps show that magnesium concentrations correspond to the oxygen concentrations, and verify brucite locations. Larger brucite crystals form in the paste compared to those in the dolomite aggregate interior where only extremely-small white spots are visible in corresponding Mg-O element maps. The extremely small grain size and dissemination along interstitial spaces in dolomite aggregate indicate that most of the brucite in dolomite aggregate interiors may exist as microcrystalline coatings on the surface of dolomite crystals. It can be clearly seen that much calcite accumulated in interstitial voids in the dolomite aggregate and in the reaction rim (zone D) of the cement paste.

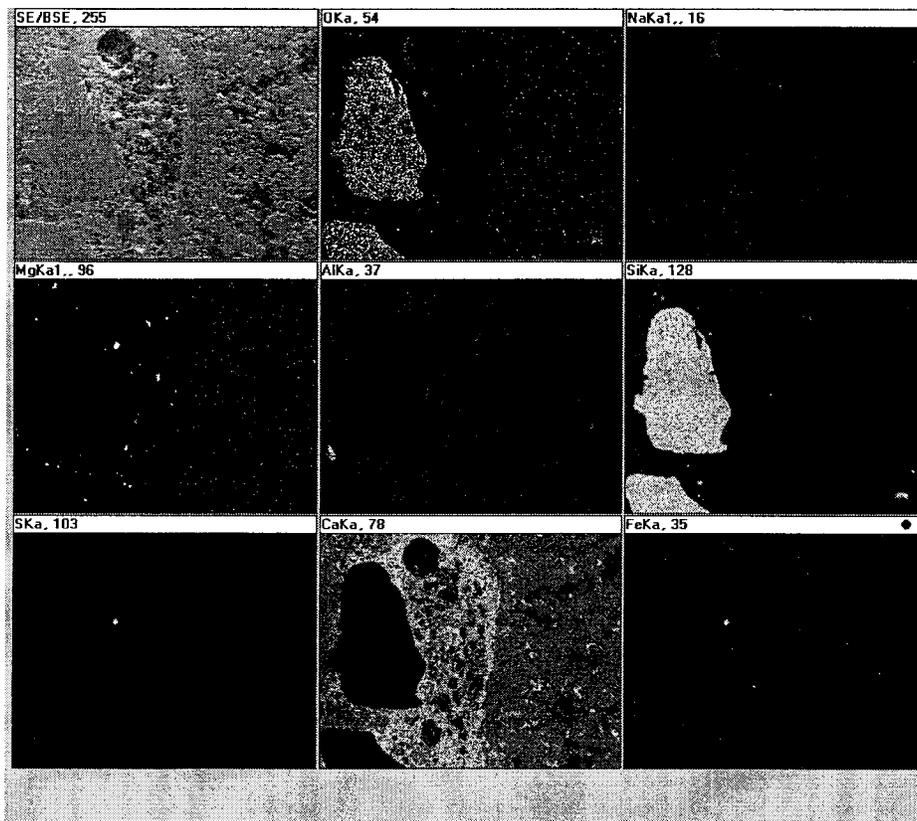
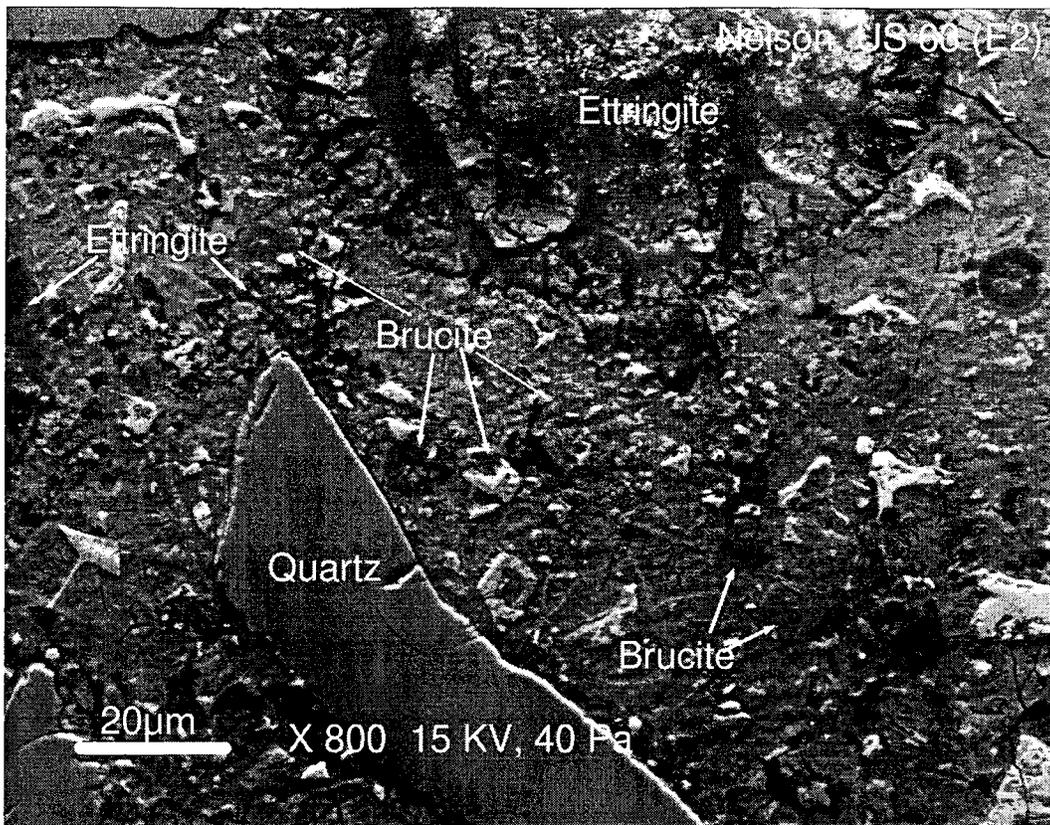
Fig. 10

Fig. 10. SEM micrograph and EDAX area maps showing the brucite and ettringite formation in the unaltered cement paste. Small brucite crystals, < 20 μm size, occur in irregular-shaped nodules in the cement matrix. Note that open spaces are developed in the vicinity of brucite. Ettringite completely fills the large air-entrainment voids and interstitial pores in the cement paste. Cracks developed in ettringite and extend into the paste, and probably were caused by ettringite expansion or ice expansion in ettringite-clogged voids. Very small ettringite deposits also occur in the cement matrix.

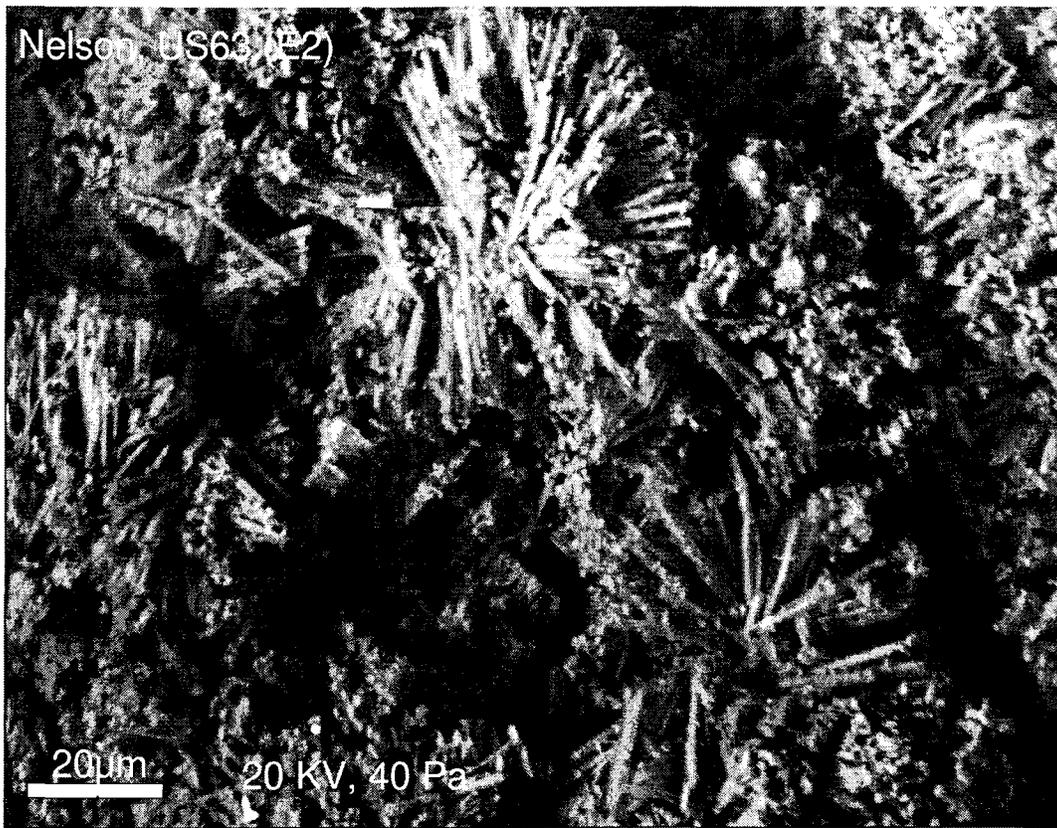
Fig. 11

63. An SEM view of acicular ettringite crystals on the wall of an air entertainment void in Iowa highway concrete. Energy-dispersive X-ray analysis of the crystals reveals strong Ca, Al, S peaks which confirm that these crystals are ettringite. The occurrence of a weak Si peak indicates that Si partially substitutes for Al in the ettringite structure.

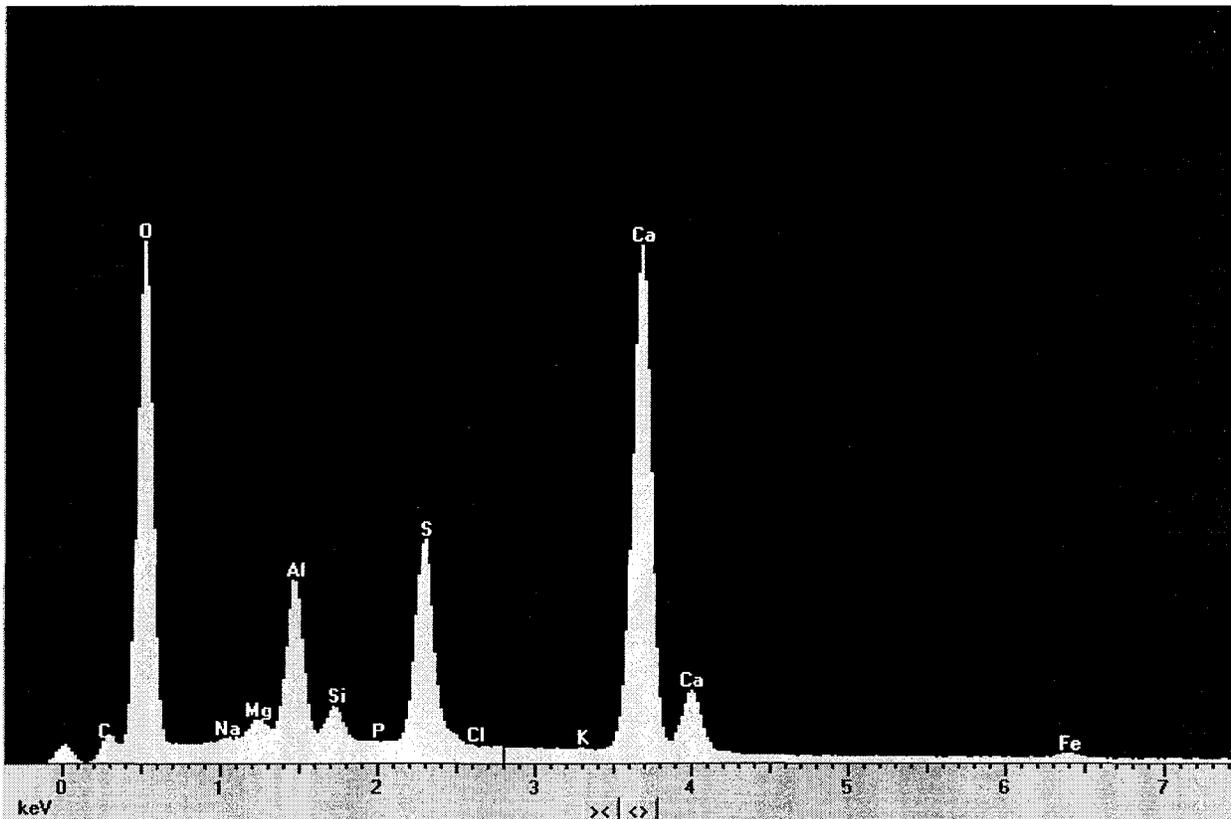
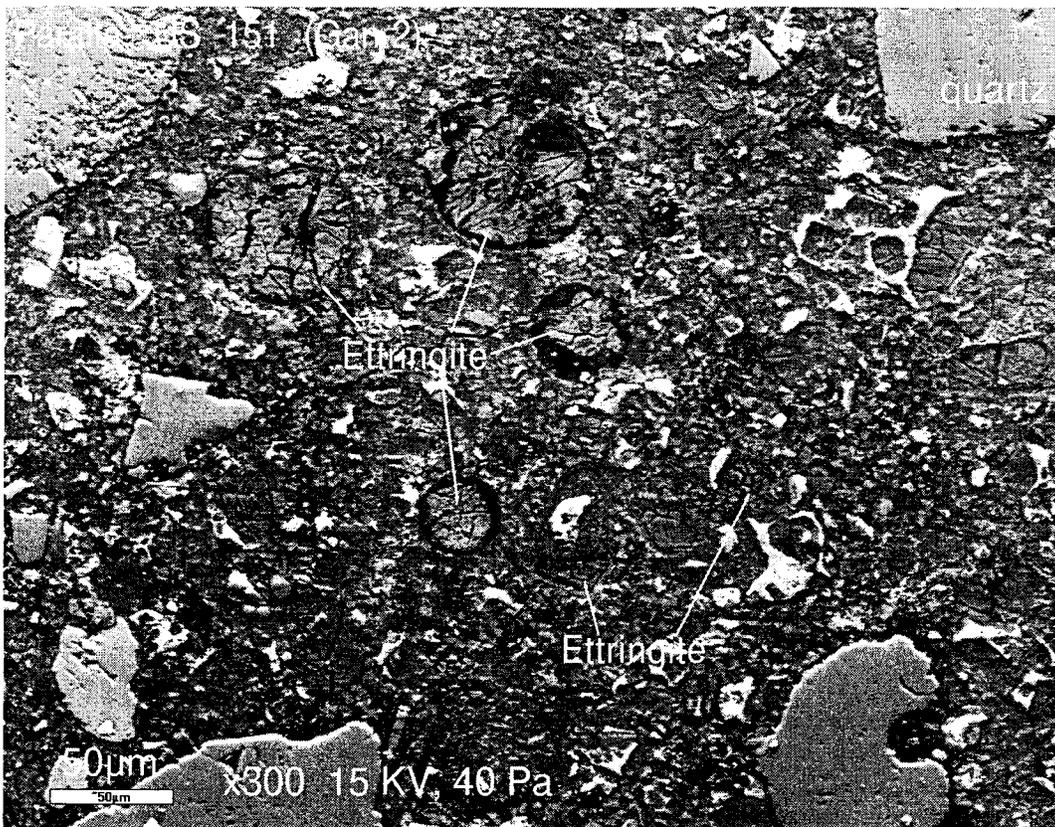
Fig. 12

Fig. 12. SEM micrograph and EDAX area maps showing void-fill ettringite in

cement paste. Ettringite completely fills air-entrainment voids ($< 100 \mu\text{m}$) in the cement paste. Irregular disruptive cracks are associated with this type of ettringite. Microcracks propagate outward into the cement paste from the ettringite. Also observable are very small areas of ettringite that formed around residual aluminate particles in the cement matrix.

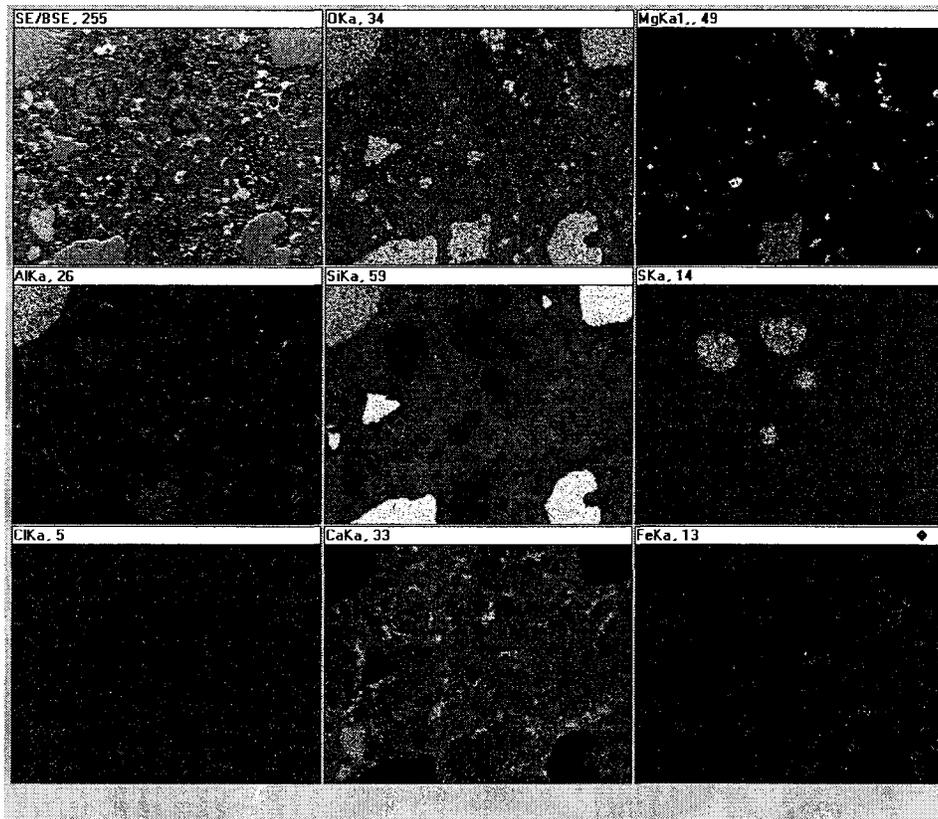
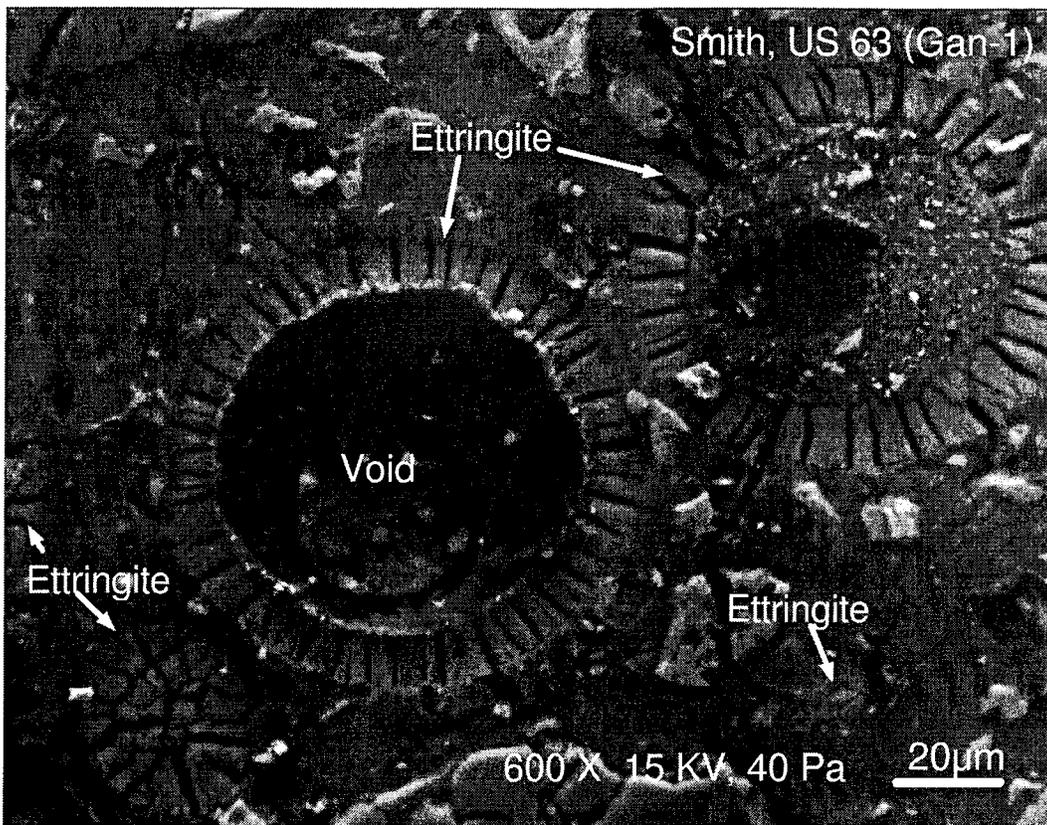
Fig. 13

Fig. 13. SEM micrographs showing both void-rim and void-fill types of ettringite in cement paste. Void-rim ettringite occurs as a rim that lines the margin of air-entrainment voids ($>100\ \mu\text{m}$) in the cement paste. Radial cracks are well-developed in this type of ettringite. Void-fill ettringite occurs in small air-entrainment voids ($<100\ \mu\text{m}$), and microcracks propagate out into cement from them.
