EXPANSIVE MINERAL GROWTH AND CONCRETE DETERIORATION

Final Report
For Iowa DOT Project HR-384

Sponsored by the Iowa Department of Transportation
Project Development Division and
the Iowa Highway Research Board

September 1997

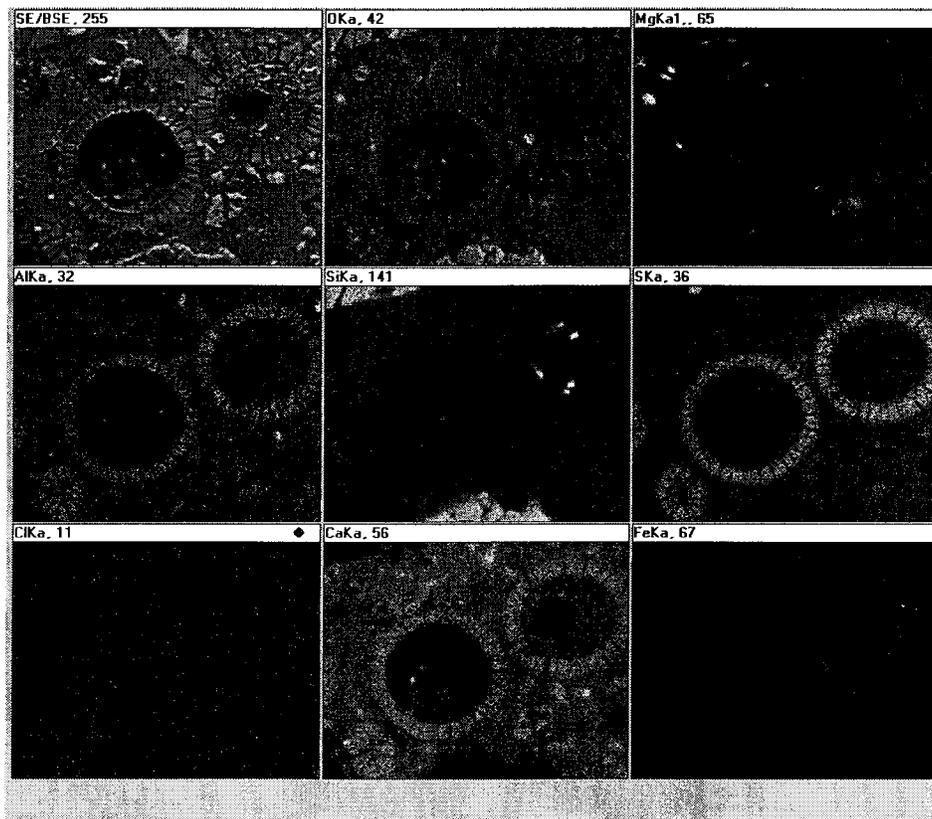
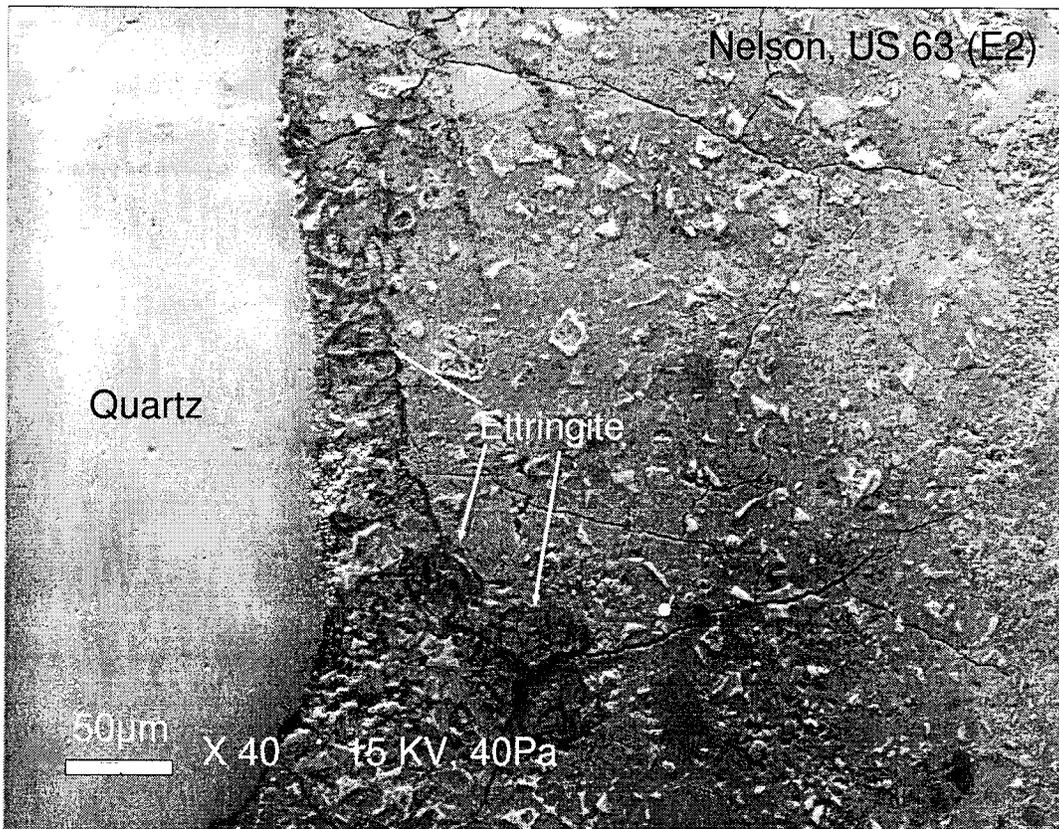
Fig. 14

Fig. 14. SEM micrograph and EDAX area maps showing ettringite in pre-existing cracks. Ettringite forms along the pre-existing cracks between quartz aggregate and cement paste. The cracks appear to be formed by expansive alkali-aggregate reaction. Microcracks extend from ettringite into the cement paste.

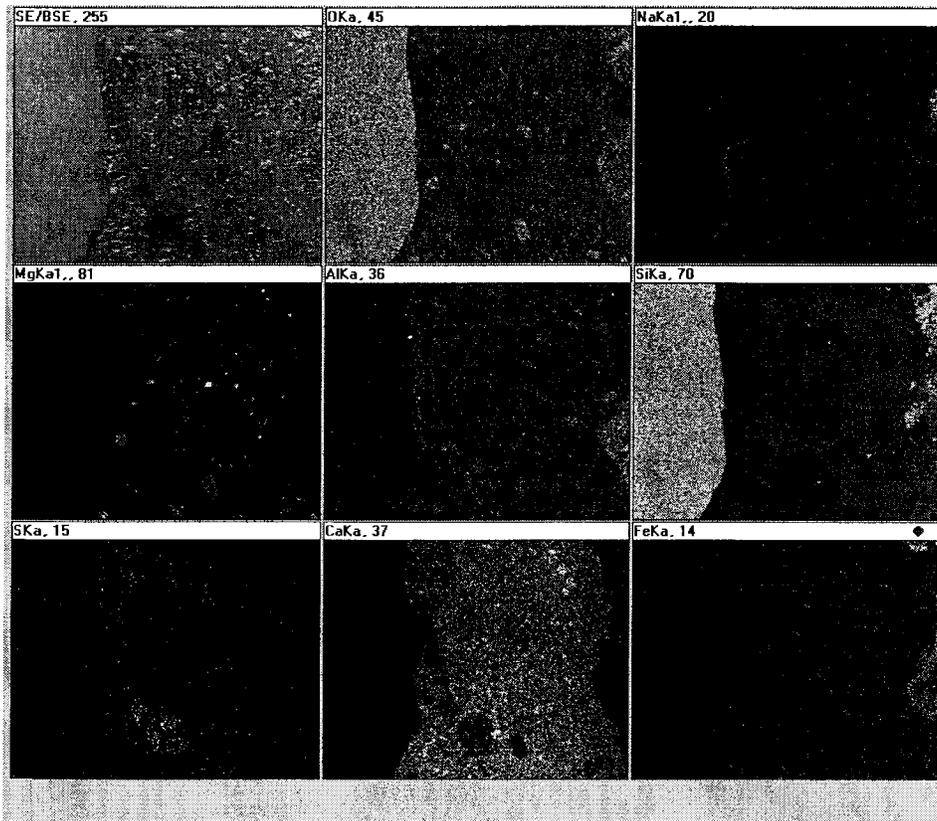
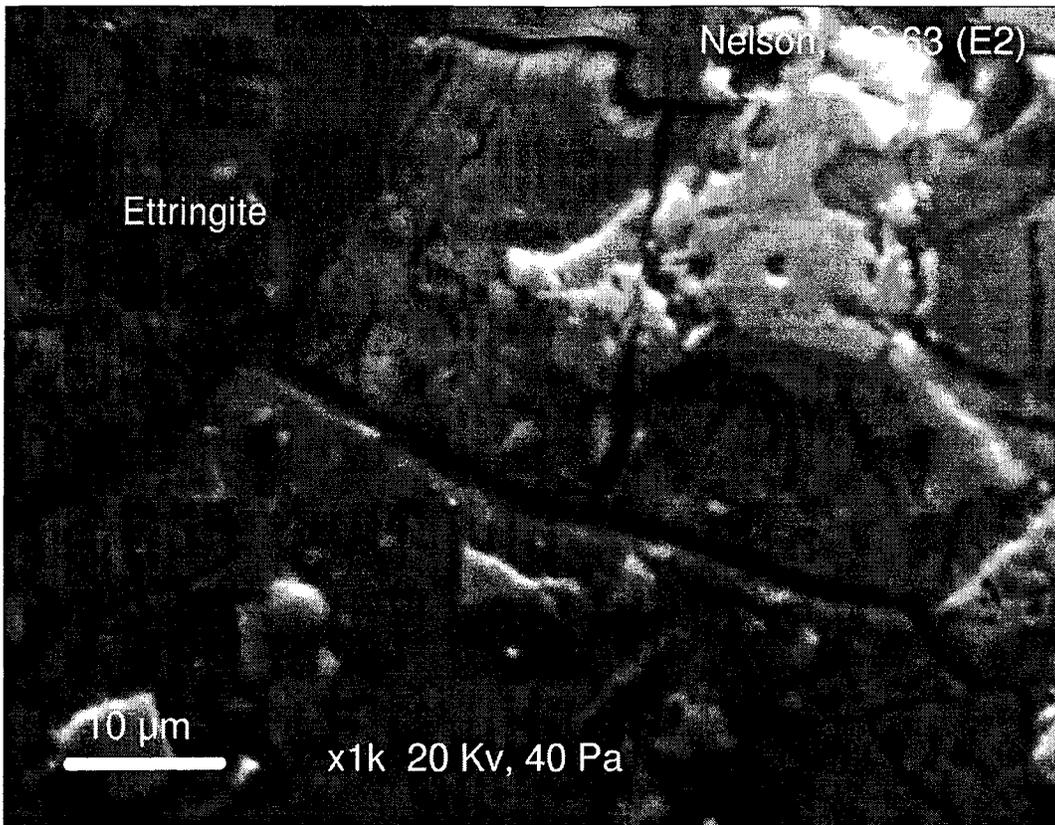
Fig. 15

Fig. 15. High magnification SEM micrograph and EDAX area maps showing lack of ettringite in microcracks. The cracks originate at ettringite void fills and rims, and the lack of ettringite accumulation in them indicates that the cracks developed after ettringite formation.

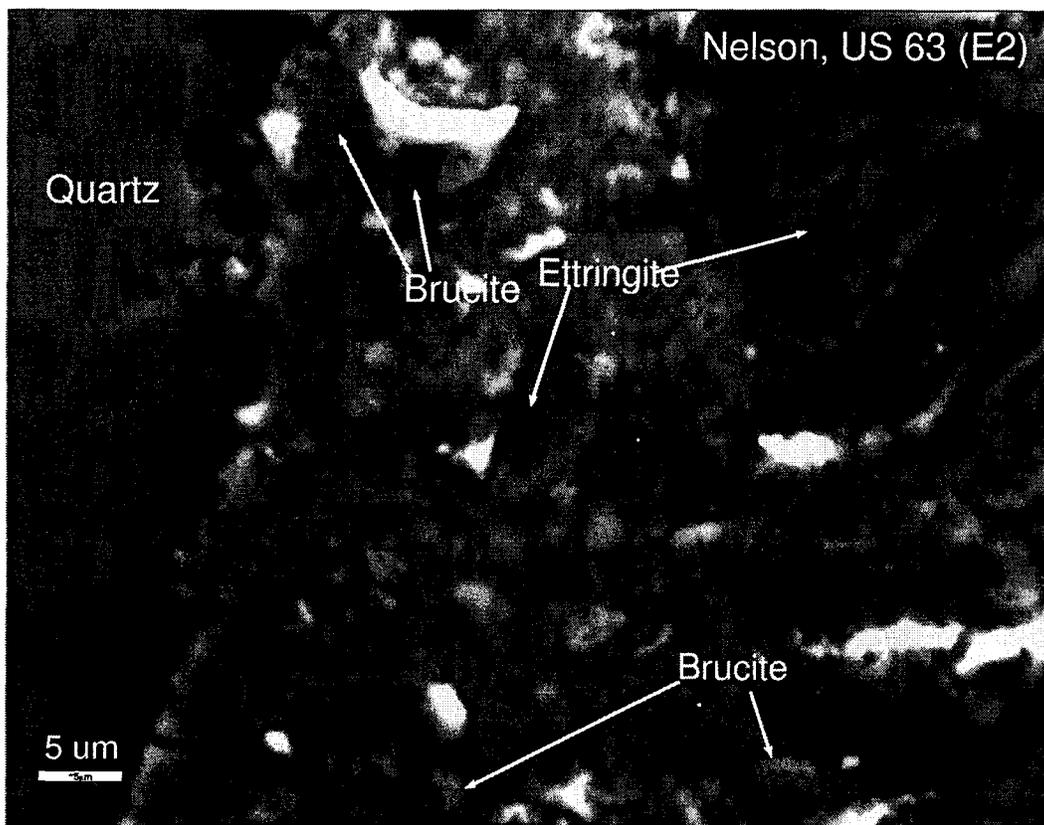
Fig. 17

Fig. 17. High magnification SEM micrograph and EDAX area maps showing small ettringite deposits around aluminate particles in cement matrix. This type of ettringite appears to form as a result of a topochemical reaction mechanism between calcium aluminate, CA, and SO_4 pore solutions. No significant microcracks are developed around this type of ettringite.

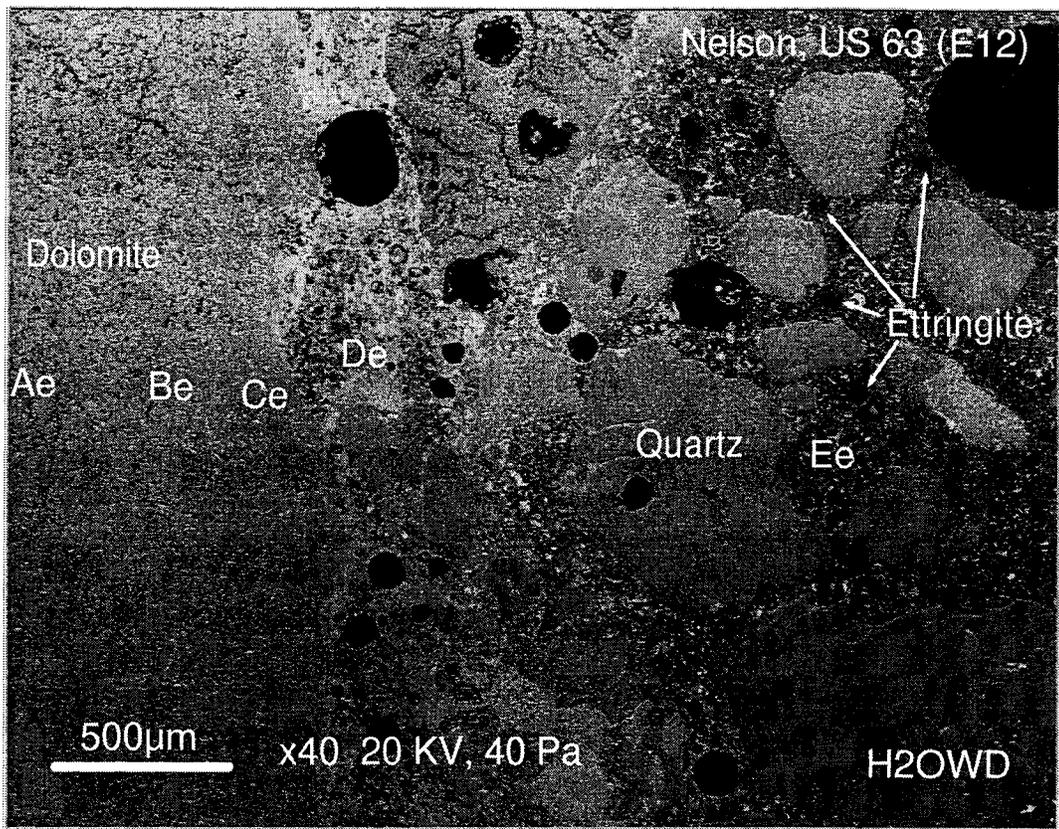
Fig. 18

Fig. 18. SEM micrograph and EDAX area maps showing results of freeze/thaw cycling in H₂O of Nelson quarry concrete from US 63. Very few effects can be detected, but pre-treatment reaction rims appear to be slightly broadened in some samples. No new brucite was detected in the light-colored dolomite and light-colored paste rim Zones Ce and De.

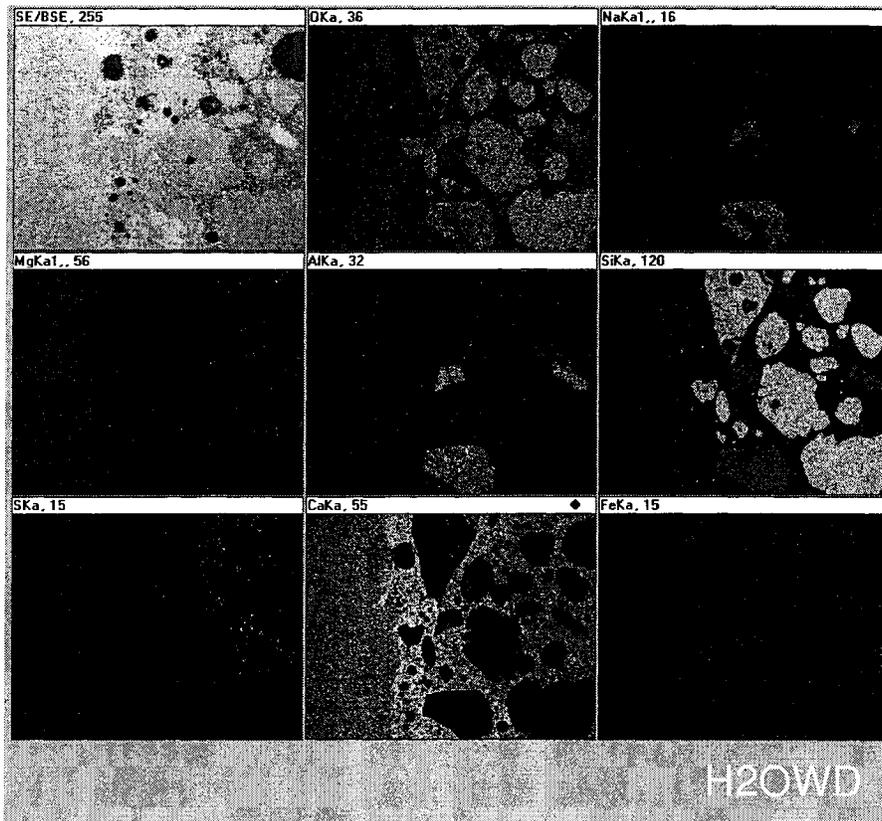
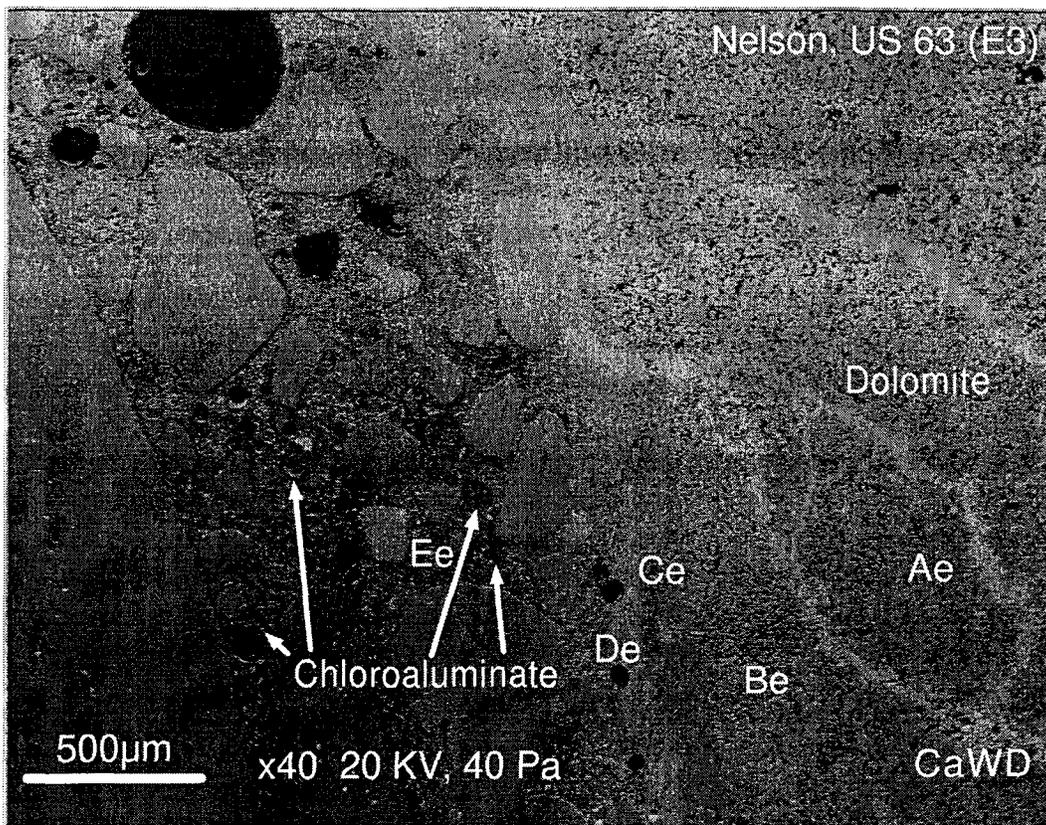
Fig. 19

Fig. 19. SEM micrograph and EDAX area maps showing experimentally-induced deterioration after wet/dry cycling in CaCl_2 of Nelson quarry concrete, US 63.

These images include the corresponding area shown in Plate IV-A. The dark-colored Zone Be and light-colored dolomite rim Zone Ce, are apparent at the margins of coarse aggregate. EDAX element maps show a decrease in Ca and significant Mg concentration indicating brucite formation in the new light-colored dolomite rim (zone Ce). No significant brucite occurs in the old rim (zone C) in untreated concrete (See Fig. 2 for comparison). Significant Cl concentrations are present in the discolored cement paste (Zone Ee).

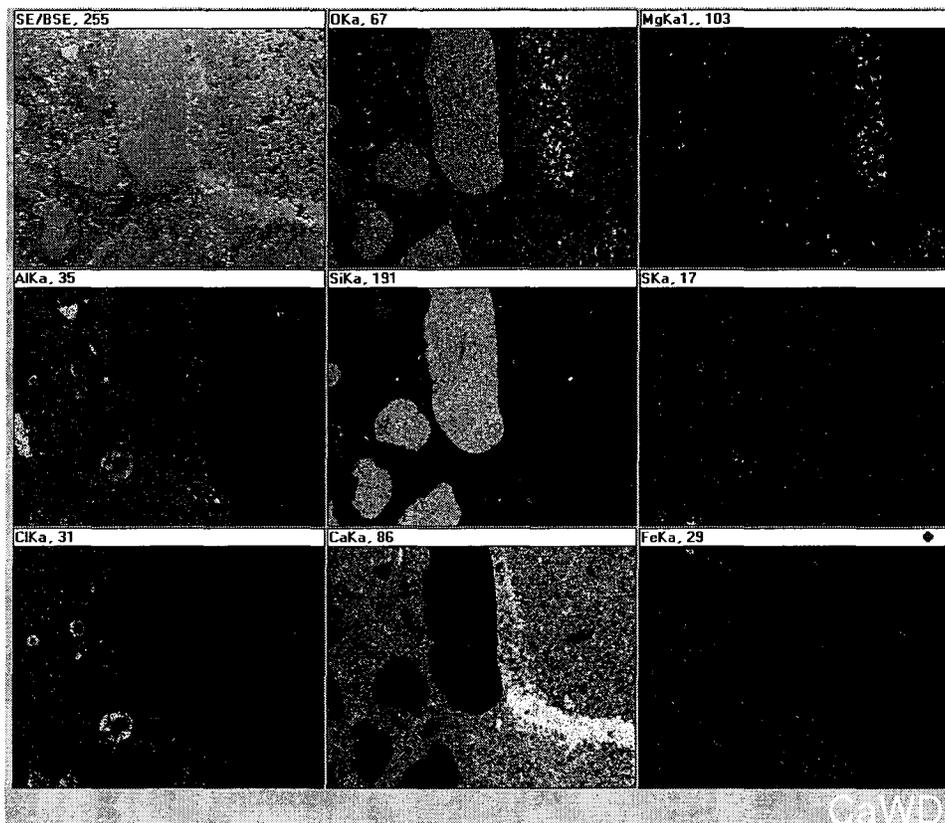
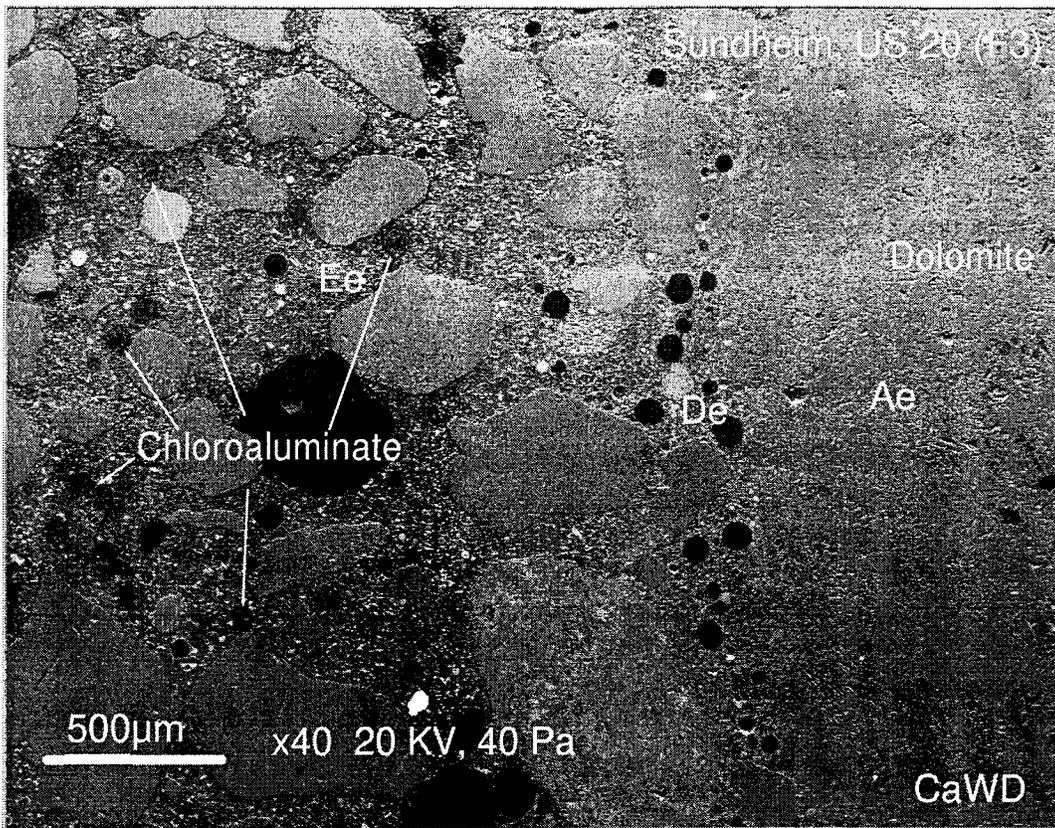
Fig. 21

Fig. 21. SEM micrograph and EDAX area map showing experimentally-induced alteration of Sundheim quarry concrete from US 20 after wet/dry cycling in CaCl_2 . No reaction rims, either pre- or post-treatment are visible in the dolomite at the interface with the cement. Large concentrations of Cl and increased Ca are present in the cement paste (Zone Ee) as a result of soaking, but otherwise, the experiments failed to produce visible changes in this durable concrete.

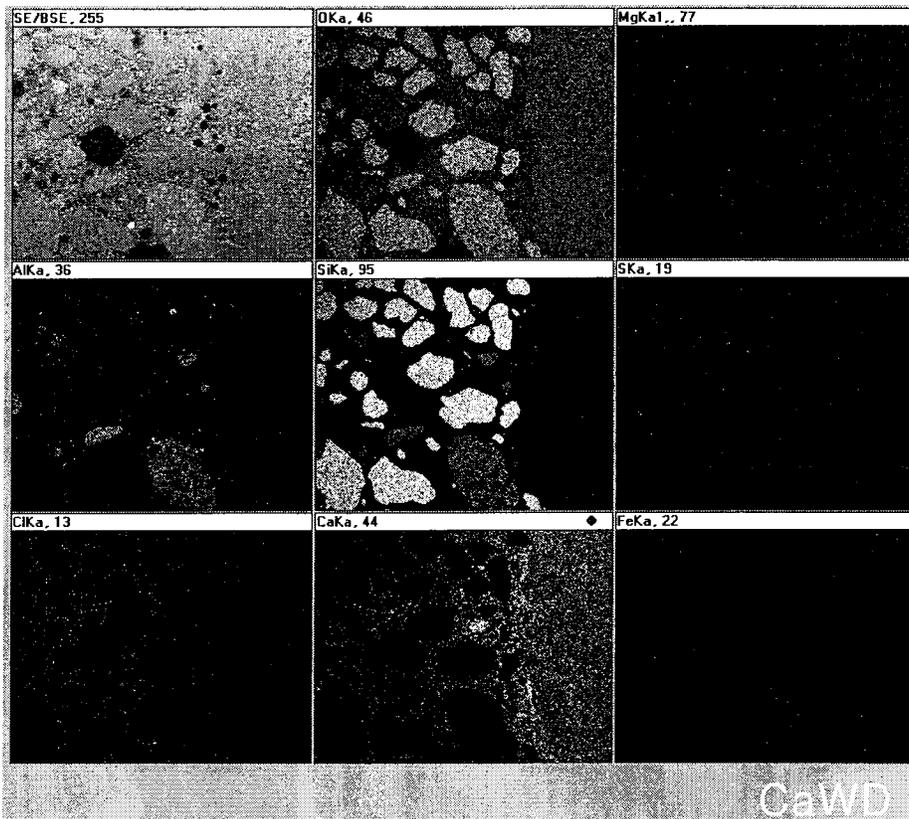
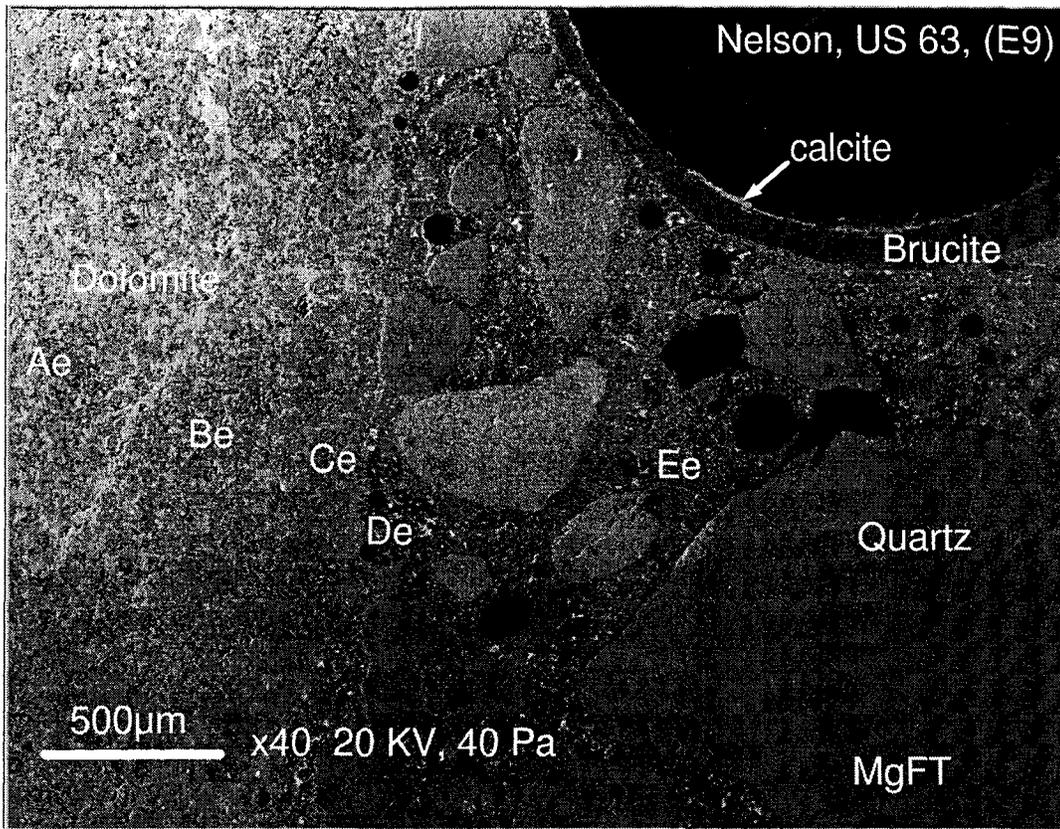
Fig. 22

Fig. 22. SEM micrograph and EDAX area maps showing experimentally-induced deterioration of Nelson quarry concrete from US 63 after freeze/thaw cycling in $MgCl_2$. The images includes the corresponding area of Plate IV-B. Dark and light-colored dolomite rims Zones Be and Ce are well developed at the aggregate-paste interface. Significant Mg concentrations indicate that interstitial brucite precipitated in the light-colored dolomite rim Zone Ce as a result of the experimental treatment. No significant amounts of brucite occur in the untreated rim Zone C (See Fig. 2 for comparison). Brucite (Br) in the air void is shown as bright white spots in Mg and O maps. A thin layer of Ca-rich material indicates calcite (Cal) which precipitated at the outer and inner margins of the brucite rim which lines the air void. Increased Mg concentration in the cement paste is probably due to the formation of magnesium silicate hydrate (MSH) as well as brucite.

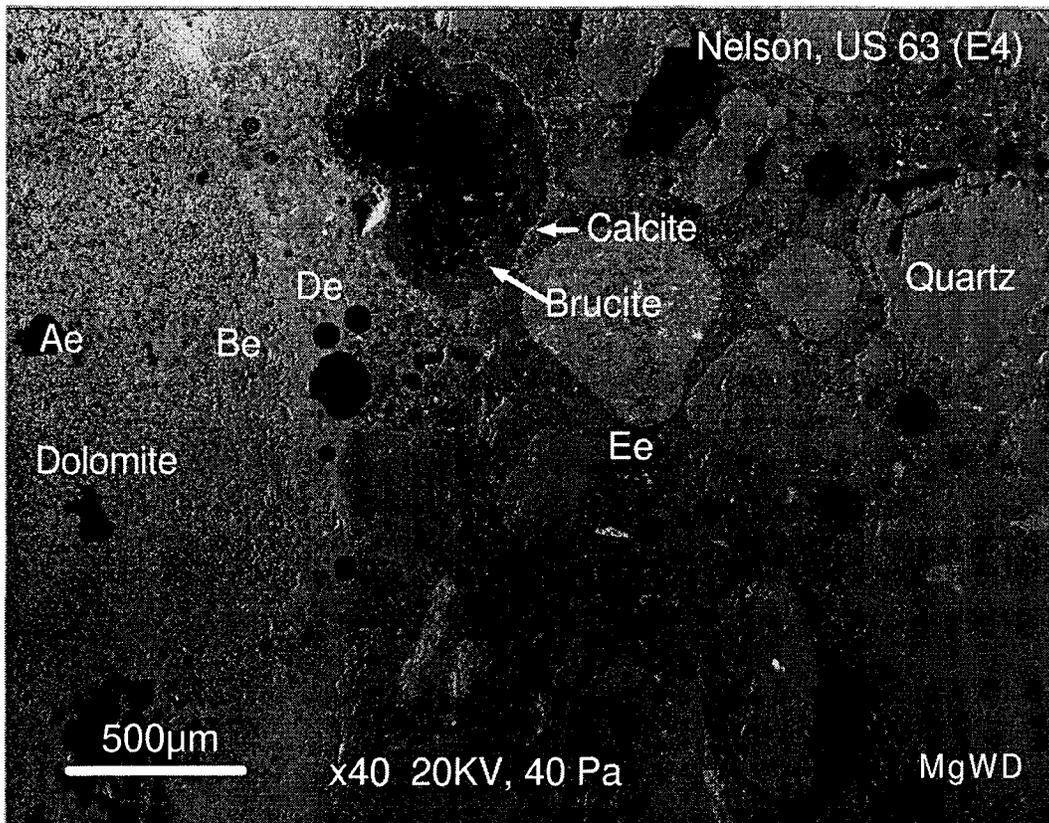
Fig. 23

Fig. 23. SEM micrograph and EDAX element maps showing the aggregate-paste interface in Nelson quarry concrete from US 63 after wet/dry cycling in $MgCl_2$. The light-colored dolomite rim, Zone Ce, is absent. After treatment, the reaction rims are similar to rims of untreated concrete. A layer of brucite is seen in a void and calcite formed at the interface between brucite and the cement paste. EDAX element maps show that Mg concentration is elevated and Ca concentration is depleted in the cement paste. This indicates the alteration of calcium silicate hydrate, CSH, to magnesium silicate hydrate, MSH, in the cement. Note that the light-colored paste rim has not changed to MHS. Paste cracking and debonding of fine aggregate also occurred during wet/dry cycling.

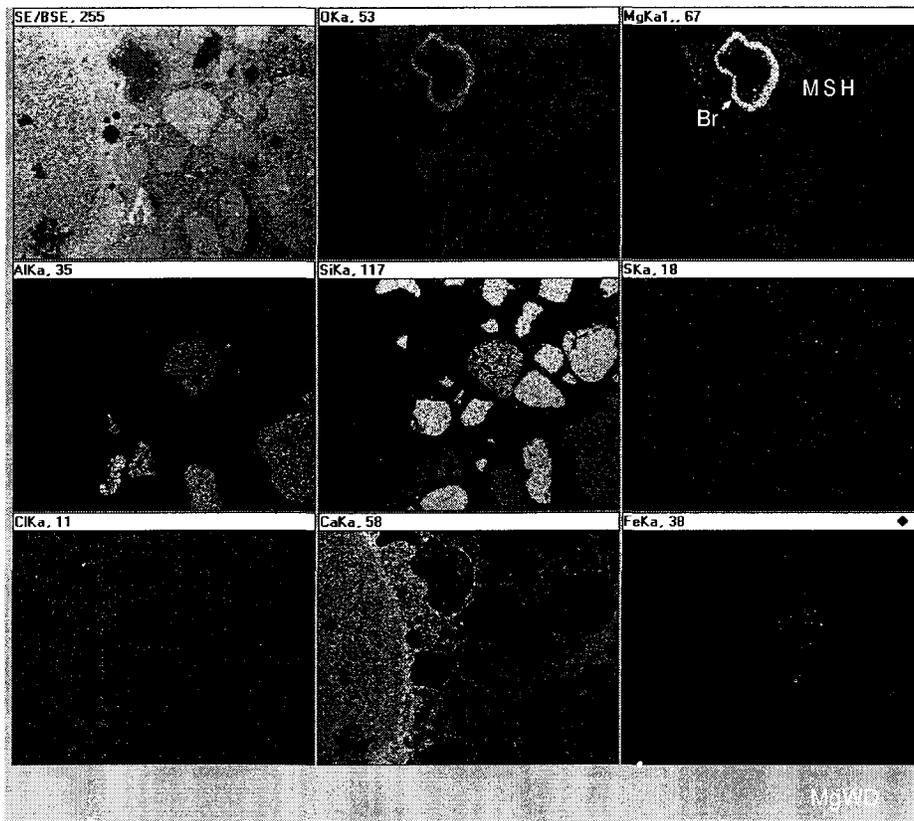
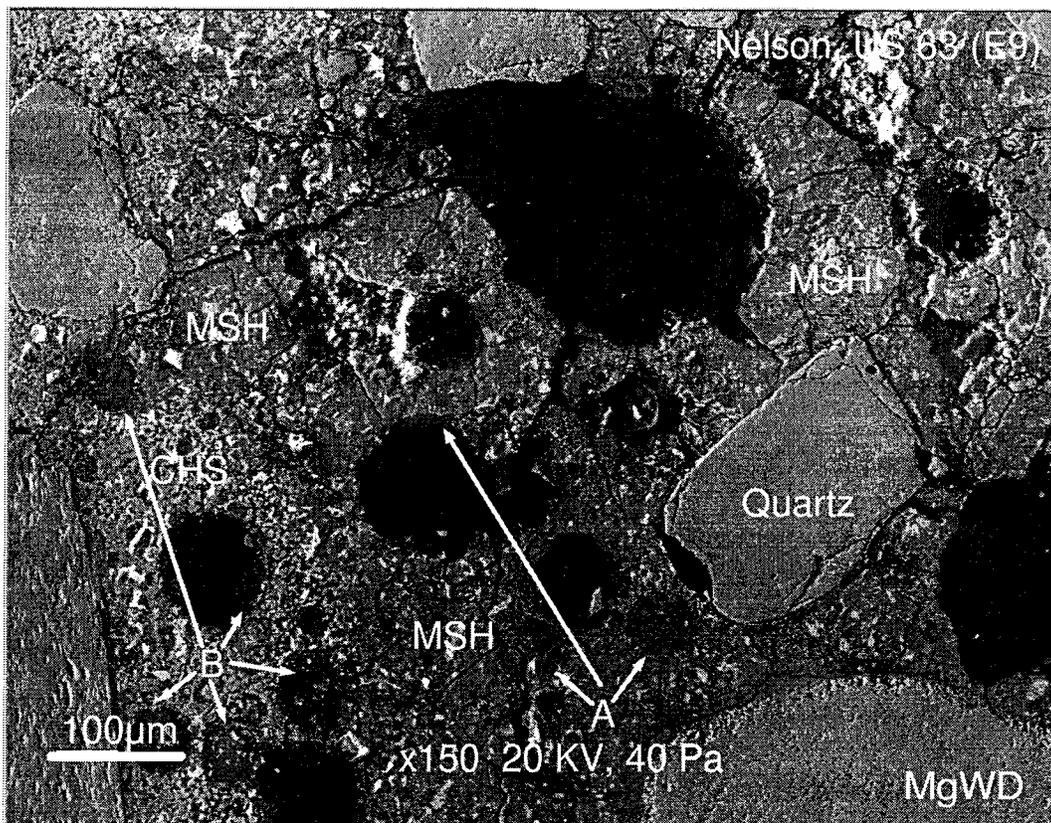
Fig. 24. SEM micrograph and EDAX area maps showing cement paste deterioration after wet/dry cycling in $MgCl_2$ of Nelson quarry concrete from US 63. In these images, several experimentally-induced features are evident. CSH in the cement paste was altered to MSH. Many shrinkage cracks developed in the MSH-enriched cement. Fine aggregate at the surface of the sample was debonded and separated from the cement paste because of the formation of non-cementitious MSH. Minerals of various compositions formed in many air entrainment voids. Voids in the less severely changed paste are filled with material rich in Ca, Mg, Al, and S, and with minor amounts of Si and Cl. This material is marked with 'B'. Voids in MSH are filled with material rich in Mg and O, and is marked with 'A'.

Fig 28. EDAX point analysis of void-filling matter shown in Fig. 24. The material marked 'B' in Fig. 24 has a complex composition of Mg, Ca, Al, Si, S, and minor Cl.

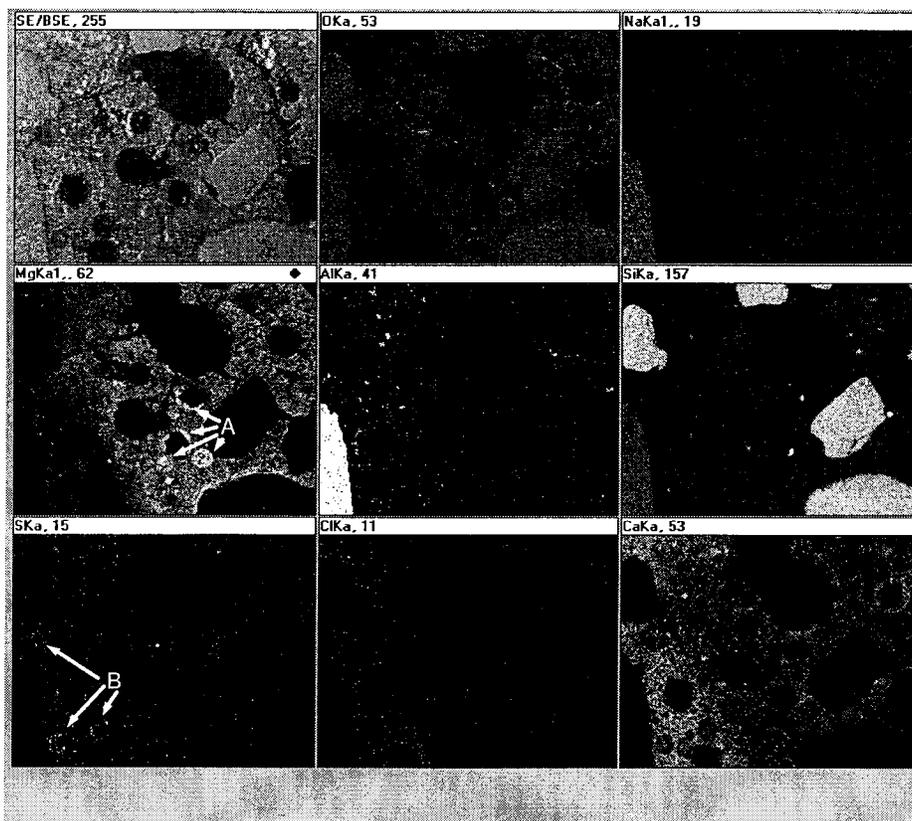
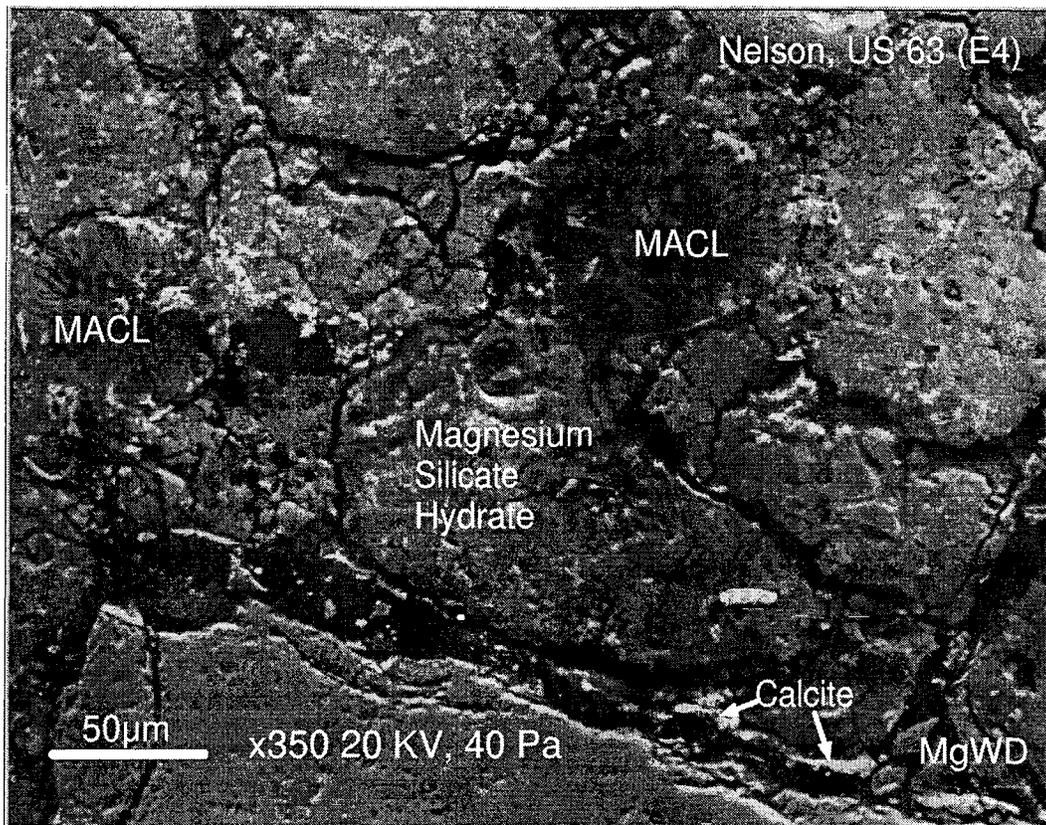
Fig. 25

Fig. 25. High magnification SEM and EDAX maps showing MSH features in cement paste.

Abundant shrinkage cracks developed in the MSH as a result of experimental wet/dry cycling in $MgCl_2$, and especially wide cracks formed at the boundary between quartz particles and cement paste. EDAX element maps and points analysis (Fig. 26) indicate that CSH in cement paste completely changed to MSH. Calcium released by MSH formation migrated into open spaces and precipitated as calcite. Mg-, Al-, and Cl-rich material with minor Si, marked as 'MACL' formed in air voids.

Fig. 26. EDAX point analysis of magnesium silicate hydrate (MSH) shown in Fig 25.

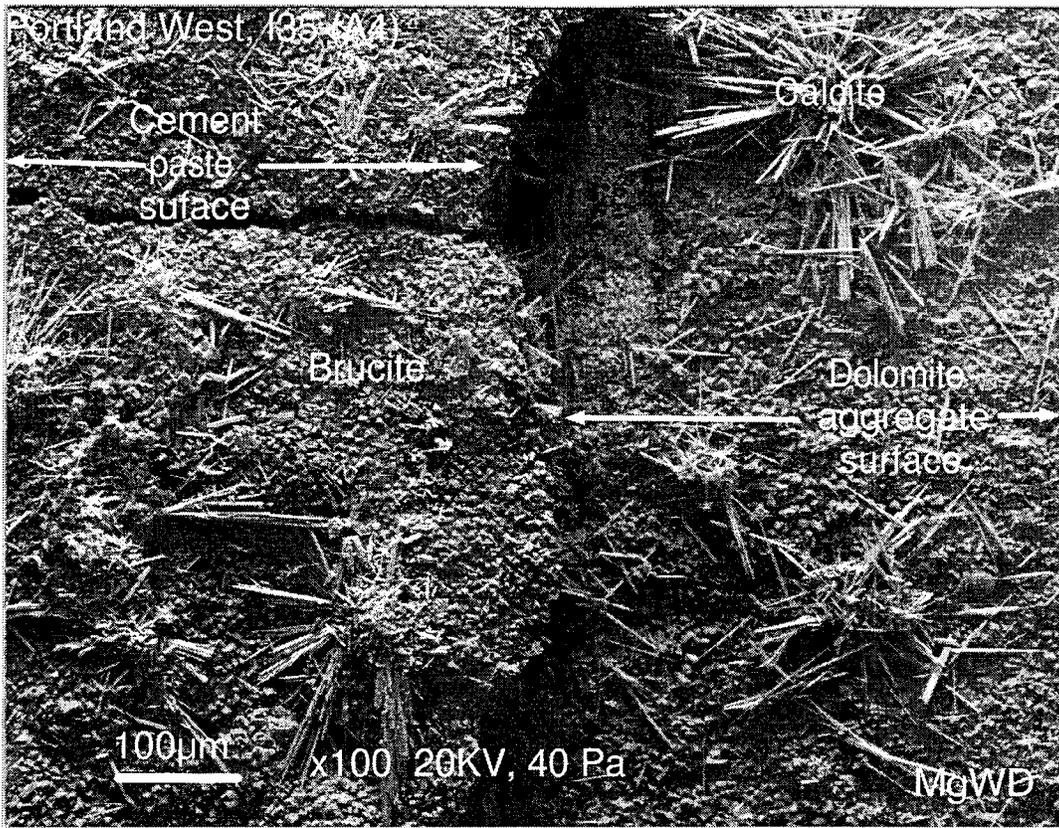
Fig. 27

Fig. 27. SEM micrograph and EDAX area maps showing the deposition of secondary minerals on the surface of concrete after wet/dry cycling in MgCl₂ of Portland West quarry concrete, I 35. Needles of calcite crystals and equant brucite crystals formed on the surface of both cement paste and dolomite coarse aggregate.

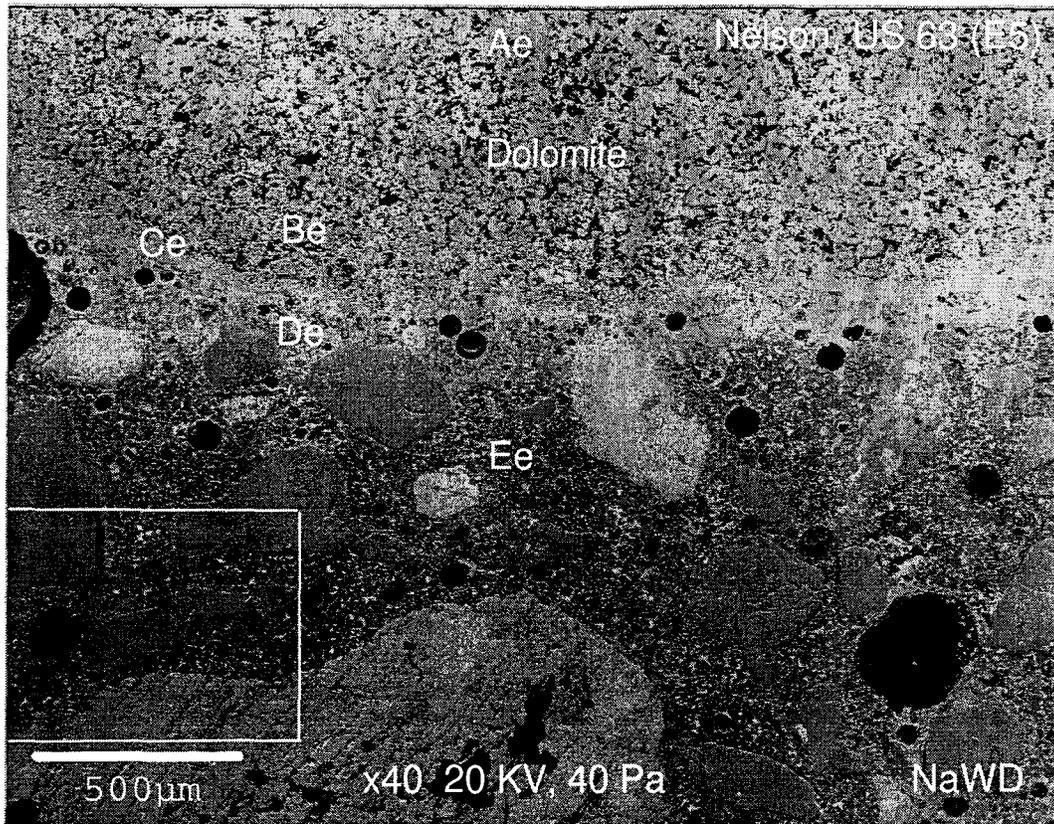
Fig. 29

Fig. 29. SEM micrograph and EDAX area maps showing Nelson quarry concrete from US 63 after wet/dry cycling in NaCl. Very little experimental alteration is visible, and the dolomite aggregate and cement paste reaction rims appear to be identical to those present in untreated concrete (see Fig 2 for composition). EDAX element maps show that no significant concentration of Mg occurs in the light-colored dolomite rim Zone Ce, and brucite only occurs in the cement paste Zones De and Ee, as in untreated concrete. Note that Cl is concentrated in air-entrainment voids where ettringite occurs. The small white-outlined rectangle shows the magnified area shown in the next figure (Fig. 30).

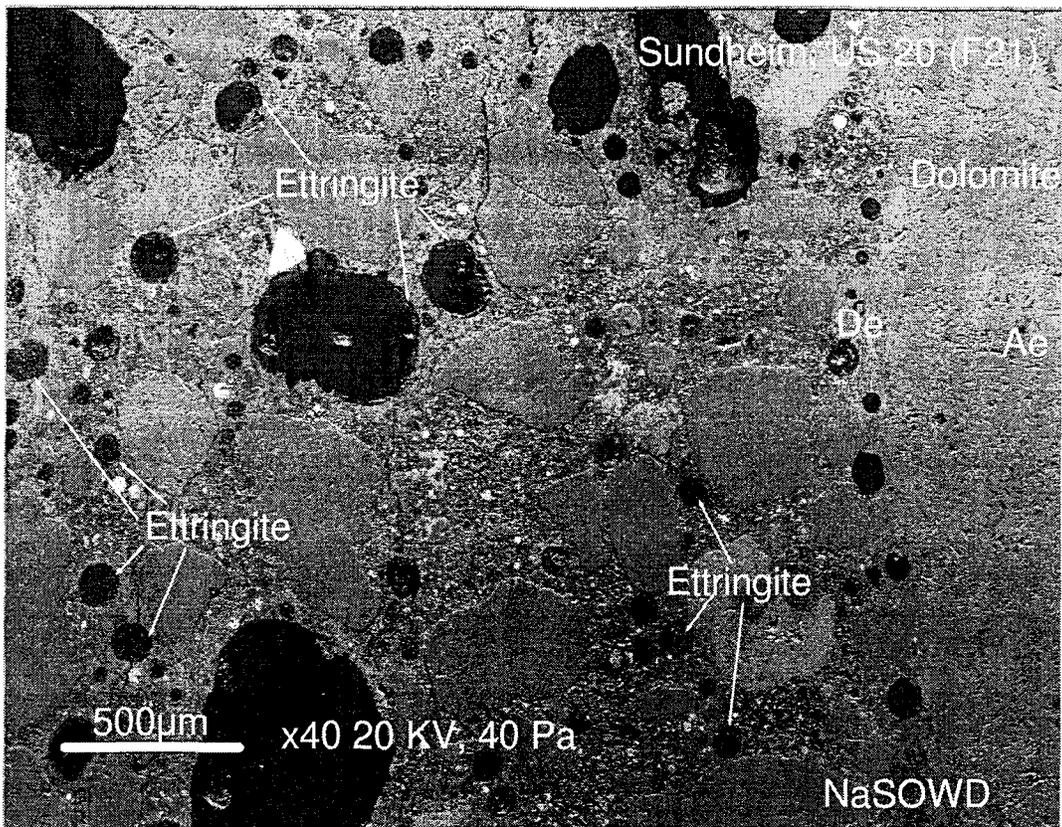
Fig. 32

Fig. 32. SEM micrograph and EDAX area maps showing deterioration in Sundheim

quarry concrete from US 20 after wet/dry cycling in Na_2SO_4 . During cycling, both void-rim and void-fill ettringite precipitated in many air-entrainment voids compared with only very small quantities of ettringite present in untreated concrete samples. Ettringite did not form in the air voids located in the narrow light-colored cement paste Zone De.

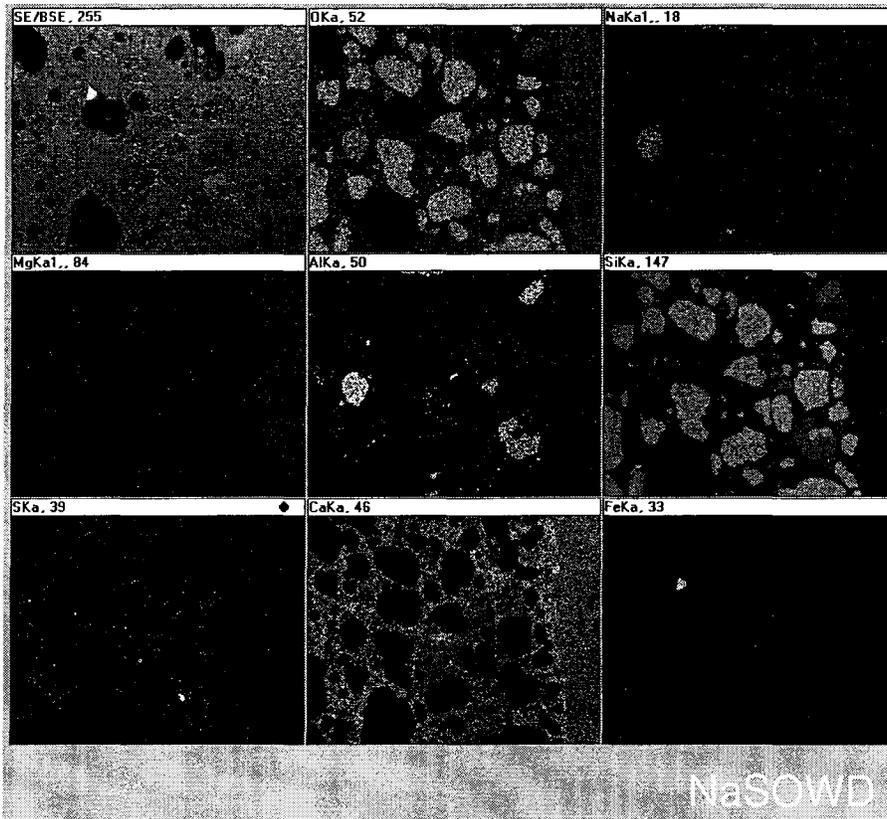
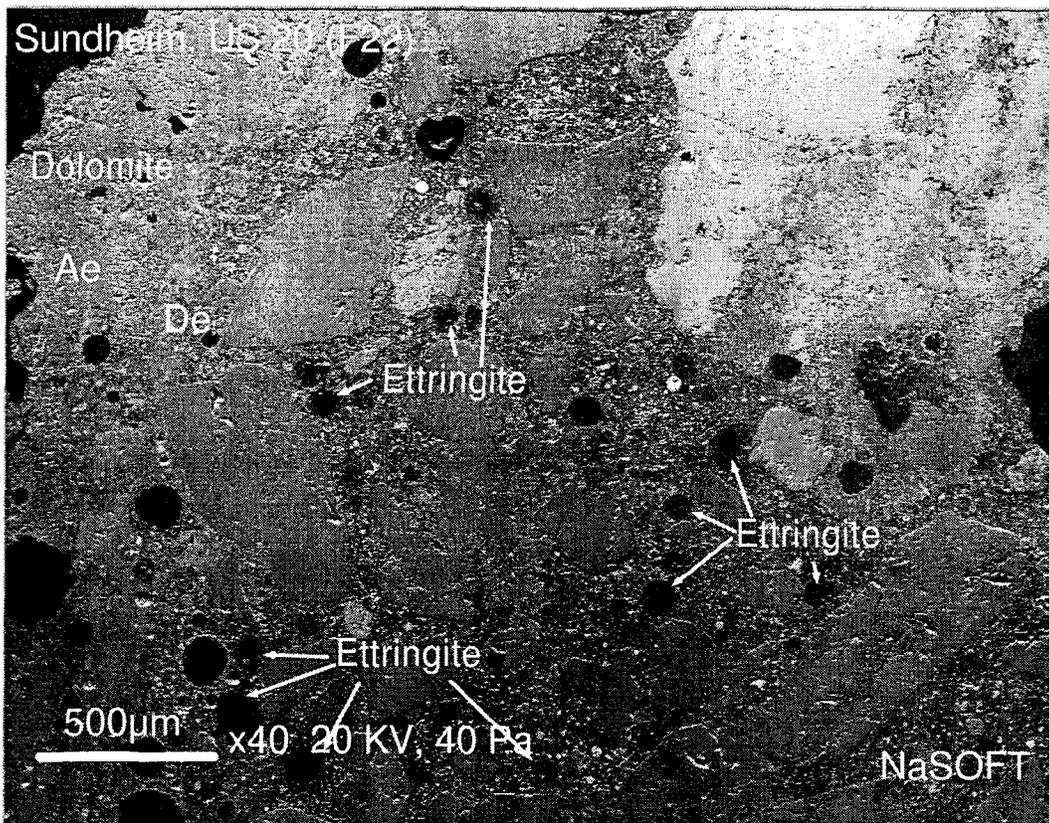
Fig. 33

Fig. 33. SEM micrograph and EDAX area maps showing deterioration in Sundheim quarry concrete from US 20 after freeze/thaw cycling in Na_2SO_4 . Freeze/thaw cycling produced similar results as wet/dry conditions in that abundant newly-formed ettringite precipitated in air entrainment voids.

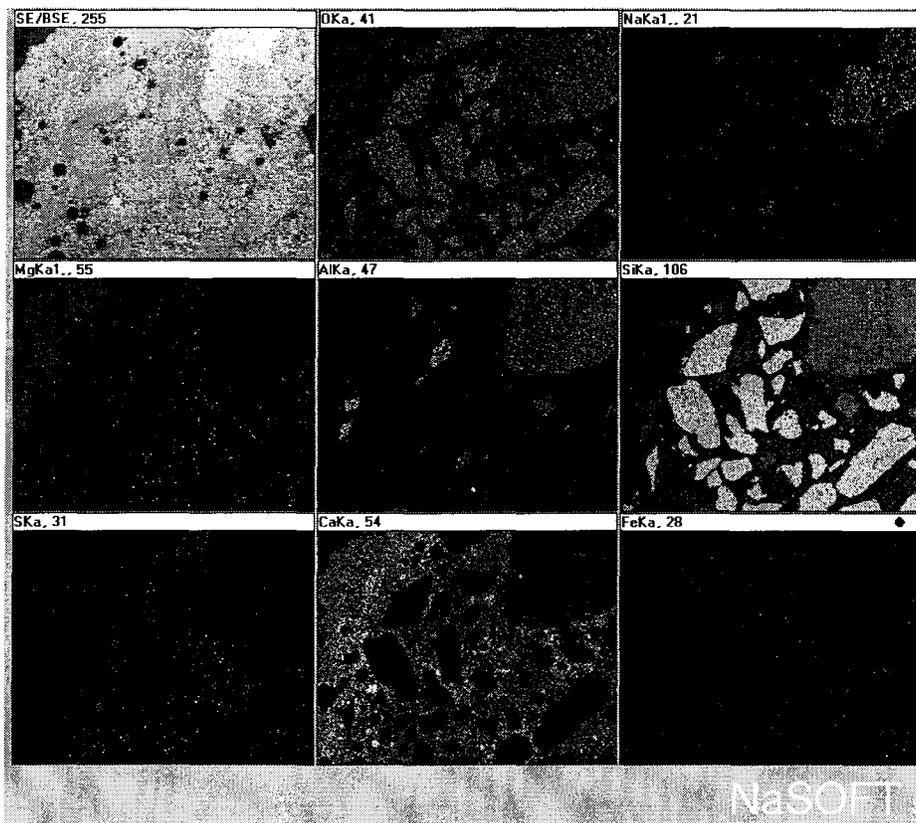
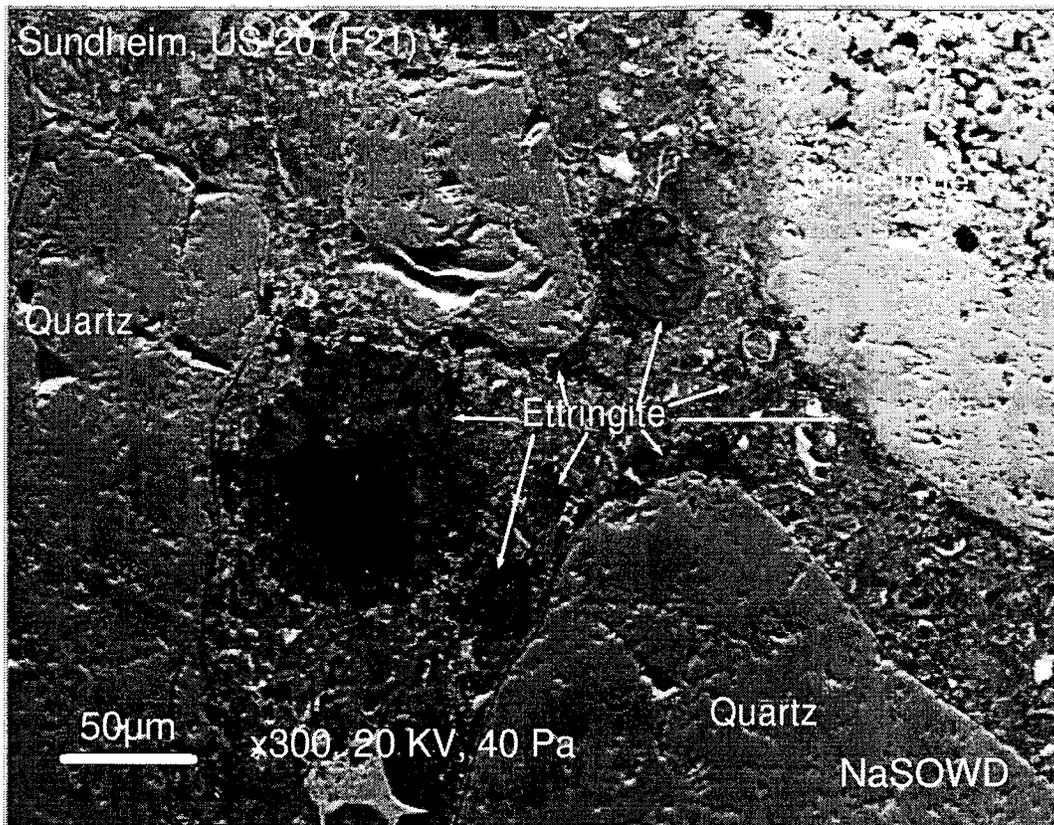
Fig. 34

Fig. 34. High magnification SEM micrograph and EDAX area maps showing deterioration in Sundheim quarry concrete from US 20 after wet/dry cycling in Na_2SO_4 .

Ettringite frequently forms in the small interstitial voids and boundary spaces between fine aggregate and the cement paste through which solutions can easily migrate. Note the narrow cracks in the paste adjacent to quartz fine aggregate particles.
