EXPANSIVE MINERAL GROWTH AND CONCRETE DETERIORATION

Final Report
For Iowa DOT Project HR-384

Sponsored by the Iowa Department of Transportation
Project Development Division and
the Iowa Highway Research Board

September 1997

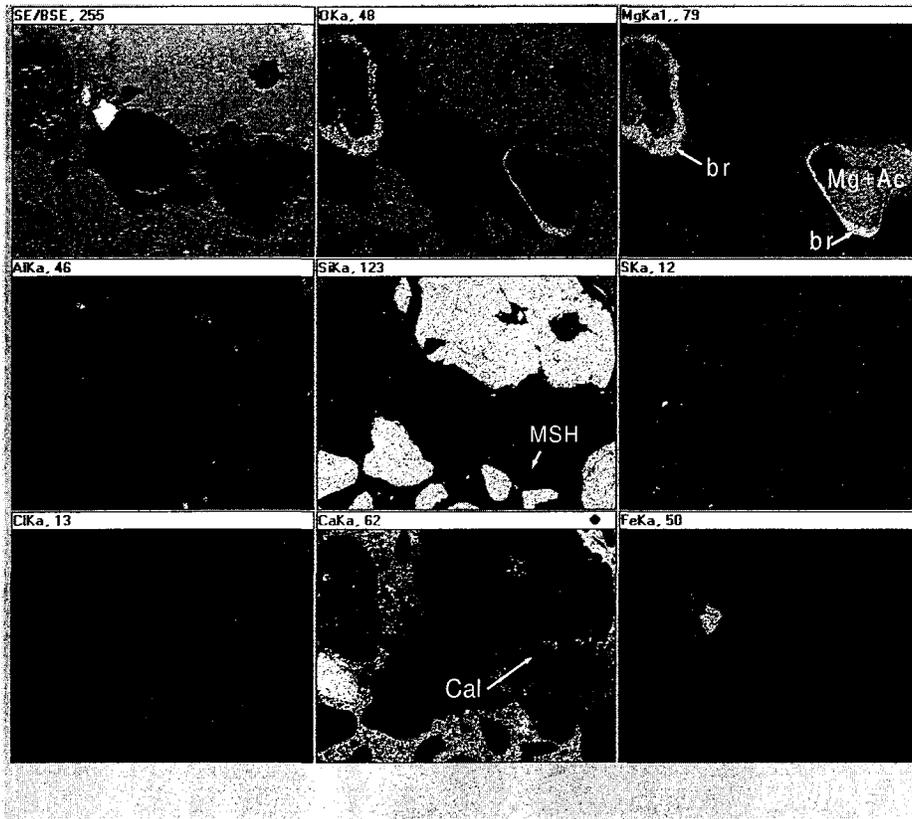
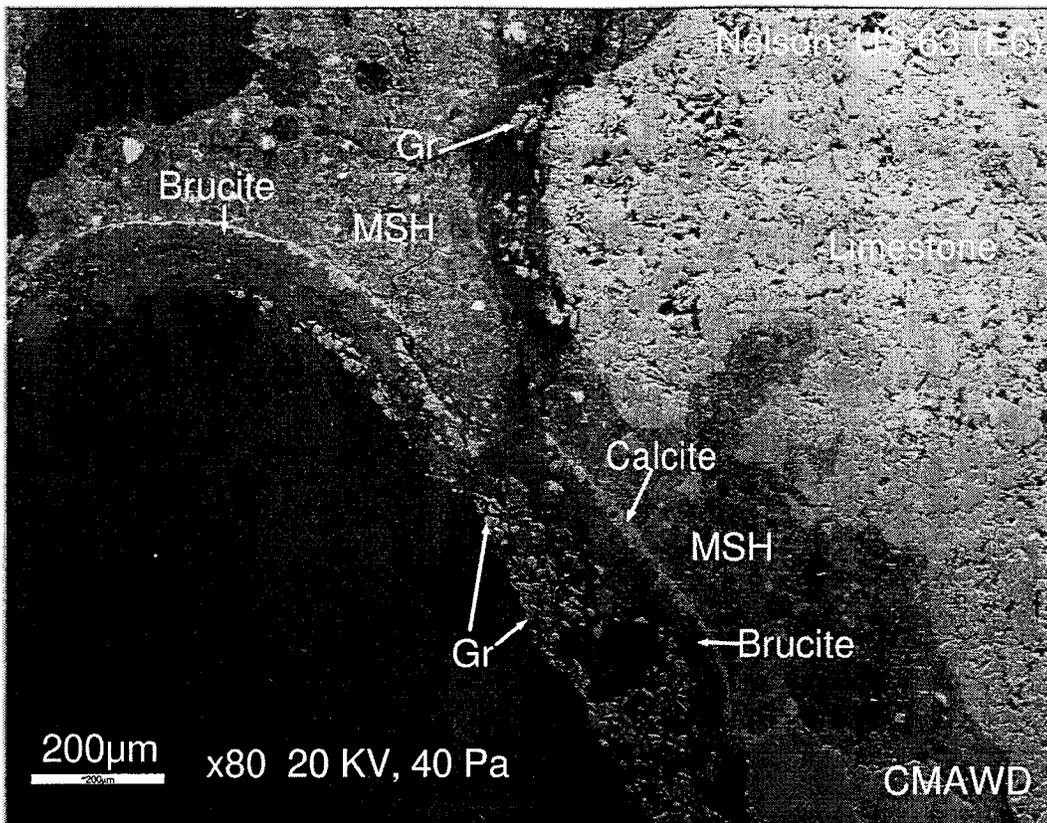
Fig. 38

Fig. 38. SEM micrograph and EDAX element maps showing the growth of brucite and calcite in Nelson quarry concrete from US63 after wet/dry cycling in CMA.

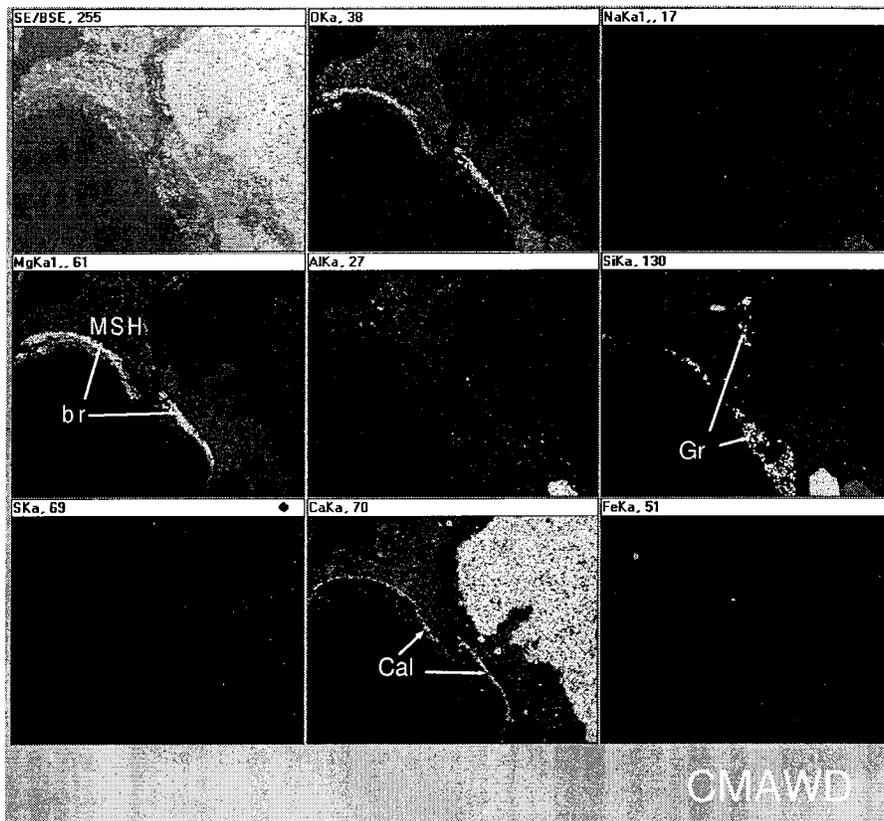
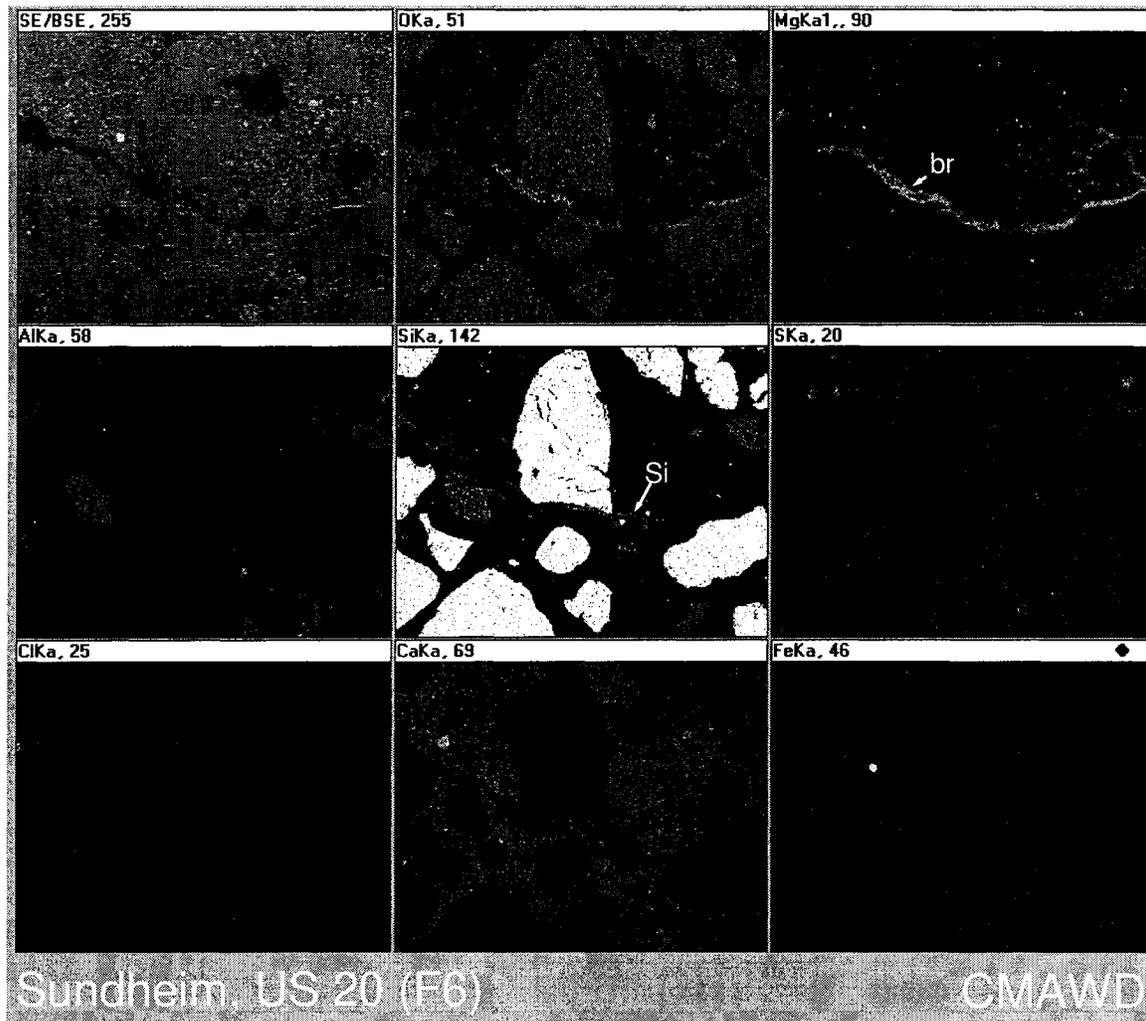
Fig. 39

Fig. 39. EDAX element maps of the same area shown in Plate VI-A showing crack-filling minerals that formed after wet/dry cycling in CMA. Brucite (br) is a major crack-filling mineral and thin layers of calcite often occur. Silica-gel (Si), in rare instances, has formed at the margins of these cracks.

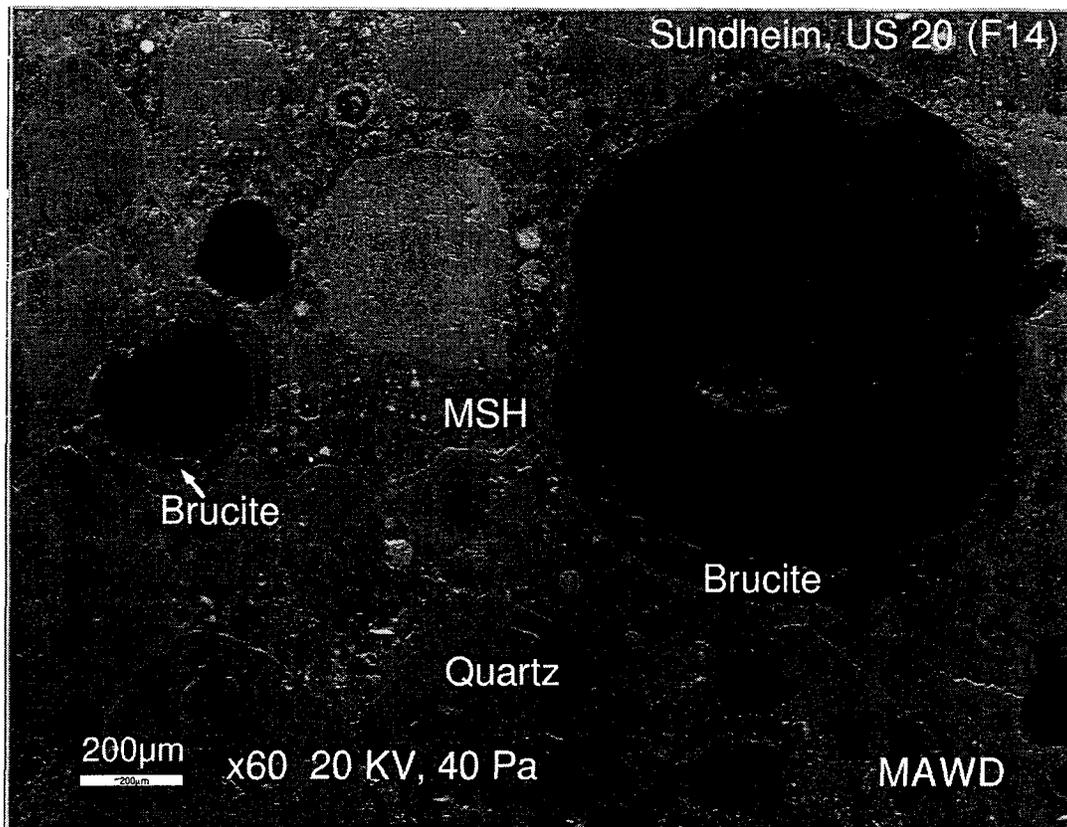
Fig. 42

Fig. 42. SEM micrograph and EDAX area maps showing experimentally-induced deterioration of Sundheim quarry concrete from US 20 after wet/dry cycling in magnesium acetate. Abundant brucite grew as thin linings in air voids of the durable concrete during wet/dry cycling. EDAX element maps show cement paste has been enriched in magnesium and depleted in calcium, indicating that CSH altered to MSH.

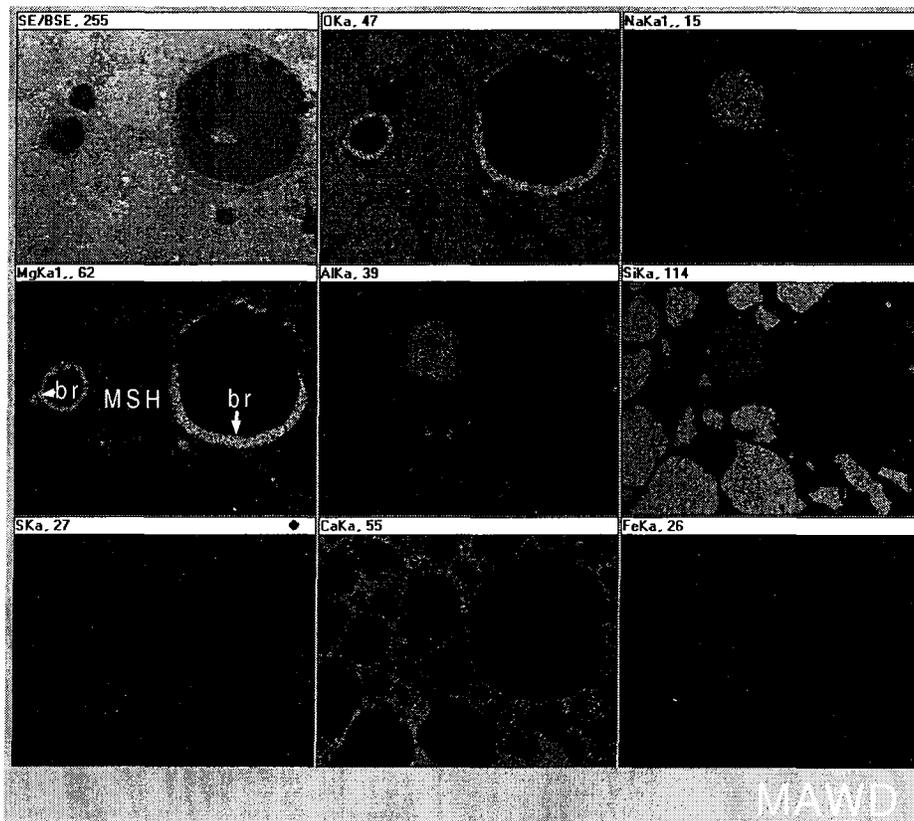
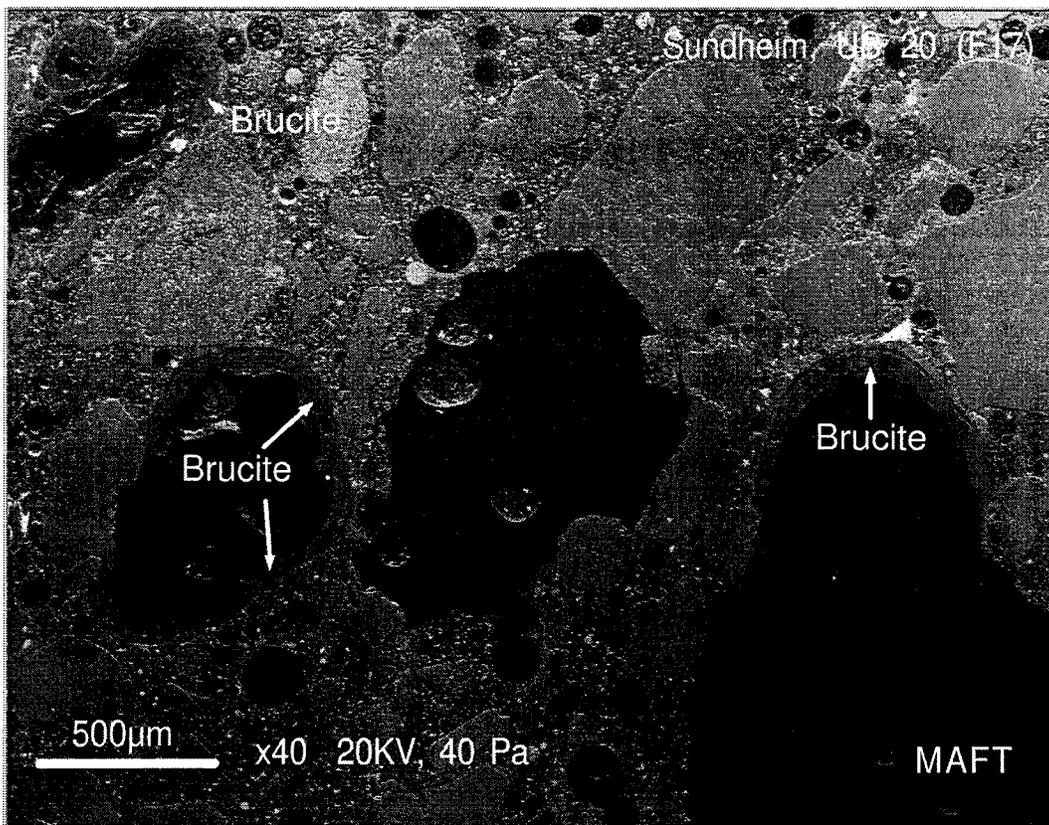
Fig. 43

Fig. 43. SEM micrograph and EDAX area maps showing the growth of brucite in voids of durable Sundheim quarry concrete (US 20) after freeze/thaw cycling in magnesium acetate. Features shown are very similar to those of Fig. 37. Many of the voids in which brucite crystals occur are caused by removal of fine-aggregate debonded from the cement. Debonding results from alteration of CSH to non-cementitious MSH.
