Review of Cold In-Place Recycled Asphalt Concrete Projects

Sponsored by the
Iowa Department of Transportation
Project Development Division and the
Iowa Highway Research Board

February 1998
Iowa DOT Project HR-392

Department of
Civil and Construction Engineering
Iowa State University

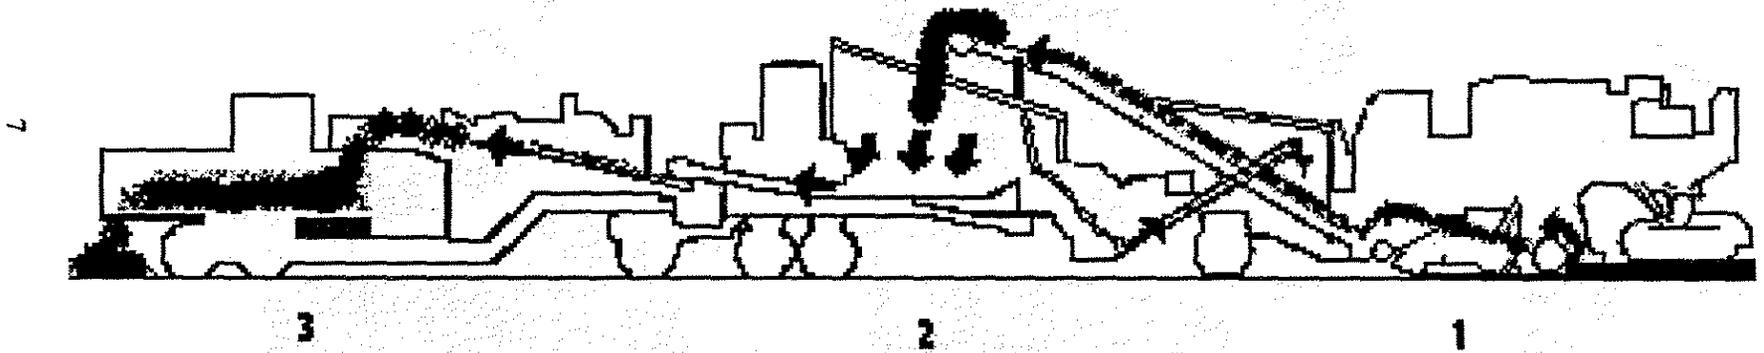
Figure 1: Typical CIR Train (moving left to right)
(1)milling machine (2)screening unit (3)pugmill and windrow

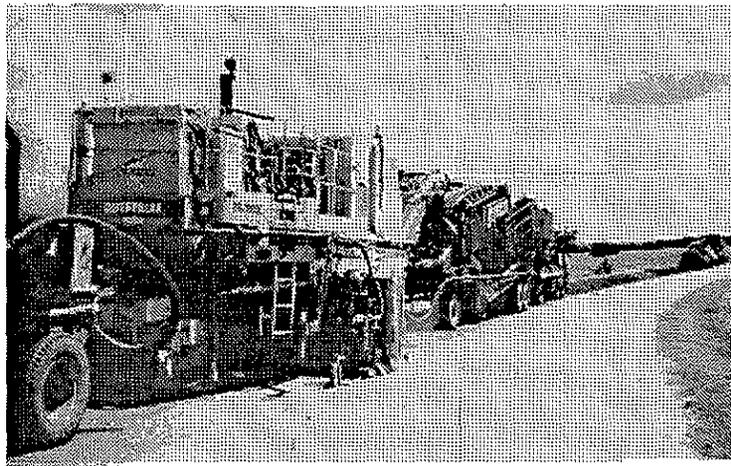
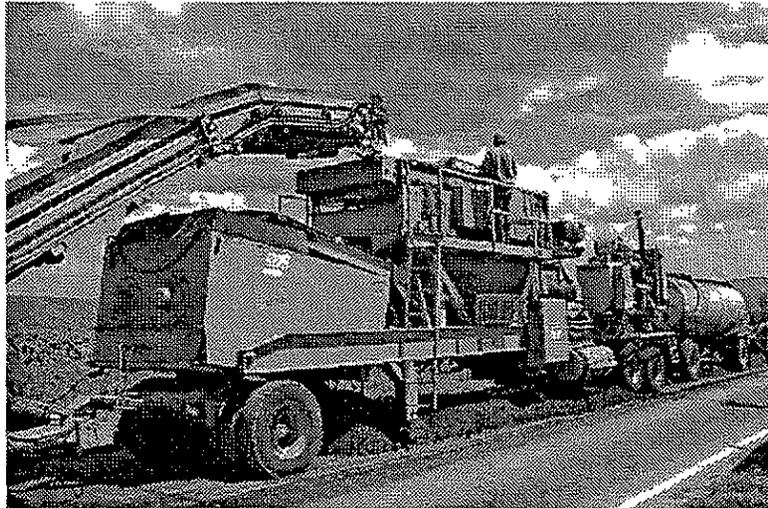
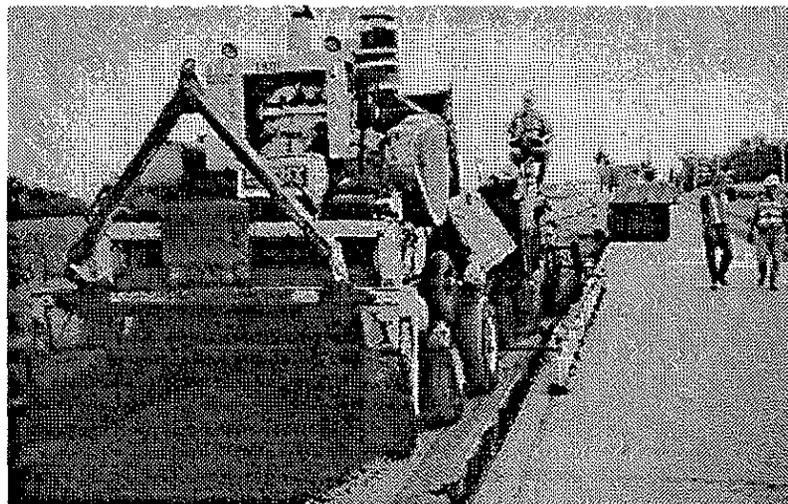
Figure 2: Operating CIR Train (Carroll County 1996 - moving right to left)
(a) milling machine (b) screening unit and pugmill (c) laydown machine

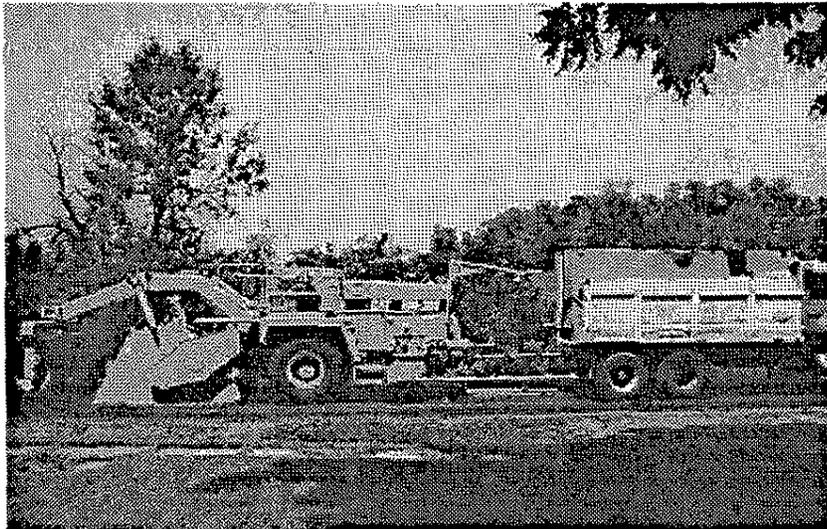
Figure 3: Reclamation Machine Used on Union County H17 (1997)

In the case of curbs and manholes, a different type of equipment may be selected. It has been done using a reclaiming machine to recycle the pavement and produce a base material (Figure 3).

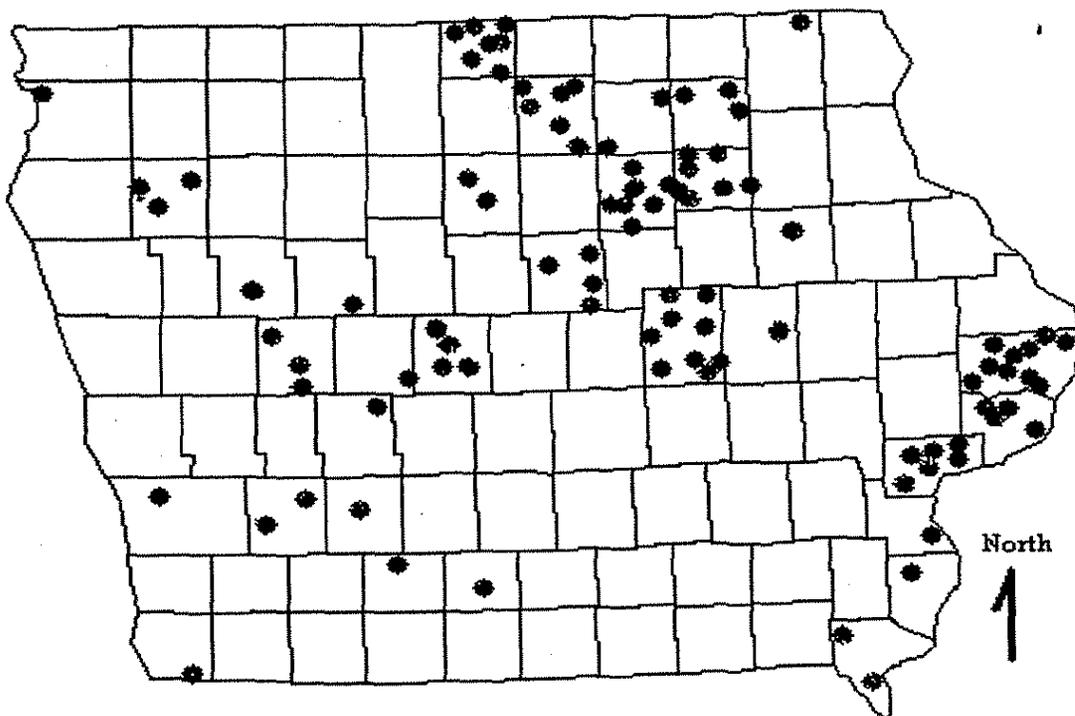
Figure 4: CIR distribution 1996

The first task of this research project was to find when and where CIR roads had been constructed in Iowa. This was accomplished by reviewing a list of CIR construction projects obtained from the Iowa DOT Office of Contracts and by surveying counties and cities. As of the 1996 construction season, 97 CIR projects had been completed throughout Iowa (Figure 4).

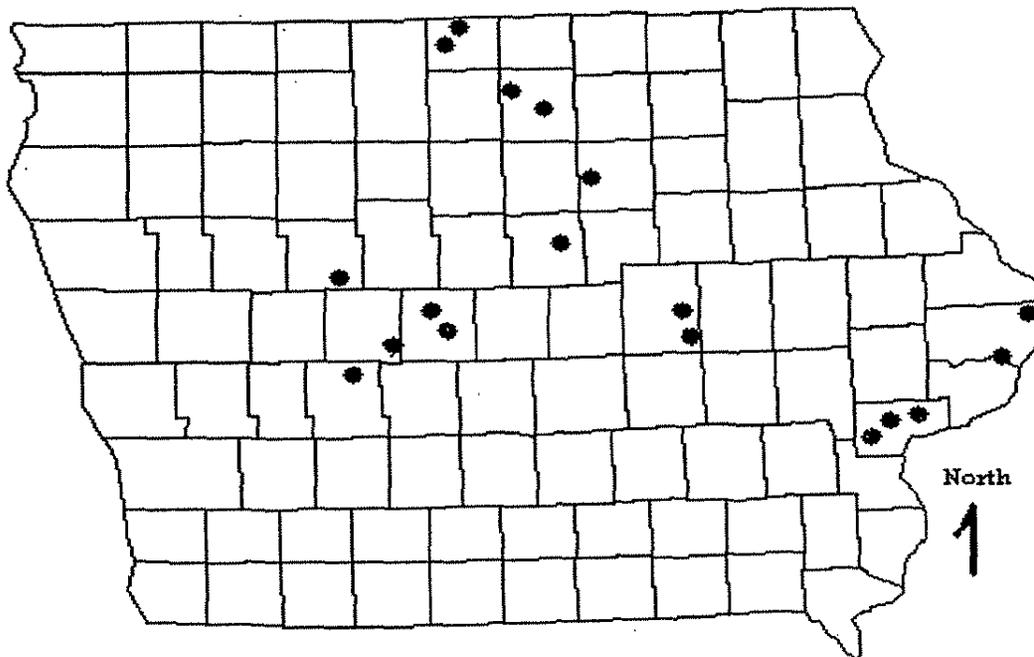
Figure 5: CIR roads performance surveyed 1996 and 1997

Using these criteria, personal conversation with engineers, and the guidance of the steering committee, eighteen roads were selected for in-depth analysis. (Table 1 and Figure 5). The sample included 15.5% of the ninety-seven county roads and one third of the nine state highways.

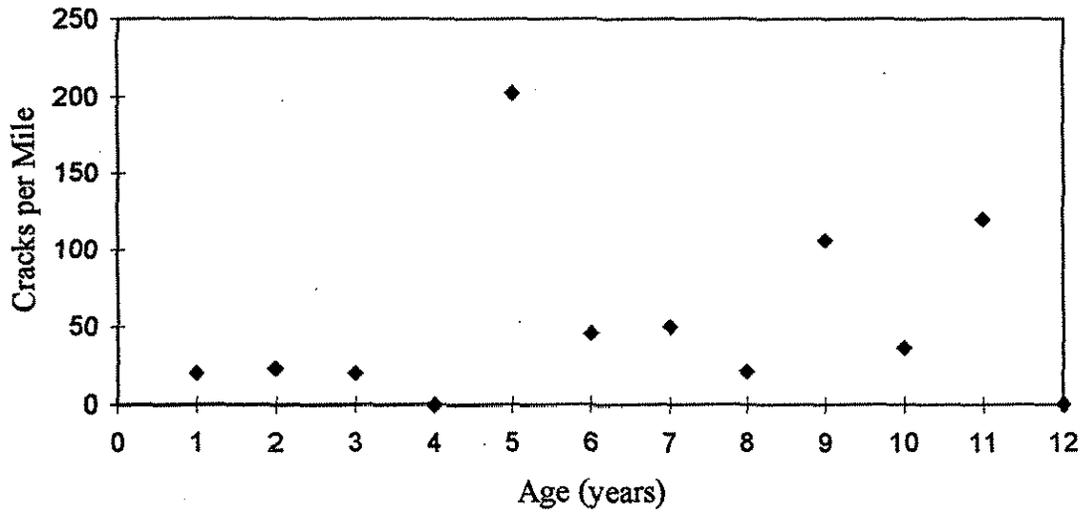
Figure 6: Frequency of transverse cracking

The highest deduction for transverse cracking was 15. More than a third of the roads received no deduction for transverse cracking. The number of transverse cracks per kilometer ranged from zero to 202. Figure 6 shows the frequency of transverse cracks. Only two of the roads exceeded 120 cracks per mile and more than two thirds had fewer than 58 cracks per mile. Records were not kept regarding the original number of cracks per mile. However, it is the writers' experience that before recycling, most roads in Iowa have transverse cracks every 20 to 30 ft. This is equivalent to 175 to 260 cracks per mile. This would indicate that CIR has been effective in mitigating transverse cracks.

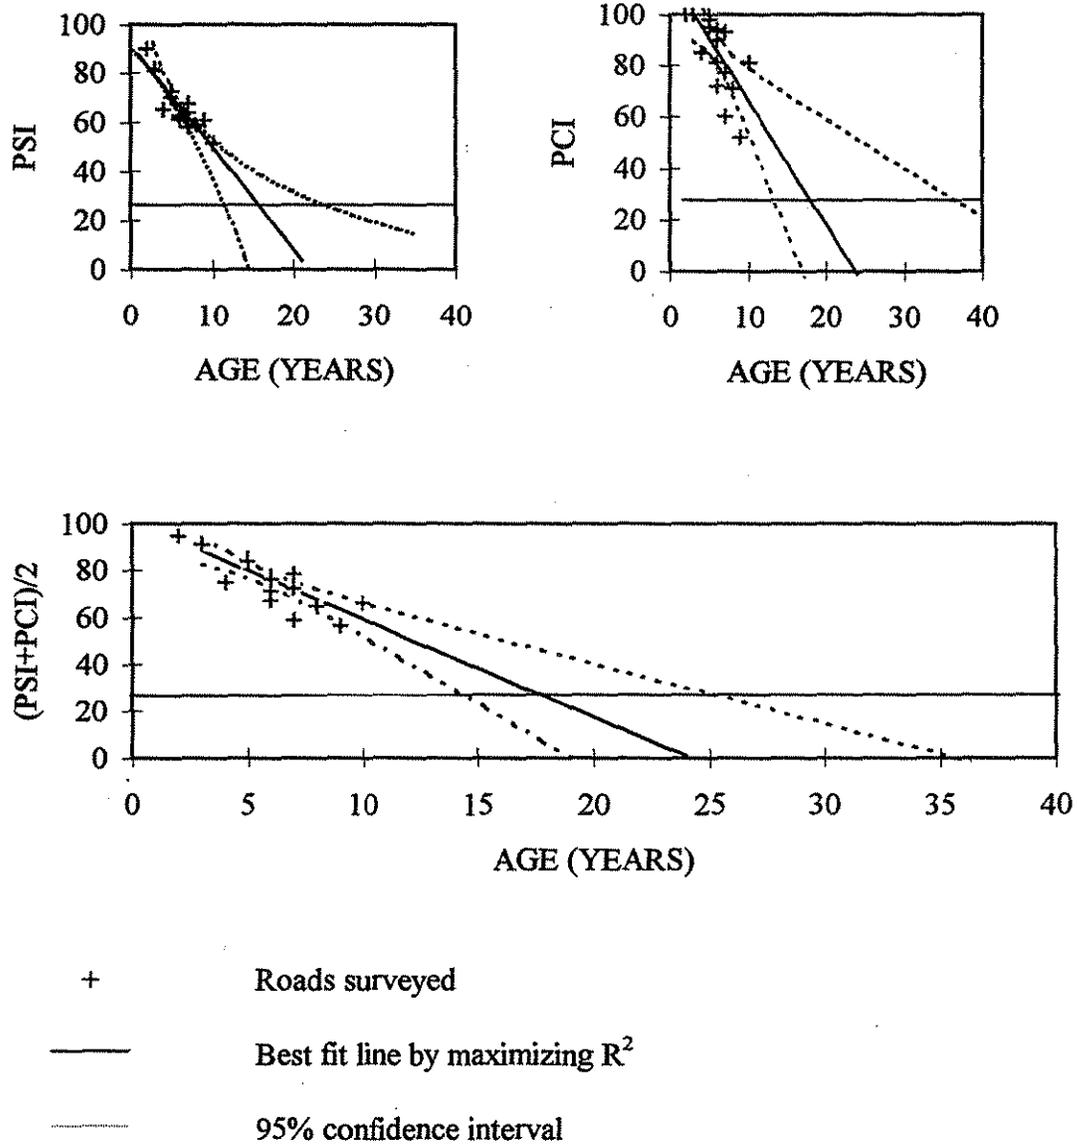
Figure 7: Life expectancy

- A. Performance exceeds 95% confidence interval (Figure 7).
- B. Performance above the regression line but below the upper 95% confidence limit.
- C. Performance below the regression line, but above the lower 95% confidence limit.
- D. Performance below the 95% confidence limit.

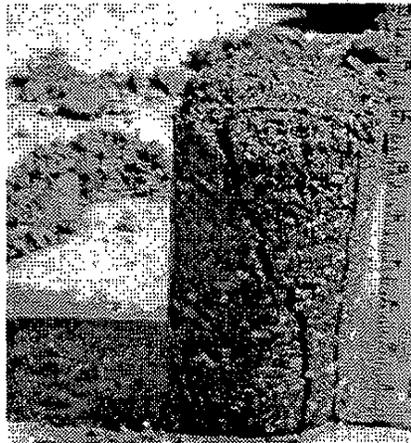
Figure 8: Reflective Crack from Carroll M-68

Cracks in pavements that were constructed during the 1995 and 1996 construction seasons were cored. These projects included M68 in Carroll County and T25 in Butler County (Tables 4 and 5). M68 consisted of 2 inch HMA overlay, 4 inches of RAP, and 1 inch of unrecycled pavement on 6 inches of base. T25 consisted of 3 inch HMA overlay, 3 inches of RAP, and 2 inches of unrecycled pavement on 2 inches of base. Some cracks in M68 went completely through the recycled pavement and the hot mix surface (Figure 8). These were likely to be reflective cracks that initiated in the unrecycled asphalt. Other cracks started in the hot mix surface and ended in the CIR (Figure 9). They are likely to be thermal cracks. The investigation of Butler County T25 showed similar results. Overall, about half of the cracks were reflective cracks and half of the cracks were thermal cracks.

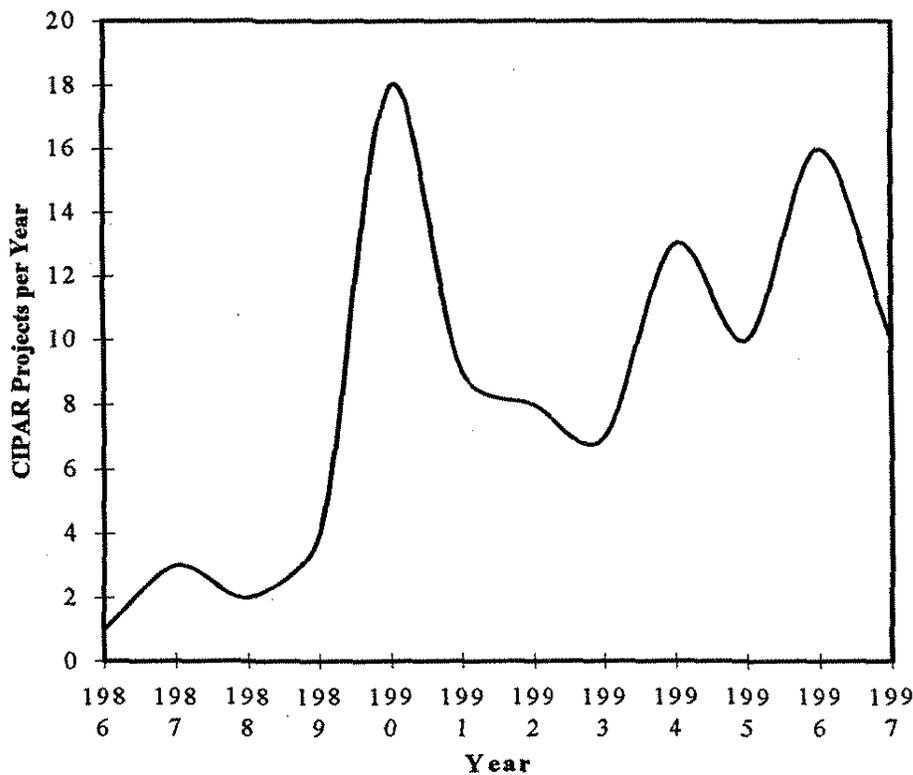
Figure 10. Number of CIR Projects per Year, 1986 - 1997

An investigation was conducted regarding the historical costs of CIR Construction in Iowa. Cost data were obtained from Iowa DOT bid tabulations. The number of projects per year has fluctuated (Figure 10). Between 1986 and 1989, there were no more than four projects per year. Nineteen ninety had the most activity with 18 projects. Since then, there have been between seven (in 1993) and sixteen (in 1996) projects per year.

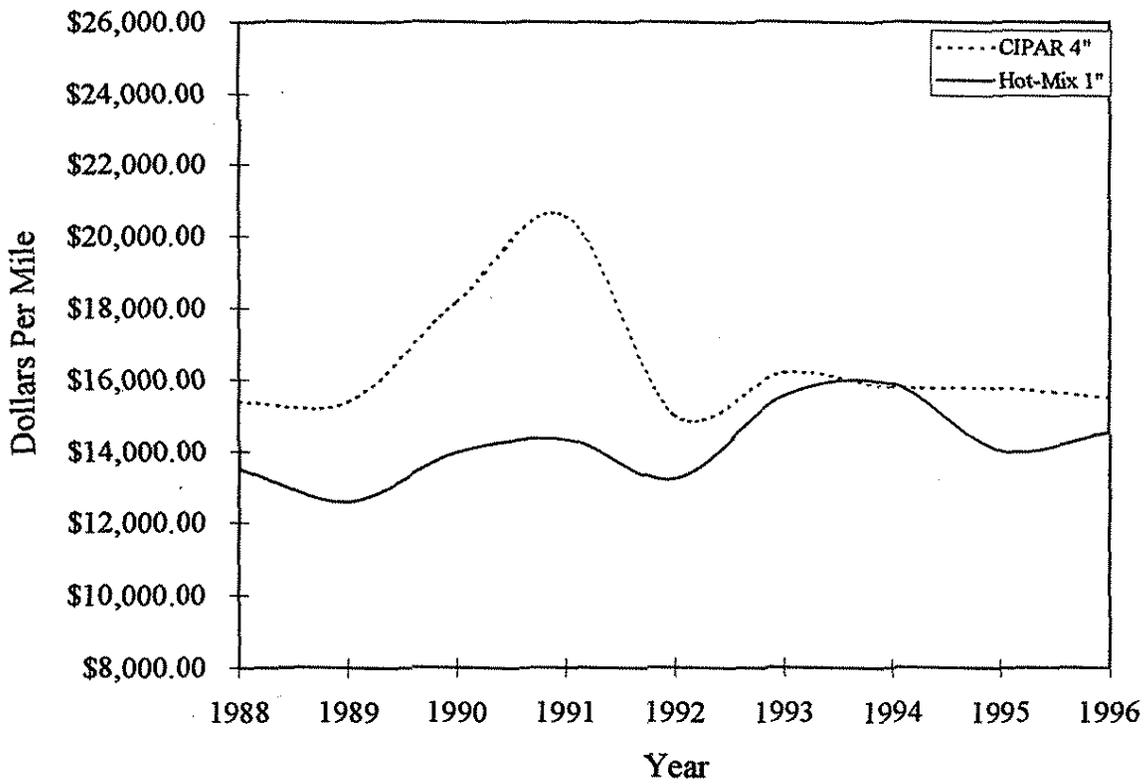
Figure 11. Cost Comparison of CIR and HMA Overlay

The average historical costs per road mile (two lane miles) for four inches of CIR and one inch of HMA are shown in Figure 11. The cost of CIR has ranged from \$14,000 to \$21,000 per road mile. The high cost occurred the season after the year of the greatest number of CIR projects. Recently the average cost of four inches of CIR and the cost of one inch of HMA has been \$13,000 to \$16,000.

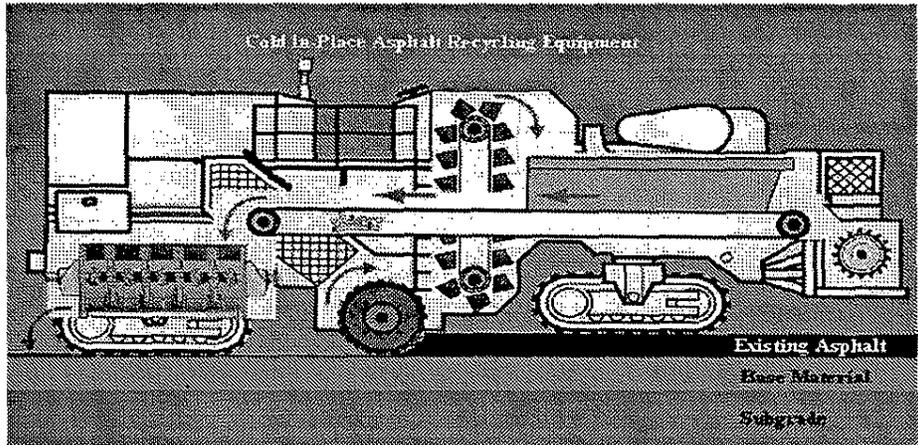
Figure 12: Milling Machine used in CIR Train (Roadtec, Inc.)

When equipment “breaks through,” it is usually due to a combination of factors. First, the equipment is heavy and applies a large vertical load to the pavement. Second, after the milling

head passes, the rear driving track of the milling machine is only supported by the remaining asphaltic concrete and the subgrade soil. This track must supply traction not only to move the milling machine (Figure 12), but also to push and pull other parts of the recycling train. The vertical load of the equipment, combined with the shear forces caused by the tractive effort can shear and puncture the remaining asphaltic concrete into the subgrade soils if they are soft and weak.

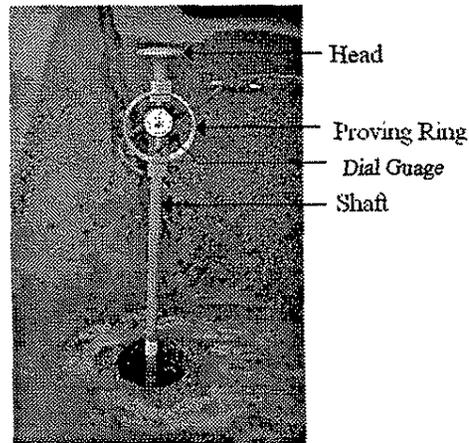
Figure 13. Soil Cone Penetrometer

A Soil Cone Penetrometer (Figure 13) was the first device used in an attempt to measure subgrade stability. A penetrometer is a device consisting a shaft with a cone-shaped tip on an end that is pushed into the soil, and a large head to apply pressure on the other. There is a proving ring near the head of the instrument that is used to determine the applied pressure. A dial gauge inside the proving ring measures the pressure in pounds per square inch.

The procedure involved using a four inch core drill to remove the asphaltic concrete and aggregate base. After the core was removed, the penetrometer was pushed into the subbase or subgrade to determine the strength of the underlying soil. The penetrometer is pushed in to the subgrade at a constant rate, and the cone resistance to penetration is measured. This test gives an assessment of subgrade stability, but the procedure is time consuming and has a potential for inaccuracy. It is difficult to achieve a constant rate of penetration, and therefore difficult to obtain exact measurements. Also, as the core drill cut through the asphalt, it introduced water into the soil, which may have reduced the stability.

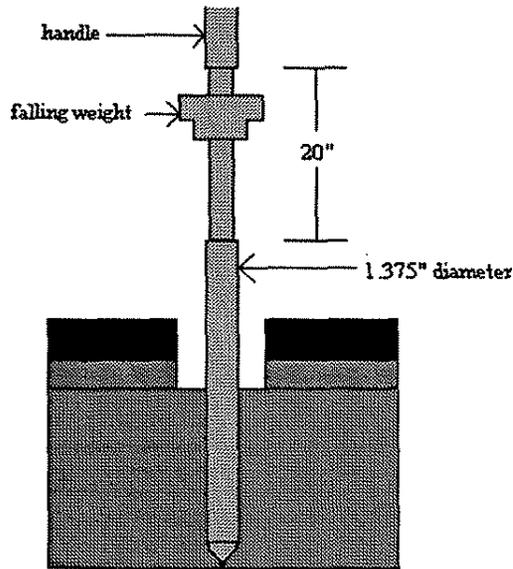
Figure 14: Dynamic Cone Penetrometer

Researchers chose a Dynamic Cone Penetrometer (DCP) to measure subgrade stability. The DCP (Figure 14) is a standard device used to measure the in-place stability of a soil (Sanglerat, 1992). The DCP is a 1.375 inch steel shaft with a 45 degree cone at its tip. The device uses a 15 pound weight that falls 20 inches to strike an anvil on the shaft and drives the

cone into the soil. The penetration into the soil can be measured for each blow, and a measure of subgrade stability determined. The test requires a hole through the existing asphalt and base materials to the subgrade of the pavement. A hammer drill with a 2 inch masonry bit was used for this purpose.

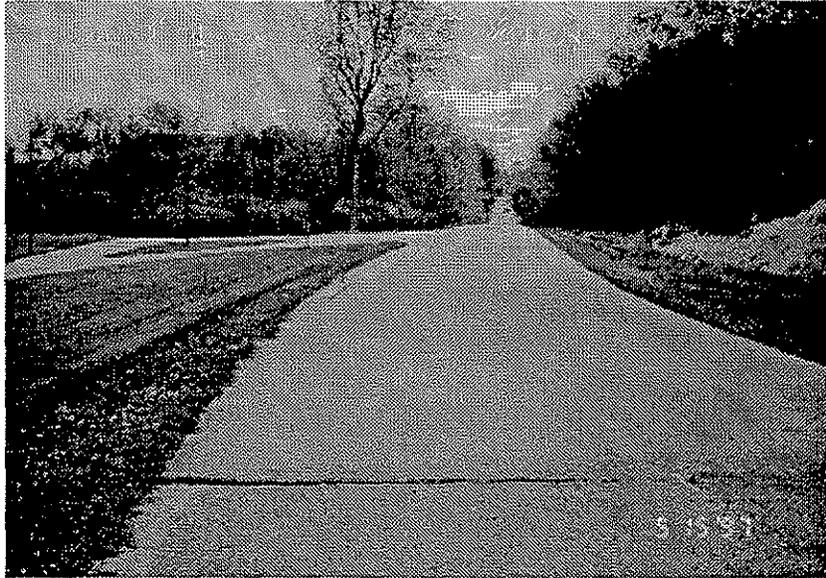
Figure 15: Condition of the Pleasant Creek State Park road before recycling

The pavement consisted of six inches of hot mix asphaltic concrete placed directly on the subgrade soil. The pavement had severe transverse cracks spaced from one hundred to two hundred feet apart as shown in Figure 15. CIR was the process chosen to eliminate these transverse cracks. As the project progressed, CIR was completed with varying degrees of success. The milling machine began the project by milling four inches of the existing pavement. After difficulty was experienced with subgrade stability, the milling depth was reduced to three inches. Subgrade instability continued to be a problem. Figure 16(a) shows an area of the project that was successfully recycled. Figure 17(a) shows an area of the project that experienced moderate distresses. Figure 18(a) shows an area of the project that experienced severe distresses. In areas

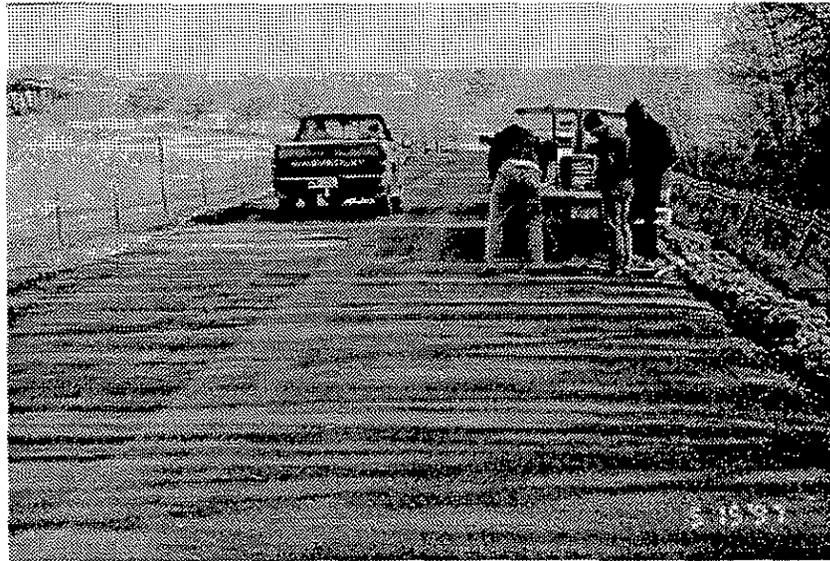
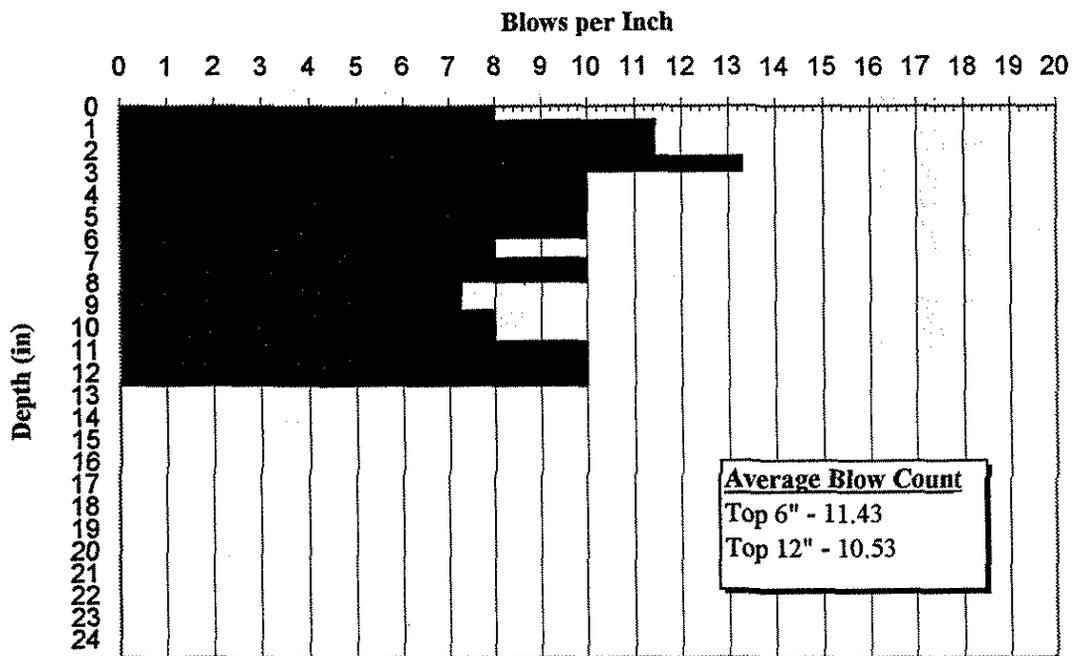
Figure 16: (a) Recycled Mat with No Distress. Pleasant Creek State Park Road
 (b) Typical DCP Profile of Subgrade where CIR Mat was in Good Condition

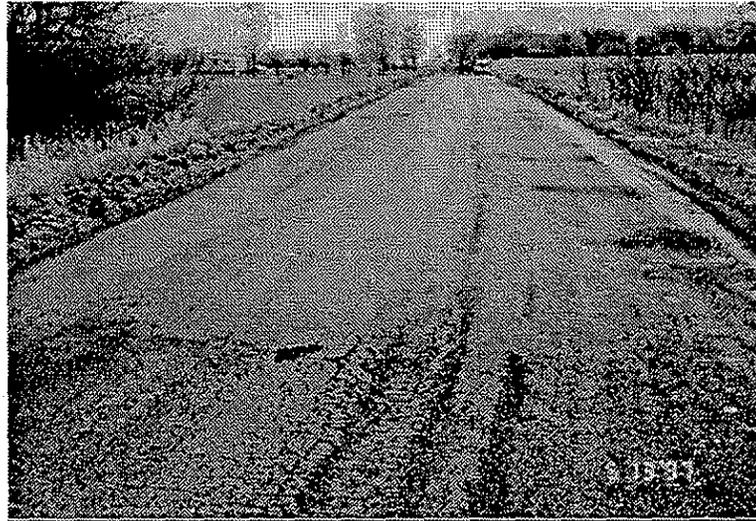
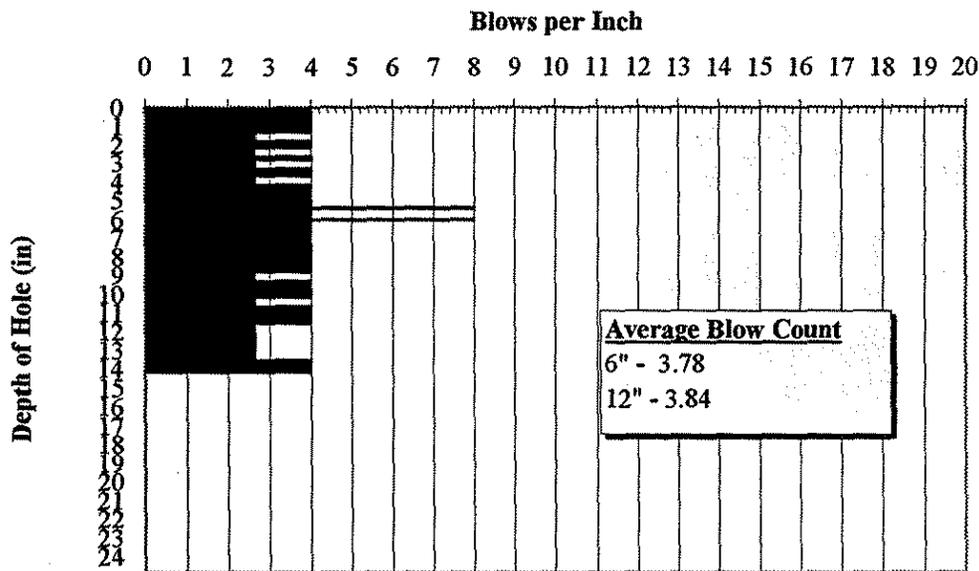
Figure 17: (a) Recycled Mat with Moderate Distresses. Pleasant Creek State Park Road
(b) Typical DCP Profile of Subgrade where CIR Mat had Moderate Distresses

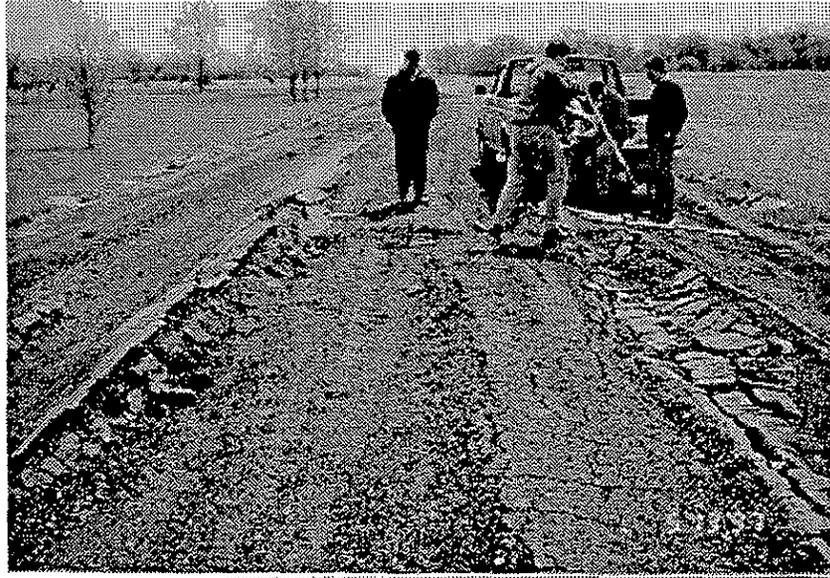
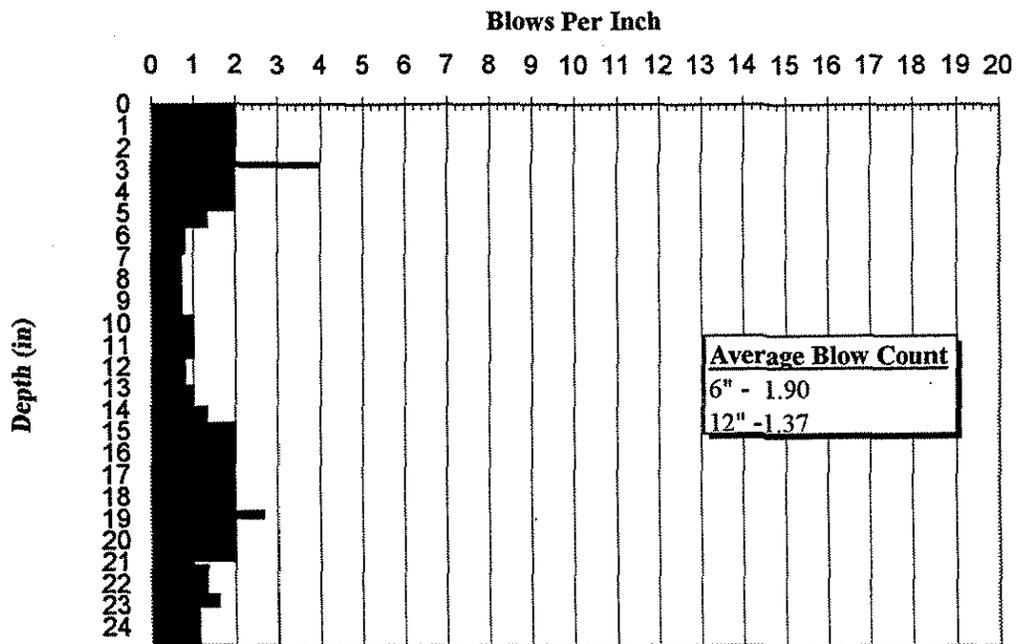
**Figure 18: (a) Recycled Mat with Severe Distresses
Pleasant Creek State Park Road
(b) Typical DCP Profile of Subgrade with Recycled Mat Heavily Distressed**

such as these, the equipment punctured through the two inches of underlying asphalt and became stuck in the subgrade. After the recycling train "broke through" in two different locations, the contracting authority decided to stop recycling, and choose an alternate rehabilitation method to complete the project. This included removing the soft subgrade on portions of the project that were raveling and the spots where the equipment "broke through". The subgrade was replaced with new granular base material. There was an additional mile of the project that was not recycled at all and where the cracks were routed and sealed. Then the entire pavement was overlaid with HMA.

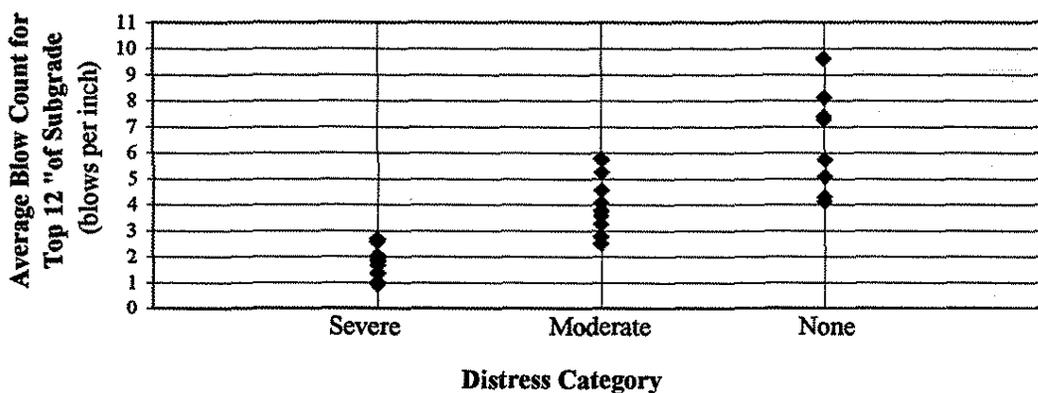
Figure 19: Average DCP Blow Count Data for each Distress Category

The results were analyzed by comparing the DCP blow counts among the various distress categories. At each test location, the amount, type, and severity of distress was recorded. Then the locations were categorized as having high, moderate, or low levels of distress. [See figures 16(a), 17(a), and 18(a)]. Figure 16(b) shows a typical blow count profile taken from a location with no distress. Figure 17(b) shows a typical blow count profile from a location with moderate distress. Figure 18(b) shows a typical blow count profile taken from a location with severe distress, where the equipment broke through. During the DCP test, the amount of penetration was measured for each blow. These data were then converted to the number of blows for one inch of penetration. Table 7 shows the DCP blow count data recorded for each distress category. Figure 19 shows the average DCP blow count per inch of penetration for the top 12 inches of the subgrade each distress category. In severely distressed areas, the average subgrade DCP blow counts ranged from 0.8 to 2.7 blows per inch of penetration. The moderately distressed areas exhibited average DCP blow counts ranged from 2.5 to 5.9 blows per inch of penetration. The areas showing no CIR distress had average blow counts ranging from 4.1 to 9.8 blows per inch of penetration. These data indicate that for subgrade stability the average DCP blow count for the top 12 inches of subgrade should be on the order of 5 blows per inch or greater.

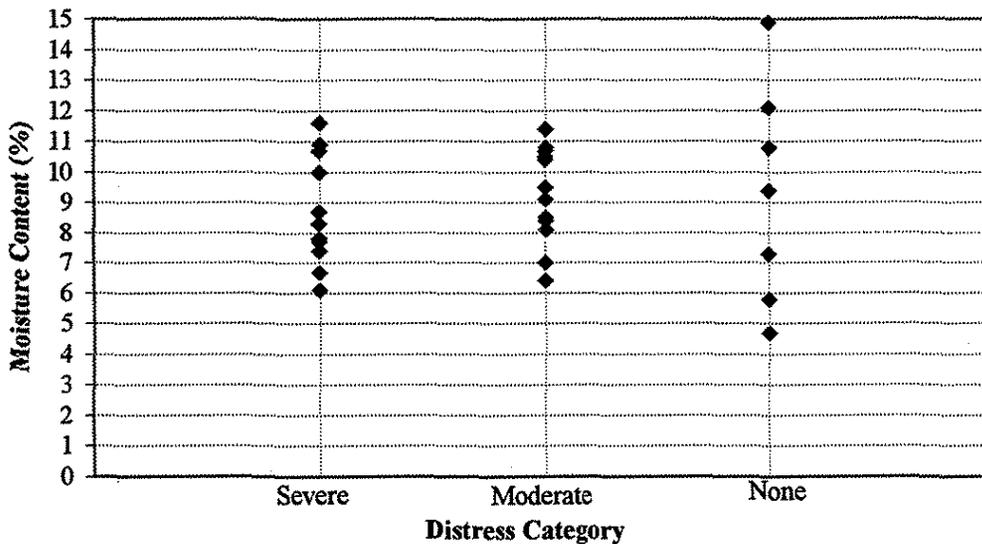
Figure 20: Moisture Contents of Each Test location for Each Distress Category

There appears to be no correlation between subgrade soil moisture content and distress category for this project. (Figure 20 and Table 8) The reason for this is probably because the soil type varied among test locations. Moisture affects each soil type in a different manner, and therefore can lead to differing levels of stability for differing levels of moisture.

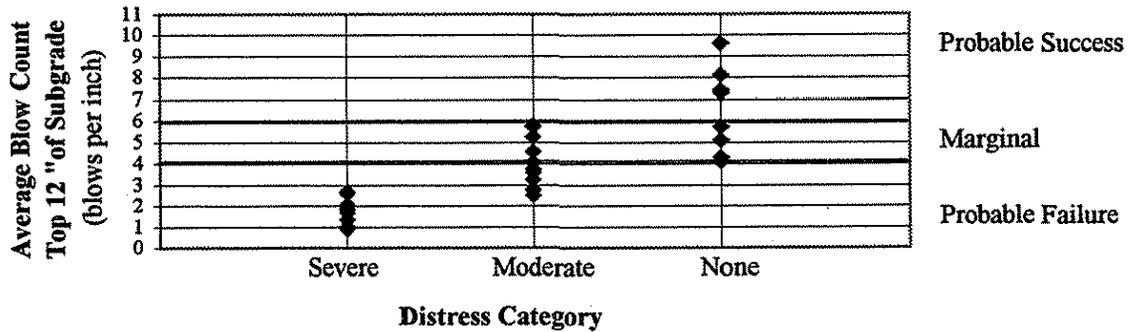
- Calculate the average DCP blowcount per inch for the top 12 inches of subgrade soil.
- Compare the results with the figure shown below and determine feasibility for construction.

(Pleasant Creek State Park Data) ③

- If the majority of DCP counts fall in the “Probable Success Range”, CIR is probably feasible.
- If the majority of DCP counts fall into the “Marginal Range”, conduct additional testing to verify areas and locations on the project that are marginal. An engineering judgment must be made before deciding to proceed with CIR.
- If the majority of DCP counts fall into the “Probable Failure Range”, it is unlikely that CIR is feasible. Consideration could be given to re-testing when subgrade conditions improve, if CIR could be scheduled during a time of improved subgrade condition.

The Dynamic Cone Penetrometer test should be performed on pavements during the project selection process. Recommended test guidelines are summarized in Figure 21 (a & b). Areas should be tested where subgrade stability is in question: heavily distressed pavement sections (especially sections exhibiting rutting, shoving, or potholes), places where evidence of moisture is nearby (cattails in ditches), or areas where pavement was placed directly on the natural soil. It requires drilling through the existing asphalt pavement and base material, while recording the thickness of each. The pointed end of the DCP is placed firmly on top of the subgrade. The falling weight is dropped and the penetration is recorded for each blow. This is repeated as a blow count is taken in the top 12 inches of the subgrade. This procedure should be done *at least* once per lane mile.
