THIN MAINTENANCE SURFACES

PHASE ONE REPORT

CTRE Management Project 97-14

APRIL 1999

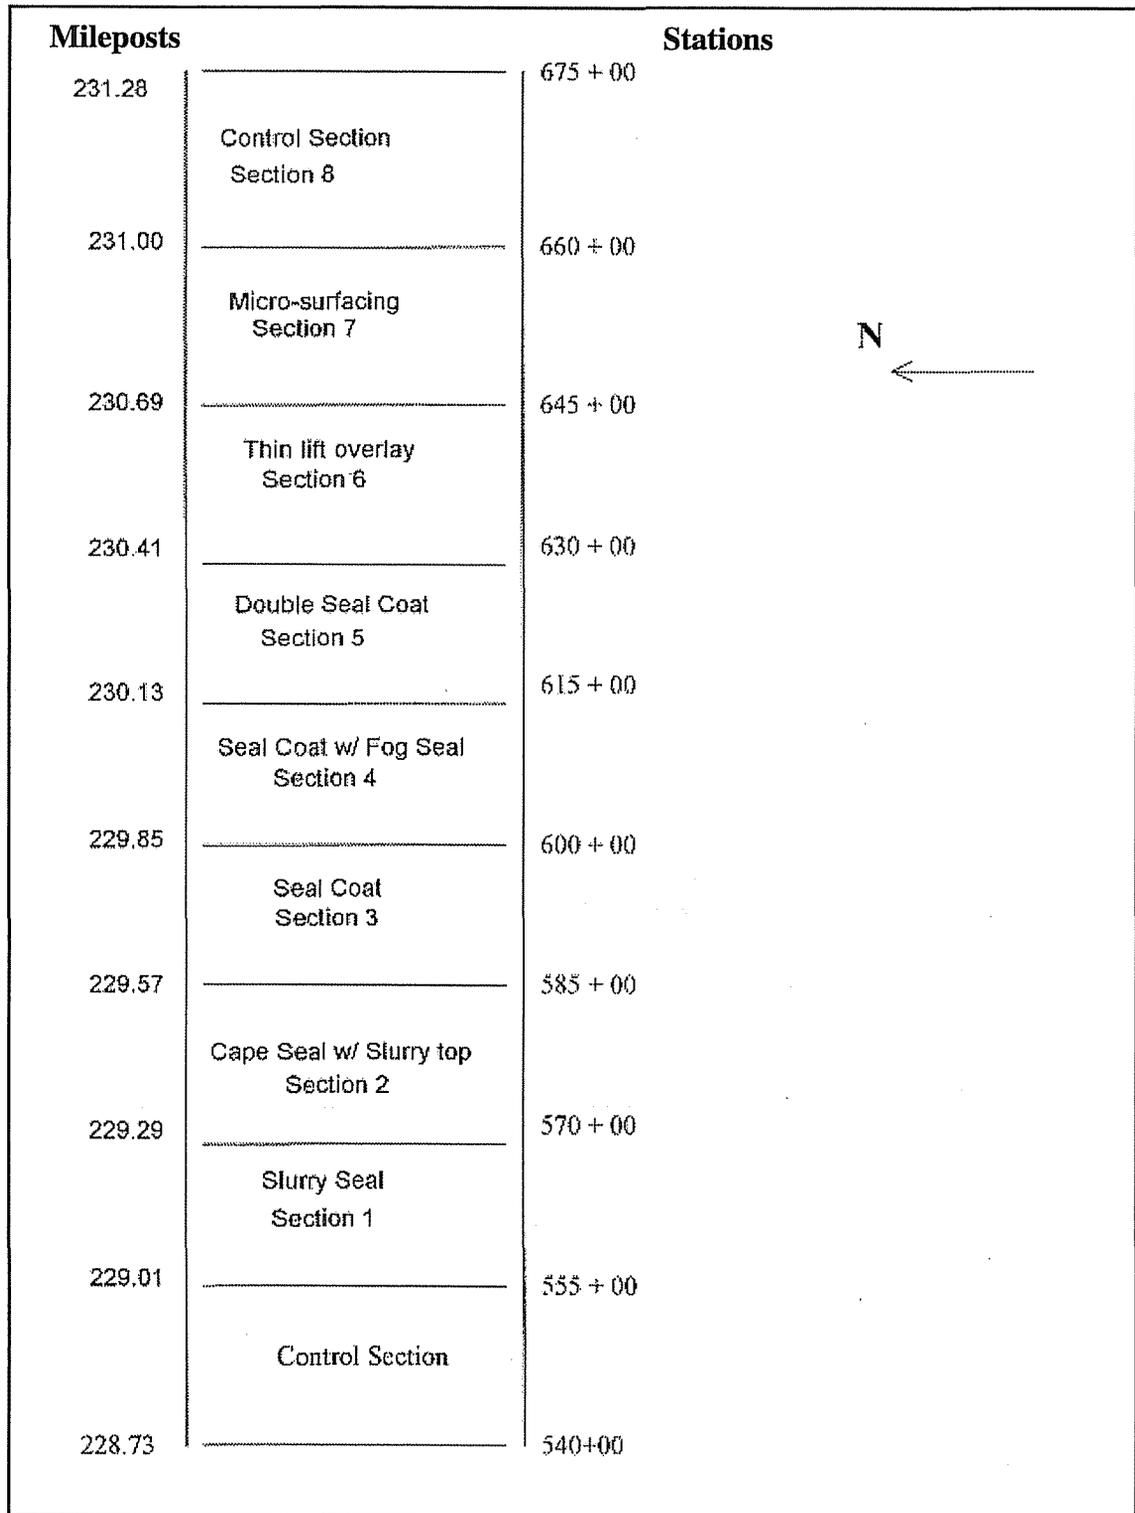
Figure 7. US 30 Test Sections

The US 30 test sections were located between the junction of US 218 north and the junction of IA 82 south from milepost 229.10 to 231.00, west of Cedar Rapids (Figure 7).

This road was originally constructed in 1949 as a 24-foot wide PCC pavement, 6.5 inches thick. It received a 3-inch ACC overlay in 1965, and 3-inch ACC overlays in 1977 and 1990. In 1997 it was in good condition with light to moderate cracks reflected from the PCC pavement below, some of which had been routed and sealed. The surface was smooth with little indication of raveling and no bleeding. The PCI (USA-COE) ranged from 65 to 83, which corresponds to a good condition. According to Stephens (4) the PCI falls in the range that should receive preventive maintenance.

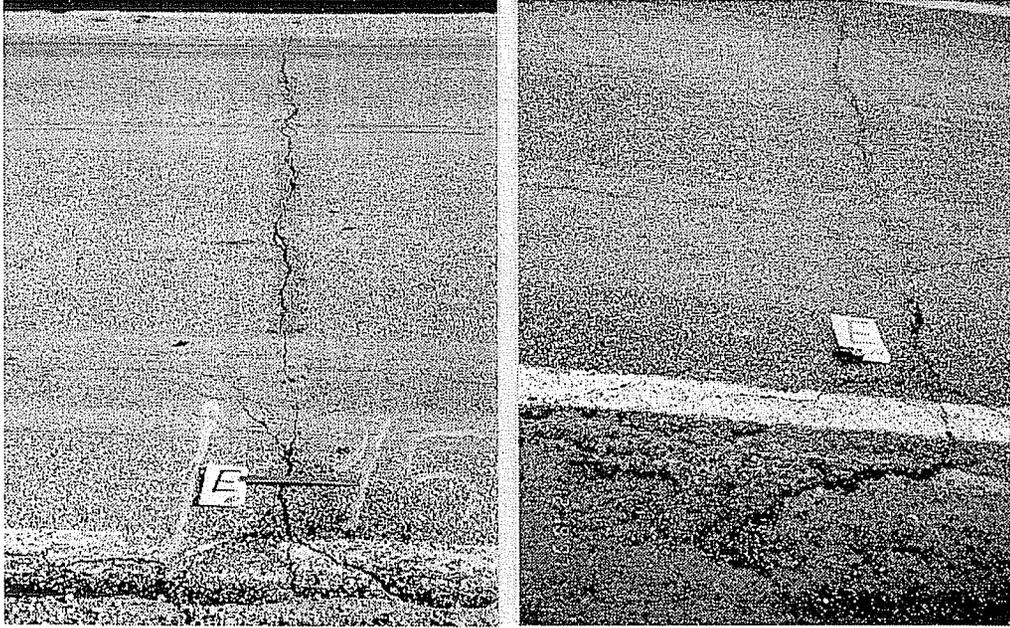
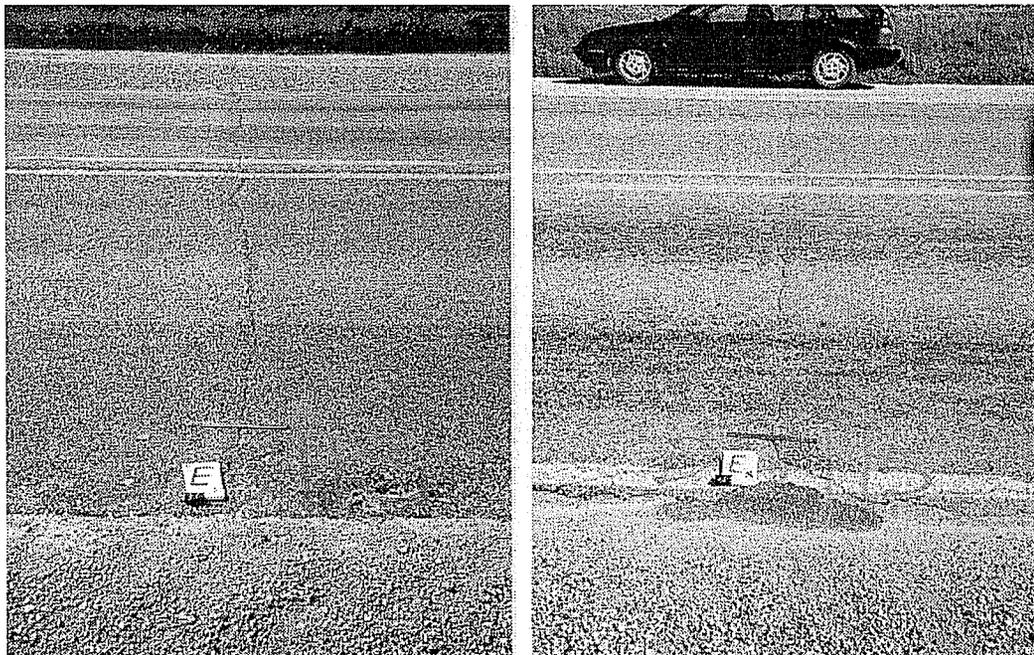
Figure 8. Pre- and Post-Construction Surveys of US 151

(a) Pre-construction survey of US 151

(b) Post-construction survey of US 151

The double seal coat provided a relatively smooth, quiet surface in the spring of 1998. Few cracks reflected through and the ones that did were sealed with binder under traffic (Figure 8). The wheel paths were somewhat flushed. The 3/8-inch chips on the top course of the double seal coat provided a desirable surface, while the 1/2-inch chips on the single seal coat provided a rough, noisy surface. Of the seal coat surfaces, researchers and Iowa DOT officials preferred the double seal coat. For this reason, this surface was not covered with micro-surfacing when the others were. Over the summer of 1998, the wheel path became increasingly flushed and by August exhibited friction numbers in the teens and 20s. The decision was made to mill off the double chip seal for safety reasons.

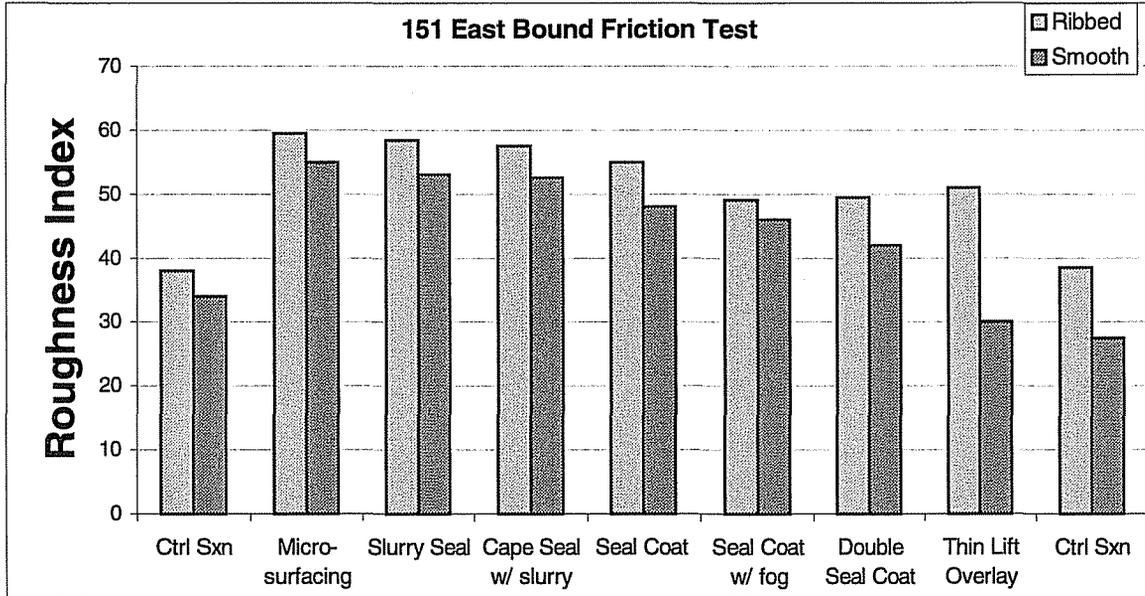
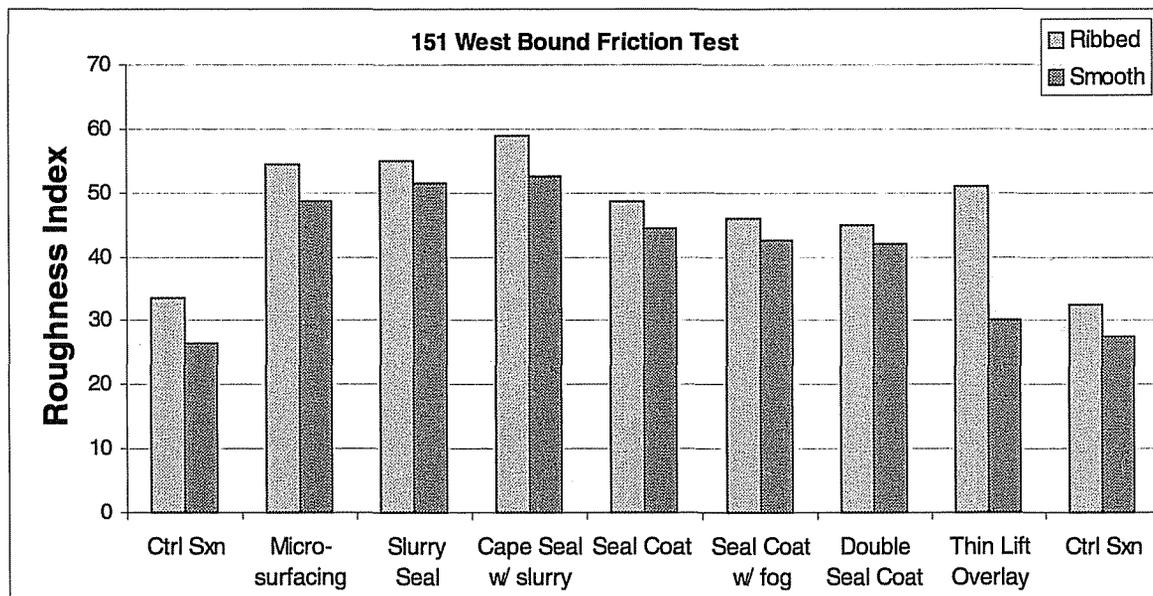
Figure 9. Comparison of Friction Numbers for US 151 Test Sections (5)

The highest friction numbers were for the southwest bound cape seal (59.0 ribbed, 52.5 smooth) and northeast bound micro-surfacing (59.5 ribbed, 55.0 smooth). The slurry seal also had high friction numbers (55.0 to 58.5 ribbed, 51.5 to 53.0 smooth) immediately after construction. The seal coat had one friction value at 55.0 for the ribbed tire. The rest of the values were below 50.0. Also, the seal coat had higher friction values than the seal coat with fog seal and the double seal coat. Lower friction was expected for the double seal coat, which has smaller surface aggregate. For seal coat with fog seal, the

lower friction may have been caused by the fog seal. The thin lift overlay had a high friction number for ribbed tire but a low number for the smooth tire test. This would be expected because thin lift overlays have less macrotexture than other treatments.

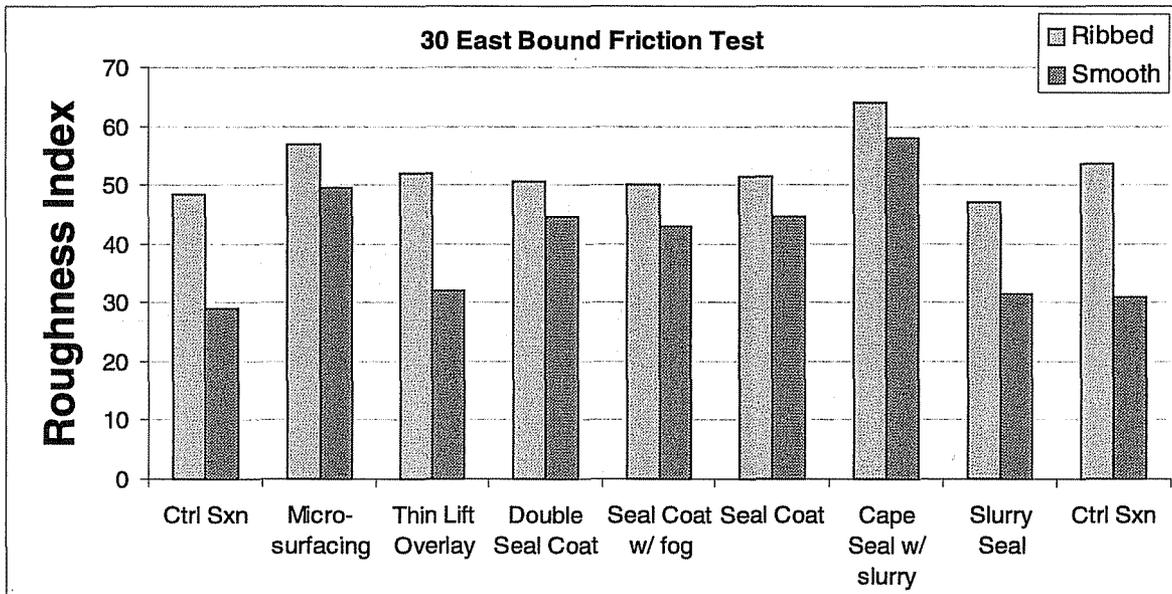
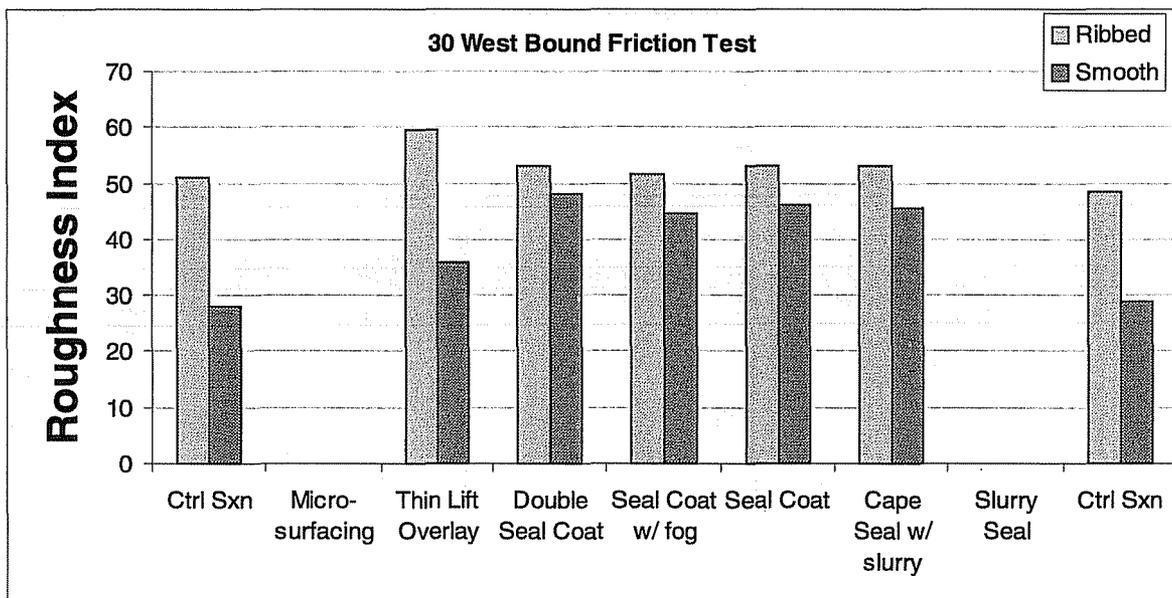
Figure 10. Comparison of Friction Numbers for US 30 Test Sections (5)

US 30 had higher friction numbers when compared to US 151. On US 30, the cape seal again had the highest friction number for the westbound lane, and thin lift overlay had the highest friction number for the eastbound lane (Figure 10).

For the westbound lane, recall that the slurry sections and micro-surfacing sections were not constructed in the fall of 1997 due to weather problems. The slurry section had lower friction numbers since it had started to ravel at the time of the test. This is especially evident in the smooth tire friction number; it had the same value as the control sections. Although only a small amount of slurry seal covered the seal coat on the cape seal section, the friction number was over 60. The cape seal section in the westbound lane that was not covered with slurry seal had the same range of values as the other seal coats. For US 30, the friction numbers for seal coats seemed more consistent with values around and above 50. The micro-surfacing had higher friction numbers when compared to chip seals (results similar to those of US 151). Thin lift overlay ribbed tire friction numbers were higher, and smooth tire friction numbers were lower (results similar to those of US 151).

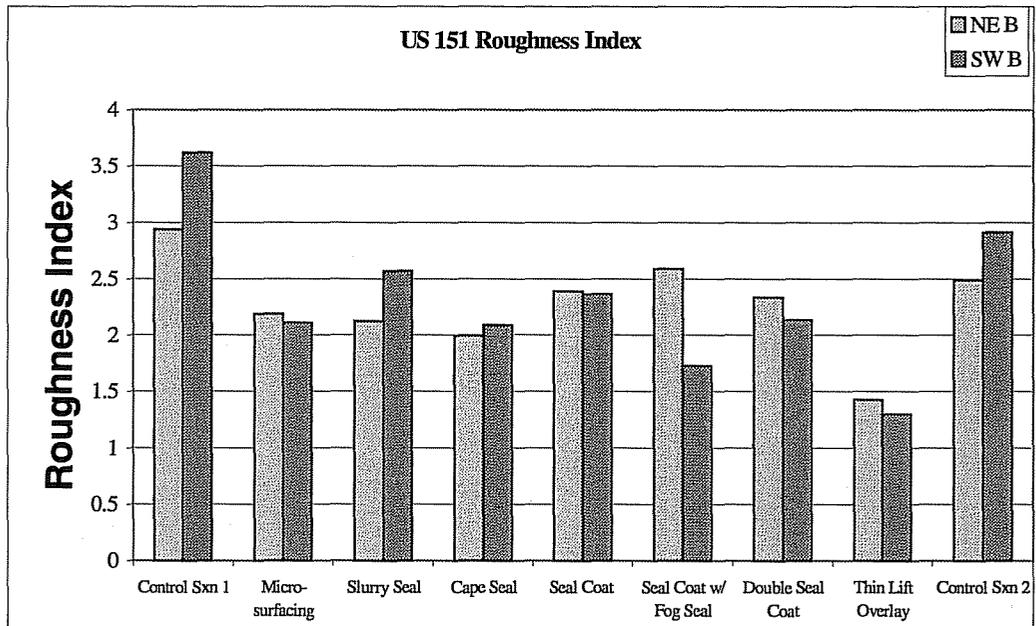
Figure 11. Comparison of Average Roughness Values for US 151 (5)

A roughness index (RI) was used to assess roughness. Data were recorded by a South Dakota Type Profiler according to ASTM standards E950 and E1170. The results were averaged over the length of the test sections. The test equipment was adjusted to detect roughness with wavelengths up to 300 feet. Wavelengths over 100 feet on highways have little effect on vehicle ride, whereas for airport runway wavelengths, 400 feet might be significant (8). The International Roughness Index (IRI) is sensitive to wavelengths between 4.2 feet and 75 feet as given by Shahin (8). Therefore the RI used in the study cannot be compared to the IRI. However the RI used in the study can be used to compare roughness among test sections.

The control sections on US 151 were rougher than those of US 30 (2.5 to 3.7 vs. 1.2 to 1.4, Figures 11 and 12). The test sections on US 151 were also rougher than those on US 30 (1.8 to 2.6 vs. 1.1 to 1.6). All of the treatments improved the roughness values for US 151.

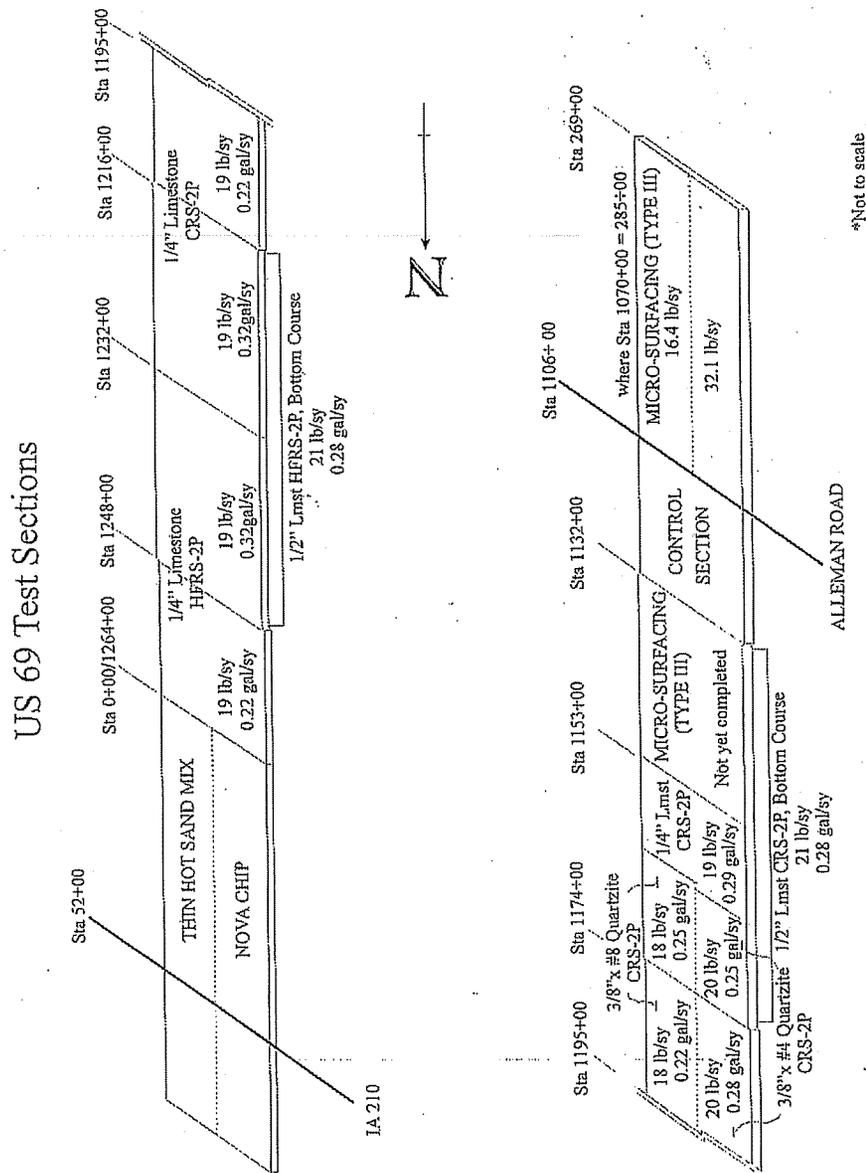
Figure 14. Materials Application Rates for US 69

The application rates for the 1998 test sections are provided in Figure 14. For comparison, Iowa DOT specifications call for 0.40 gal/yd² of binder and 30 lb/yd² of aggregate when 1/2-inch aggregate is used. When 3/8-inch aggregate is used, the binder application rate is 0.30 gal/yd² and the aggregate application rate is 25 lb/yd² (specified for second course of two-course seal coats).

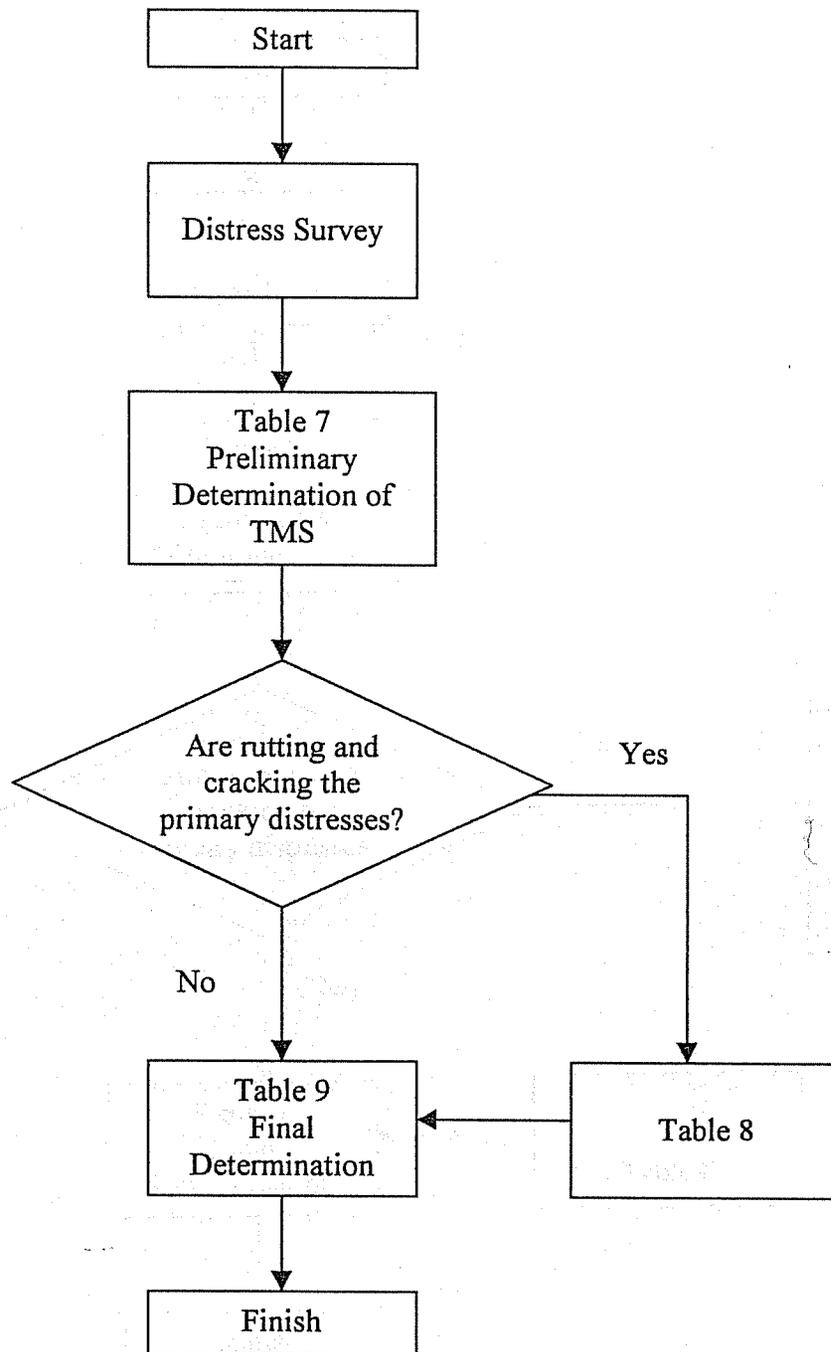
Figure 15. TMS Selection Flowchart

A three-step decision procedure is recommended (see flowchart, Figure 15).

Step 1 - *Collect information on candidate roads for thin maintenance surfaces.* A performance survey should be conducted to assess the amount and type of distress that the road is suffering. The survey could be a detailed distress survey to provide input for PCI calculations. If a pavement management system is in place, the PCI has been calculated and tracked for a number of years. Thus additional helpful information regarding the rate of deterioration is available. At least a visual assessment should be made and rut depths should be noted. The traffic count should also be obtained and areas that must withstand many turning and stopping movements should be noted.

Step 2 - *Identify feasible treatments.* Using Table 7, identify feasible treatments. Table 8 provides additional guidance for selecting treatments for roads where rutting is the primary distress.

Step 3 - *Consider other factors before making a final selection.* Table 9 provides a list of other factors that should be considered before making a final selection.

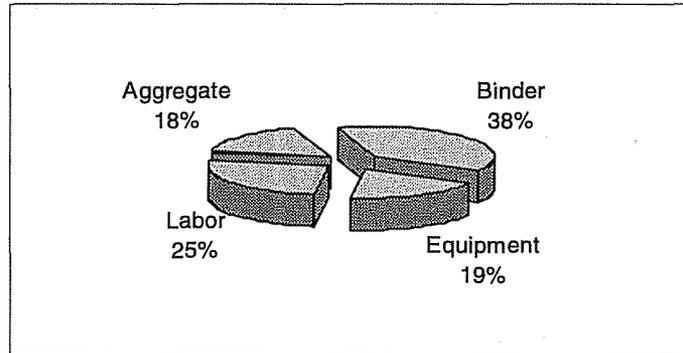
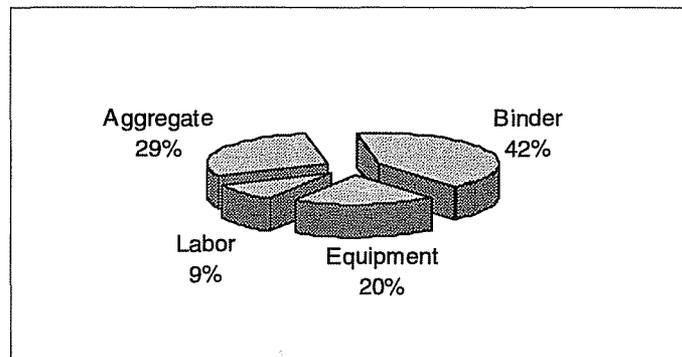
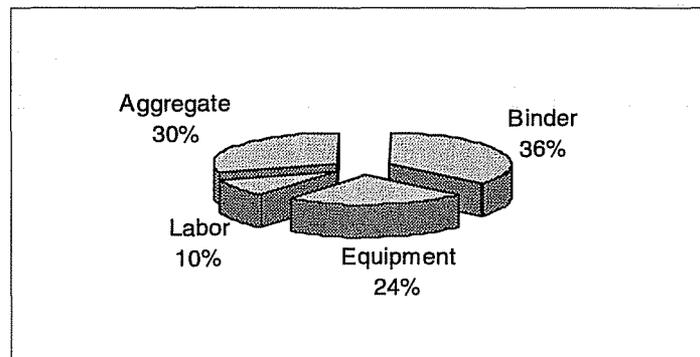
Al-Hammadi (3) calculated the proportion of cost that is associated with binder, aggregate, labor, and equipment for seal coats, slurry seals, and micro-surfacing (Figure 16).

(a) Slurry Seal cost breakdown (using local aggregates) (b) Seal Coat cost breakdown (using local aggregates) (c) Micro-Surfacing cost breakdown (using imported aggregates)
