**IOWA
DEPARTMENT OF TRANSPORTATION
DIVISION OF HIGHWAYS
OFFICE OF MATERIALS**

SPECIAL REPORT

**AN EVALUATION
OF THE
ROTO-MILL PROFILER
ON
CONCRETE PAVEMENTS IN IOWA**

NOVEMBER 1976

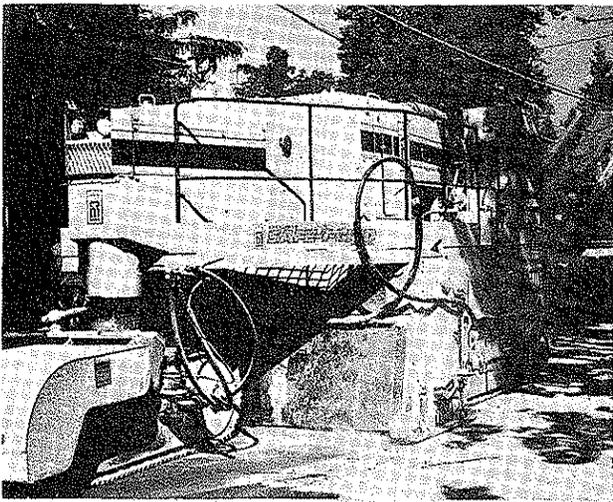
Figure 1
ROTO-MILL Profiler

The ROTO-MILL Profiler, (Figure 1) manufactured by C.M.I. Corp. of Oklahoma City, Oklahoma, can make a pass 9 feet 3 inches wide and remove approximately 1/4 inch from the entire surface, in addition to the faulted joints. This machine used a ski that provided a leveling action in the surface cutting operation. Approximately as long as the wheel base of the machine, the ski activated an automatic vertical control sensing device. Removal of material from the entire surface rather than just the faulted joints prevented leaving a surface with differential skid resistance.

The material resulting from the grinding was picked up by the machine and, by means of an attached conveyor, was deposited either onto the shoulder or into a truck. The material is in a size range of approximately 3/4 inch down to dust. This material is very useful for repairing aggregate shoulders.

An improvement in future machine development would be a cutting head at least 12 feet wide. Assuming that gross weight and power limitations would allow such a modification, the wider machine could "process" a full 12-foot travel lane during each pass. This should be more efficient when considering the crown in normal two-lane pavements.

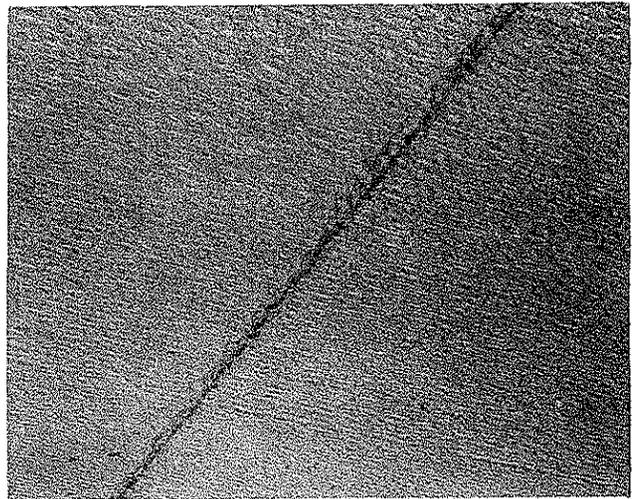
Figure 2
Pavement Surface after Grinding

Re-profiling or improving skid resistance, can be done under traffic with a flagman. After the ground surface is swept with a rotary broom it is ready for traffic. (Figure 2)

One detrimental feature of the ROTO-MILL Profiler is that some spalling results at transverse joints and along the outer edge of a concrete pavement. The spalls at the joints varied in width up to approximately one inch. The degree of detriment was difficult to determine. It is reasonable to expect some tire noise at these joints, but not to a degree that would be considered objectionable. The manufacturer of the machine is still experimenting with techniques that will hopefully lessen, if not entirely eliminate, the above mentioned spalling condition.
