**Investigation of Two Bridge Alternatives for
Low Volume Roads - Phase II
Volume 2 of 2**

**Concept 2:
Beam In Slab Bridge**

July 2000

Iowa DOT Project TR-410

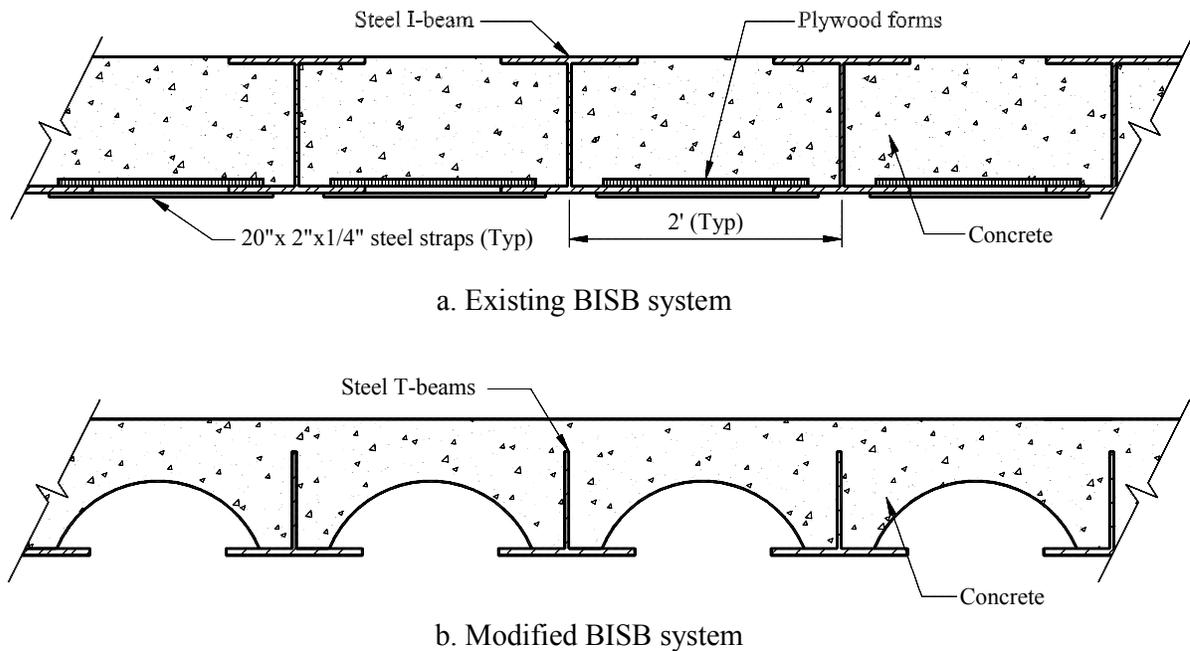
Figure 1.1. Existing and modified BISB systems.

The second proposed modification required the removal of concrete in the tension zone by changing the lower profile. One method proposed was to replace the plywood forms

with pipe sections between the beams. This reduces the self-weight and subsequently allows the system to span longer distances.

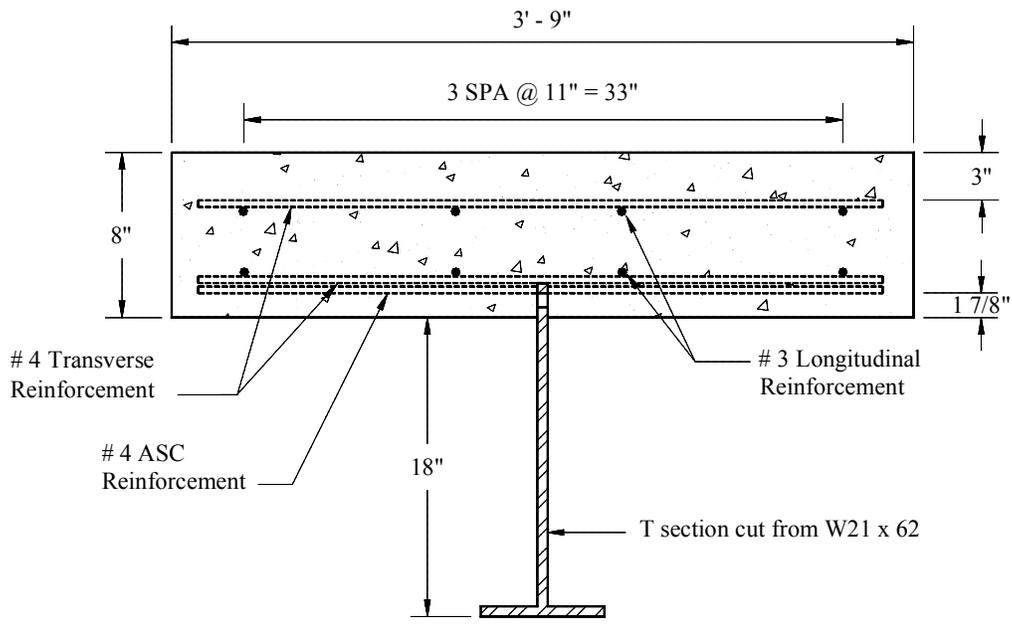
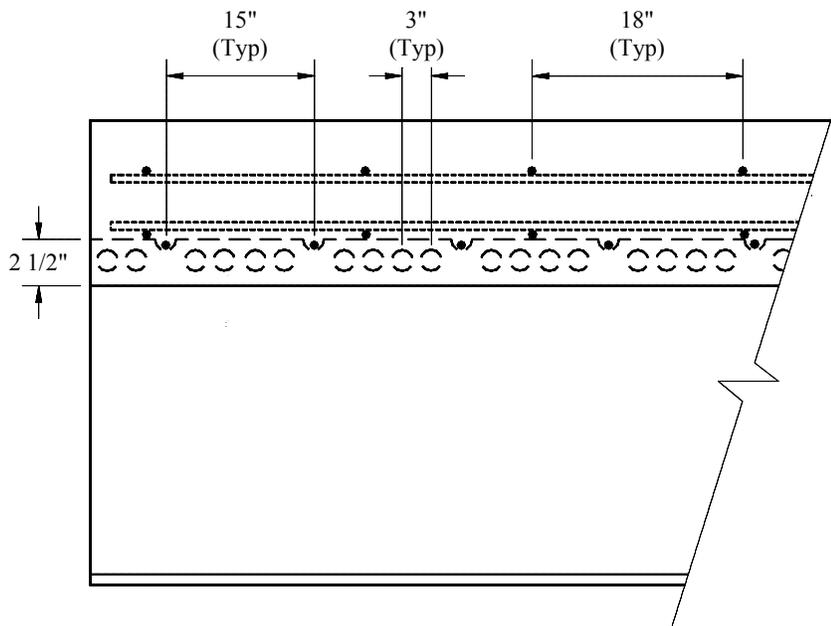
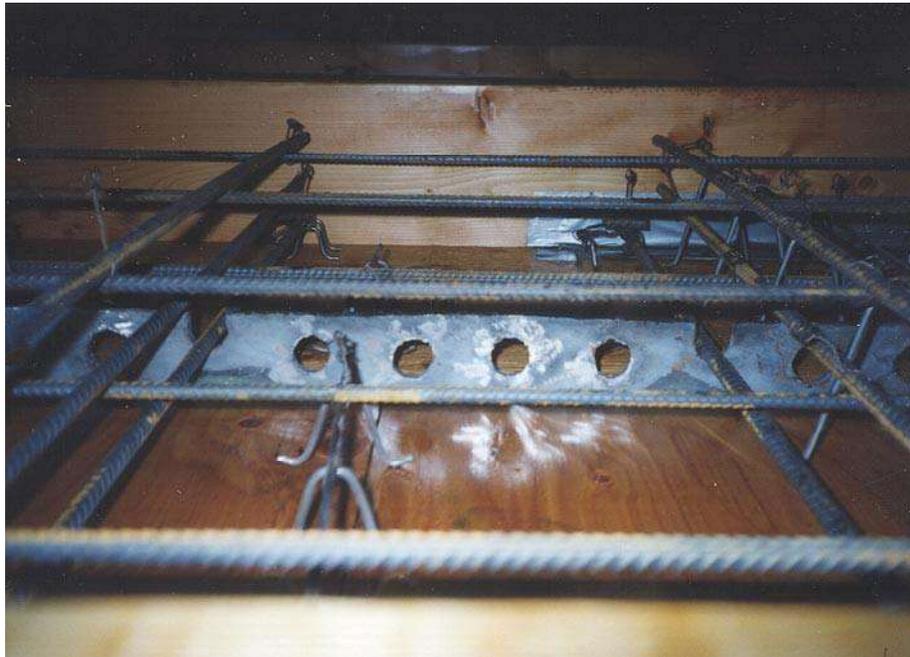
Figure 3.1. Details of Specimens 1 and 2.

a. Cross-section view

b. Side view

c. Photograph of ASC and slab reinforcement

Specimens 1 and 2, shown in Fig. 3.1, each consisted of a W21x62 with its top flange and 1 in. of the web removed, resulting in an inverted T-beam with a depth of 19 1/2 in. The

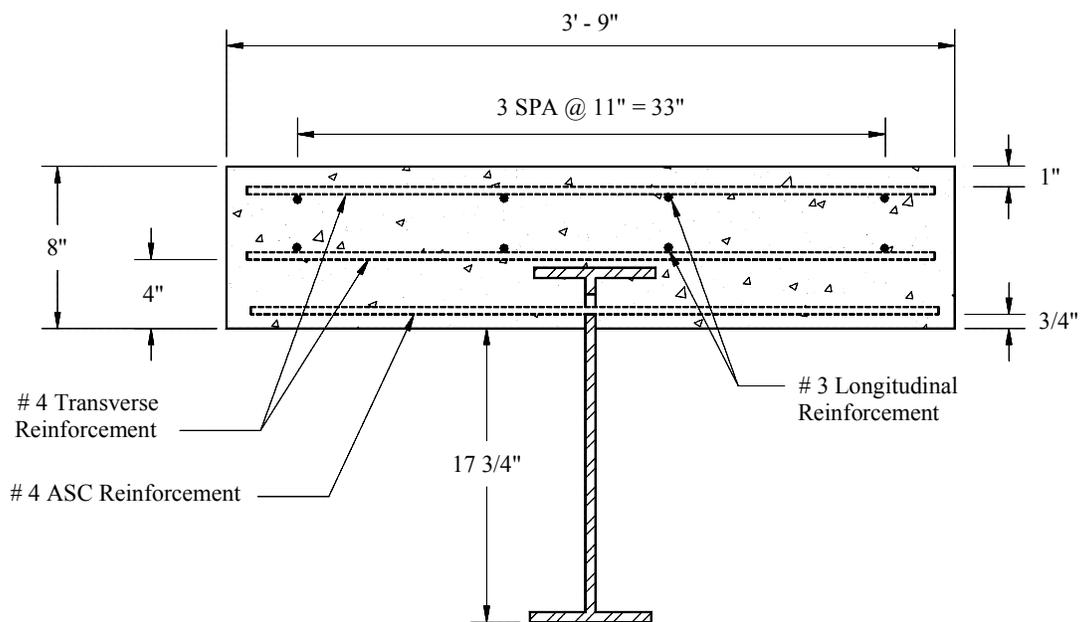
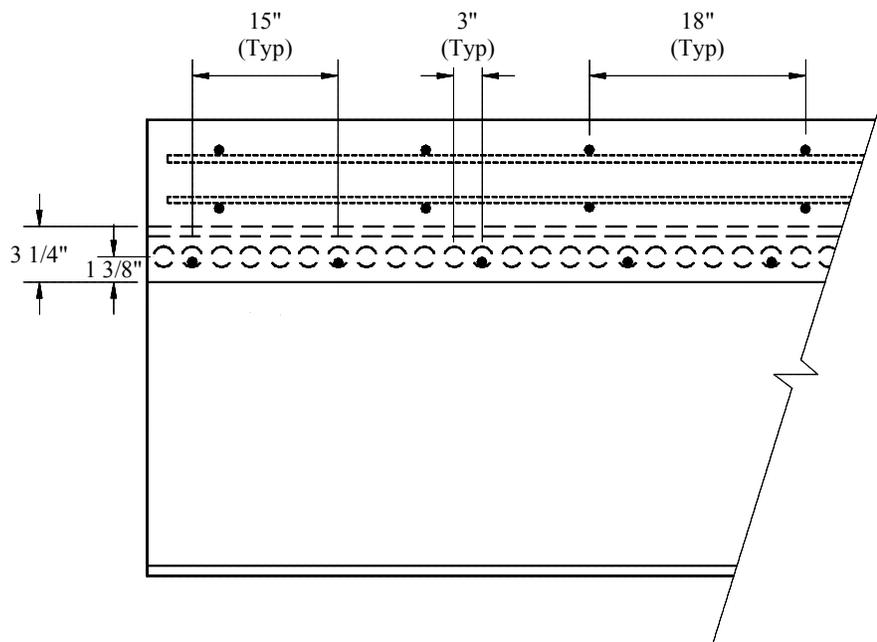
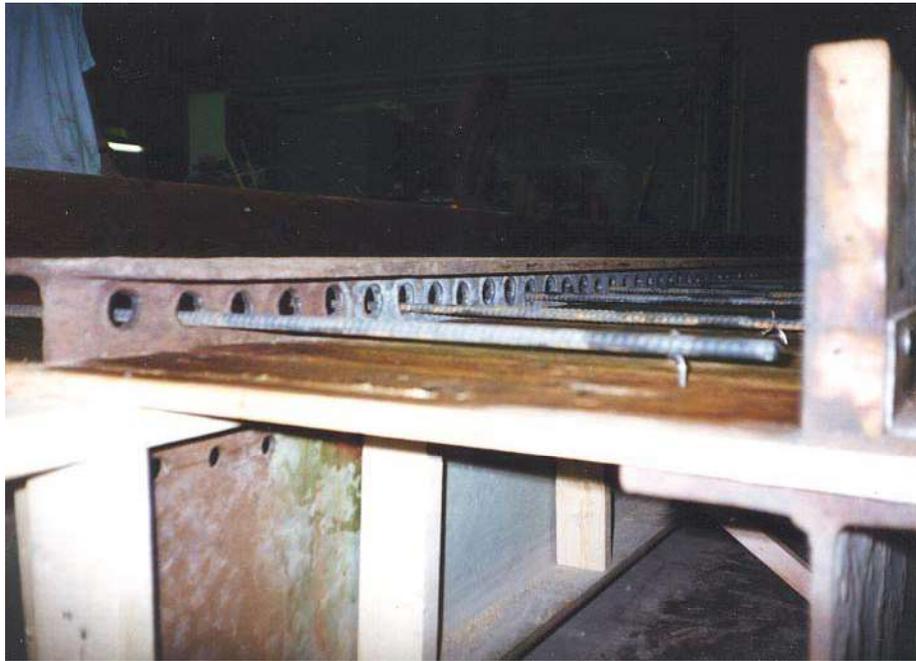
Figure 3.2. Details of Specimen 3.

a. Cross-section view

b. Side view

c. Photograph of the embedded top flange and the ASC

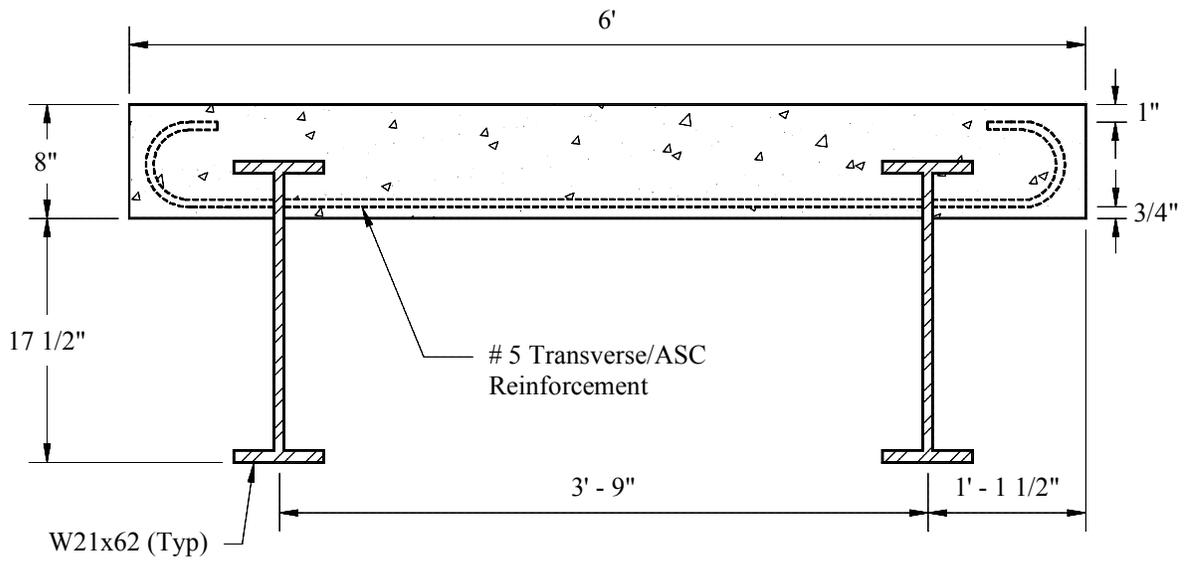
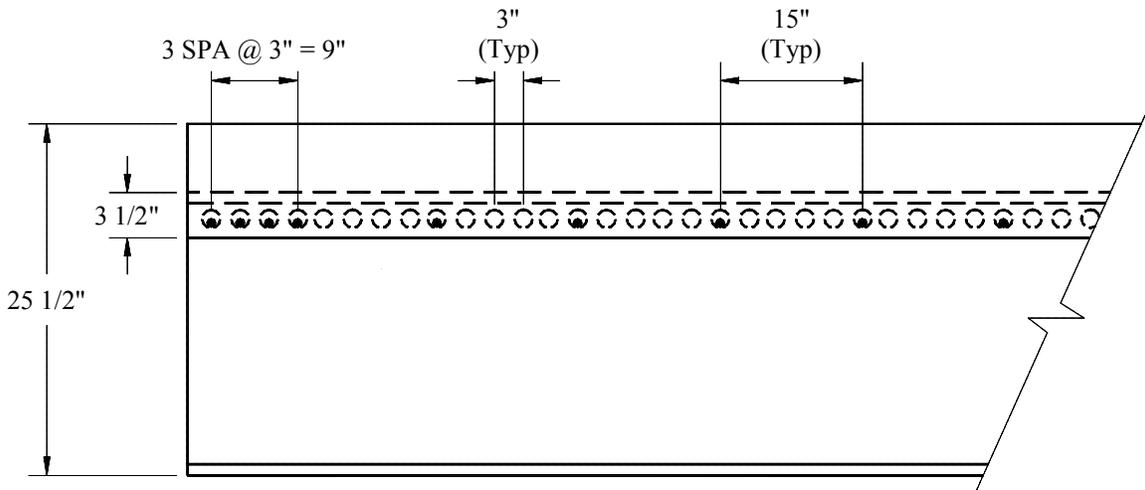
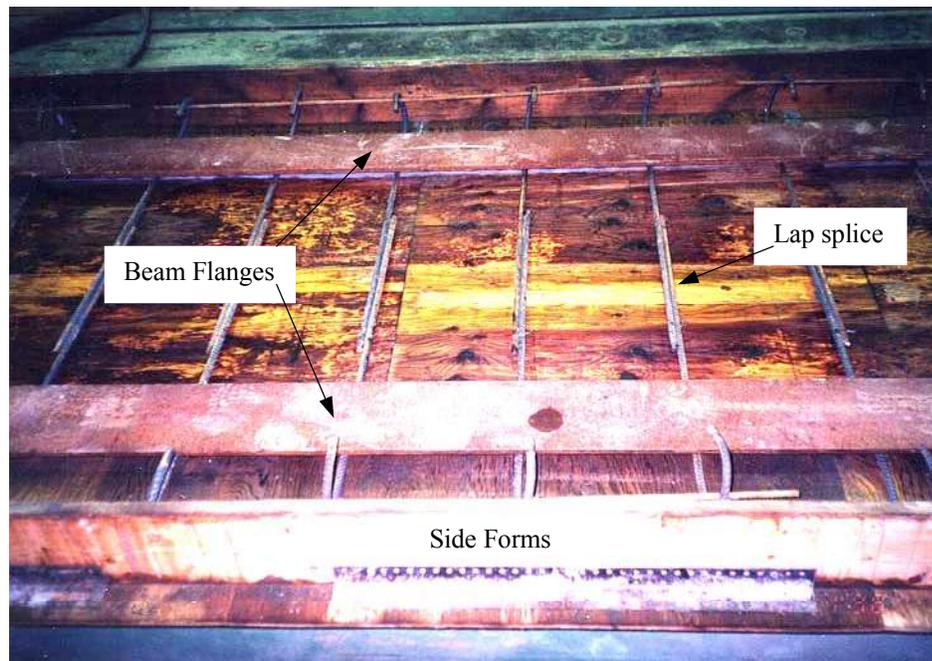
Figure 3.3. Details of Specimen 4.

a. Cross-section view

b. Side view

c. Photograph of transverse/ASC reinforcement

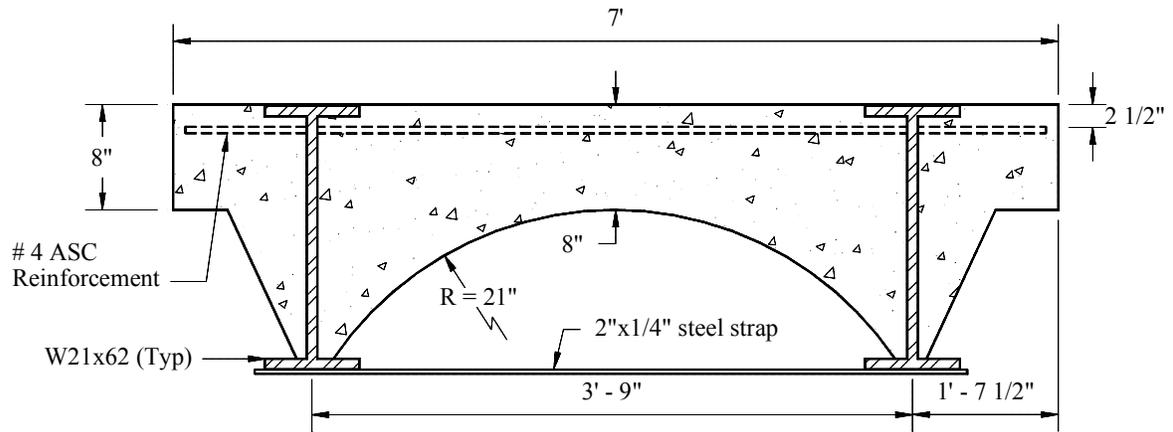
a. Cross-section view

In the design of Specimen 5, a minimum concrete thickness at the top of the arch was conservatively chosen to be 8 in., which is consistent with the thickness of the slabs in the previous specimens. A pipe section, cut from a 42 in. diameter plastic pipe, was used to form

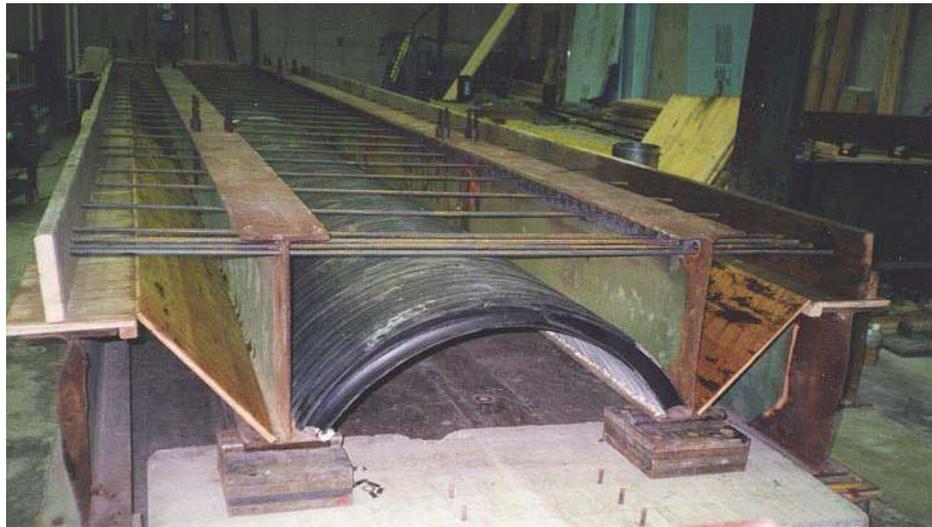
c. Photograph of formwork and reinforcement

Illustrated in Fig. 3.4 is Specimen 5; this specimen consisted of two W21x62s fully embedded in a concrete arch system with the arch spanning between the beams. Again, a beam spacing of 3 ft – 9 in. was used. This specimen is more directly related to the BISB than Specimen 4 and incorporates the proposed modifications, stated in Chapter 1. Such modifications include removing some of the concrete on the tension side of the specimen by using pipe sections in between the beams and utilizing composite action by connecting the steel beams and the concrete.

the arch and reduced the amount of concrete between the beams by 36%. The use of a 42 in. diameter pipe was necessary to obtain a pipe section that satisfied the geometric conditions (i.e., beam spacing and depth, and minimum concrete thickness). The sides of the specimen were formed with plywood to simulate a half arch shape.

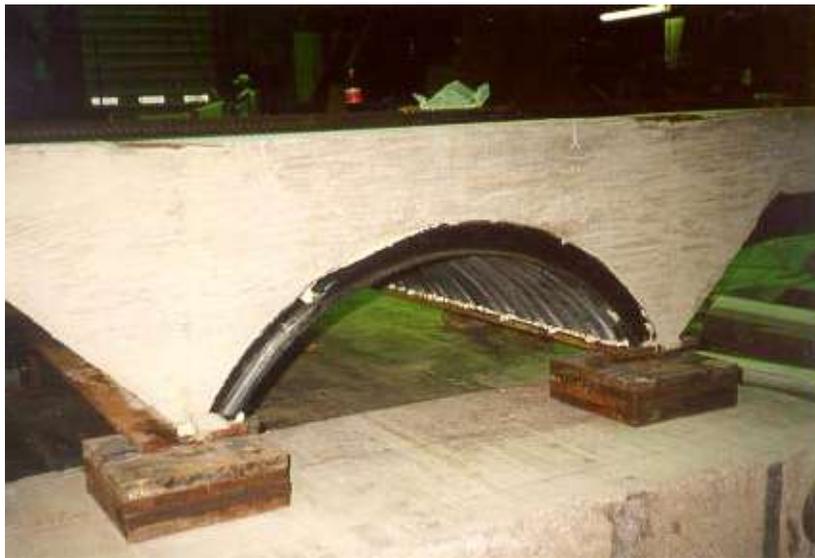
d. Photograph of end with concrete

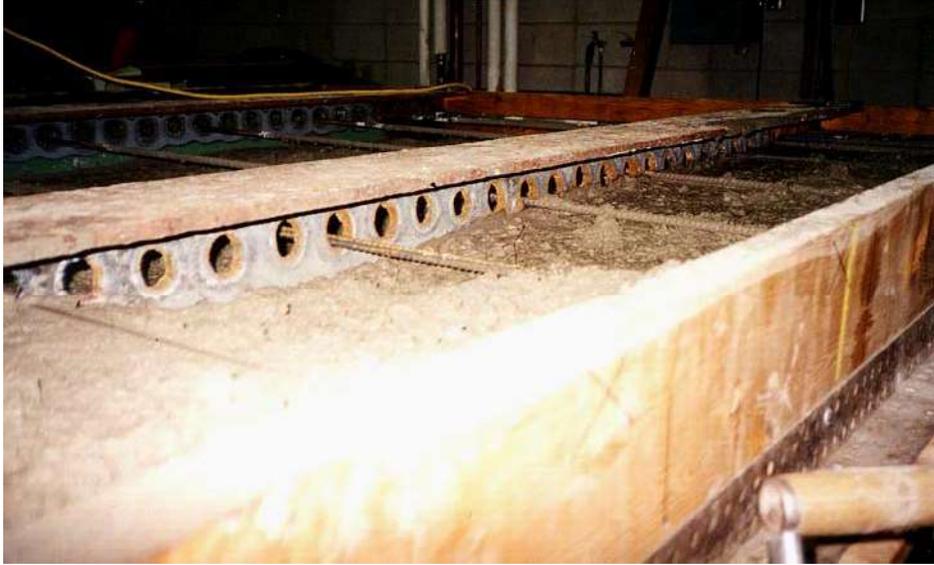
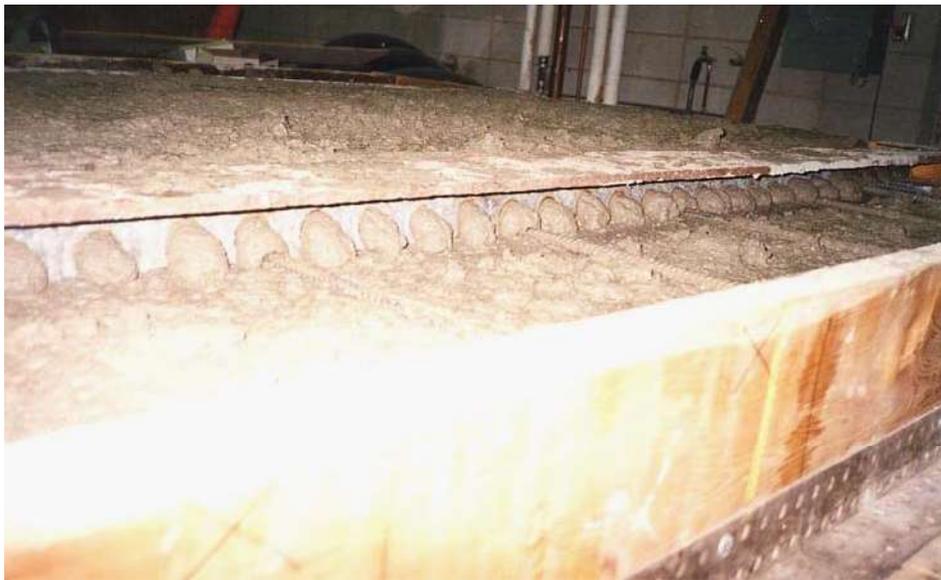
Figure 3.5. Placement of concrete for Specimen 5.

a. Photograph after first two lifts

b. Photograph after vibration of third lift in between the beams

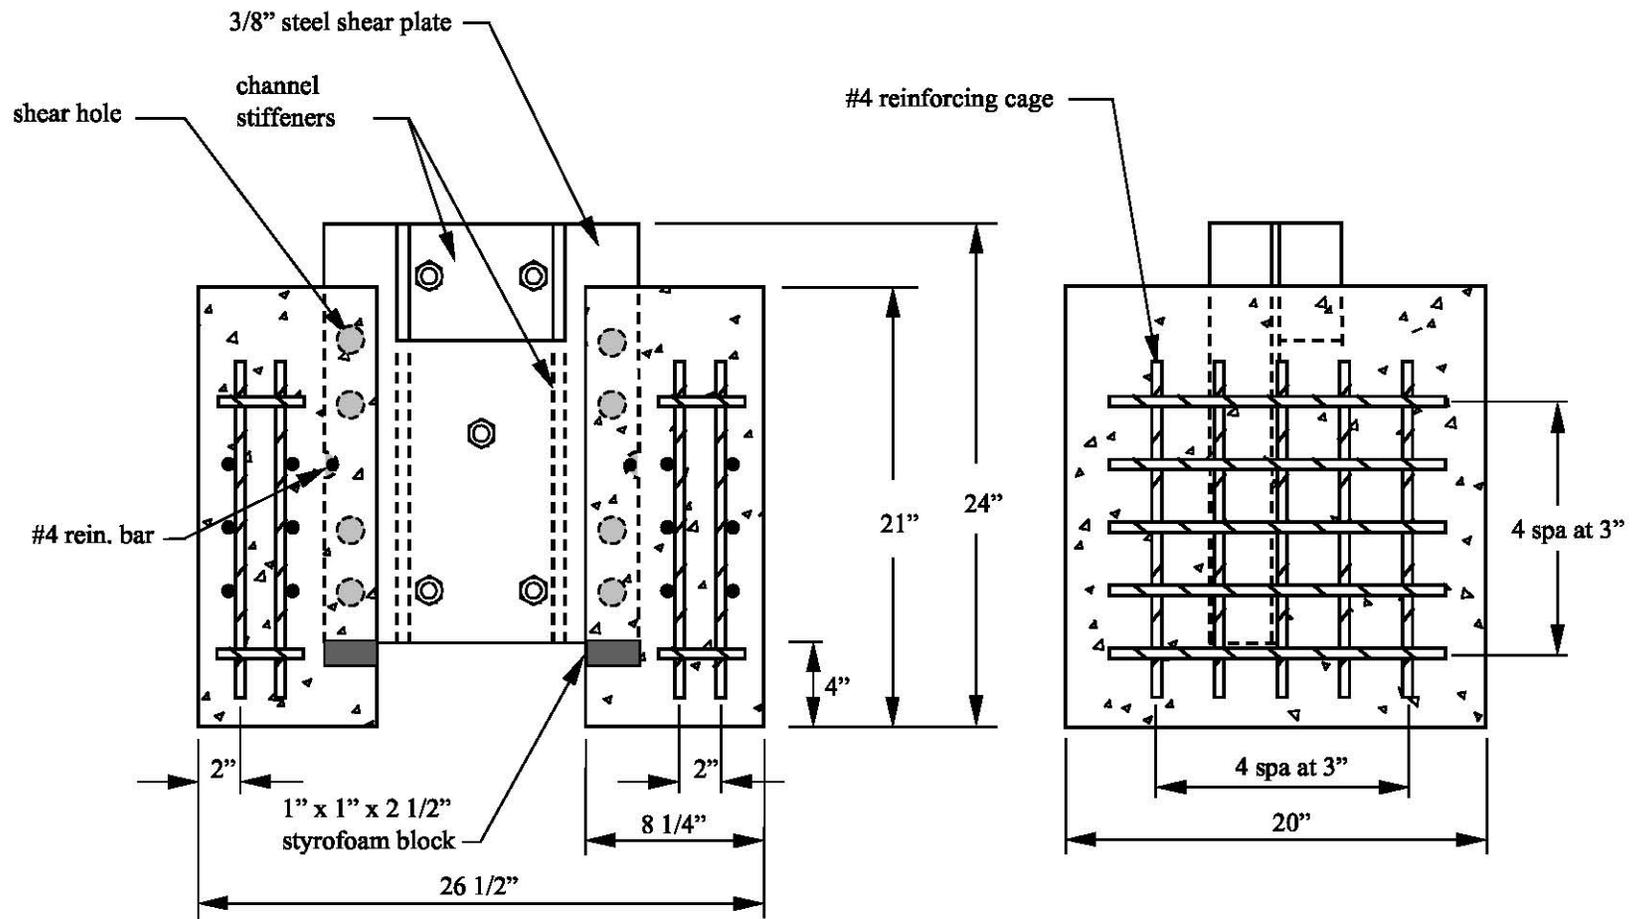
Figure 3.6. Push-out specimen for SH1.

An initial concern was that large loads applied on the 3/8 in. thick steel shear plate might induce lateral buckling. To prevent such buckling, C8 x 11.5 channel stiffeners were bolted on each side of the steel shear plate; as illustrated in Fig. 3.6, one stiffener was cut shorter than the other to facilitate the instrumentation.

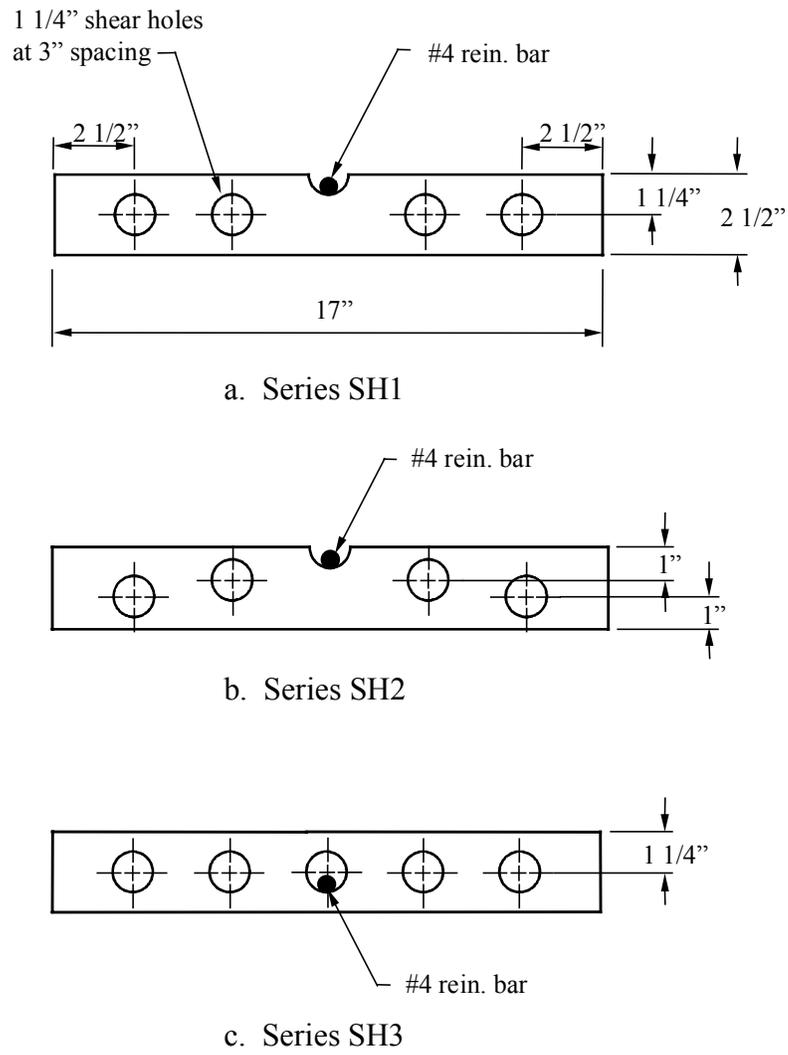
Figure 3.7. Shear hole arrangements used in the push-out tests.

Fabrication of the push-out specimens involved torching shear holes in the 3/8 in. shear plate. The shear holes were torched instead of drilled because torching is more suitable for available county bridge equipment. To fasten the lateral stiffeners, five 3/4 in. diameter holes were drilled in the shear plate. An unrestricted slip path for the shear plate was created by attaching styrofoam to the bottom edge of the shear plate (Fig. 3.6). Reinforcing steel cages illustrated in this figure were fabricated to provide transverse slab reinforcement. Steel forms were constructed so that three specimens could be cast simultaneously (see Fig. 3.8). Once the plywood dividers were placed in the steel form, form oil was applied to the interior surfaces of the forms to facilitate removal. Figure 3.9 illustrates how the 16 in. long #4 reinforcing bars were placed through the shear holes. Each reinforcing bar was held in place against the shear plate by wire through the plywood portion of the forms. Once the pre-fabricated reinforcing steel cages were placed in the forms, the forms were sealed.

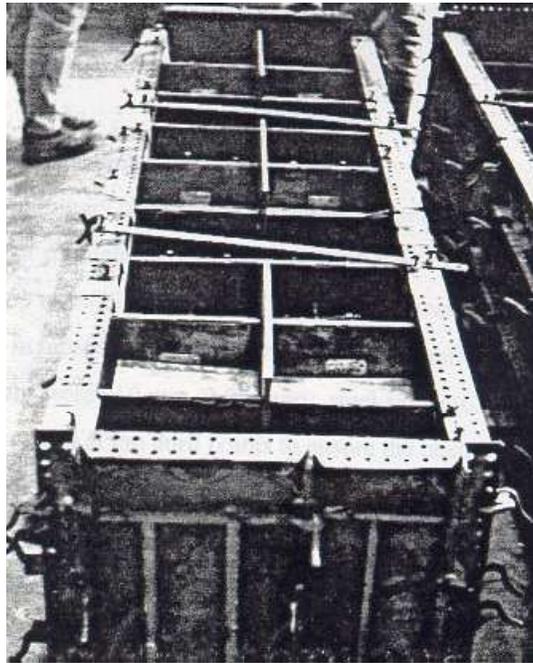
Figure 3.8. Photograph of formwork.

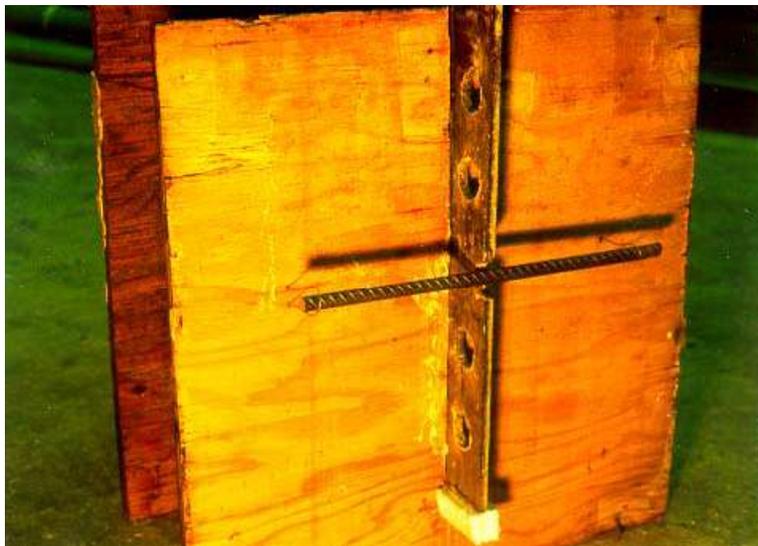
Figure 3.9. Reinforcing bar placed through the shear hole.

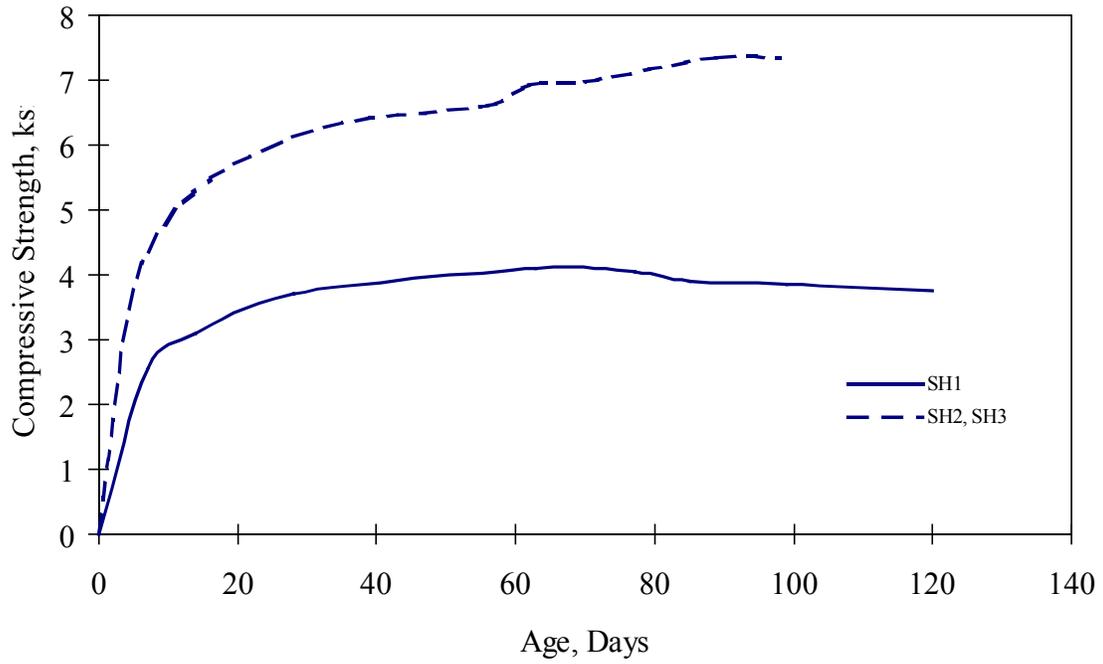
Figure 3.10. Push-out specimen cylinder strength curves.

In addition to the push-out specimens, 24 - 6 in. diameter x 12 in. high - standard ASTM concrete test cylinders and four 6 in. x 6 in. x 5 ft modulus of rupture beams were cast from each batch of concrete. Table 3.1 and Fig. 3.10 show the concrete properties and cylinder strength curves of the concrete, respectively.

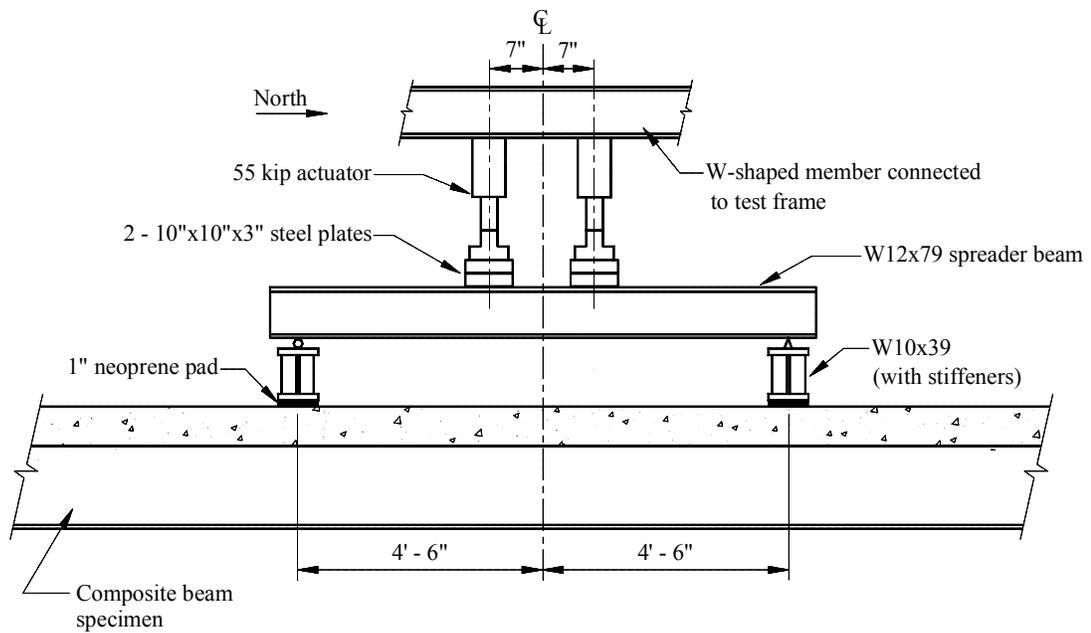
Figure 4.1. Load setup for composite beam tests.

b. Side view of load setup

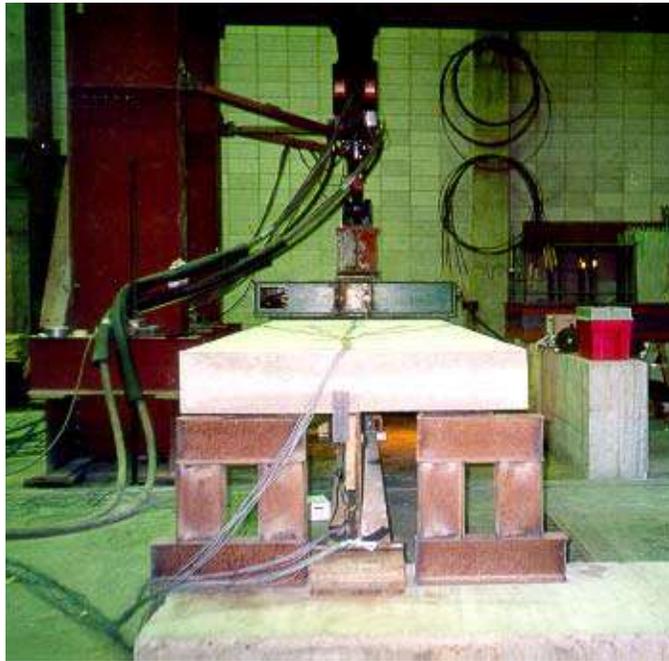
c. Photograph of end view of load setup

As illustrated in Fig. 4.1, the load setup used during the composite beam tests consisted of two line loads across the slab width, each located 4 ft – 6 in. from midspan. The load was applied using two, 55 kip capacity, hydraulic actuators. These actuators were used for both static loading and cyclic loading. It was necessary to use two actuators to obtain the force needed to fail the specimens. The actuators were controlled by two Materials Testing System (MTS) 443 controllers.

Each specimen was situated so that the two actuators were centered at midspan to ensure symmetrical loading. To ensure in-plane loading, each specimen was positioned so that the actuators were directly above the specimen's steel beam web. This alignment is illustrated in Fig. 4.1c; also shown in this photograph are the steel frames used at the ends of the specimen to prevent it from tipping.

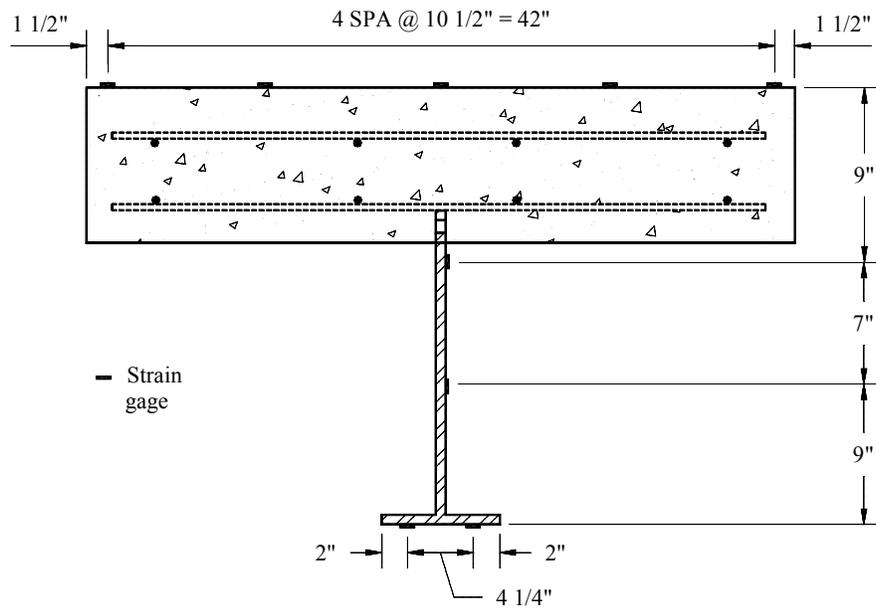
a. Specimens 1 and 2

The location of the various instruments used during the composite beam tests are shown in Figs. 4.2 through 4.5. Strain gages were placed at the quarter point, midspan (see Fig. 4.2), and the three-quarter point in all three specimens. A minimal number of gages were installed at the quarter point, primarily to check for symmetry about midspan. Since a

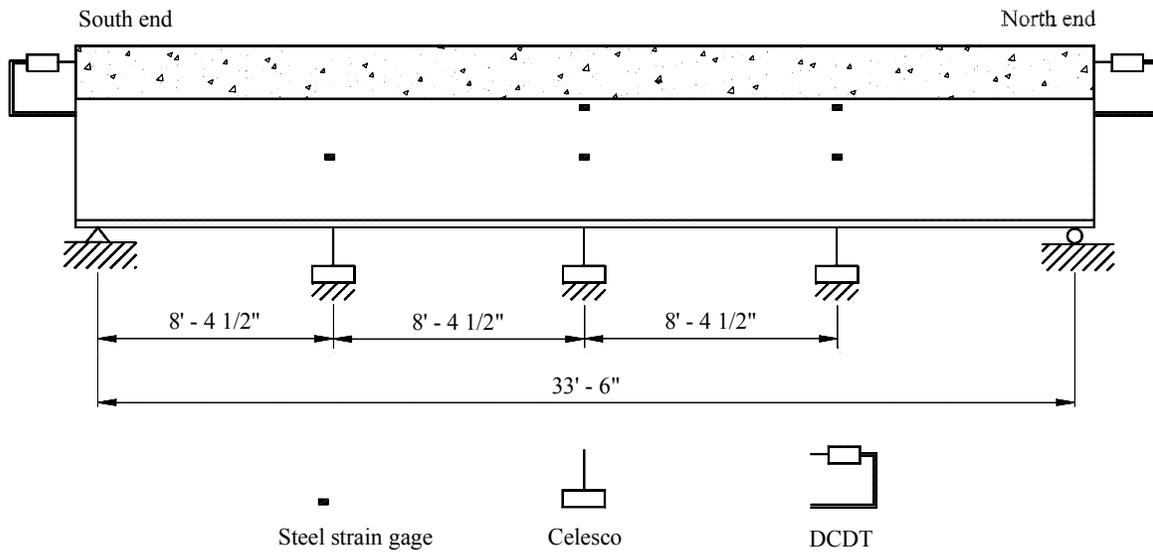
Figure 4.5. Side view of instrumentation.

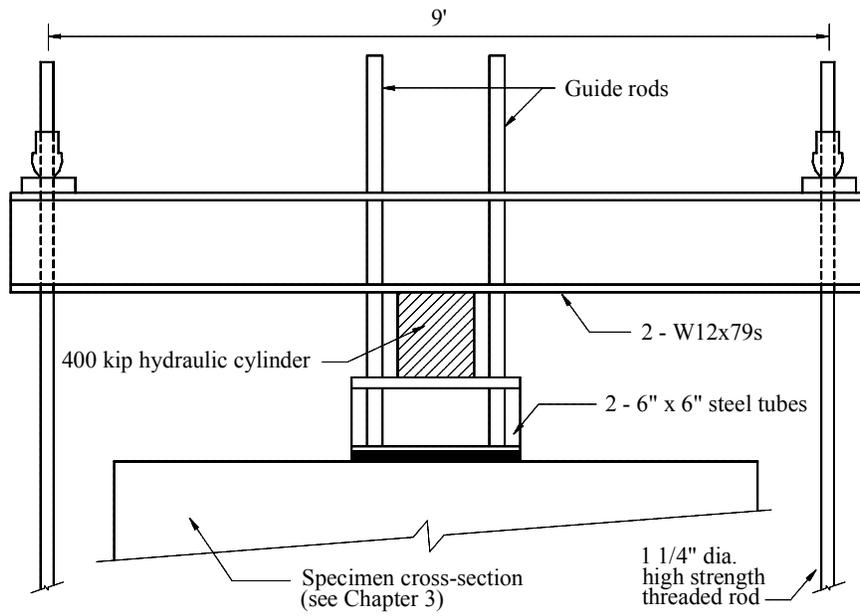
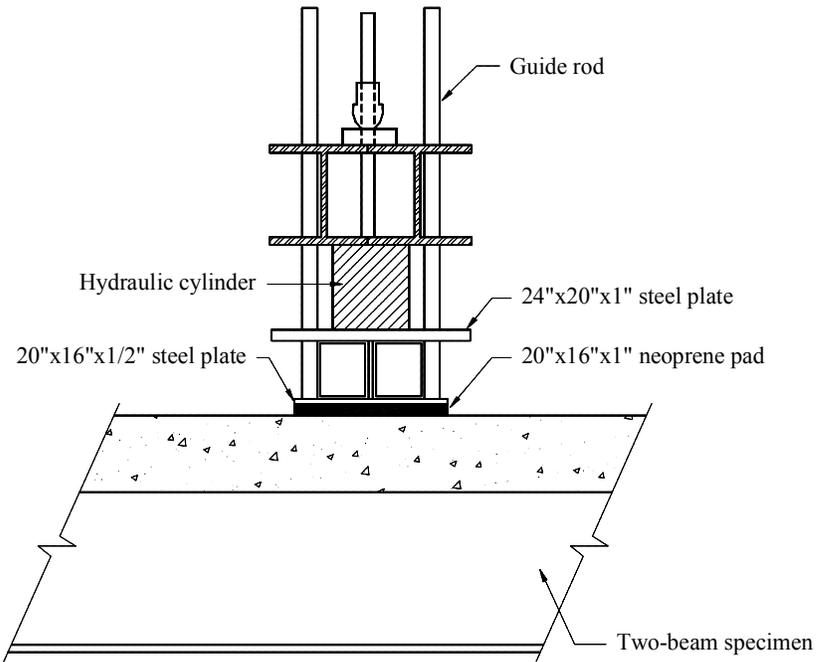
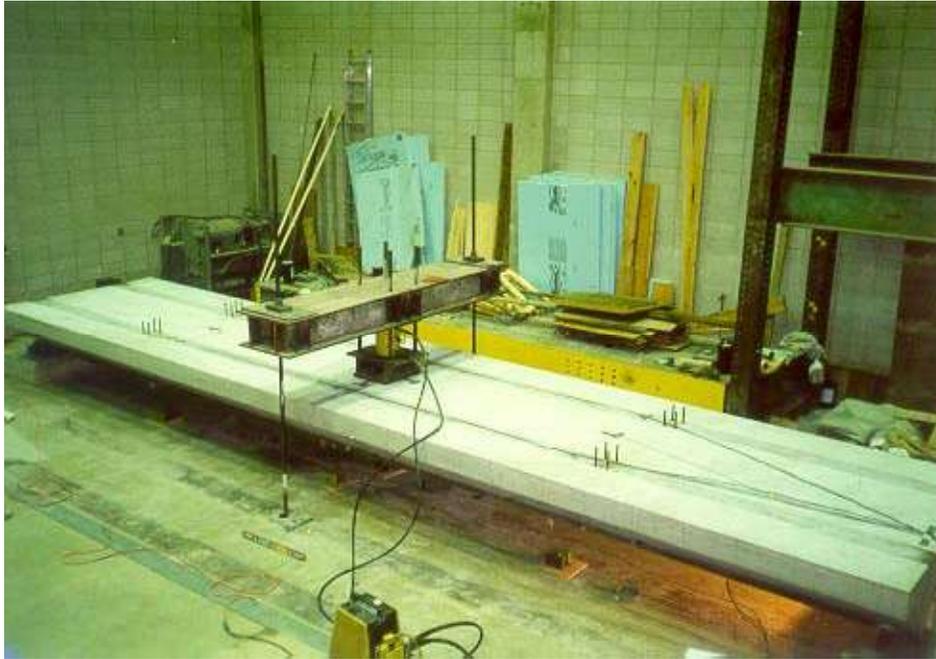
Figure 4.6. Load setup for two-beam tests.

a. Side view

b. End view

c. Photograph of typical load setup at Load Position 1

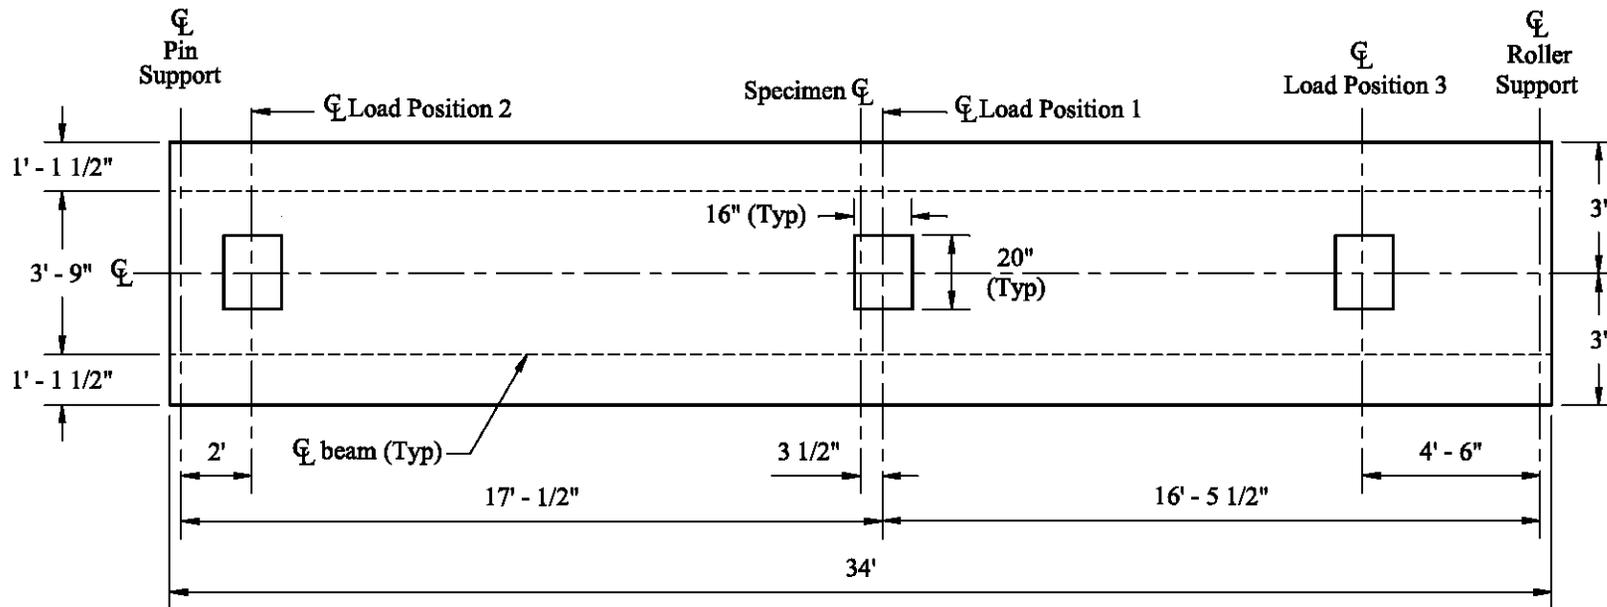
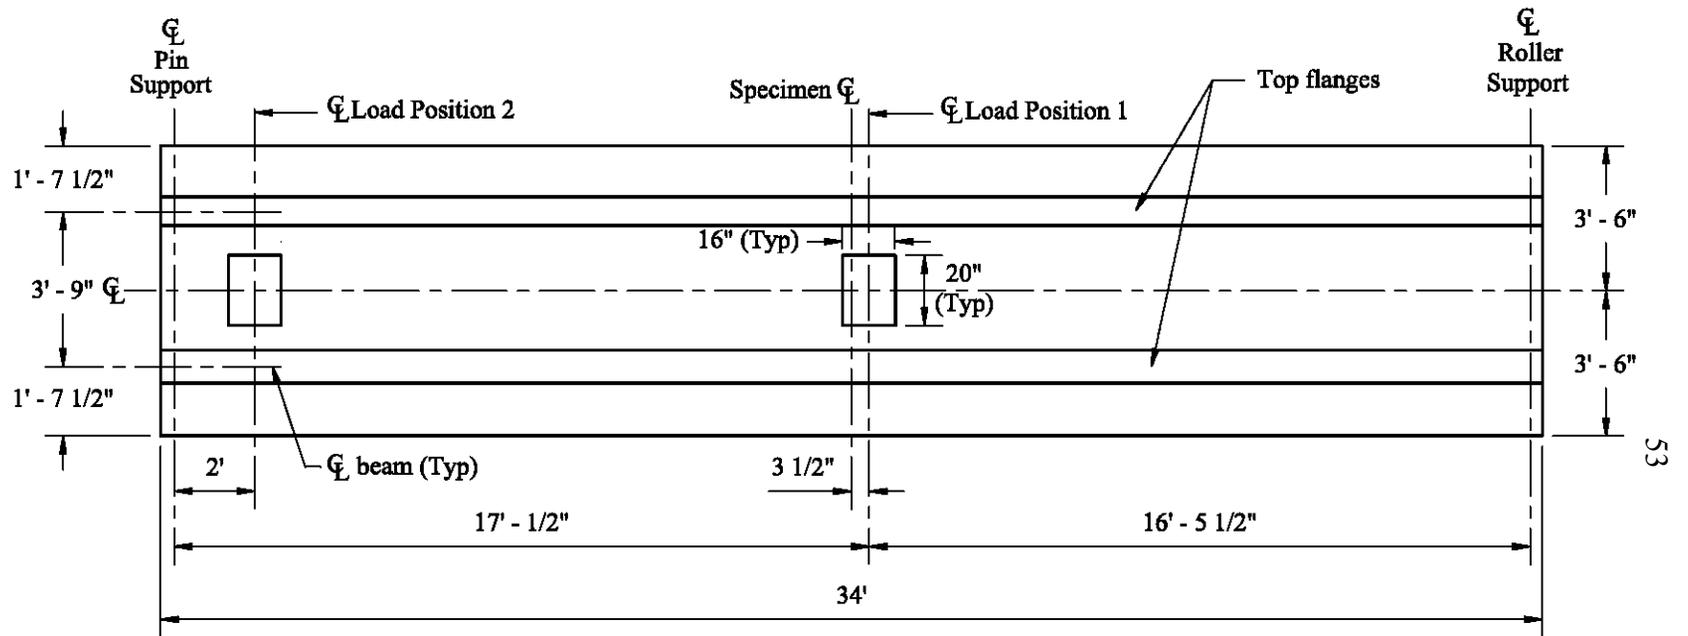
Figure 4.7. Load Positions on Specimens 4 and 5.

a. Specimen 4

b. Specimen 5

The concentrated load represented a wheel load with a footprint as specified by the AASHTO LRFD Bridge Design Specifications [1]. Width of the wheel footprint was specified as 20 in.; the code only recognizes the width of a dual truck tire. Assuming a uniform contact pressure of 125 psi, the length of the footprint was determined to be 16 in. Orientation and size of the footprint are illustrated by Fig. 4.7.

For both specimens, it was necessary to offset the center of Load Position 1, 3 1/2 in. from midspan, to position the load between transverse reinforcing bars in the slab. This was done to simulate a worst case scenario. The centers of Load Positions 2 and 3 were 2 ft from the pin support and 4 ft – 6 in. from the roller support, respectively. All load positions were centered on the longitudinal centerline of the specimen.

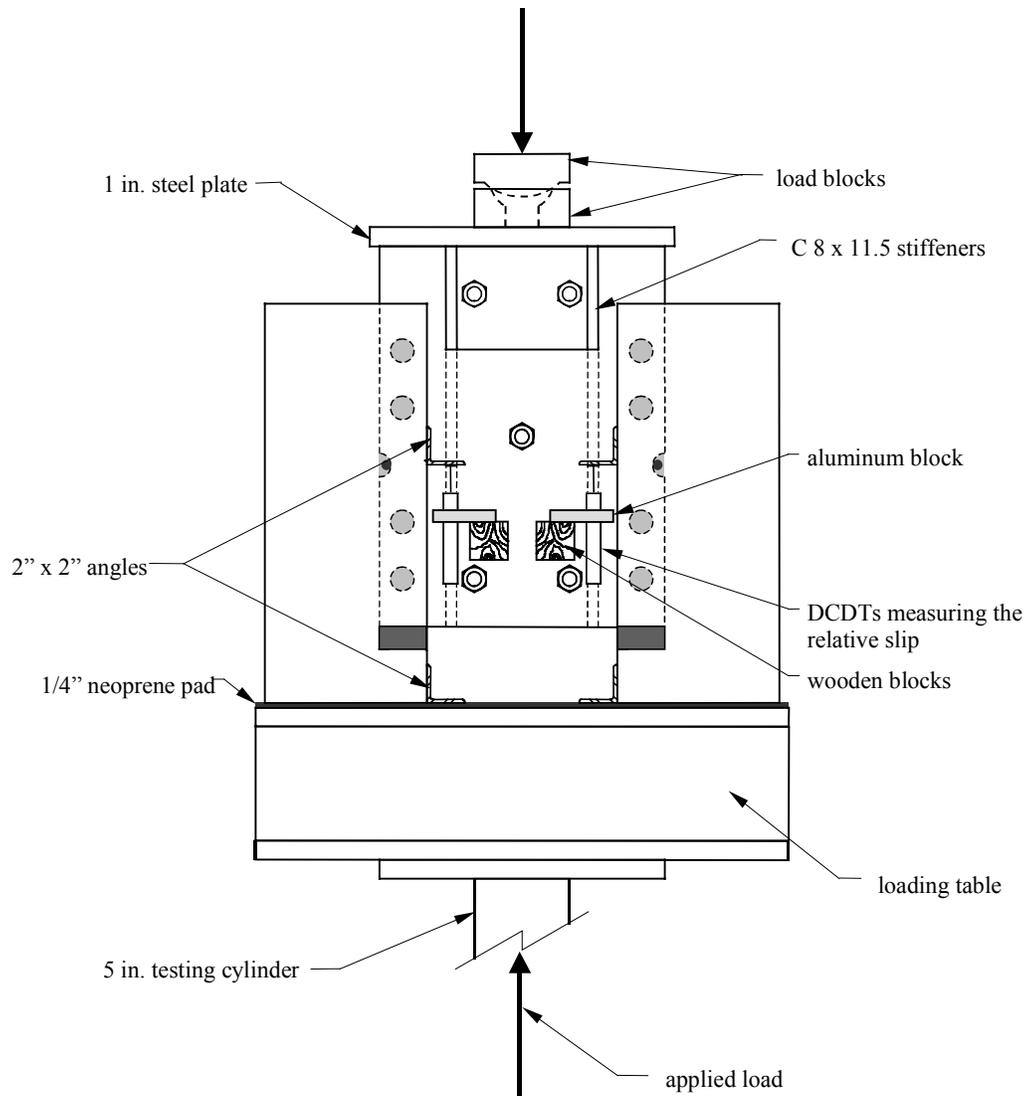
Figure 4.11. Push-out specimen loading arrangement and instrumentation.

For each series, two specimens were tested statically to determine the ultimate static strength of the connectors. Fatigue tests, cycling between a constant minimum load level and various maximum load levels, were conducted to develop the relationship between the fatigue load and the fatigue life of the ASC, and to determine the slippage of the connector

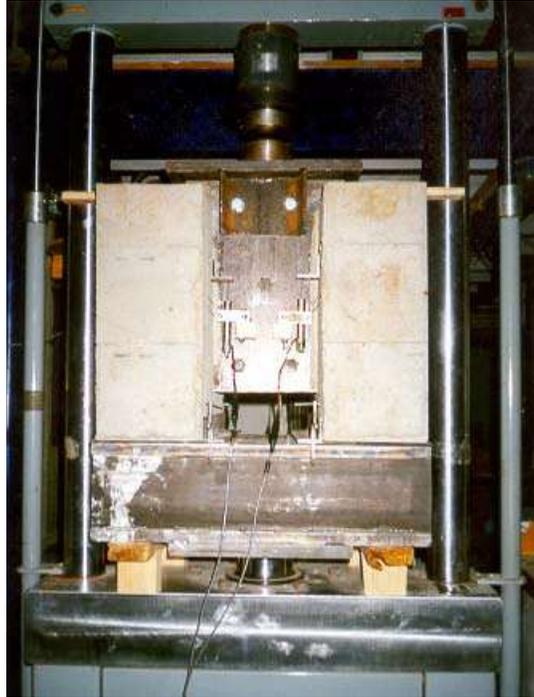
Figure 4.12. Photograph of push-out test set-up.

After installing the two DCDTs, they were connected to a computer-controlled DAS. With the use of the high speed DAS, displacements were measured and recorded without stopping the fatigue test. The number of cycles was recorded electronically by the MTS machine. A photograph of the overall test set-up and instrumentation is shown in Fig. 4.12.
