**Investigation of Two Bridge Alternatives for
Low Volume Roads - Phase II
Volume 2 of 2**

**Concept 2:
Beam In Slab Bridge**

July 2000

Iowa DOT Project TR-410

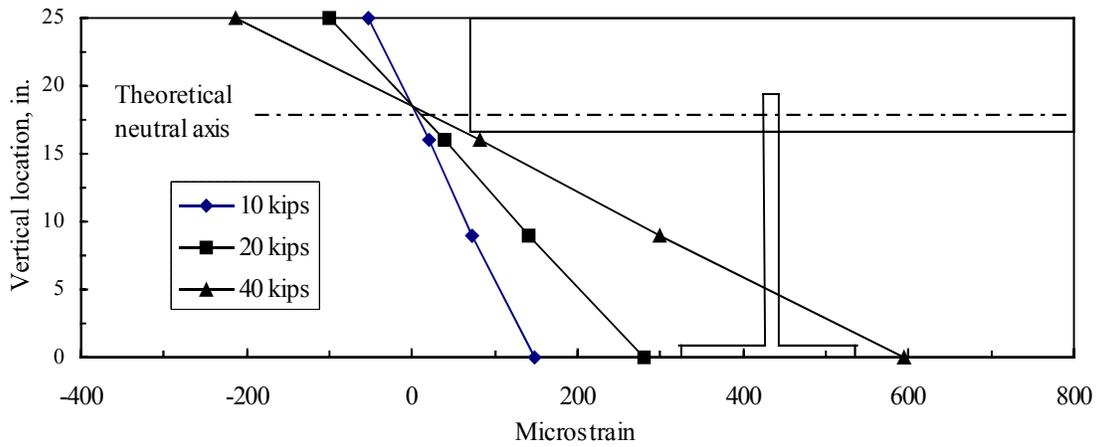
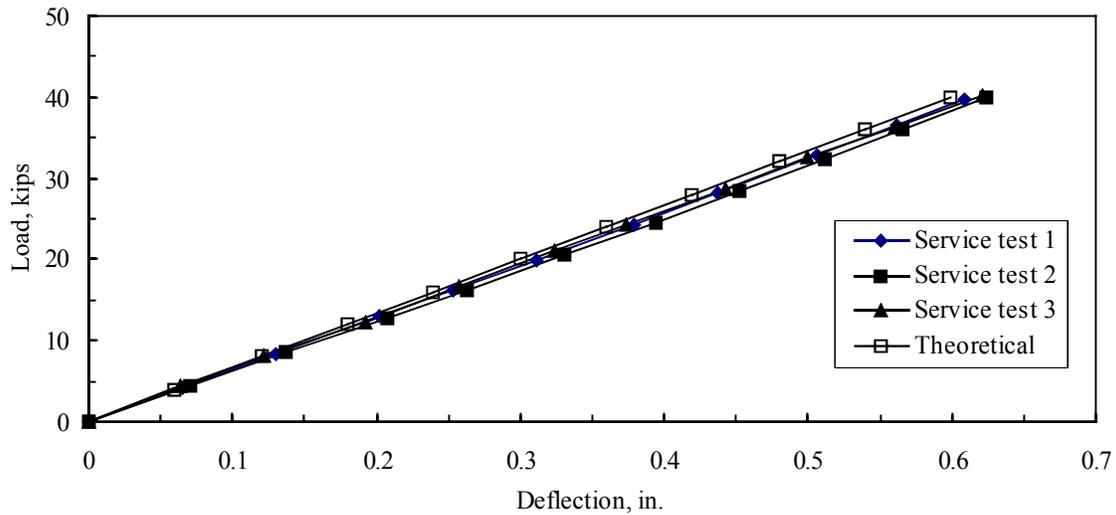
Figure 5.1. Specimen 1 service load test results.

a. Strains within cross-section at midspan

d. Deflections at midspan for all three service tests

All strains and deflections plotted in Fig. 5.1 increased in a linearly fashion. This indicates full composite action throughout the entire service load test. In addition, horizontal slip of only 0.002 in. at the South end of the specimen and 0.001 in. at the North end

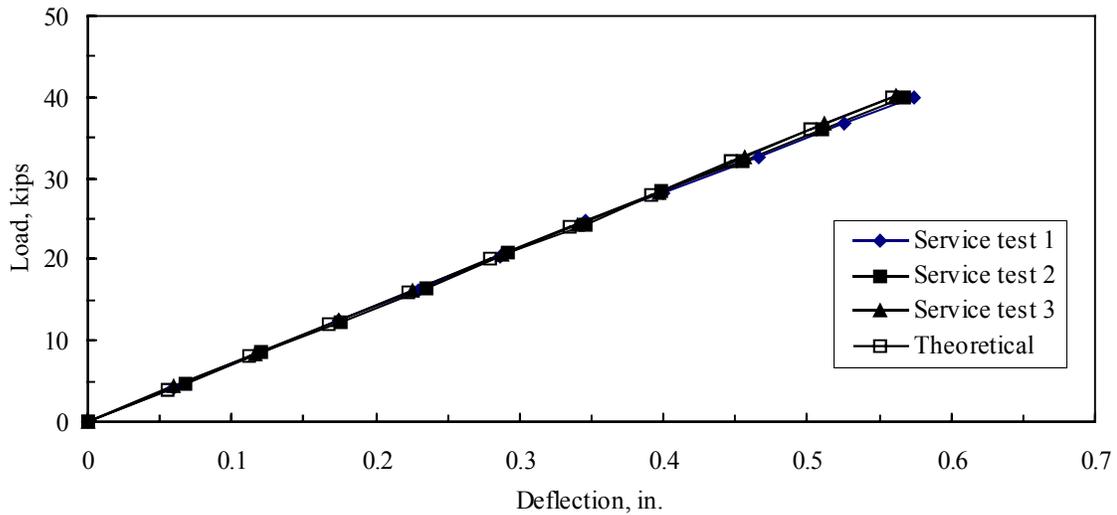
Figure 5.2. Specimen 3 service load test results.

d. Deflections at midspan for all three service tests

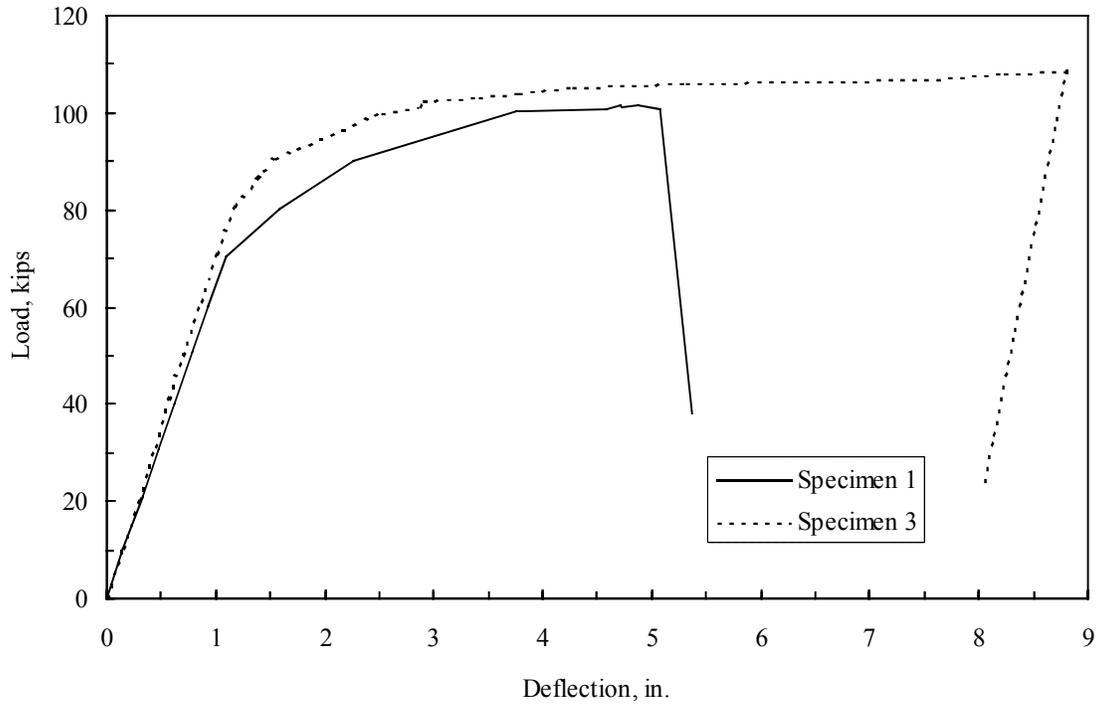
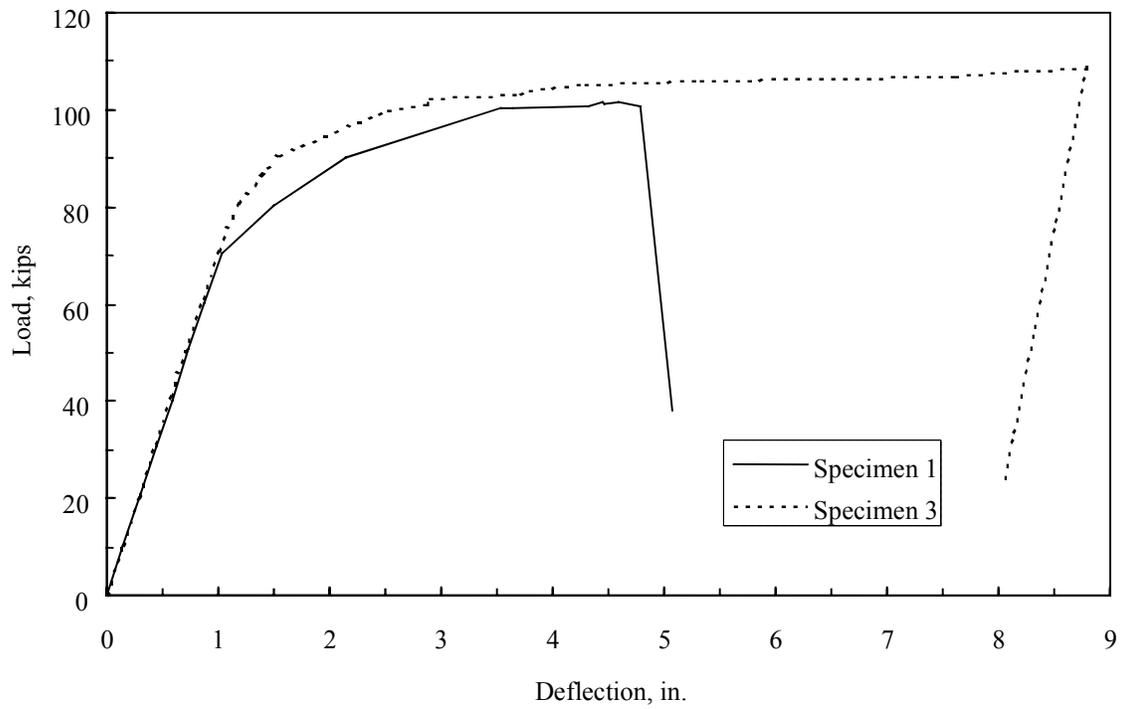
a. As tested

b. Adjusted for difference in flexural stiffnesses

Since the strain data and deflection data exhibited similar behavior, only deflection data are presented for the other composite beam specimens presented in this section. The midspan deflections measured during the ultimate load testing of both specimens are shown in Fig. 5.3. As shown in Fig. 5.3a, the specimens have different flexural stiffnesses (i.e., moment of inertia). Specimen 3 had a greater stiffness due to the embedded top flange. The deflection data for Specimen 1 were adjusted by dividing each deflection value by the ratio of Specimen 3's moment of inertia to Specimen 1's moment of inertia. As apparent in

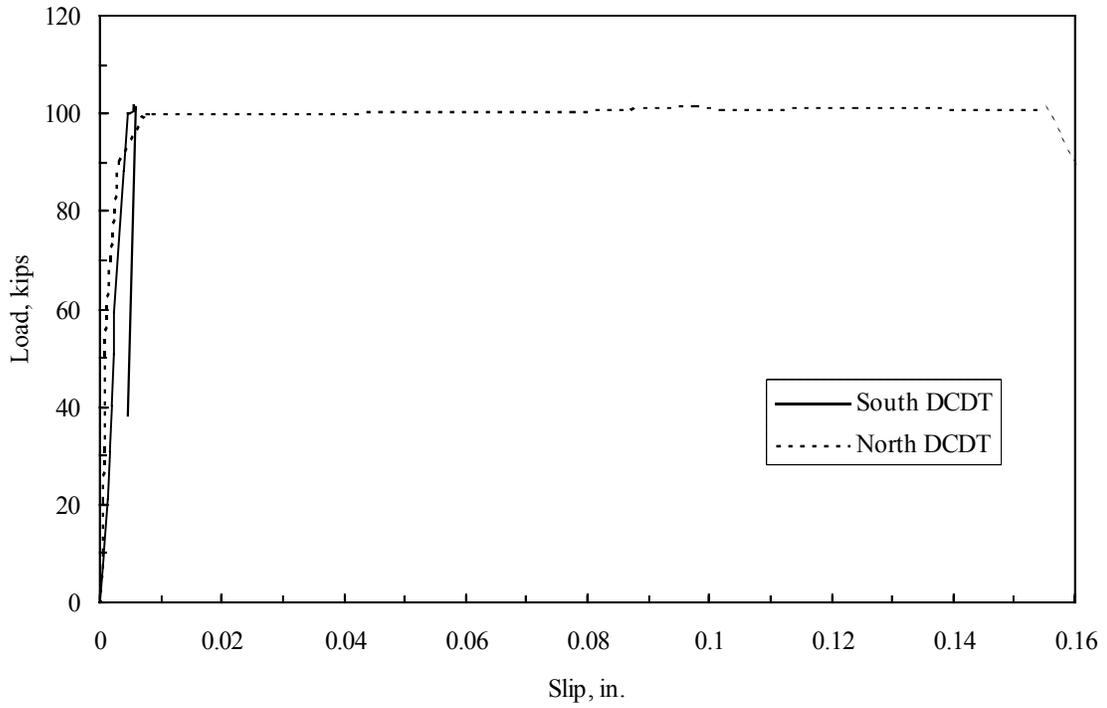
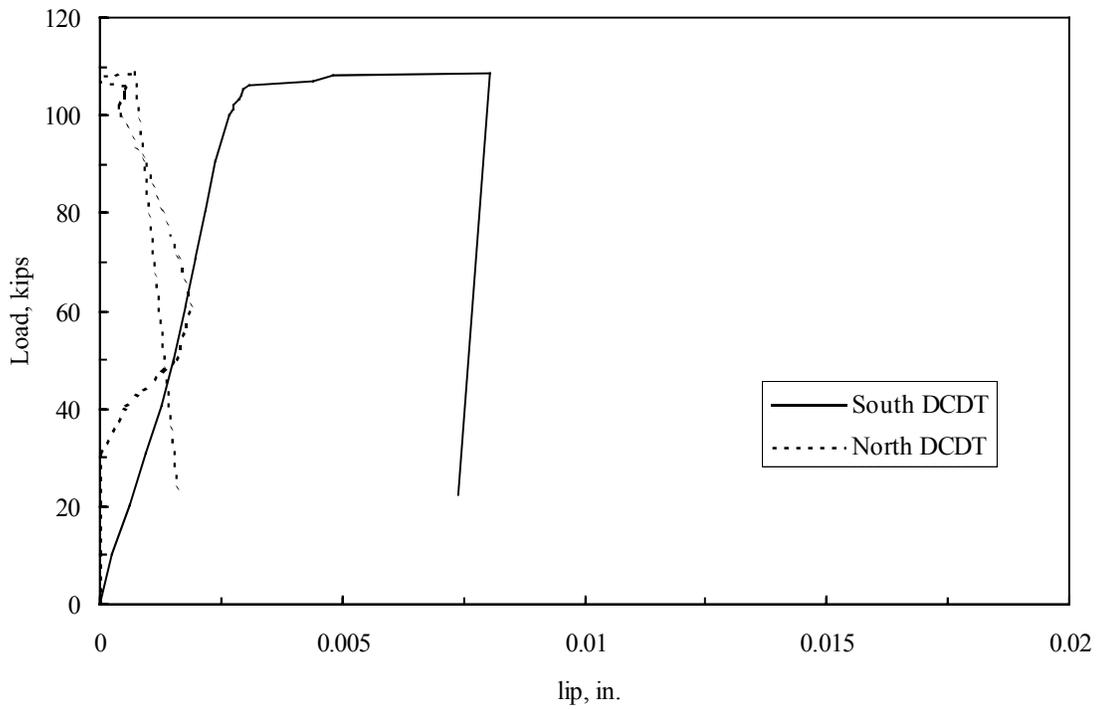
a. Specimen 1

b. Specimen 3

Figure 5.4 confirms that the ASC failed in the North shear span of Specimen 1 (see North DCDT curve in Fig. 5.4a) and started to fail in the South shear span of Specimen 3 (see South DCDT curve in Fig. 5.4b). The maximum horizontal slip that occurred in Specimens 1 and 3 was 0.155 in. and 0.008 in., respectively. The load-slip behavior illustrated in Fig. 5.4, suggests that the ASC performed like a rigid connector – little or no

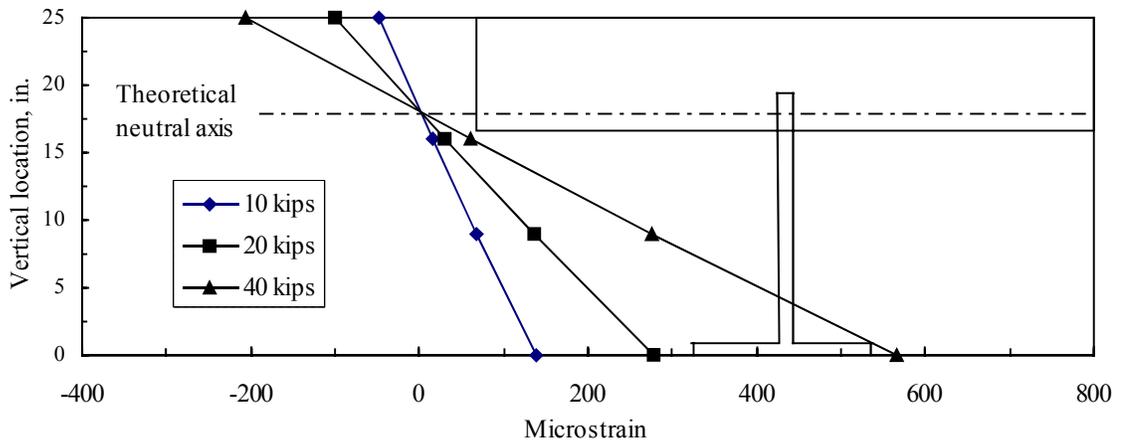
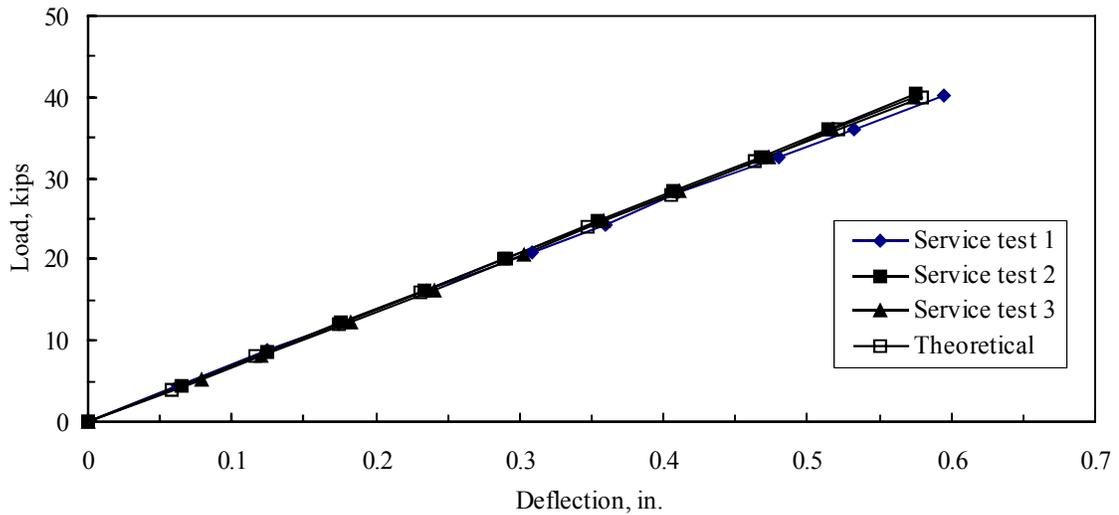
Figure 5.5. Specimen 2 service load test results.

a. Strains within cross-section at midspan

d. Deflections at midspan for all three service tests

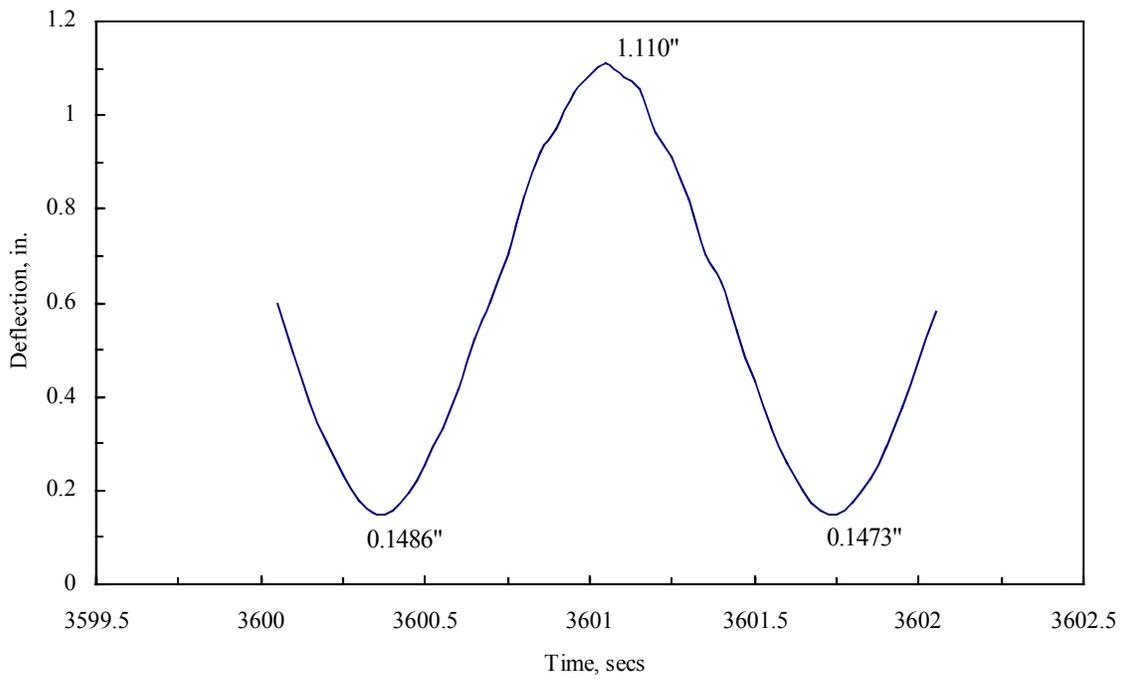
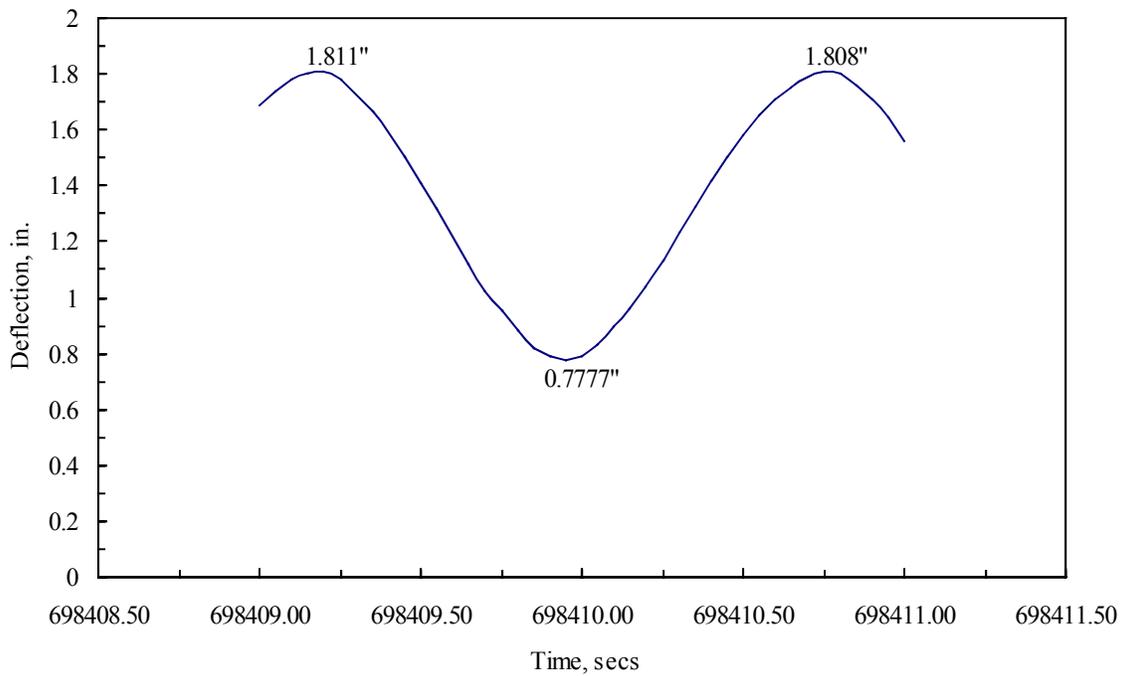
Figure 5.6. Midspan deflections during fatigue testing of Specimen 2.

a. After 2,700 cycles (1.5 cycles shown)

b. After 462,800 cycles (1.3 cycles shown)

The specimen failed after 464,000 cycles, which is less than the desired 500,000 cycles. However, it was the steel beam that failed and not the shear connector. The steel beam failed due to a fatigue crack that initiated at a set of holes in the beam web that had been used for a diaphragm connection when the beam was in service (see Fig. 5.8). The set of holes was located approximately 1ft – 7 in. North of the North line load (see Fig. 4.1 for the load setup). Note that the maximum midspan deflection increased from 1.11 in. to

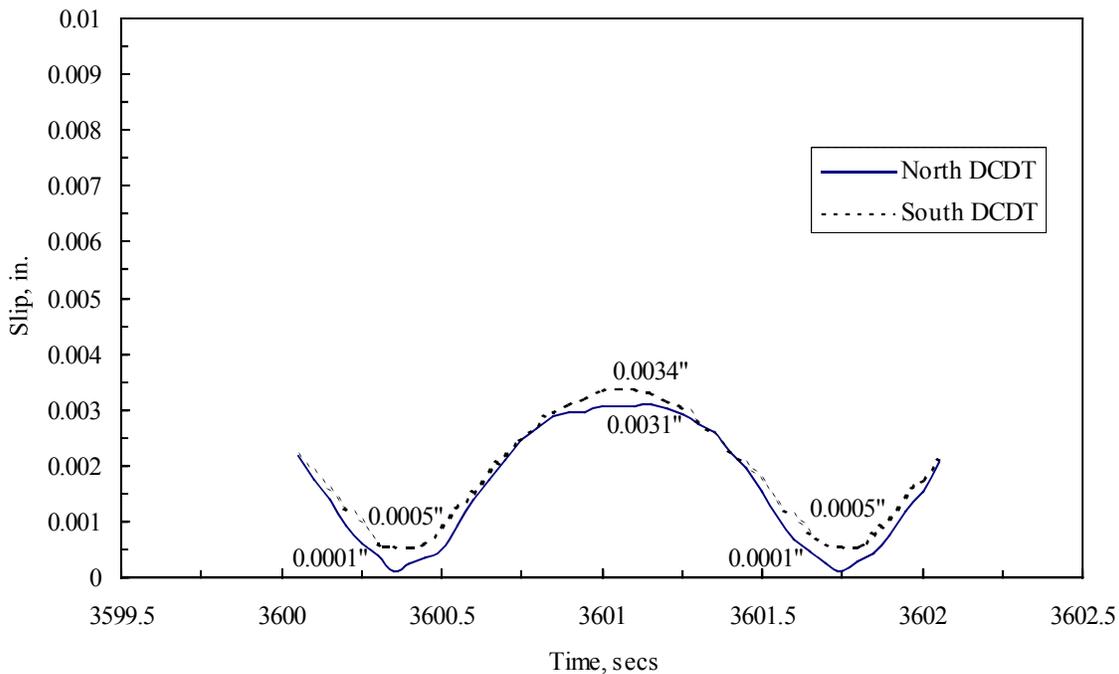
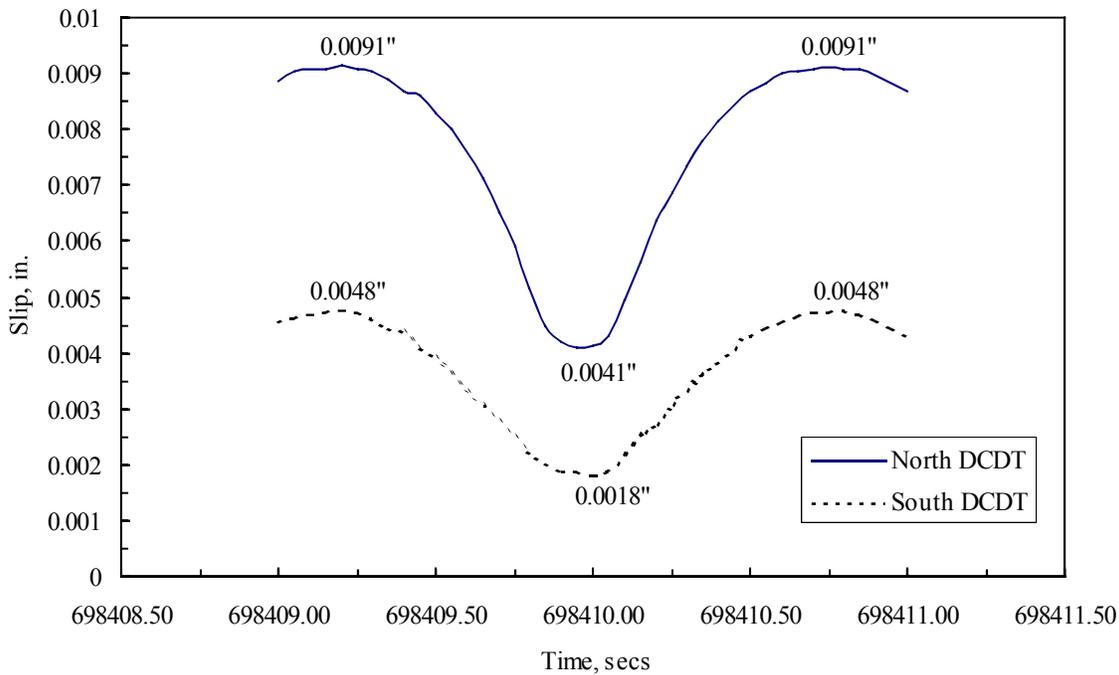
Figure 5.7. Horizontal slip during fatigue testing of Specimen 2.

a. After 2,700 cycles (1.5 cycles shown)

b. After 462,800 cycles (1.3 cycles shown)

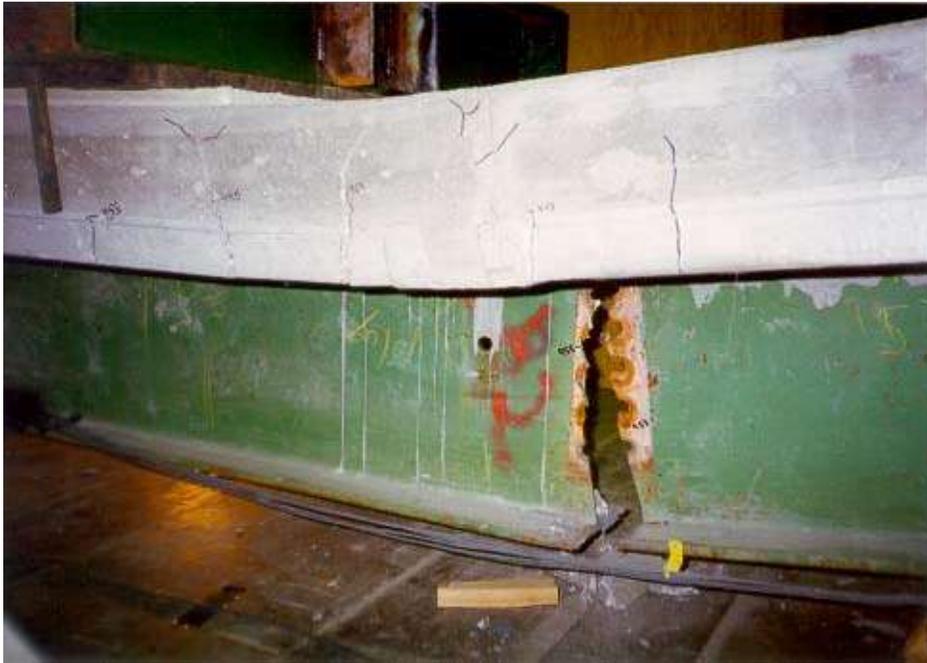
Figure 5.8. Fatigue failure of the steel beam in Specimen 2.

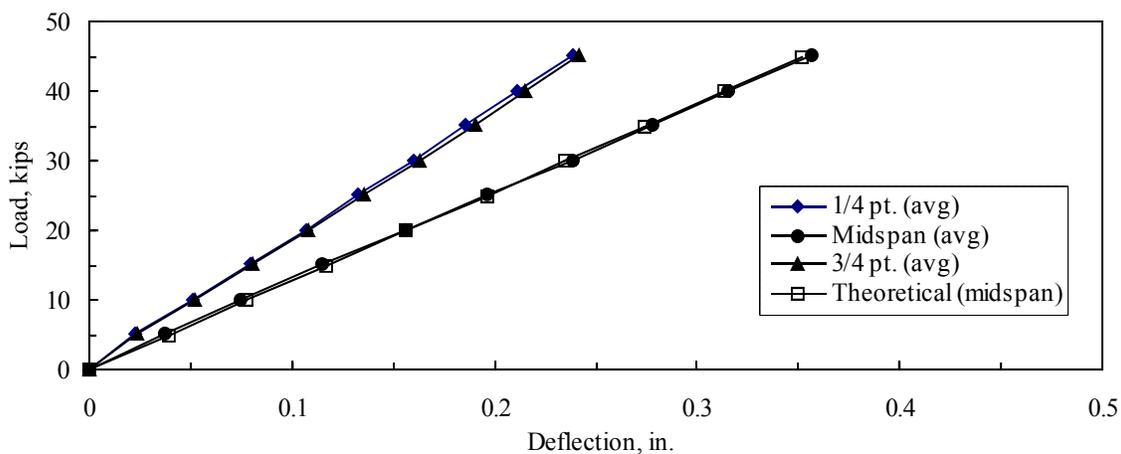
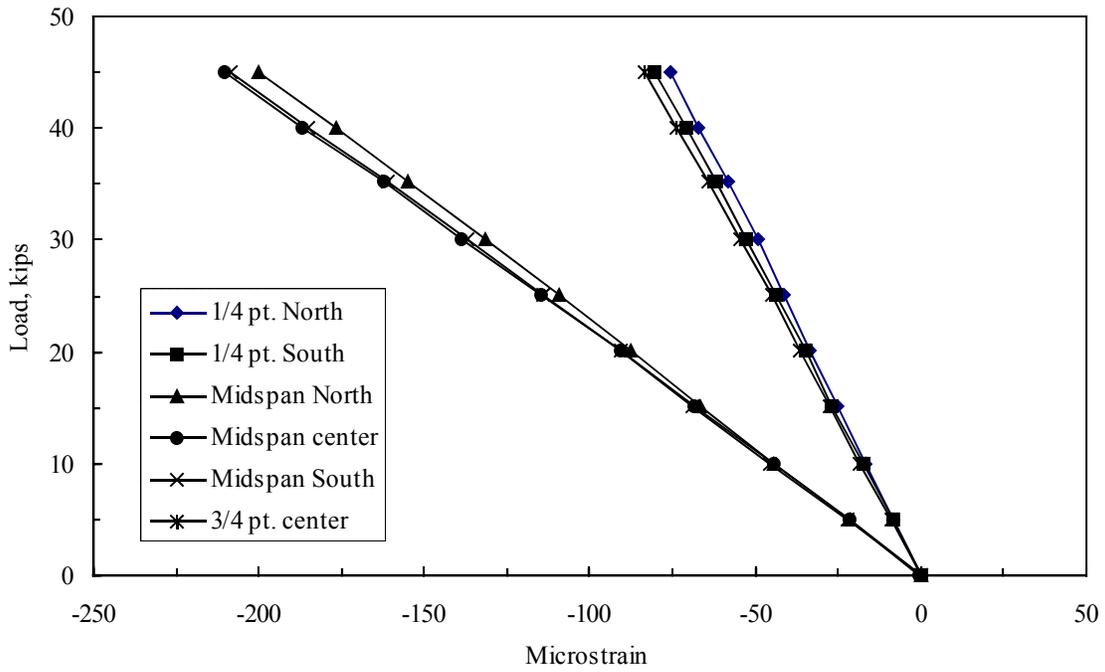
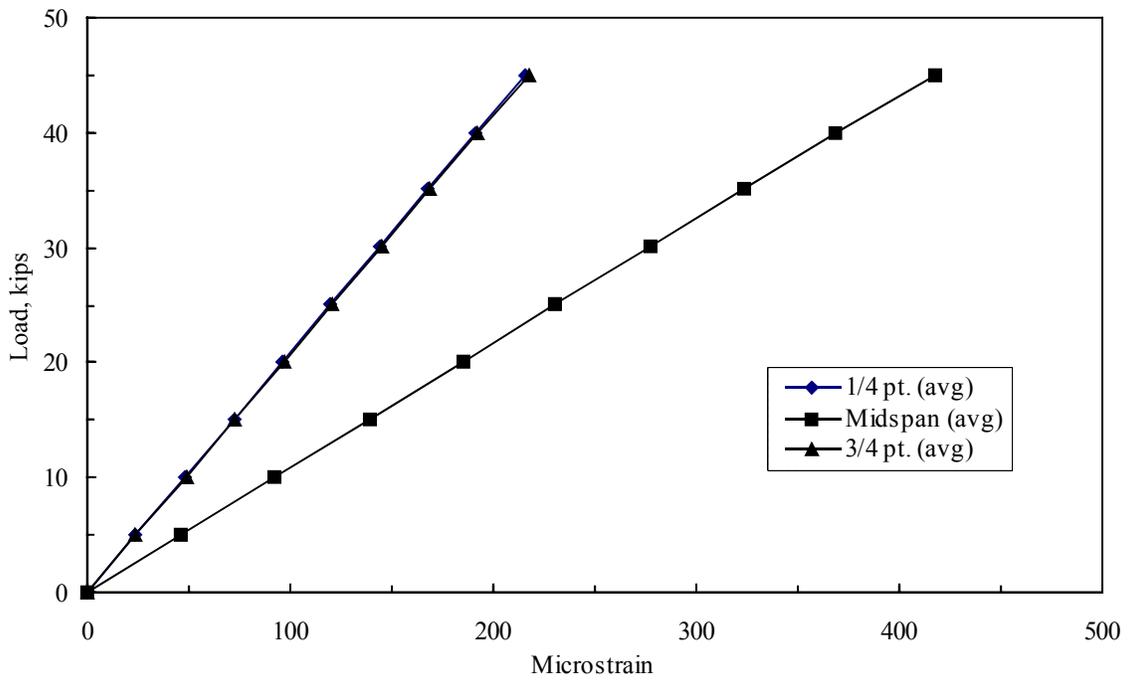
Figure 5.9. Service load test results for the load at Load Position 1 on Specimen 4.

b. Beam deflections

d. Longitudinal concrete strains

e. Bottom flange strains

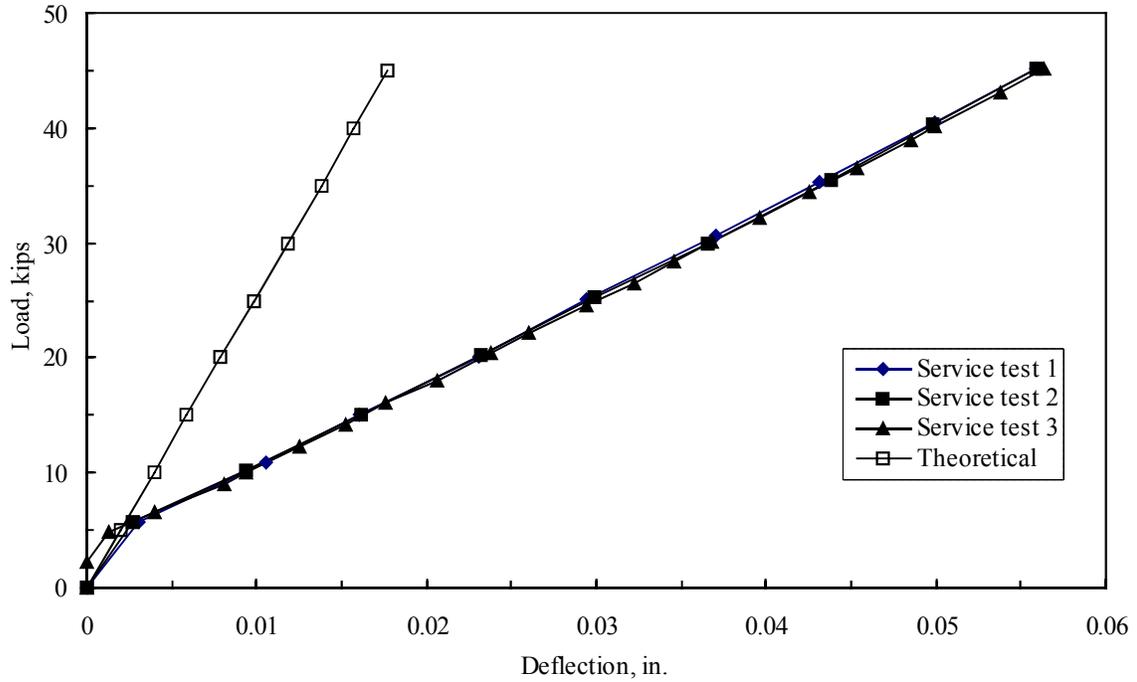
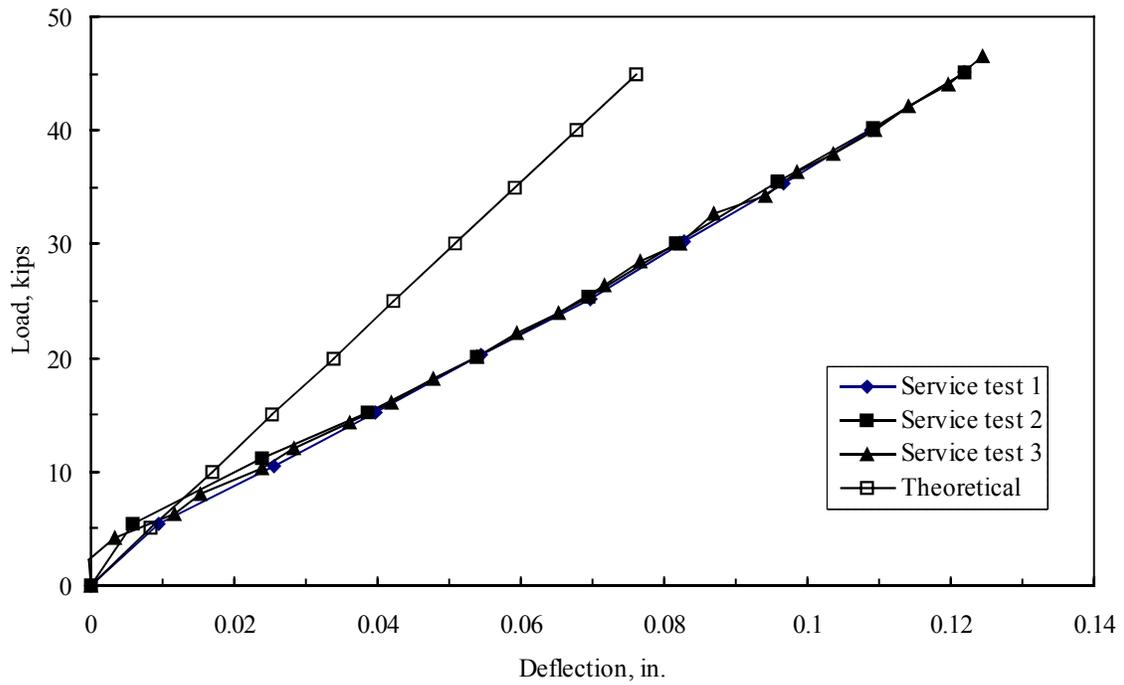
a. Load Position 2

b. Load Position 3

Figure 5.10. Deflection under load during service load testing at Load Positions 2 and 3 on Specimen 4.

The decrease in ultimate load when the load was located closer to the end of the specimen (transverse free-edge) could be an indication that the transverse free-edges required more stiffening than the four #5 bars provided (see specimen details in Fig. 3.3b). However, the failure patterns shown in Fig. 5.12 do not confirm this because all were punching shear failures. If the edge required more stiffening, the failure mode of the slab would have been a combination of punching shear and transverse flexural failure modes, especially at Load

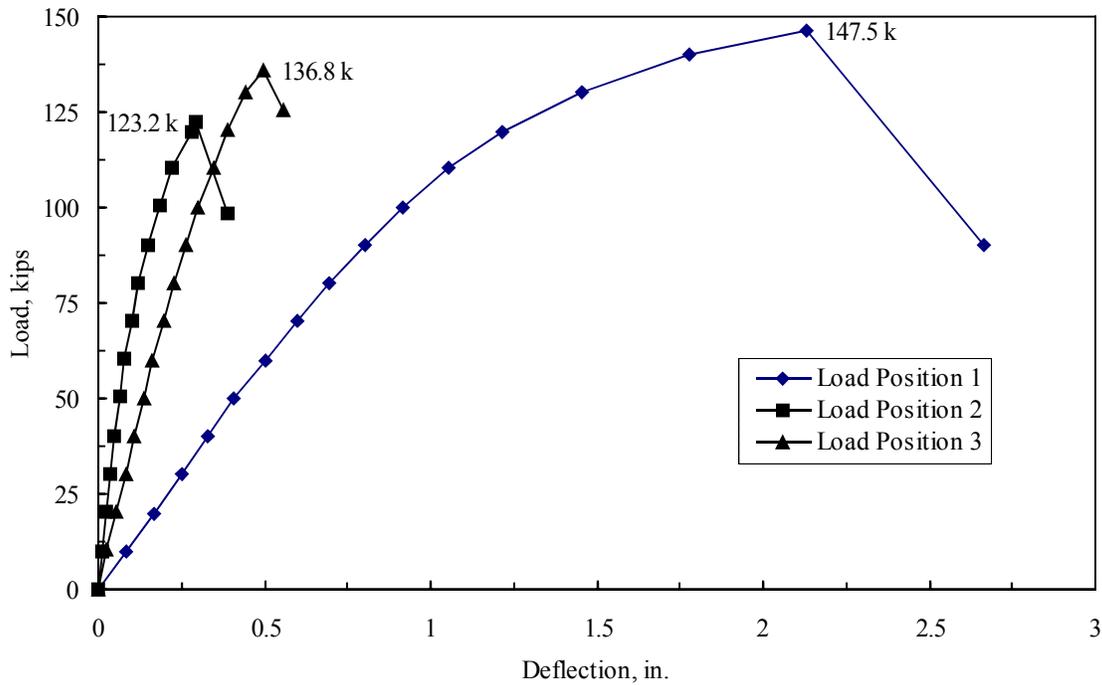
Figure 5.11. Deflections under load during ultimate load testing of Specimen 4.

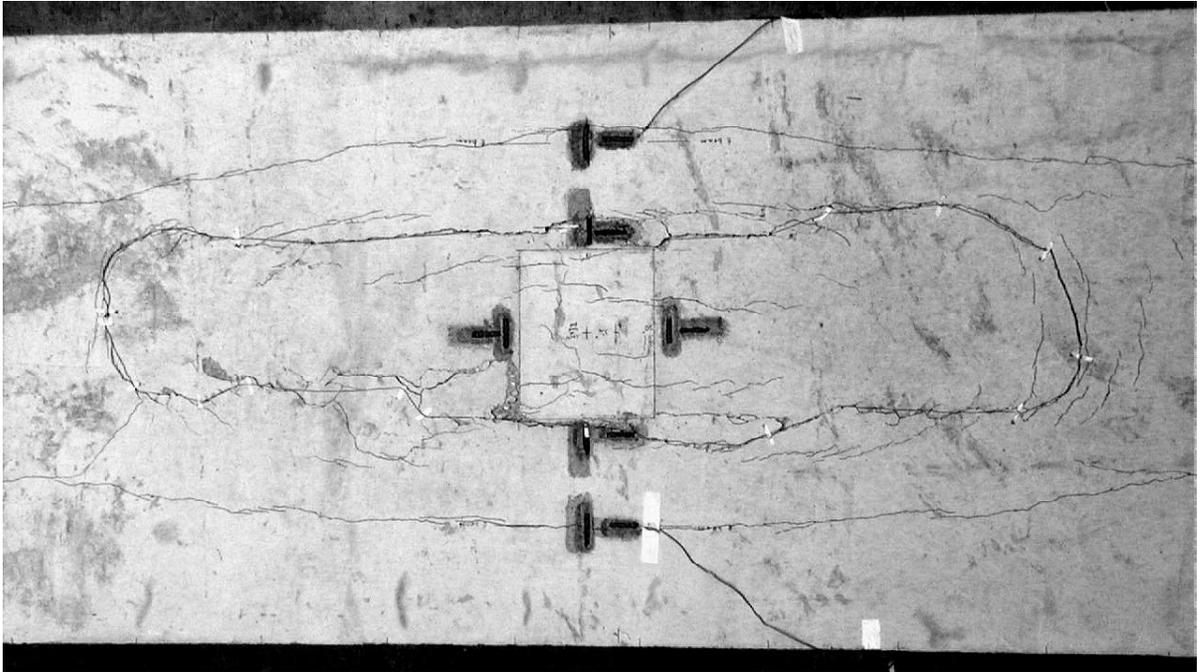
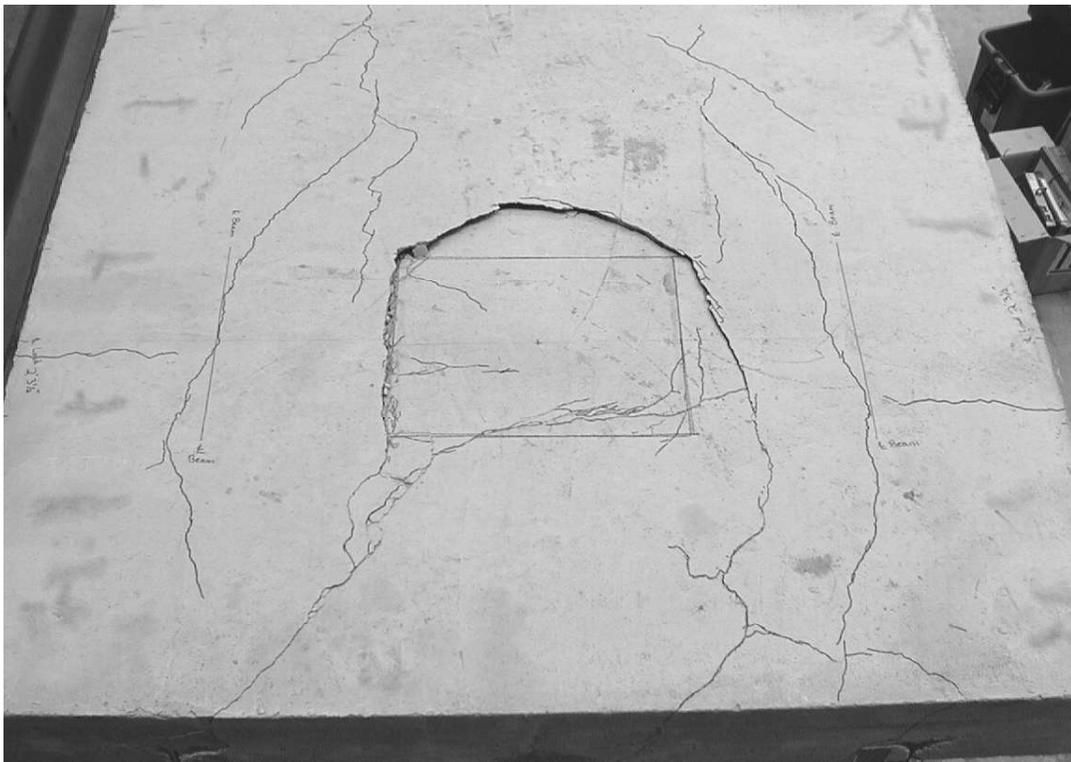
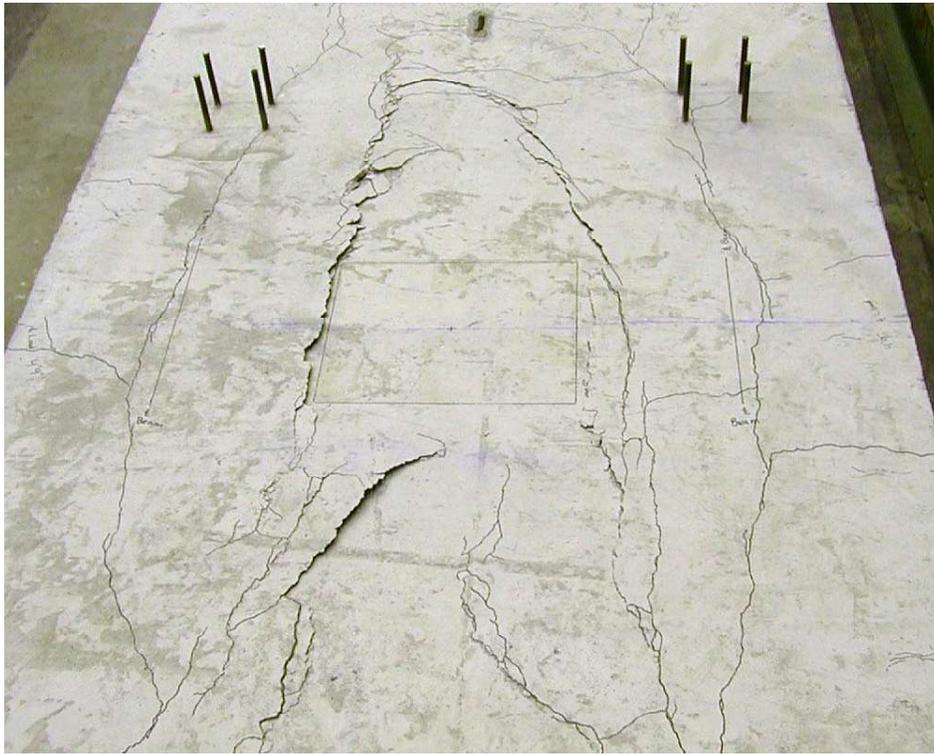
Figure 5.12. Photographs of Specimen 4 failure patterns on top surface of slab.

a. Failure pattern at Load Position 1

b. Failure pattern at Load Position 2

c. Failure pattern at Load Position 3

As previously noted, the failures at all the load positions were punching shear failures (see Fig. 5.12) indicating that adequate lateral restraint was provided by the #5 reinforcement bars spaced on 15 in. centers and the four #5 bars at each end provided for edge stiffening. Therefore, the Steel-free Deck System exhibited the same load-carrying characteristics as a

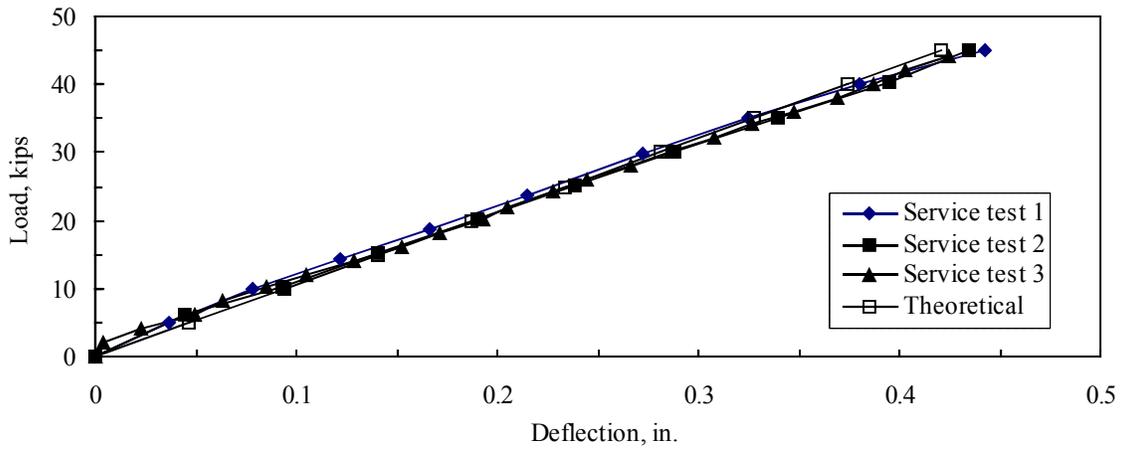
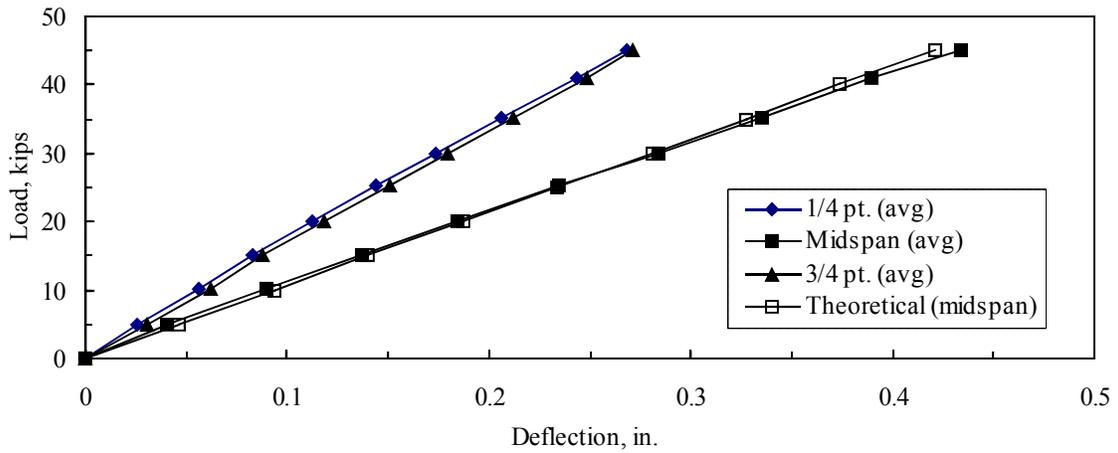
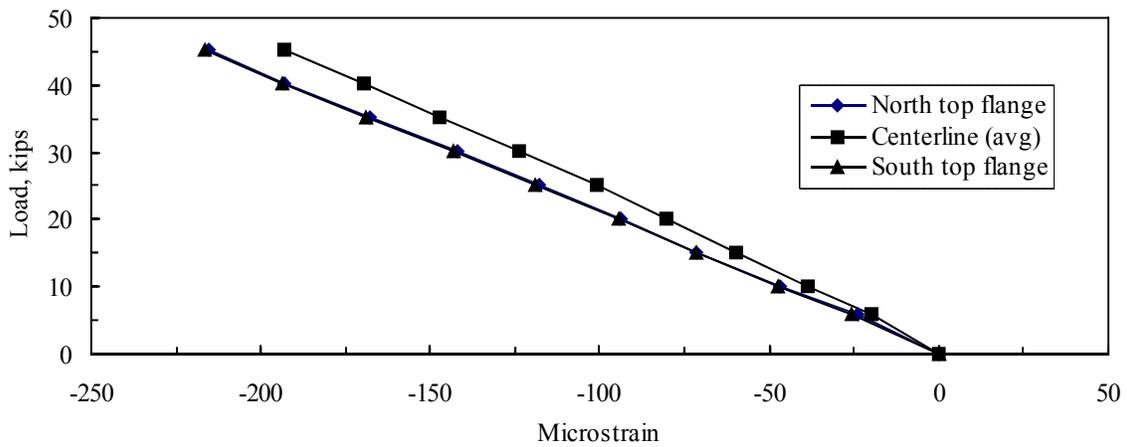
a. Deflections under load

b. Beam deflections

c. Longitudinal strains at midspan

Specimen 5 service load test results with the load at Load Position 1 are presented in Fig. 5.13. The graphs in Figs. 5.13b, 5.13c, and 5.13d were plotted using data from the second service test. Average beam deflections were plotted in Fig. 5.13b for clarity. Theoretical deflections were calculated using the section properties of the entire specimen cross-section (both beams and all the concrete).

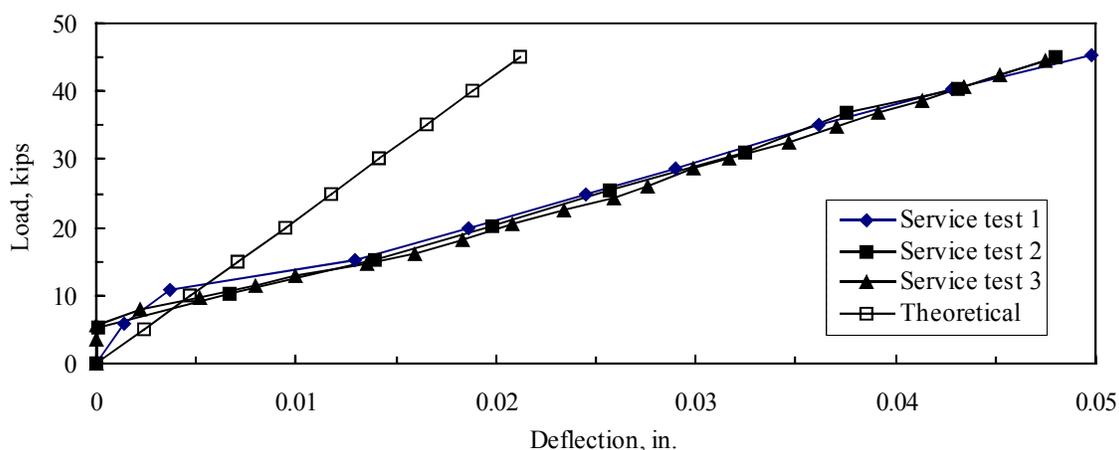
Figure 5.14. Deflections under load during service load testing at Load Position 2 on Specimen 5.

Figures 5.13 and 5.14 confirm that strain and deflection data were reproducible at both load positions. Furthermore, strains and deflections increased linearly with load and exhibited similar behavior. Therefore, only deflection data will be presented in the remainder of this section.

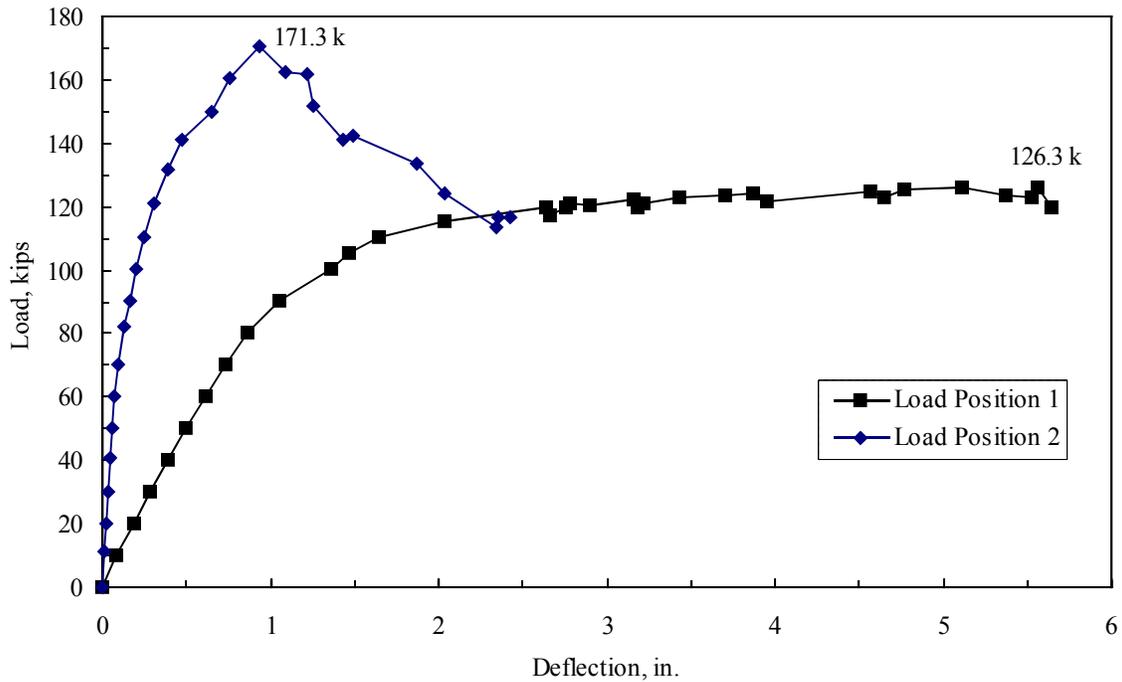
Figure 5.15. Deflections under load during ultimate load testing of Specimen 5.

The ultimate load at Load Position 2 was 1.36 times that at Load Position 1; therefore, unlike Specimen 4, the ultimate load was greater near the end of the specimen than at midspan. That is because the transverse restraint of this system is much better than that offered by the system in Specimen 4. This was demonstrated by a flexural failure that occurred at Load Position 1 before the wheel footprint was able to punch through the concrete arch. Since flexure does not play a major role near a support, failure did not occur at Load Position 2 until the concrete arch failed in punching shear. Hence, a greater ultimate load was achieved.

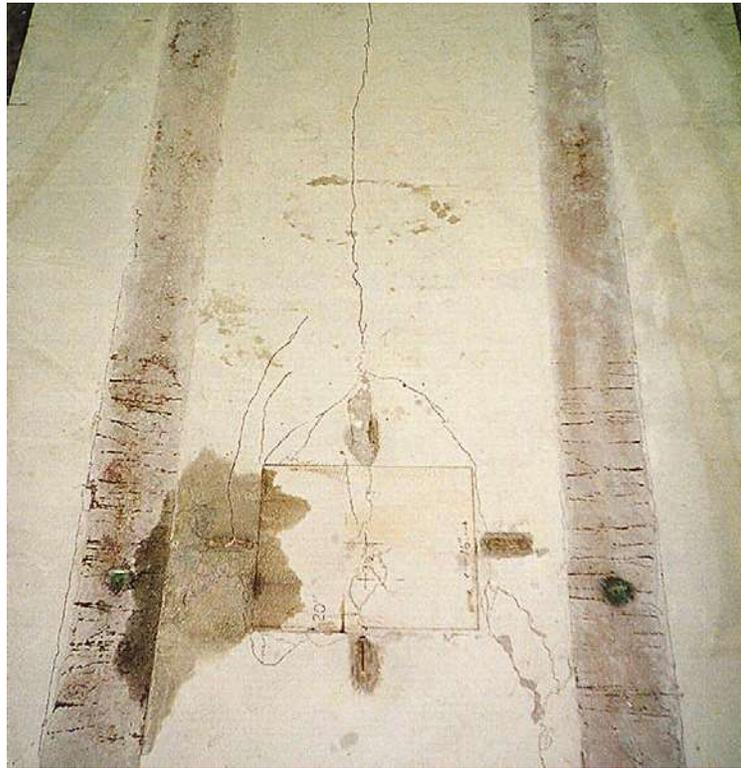
Figure 5.16. Photograph of failure patterns in Specimen 5.

a. Top view of failure pattern at Load Position 1

b. End view of failure pattern at Load Position 2

The failure pattern resulting from this test is illustrated in Fig. 5.16a. The longitudinal crack shown in the photograph extends approximately 16 ft. to the West end of the specimen (opposite of Load Position 2) and was the reason for not performing a third test near this end. A photograph of the punching shear failure at Load Position 2 is shown in Fig. 5.16b; in this end view, a typical vertical crack, associated with splitting of the top of the arch may be seen. Longitudinal splitting initiated the punching failure just as it did during the second failure test at Load Position 1. Note the vertical crack ends at the reinforcing bar which is identified in the photograph.

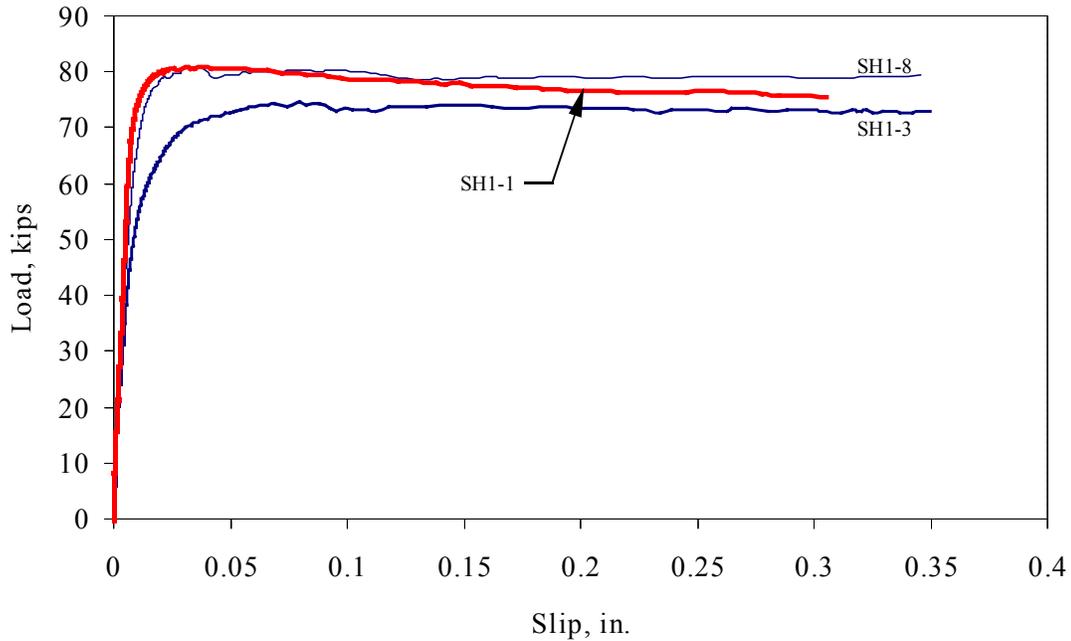
Figure 5.17. Static load-slip curves for series SH1.

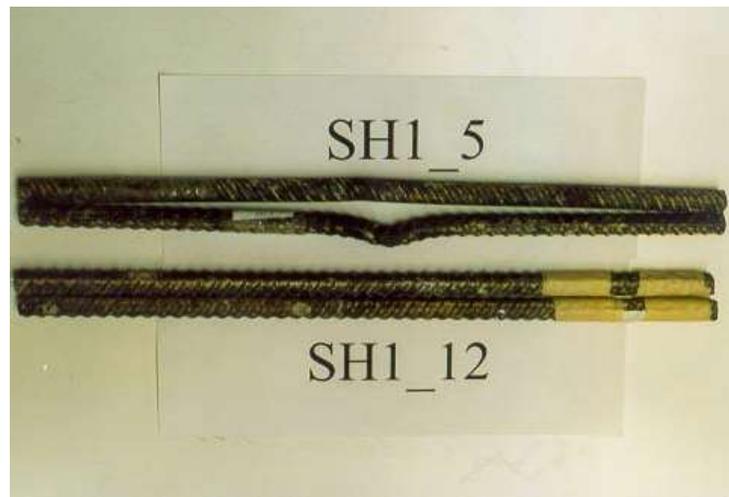
Figure 5.18. Reinforcing bars from specimens SH1-5 and SH1-12.

Data from specimen SH1-12 were also not used in the evaluation of the connection performance. Upon examination of the reinforcing bars placed through the shear holes, all bars, except for the one in specimen SH1-12, were bent. This suggests that the reinforcing bars of specimen SH1-12 were not properly placed in the shear holes before the concrete was poured (Fig. 5.18). Since the reinforcing bars were held against the shear plate by soft wire loops, it is possible that the bars were knocked loose by the concrete during pouring. This is probably the reason specimen SH1-12 failed prematurely, compared to the other specimens tested at the same load level.

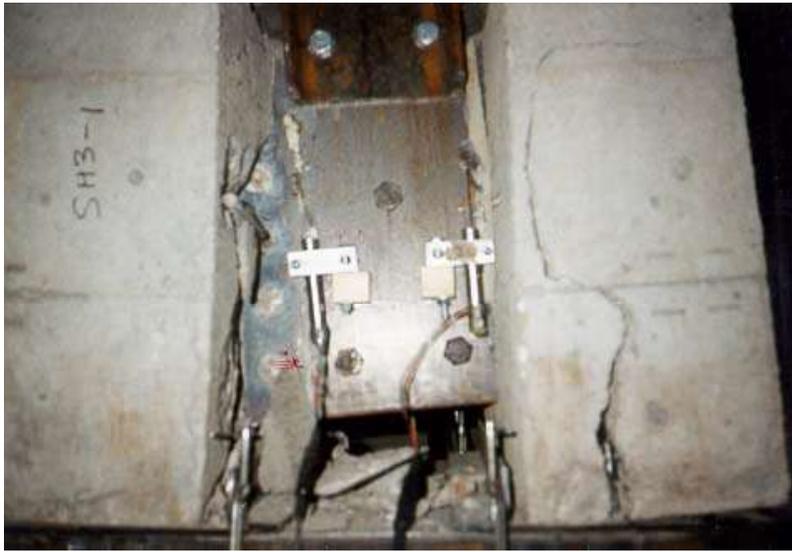
Figure 5.19. Photograph of specimen SH3-1 after failure.
